Inspection Report

Property Address:
5955 Bicentennial Ln
Beaumont TX 77706

PROPERTY INSPECTION REPORT FORM

3/27/2023

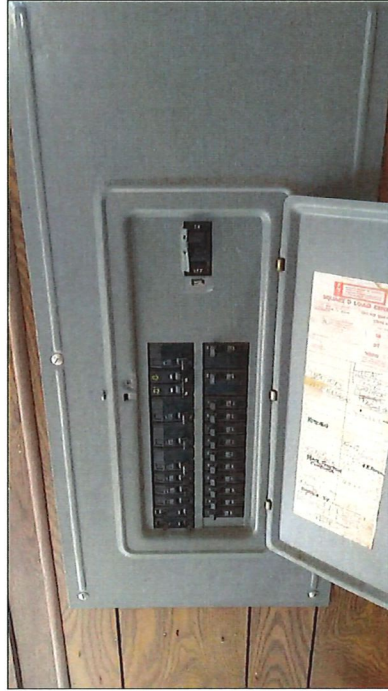
A. (Picture 1)

(1) A 200 amp panel box was noted at the garage.

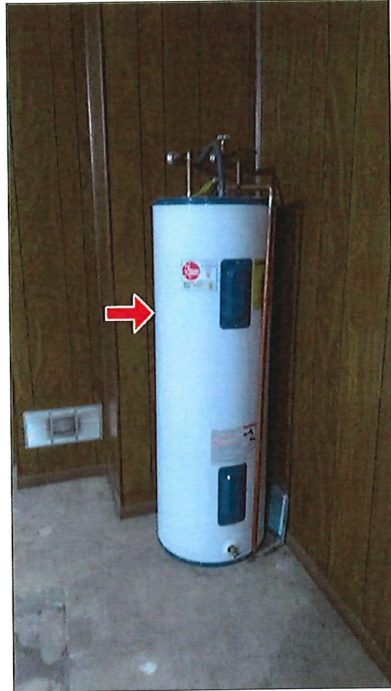
C. (Picture 1)

(1) A 50 gallon electric water heater was noted in the garage. It was manufactured in 2009.

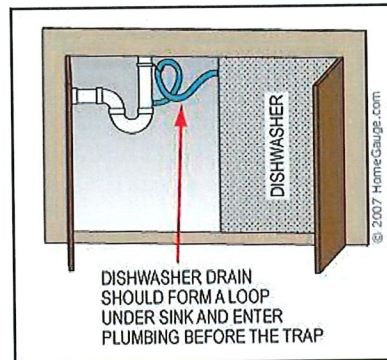
A. (Picture 2)

The drain line for the dishwasher should be installed with a loop or an anti-siphon device per TREC recommendations- (easy fix, see illustration).
