MOMENTUM STRUCTURAL ENGINEERING LLC.

Project No.: MSE-232-25

12014 RAINFOREST LN., MONTGOMERY TX 77356

FOUNDATION & STRUCTURAL INSPECTION REPORT:

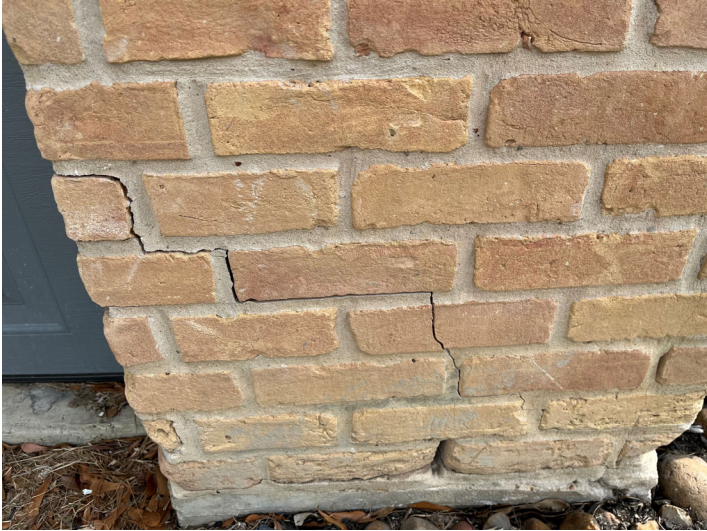
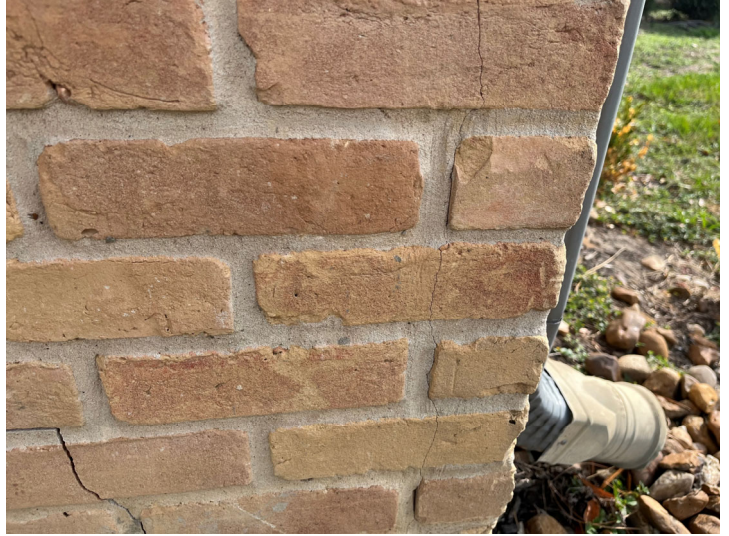
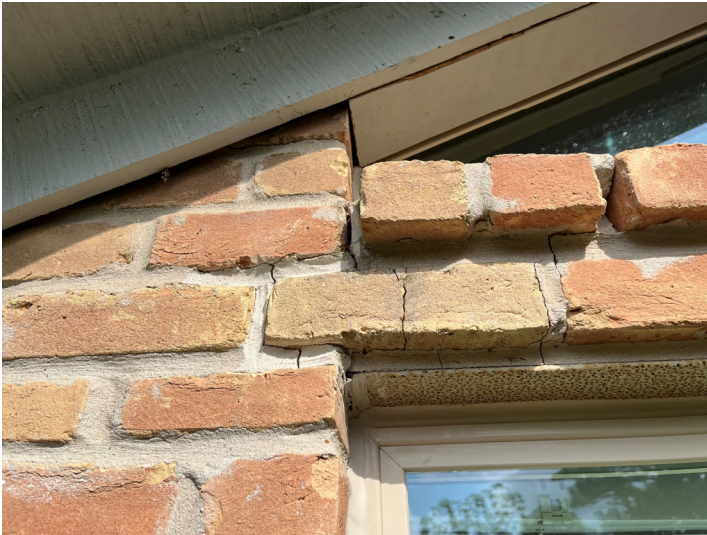
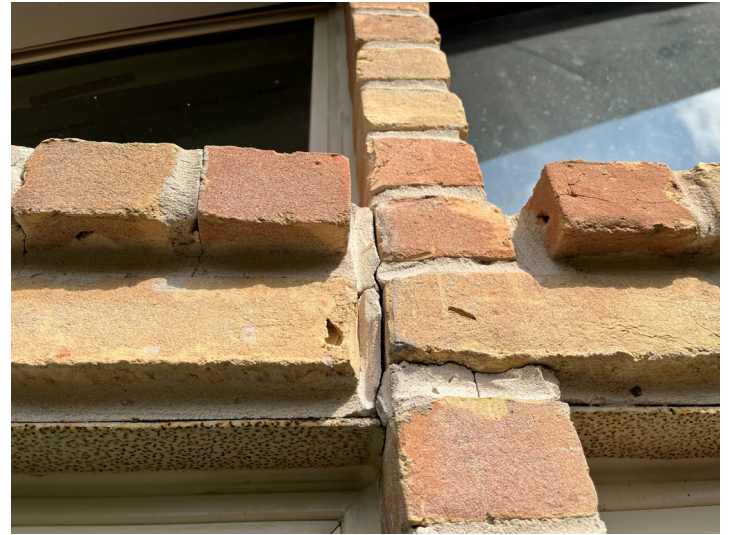
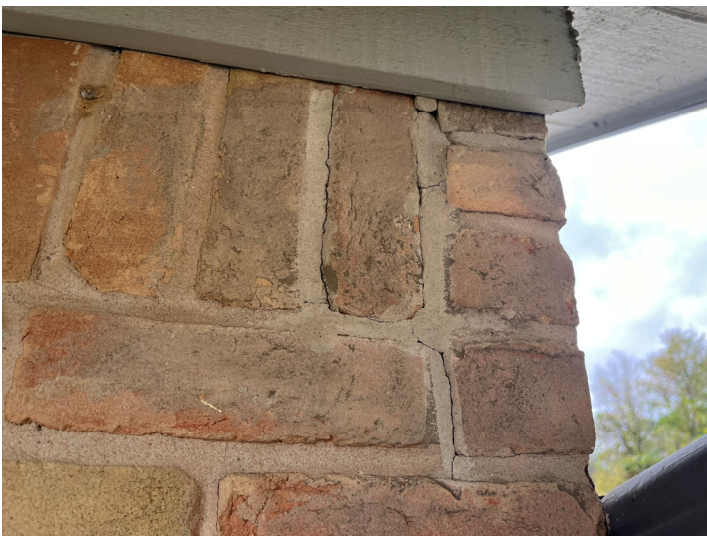
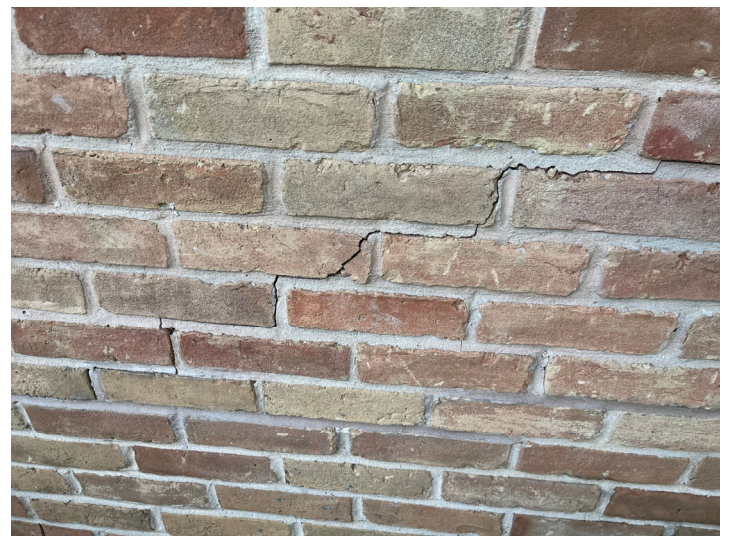
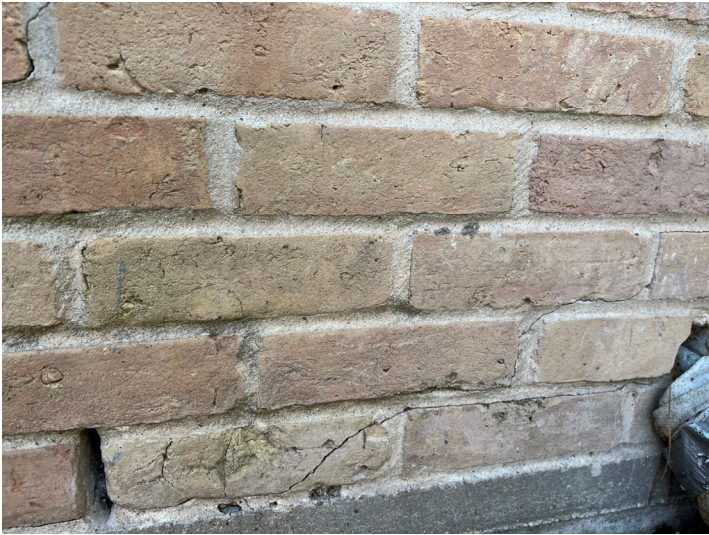
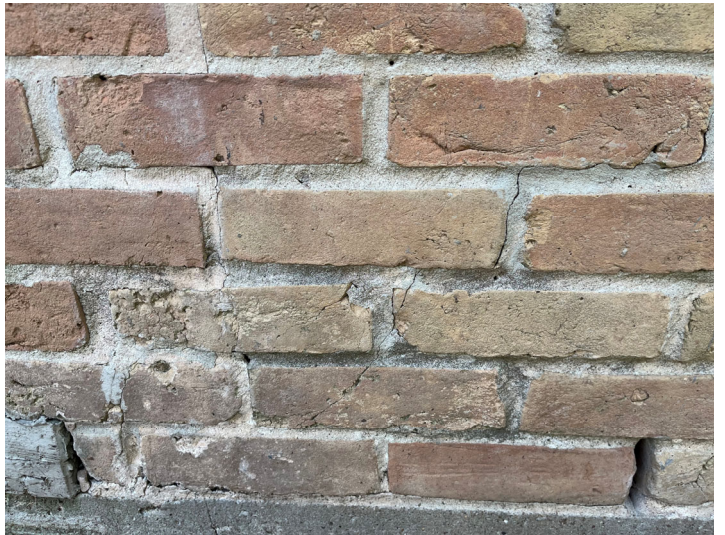
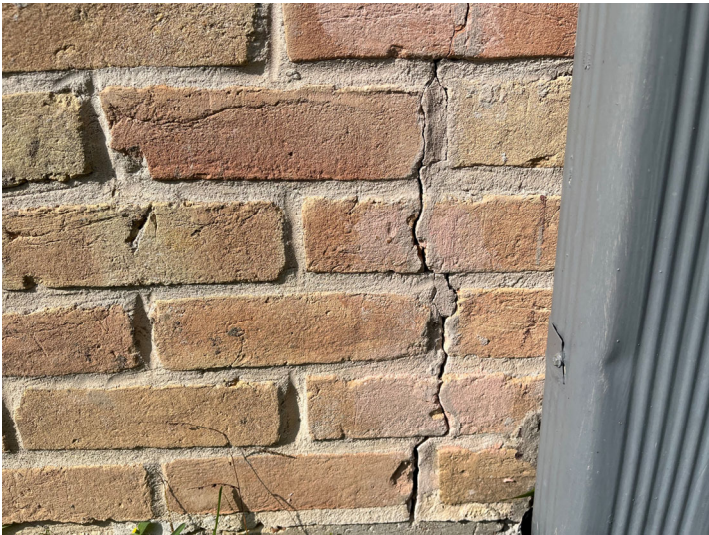
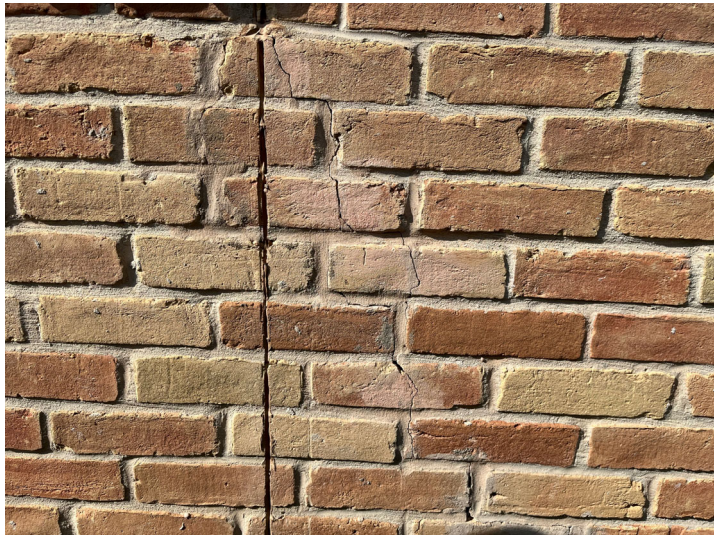
BRICK VENEER CRACK(S) & SEPARATION(S)

Brick veneer cracks and separations were noted. (See photo)

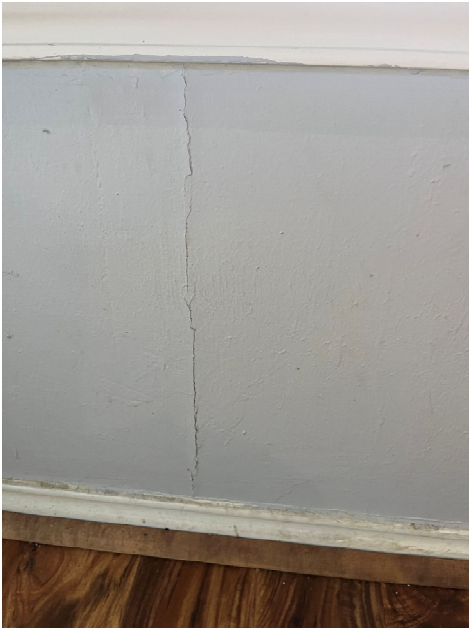
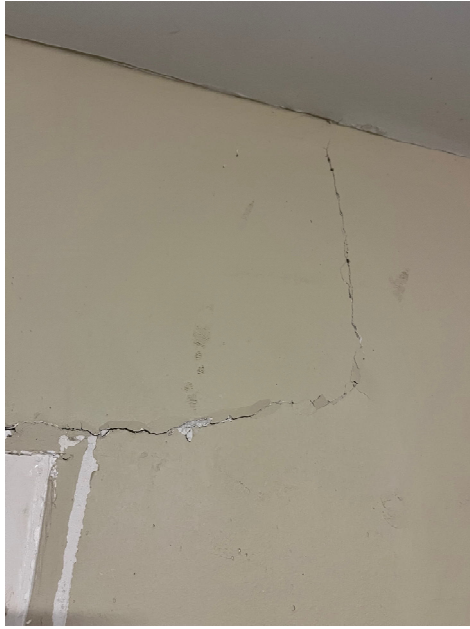
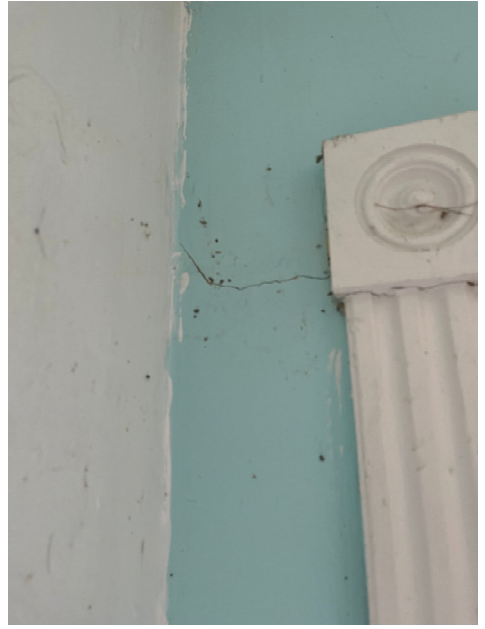
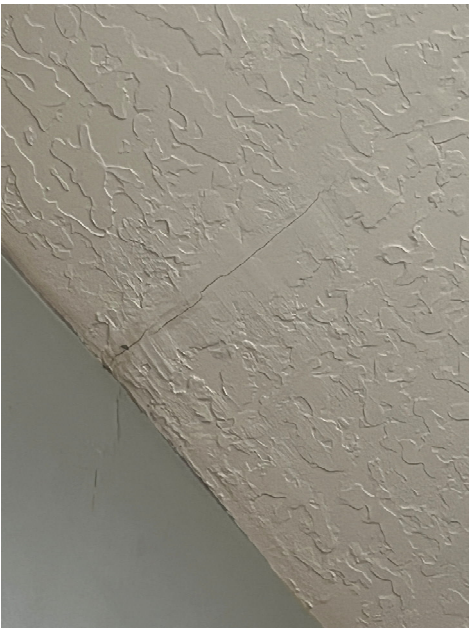
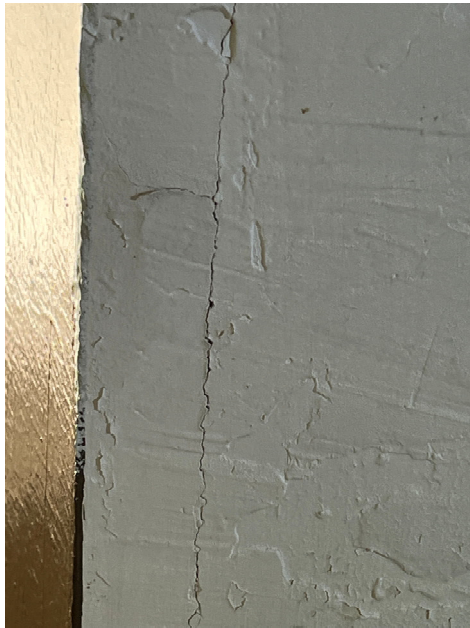
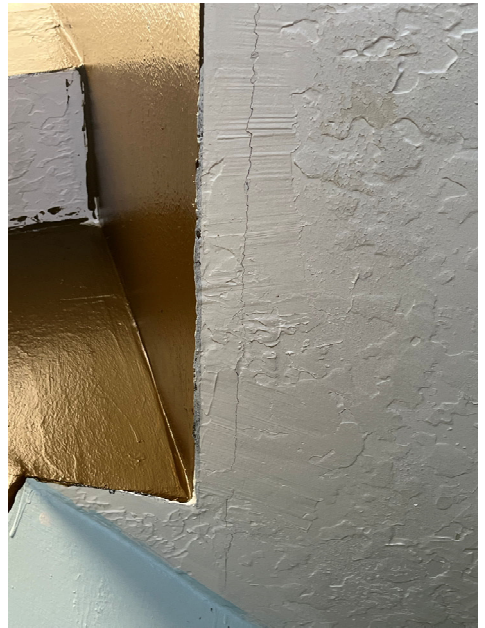
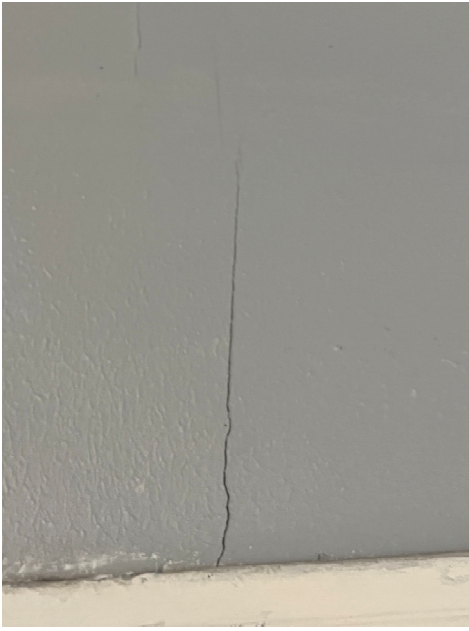
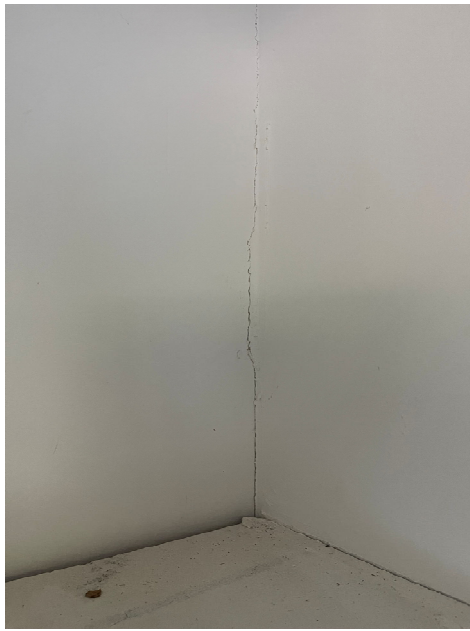
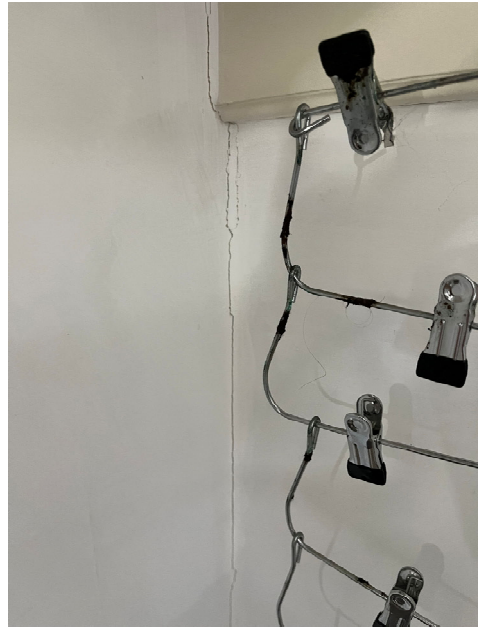
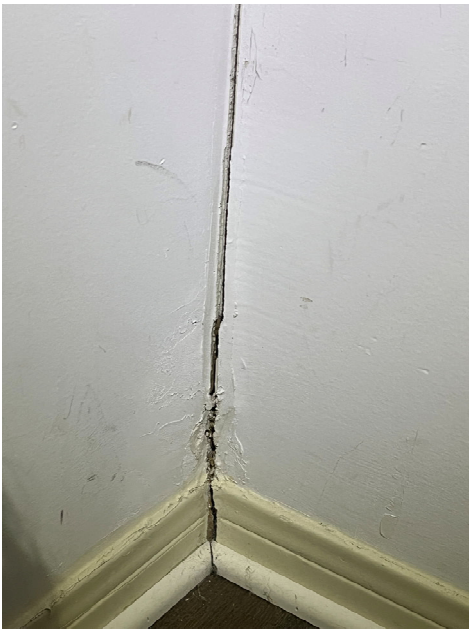
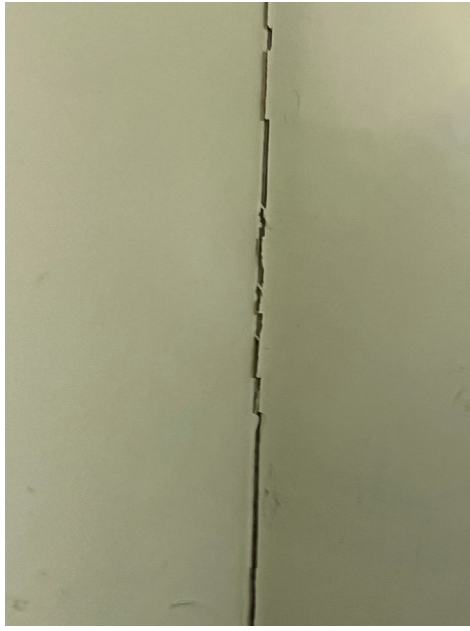
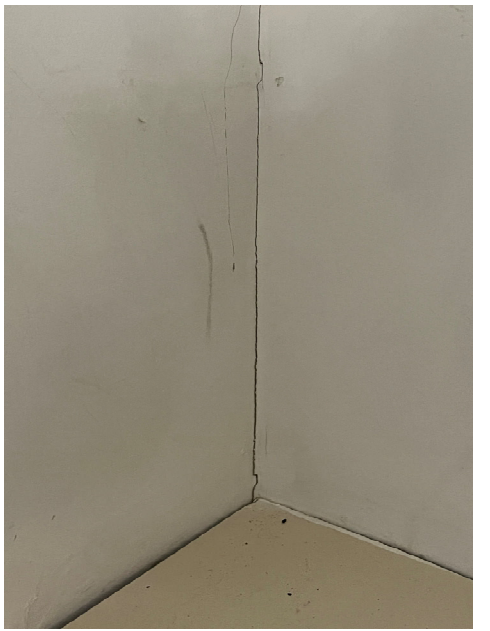
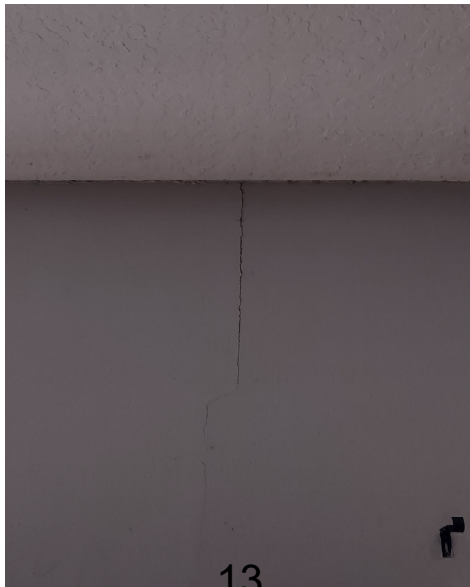
SHEETROCK CRACK(S) & SEPARATION(S)

A. Cracks and separations were noted in the sheetrock (see photo).

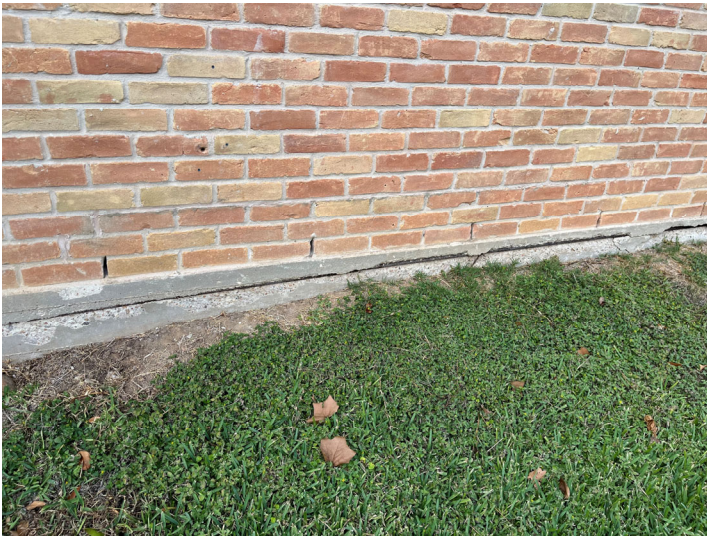
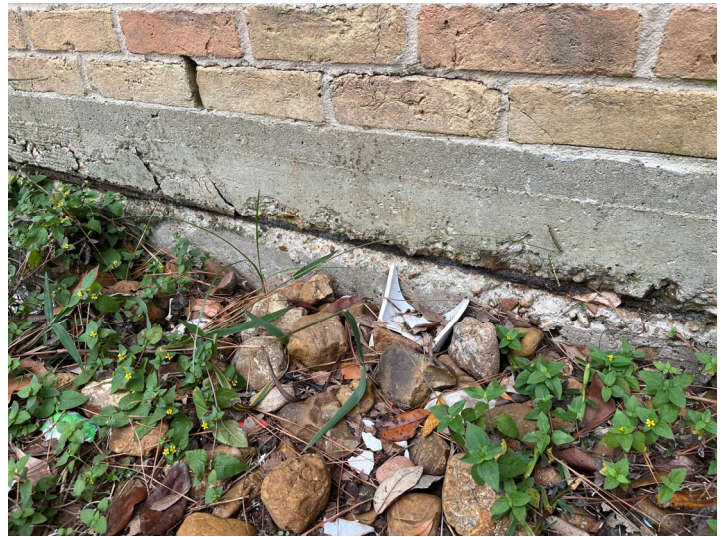
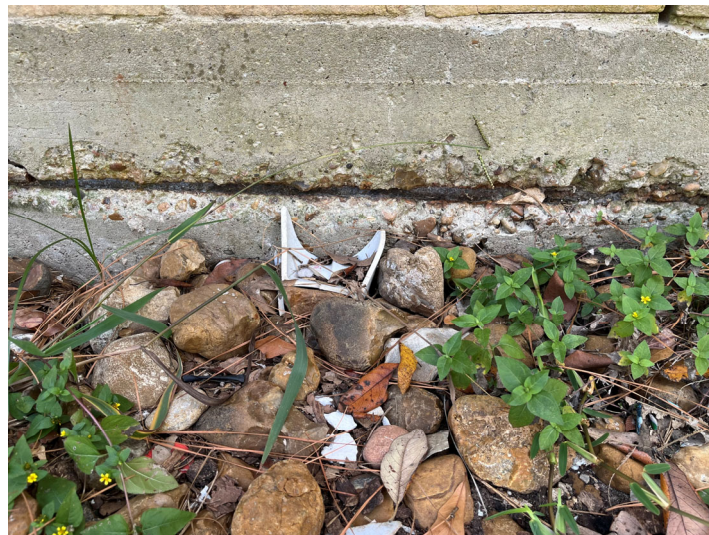
EXPOSED REBAR

Exposed rebar was observed on the foundation/grade beam. We recommend sealing the exposed area with an appropriate epoxy product and repairing/protecting the rebar to prevent further deterioration (see photo).

We recommend covering exposed rebar with epoxy to prevent moisture intrusion and potential water-related deterioration.

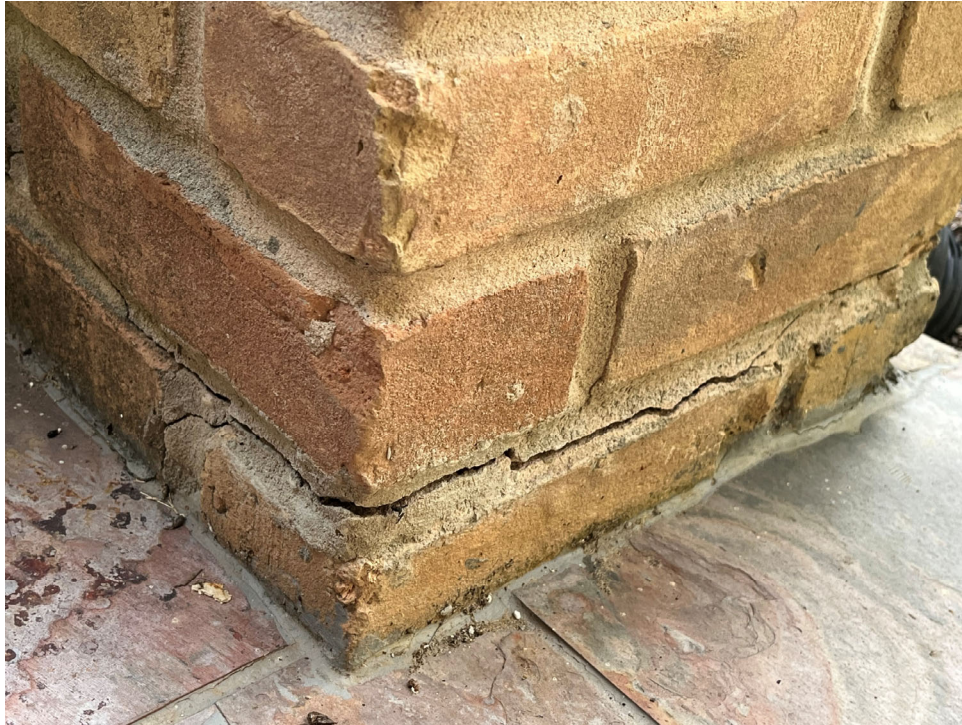
COLUMN SEPARATION

Separation at the front porch column was noted, along with a void underneath the column (See photo)

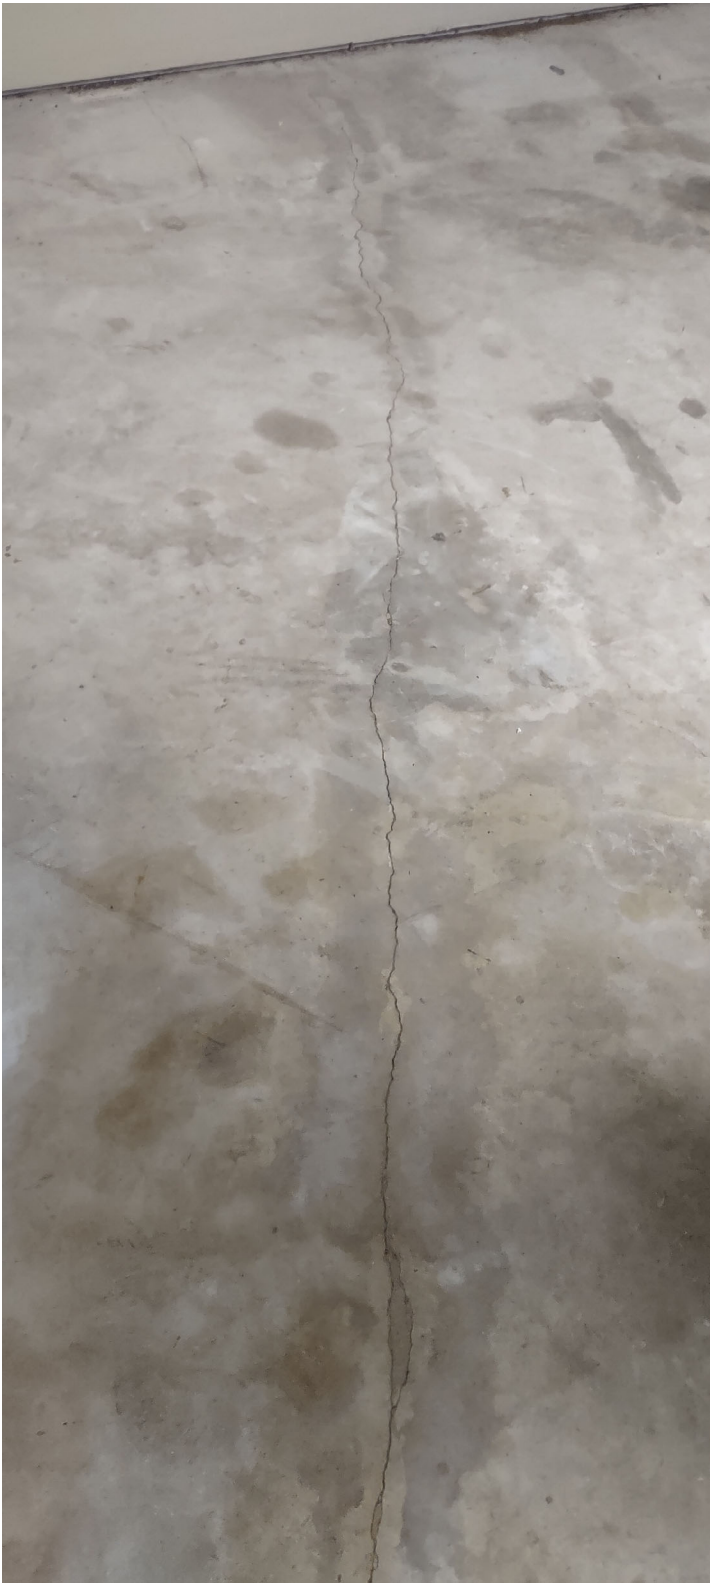
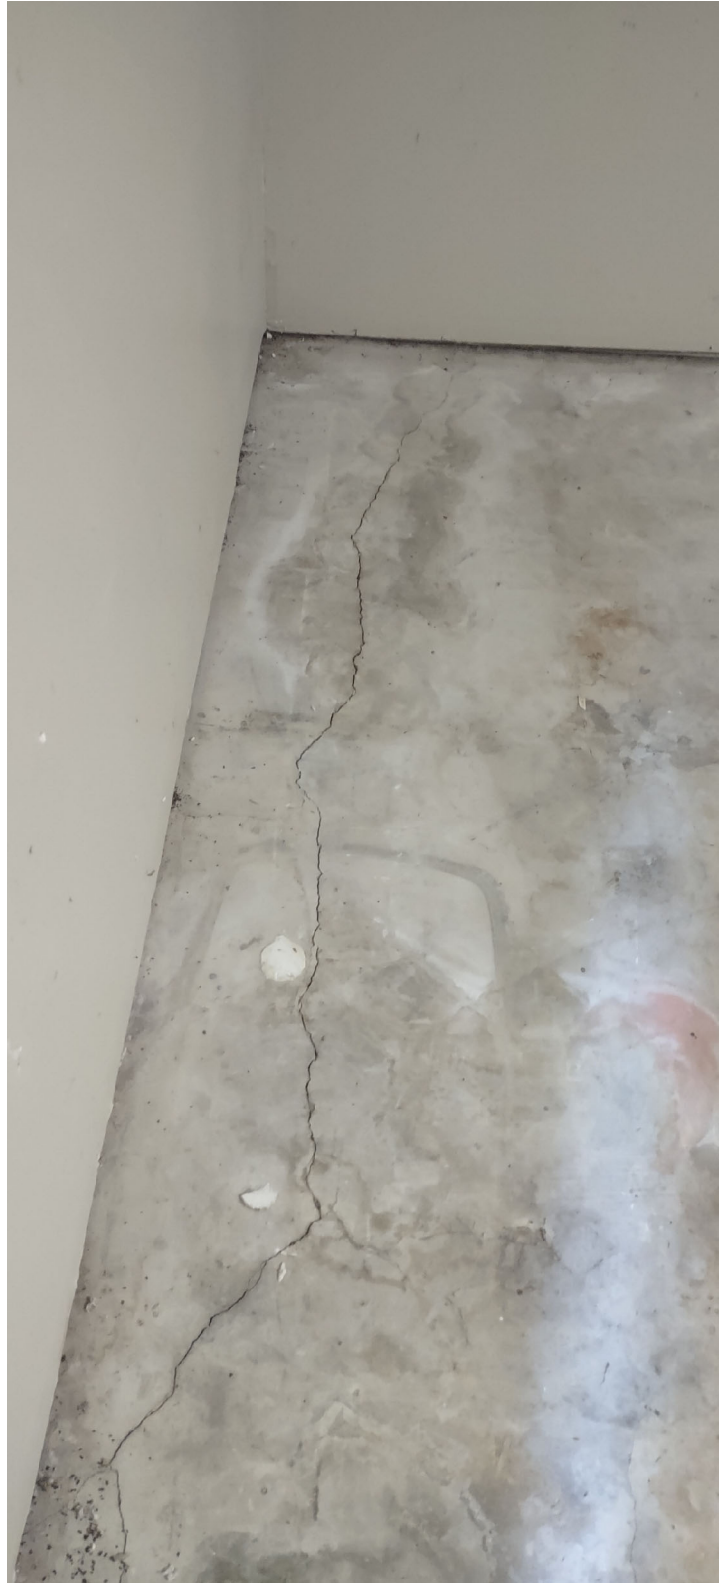
SURFACE SLAB CRACK(S)

C. Surface cracks were noted in the garage slab (see photo).

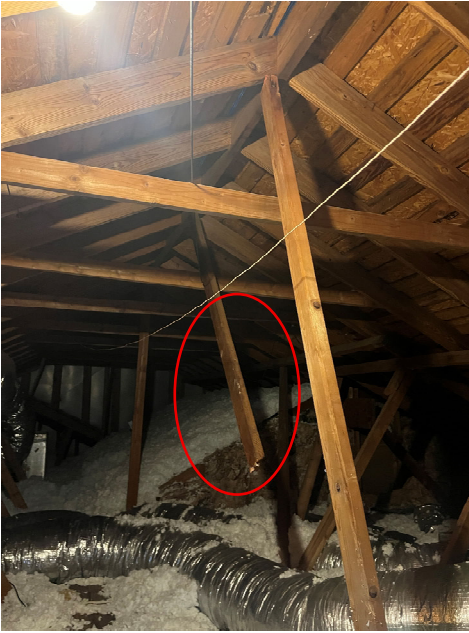
Damaged/broken Post noted. Replacement is recommended. (See photo.)

Broken post; we recommend replacing the post to provide proper structural support.

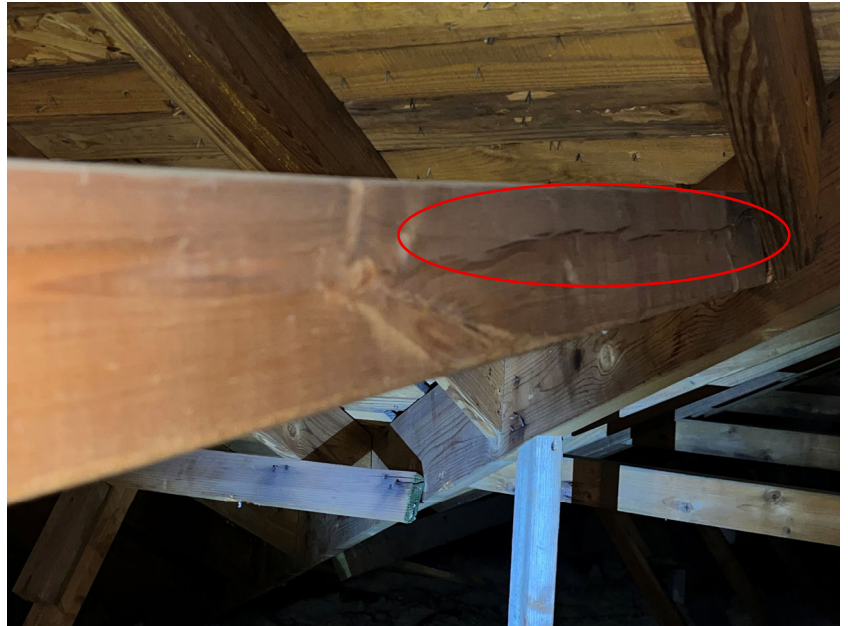
A cracked collar tie was observed. Reinforcement or replacement is recommended to maintain structural stability. (See photo.)

Hairline crack(s) noted in collar tie, we recommend replacing or reinforcing the collar tie to provide proper structural support.

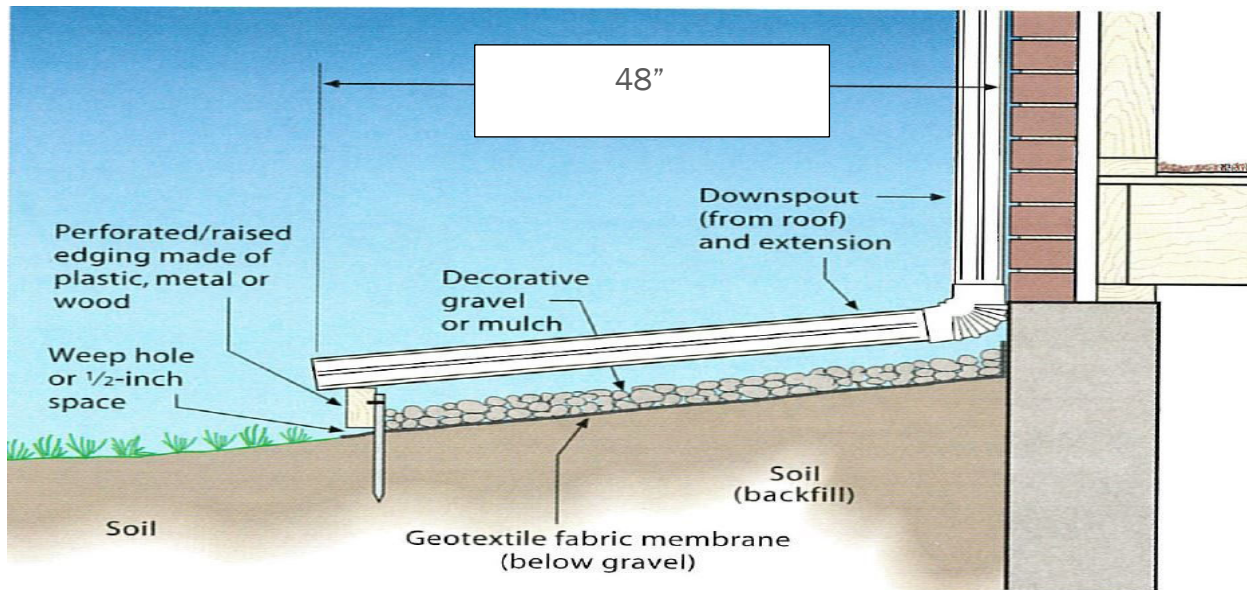
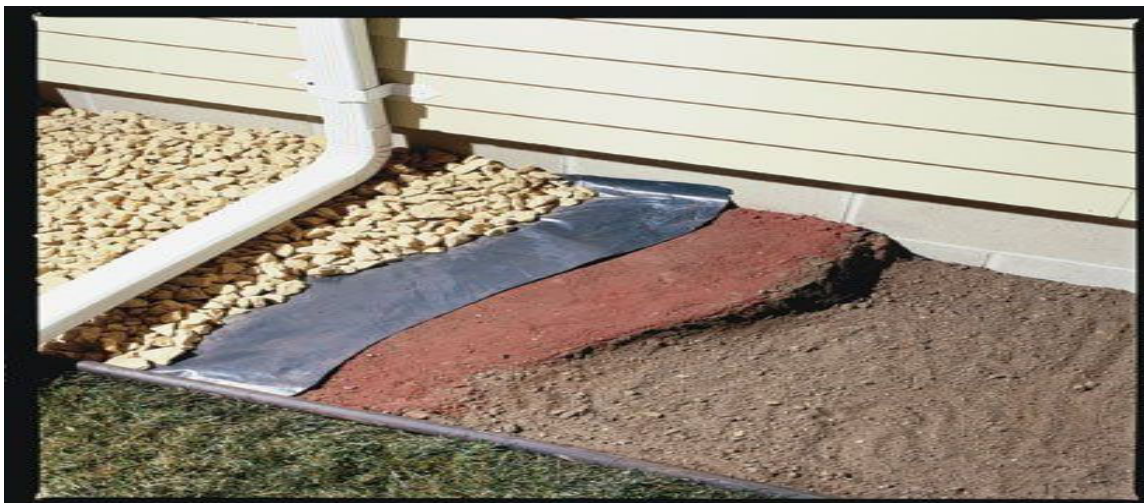
POSITIVE GRADING PLAN

Improper grading was observed around multiple areas of the home, which can allow water to accumulate near the foundation. We recommend establishing positive grading to direct water away from the structure and reduce the risk of foundation movement or moisture intrusion. (Refer to the attached Positive Grading Plan.)

- A) CLEAN PERIMETER AROUND RESIDENCE FOUNDATION FROM DEBRIS.
- B) FILL AROUND FOUNDATION WITH SOIL, SLOPE AWAY FROM BLDG., & COMPACT PROPERLY.
- C) INSTALL VAPOR/MOISURE BARRIER 8 mil. MIN. THICKNESS.
- D) USE FINE AGGREGATE BASE OVER MOISTURE BARRIER.
- E) WE RECOMMEND POSITIVE GRADING AROUND THE HOME TO HELP ESTABLISH A POSITIVE SLOPE. NO PONDING ALLOWED..

POSITIVE GRADING MUST BE ESTABLISHED AROUND THE HOME'S PERIMETER. NO WATER PONDING OR NEGATIVE SLOPES ALLOWED.
