HEDDERMAN ENGINEERING. INC.

## FOUNDATION INSPECTION

6115 Lymbar Dr  
Houston, TX 77096

09/23/2025

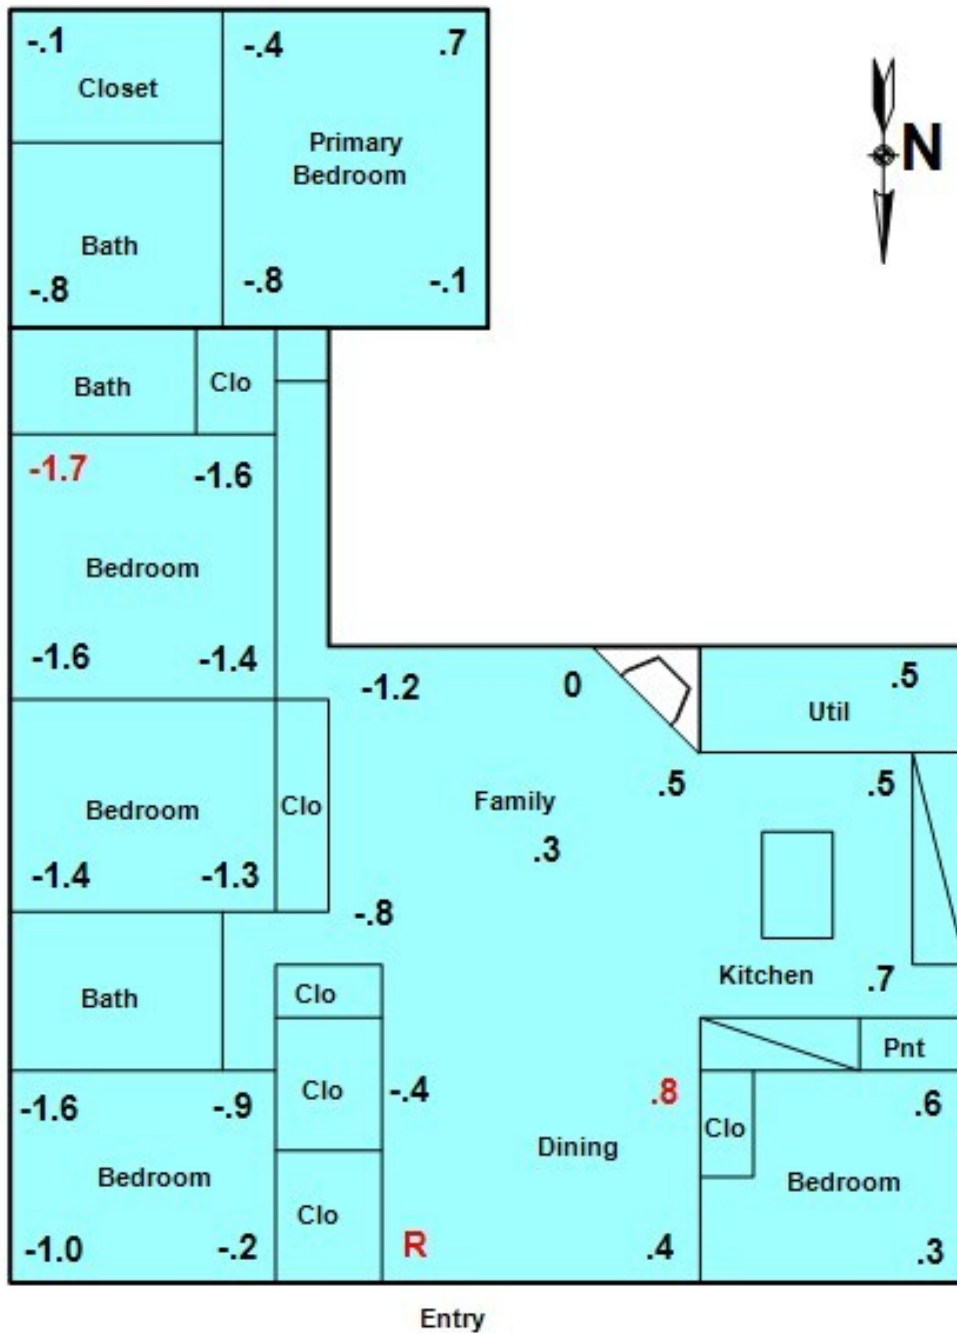
**Elevations Readings  
6115 Lymbar Drive**

The floors were checked with an electronic level, and were observed to be sloping towards the east side of the house. The difference in elevation between the high point and low point was 2.5 inches. The high point was located at the dining room, and the low point was located at the south bedroom. The unlevelness takes place over a horizontal distance of approximately 50-55 feet.

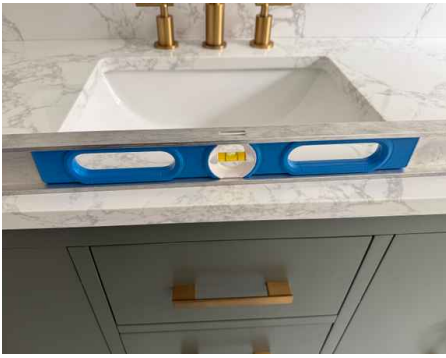
Hallway Bathroom

**Differential Movement:** Horizontal surfaces - Relatively level

Normally horizontal surfaces (countertops, door frames, etc.) were observed to be generally level

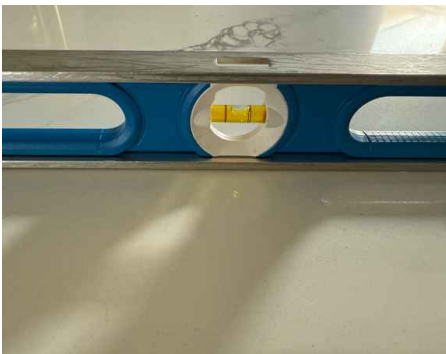
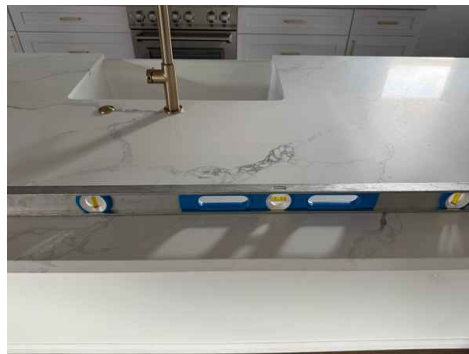
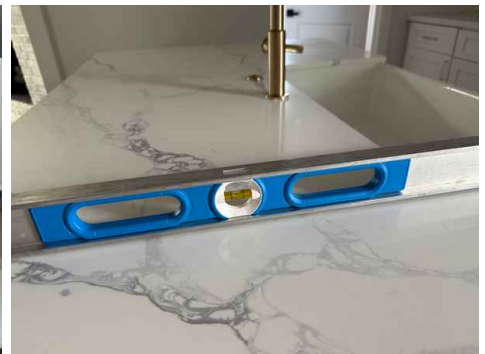
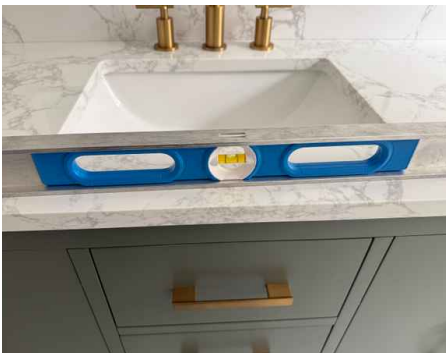
Kitchen

**Differential Movement: Horizontal surfaces out of level**

Horizontal surfaces (countertops, door frames, etc.) were out of level in the direction of the foundation movement.

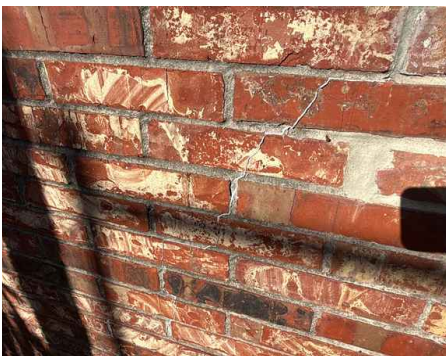
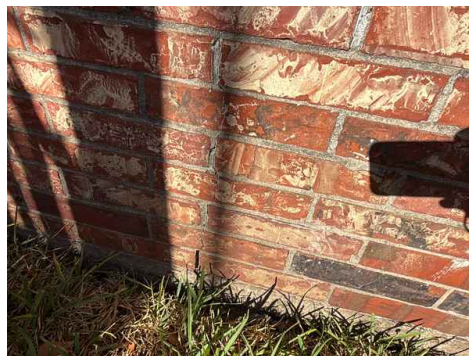
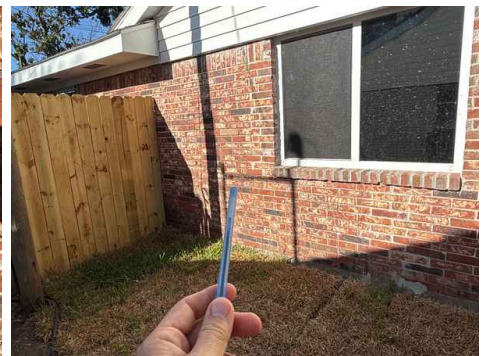
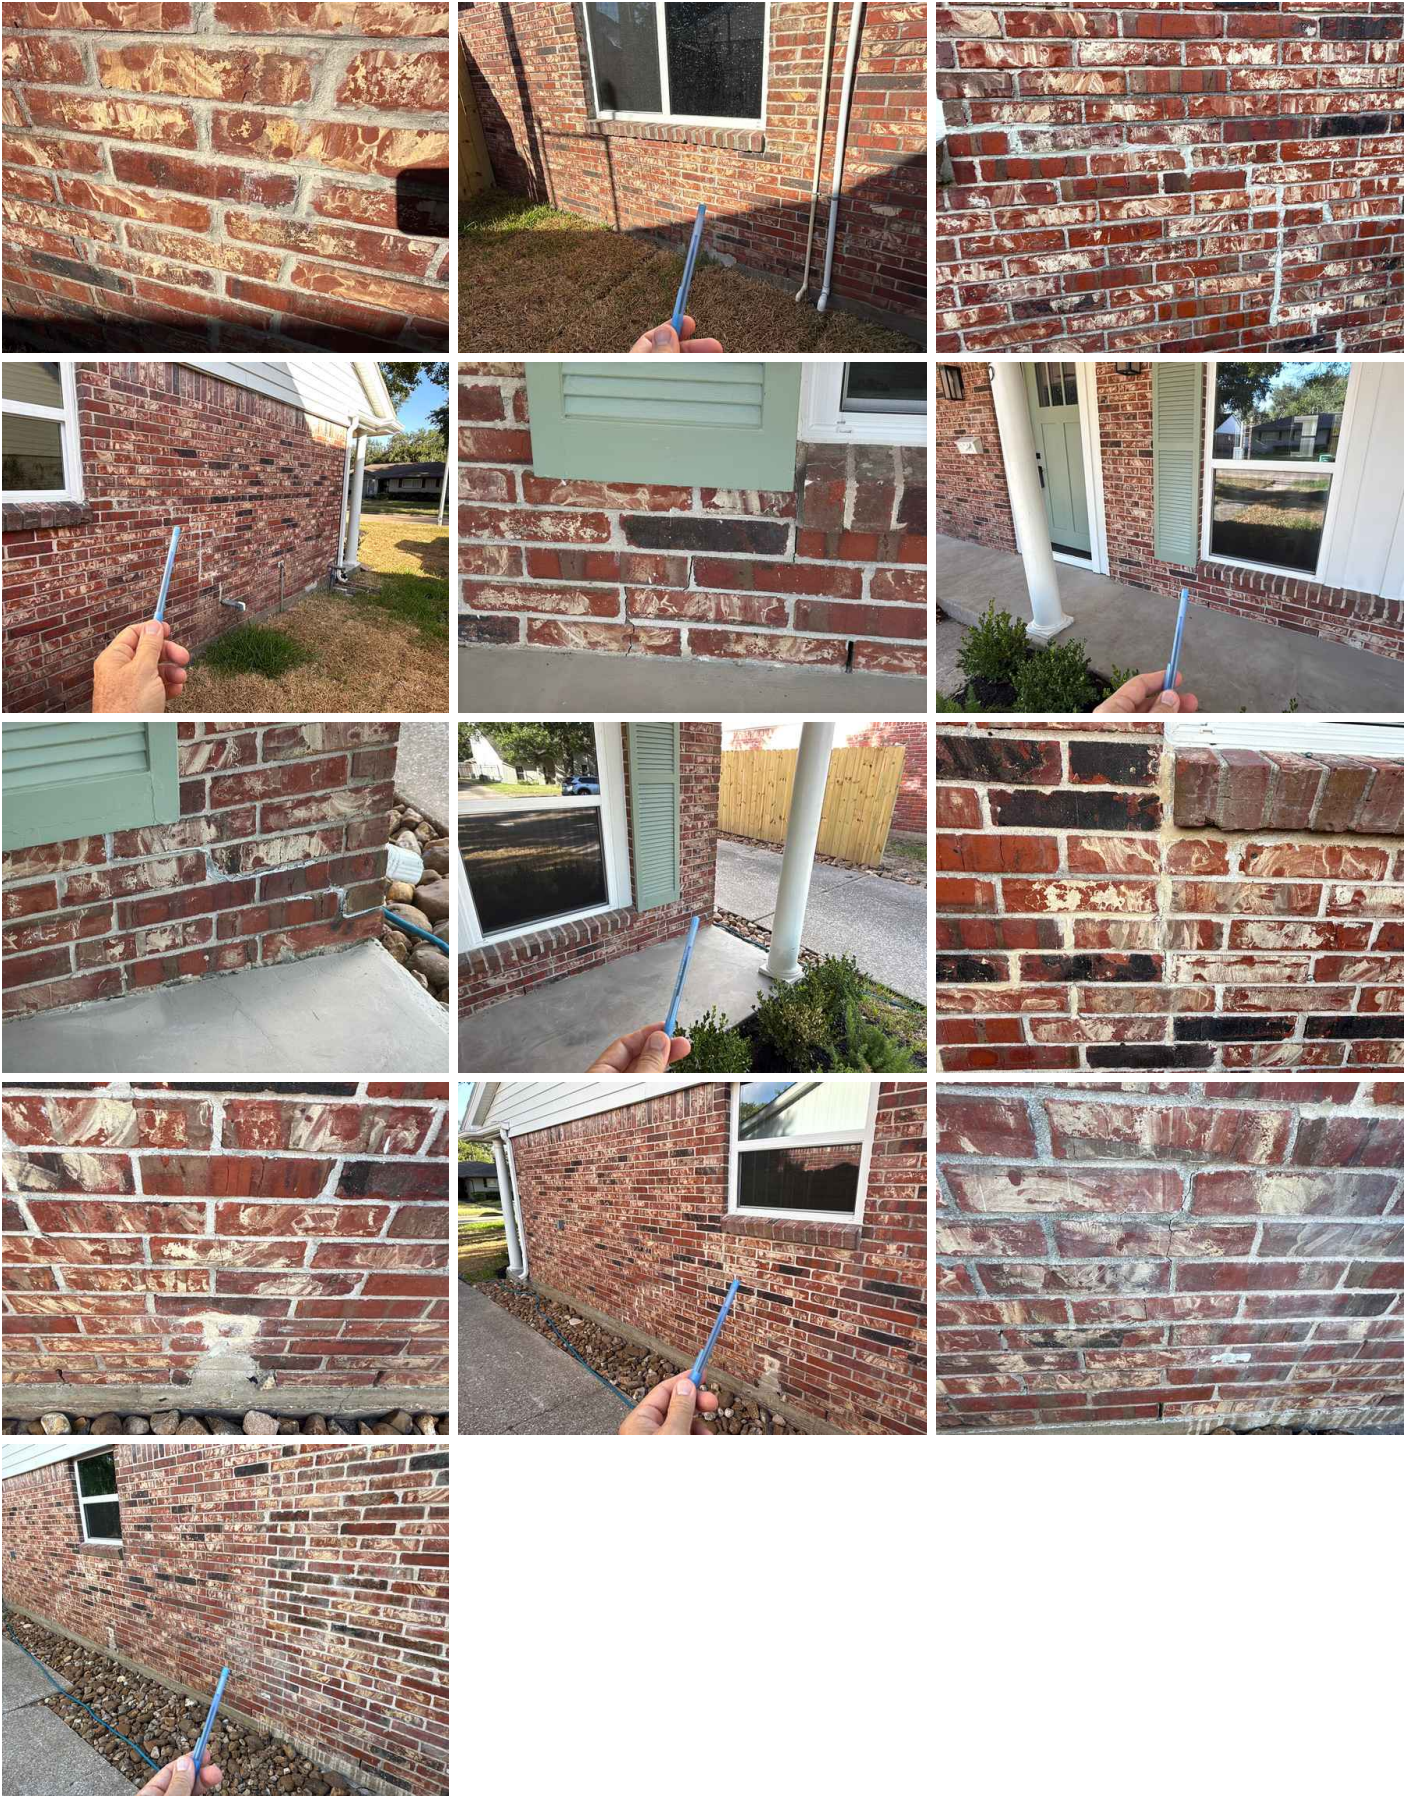
Throughout the house

**Differential Movement: Veneer - Cracks/Patches**

Cracks and/or patches were observed in the exterior veneer at the time of the inspection, including at the locations shown in the photos.

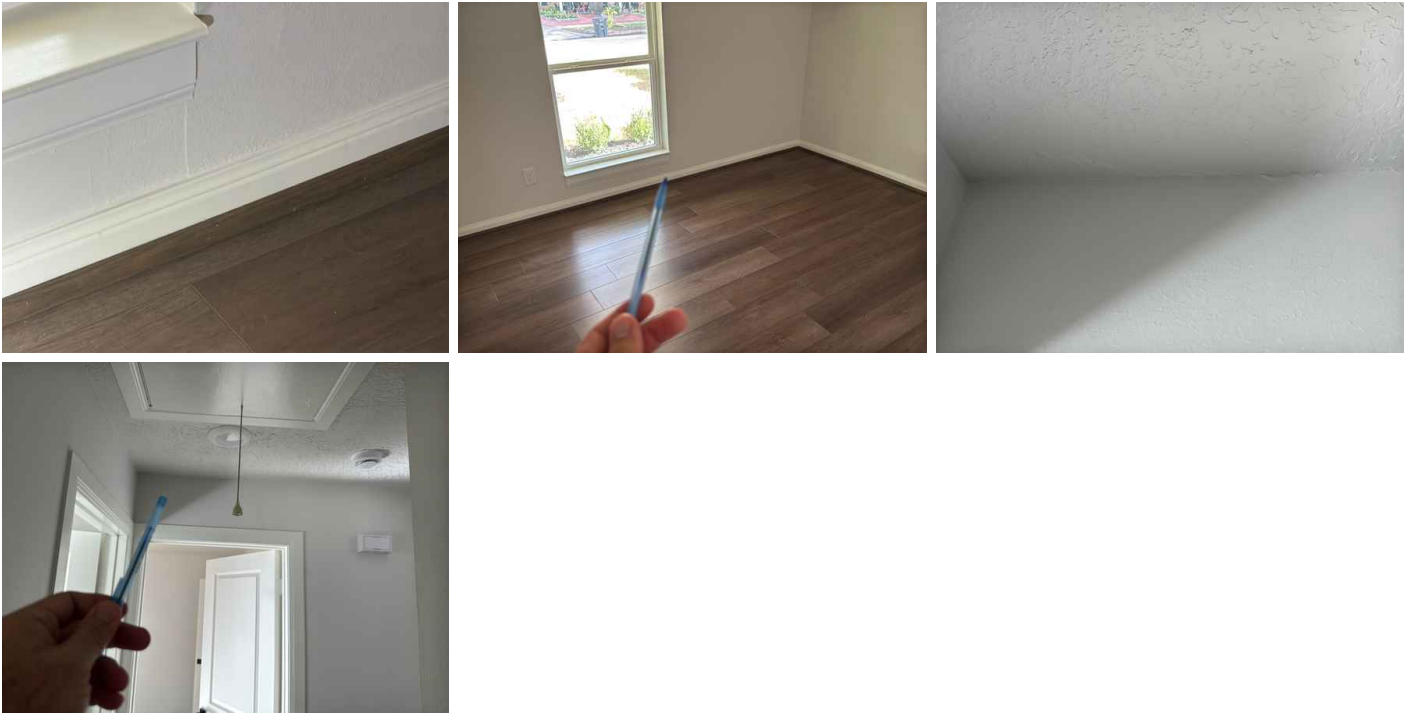
Northeast Bedroom Hallway

**Differential Movement: Sheetrock Cracks/Patches/Compression ridges**

Sheetrock cracks, patches, and/or compression ridges were observed in the house during the inspection, including at the above locations.

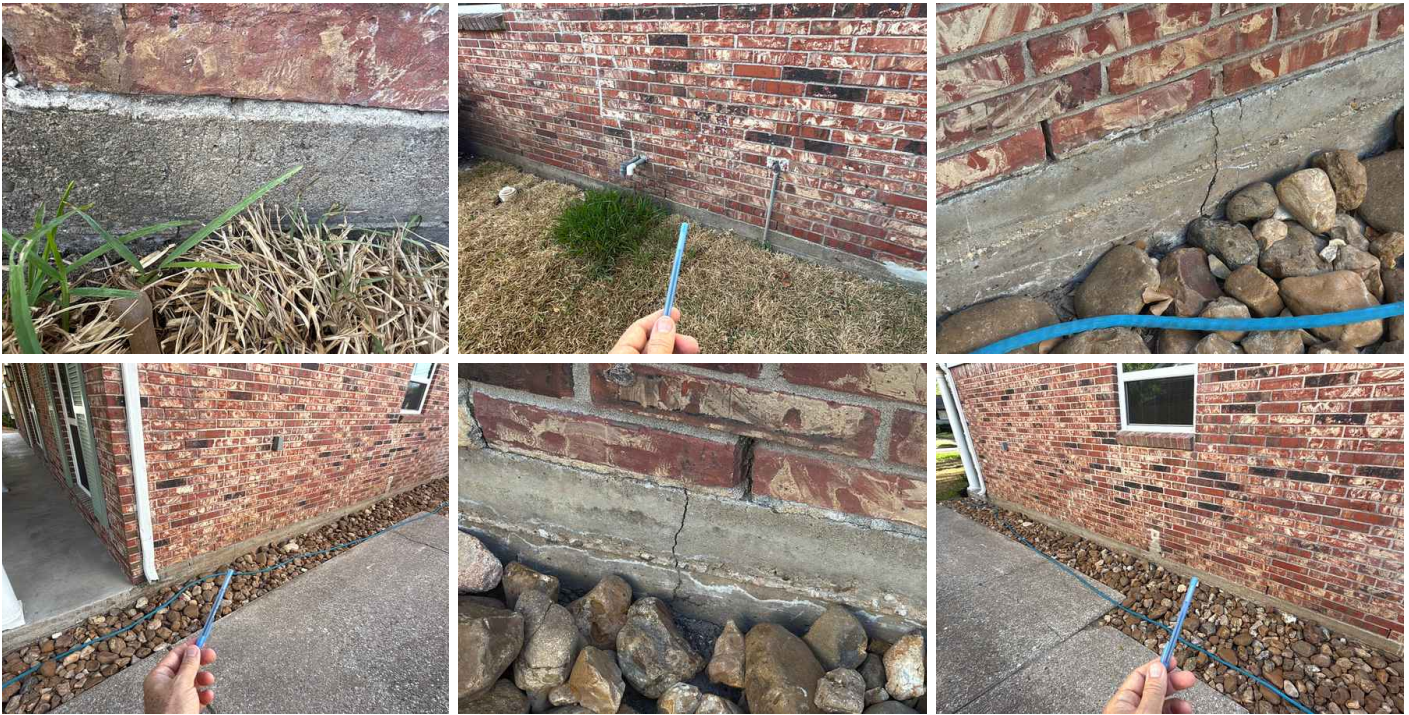
East West

**Differential Movement: Concrete Cracks - Observed**

The foundation concrete was observed to have hairline cracks, including at the above locations.

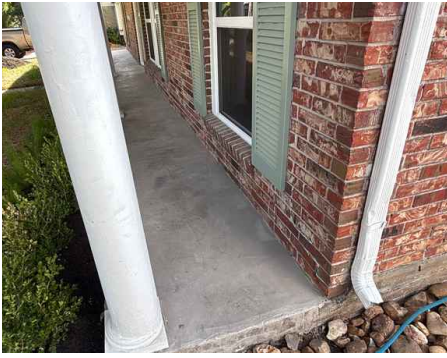
**Differential Movement: Slab not Visible - Patio**

It is pointed out that a portion of the foundation concrete could not be viewed due to the concrete patio that adjoined the foundation.

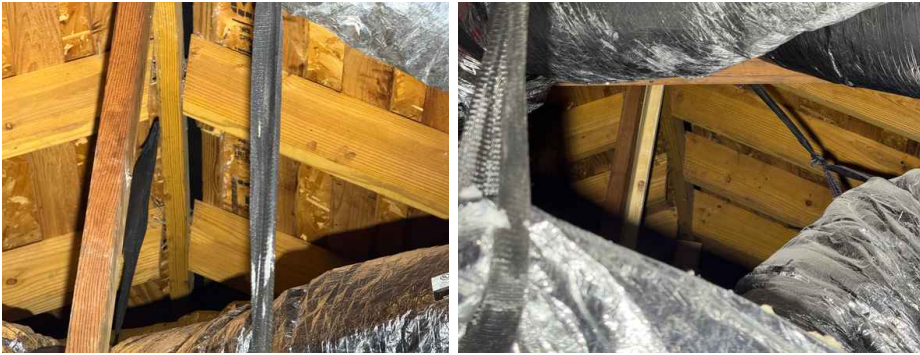
east

### Separation of Materials: Rafter separation

One or more rafters were observed to be separated from the ridge beam in the attic, which can be an evidence of movement.

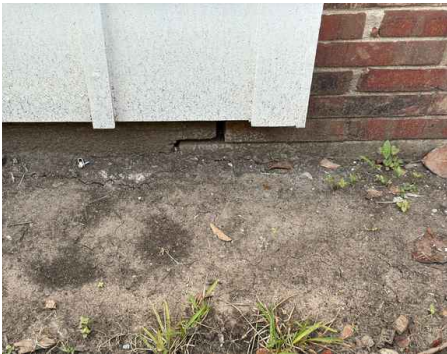
East

### Other Observations: Cold Joint

A cold joint was observed in the foundation as shown below in the photo(s). The presence of a cold joint is an indication of an addition being constructed at some point in the past. It is noted that the separate slabs can move independently from one another.

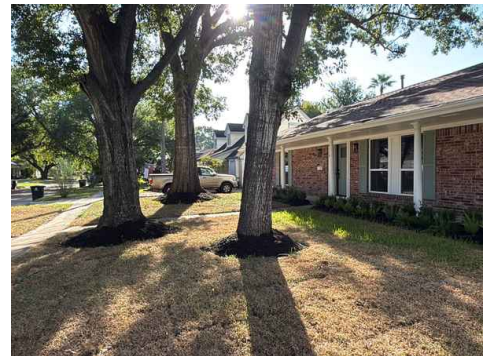
#### **TREES AND/OR FOLIAGE**

Trees and/or foliage were observed in the vicinity of the house which can contribute significantly to differential movement of the house foundation. Care should be taken to prevent the trees and foliage from removing an excessive amount of water from near the foundation of the house.

Contact a qualified professional.

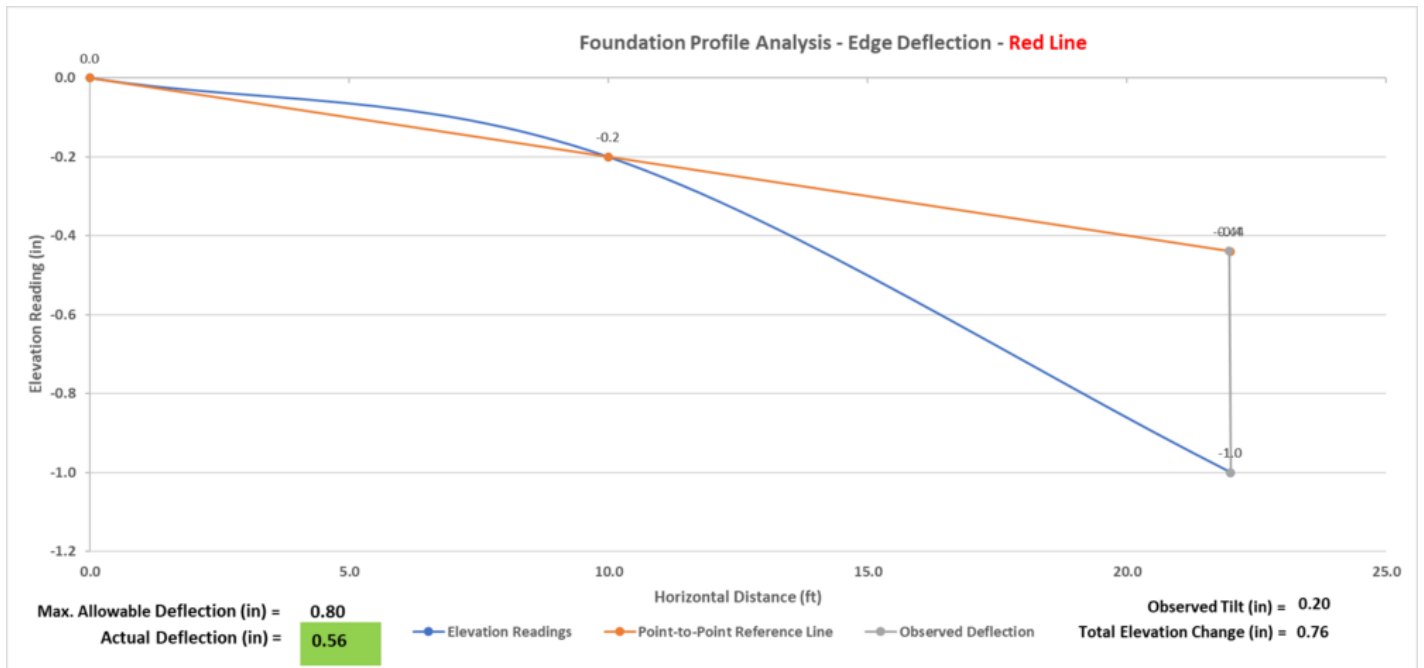
From the point of curvature located at the northeast bedroom (west) to the northeast bedroom (east) ( $L = 12$  feet), the maximum allowable deflection is 0.80 of an inch. We calculated a deflection of 0.56 of an inch at the time of inspection across this span, which is **less than the maximum allowable deflection, and is acceptable**. This observation can be observed along the **Red Line** in the sketch below.

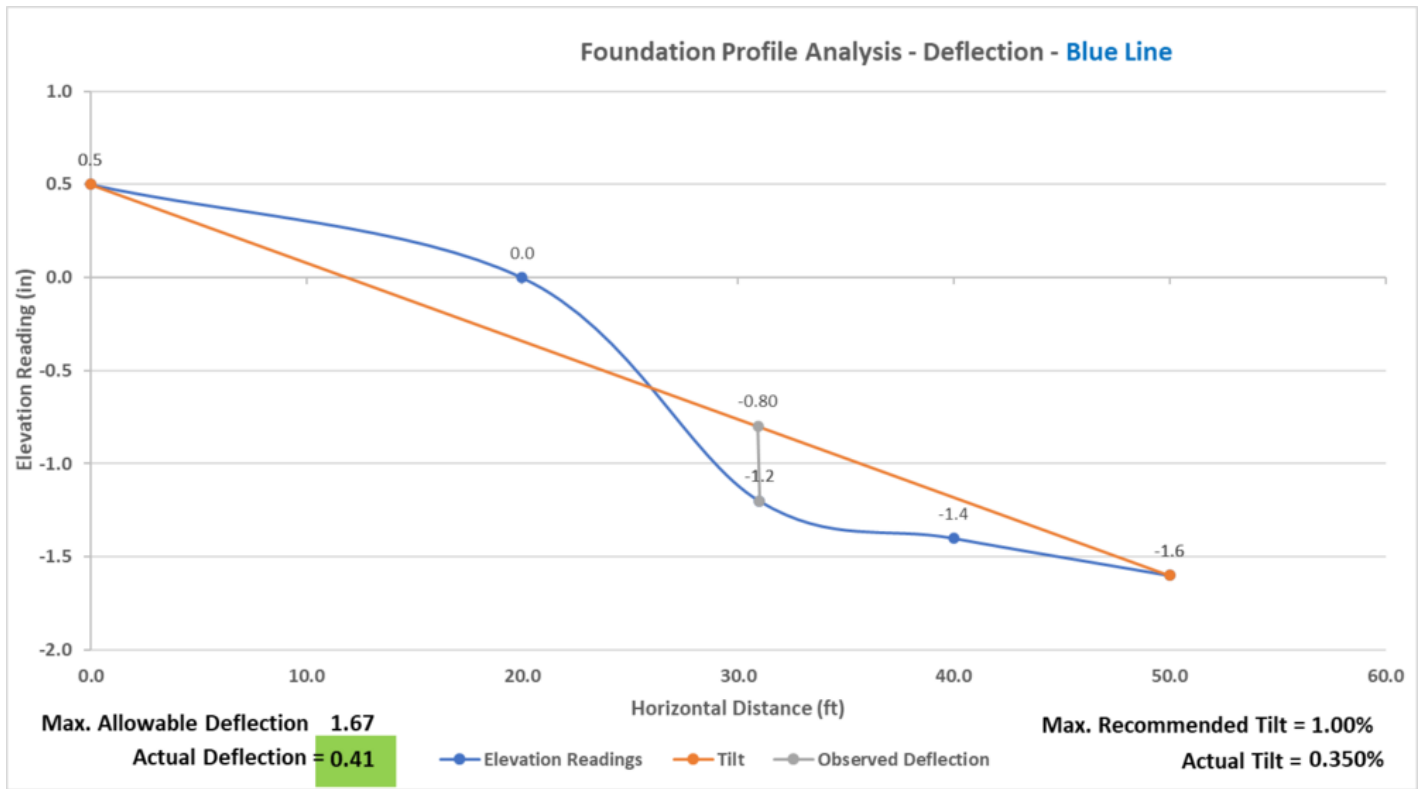
From the utility room to the south bedroom (L = 50 feet), the maximum allowable deflection is 1.67 inches. We calculated a deflection of 0.41 of an inch at the time of inspection across this span, which is **less than the maximum allowable deflection, and is acceptable**. This observation can be observed along the Blue Line in the sketch below.

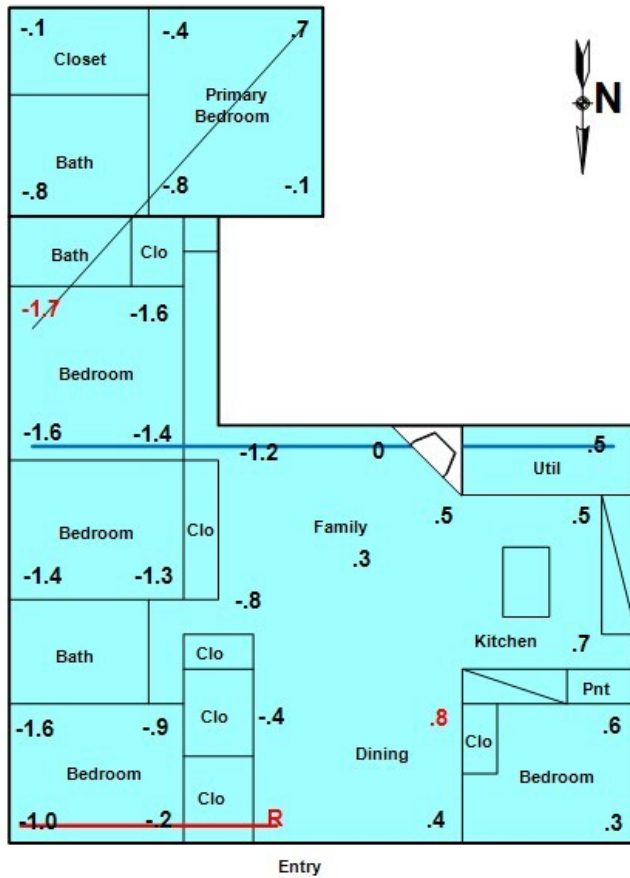
**Elevations Readings  
6115 Lymbar Drive**

**FOUNDATION CONCLUSIONS: Marginal**

Most of the structures previously inspected by this firm have experienced some degree of differential foundation movement, and this structure was no exception. After careful examination, it is our opinion that the degree of the foundation movement is such that the condition of the foundation can still be considered as acceptable, yet marginally so. It is recommended that the evidences of differential movement be monitored in the future to determine if the condition has stabilized, or if the foundation is continuing to move. It is emphasized that repairs could become necessary in the future should the foundation continue to move, particularly in the areas outlined above. It is pointed out for your information that, due to the nature of the soils in this area, it is reasonable to expect that some movement of the foundation will happen in the future.
