## **Inspection Report**

2000 Bagby St

# PROPERTY INSPECTION REPORT FORM

4/6/2026
Name of Client	Date of Inspection
2000 Bagby St, Unit 13432, Houston, TX 77002	
Address of Inspected Property	
Clete Pfeiffer	TREC# 21002
Name of Inspector	TREC License #
Name of Sponsor (if applicable)	TREC License #

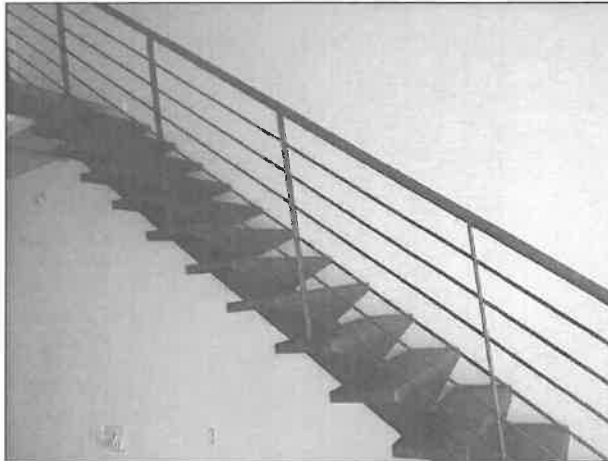
(1) The railings at the stairway are horizontal. They should be vertical that can not be climbed.

(2) The risers at the staircase are not uniform in height. Current building standard require all risers to be uniform within 3/8 of an inch and a maximum riser height of 7 3/4 inches.

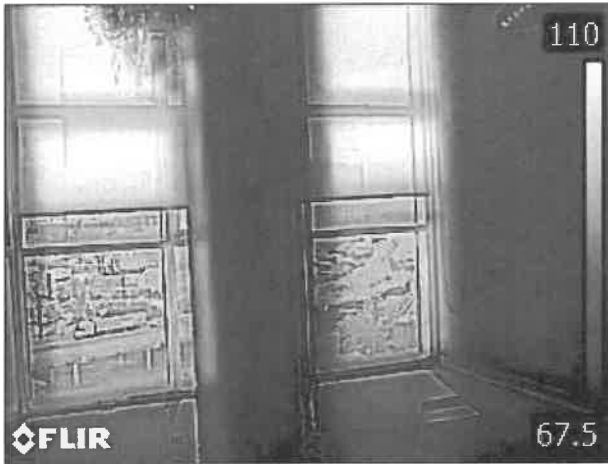
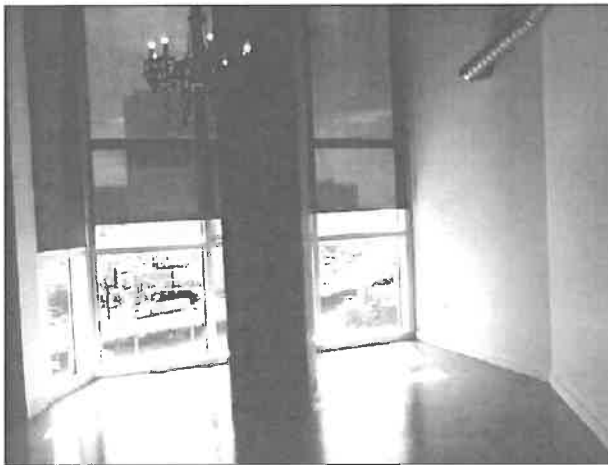
An infrared camera was used to perform a thermographic scan of the interior of the house and the electrical panel to detect water penetration, electrical overheating, and insulation issues. No defects were observed with the infrared camera at the time of the inspection.

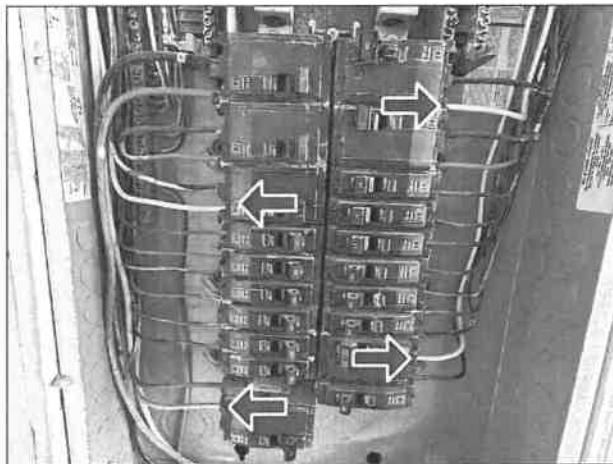
(2) There are white wires used as hot conductors connected to one or more of the 240 volt breakers. Normally, the white wires are neutral. When used as a hot conductor, the white wires should be color coded.

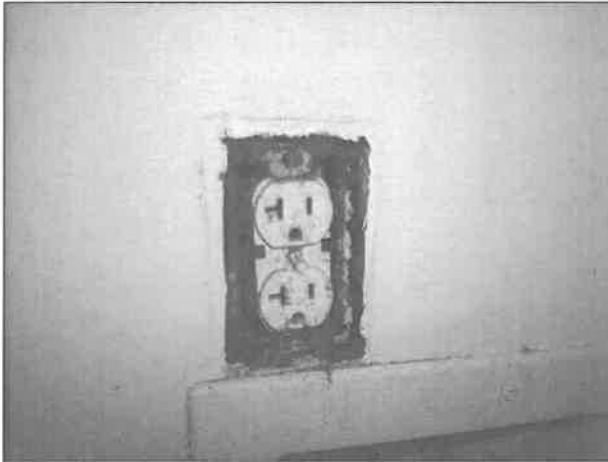
(2) There is no cover on the receptacle at the washer / dryer space in the utility room. This receptacle is loose in the wall.

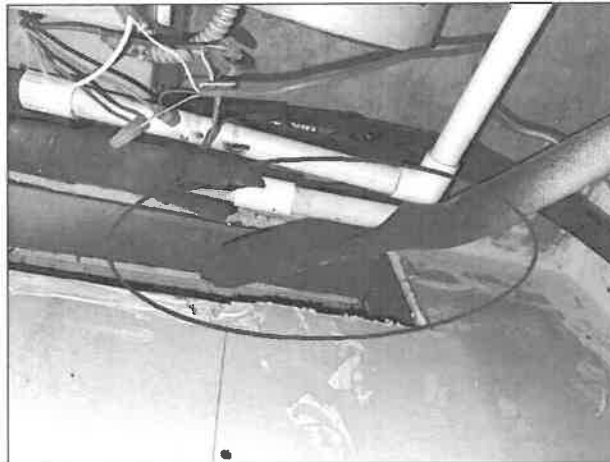
(3) The insulation has pulled away from a portion of the primary drain at the upstairs cooling system. Recommend reinsulating.

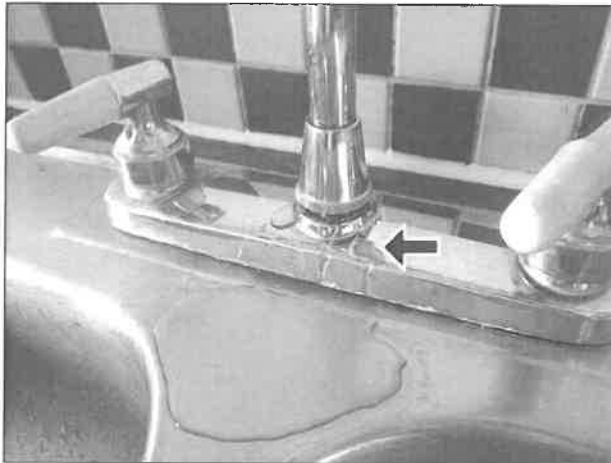
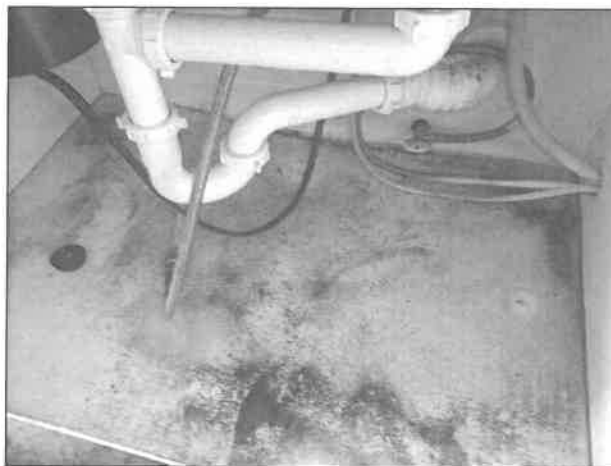
(1) There is a leak from the faucet at the kitchen sink. This water is draining into the cabinet below. The cabinet is damaged and there appears to be mildew / mold in this area. Recommend repair and replacement of all affected materials.

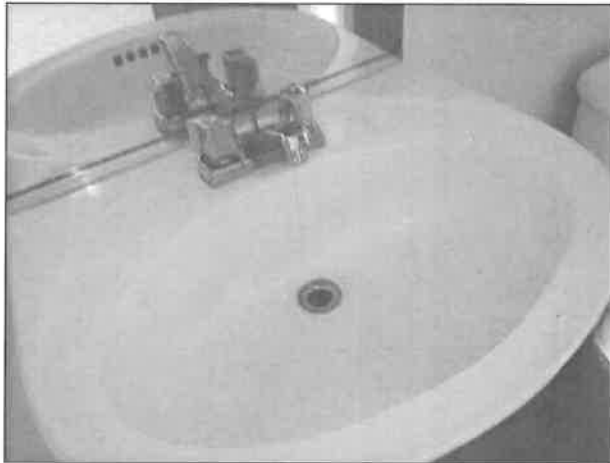
(2) The faucet at the half bathroom sink will not completely shut off. The valves under the kitchen sink were closed after testing.

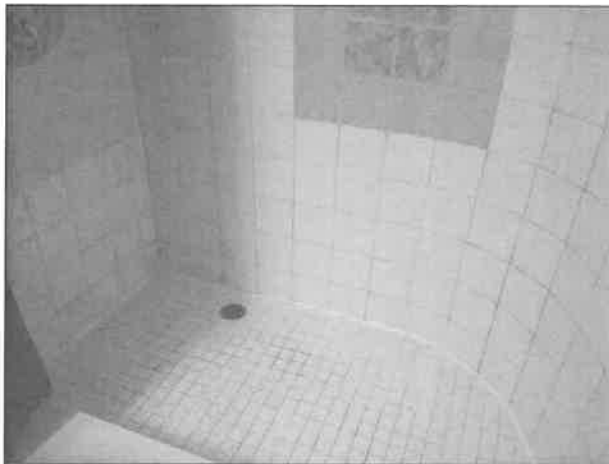
(3) There have been previous repairs to the tiles at the shower surround in the upstairs bathroom. There are gaps in the grout between these tiles. Recommend repairs to reduce water penetration behind the tiles.

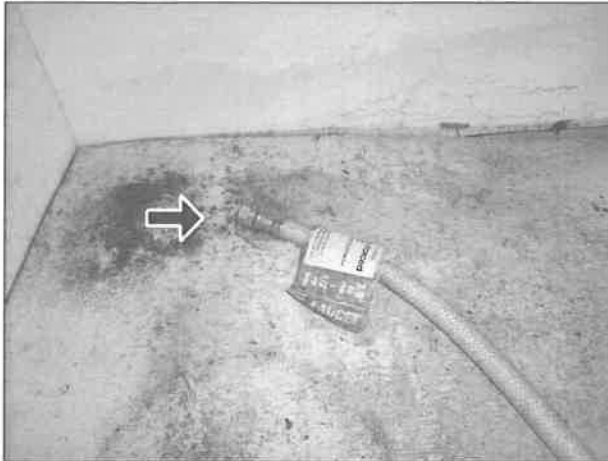
(4) The hand-held sprayer at the kitchen sink is disconnected.

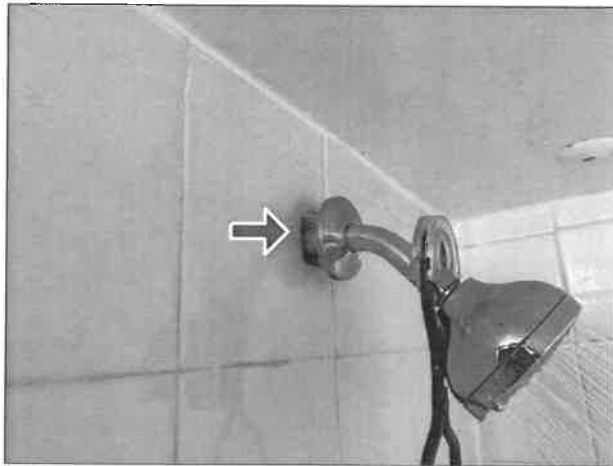
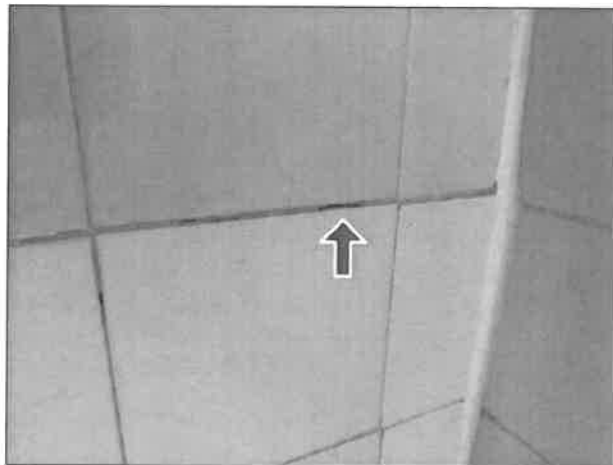
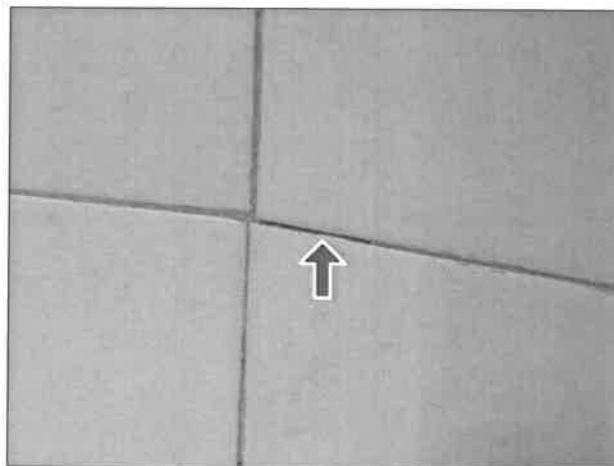
(5) There are cracks and gaps around tubs, shower pans, tub spouts, and faucets. Recommend cleaning and caulking to reduce water penetration.

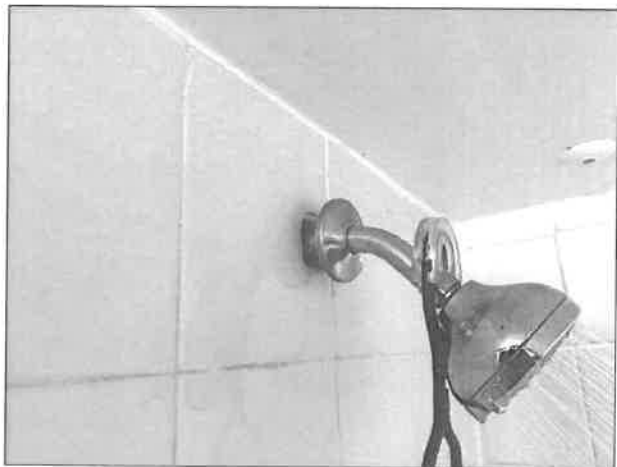
(6) The plumbing head for the upstairs shower is loose in the wall.

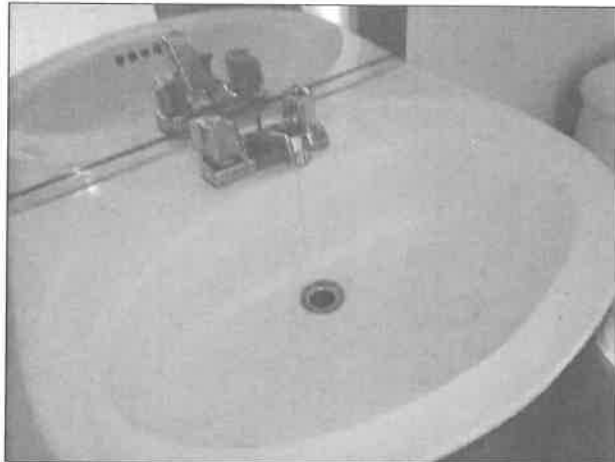
(2) There is no stopper in the half bathroom sink.

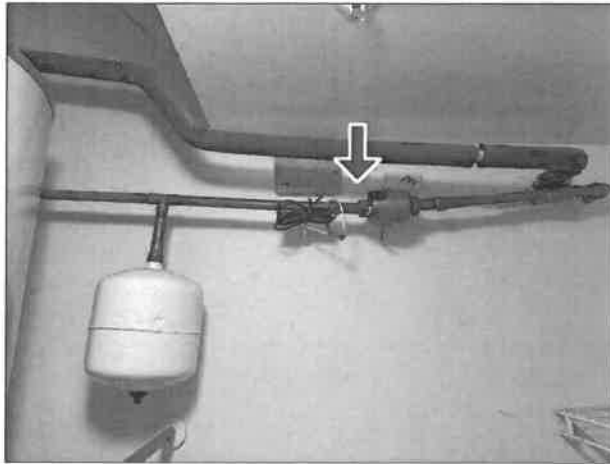
(2) The water supply pipe and pressure compensator to the water heater are not properly supported and sagging in the middle. Recommend repair / supporting by a licensed plumber.

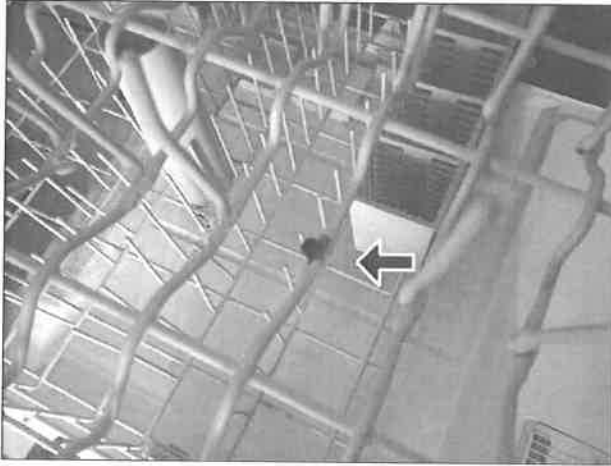
(2) There is rust on the dishtrays.

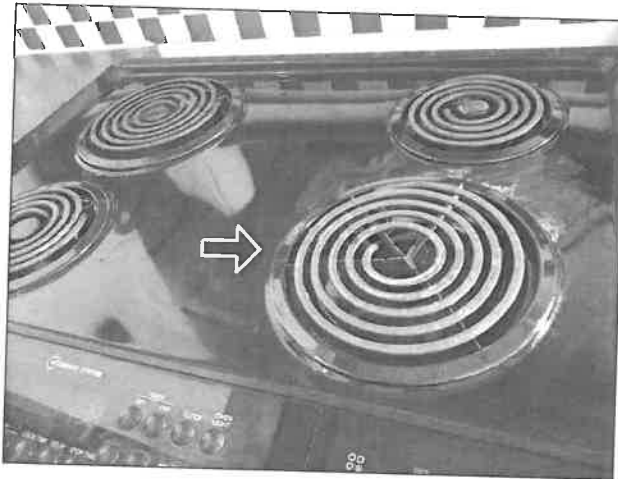
(2) The front right burner is not connected and does not heat.
