PROPERTY INSPECTION REPORT FORM

Rosa Caffarena <i>Name of Client</i>	11/11/2023 <i>Date of Inspection</i>
5638 Briar Dr., Houston, TX 77056 <i>Address of Inspected Property</i>	
Will Worthen <i>Name of Inspector</i>	24920 <i>TREC License #</i>
<i>Name of Sponsor (if applicable)</i>	<i>TREC License #</i>

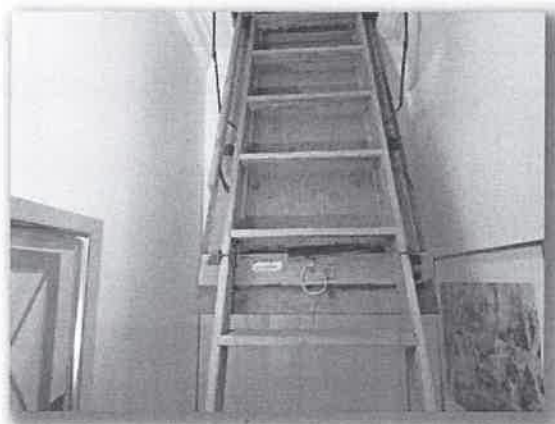
Attic Ladder/Hatch Opening

- One or more of the attic ladder components were observed to be damaged. This condition should be corrected for reasons of safety.

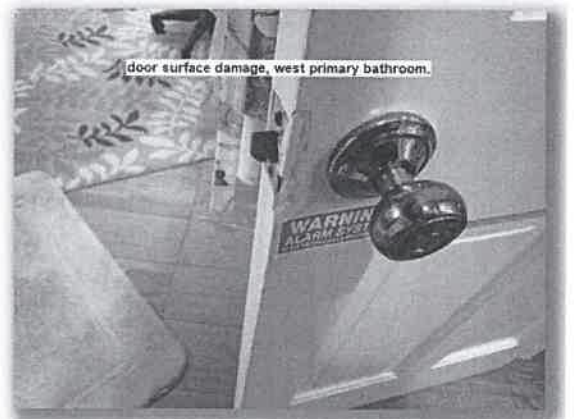
Interior Doors

- The door is sticking and will not close properly to the primary bathroom, guest quarters closet.
- Surface damage was observed to the door in the primary bathroom.
- The upstairs side middle bedroom door was not fitting the opening properly. Adjustments may be needed.
- The door is not latching properly to the guest apartment bathroom.
- The laundry room door hinge is missing its pin.

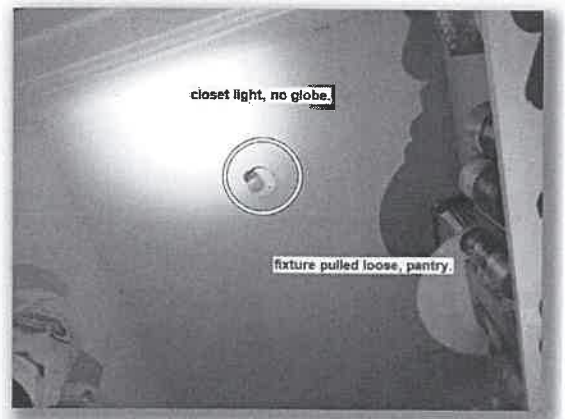
Fixtures

- One or more of the light fixtures are inoperative in the kitchen, Jack and Jill bathroom. This may be due to a bad bulb or some other unknown condition. This condition should be further evaluated and corrected as necessary.
- One or more of the closet light fixtures are installed without globes and/or covers. Safety precautions should be taken around these light fixtures.
- One or more of the light fixtures are loose at the mount in the pantry.
- One or more of the light fixture globes and/or covers are missing in the north hall bathroom, primary bathroom.

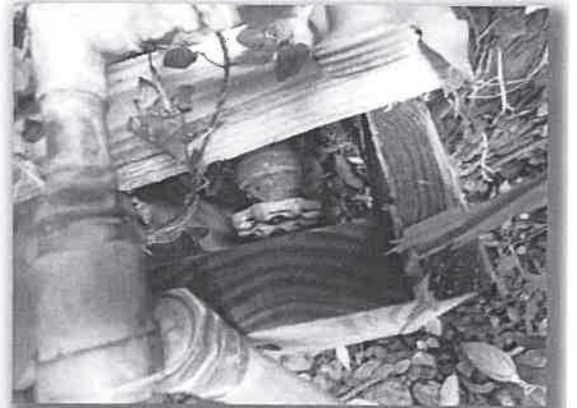
Water Supply System

- The main water shutoff is difficult to reach on the south side of the structure.

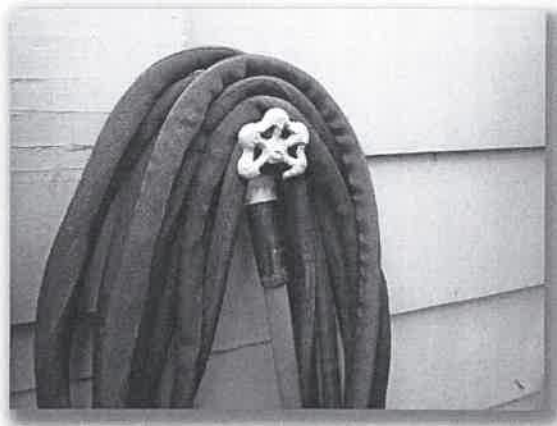
Exterior Faucets/Fixtures

- The hose bib vacuum breaker was observed to be damaged on the north side of the structure.

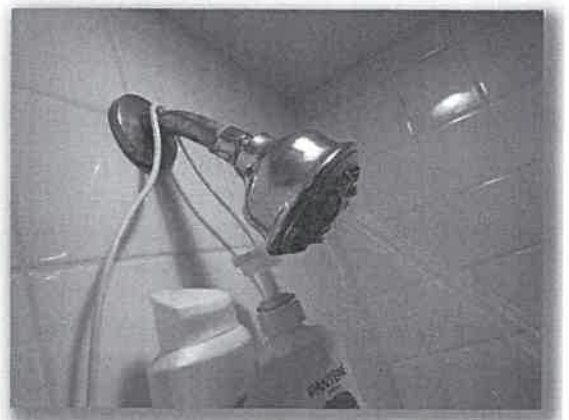
Guest Apartment Bathroom

- The shower spout is leaking at the neck connection.

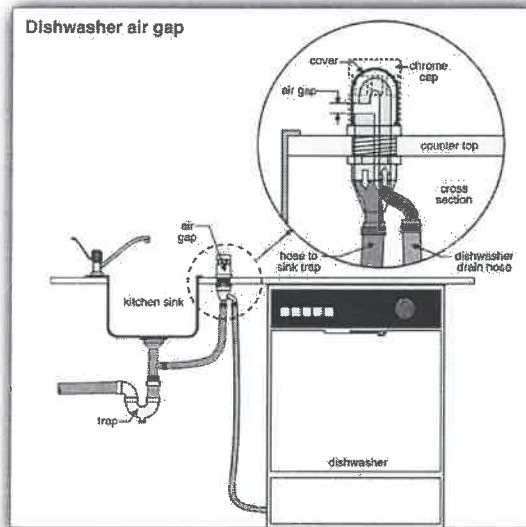
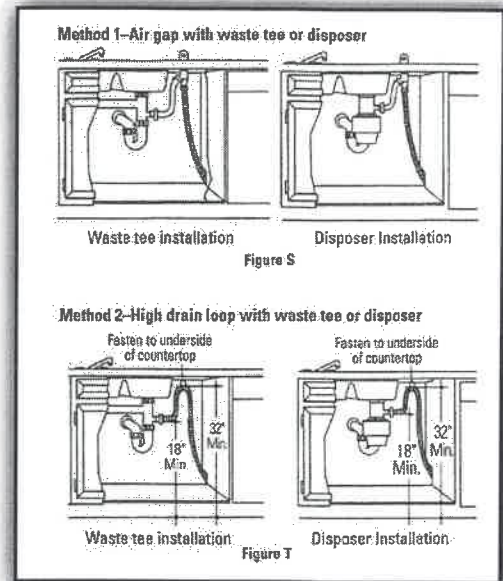
Brand Name: Samsung

- The dishwasher was inoperative at the time of this inspection.
- The dishwasher drain hose is not properly installed to prevent back flow or anti-siphoning. It is recommended that an air gap device or high drain loop be installed in the drain line.

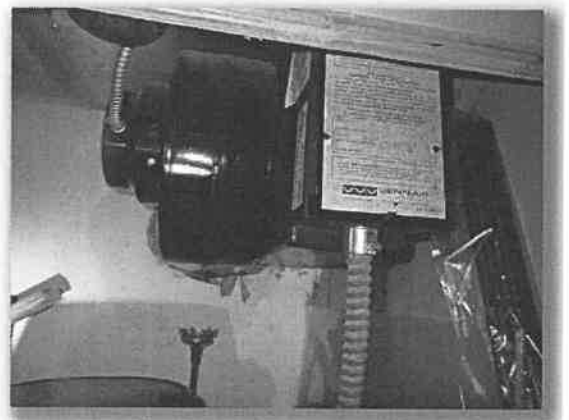
Guest Apartment Range Exhaust Systems

- The range exhaust vent fan is inoperative.
- The range exhaust vent pipe termination is not properly sealed in the cabinet.

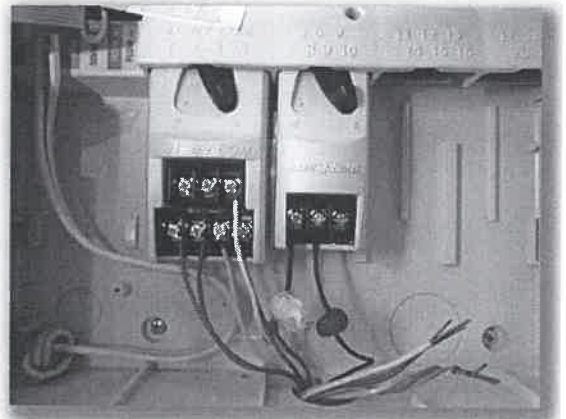
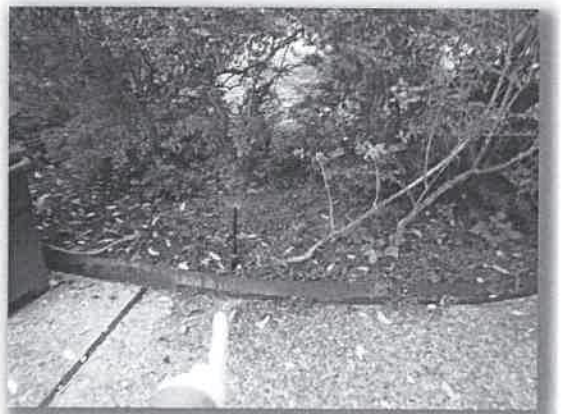
Sprinkler System and Associated Components

- I was unable to locate a moisture (rain / freeze) sensor device for the sprinkler system. This is an “*as-built*” condition, but Per TREC standards of practice we are required to report this condition as a deficiency.
- One or more of the sprinkler heads should be adjusted so not to disperse water onto concrete flatwork (such as; roadways, sidewalks, porches, patios or driveways) in station(s); 2, 3.
- One or more of the sprinkler heads were observed to be damaged and/or missing in station(s); 4.

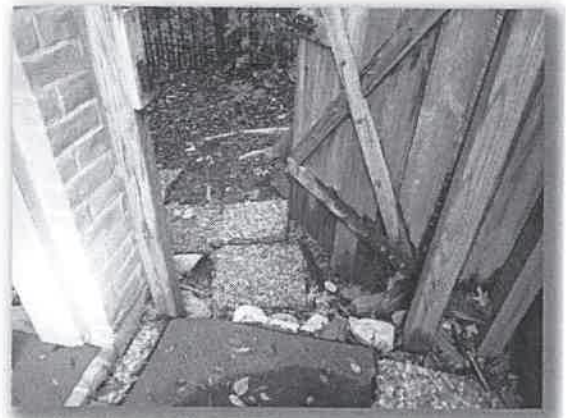
C. Fences

- The gate for the fence does not function properly and repairs are recommended.
