PROPERTY INSPECTION REPORT FORM

Report I.D. # 041323-A

Concerning: 1115 E. 27th Street
Houston, Texas 77009

Clear View Inspections
Lee Fasbinder, T.R.E.C. #7507
713.409.4631 or cvi@att.net

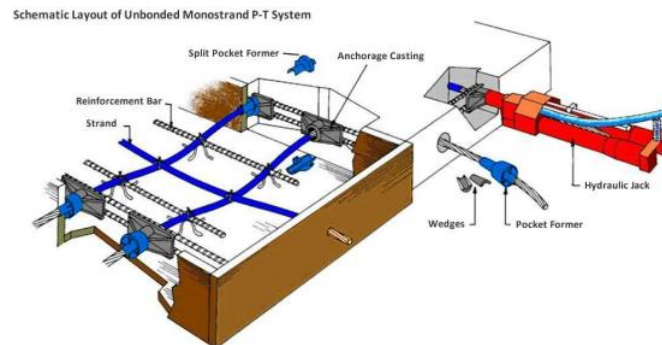
Post tension cables are added to the foundation with tension to increase the integrity of the slab. The tension cables are cut off at the sides of the foundation wall (right and left side of the home) and the ends of the cables are sealed with exterior caulking or epoxy to prevent the tension ends from corrosion (rusting).

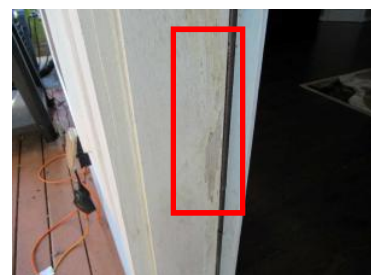
The exterior frame surrounding the back door needs to be painted in order to preserve the wood. No decay present at this time.

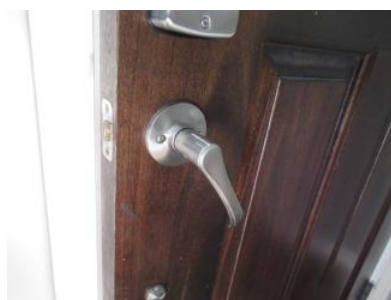
The internal spring on the front door handle no longer has "action" in the mechanism. In need of repair/replacement.

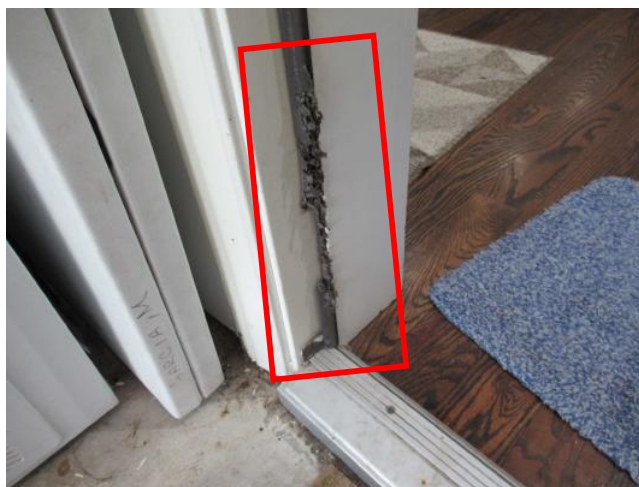
The garage passage door needs a new weather seal/strip in the frame.

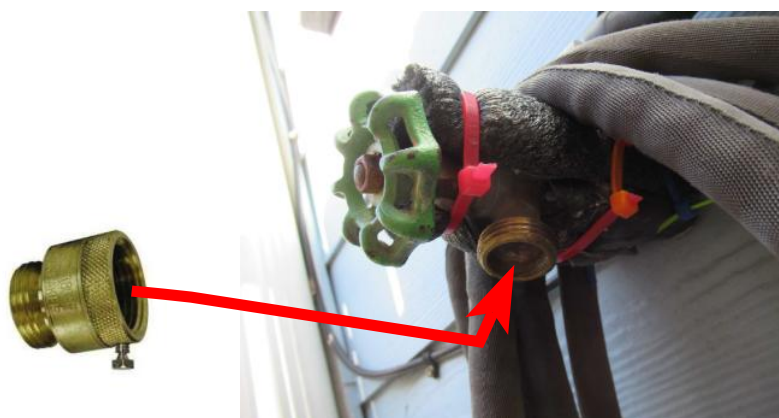
Install a back flow prevention device on the exterior hose bib located on the left side of the home. These are available at Home Depot/Lowes in the plumbing department (about \$8.00 ea) and are very easy to install (common pliers only).

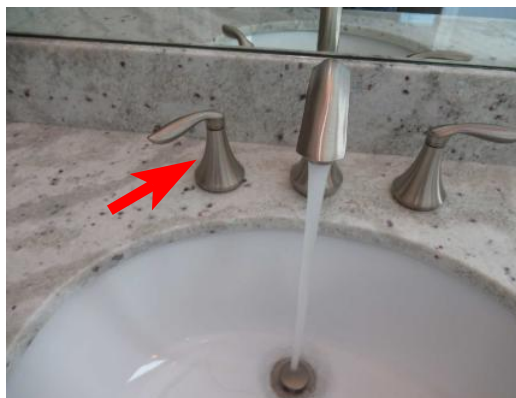
The left side sink faucet on the left side master bathroom sink is loose. In need of repair.

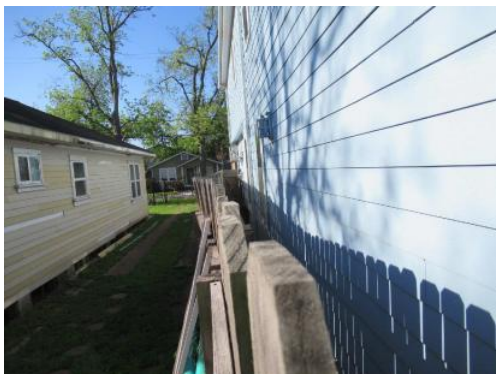
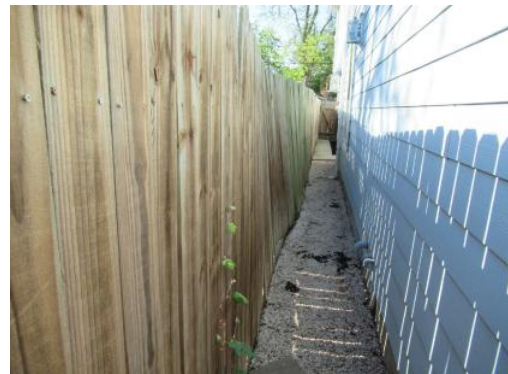
The fence on the right side of the home is leaning. Requires additional support/repair.
