# 25243 Saddlebrook Ranch Dr

| Type | <b>Home Inspection and Floor Plan Report - 25243 Saddlebrook Ranch Dr</b> |
| Inspected by | <b>HomeTeam Inspection Service - North Houston</b> |
| Completed | <b>September 13, 2025, 12:43 AM</b> |

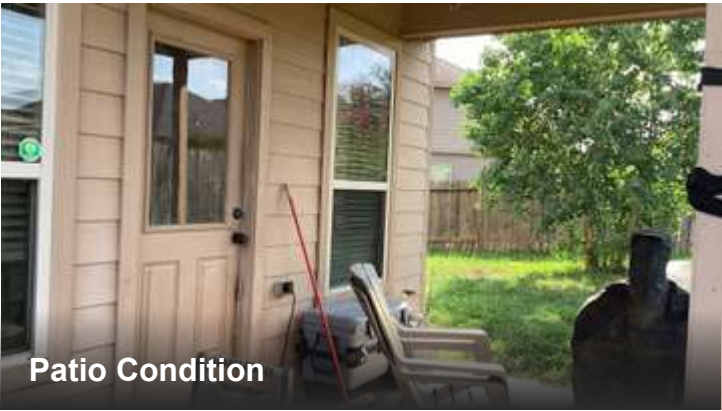
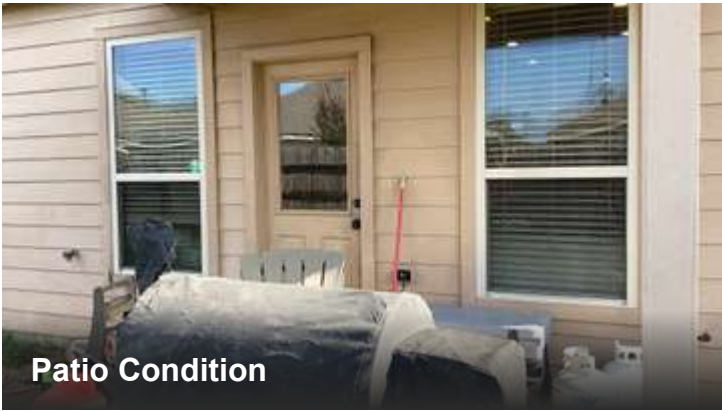
Monitor deficiency

**Minor Cracks in Patio / Porch**

There are minor cosmetic cracks on the patio / porch.

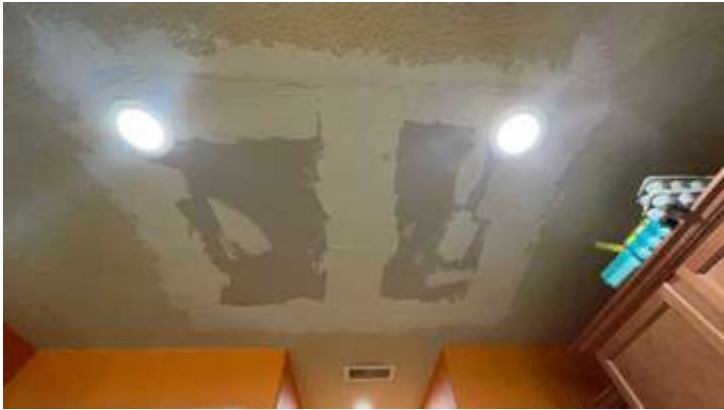
**Repair deficiency**

**Damaged ceiling**

The ceiling was damaged.

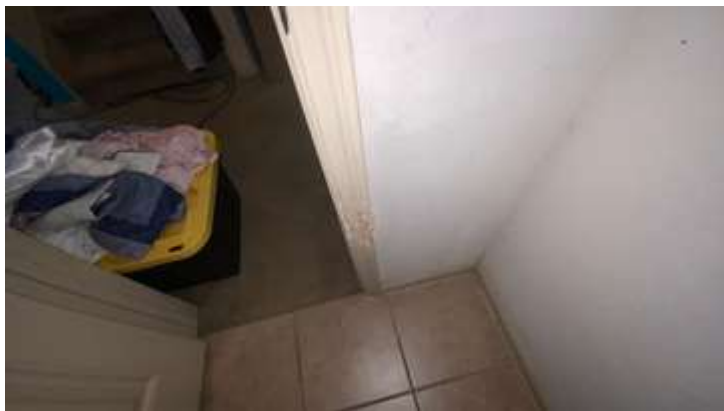
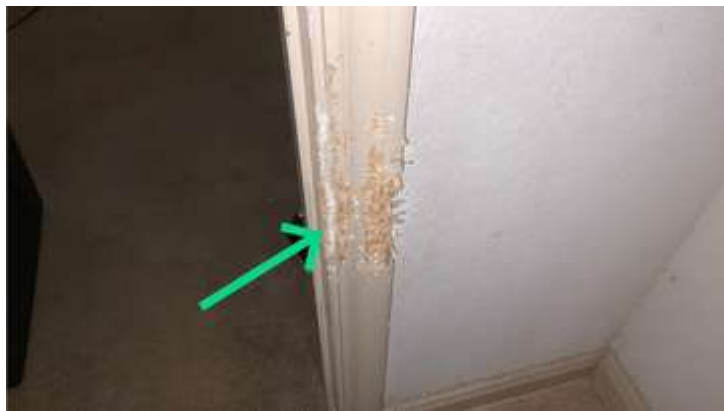
**Repair deficiency**

## Damaged Door Jamb

The door jamb is damaged.

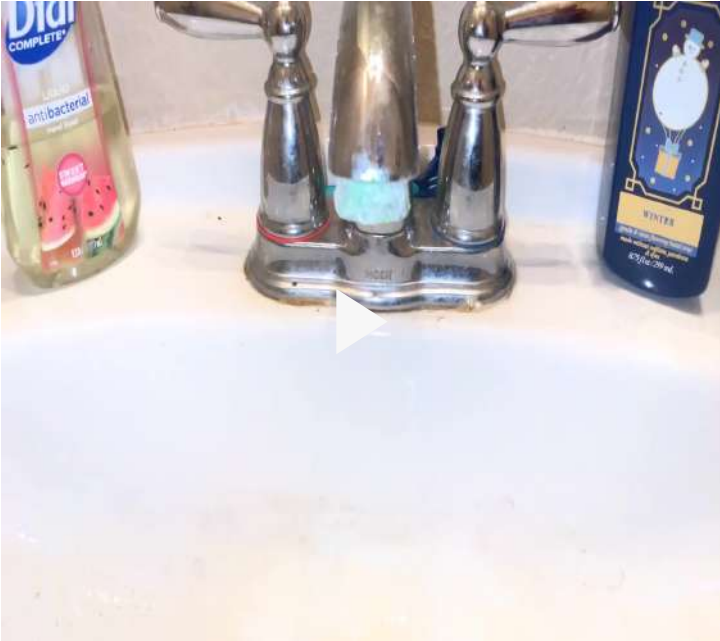
**Repair deficiency**

## Faucet not Stopping Water Flow

The water will not shut off completely.
