# 166 Hawkhurst Cir

# Magnolia, Texas 77354

| Type | <b>Home Inspection and Floor Plan Report - 166 Hawkhurst Cir</b> |
| Inspected by | <b>HomeTeam Inspection Service - North Houston</b> |

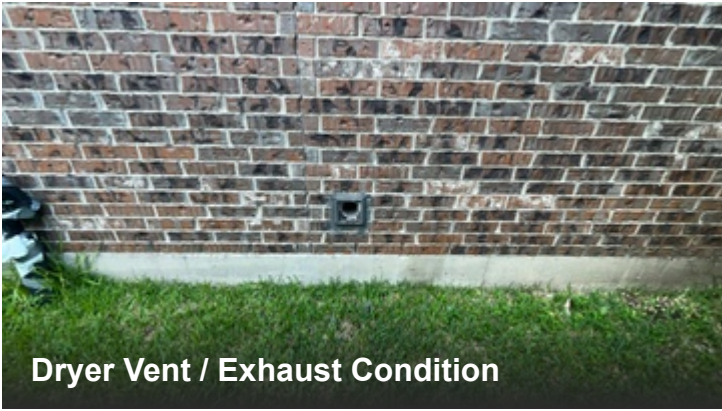
Repair deficiency

## Damaged / Missing Exterior Dryer Flapper

The outside flapper is damaged or missing.

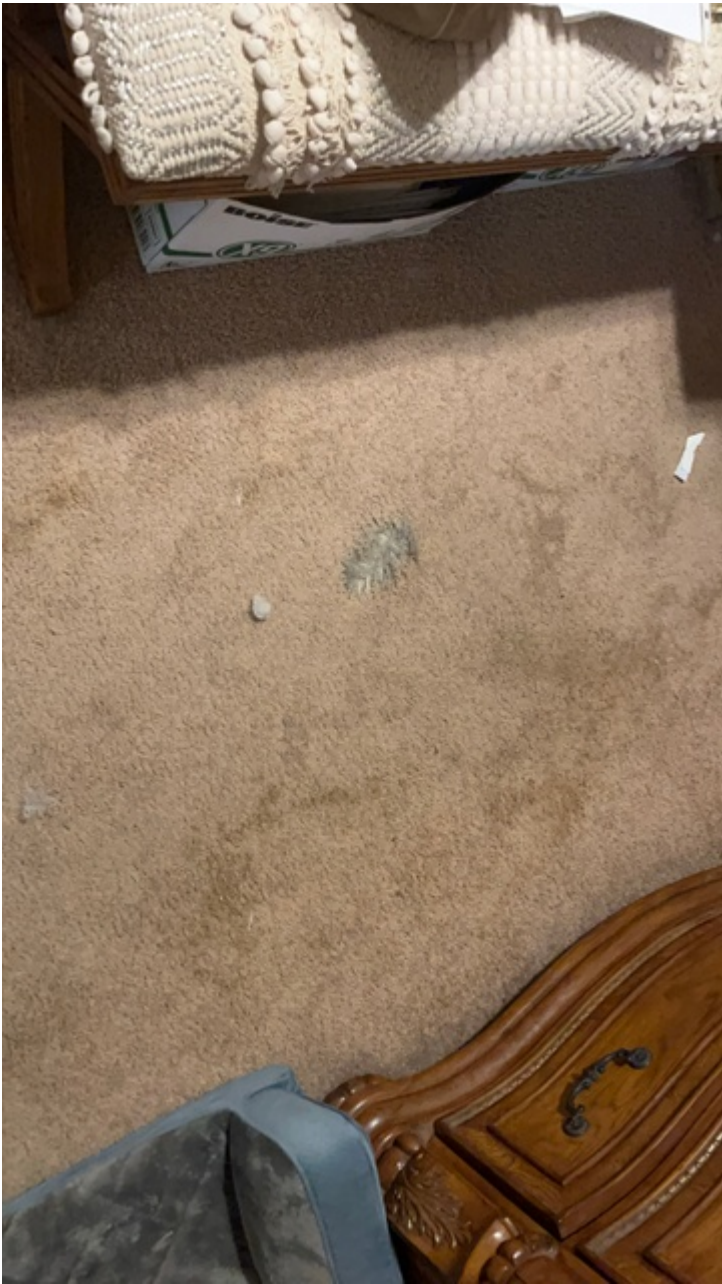
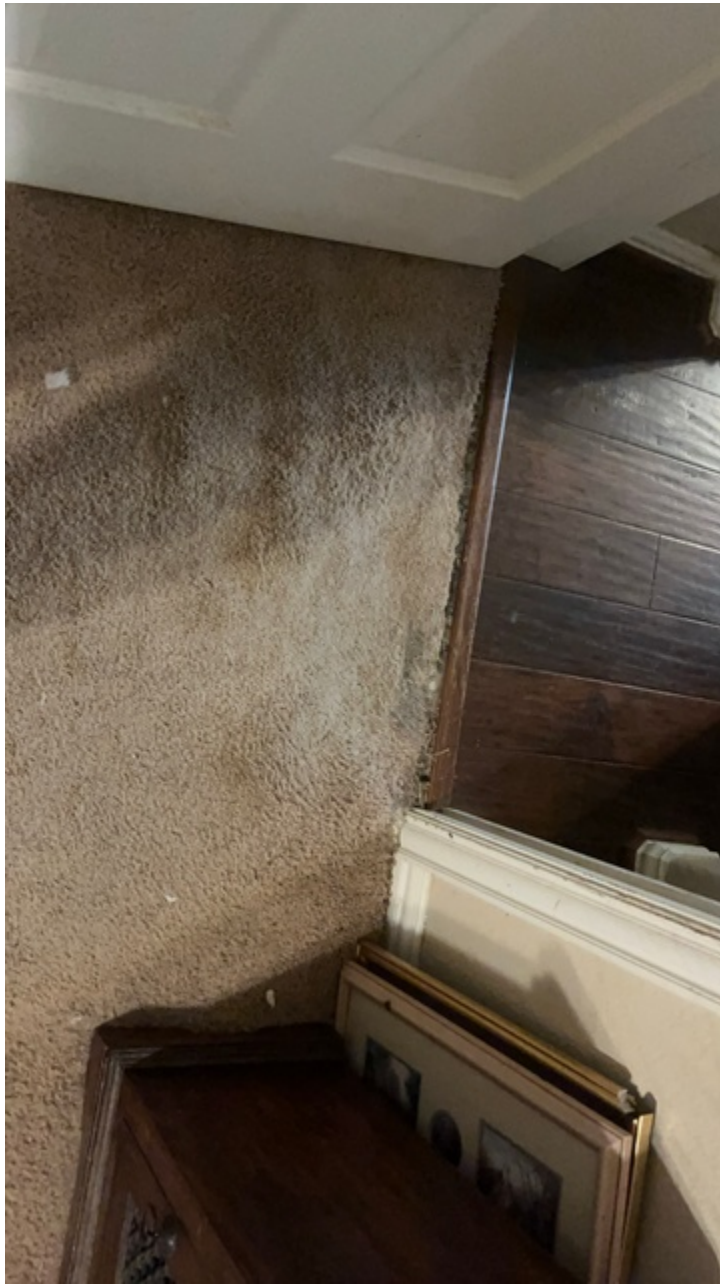
Monitor deficiency

Damaged or Torn Carpet

The carpet floor is damaged or torn in one or more areas.

Flooring Beyond Repair

Flooring Needs Minor Repairs

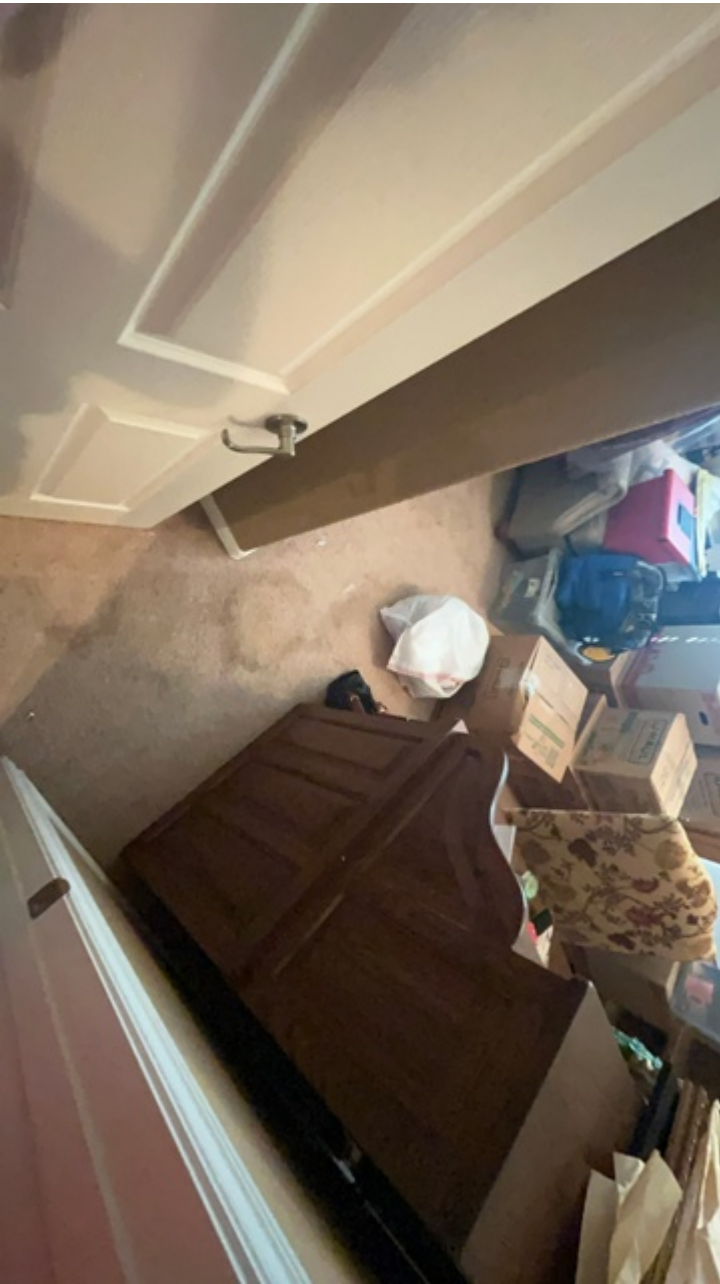
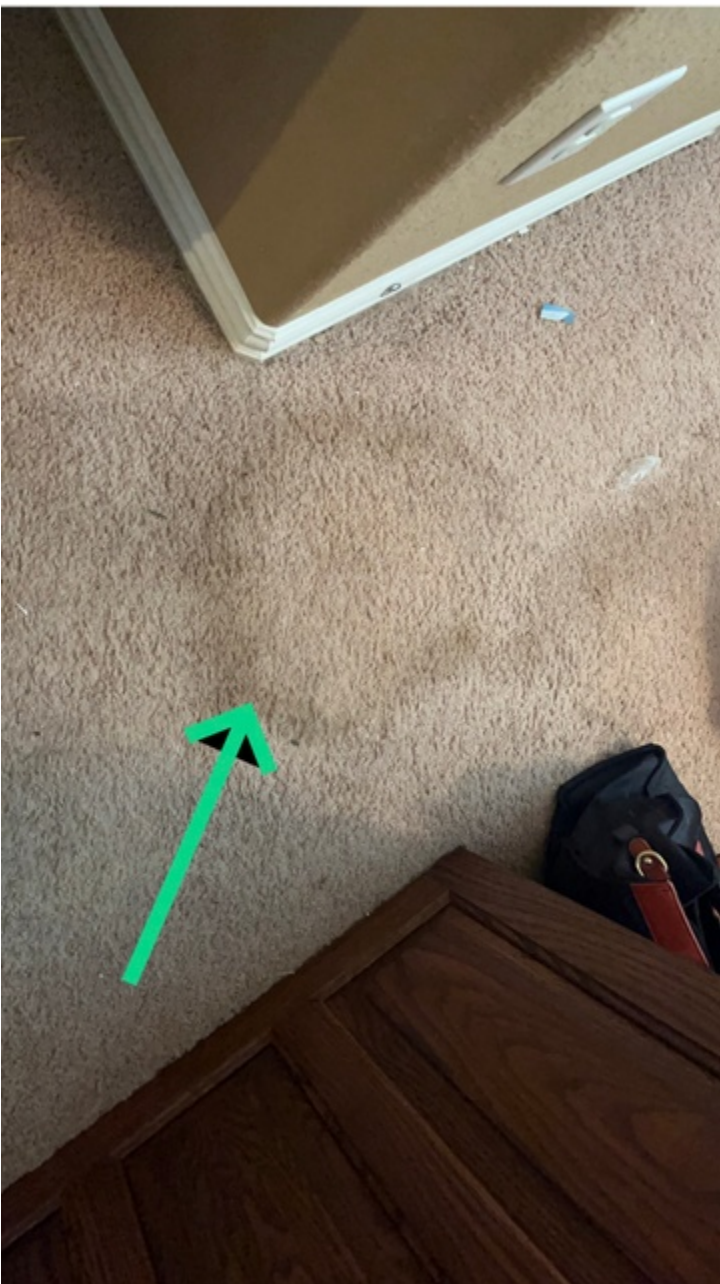
Monitor deficiency

## Stained Carpet

The carpet has areas of staining or discoloration.

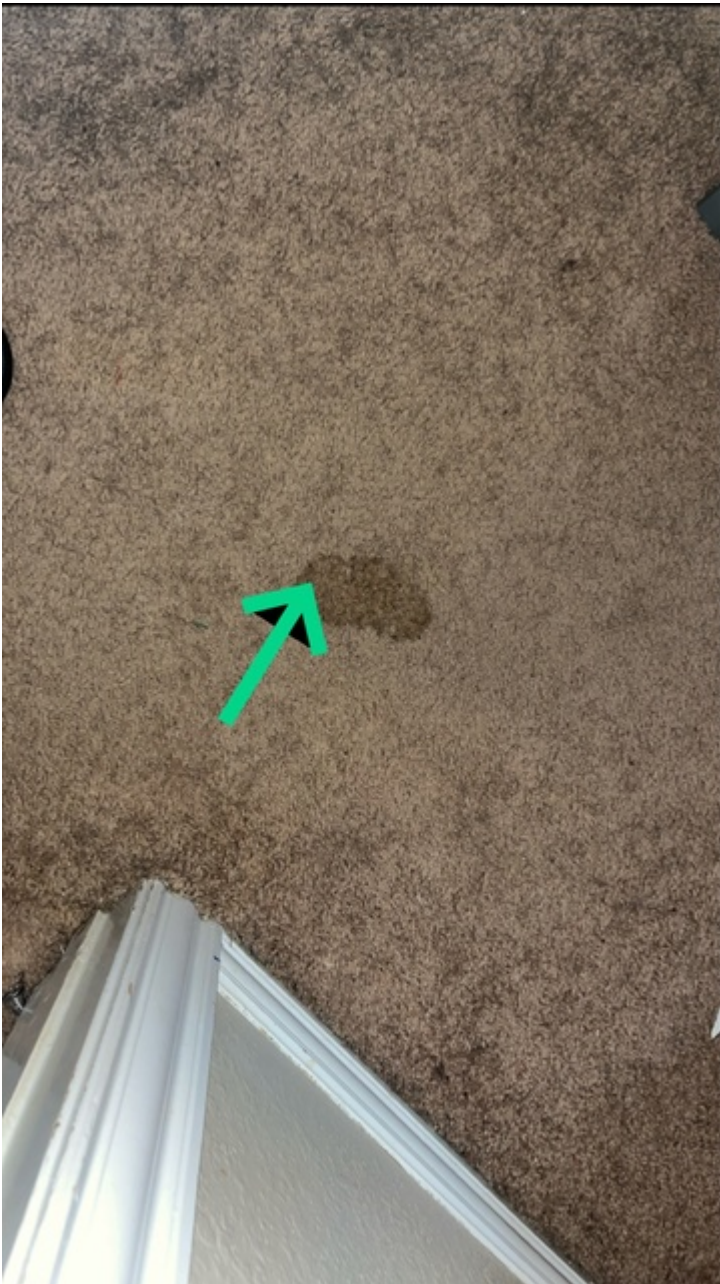
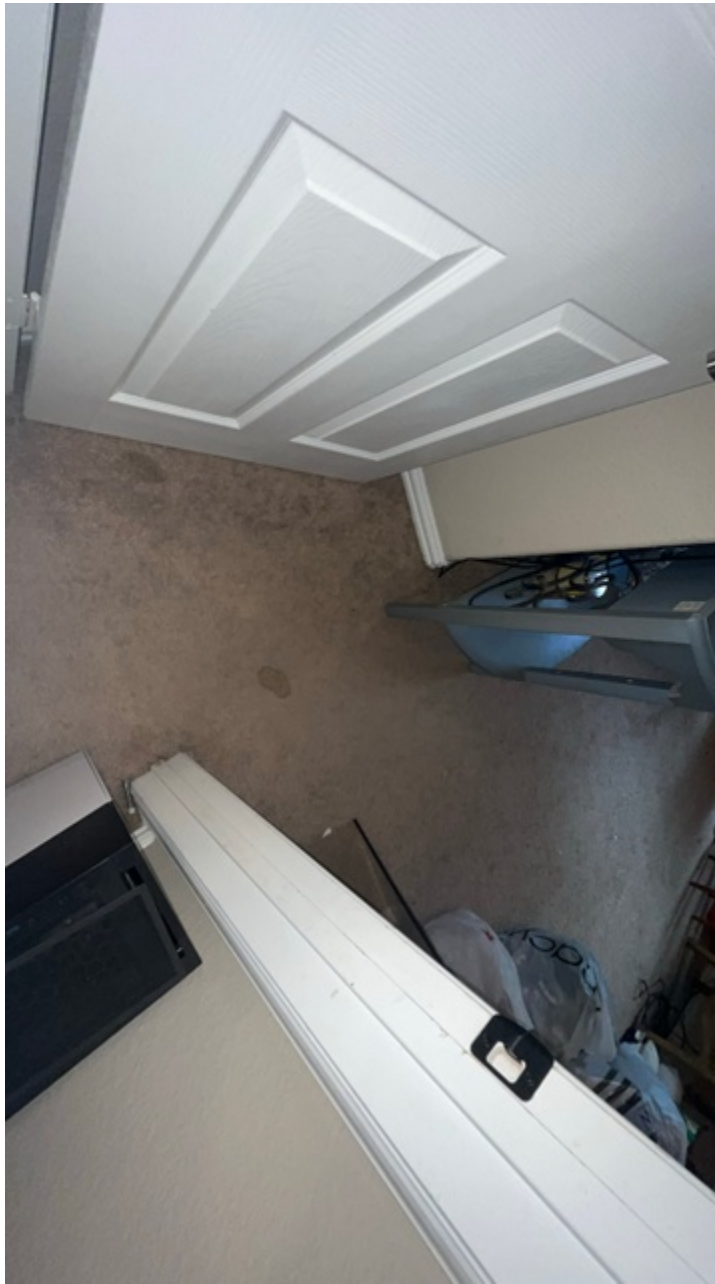
Monitor deficiency

## Stained Carpet

The carpet has areas of staining or discoloration.

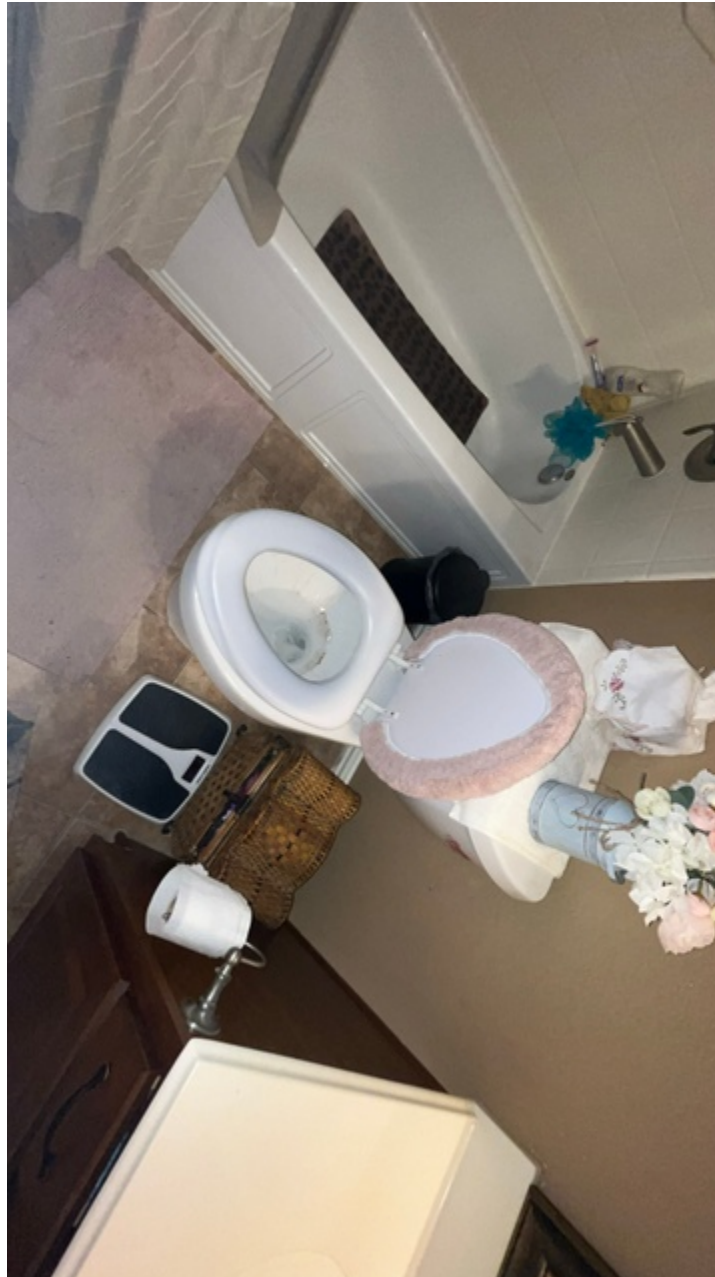
#### Repair deficiency

### Toilet Not Flushing / Improperly Flushing

The toilet does not flush properly or at all.
