Property Inspection Report

LOCATED AT:
607 Fernwood Dr
Friendswood, TX 77546

INSPECTED ON:
Friday, January 19, 2024

Inspector, Cory Bryan TREC # 24725
HiLo Home Inspections Of Texas

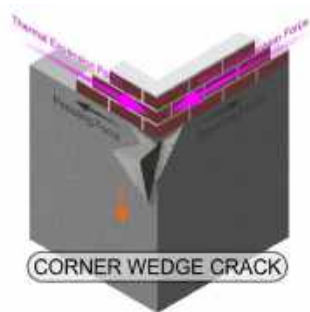
IMPR Corner pops were present, which are fairly common and seen at a majority of homes with slab foundations. Normally these are not structural, but may allow for concealed subterranean termite infestation. It is recommended that the soil at these locations be treated periodically by a qualified pest control contractor to help prevent infestation.
