True Grit Home Inspection

Property Inspection Report

12726 Shady Knoll Ln, Cypress, TX 77429

Date of Inspection: 2/6/2021 Time: 10:00 AM

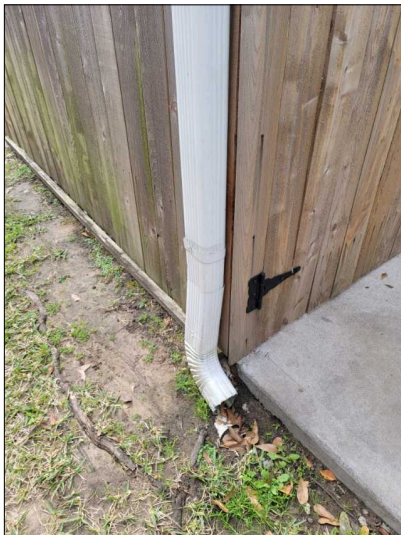
Missing splash block..front left

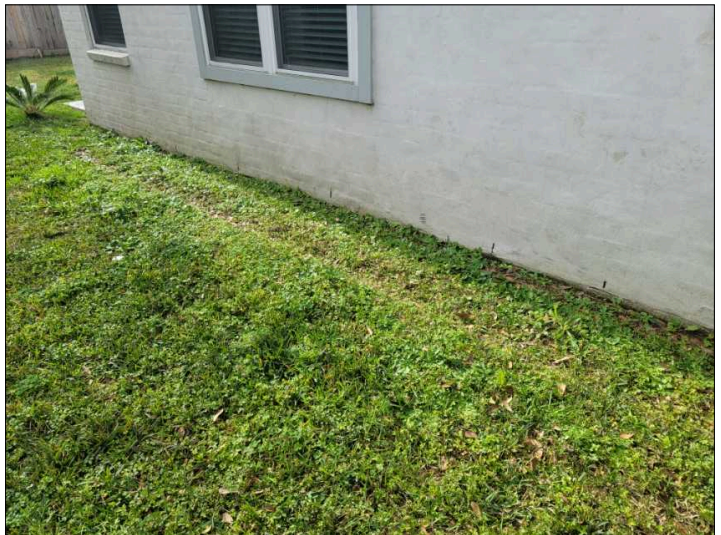
Grade too high..left side

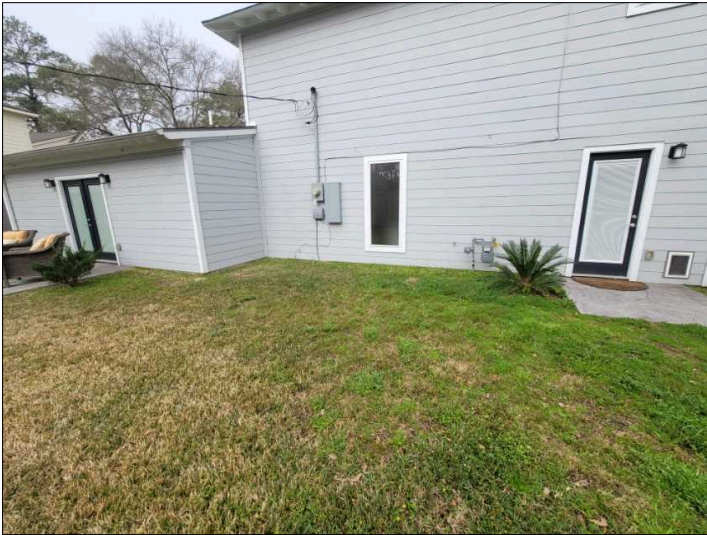
Grade too high..rear

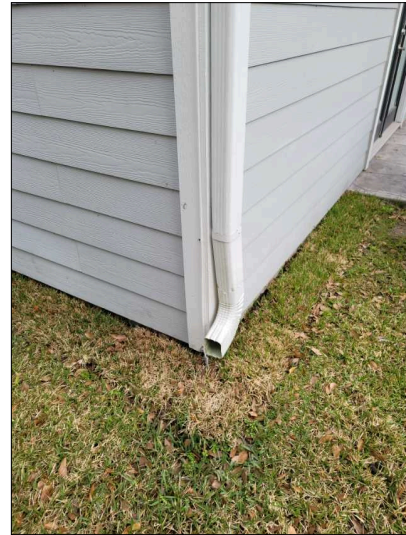
Missing splash block..rear right

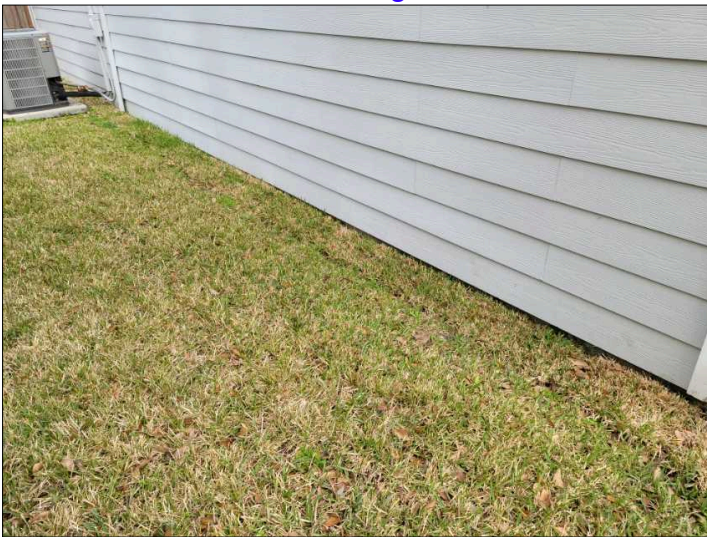
Grade too high.. right side

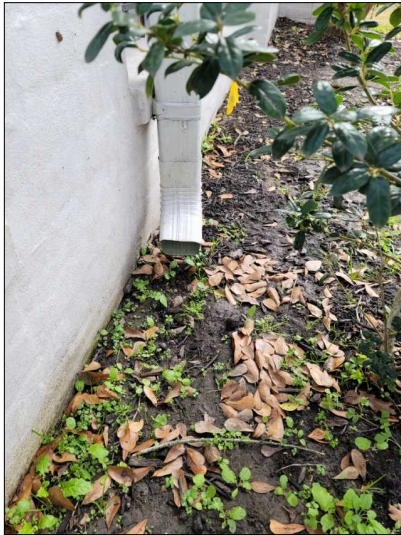
Missing splash block..front right

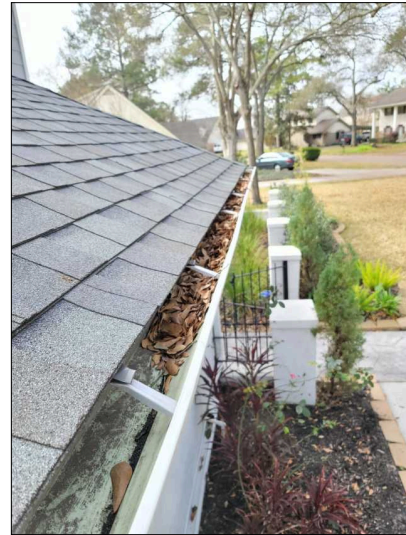
Front gutter sagging and full of debris

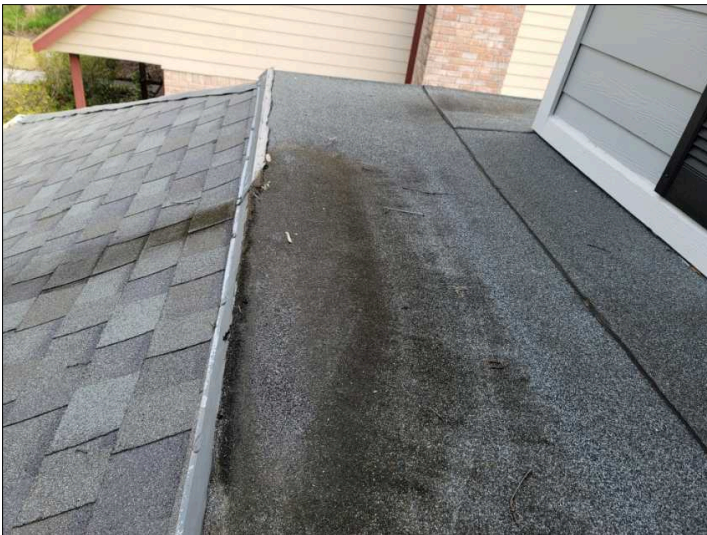
Low sloped section appears to be holding water, lifted flashing, may leak.. over garage

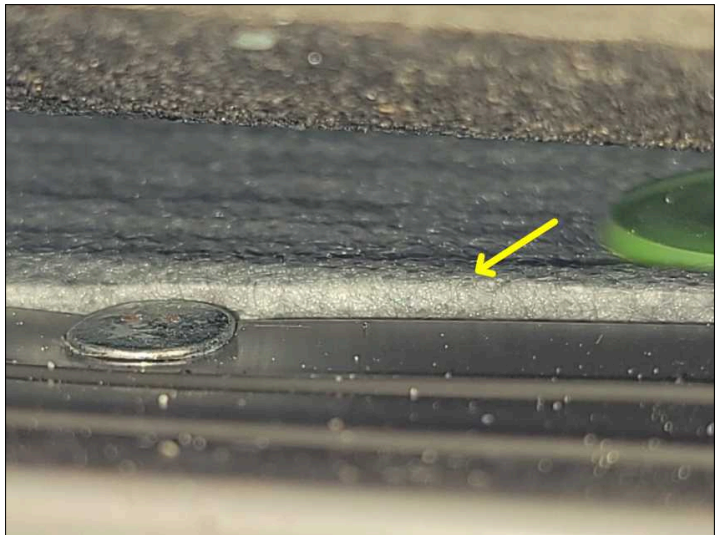
Roof felt underlayment should be on top of eave drip edge..front

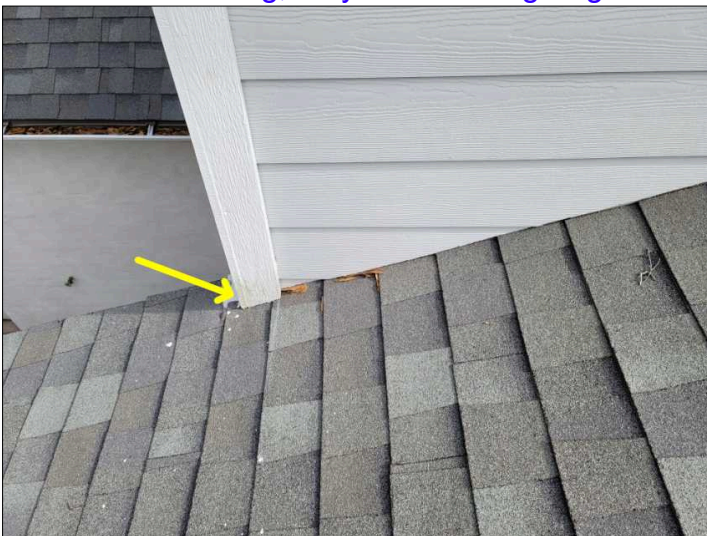
Missing kickout flashing.. right

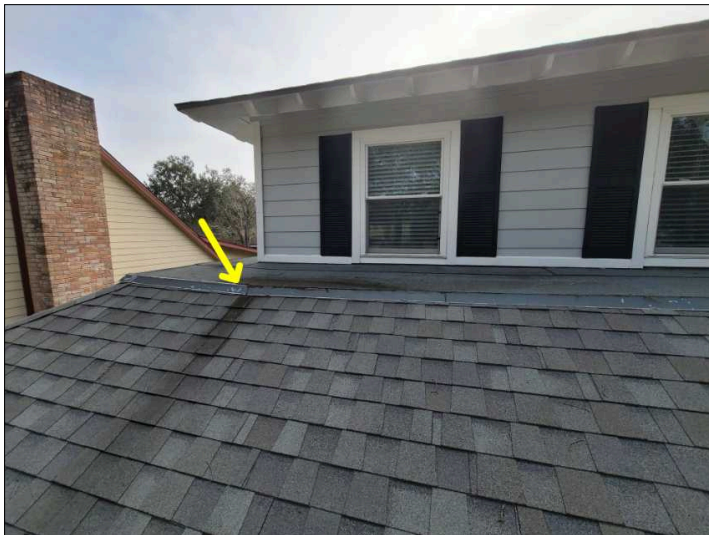
Sag evident above garage

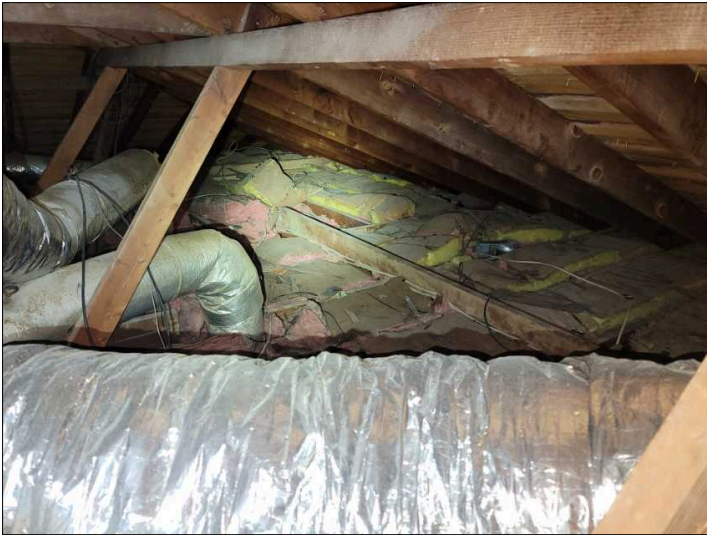
Missing, compressed insulation in several areas..upper attic

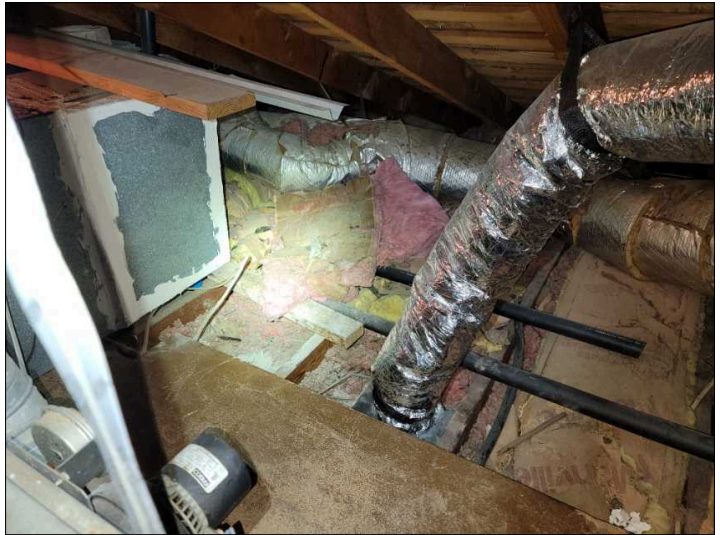
Missing insulation in several areas..upper attic

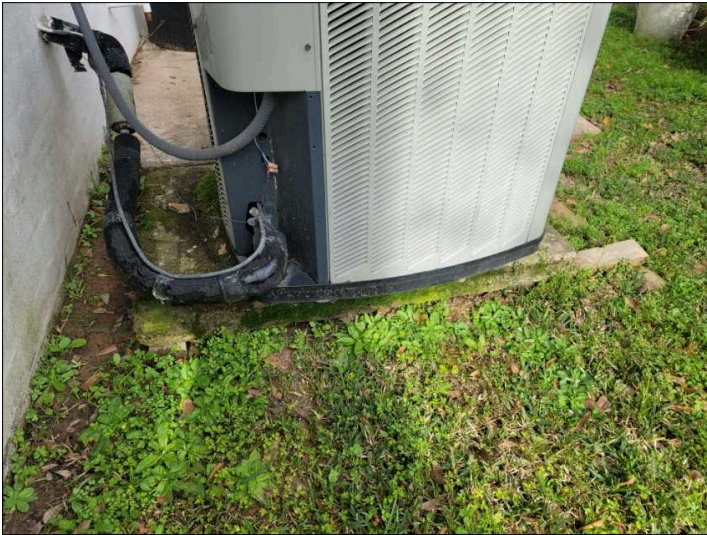
Wood to ground contact under AC unit near left side wall

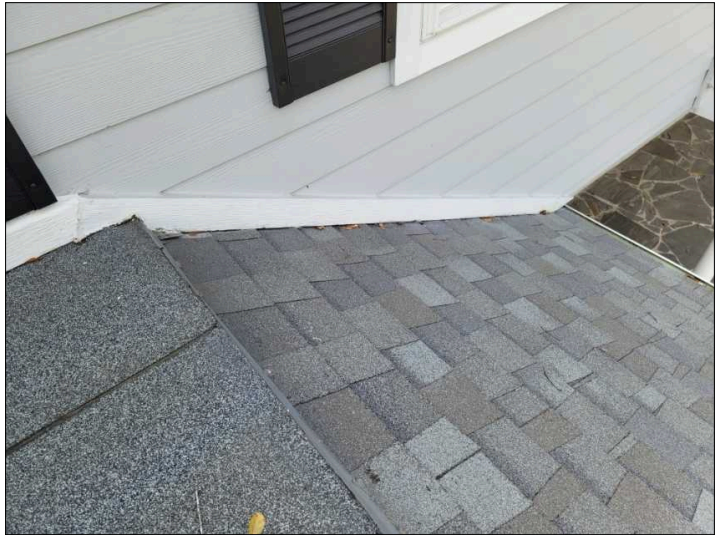
Wall lacks minimum 1" clearance from shingles..front

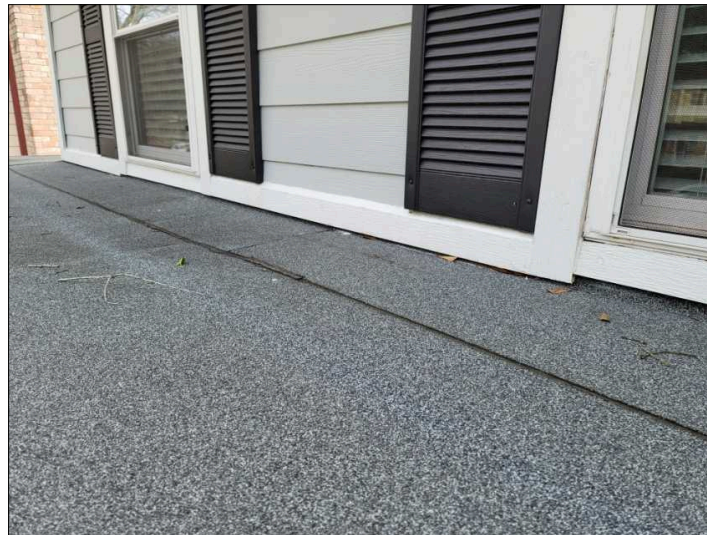
Wall lacks proper clearance from roofing material.. front

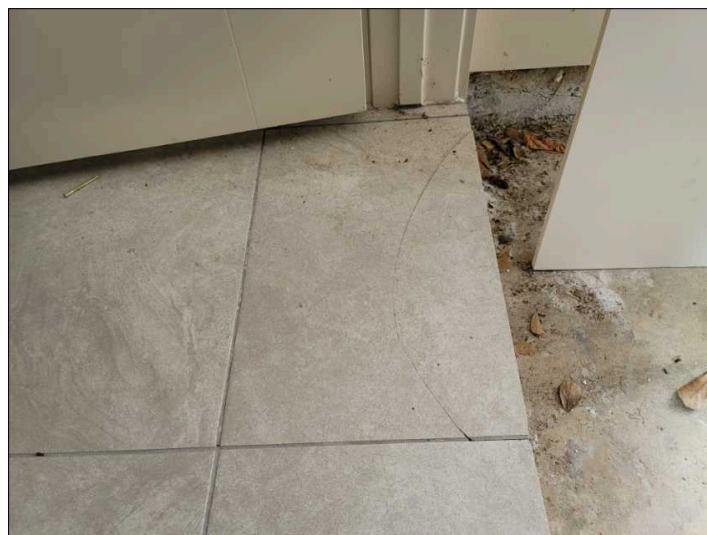
Broken tile.. garage utility room

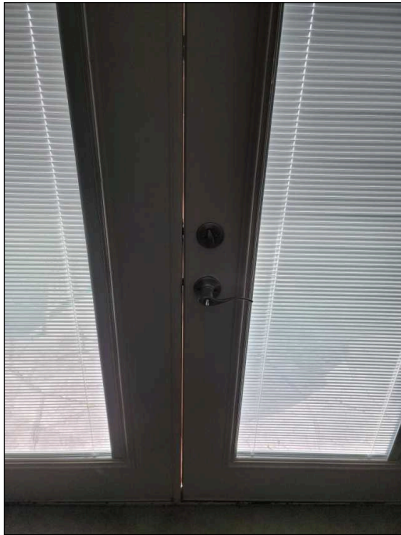
Double doors not sealing..primary bedroom

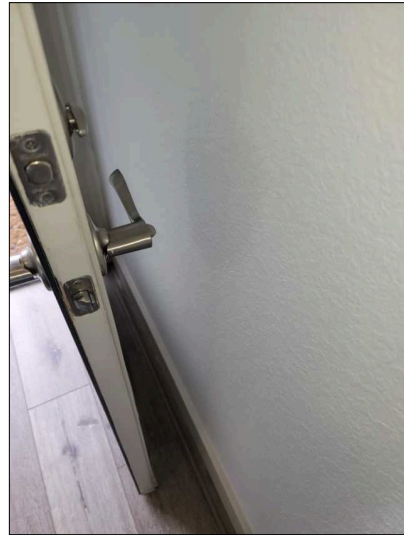
Missing door stop, patched wall.. back door

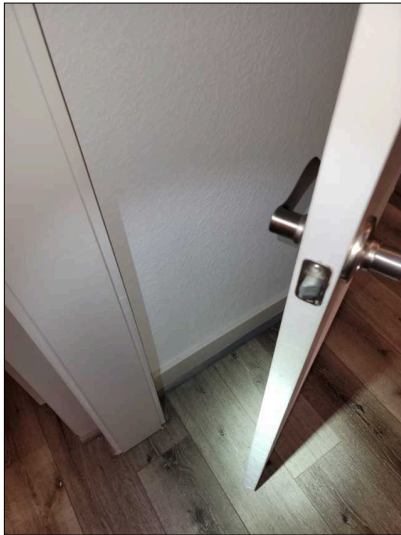
Missing door stop..laundry

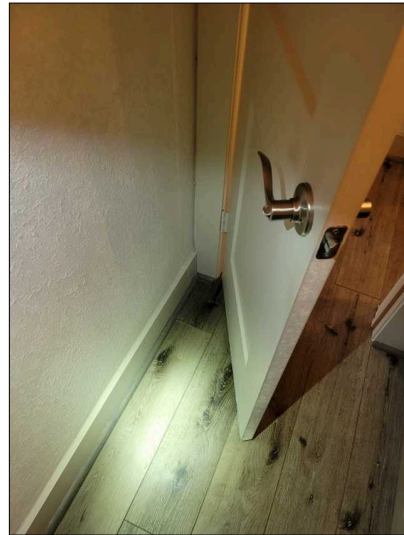
Missing door stop..downstairs half bath

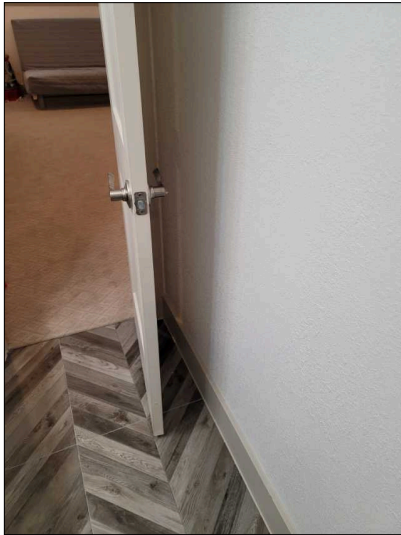
Missing door stop..upstairs rear left bathroom

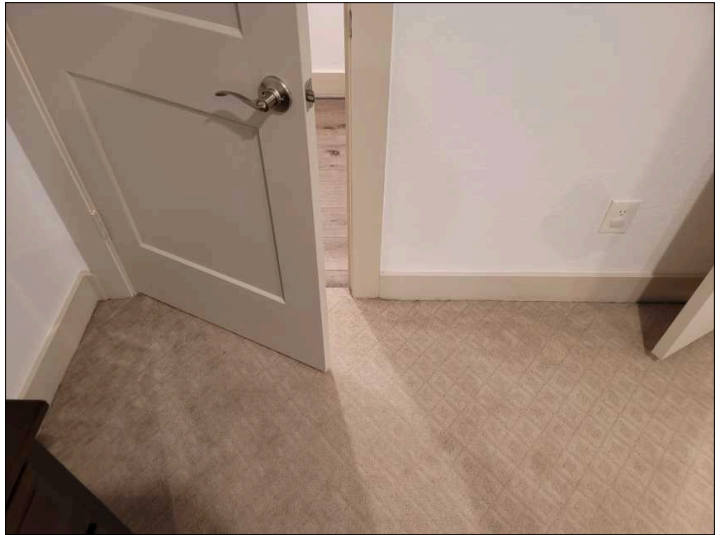
Missing door stops..primary bedroom

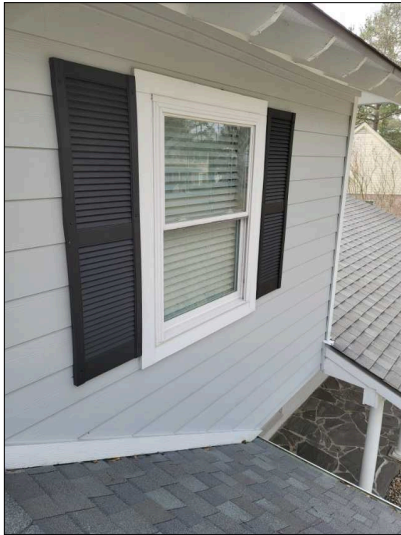
Missing screen..front

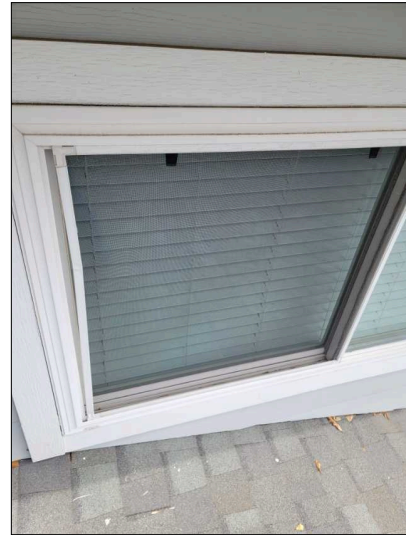
Damaged screen frame.. right side

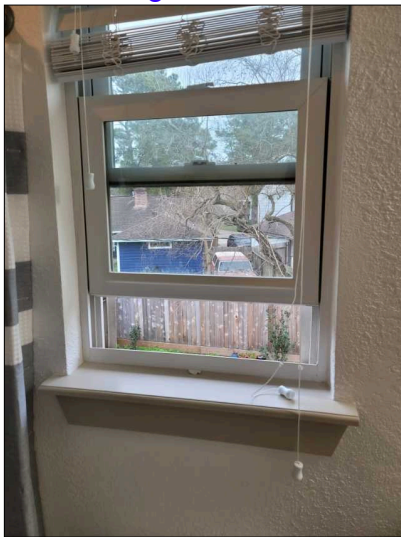
Missing screen..upstairs rear left bathroom

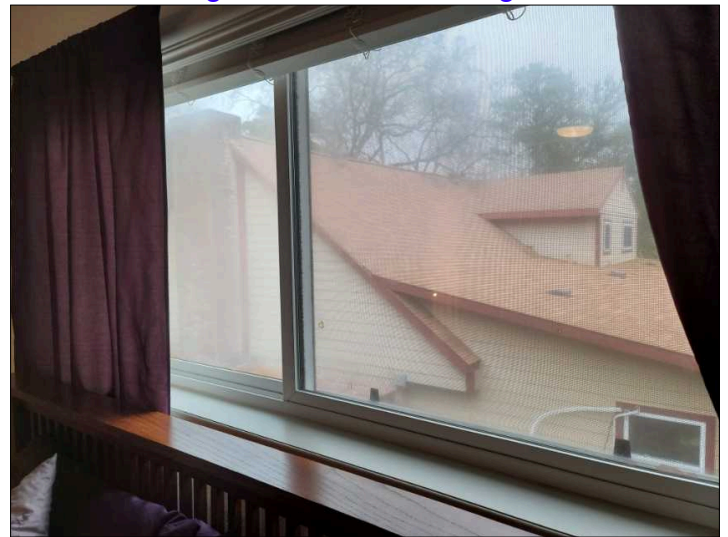
Fogged windows..rear left upstairs bedroom

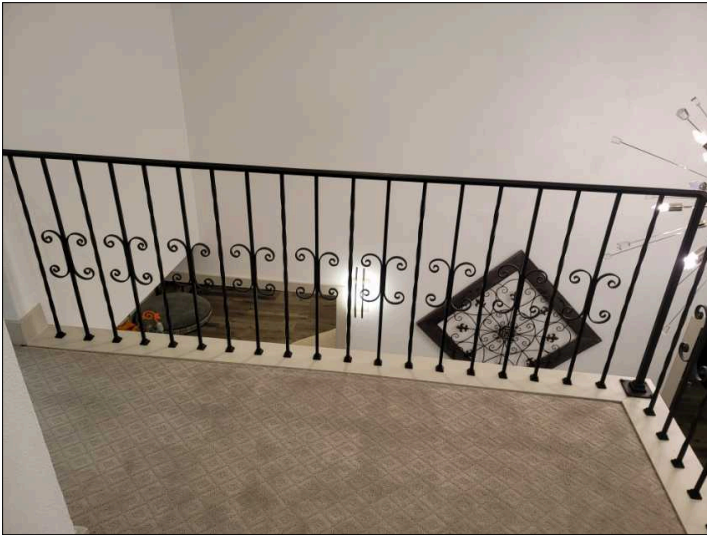
Guardrail balusters too far apart, rail lower than 36"

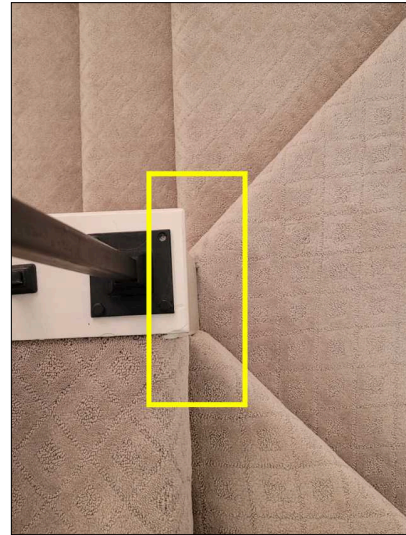
Stairway winder comes to a point, trip/fall hazard

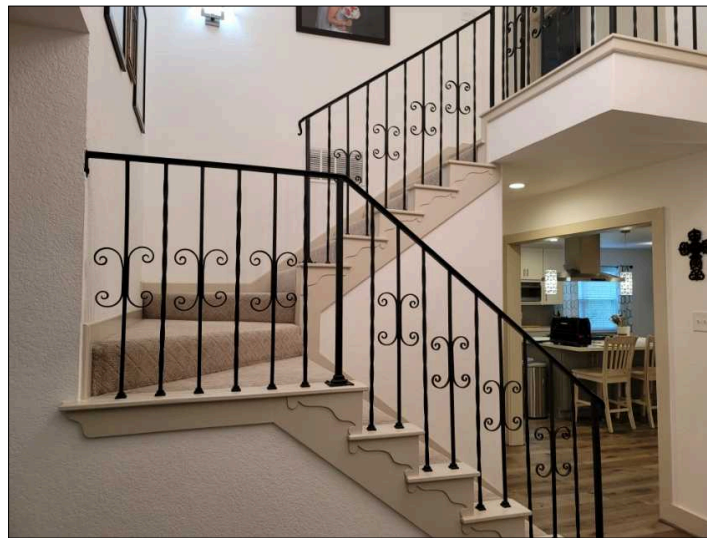
Balusters too far apart

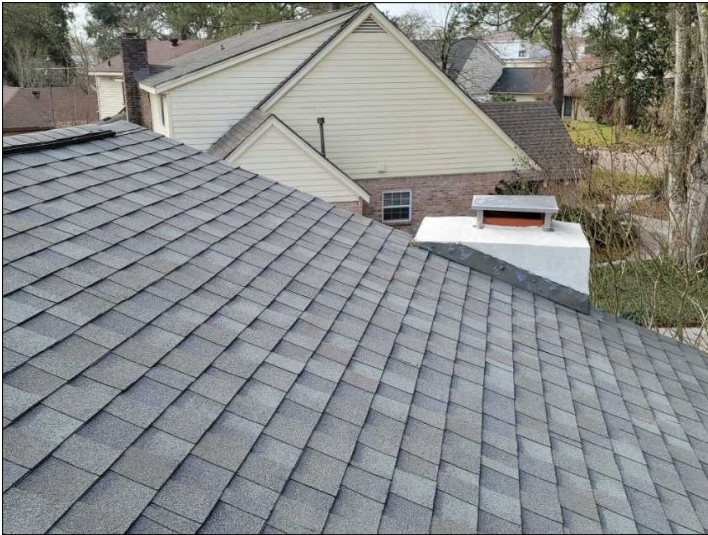
Chimney height inadequate. Should be minimum 3' above shingles and 2' above any structure within 10'

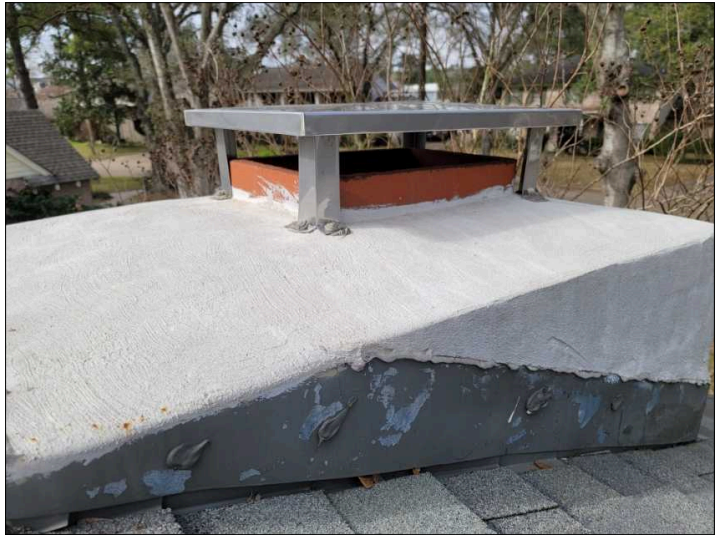
Lacks spark arrestor

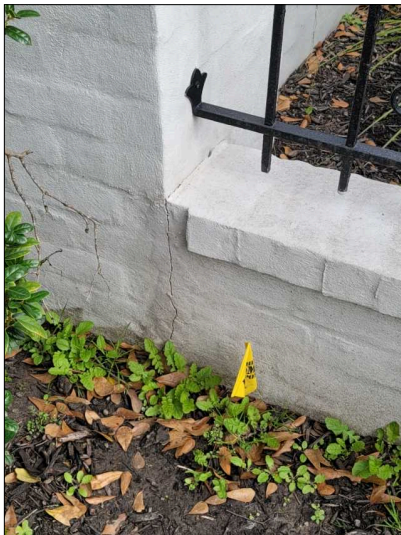
Brick crack at front patio wall.. right side

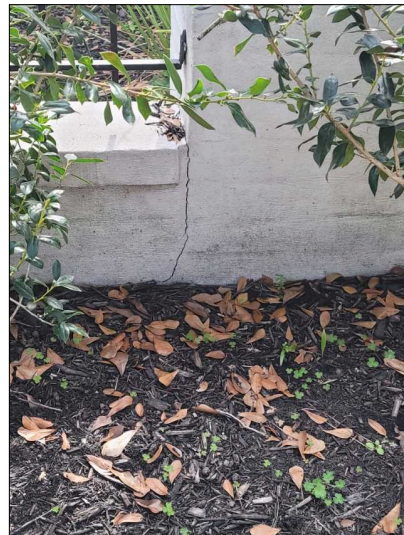
Brick crack at front patio wall.. front

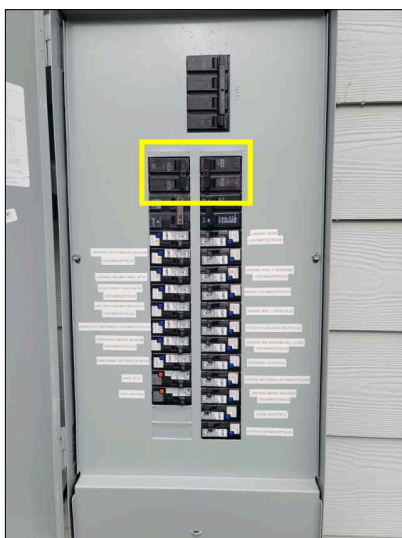
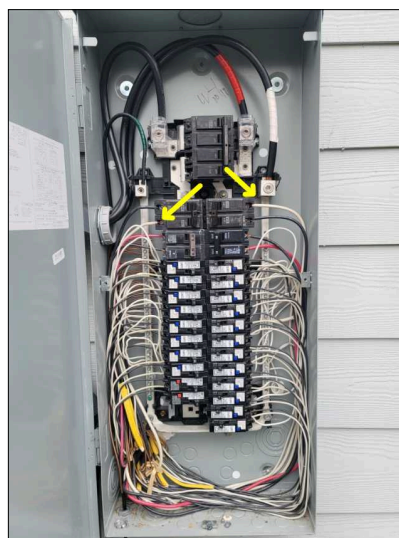
200 amp service panel, missing labels. 50 and 40 amp breakers feed outside AC compressors rated for 40 and 30 amp maximum. Fire hazard. Recommend repair by licensed electrician.

AC white conductors used as hot should be marked red or black

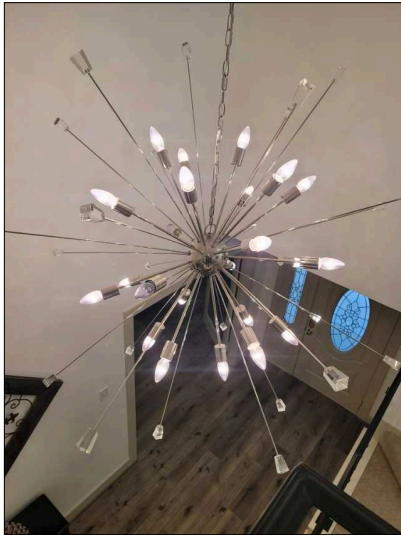
Bulb out.. front entry

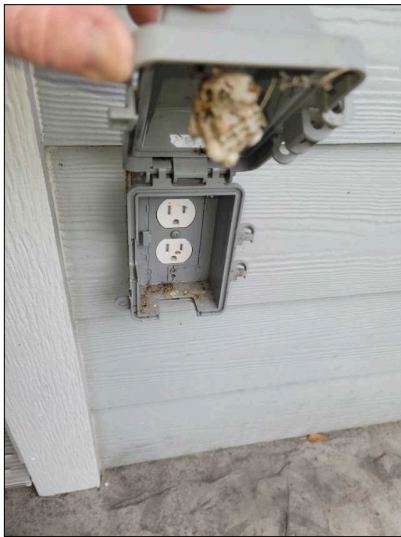
No GFCI protection at outdoor outlet.. rear

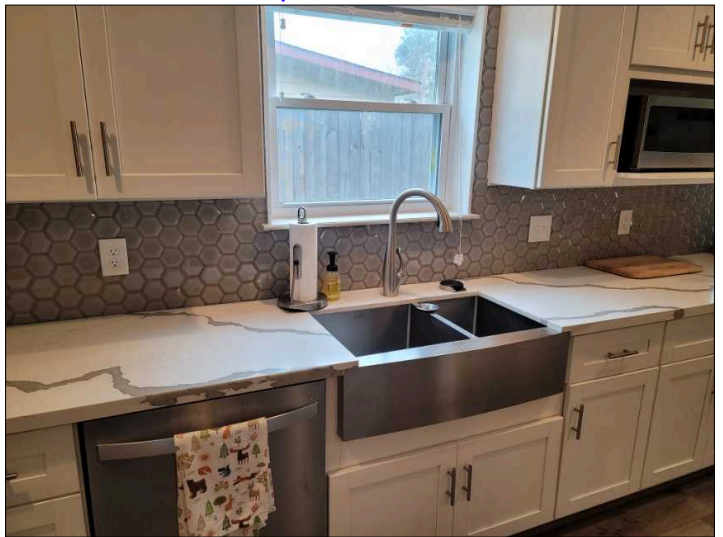
No GFCI protection at kitchen sink outlets, loose right outlet

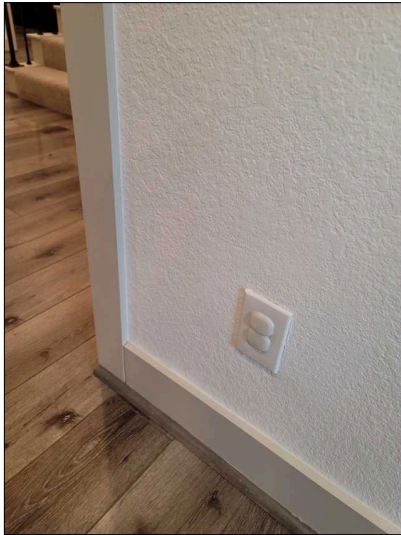
Loose outlet..breakfast area

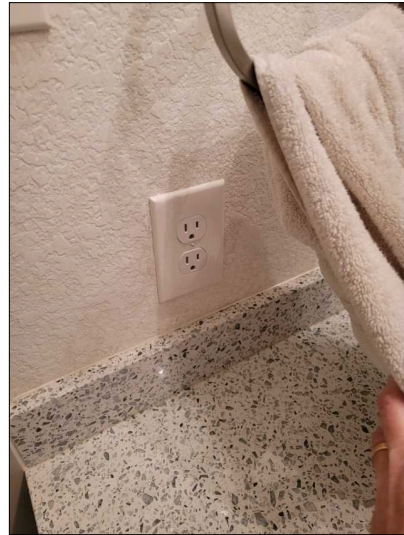
No GFCI protection..downstairs half bath

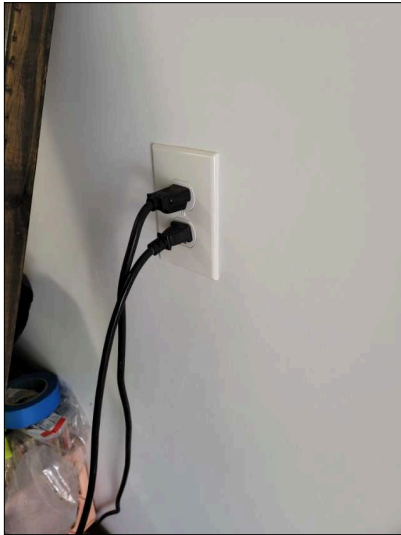
No GFCI protection at garage outlets

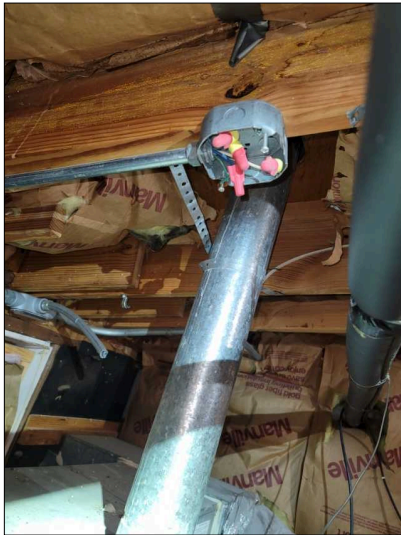
Junction box missing cover..lower attic

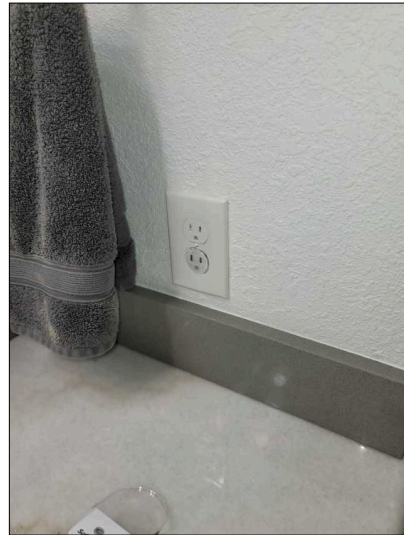
No GFCI protection upstairs rear left bathroom

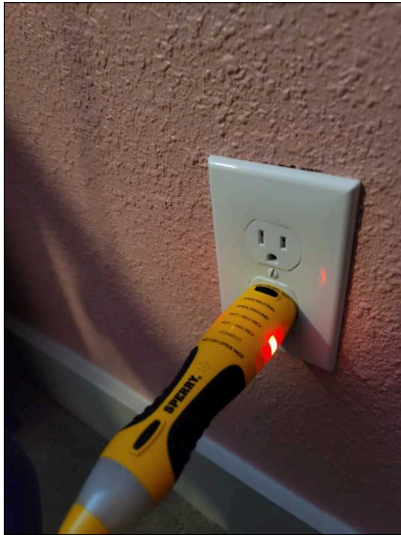
Hot neutral reversed.. front left bedroom

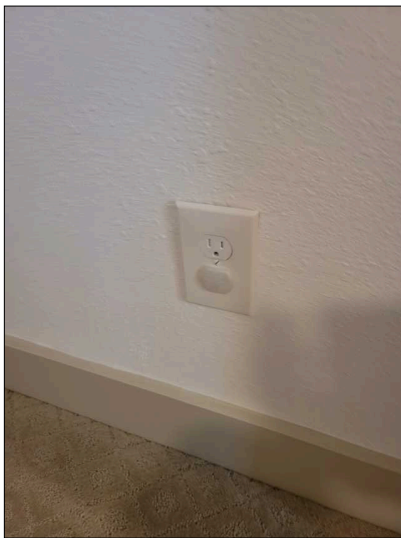
Loose outlet.. rear left upstairs bedroom

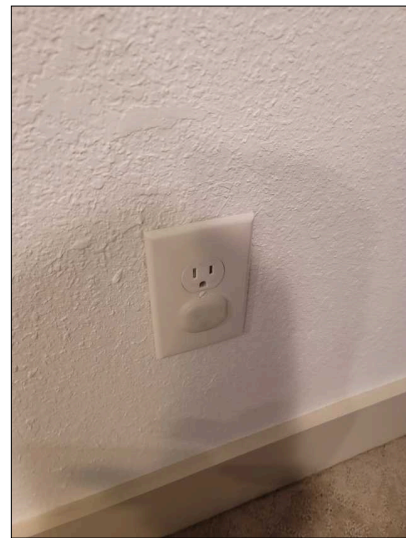
Loose outlet..primary bedroom

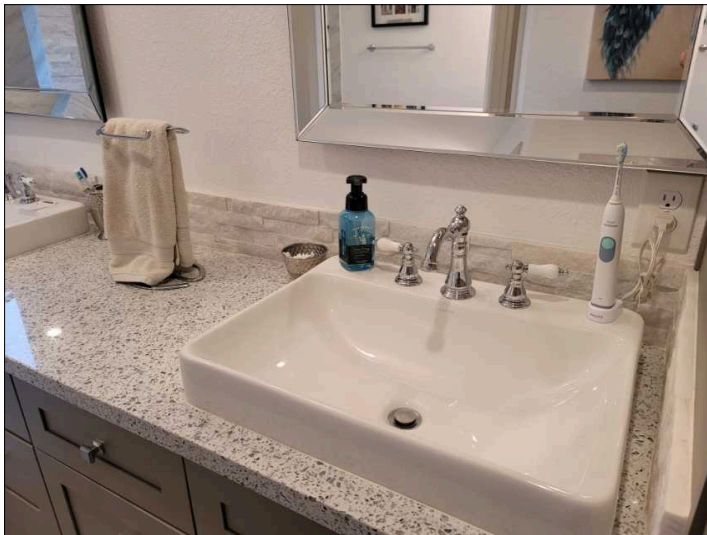
Lack of outlets, no GFCI protection..primary bathroom

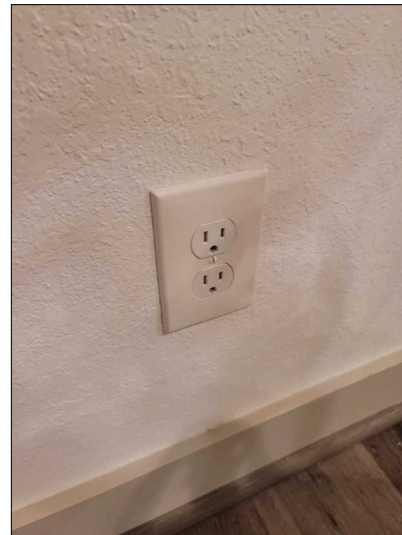
Loose outlet.. living room

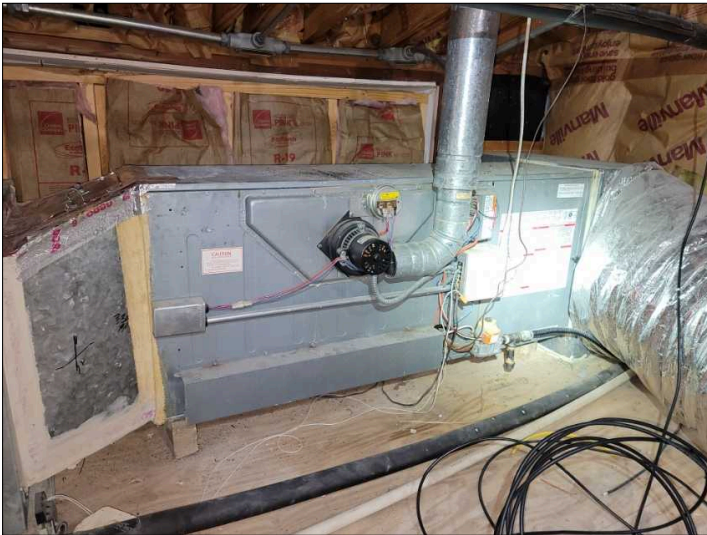
- **Rust / corrosion found on furnace burner tubes. Possible rust corrosion on heat exchanger. Recommend HVAC contractor evaluate both furnaces.**

Downstairs gas furnace (lower attic), old unit, rusted heat exchanger needs to be evaluated by HVAC contractor

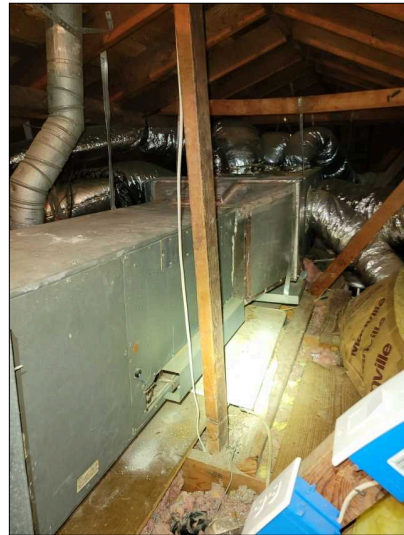
Upstairs gas furnace (upper attic), old unit, rusted heat exchanger needs evaluation by HVAC contractor. Lacks proper access.

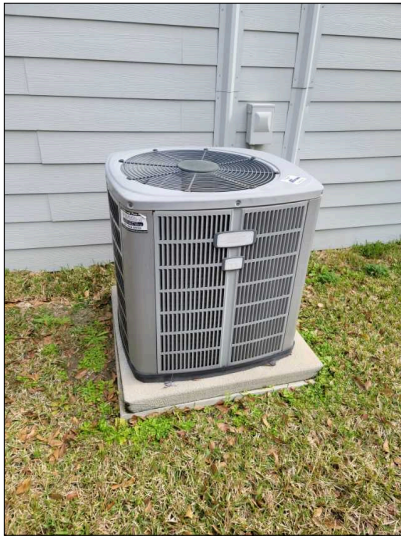
- R-22 refrigerant present. This refrigerant is no longer being used, and may be very difficult to have serviced or parts replaced. Suggest contact with a HVAC contractor to see if unit can be retrofit with R410a or others.

Downstairs (right side) AC compressor, R22 refrigerant, 3 ton unit, manufactured June 2009. Rated for 30 amp maximum, fed by 40 or 50 amp breaker.

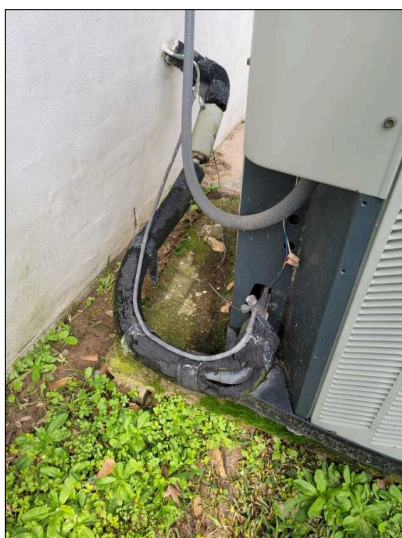
Missing insulation on AC cold line..left side

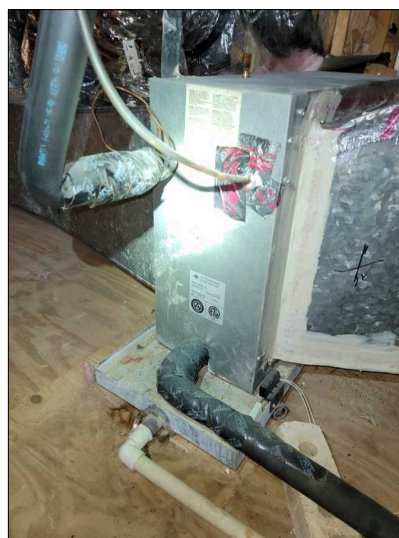
Downstairs AC evaporator coil (lower attic), manufactured April 2004, 8F temperature differential. Lacks secondary drain line

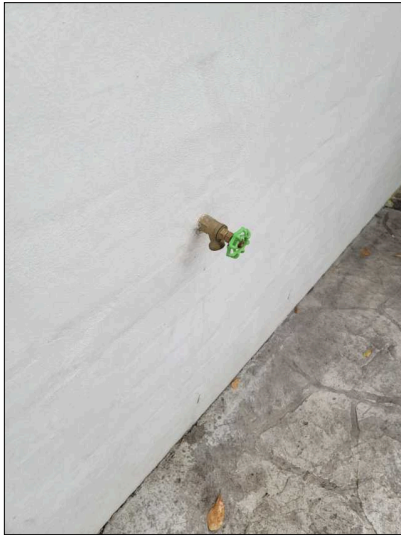
Hose bib lacks backflow preventer..front

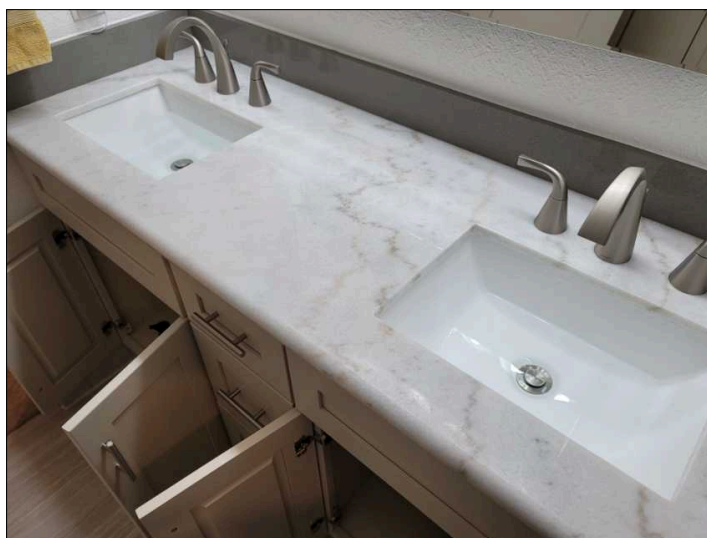
Slow draining sinks in several locations

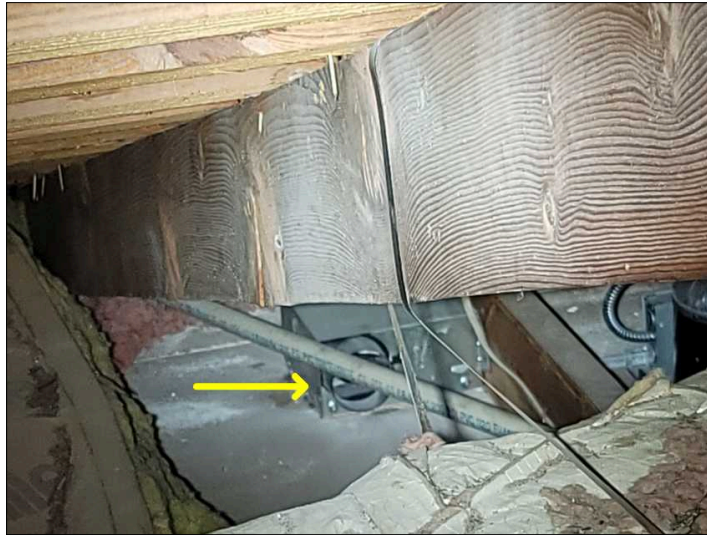
Bathroom exhaust venting into upper attic
