Greg A. Brooks, P.E.
PO Box 2373
Freeport, TX 77542

FOUNDATION INSPECTION REPORT

LOCATION: 51 Orchid Ct
Lake Jackson, TX

DATE OF INSPECTION: Dec 22, 2025

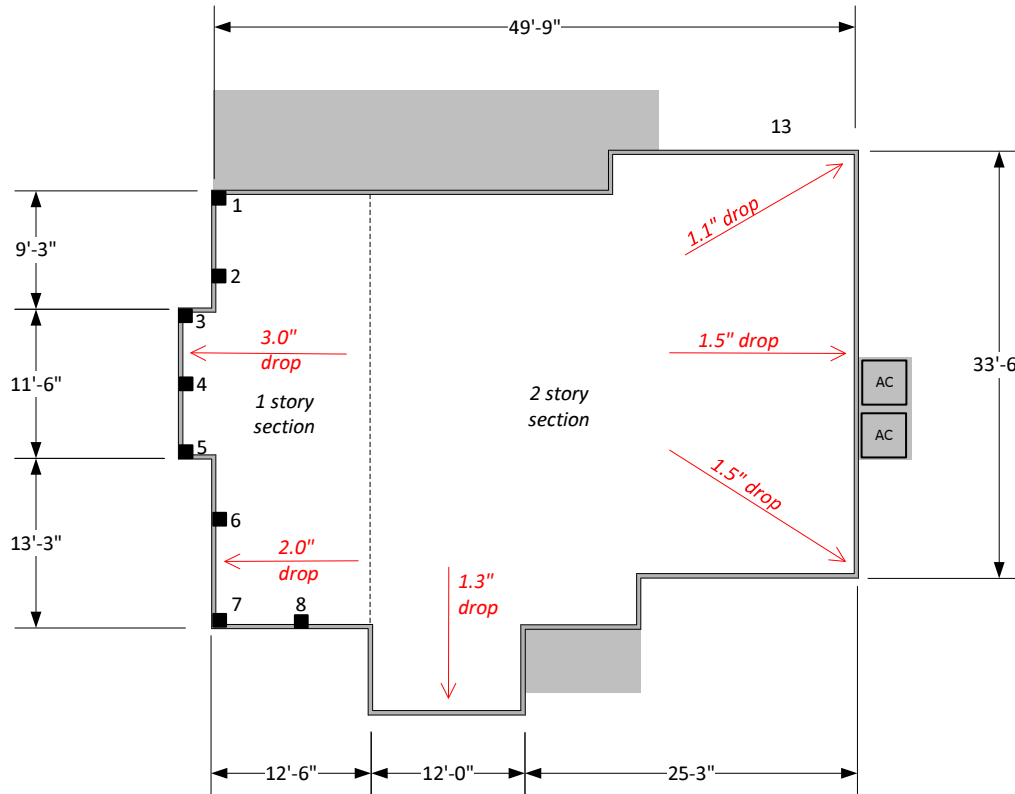
Proposed Pile Placement

Moderate foundation settlement is present along the west perimeter of the structure. Laser level measurements indicate approximately 2.0 to 3.0 inches of settlement in this area. Based on the magnitude of elevation change relative to observed distress, it is likely that a portion of this settlement occurred prior to framing. However, door misalignment and separation at kitchen cabinets indicate that additional movement has occurred since construction. Stabilization of the west perimeter is recommended.

Install eight (8) perimeter pressed piles at the locations shown on the attached drawing. Lifting of the structure is not recommended due to recent remodeling. All work shall be performed in accordance with the details and specifications provided in the attached drawing. These repairs are expected to stabilize the affected portion of the foundation for the remaining service life of the structure.

Piles 1-8 placed as shown on drawing, do not exceed 8'-0" foot spacing between pilings.
