NOBLE PROPERTY INSPECTIONS

PROPERTY INSPECTION REPORT

51 Orchid Ct
Lake Jackson, TX 77566

Rachel Minter <i>Name of Client</i>	12/15/2025 2:00 pm <i>Date of Inspection</i>
51 Orchid Ct, Lake Jackson, TX 77566 <i>Address of Inspected Property</i>	
Jake Bullock <i>Name of Inspector</i>	Professional Home Inspector (#26806) <i>TREC License #</i>
<i>Name of Sponsor (if applicable)</i>	<i>TREC License #</i>

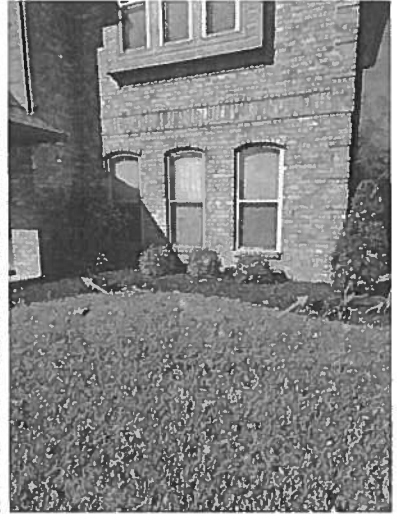
Front Left

Some areas of the foundation are not visible due to overgrowth and the natural ground being built-up too high. In these areas, the inspector is not able to evaluate the foundation from the exterior and is limited to walking the interior for visible foundation problems.

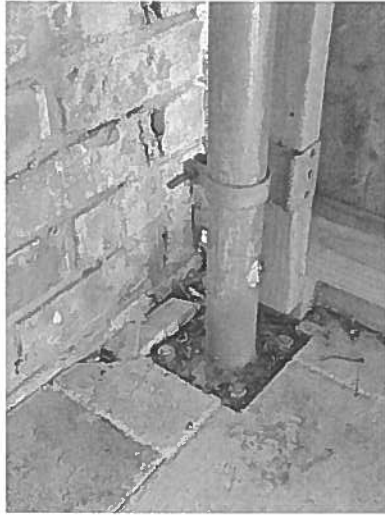
Back Left

Corner cracks are visible in the foundation slab but are of minimal structural concern. Shrinkage is a natural part of the curing process of concrete and cracks located in corners of structures are common. Recommend patching the corner cracks to prevent moisture/pest intrusion. Also recommend monitoring to confirm the cracking does not worsen.

Recommendation: Recommend monitoring.

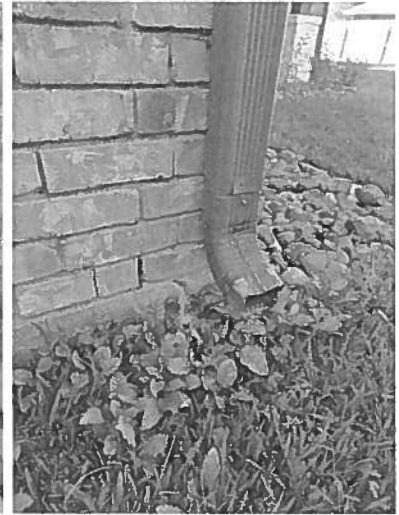
Right Back

The elevation plot resulted in the possibility of foundation issues. It is recommended that an engineering foundation evaluation be performed to ensure elevation, deflection, tilt is computed and analyzed to the Foundation Performance Association (FPA) standards. Inspector is not an Engineer, so engineering level of performance and repair recommendations are limited: recommend contacting Noble for discussion with an Engineer.

Again, the elevation plot did result in the possibility of foundation issues with this structure; elevation differences throughout the structure are considered above normal levels (+2.0 inches). Differences of this magnitude should be further investigated. Recommend involving an Engineer (if not engaging with one at our

Recommendation: Contact a foundation contractor.

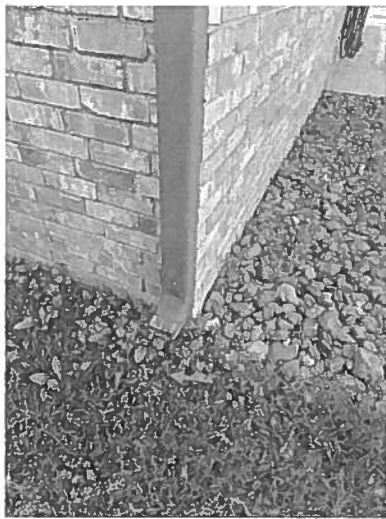
Back Right

Some or all of the gutter downspouts are missing splashblocks. Splashblocks help to disperse the water away from the foundation and prevent erosion of soils. Recommend installation.

Recommendation: Recommended DIY Project

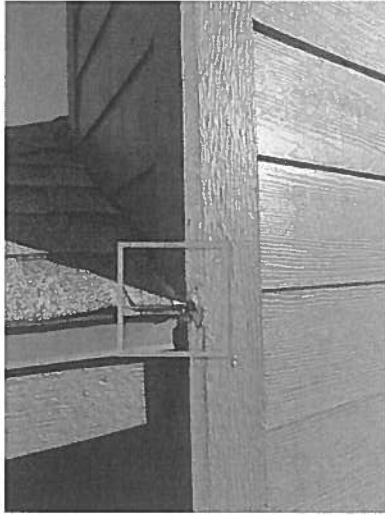
Chimney Left Back

1: Wood rot

Recommendation: Contact a qualified general contractor.

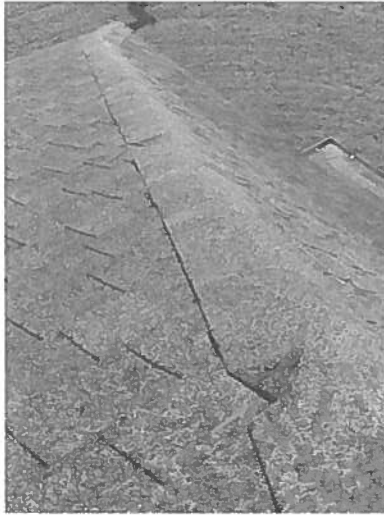
Top Front Right

The asphalt shingle roof shows signs of delamination. Delamination is separation of the surface layer of asphalt on the shingle and can be a normal aging process of any roof. It is not always a sign of roofing shingle failure unless it is progressive and the severity does not match the age of the roof. Recommend monitoring the delamination for future issues.

Recommendation: Contact a qualified roofing professional.

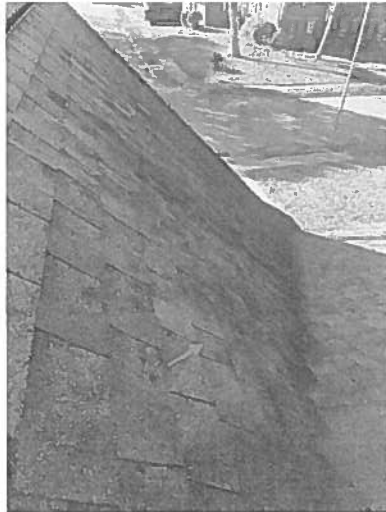
Garage Left

Roof shingles were discolored, which can be caused by moisture, rust or soot. Recommend a qualified roofing contractor evaluate and remedy with a roof cleaning or repair.

Recommendation: Contact a qualified roofing professional.

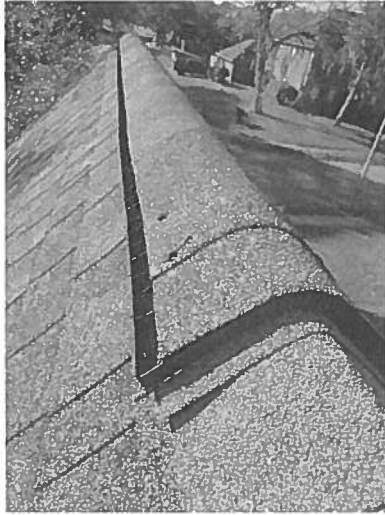
Garage Back Middle

Under-driven or exposed nails were found in one or more roof coverings. Recommend a qualified roofer evaluate and correct.

Recommendation: Contact a qualified roofing professional.

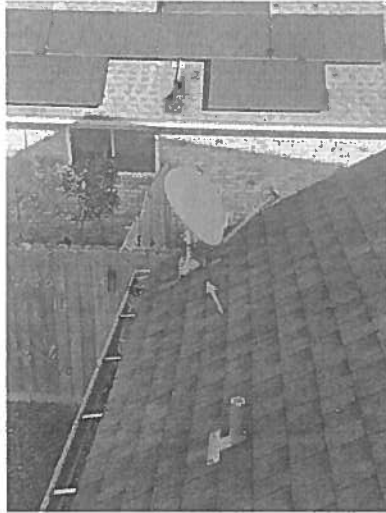
Back Right

Satellite is mounted to roof structure. This could allow for water intrusion at penetrations. Recommend Satellite be relocated and penetrations repaired.

Recommendation: Contact a qualified roofing professional.

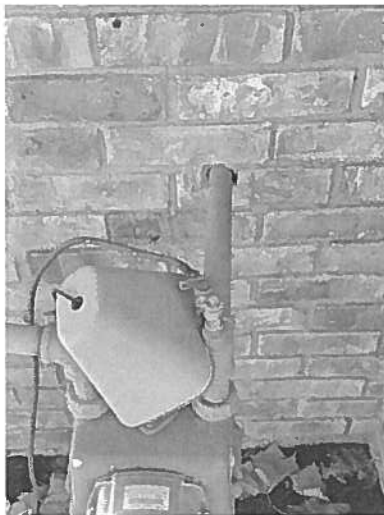
Left Back

Caulking is necessary to seal gaps less than 1/2-inch. Caulking that is missing can provide for water penetration and allow insect access into the structure.

Recommendation: Contact a qualified general contractor.

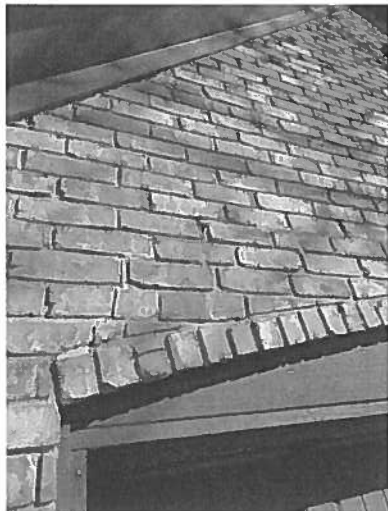
Garage Front Left

structural cracks). Recommend monitoring and discussing with the owner the possibility of previous foundation work completed. Monitor these areas for future cracking.

Recommendation: Recommend monitoring.

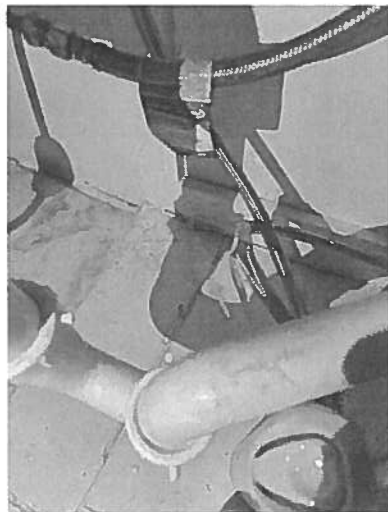
Kitchen Sink

One or more areas of the cabinet show signs of rotting wood. This is caused by continual water inundation or active leaking of the plumbing fixtures from above. Recommend replacement of the cabinetry and further evaluation for active moisture issues and signs of mold.

Recommendation: Contact a qualified cabinet contractor.

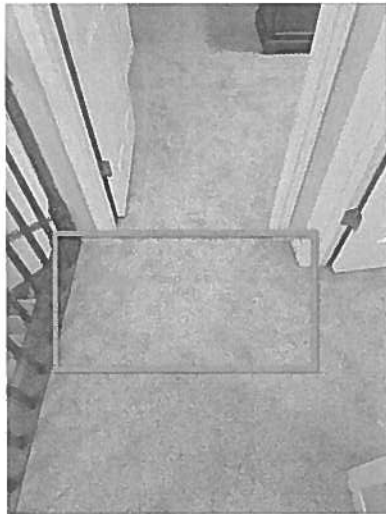
2nd Floor Hall Left

The flooring is spongy, moves, and/or squeaks as weight is distributed across it. This is typically a sign of weakness in the underlying joists, rotting subfloor, or separation of the flooring from the subfloor. A flooring contractor is recommended for further evaluation.

Recommendation: Contact a qualified flooring contractor

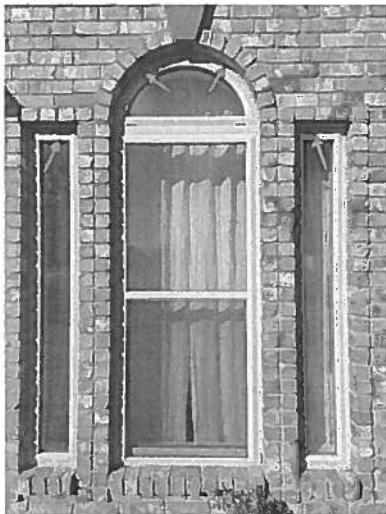
Front Middle

The property has windows that have aged, cracked, and/or missing caulking that should be replaced. Inspector notes noticeable gaps around most/all windows of the property. This can lead to water penetration and insect intrusion. Windows should be recaulked with a silicone based sealant.

Recommendation: Contact a qualified window repair/installation contractor.

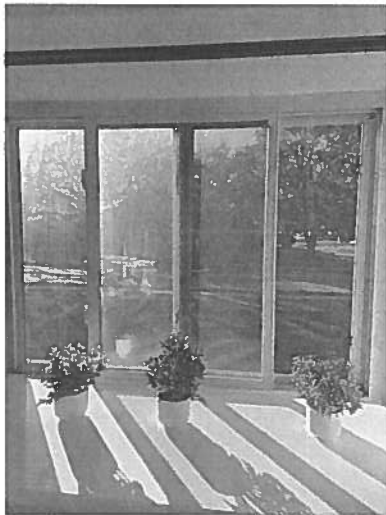
Kitchen Left Front

One or more windows are difficult to open. This could be caused by a number of reasons, including structural deficiencies that apply force to the frame, windows have broken springs, or windows that are off their track(s). Recommend windows be restored to functional use by an window repair and installation contractor.

Recommendation: Contact a qualified window repair/installation contractor.

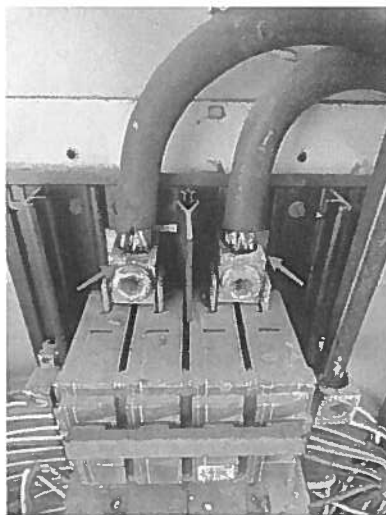
Conductor antioxidant termination paste/gel/compound is used on termination connections of aluminum wires to an electrical breaker panel. The substance gets used to retard oxidation at the conductor/connector interface and protect the aluminum from lowered conductivity. Primary service wires into the lugs of a electrical panel should have antioxidant the substance applied to the wires. Recommend an electrician remove the conductors and add.

Recommendation: Contact a qualified electrical contractor.

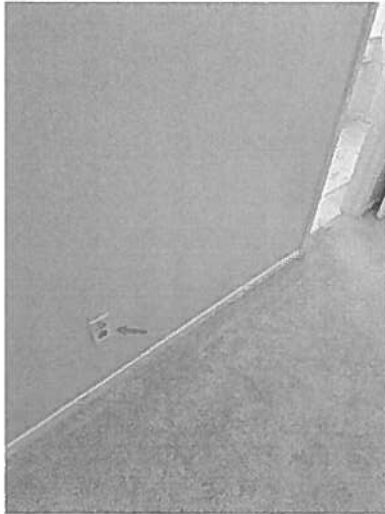
2nd Floor Hall Left

An outlet is loose and not securely fastened to the gang-box and/or the structure behind the sheetrock. Loose outlets will become worse over time as contact points start to wear down and wires bend back and forth. Loose outlets can eventually lead to broken wires, dead circuits, flickering lights, or other electrical problems (including electrical fire). Recommend an electrical contractor tighten the outlet so it does not move.

Recommendation: Contact a qualified electrical contractor.

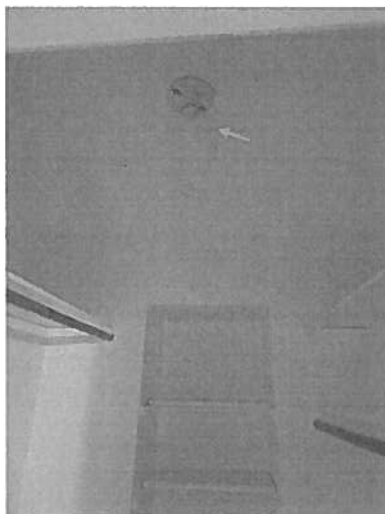
2nd Floor Back Left Bedroom Closet

One or more lighting fixtures failed to illuminate (fixtures did not turn on when nearby switches were activated). It is advised to further evaluate by replacing bulbs and/or consulting with the property owner. If changing bulbs proves ineffective and/or no additional switch(es) can be found, then recommend that a qualified electrician examine and repair or replace light fixtures.

Recommendation: Contact a qualified electrical contractor.

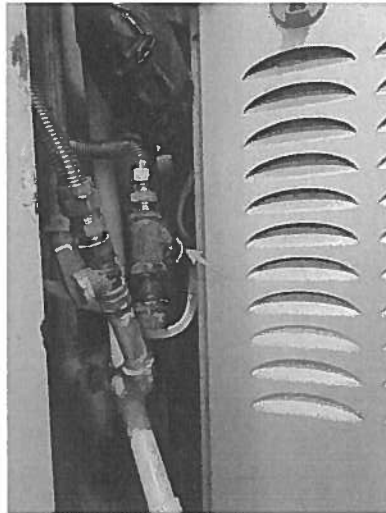
1st

Inside blower fan, evaporator unit, and/or furnace was corroded in one or more areas. There are significant areas of rust and zinc oxide deposits. This could be the result of improper venting, which the source would need to be identified. Recommend a HVAC contractor evaluate and repair.

Recommendation: Contact a qualified HVAC professional.

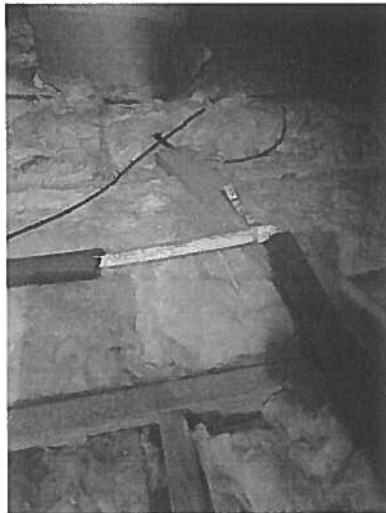
2nd

Missing or damaged insulation on the condensation drain line can cause damage to equipment and/or an overflow if the space reaches freezing temperatures. Recommend contacting an HVAC professional to replace the missing or damaged insulation.

Recommendation: Contact a qualified HVAC professional.

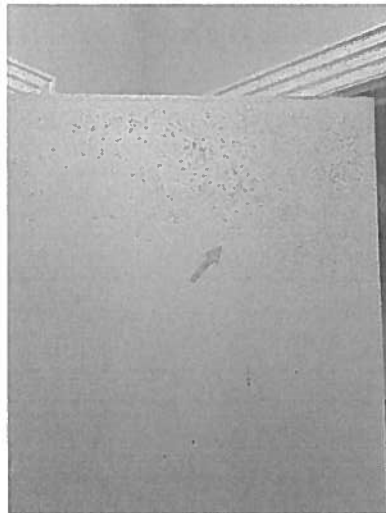
1st

Mildew (or black mildew-like substance) is present in areas of HVAC evaporator. Areas that have mildew are often higher in moisture content and will need to be cleaned more frequently. Recommend cleaning areas with a antimicrobial and possibly testing for the presence of mold.

Recommendation: Recommended DIY Project

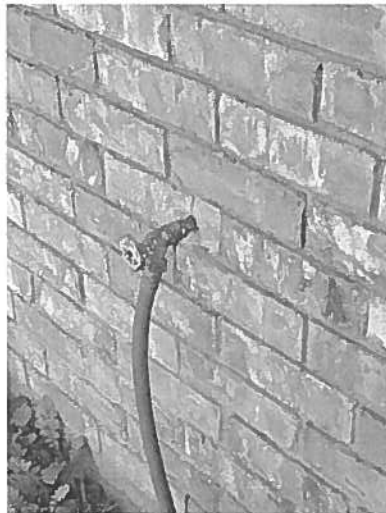
Right Front

The water spigot is missing insulation. Some owners decide to install thermal protection as necessary when freeze warnings are in-place. Client should consider installing insulation on piping that is permanent and will help prevent pipe burst.

Recommendation: Recommended DIY Project

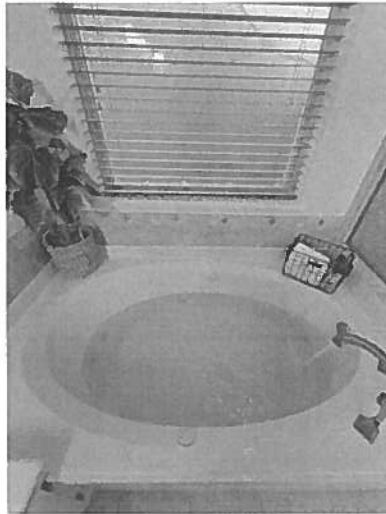
Hydro massage tubs should have a GFCI trip breaker installed at a receptacle to lower the risk of electrocution. These are commonly located in the master closet or the toilet room at a distance from the tub itself. No GFCI trip breaker was discovered.

Recommendation: Contact a qualified electrical contractor.
