Report V1.0

# Engineer's Foundation Evaluation

51 Orchid Ct, Lake Jackson, TX, 77566

On 12/15/2025 a foundation evaluation was performed at the property located at address 51 Orchid Ct, Lake Jackson, TX, 77566, which consists of a 2614 square-foot single family attached structure built in 1989 (36 years old) with a slab on grade foundation.

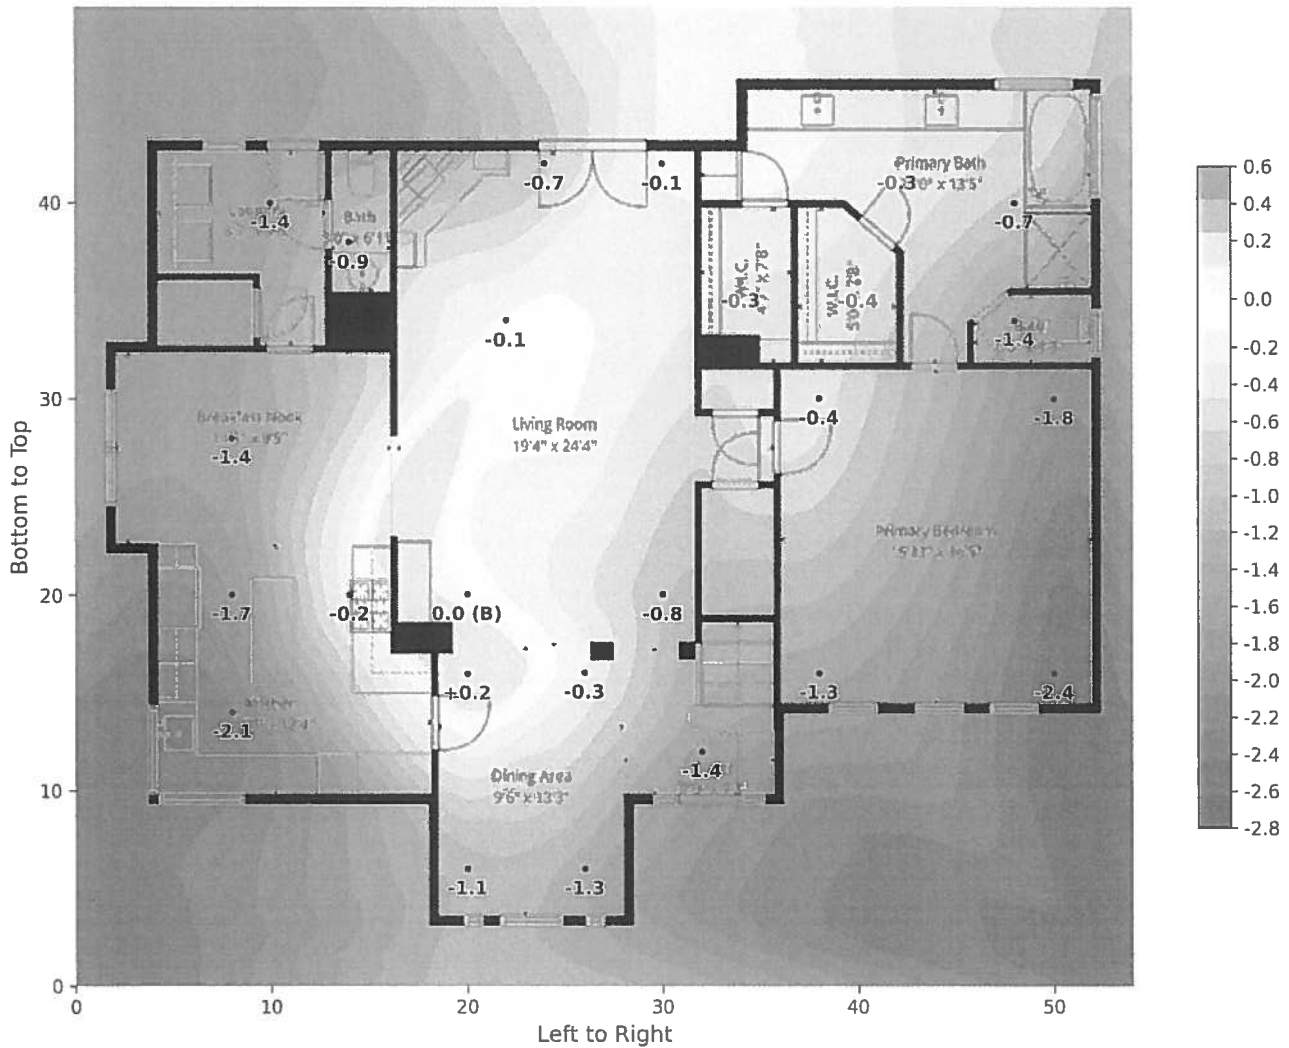
**Elevation Plot Graphic (Figure A)**

The elevation plot resulted in the graphic as depicted above in Figure A. The red-points and areas are elevation measurements that were lower than the base station elevation (0.0). The green-points and areas are elevation measurements that were higher than the base station elevation (0.0). The blue-points (and white areas) are equal to the base station elevation (0.0). The base station is depicted with a (B) symbol. The elevation plot takes into account differences in flooring thicknesses. The maximum elevation point was determined to be 0.2 inches and the minimum was -2.4 inches, resulting in an elevation difference of 2.6 inches of difference across the structure.

Elevation differences across the structure are the first indicator that a foundation problem may or may-not exist. As documented above, the maximum elevation point of this structure was determined to be 0.2 inches and the minimum was -2.4 inches, resulting in an elevation difference of 2.6 inches of difference across the structure. The elevation plot takes into account differences in flooring thicknesses. The elevation deflection across an entire structure should, best-case-scenario, remain within 0.5 to 1-inch depending on the age of the structure. Measured differences approaching 2-inches are an initial sign of possible foundation fatigue. The maximum allowable elevation difference is subjective, depending on other factors such as the visual condition, size, and age of the structure (36 year(s) old) along with how the foundation performs when calculating deflection and tilt.

Based on observed elevations of the foundation from the elevation plot, the elevation differences do not fall within industry standards and tolerable limits. These findings indicate that the foundation does not have consistent and uniform elevation measurements. Note: elevation measurements alone is not the only indicator of foundation problems; see the deflection and tilt calculations (and the report's overall conclusion) for a complete understanding of foundation stabilization. If elevations fall outside of industry standard/tolerable limits, it is a first indicator that the foundation will fail in deflection and/or tilt.

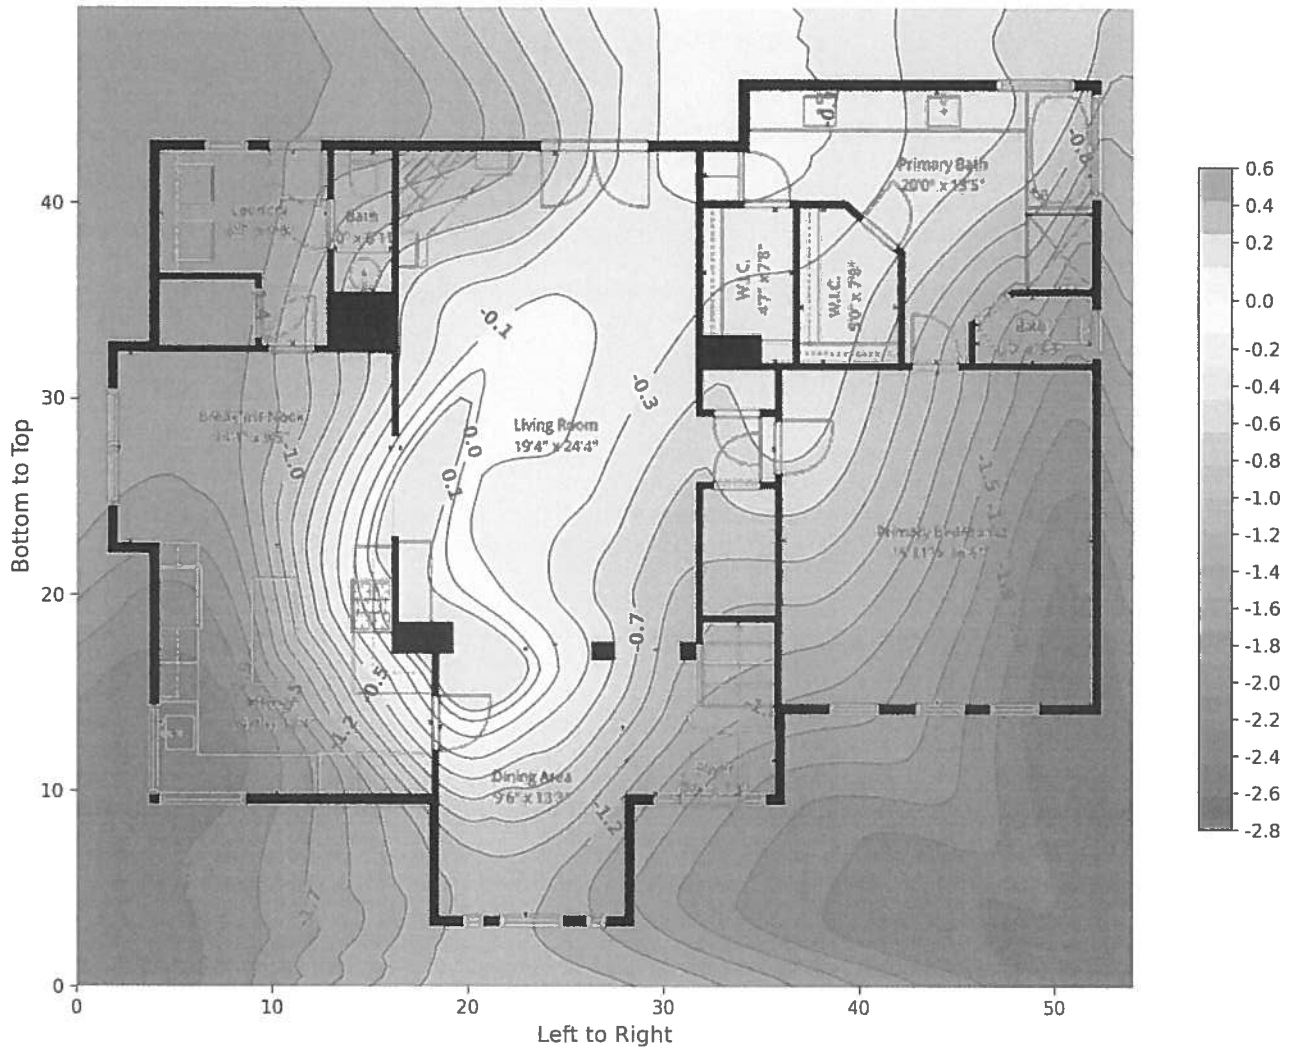
**Mesh Contour Graphic (Figure B)**

The mesh contours graphic depicted above in Figure B is similar to the elevation plot. The red, green, and white areas depict areas that are lower, higher, and equal to the base station elevation (0.0). The lines or contours (similar to map topography) are labeled at specific intervals.

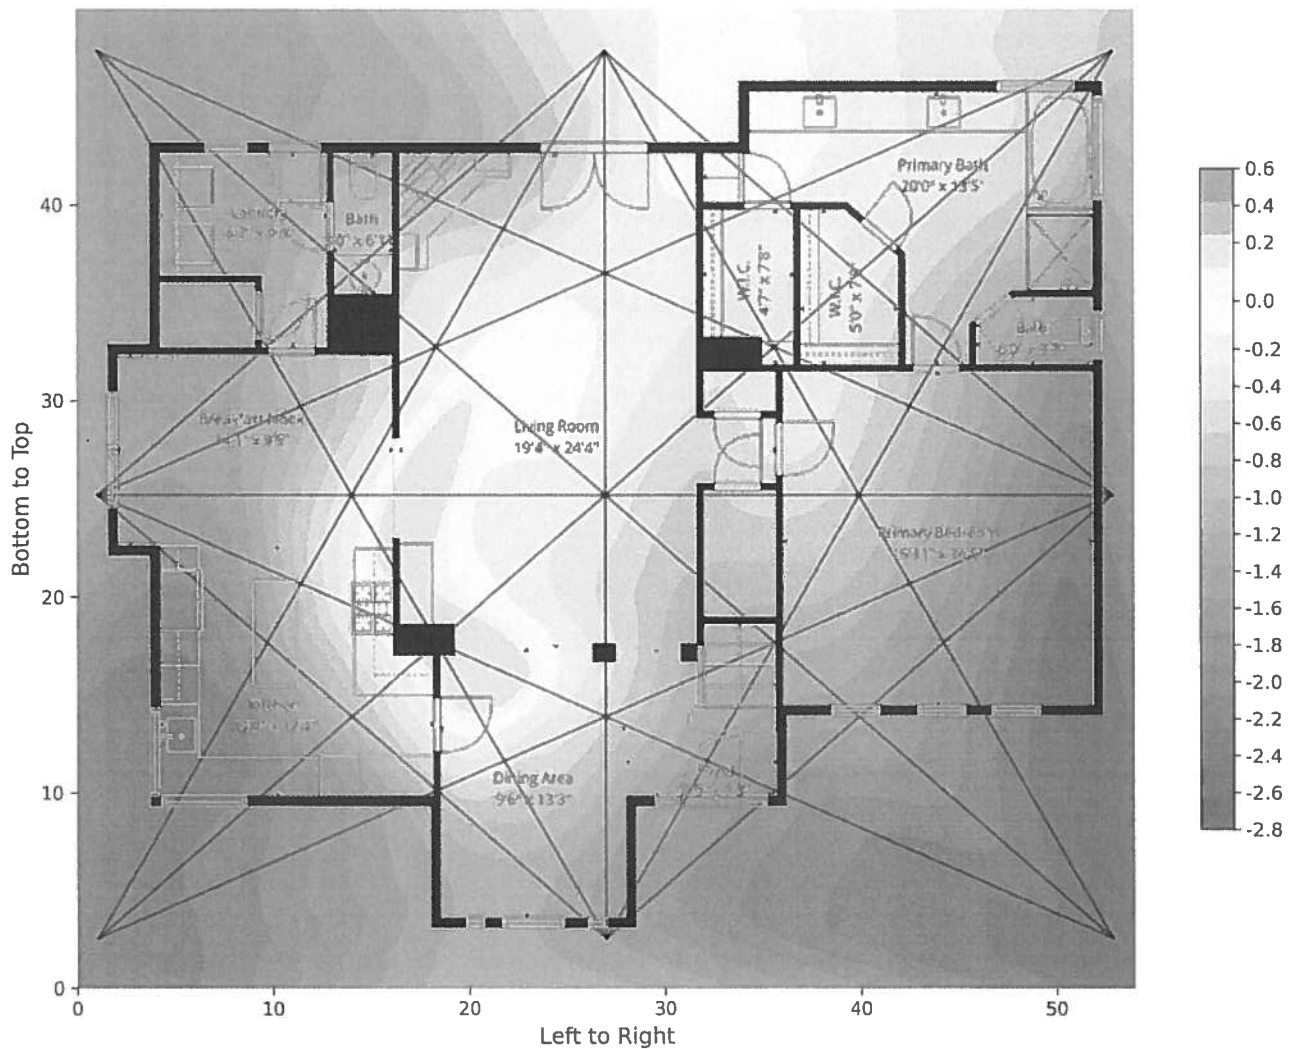
**All Profiles Graphic (Figure C)**

Below is a graphic that shows the locations of deflection and tilt profiles that were calculated. The total profiles calculated was 16 with a total usable profiles (above the effective length threshold) of 16.

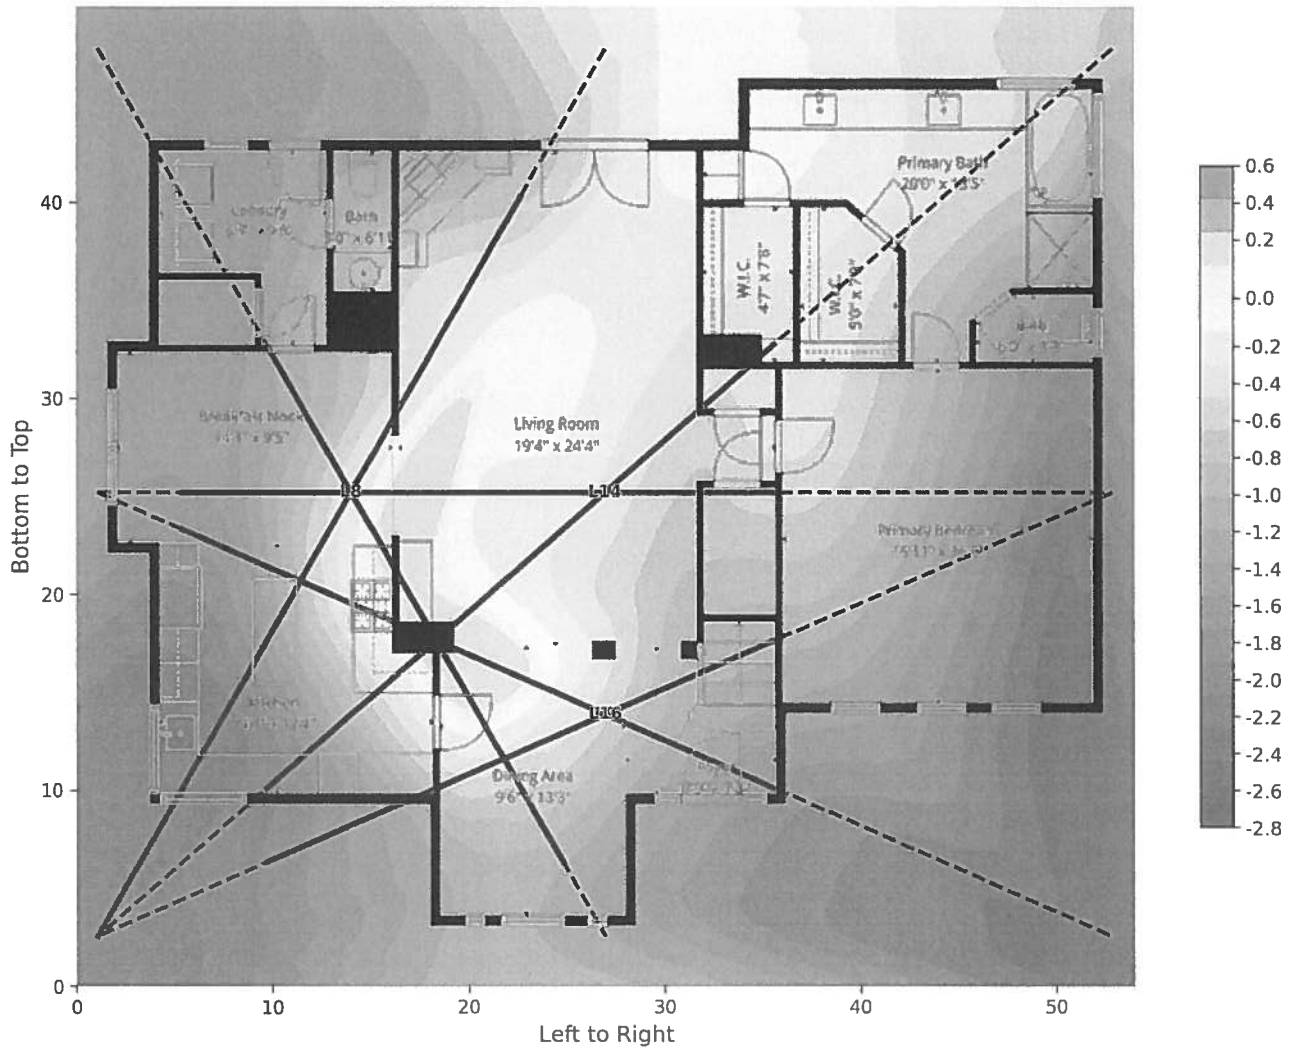
**Deflection Failures Graphic (Figure D)**

The above Figure D shows deflection failures along the foundation. Deflection failures can be considered localized failures in (sometimes) isolated portions of the foundation. The profile lines that were calculated are represented by a dashed black line and the areas that the deflection failures occur are represented by a dark red line segment. Of the 16 deflection profiles calculated, 6 profile failures were identified.

Deflection failures can be considered localized failures of the foundation in (sometimes) isolated portions of the foundation. Of the 16 deflection profiles calculated, 6 failures were identified.

Deflection failures are above standard acceptable limits; they exceed industry-standard thresholds and the structure should be considered actively moving/settling in areas where deflection failures are occurring. See the report's overall conclusion for a complete understanding of the overall foundation stabilization issue.

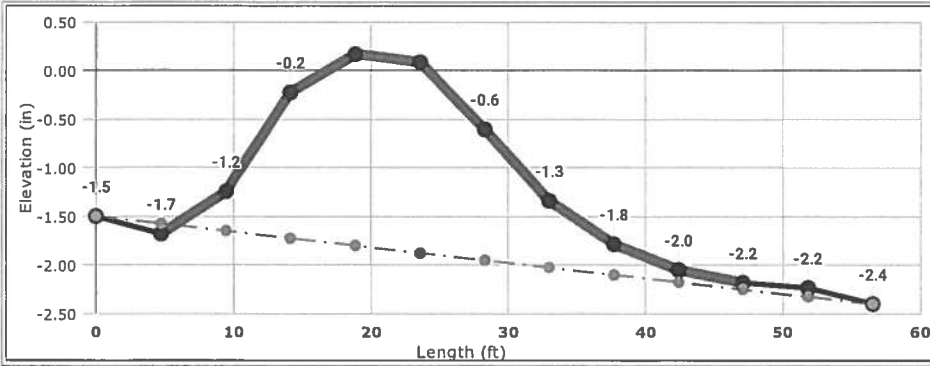
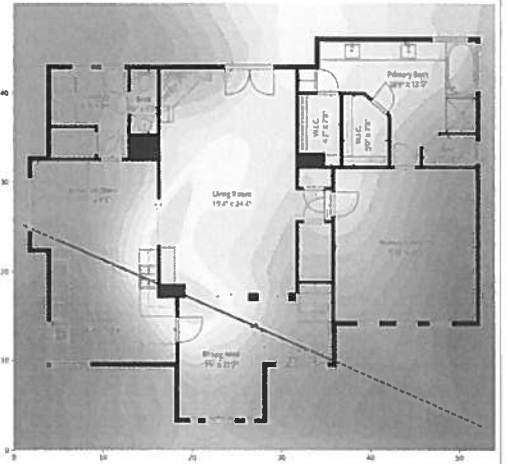
## Exhibit B: Identified Deflection/Tilt Failure (L9)

Profile Data for L9		Actual Length (ft)											Effective Length (ft)	
Point (#)	1	2	3	4	5	6	7	8	9	10	11	12	13	20
Length (ft)	0	5	9	14	19	24	28	33	38	42	47	52	57	
Tilt (in)	-1.5	-1.6	-1.6	-1.7	-1.8	-1.9	-1.9	-2.0	-2.1	-2.2	-2.2	-2.3	-2.4	
Z (in)	-1.5	-1.7	-1.2	-0.2	0.2	0.1	-0.6	-1.3	-1.8	-2.0	-2.2	-2.2	-2.4	
Deflection 1 (Failures)			-1.2	-0.2	0.2	0.1	-0.6	-1.3						
Deflection 2 (Failures)		-1.7	-1.2	-0.2	0.2	0.1	-0.6	-1.3						
Deflection 3 (Failures)			-1.2	-0.2	0.2	0.1	-0.6	-1.3						
Deflection 4 (Failures)		-1.7	-1.2	-0.2	0.2	0.1	-0.6	-1.3	-1.8	-2.0				
Deflection 5 (Failures)			-1.2	-0.2	0.2	0.1	-0.6	-1.3	-1.8	-2.0	-2.2
