16418 Teak Dr

Missouri City, Texas 77489

Client	--
Reference id	a4xPd000002uskXIAQ
Type	Home Inspection and Floor Plan Report - 16418 Teak Dr
Inspected by	HomeTeam Inspection Service - North Houston
State license	TREC 20811
Scheduled	October 11, 2025, 5:00 PM
Completed	October 12, 2025, 12:18 AM

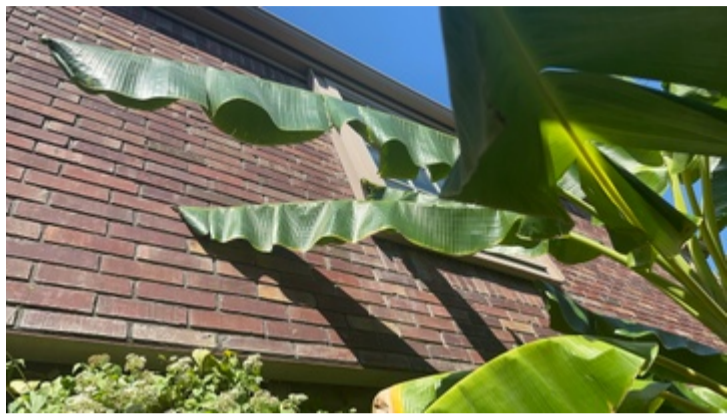
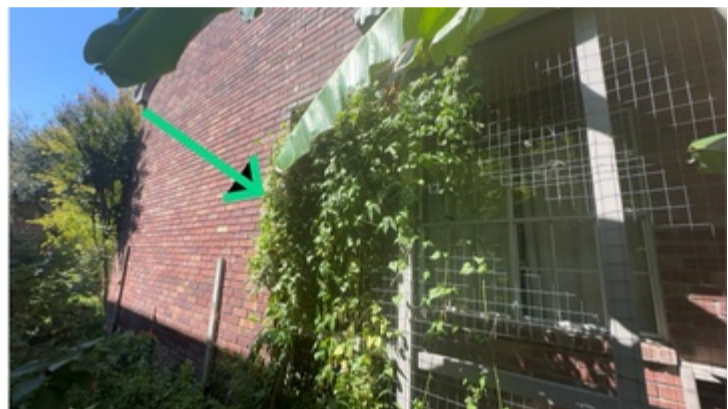
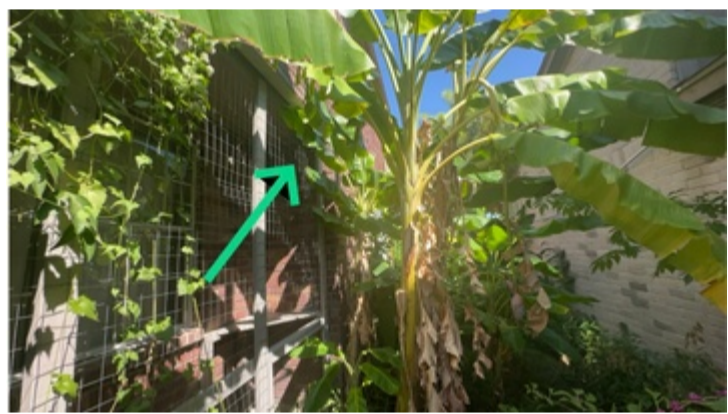
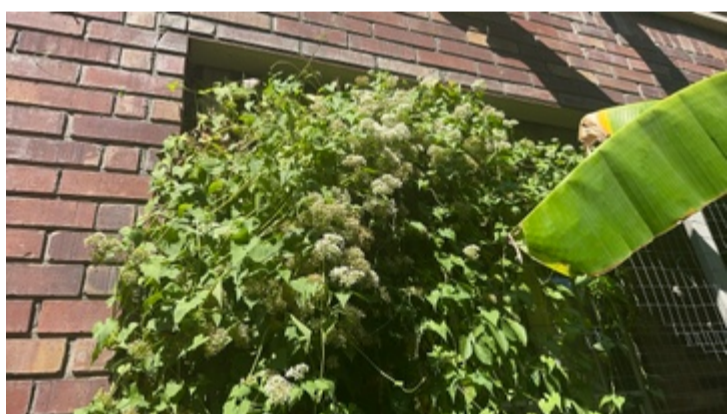
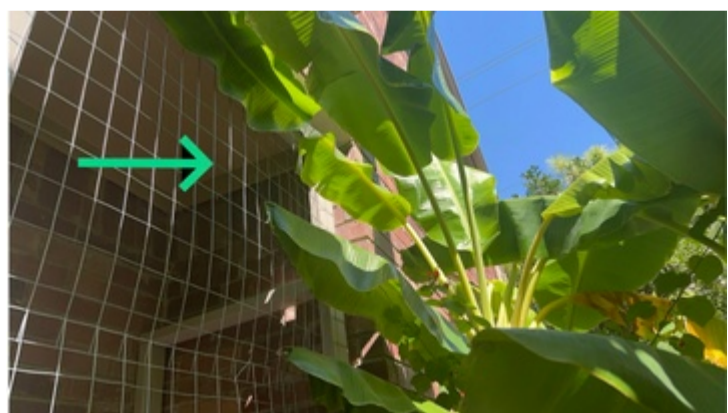
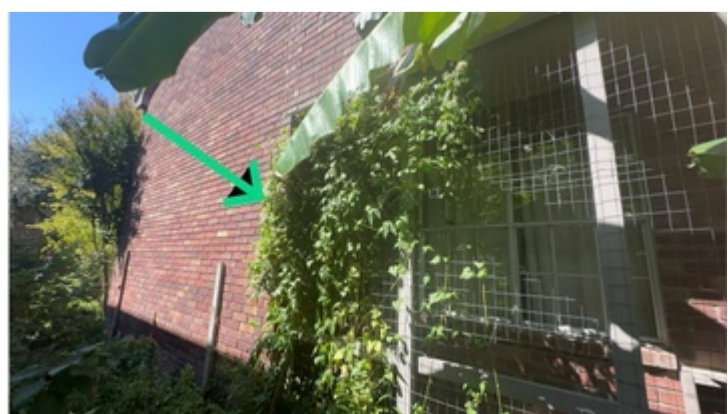
There is vegetation too close to the structure. Recommend monitoring this, and further evaluation by a qualified professional.

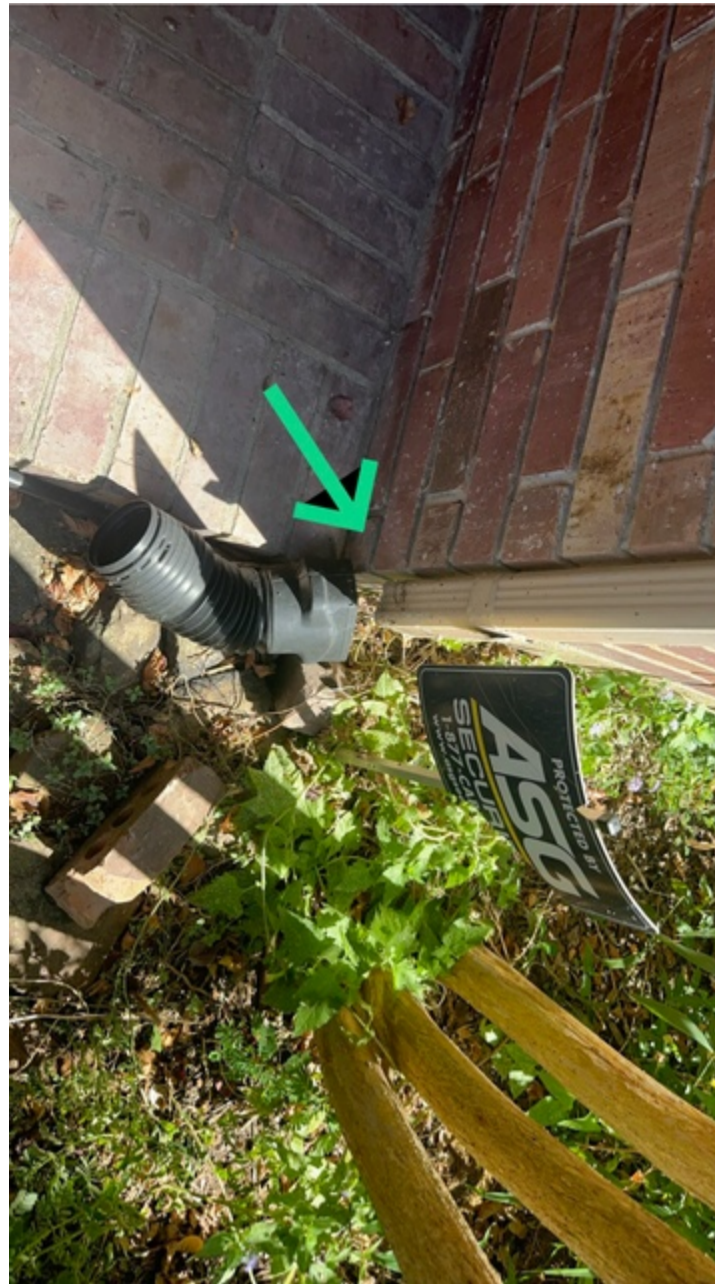
Missing downspout elbow joint.

One or more downspouts are missing the elbow joint. Recommend repairs or replacing by a qualified professional.

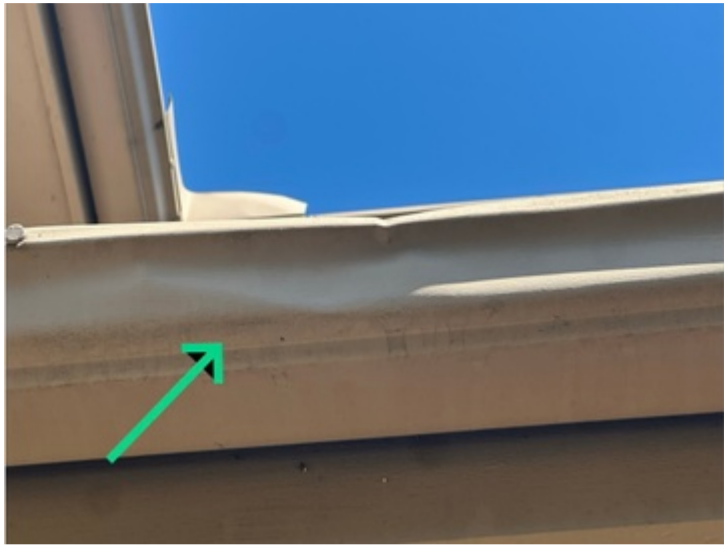
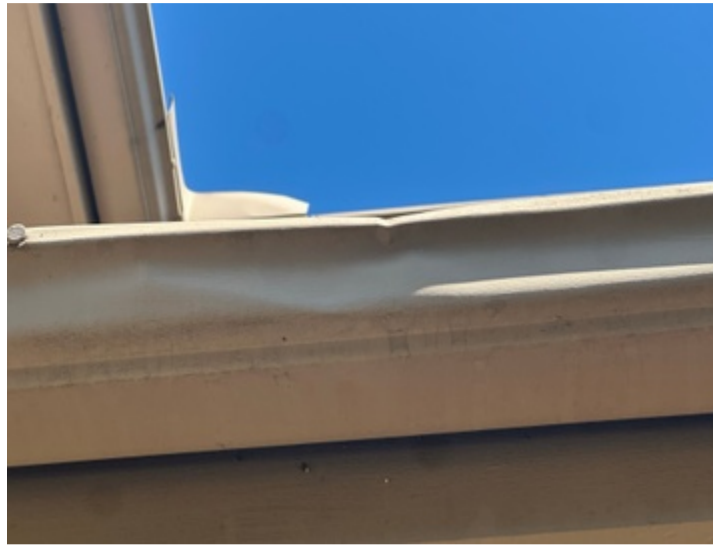
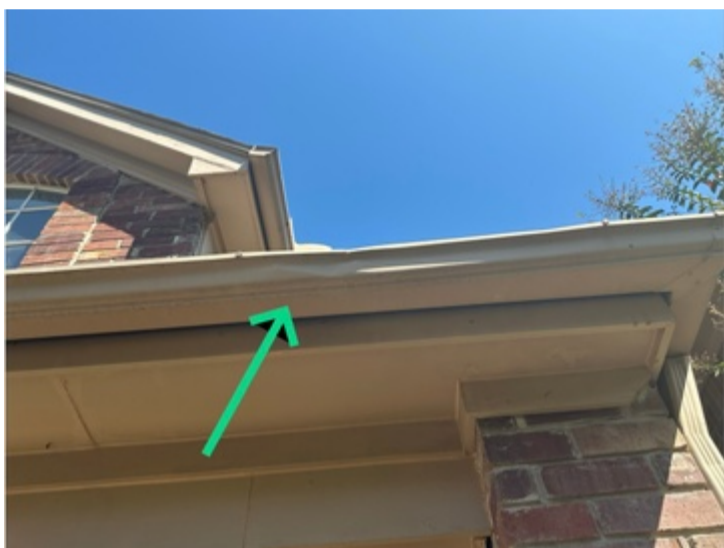
Damaged Gutters

The gutters are damaged. Recommend further evaluation by a qualified professional.

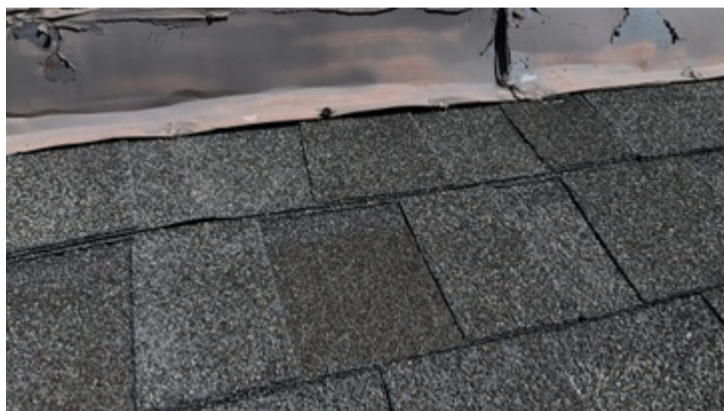
There are exposed fasteners for the flashing. Recommend repairs or replacing by a qualified professional.

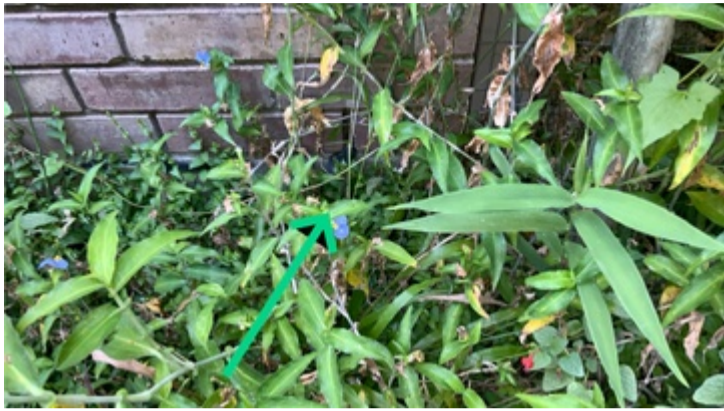
There are areas of high soil around the foundation.

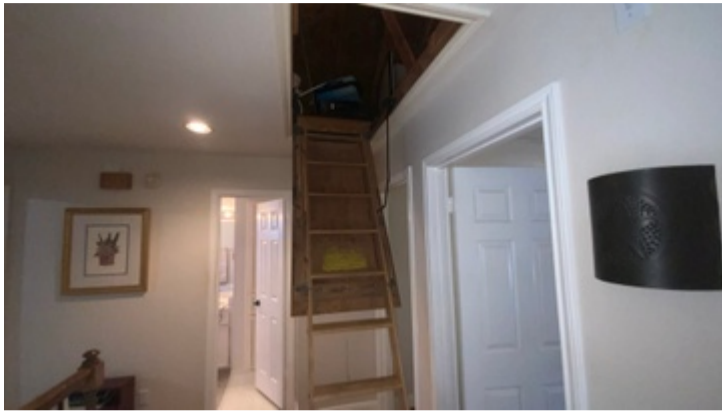
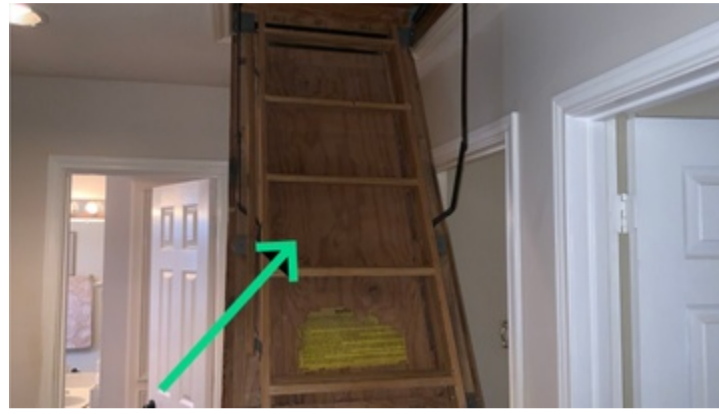
The attic pull-down stairs are not insulated. Recommend repairs or replacing by a qualified professional.

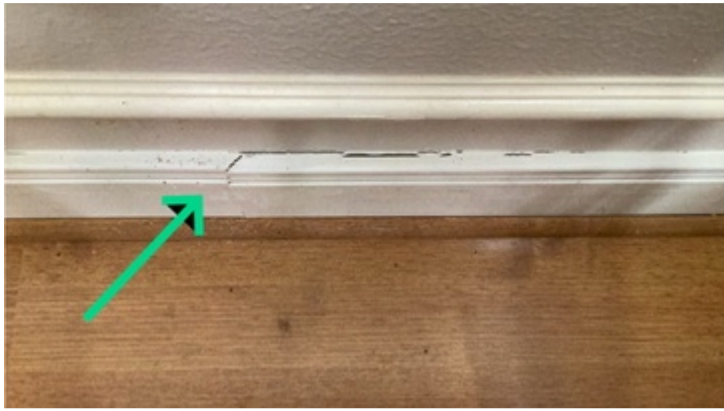
Damaged / Broken Baseboards

One or more areas of floor baseboards are damaged or broken. Recommend repairs or replacing by a qualified professional.

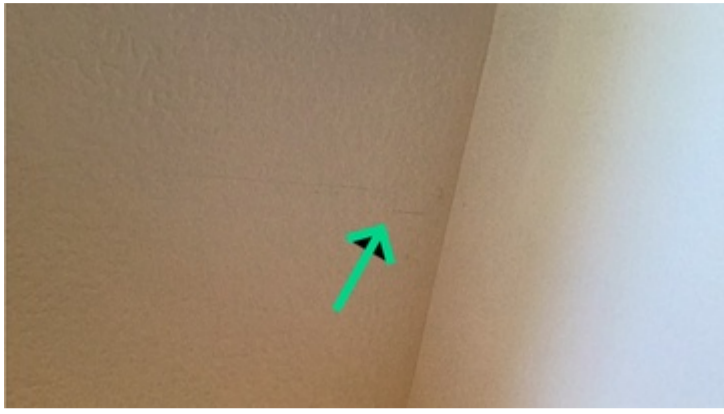
Small minor cracks in ceiling

One or more small minor cracks in ceiling Recommend repairs or replacing by a qualified professional.

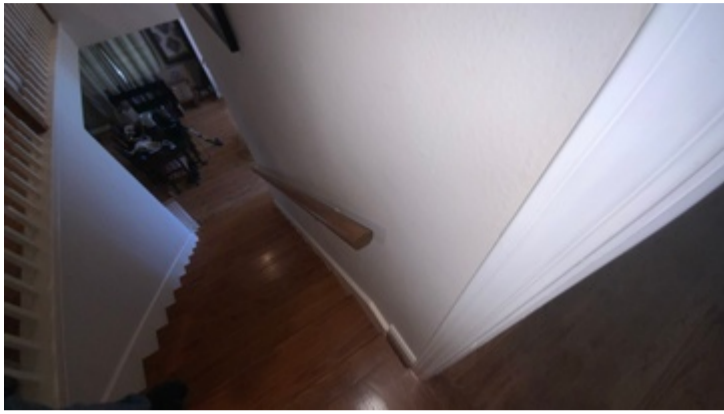
Inadequate Handrail Return to Wall

The handrail extensions must return to a wall or the walking surface. Recommend monitoring this, and further evaluation by a qualified professional.

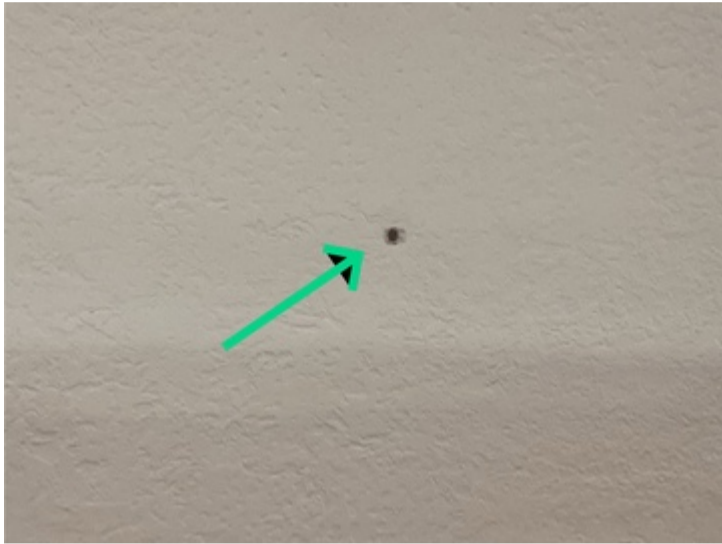
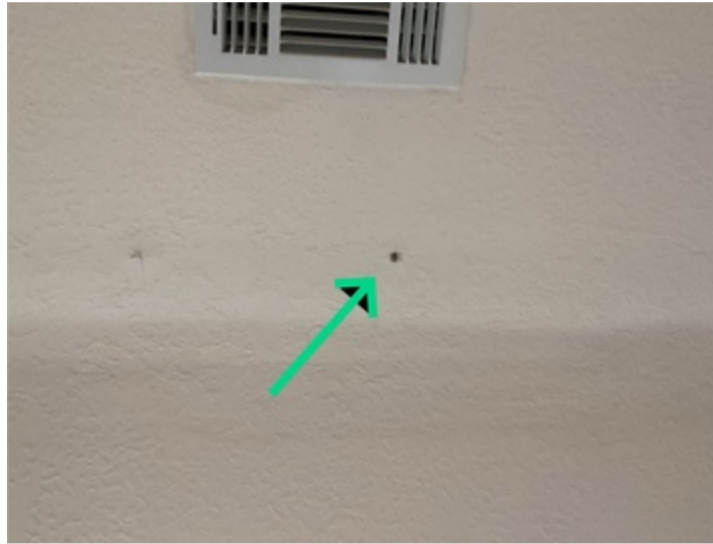
One or more nail pops in ceiling Recommend monitoring this.

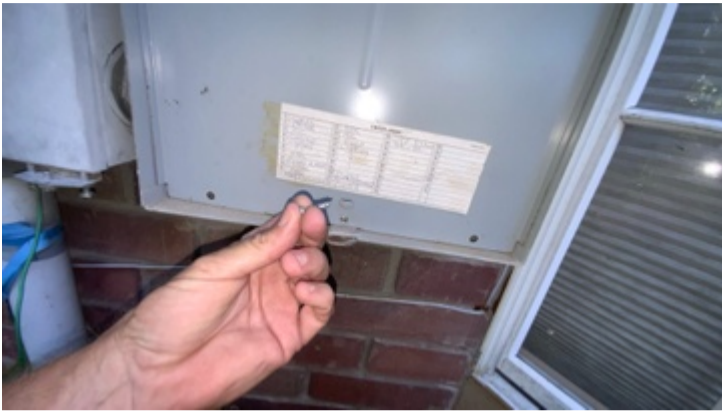
Missing / Incorrect Screws for Electrical Panel

There are missing / incorrect screws.
