BUYERS INSPECTION SERVICES

20219 Creekdale Bend Dr  
Cypress, TX 77433

# PROPERTY INSPECTION REPORT FORM

Glenn Taylor <i>Name of Client</i>	06/16/2022 9:00 am <i>Date of Inspection</i>
20219 Creekdale Bend Dr, Cypress, TX 77433 <i>Address of Inspected Property</i>	
Dean Limbaugh <i>Name of Inspector</i>	#4599 <i>TREC License #</i>
<i>Name of Sponsor (if applicable)</i>	<i>TREC License #</i>

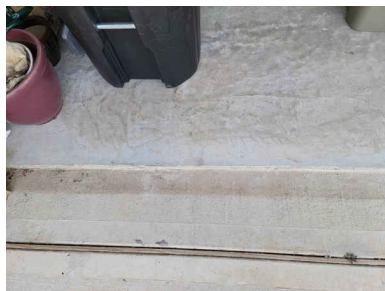
Garage

The foundation has experienced movement as evidenced by separation/cracking in one or more of the following locations:

Slab perimeter (i.e. hairline crack at the grade beam and less than 1/16” at garage interior)

Exterior veneers (i.e. crack(s) at the mortar / brick veneer)

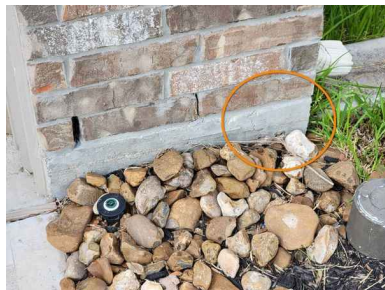
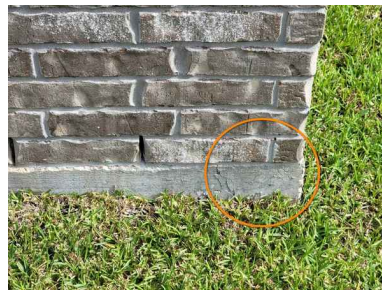
Wedge chip or “comer cracks” were observed at the slab perimeter. Informational: Wedge chip cracks should be repaired when more than one third of any masonry is not supported or cracks develop in the overlying brick veneer. This can be conducive to wood destroying insects. Wedge chip cracks and the repair should not be confused with underpinning of the foundation. Repair should be performed by a qualified foundation repair company.

Recommendation: Contact a foundation contractor.

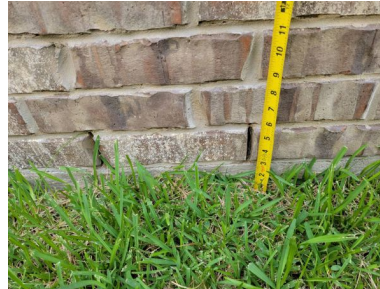
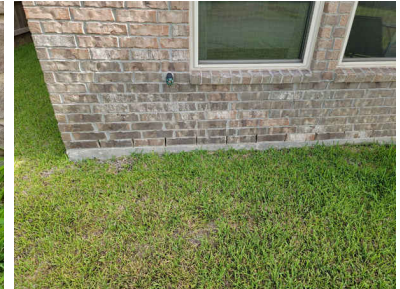
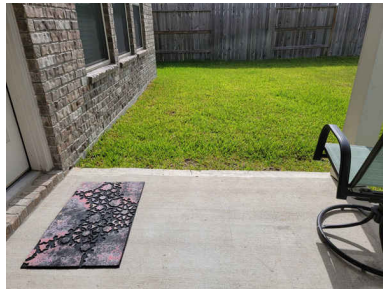
The existing grade at the slab perimeter is not adequate for shedding water away from the foundation. The soil level isn't 4 inches below the masonry. Informational: The grade should fall away from the foundation (6" in the first 10' where possible). IRC R401.3

Recommendation: Contact a qualified grading contractor.

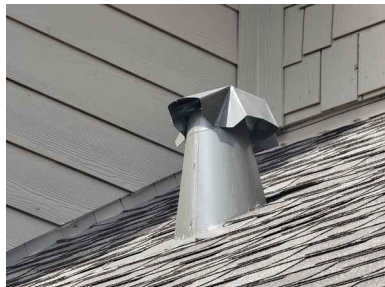
The top of the roof jack is off center. Informational: Recommend checking that it's properly secured.

Recommendation: Contact a qualified roofing professional.

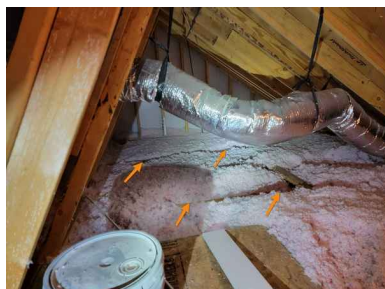
Insulation levels less than 10" were observed. Informational: Recommend additional insulation for increased energy efficiency (R30 is the current minimum at the floor of the attic). [Attic Insulation](#)

Recommendation: Contact a qualified insulation contractor.

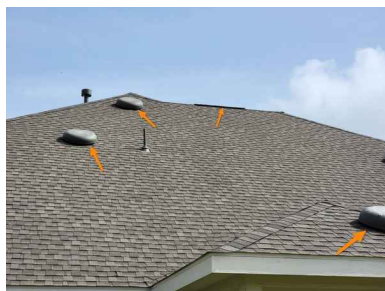
Vents are at different heights (elevations). Informational: Venting at different levels will result in air being drawn from the lower ridge vents exiting the upper ridge vents. This will result in less air movement or stagnant air in the lower areas of the attic. The total net free ventilation area shall not be less than 1/150 of the space ventilation (roughly divided between upper and lower vent areas) to 1/300. Proper ventilation will help to keep the house cooler during warm weather and extend the life of roofing materials.

Recommendation: Contact a qualified roofing professional.

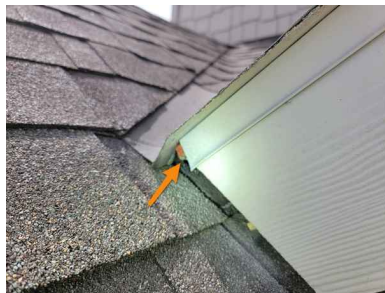
Front

Decking (OSB) is exposed at the soffit junction.

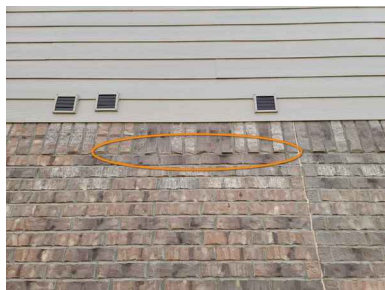
Right Side

Cracks observed at the exterior veneers (i.e. brick veneer). Informational: All exterior veneers should be properly sealed to provide a barrier against weather, insects and provide environmental control of the interior. Attachment of exterior veneers should be per existing building codes or manufacturer's written instructions.

Recommendation: Contact a qualified masonry professional.

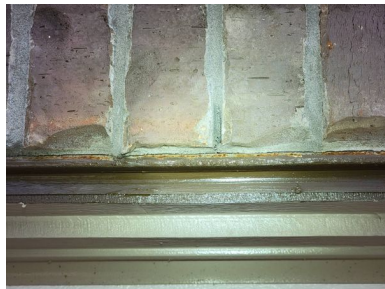
Mortar blocks several observed openings at the weep holes at the lintels. Informational: When mortar blocks the openings the drainage plane may not function properly. IRC R703.8.6

Rust and/or corrosion was observed at one or more lintels.

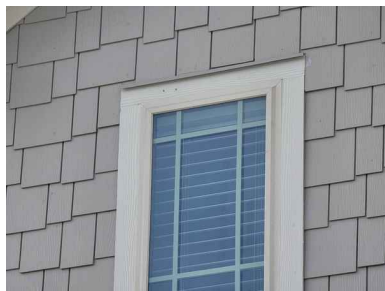
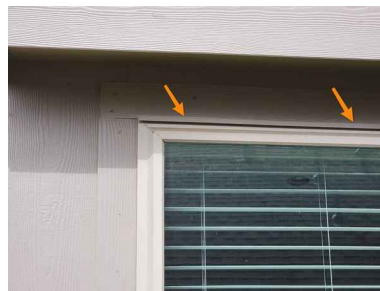
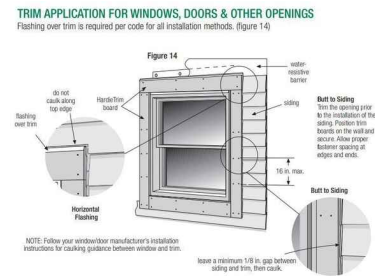
Z flashing or head flashing is not provided above the windows. The clearance between the bottom of the trim and the Z flashing should be 1/4" and not caulked – per manufacturer’s installation requirements. Informational: A gap is intended to allow the drainage plane to function properly. [Plank Install](#)

Recommendation: Contact a qualified professional.

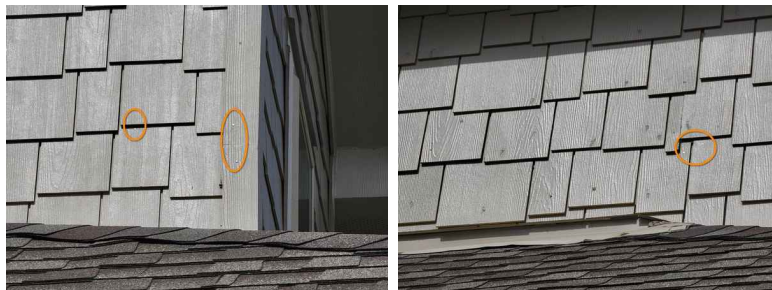
Left Side

Unpainted nail heads were noted. Informational: Painting is required per manufacturer’s installation instructions.

Recommendation: Contact a qualified professional.

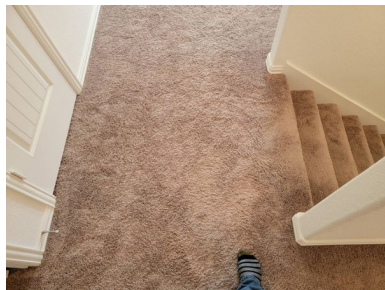
The upstairs flooring pops and/or squeaks. Informational: Noise is typically caused by a gap at the joists and subfloor. It may also be present if the adhesive has dried or partially dried before the ply or OSB was installed. This is typically not a structural concern.

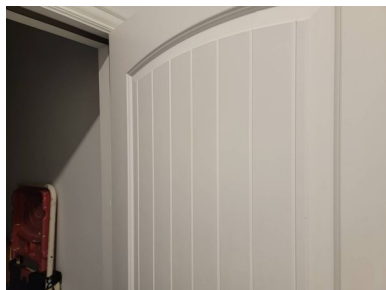
Portions of the garage entryway door are less than 1 3/8" solid core door (i.e. around panels). Informational: A data plate wasn't observed. A 1 3/8" solid core or 20 minute fire-rated type door is required. IRC R302.5.1

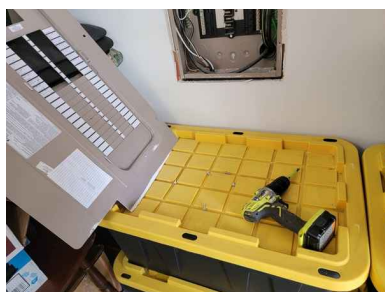
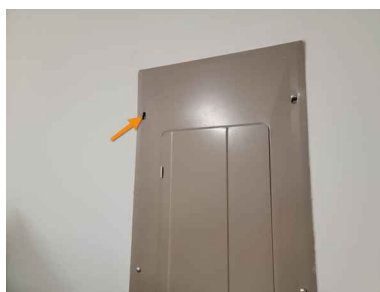
Missing fasteners were observed at the dead front cover as it fell behind stored items upon opening. Blunt end screws are required at this location.

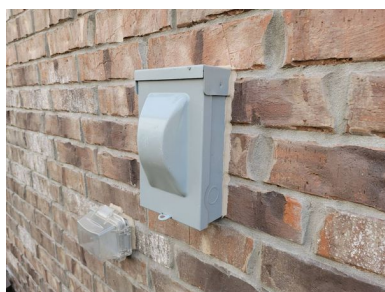
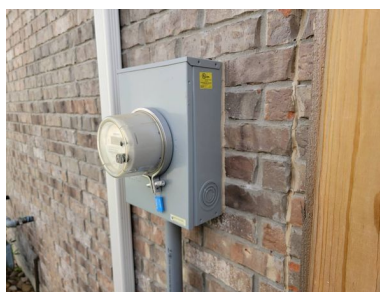
Panelboards, service disconnect(s) are sealed at the wall. Informational: Sealing is generally not recommended at the service disconnects, around the can for the electrical meter and panel boards to allow for heat dissipation.

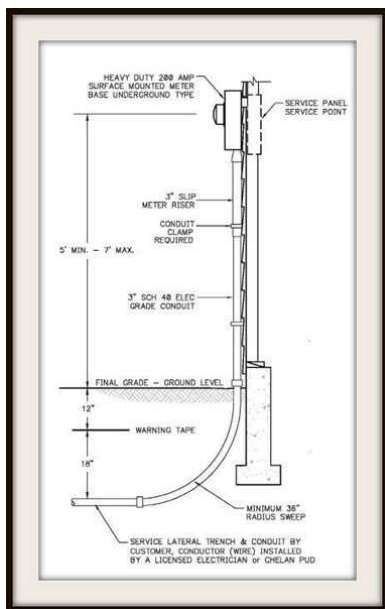
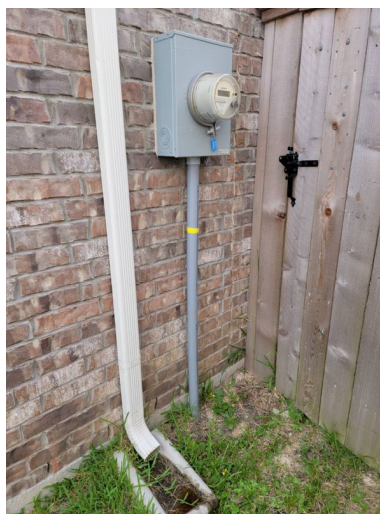
The conduit for the underground service doesn't have a slip joint to allow for movement of the foundation. Informational: Where direct-buried conductors, raceways, or cables are subject to movement by settlement or frost, direct-buried conductors, raceways, or cables shall be arranged so as to prevent damage to the enclosed conductors or to equipment connected to the raceways. NEC 300.5

Recommendation: Contact a qualified electrical contractor.

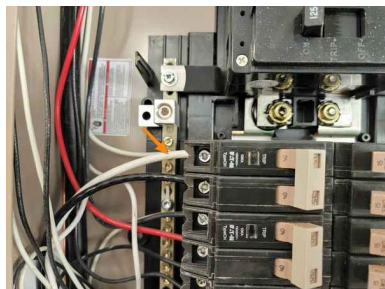
White wire(s) used as conductors are required to be properly color-coded.

Recommendation: Contact a qualified electrical contractor.

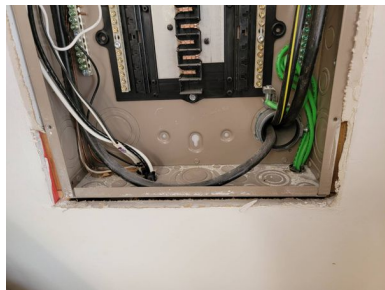
Gaps or open spaces were observed that shall be repaired so gaps are not greater than 1/8" at the edge of the cabinet. Informational: IRC E3907.3 NEC 312.4

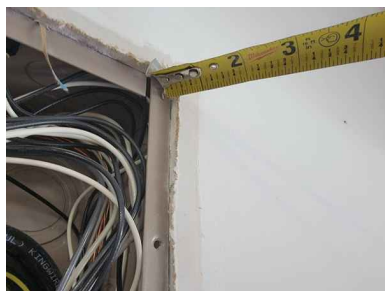
The panel is too far back from the edge of the drywall. Informational: Electrical panel can't be set back more than 1/4" from the finished surface. IRC E3907.3

Recommendation: Contact a qualified electrical contractor.

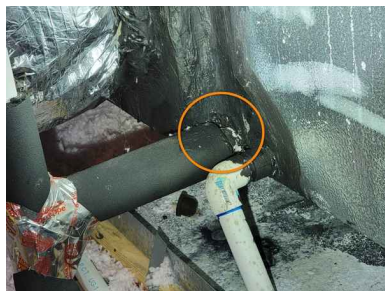
Missing insulation was observed at the primary drain line. Informational: The primary drain line should be fully insulated in the attic.

Recommendation: Contact a qualified heating and cooling contractor

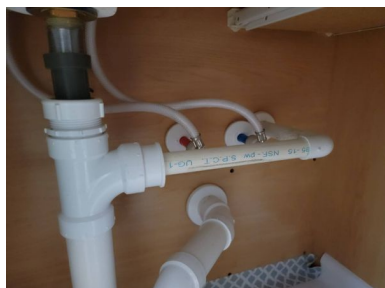
Primary drain line(s) appears to be glued pipe. Informational: Condensate drain lines shall be configured to allow the clearing of blockages and performance of maintenance without having to cut the line. IMC Code (307.2.5) and IRC (M1411.3.3)

Recommendation: Contact a qualified heating and cooling contractor

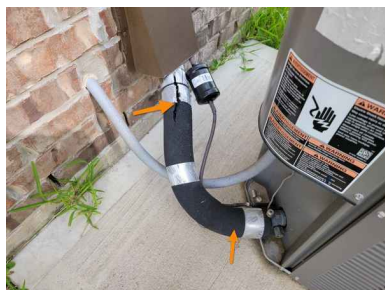
Insulation at the suction line(s) isn't protected from the weather and UV exposure. Deterioration was observed at the insulation. Informational: The low side / suction line shall be insulated not less than R-4 and exterior surface permanence not exceeding 0.05 perm per testing standards. IRC M1411.6 & N1103.4.1 (R403.4) Adhesive tape shall not be permitted.

Recommendation: Contact a qualified heating and cooling contractor

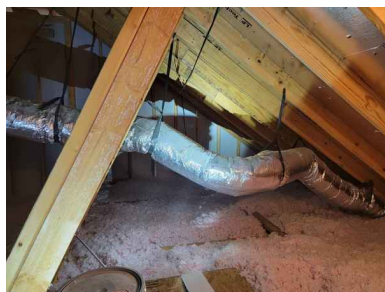
Rear Lower Attic

Sag was noted at a supply ducts. Informational: Straps should support ducts every 4'. Maximum sag for duct is 1/2" per foot.

Recommendation: Contact a qualified heating and cooling contractor

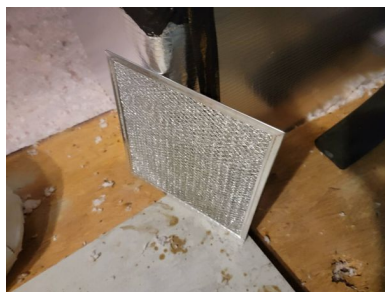
The fresh air filter located in the attic should be cleaned.

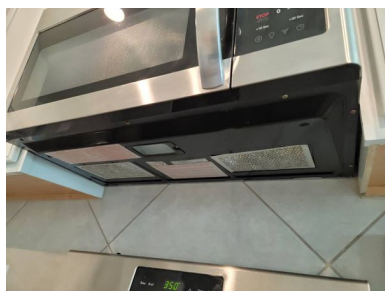
Grease was observed and the filter(s) and/or range hood requires cleaning. Informational: Grease is a combustible material.

Recommendation: Contact a qualified cleaning service.

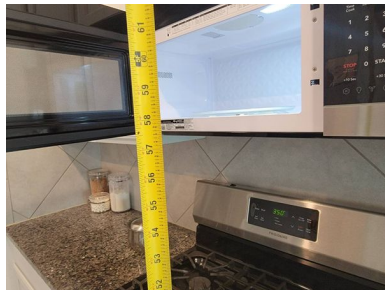
Microwave oven is installed more than the recommended height (National Kitchen and Bath Association). Informational: Safe for access and removal of hot food items. The National Kitchen and Bath Association says that "the bottom of the microwave to be no higher than 54 inches off the floor. If anyone likely to use the microwave is shorter than, say 5'4", even the recommended standard might be uncomfortably high."

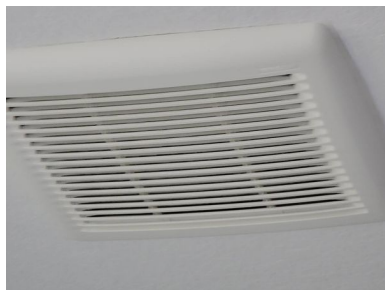
Dust/debris (possible combustible material) was observed at the interior or cover of one or more of the mechanical exhaust vents. Informational: Cleaning as required or replacement is recommended.

Recommendation: Recommended DIY Project

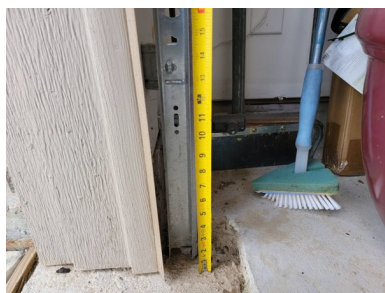
The garage door operator(s) worked, however; the safety reverse sensor(s) are installed too high. Informational: The sensors should be installed to a maximum height of 6” or less and / or per manufacturer’s requirements.

Recommendation: Contact a qualified garage door contractor.

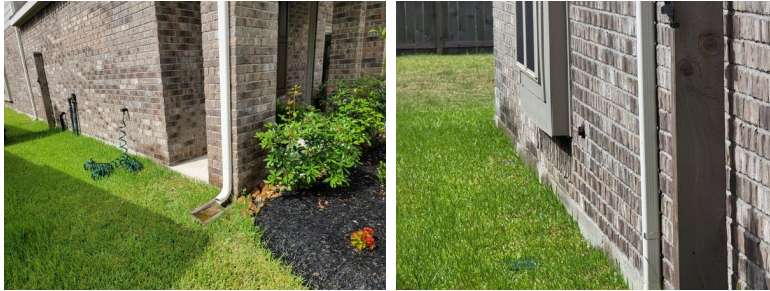
Water spray from the sprinkler system should be redirected where necessary away from the structure to decrease the possibility of damage.

Recommendation: Contact a qualified professional.
