HOME INSPECTION REPORT

PROPERTY INSPECTION REPORT

Concerning: _____ 651 Bering Dr, Unit 1502, Houston, TX, 77057
(Address or Other Identification of Inspected Property)

By: _____ David Jones 22116
(Name and License Number of Inspector) _____ 3-24-2021
(Date)

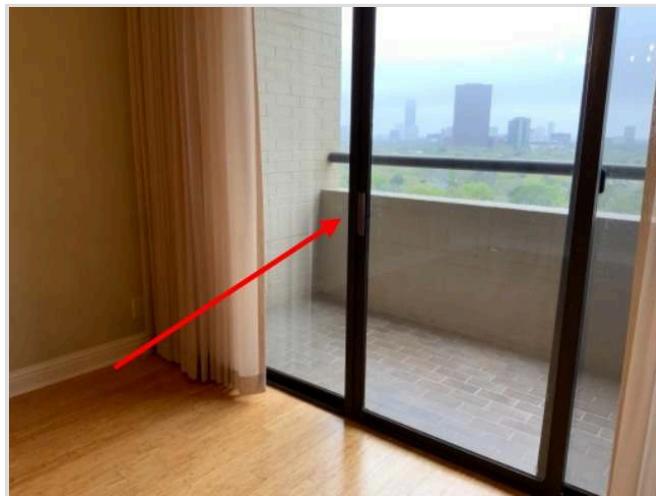
Balcony door latch was found to be damaged/broken and would not lock or latch.

Latch damaged/broken

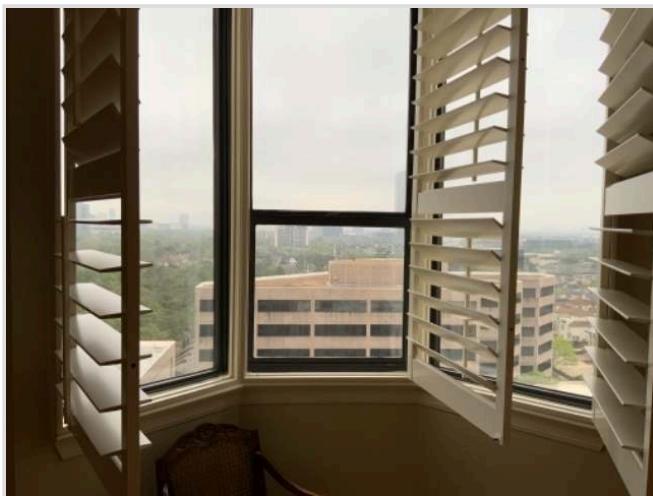
Windows in the bedrooms and in the living room were stuck in the closed position preventing emergency egress.

Stuck in the closed position (guest bedroom)

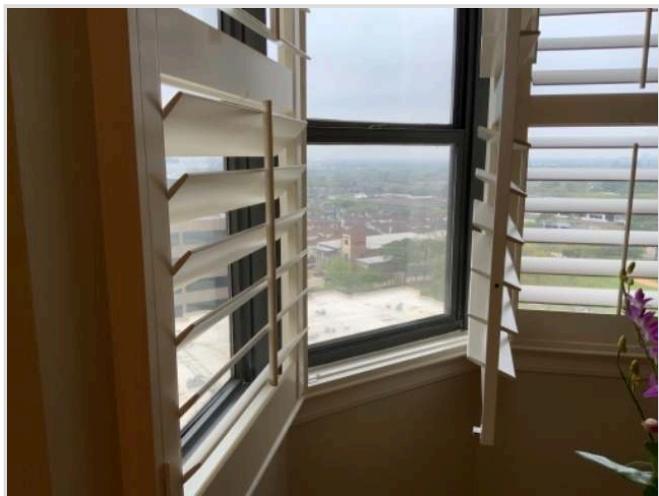
Stuck in the closed position (living room)

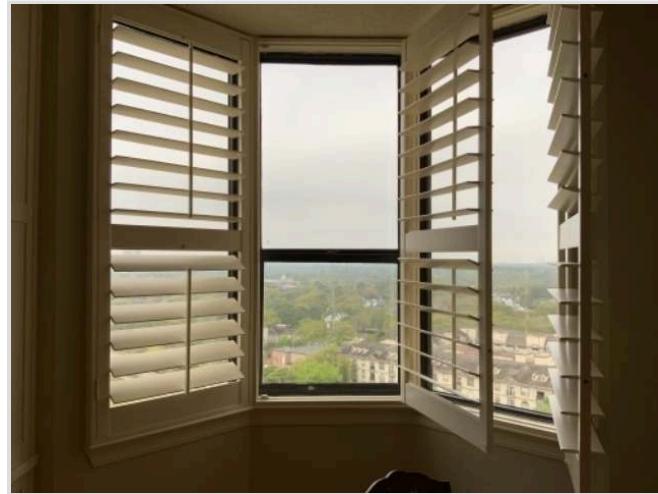
Stuck in the closed position (master bedroom)

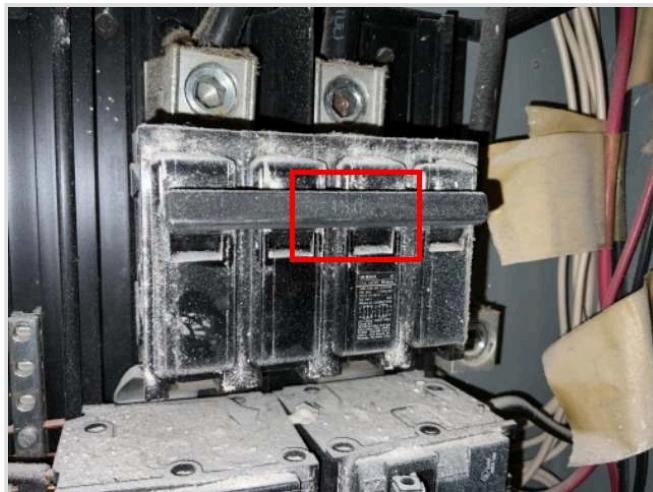
150 Amp main breaker was on #1/0 aluminum wire (main breaker oversized). #1/0 Aluminum wire is rated for 125 Amps.

150 amp main breaker

It is recommended that an electrician be contacted.

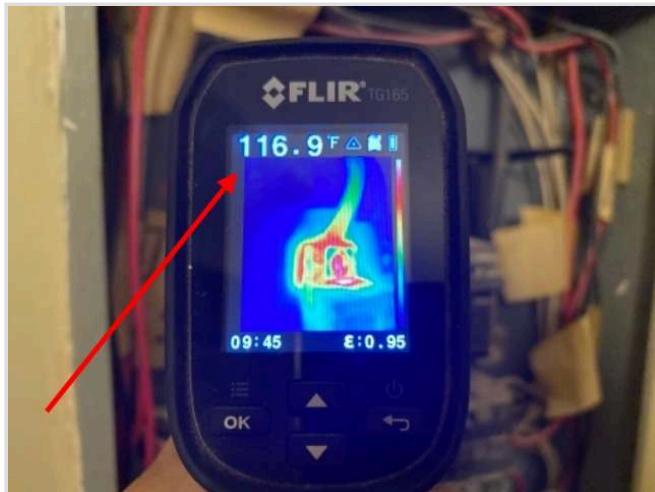
Service wire on the left side of the main disconnect was found to be operating at 116.9 degrees Fahrenheit. Indicating a loose connection and/or main breaker has a partial failure.

Temperature of service wire at main breaker

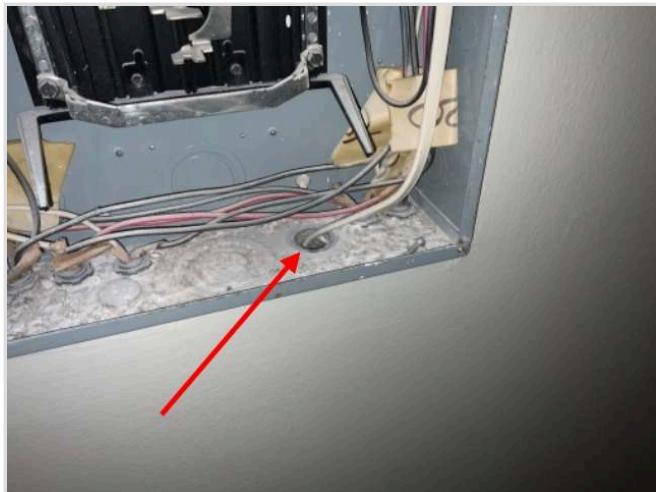
One or more conductors entering the panel box were not protected from abrasion (no grommets, collars and/or bushings).

Not protected from abrasion

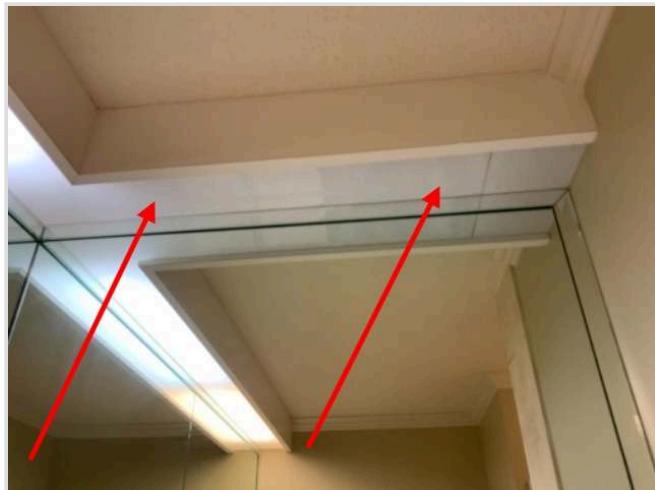
Fluorescent light above the sink/vanity counter in the master bathroom and the light in the mechanical exhaust vent in the hall bathroom would not illuminate, possibly due to burned out bulbs.

Would not illuminate (master bathroom)

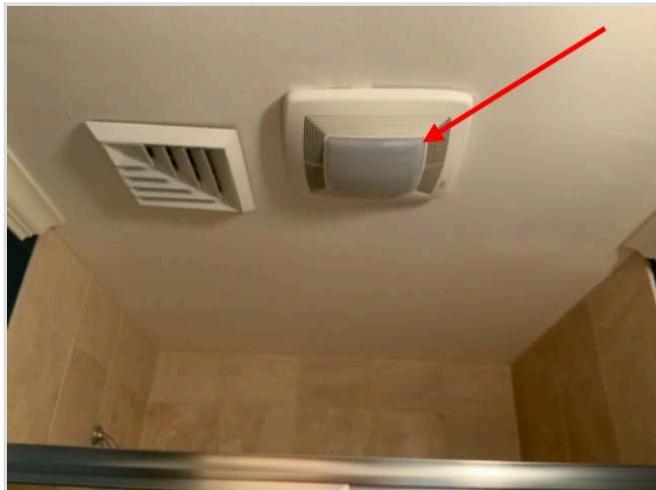
Would not illuminate (hall bathroom)

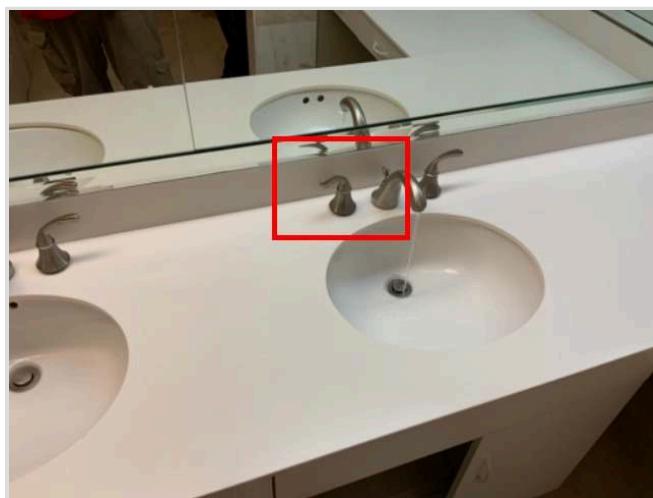
Hot water valve for the right sink in the master bathroom was difficult to operate.

Difficult to operate

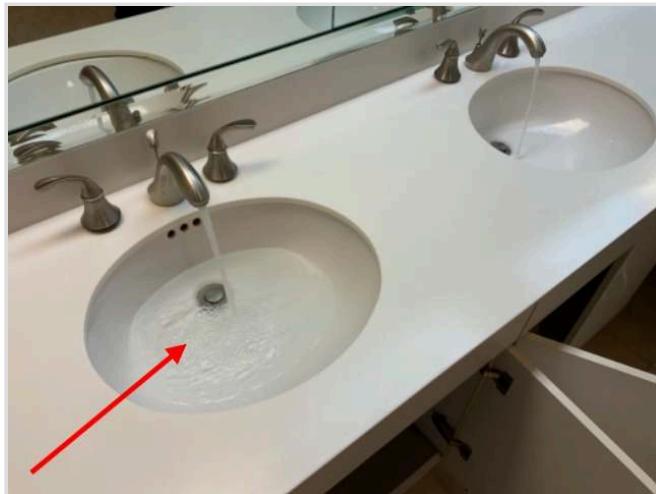
Left sink in the master bathroom was slow to drain.

Slow to drain (right side sink)

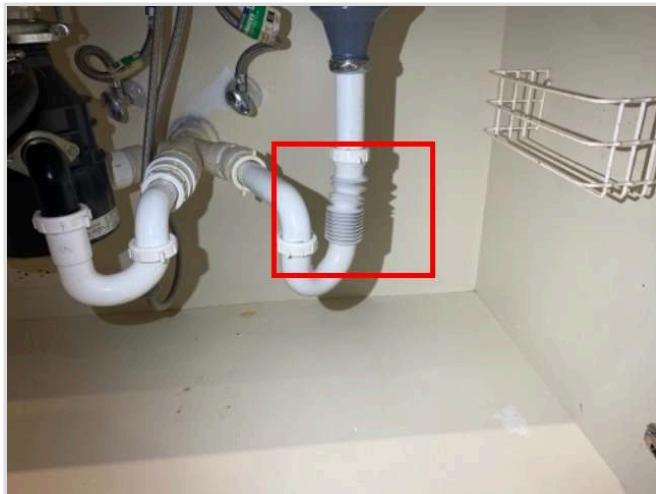
There was improper drain line material installed beneath the kitchen sink. Flex type drain lines are more susceptible to clogs and damage than thicker PVC type solid drain lines.

Improper material(kitchen sink)

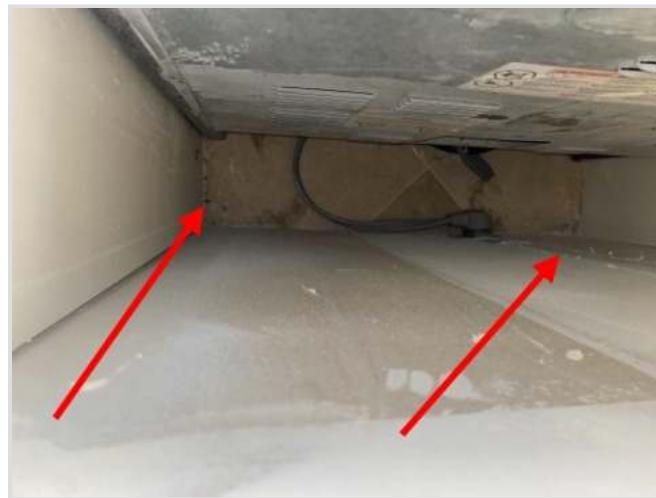
An anti-tip device was not installed at the time of inspection.

No anti-tip device installed

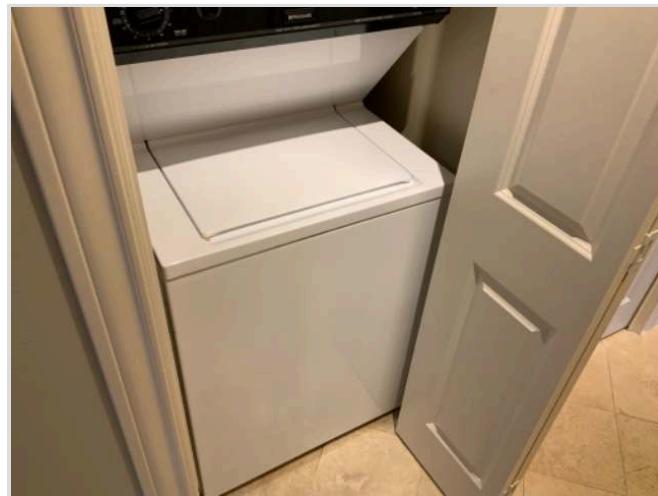
Clothes washer portion of the double unit would vibrate excessively during spin cycle.
