**BPG Inspection, LLC**

**21022 Waymare Lane  
Spring TX 77388**

Client(s): Wedemeyer  
Inspection Date: 7/1/2024  
Inspector: Murray Campbell , TREC #22455 (TX)

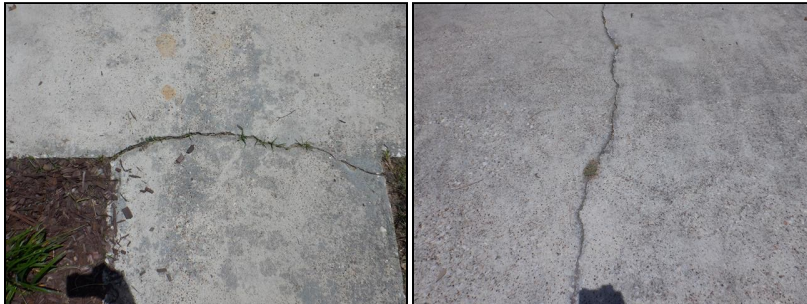
Noted cracks and slab shifting at driveway, patio slabs and sidewalks. Recommend having all concrete slab cracks filled with exterior grade sidewalk repair flexible caulking. This will allow sealant of cracks preventing water infiltration into area that causes further damage until full concrete seal can be applied or total replacement of slabs. Sidewalk repair caulking is the typical product used for this repair.

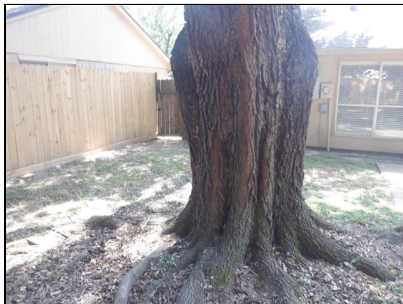
It is recommended that trees be placed no closer than 15ft from foundation structures. All tree roots that are growing beneath the slab should be severed to prevent foundation damage. (Root damming in this area will prevent future grow beneath the slab). Consult with an arborist if tree health is a concern.

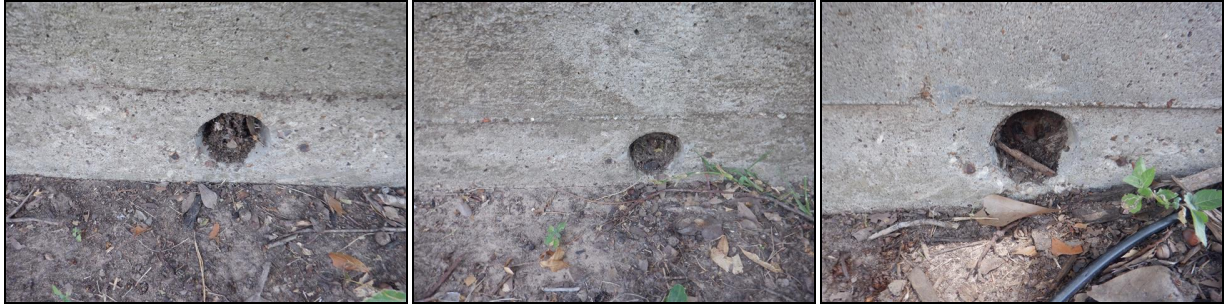
Noted exposed post-tension cable ends. This condition typically occurs over time if the original patching/filling in of area ages or deteriorates. To properly protect the ends they should be cleaned, repaired and fully covered by a qualified tradesman.

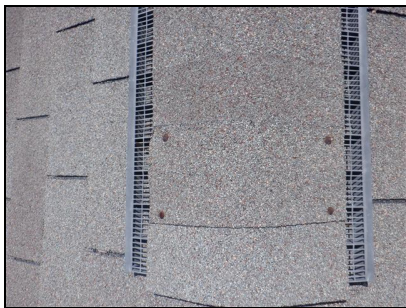
There were several roofing fasteners observed to be improperly sealed or exposed. Left unsealed the fastener

penetrations could present a point of water penetration into the roof structure. Seal (caulk) all exposed roofing fasteners (i.e. plumbing vents, flue pipe roof jacks, flashings, and ridges lines).

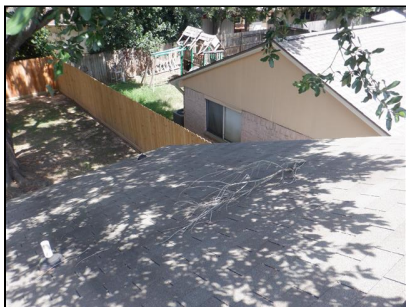
- 1. Remove all debris from roof slopes and valleys. Leaf debris may hide possible defects and damage to roofing materials. Debris may also cause water to dam up under shingle tabs.
- 2. Vents (sewer) did not extend to proper height above roof. Current standards require vents extend 6-12 inches above roof.

Remove all debris from roof slopes and valleys. Leaf debris may hide possible defects and damage to roofing materials. Debris may also cause water to dam up under shingle tabs.

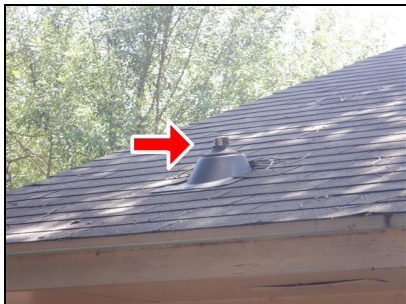
Vents (sewer) did not extend to proper height above roof. Current standards require vents extend 6-12 inches above roof.

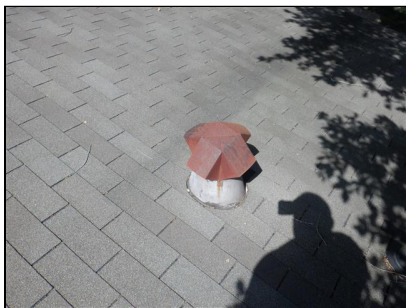
Rust is present on flashing in areas. Though maybe not an immediate concern, if left unattended for a long period the metal flashings may fail and cause water penetration in those areas. Recommend rust remediation, applying rust prohibitive paint. All remaining exposed metal flashing should also be painted.

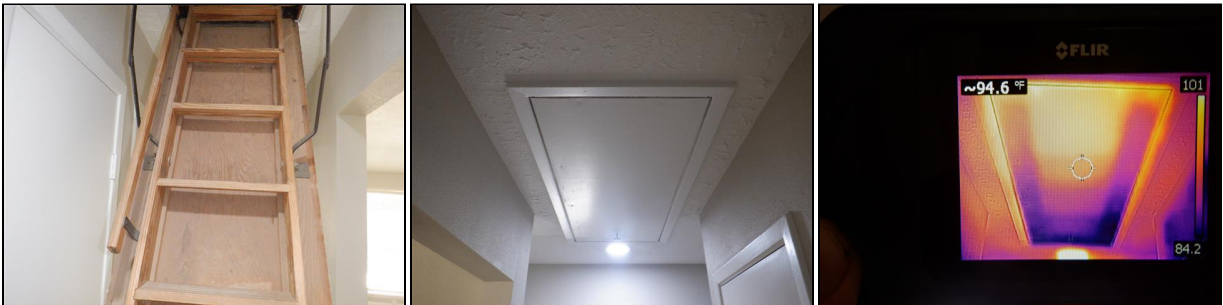
The attic pull down ladder is not insulated completely, nor does it have weather stripping installed at edge of door that meets ceiling framing. Recommend fully insulating the attic stairway to keep the house more energy efficient. On average the insulation R-value for the entire attic area will drop approx. 27% when the attic stairs/hatch is not fully and properly insulated. The reason for this is that, although the attic stairs/hatch account for only 1% of the total attic area, the rate that heat flows through them by conduction (per square foot) is 38 times higher than in the insulated part of the attic.

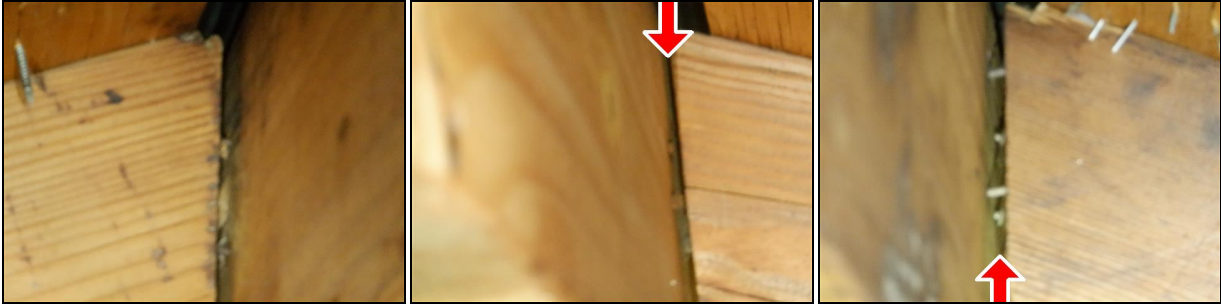
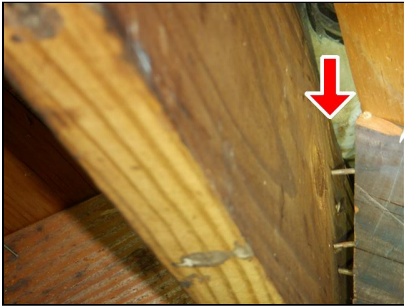
- 3. Rafters have separated from the ridge beam in areas. At least one vertical support for purlins has become detached. This is typical with settling on older homes, but should be addressed and repaired within near future.
- 4. There was evidence of rodent/pest activity in attic (trails in insulation, droppings). Pest control service is recommended.

Rafter have separated from the ridge beam in areas. At least one vertical support for purlins has become detached. This is typical with settling on older homes, but should be addressed and repaired within near future.

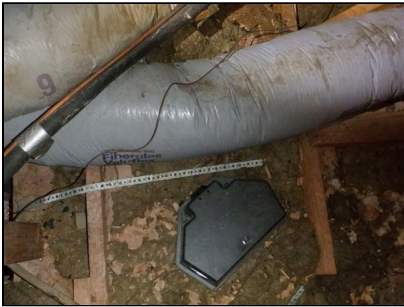
There was evidence of rodent/pest activity in attic (trails in insulation, droppings). Pest control service is recommended.

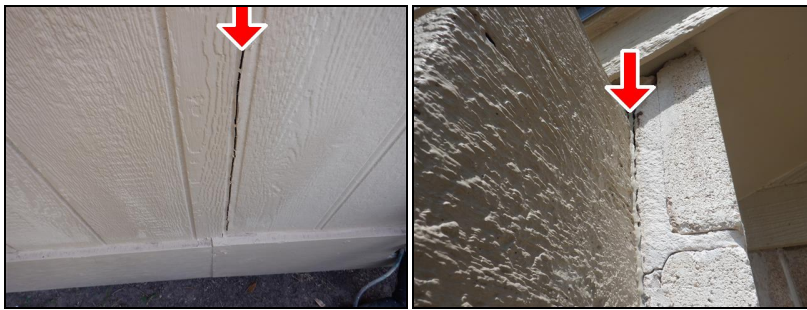
There are cracks on the walls in various locations. These cracks appear to be typical settlement/shifting cracks with no other visible displacement and no signs of cracking extending into foundation. Noted no signs of stress or movement on interior side of concern. Recommend sealing (mortar) crack to prevent moisture incursion and monitor for further settlement/separation.

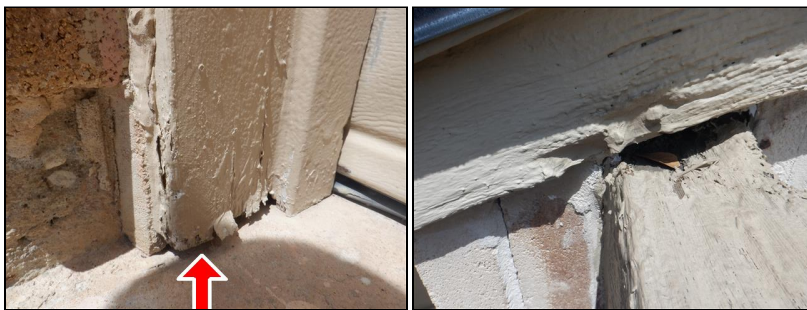
- 5. There are areas of the front of exterior in areas that have sustained varying levels of water (rot) damage and is in need of repair.
- 6. There is evidence of vermin trying to enter roof/attic structure (damaged siding, soffit, eaves etc). Repairing these areas and installing pest prevention barriers is recommended.
- 7. Seal (grout/caulk) around the tub and shower tile/fixtures to wall abutment joints in the guest bath.

There are areas of the front of exterior in areas that have sustained varying levels of water (rot) damage and is in need of repair.

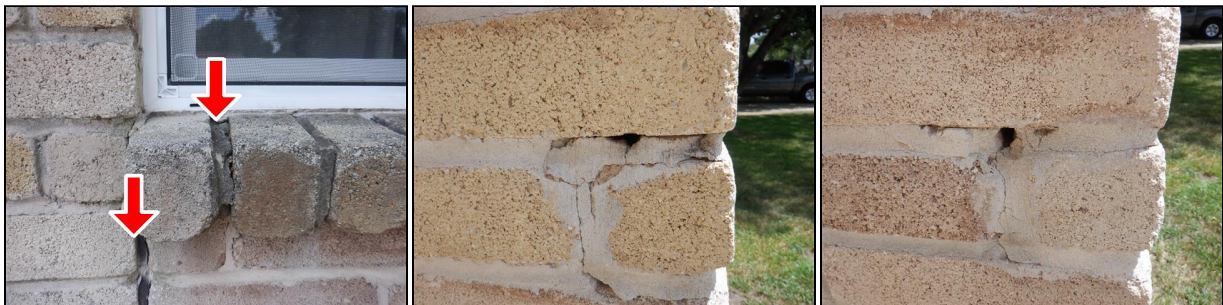
There are cracks on the walls in various locations. These cracks appear to be typical settlement/shifting cracks with no other visible displacement and no signs of cracking extending into foundation. Noted no signs of stress or movement on interior side of concern. Recommend sealing (mortar) crack to prevent moisture incursion and monitor for further settlement/separation.

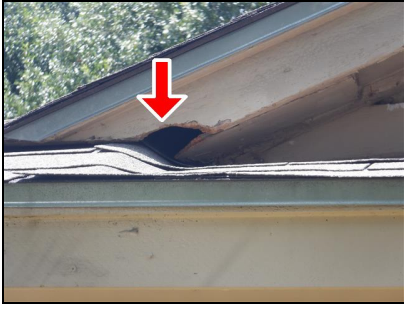
There is evidence of vermin trying to enter roof/attic structure (damaged siding, soffit, eaves etc). Repairing these areas and installing pest prevention barriers is recommended.

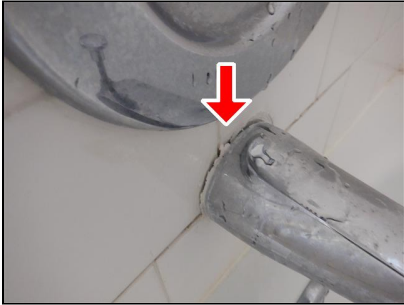
Seal (grout/caulk) around the tub and shower tile/fixtures to wall abutment joints in the guest bath.

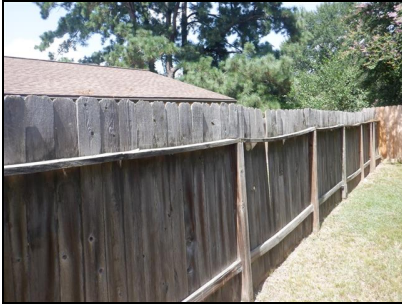
Fences were old and in disrepair based on missing boards/age/poorly supported post. The Inspector recommends that you consult with a qualified contractor to gain an idea of options and costs for repair or replacement.

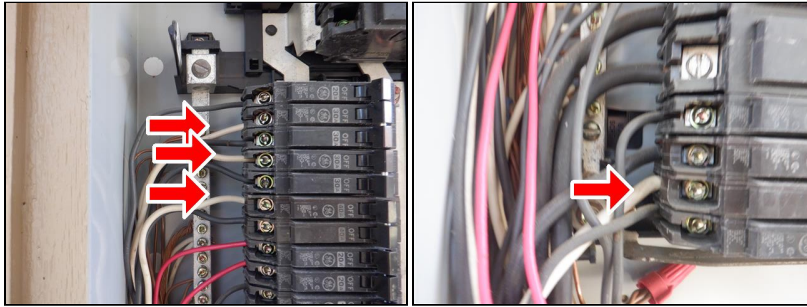
White (neutral) wires are being used as hot wires in the main panel, without the proper identifiers. These should be marked black or red to indicate that they are hot.

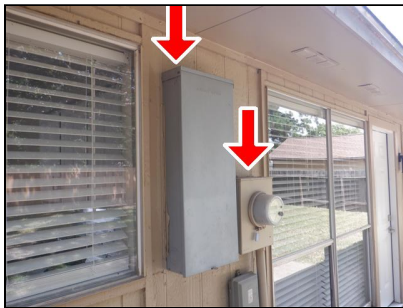
All breakers should be properly clearly labeled to identify branch circuits controlled

Recommend sealant between panels/meters and wall to prevent moisture entry into wall.

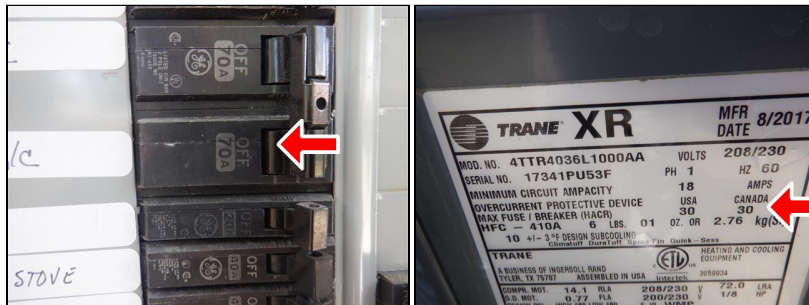
- 13. Recommend sealant between panels/meters and wall to prevent moisture entry into wall.
- 14. The A/C condenser circuit breaker is oversized for unit. Per the manufacturer's data plate a 30 amp maximum breaker required; a 70 amp is installed in the service panel. Replace the breakers to the specified rating to properly protect the condenser and ensure any warranties to be in effect.

The A/C condenser circuit breaker is oversized for unit. Per the manufacturer's data plate a 30 amp maximum breaker required; a 70 amp is installed in the service panel. Replace the breakers to the specified rating to properly protect the condenser and ensure any warranties to be in effect.

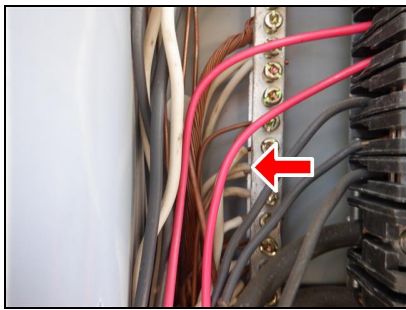
Neutral wires are not individually lugged to the sub panel neutral bus bar as called for by today's standards.

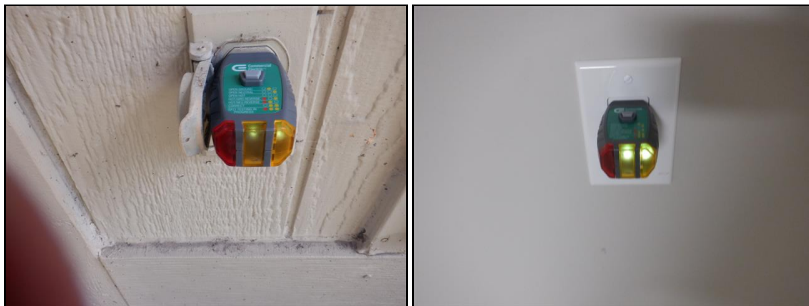
- ❌ 15. There are no GFCI (Ground Fault Circuit Interrupt) protected outlets in locations called for by today's standards: garage, laundry, exterior outlets,. I recommend updating to current standards. All receptacles within 6 ft of a water source by today's standards should be GFCI protected.

There are no GFCI (Ground Fault Circuit Interrupt) protected outlets in locations called for by today's standards: garage, laundry, exterior outlets,. I recommend updating to current standards. All receptacles within 6 ft of a water source by today's standards should be GFCI protected.

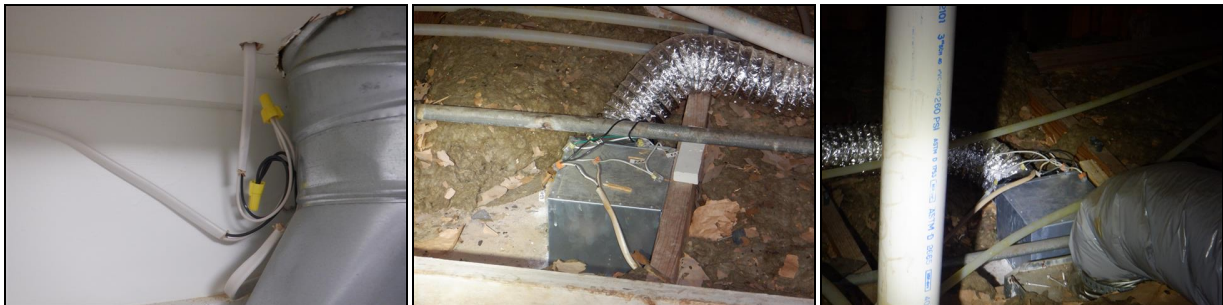
There were exposed connections, open boxes observed on wall, attic. Secure, enclose in rated enclosures to prevent hazards.

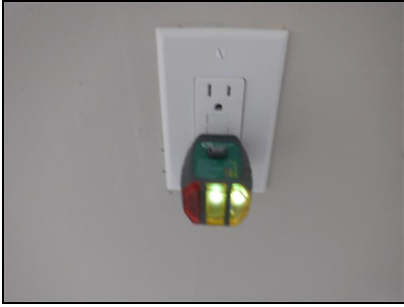
A GFCI is not functioning in the garage. I recommend an electrician to evaluate and repair or replace as needed.

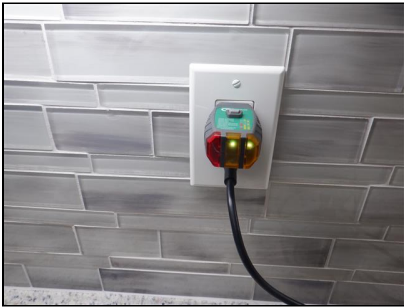
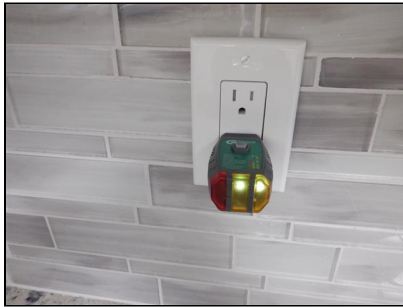
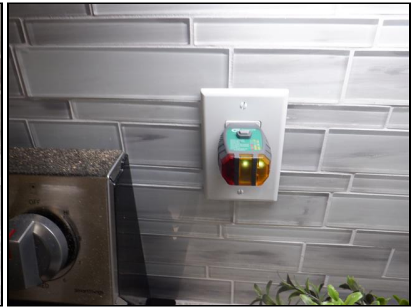
Kitchen counter top outlets are not Ground Fault Circuit Interrupt (GFCI) protected as called for by today's standards.

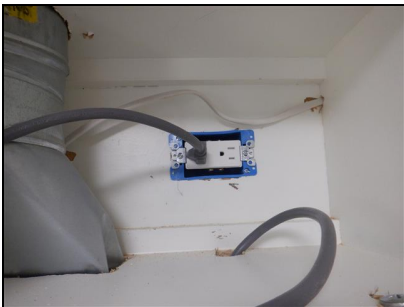
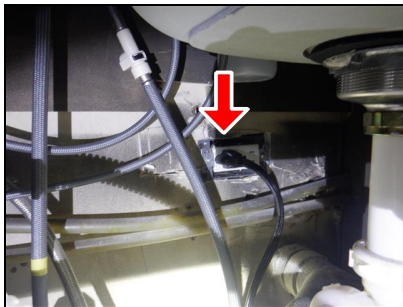
Replace missing/damaged cover plates on various outlets and switches. Prevent access to live components that can cause injury or electrocution.

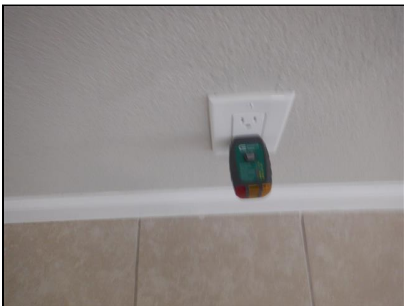
There was an outlet found to be non-functional in the living room. I recommend further evaluation/ diagnosis and repair by a licensed electrician.

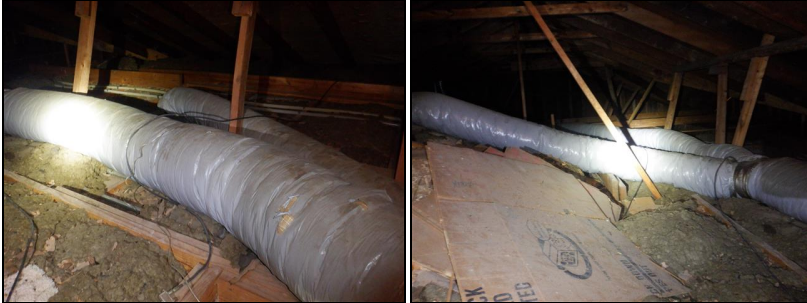
There are several duct runs that are not strapped up to the roof framing as called for by today's standards

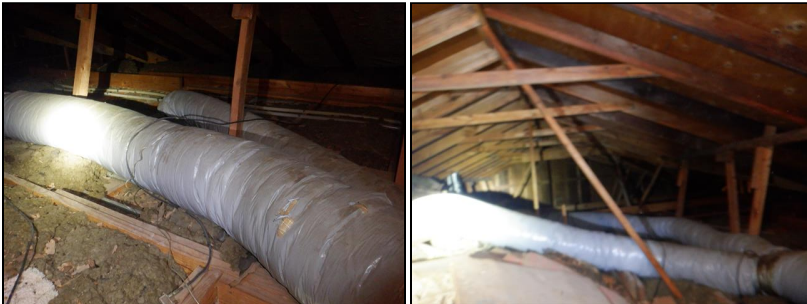
Sections of the HVAC ducts appear to be Goodman gray flex-duct. The exterior vapor wrap on this product was found to deteriorate when exposed to normal attic conditions. There are several areas where the vapor wrap has failed and is in need of repair/replacement

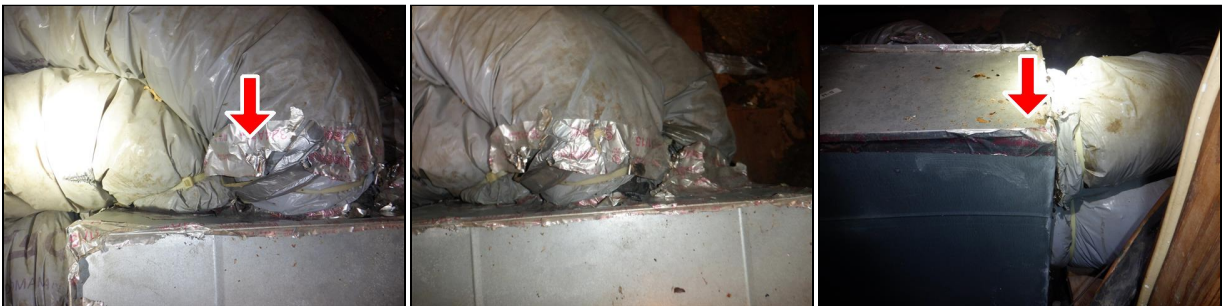
- ❌ 21. Sections of the HVAC ducts appear to be Goodman gray flex-duct. The exterior vapor wrap on this product was found to deteriorate when exposed to normal attic conditions. There are several areas where the vapor wrap has failed and is in need of repair/replacement
- ❌ 22. The seals are deficient at the plenum and/or evaporator coils and/or improper sealant material is used such as duct tape. When duct tape is used the tape has to be pressure sensitive tape UL 181 B-FX type. Recommend having licensed HVAC technician further evaluate and repair as needed.

The seals are deficient at the plenum and/or evaporator coils and/or improper sealant material is used such as duct tape. When duct tape is used the tape has to be pressure sensitive tape UL 181 B-FX type. Recommend having licensed HVAC technician further evaluate and repair as needed.

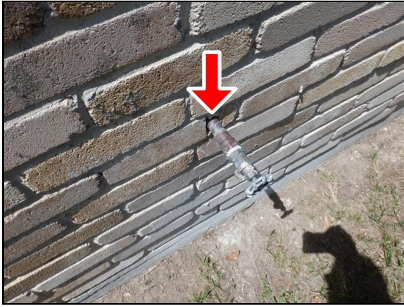
Supply pipes should be properly insulated to prevent them from freezing.

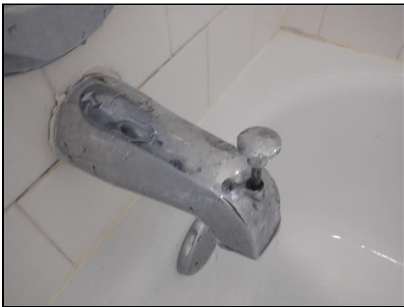
The water at tub nozzle would not terminate when showerhead was activate over the tub. Each is to dispense water independently of each other at 100%. Recommend properly repair/replace the shower diverter at the tub.

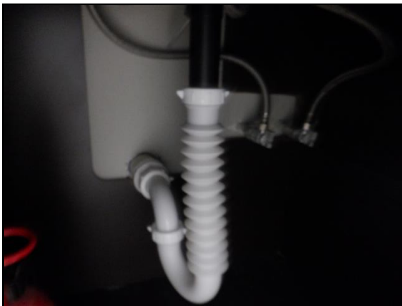
Flex drain lines are not recommended as they tend to accumulate debris, promote clogging and wall of pipe is thinner so can leak easier. Recommend replacement with rigid pipe.

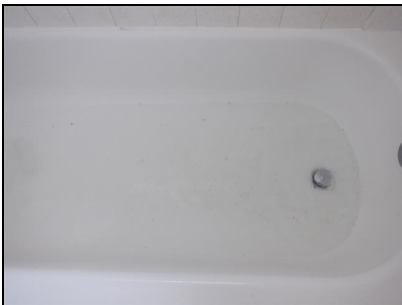
The drain was slow, and may be clogged in the master bath tub. I recommend repair by a plumber.

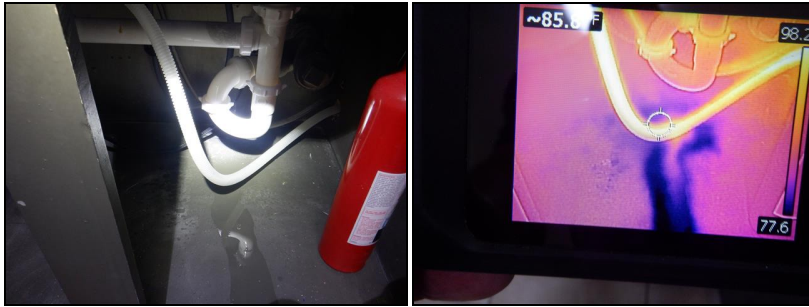
The p-trap on waste line is leaking at the kitchen sink sink. I recommend a qualified licensed plumber repair or correct as needed.

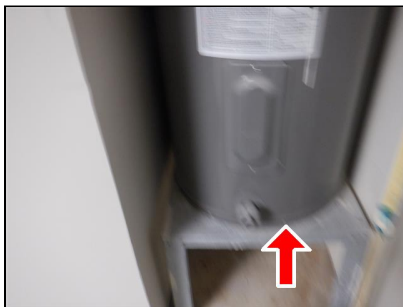
The water heater abuts to an interior wall and there is no emergency leak catch pan installed. Today's standards now require a catch pan that is plumbed to the exterior in locations where tank leaks could cause interior water damage from dripping leaks or condensation.

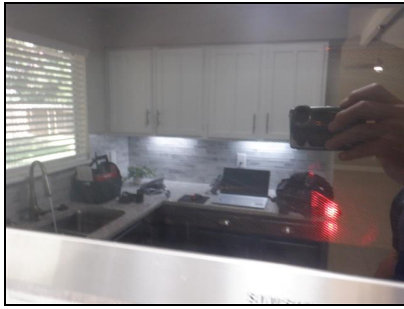
There is no child protection anti-tip device installed. Anti-tip brackets prevent the stove from accidentally tipping over if weight is placed on the oven door

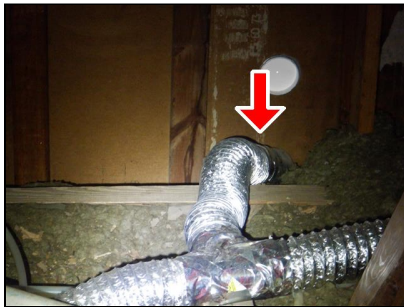
Bathroom exhaust fans vent to the attic. Today's standards now require bath exhaust to be directed to the exterior in bathrooms without opening windows
