# 7510 Rosepath Ln

# Richmond, Texas 77407

| Type | <b>Home Inspection and Floor Plan Report - 7510 Rosepath Ln</b> |
| Inspected by | <b>Noble Property Inspections - Houston</b> |

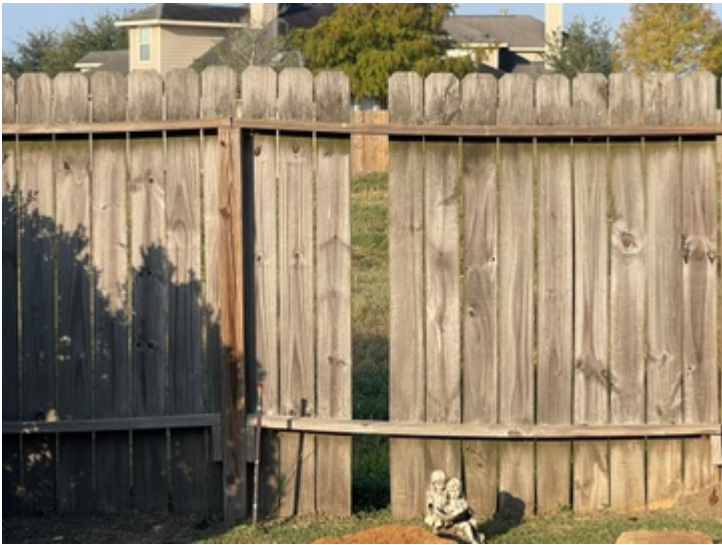
Damaged / Missing Fence Boards

One or more fence boards are missing or damaged.

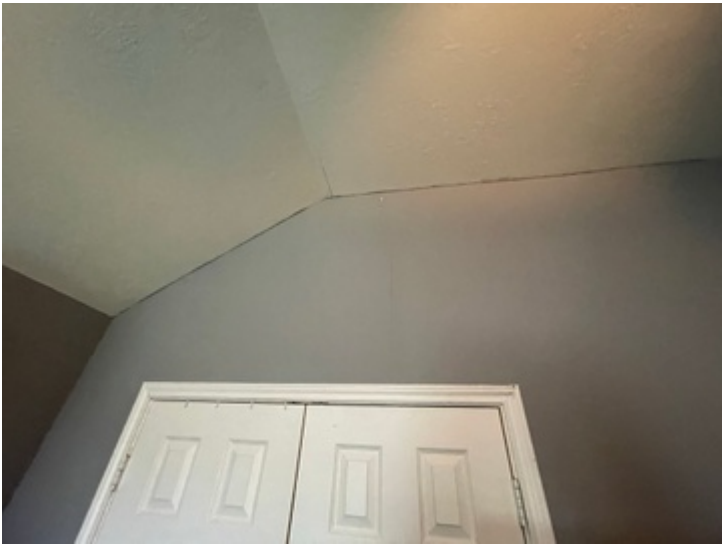
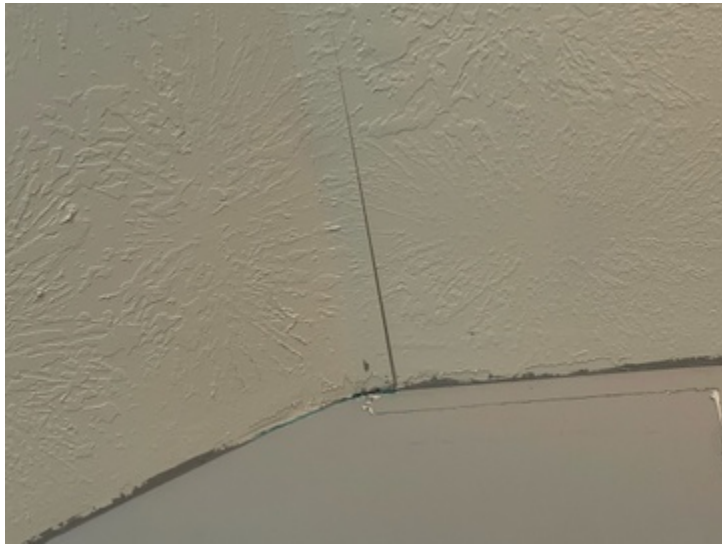
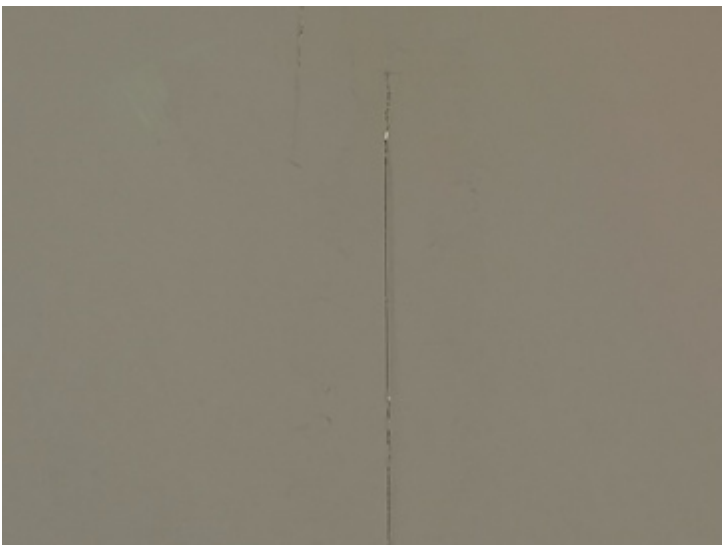
## Minor Wall Cracks

There is minor cracking on the wall / ceiling.

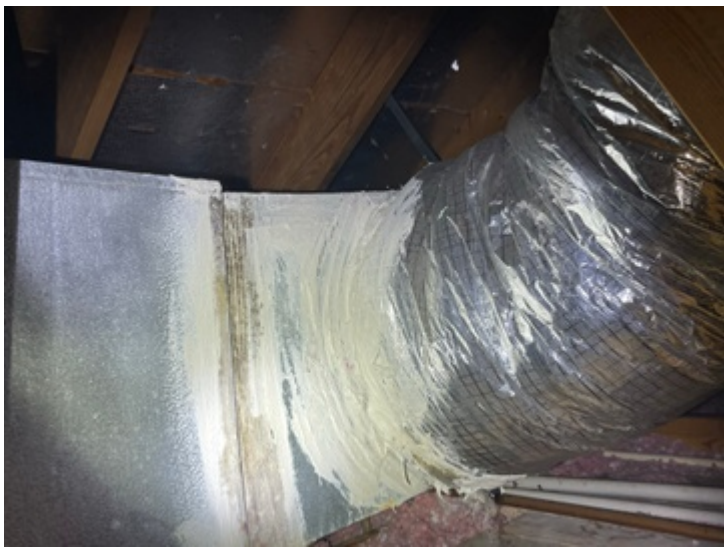
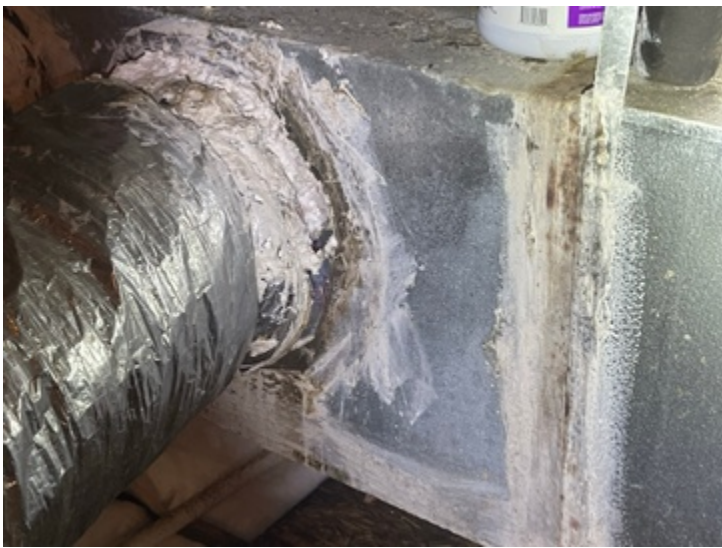
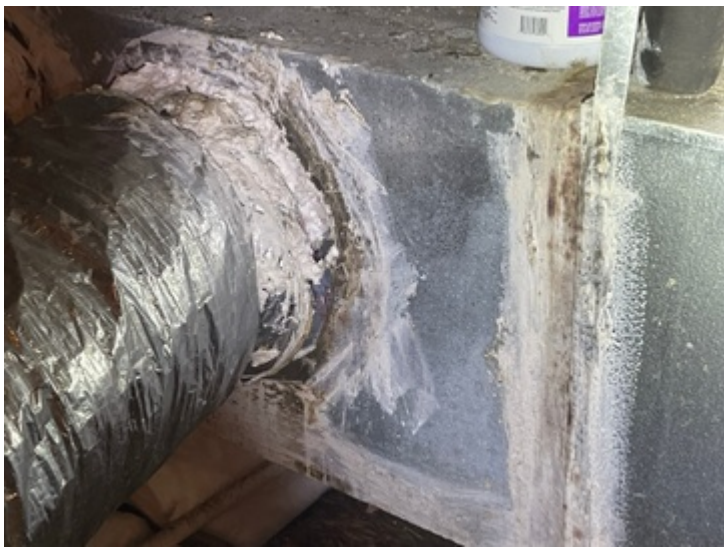
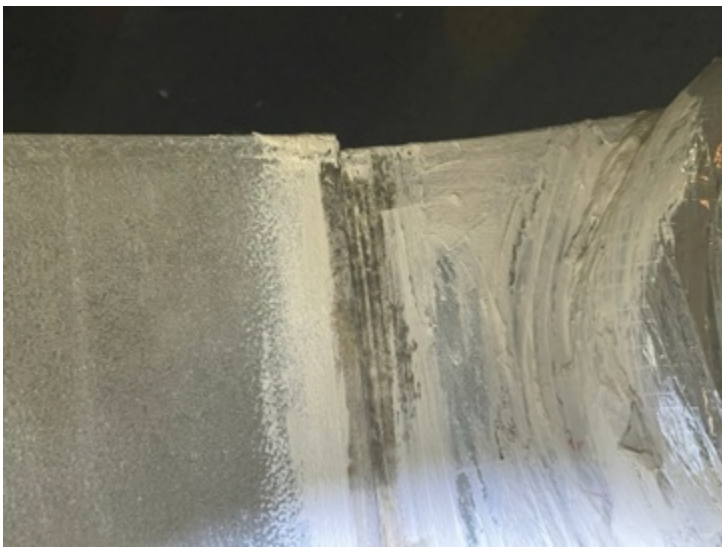
There is discoloration and possible mold growth in the attic.

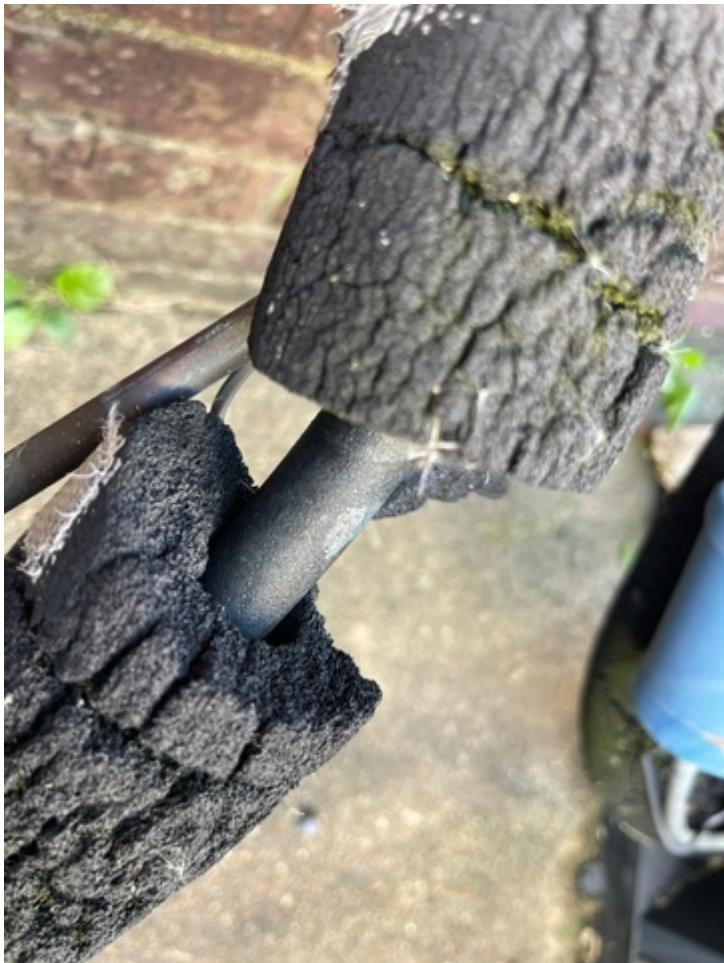
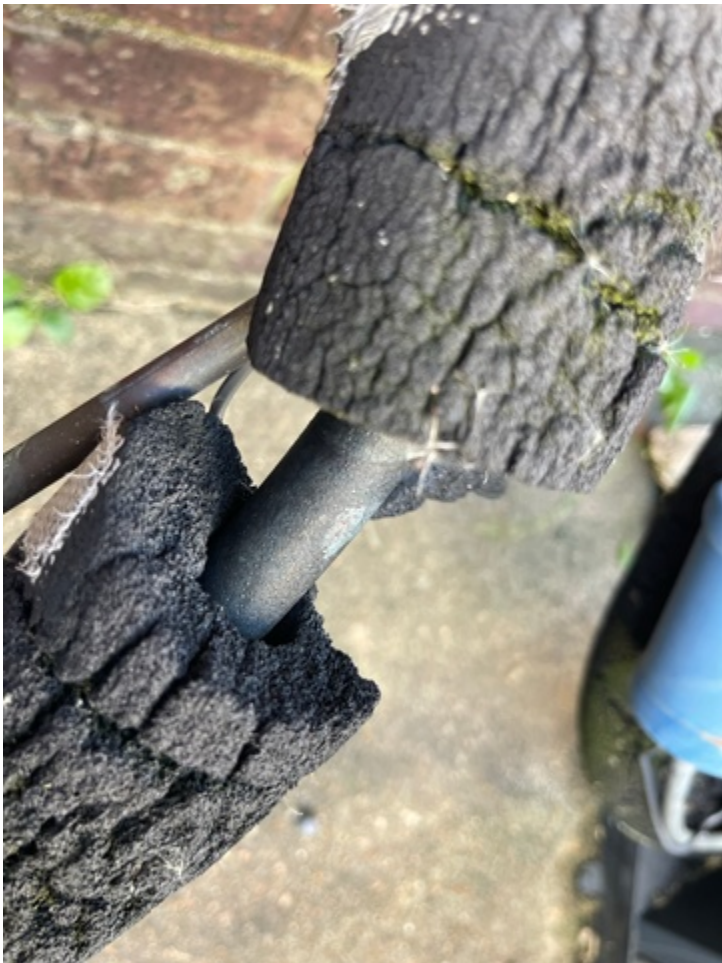
Missing or Damaged HVAC Line Insulation

The refrigerant line insulation is missing or damaged.

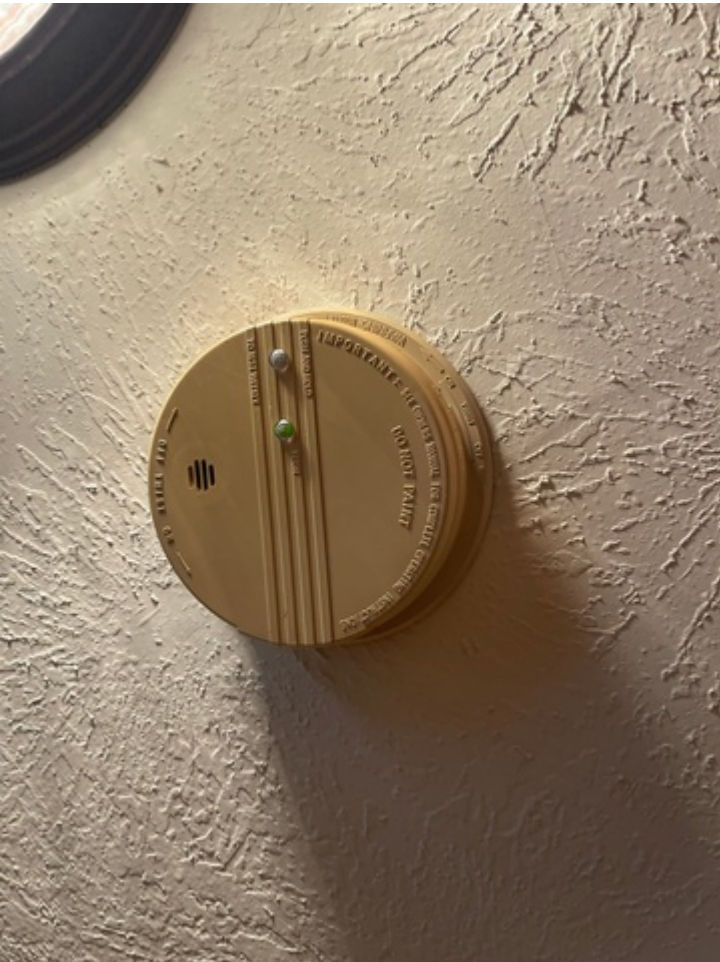
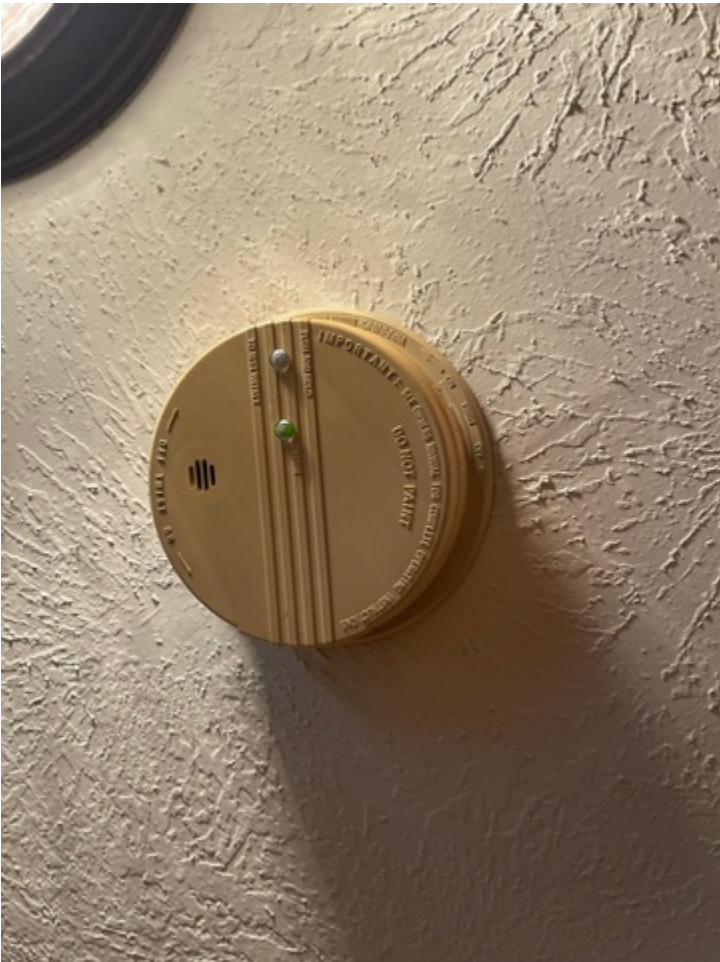
Missing Carbon Monoxide Detector(s)

One or more carbon monoxide detector(s) is missing or not installed.
