12325 Green Ridge Dr Willis, Texas 77318

Client	--
Reference id	a4xPd000003GAo5IAG
Type	Home Inspection and Floor Plan Report - 12325 Green Ridge Dr
Inspected by	HomeTeam Inspection Service - Northwest Houston
State license	Texas: TREC 22223
InterNACHI	Certified Professional Inspector (CPI): NACHI16110228
Other license	Texas Mold Assessment Consultant: MAC1506
Scheduled	December 5, 2025, 12:00 PM CST
Completed	December 5, 2025, 6:03 PM CST

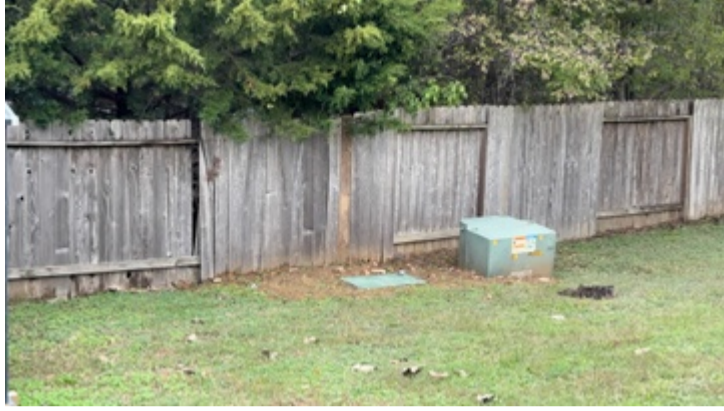
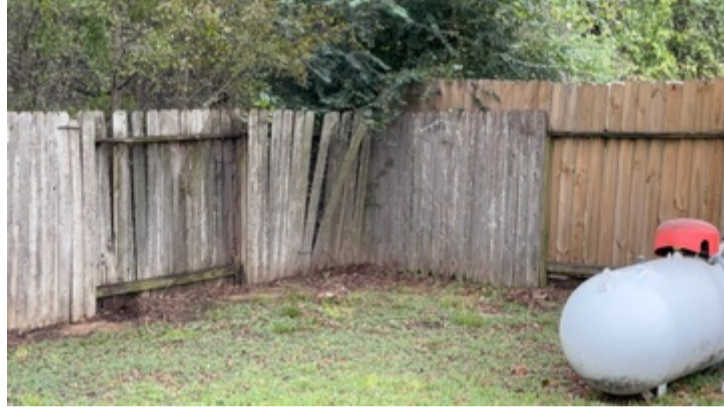
Damaged / Missing Fence Boards

One or more fence boards are missing or damaged.

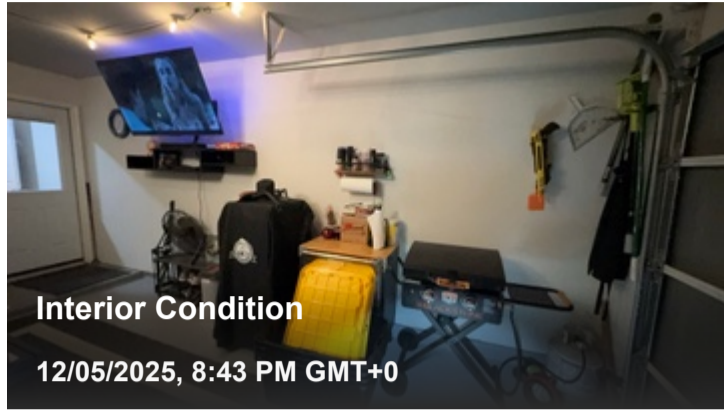
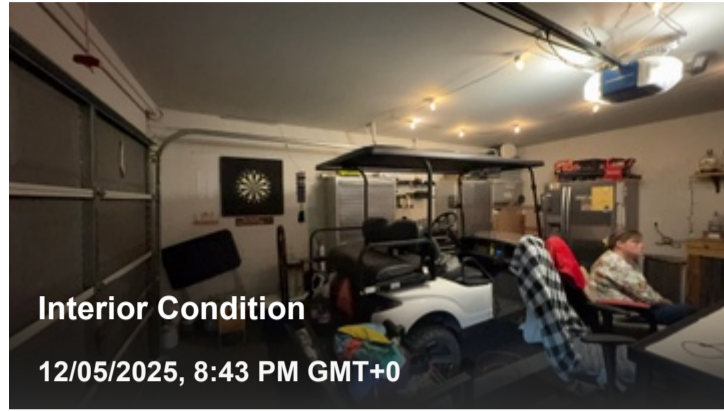
Missing GFCI

There is no GFCI (Ground-Fault Circuit Interrupter) protection.

Some garage receptacles were not GFCI protected

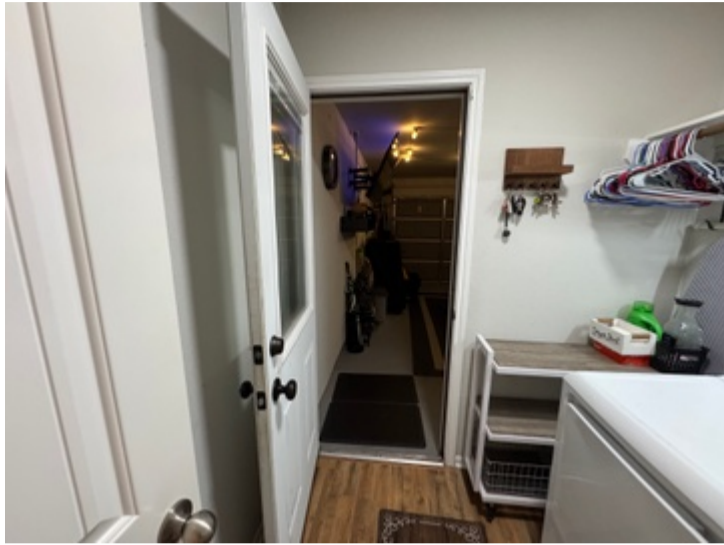
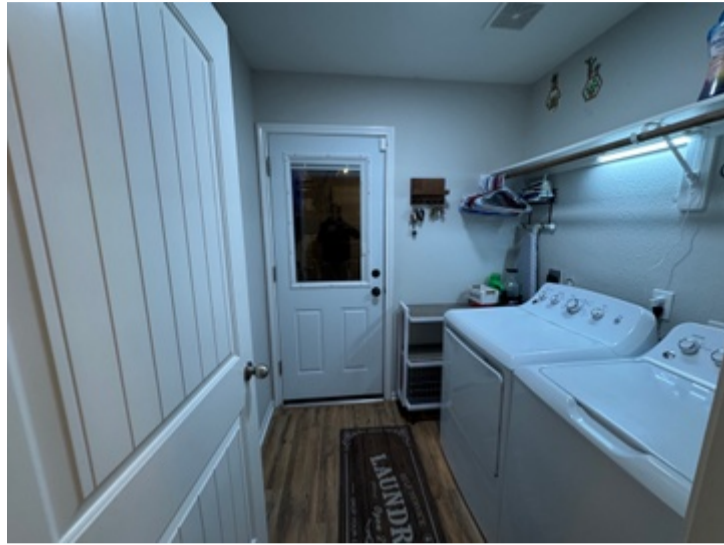
Missing / Inoperable Self-Closing Door Hinges

The self-closing door hinges are missing / inoperable.

Also, we could not confirm the door was fire rated with the window in the door.

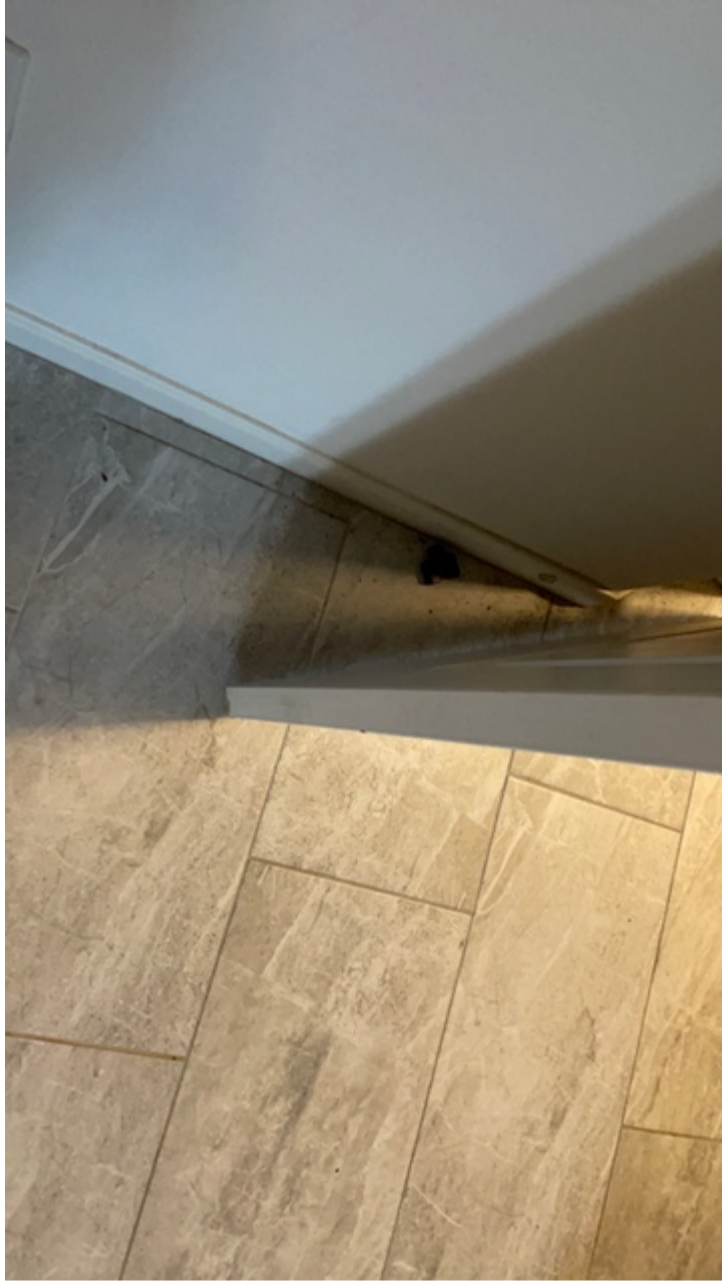
Missing / Damaged Door Stop(s)

Door stops are missing or damaged for an interior door.

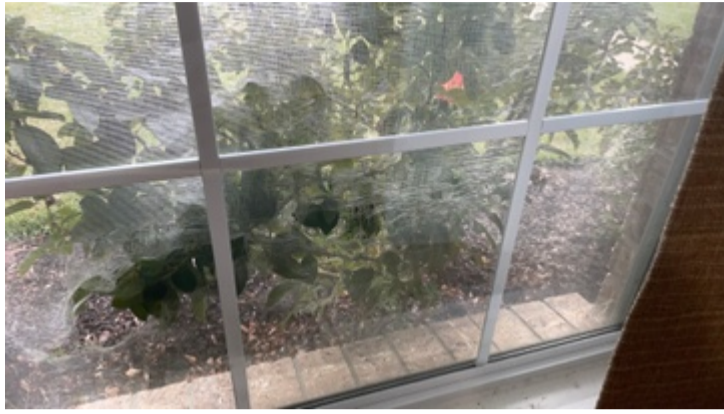
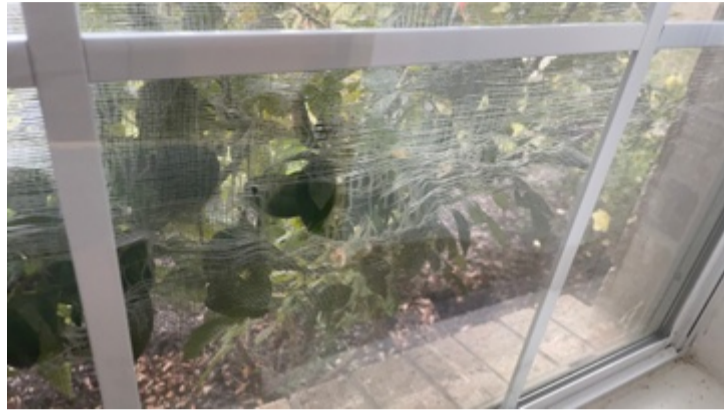
Damaged Screen

One or more window screens are damaged.

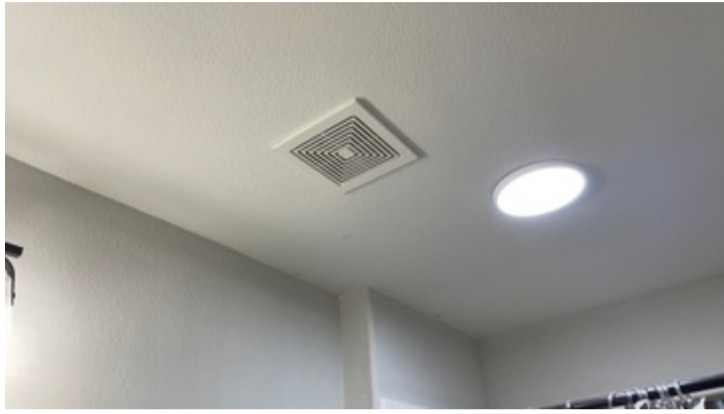
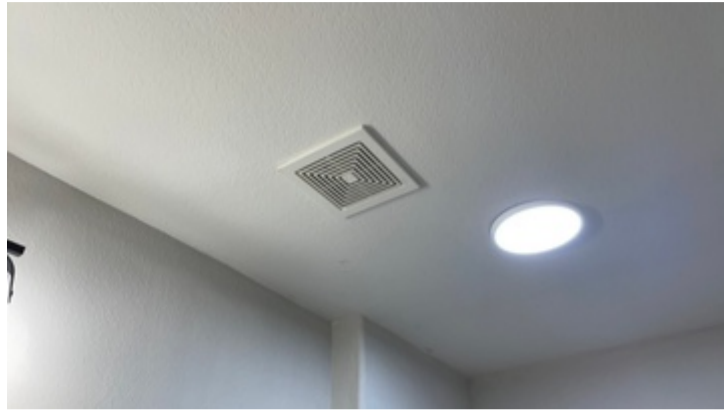
The bathroom exhaust fan is inoperable.

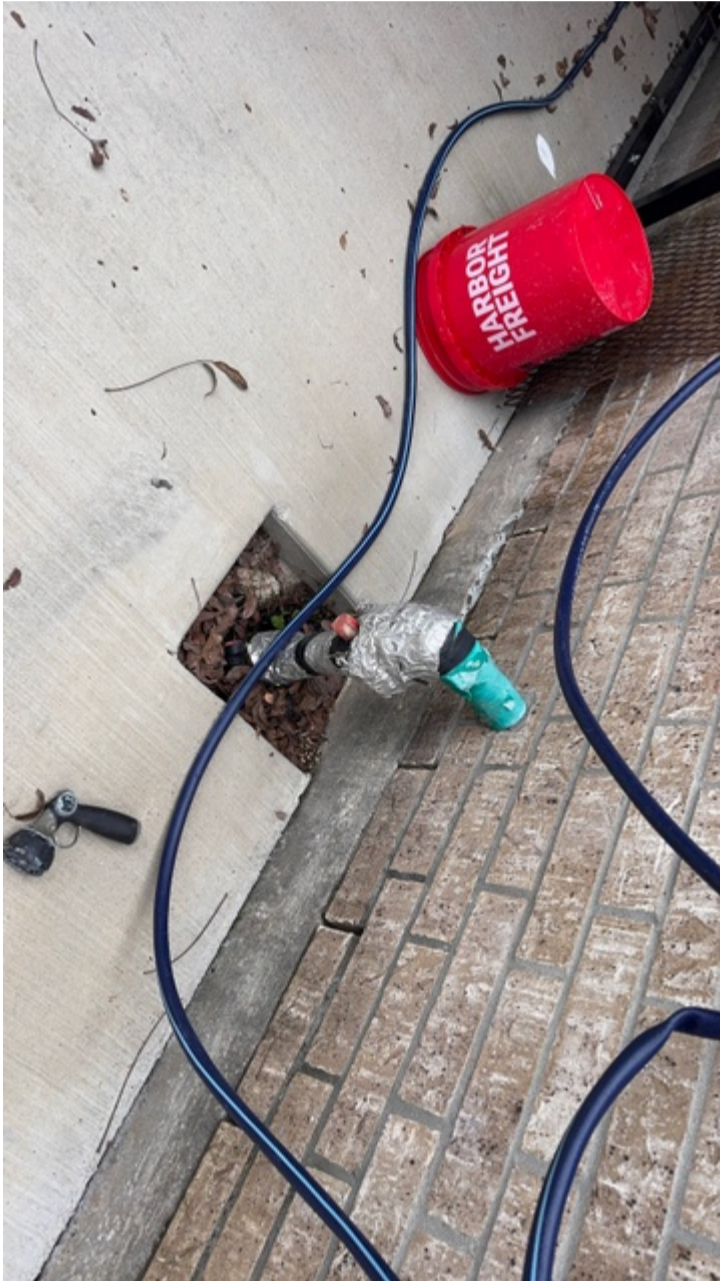
Deteriorated / Damaged Water Valve

The valve is deteriorated / damaged.

No handles for the main water shut off valve

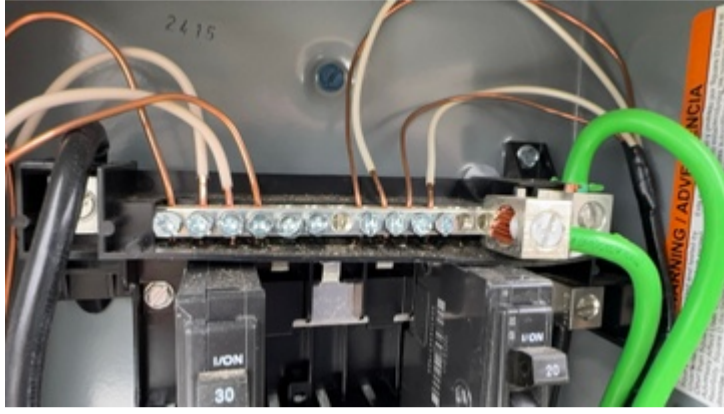
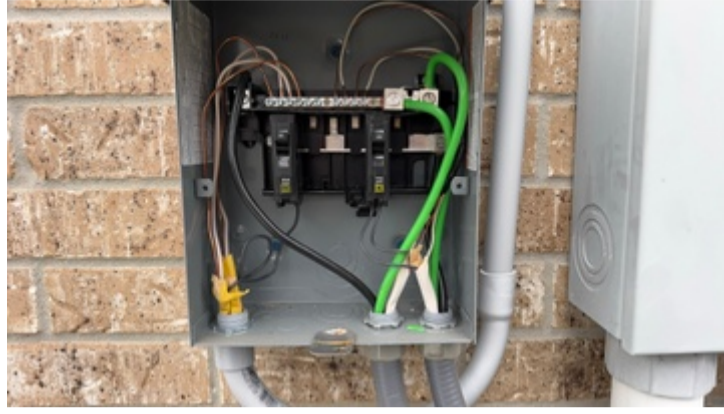
Missing Electrical Panel Knockouts

The electric panel knockouts are missing.
