10210 Crooks Way Ct

Houston, Texas 77065

Client	--
Reference id	a4xPd000002uG7NIAU
Type	Home Inspection and Floor Plan Report - 10210 Crooks Way Ct
Inspected by	ArchiTech Home Inspections
State license	026393
InterNACHI	24043013
Scheduled	October 11, 2025, 4:15 PM
Completed	October 11, 2025, 8:33 PM

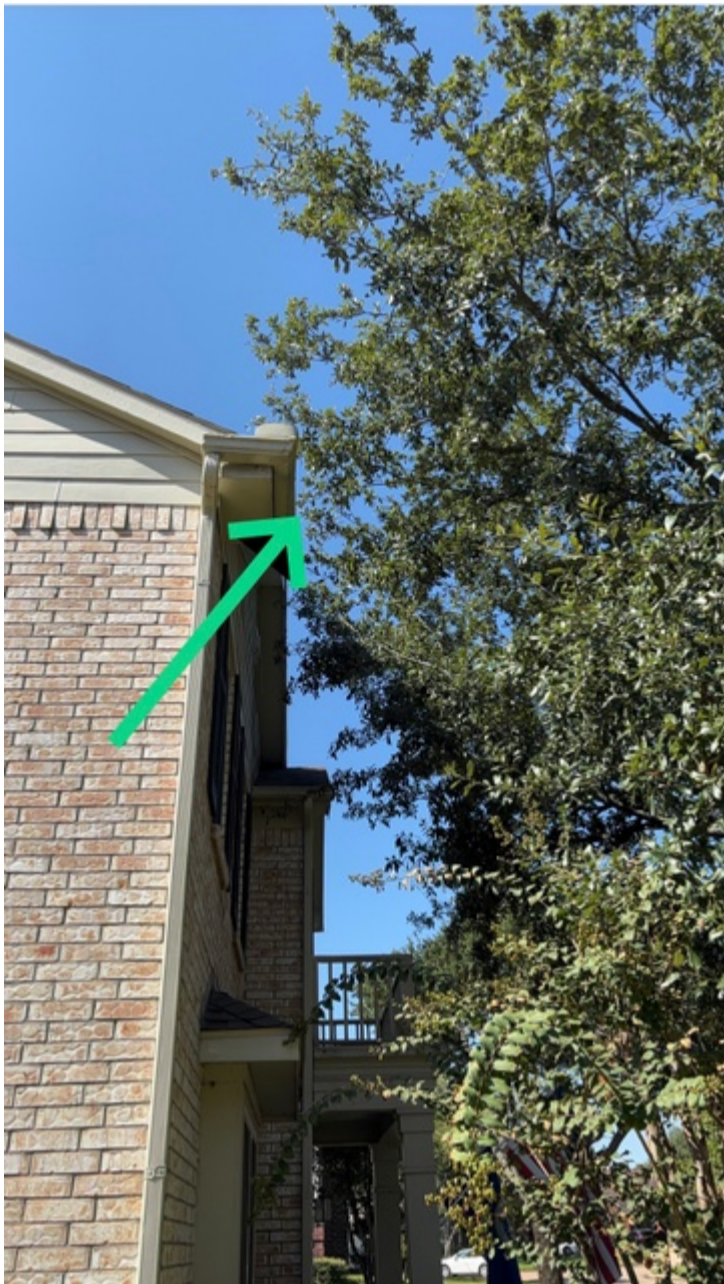
Monitor deficiency

Trim and Monitor Trees

Trees need to be trimmed. Recommend further evaluation by a qualified professional.

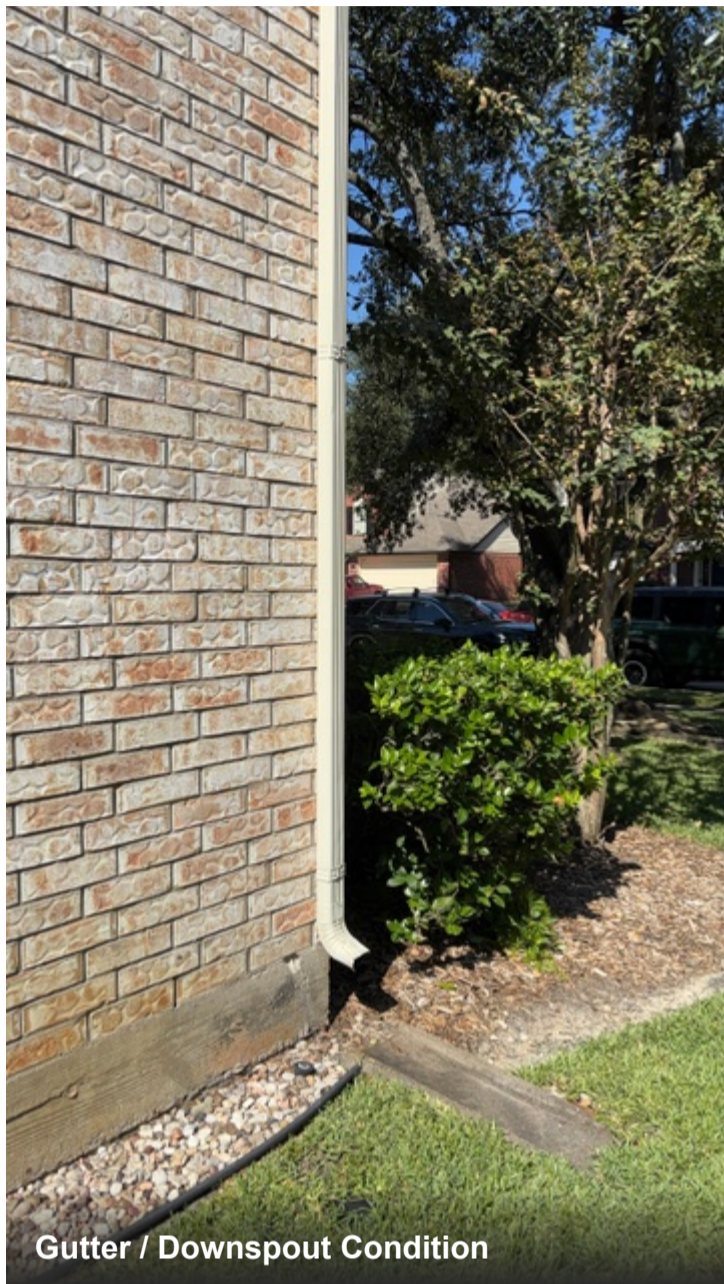
**Repair deficiency**

One or more downspouts / downspout extensions drain too close to the property's foundation. Recommend repairs or replacing by a qualified professional.

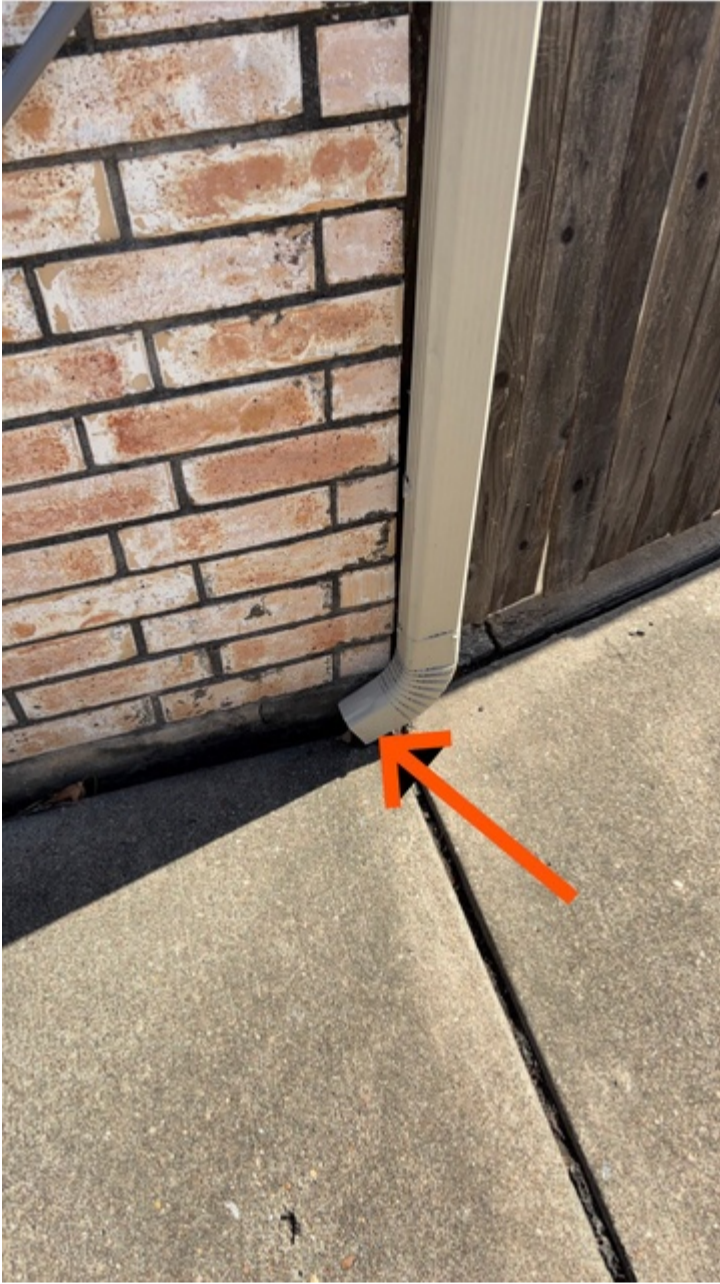
**Repair deficiency**

Loose Gutters

One or more gutters are loose and need to be re-fastened to fascia and pitched properly. Recommend further evaluation by a qualified professional.

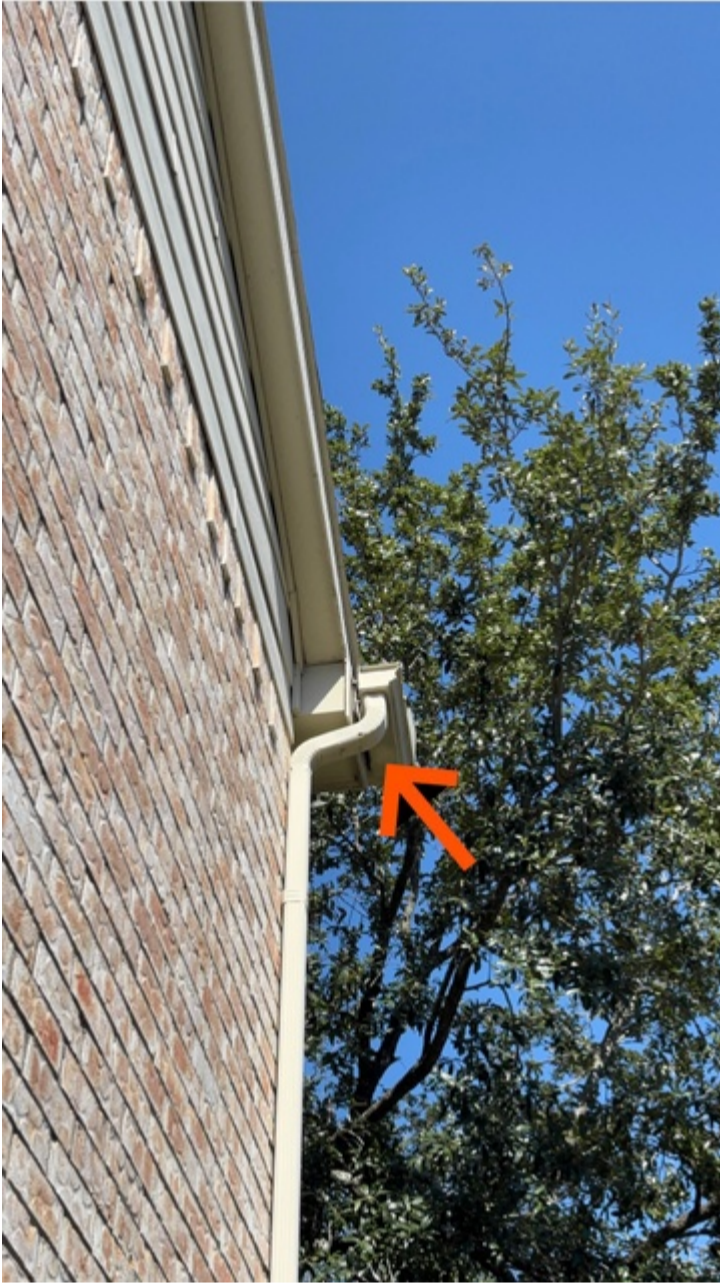
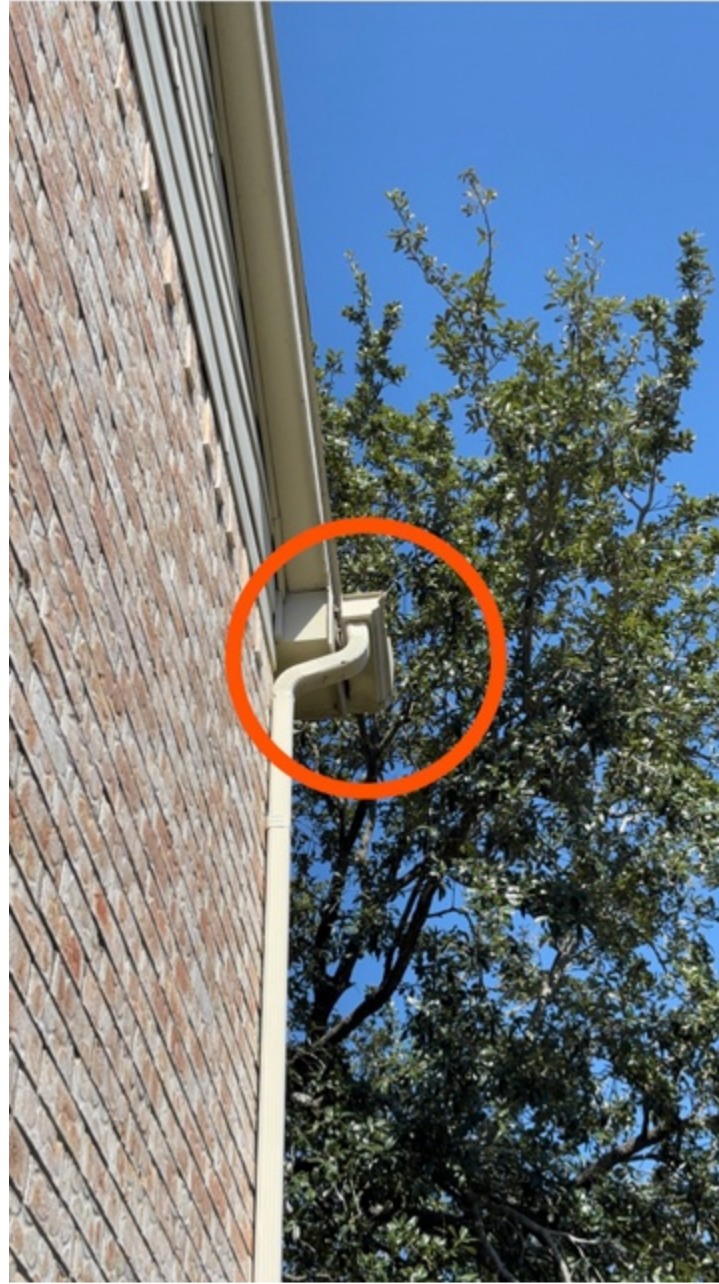
**Repair deficiency**

Damaged Gutter / Downspout

The gutter / downspout is damaged. Recommend further evaluation, and repairs or replacing by a qualified professional.

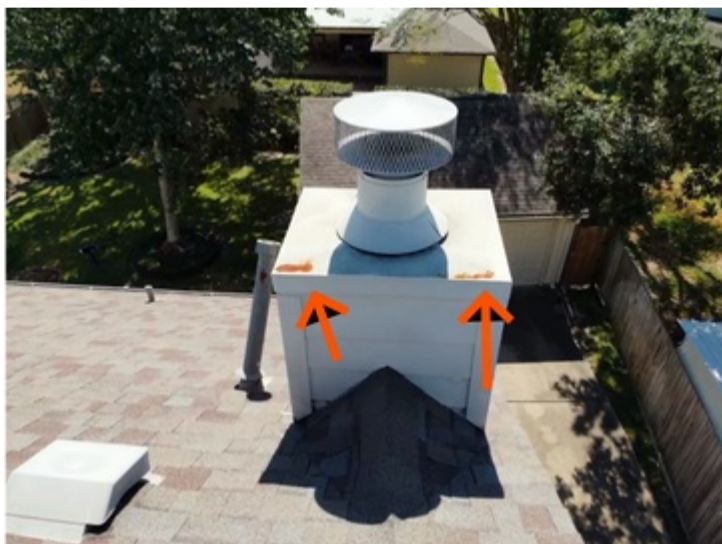
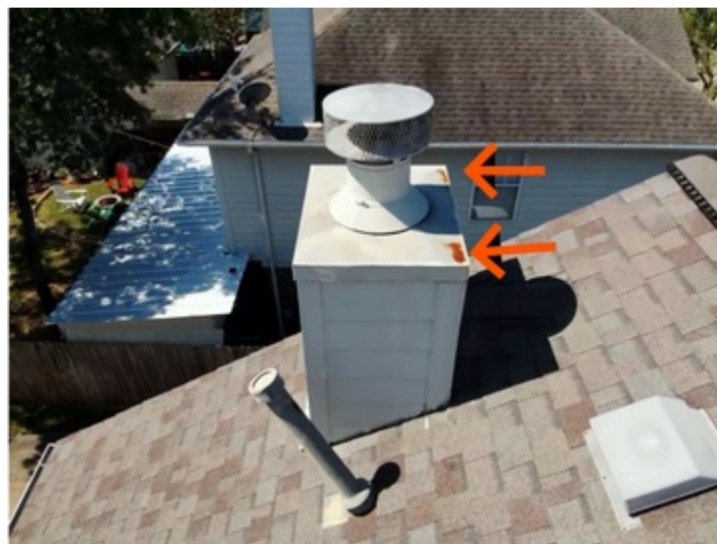
🔧 Repair deficiency

Corroded Chimney Cap

The chimney cap is corroded. Recommend further evaluation by a qualified professional.

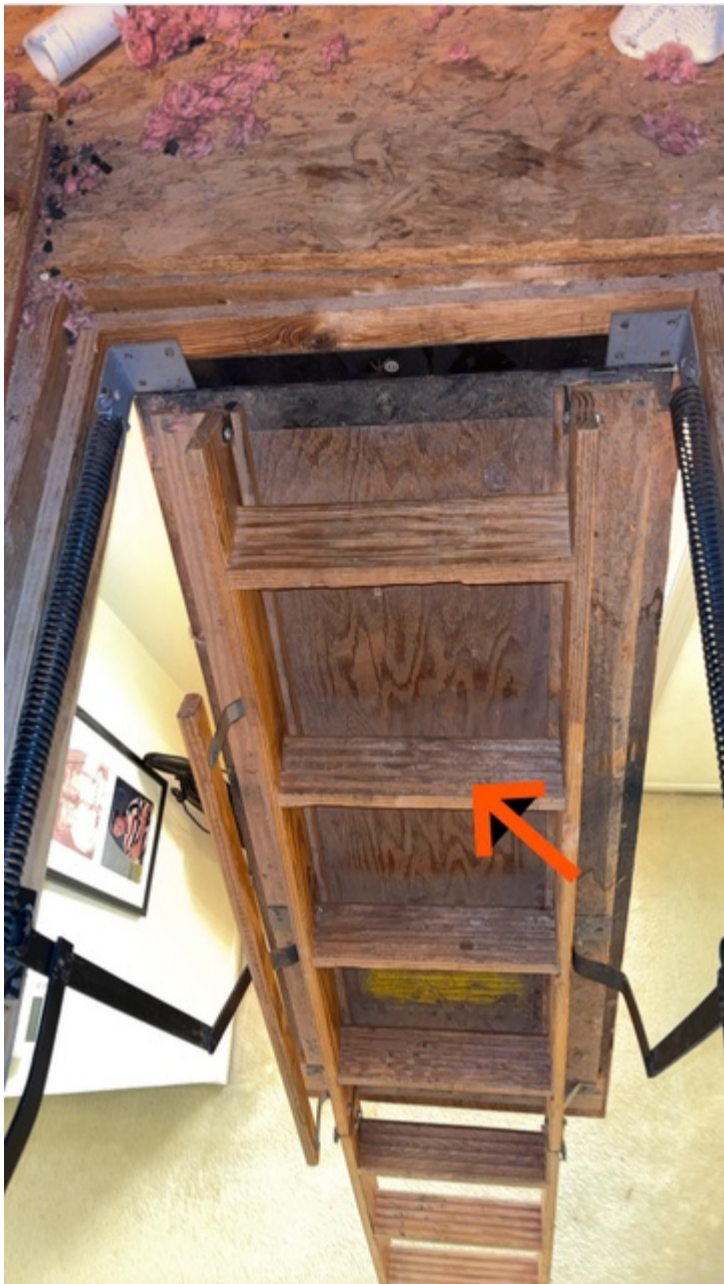
**Repair deficiency**

Missing Attic Hatch Insulation

There is no insulation for the attic access hatches. Recommend further evaluation by a qualified professional.

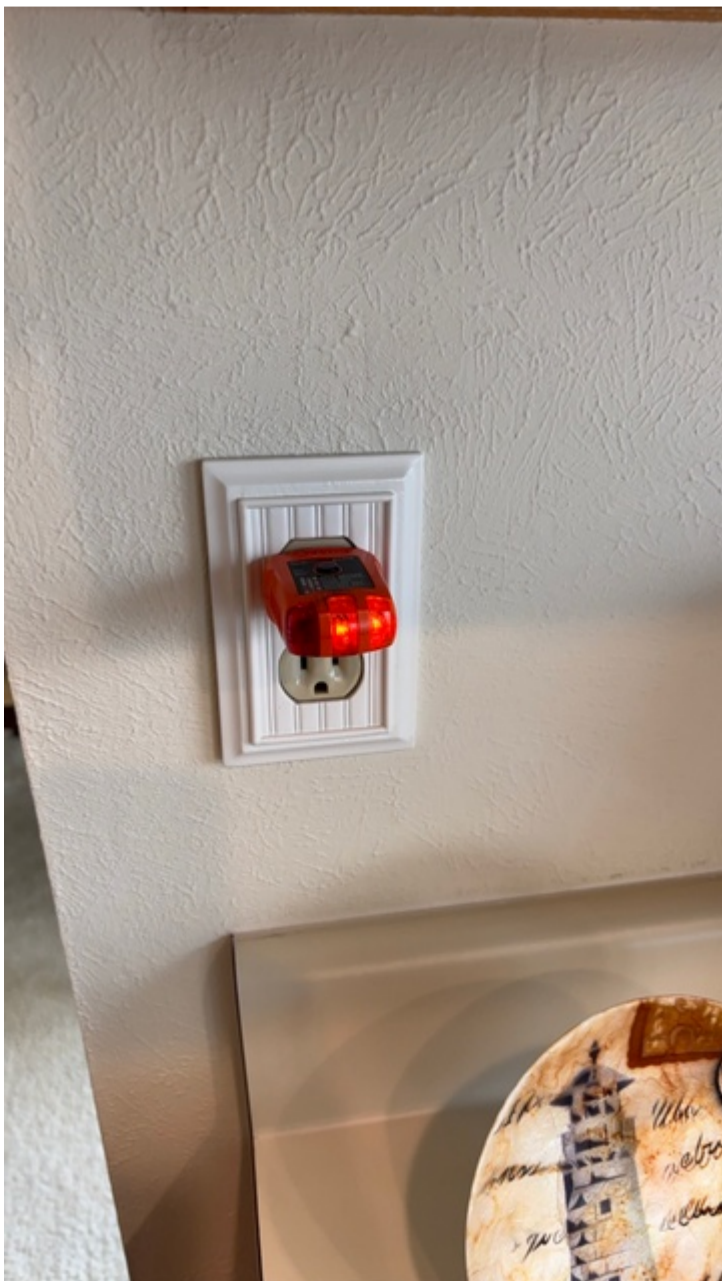
**Repair deficiency**

Missing GFCI

There is no GFCI (Ground-Fault Circuit Interrupter) protection. Recommend further evaluation, and repairs or replacing by a qualified professional.

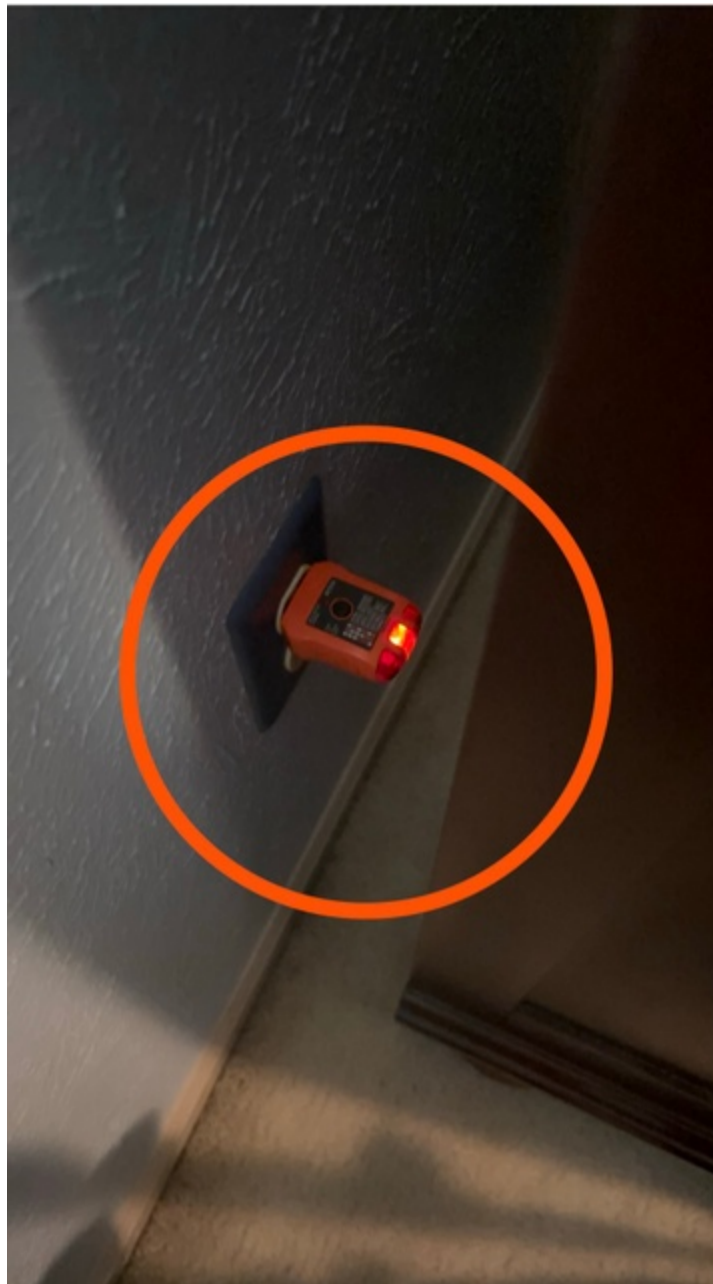
**Safety deficiency**

One or more outlets do not have a connected ground wire. Recommend further evaluation, and repairs or replacing by a qualified professional.

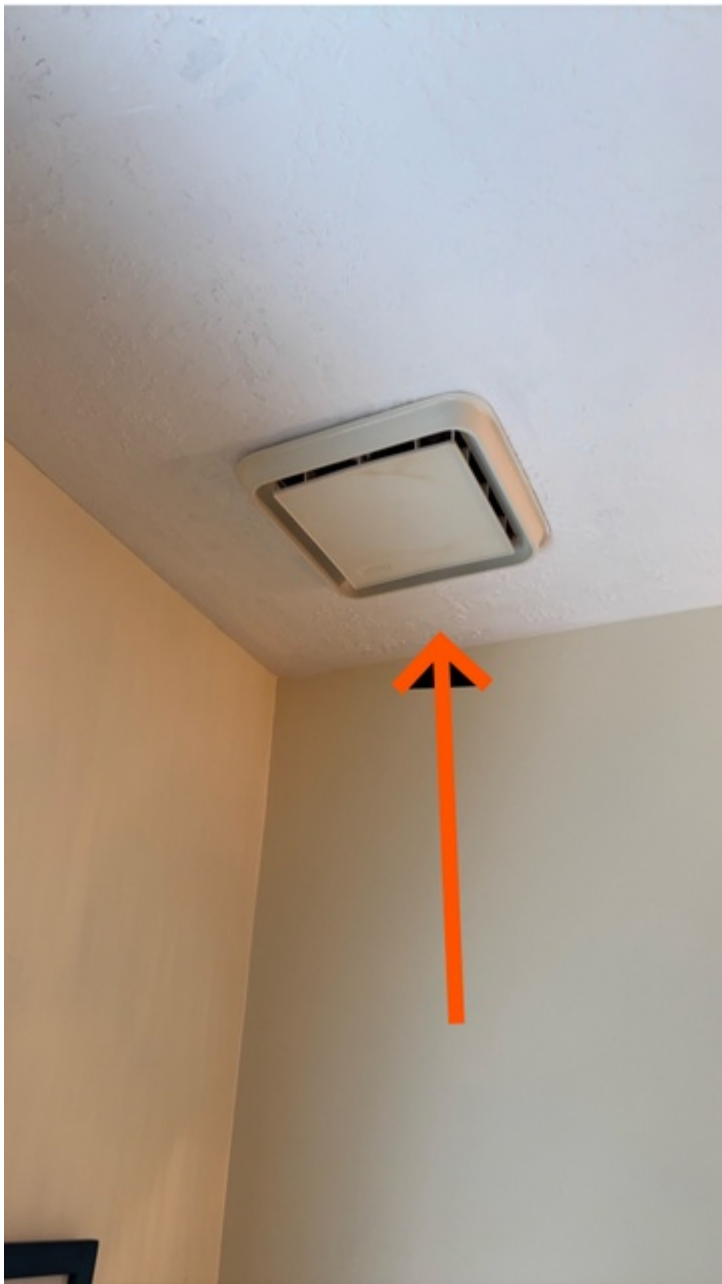
**Repair deficiency**

The bathroom exhaust fan is inoperable. Recommend further evaluation, and repairs or replacing by a qualified professional.

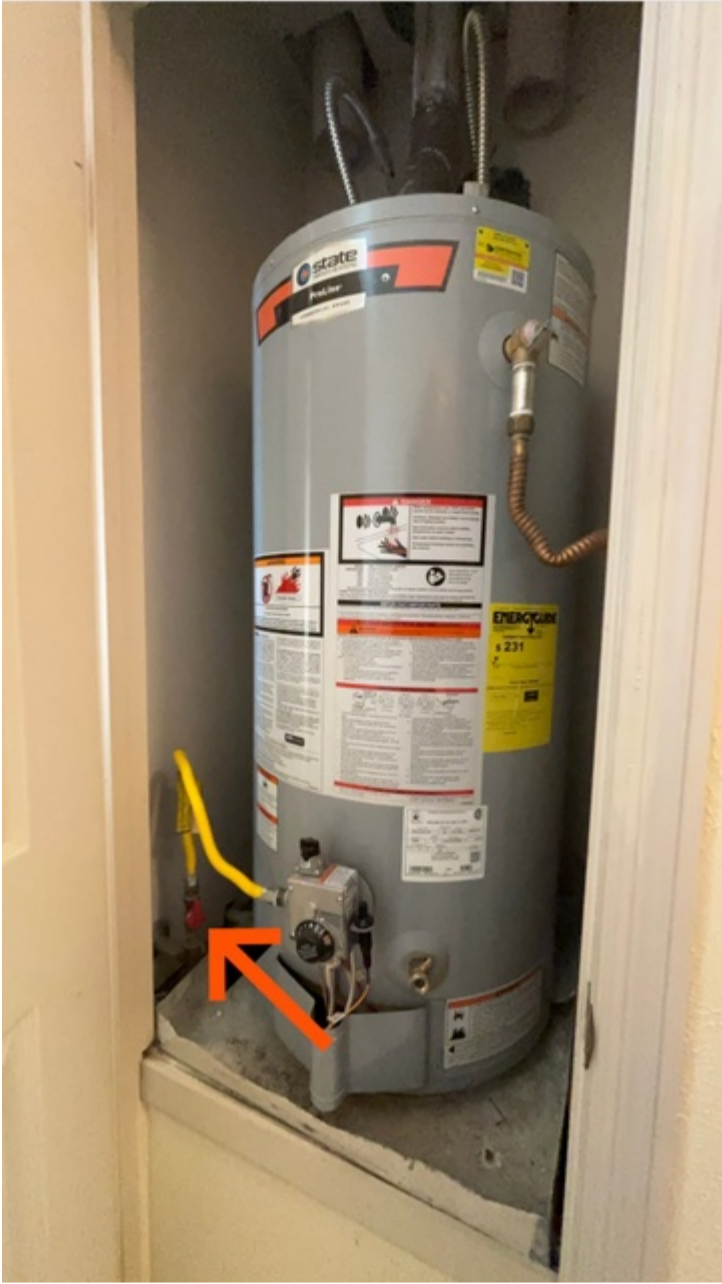
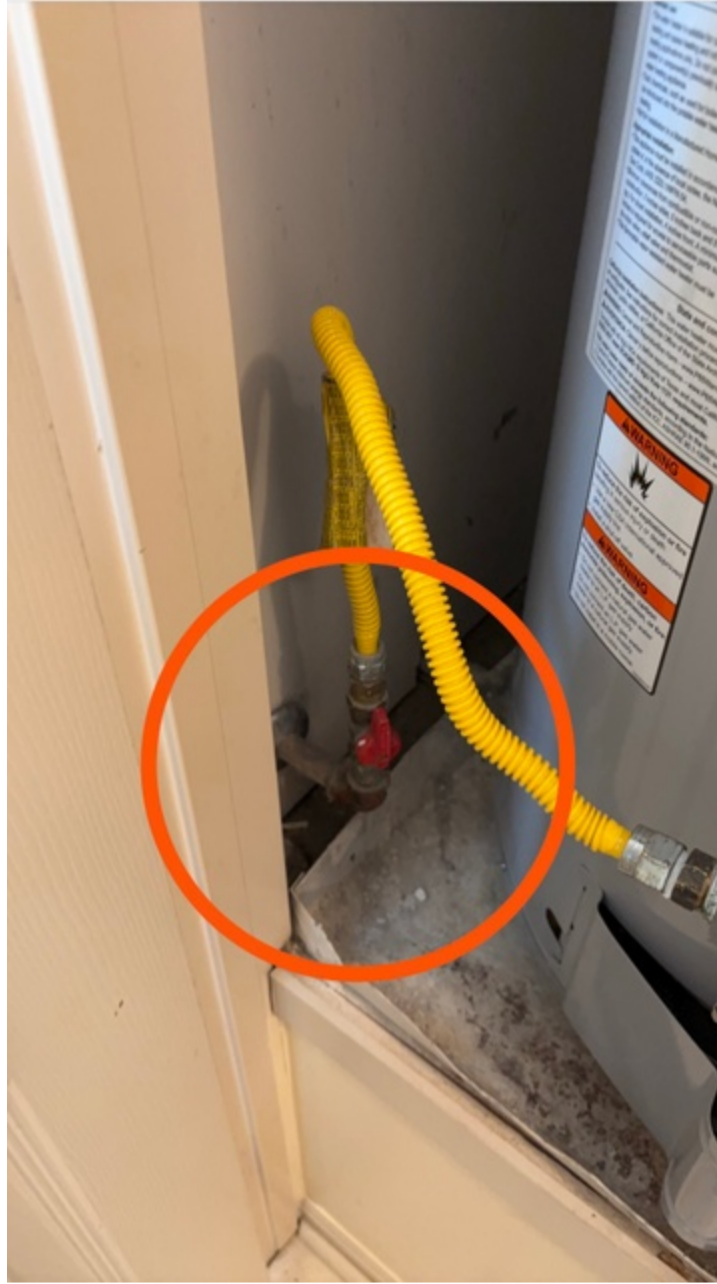
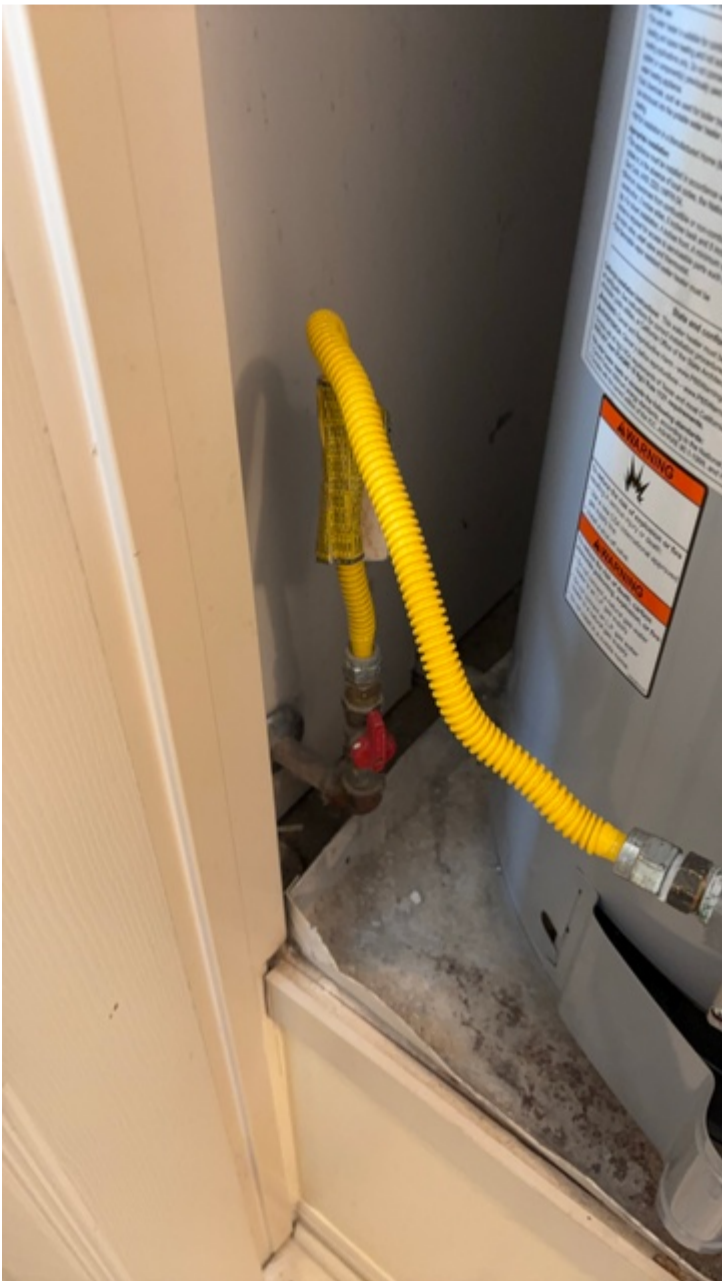
**Repair deficiency**

Missing Gas Line Sediment Trap

The gas line does not have a sediment trap installed. Recommend further evaluation by a qualified professional.

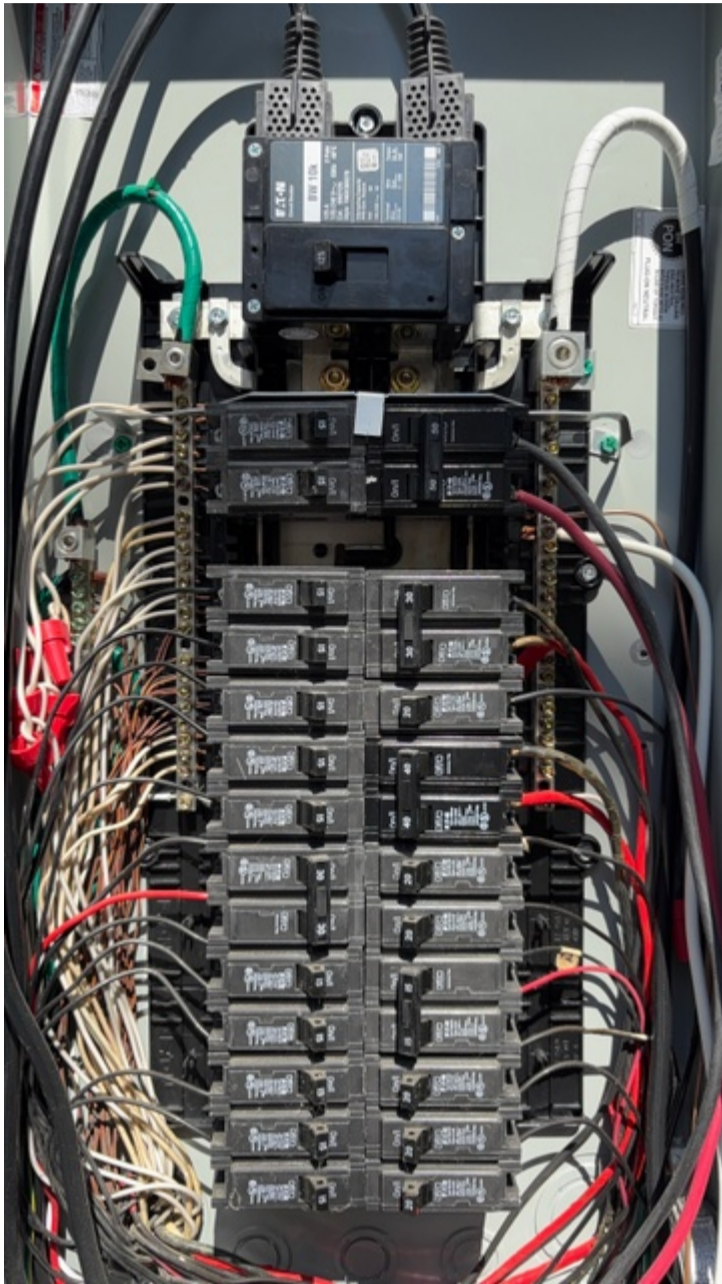
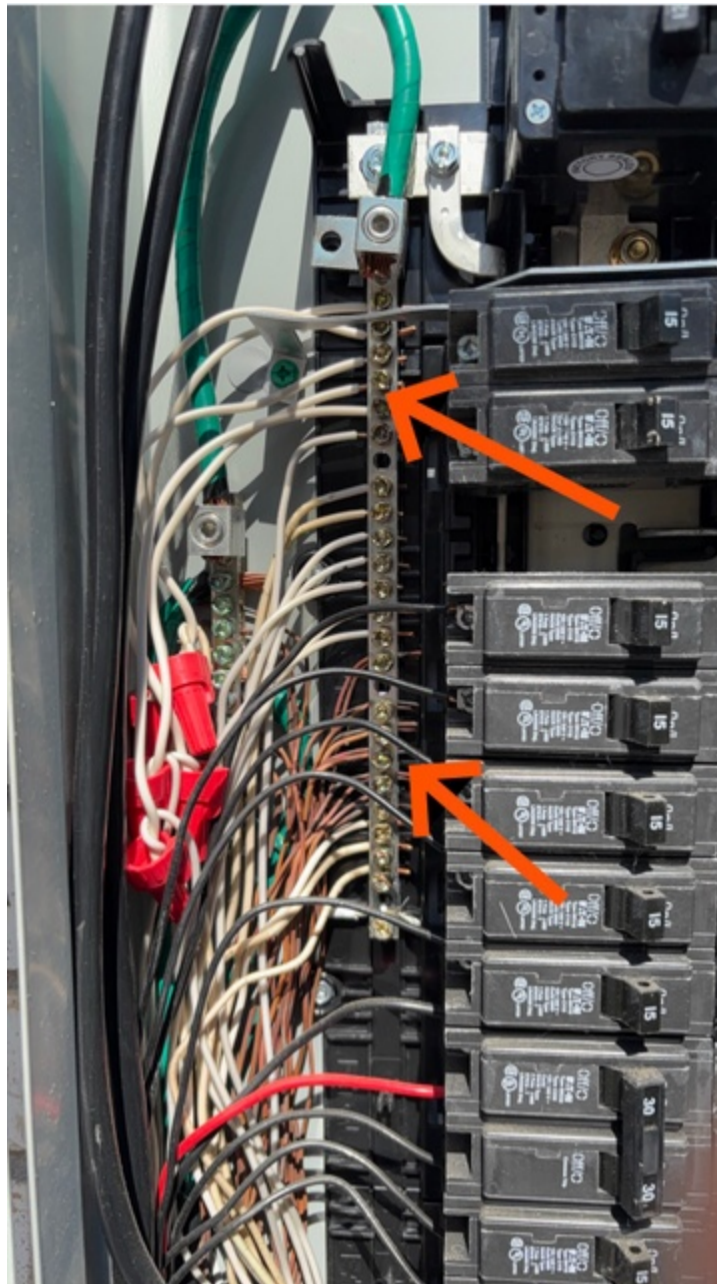
⚠️ Safety deficiency

Neutral / Ground Shared Bus Bar

The neutral (white wire) and equipment grounding conductors (bare wire) terminate under the same lug. Recommend further evaluation by a qualified professional.

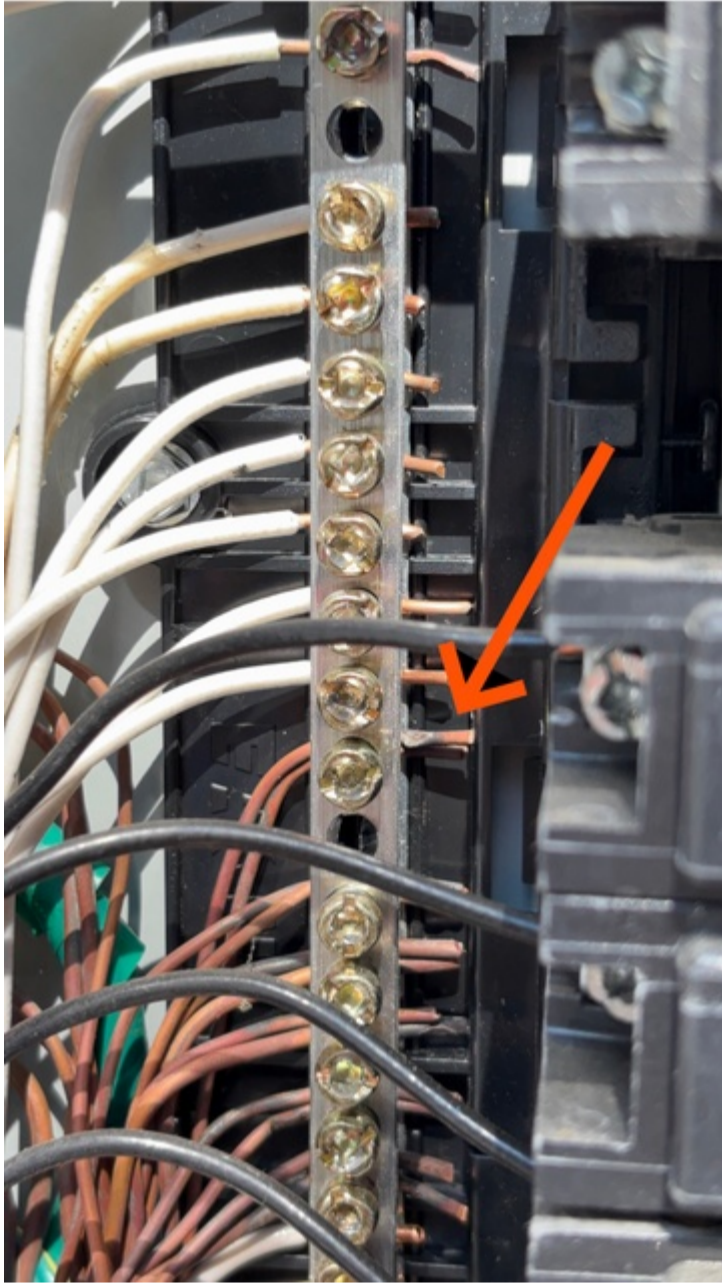
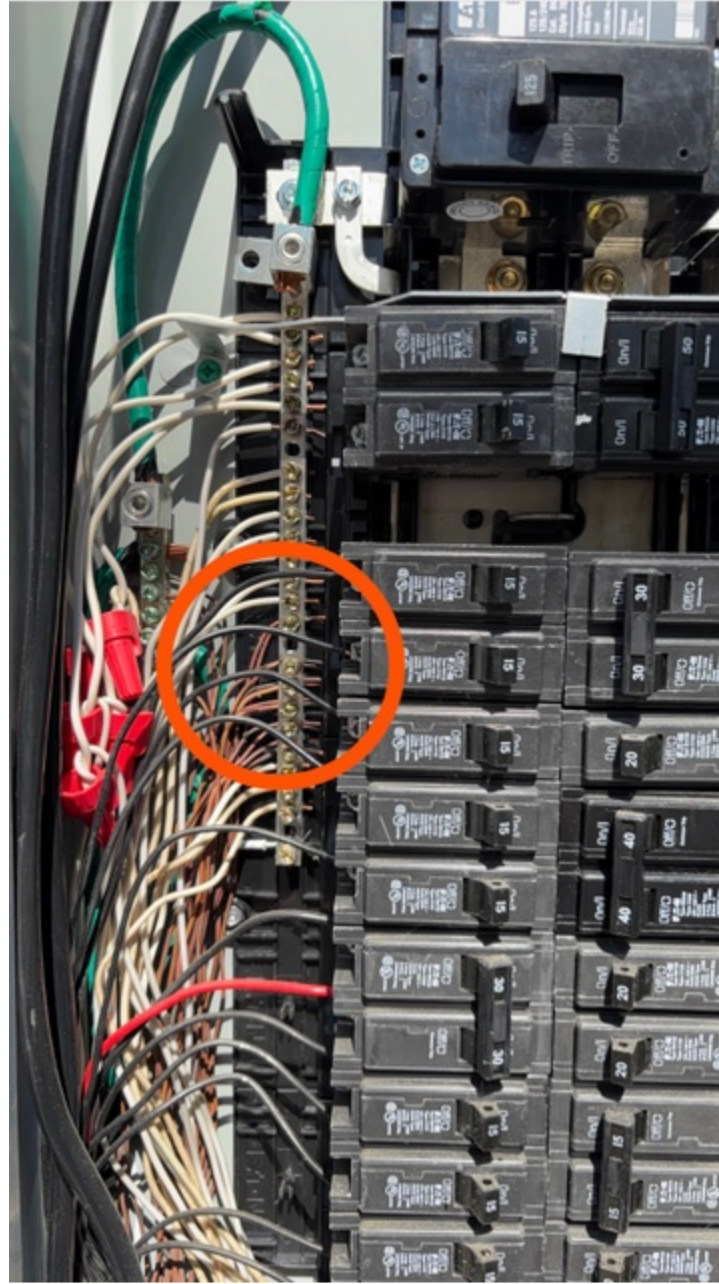
+ Safety deficiency

Scorched Wire(s)

One or more wire(s) are scorched. Recommend further evaluation by a qualified professional.
