# 14 S Duskwood Pl

## Spring, Texas 77381

| Type | <b>Re Visit Report - 14 S Duskwood Pl</b> |
| Inspected by | <b>Local Property Inspections PLLC</b> |

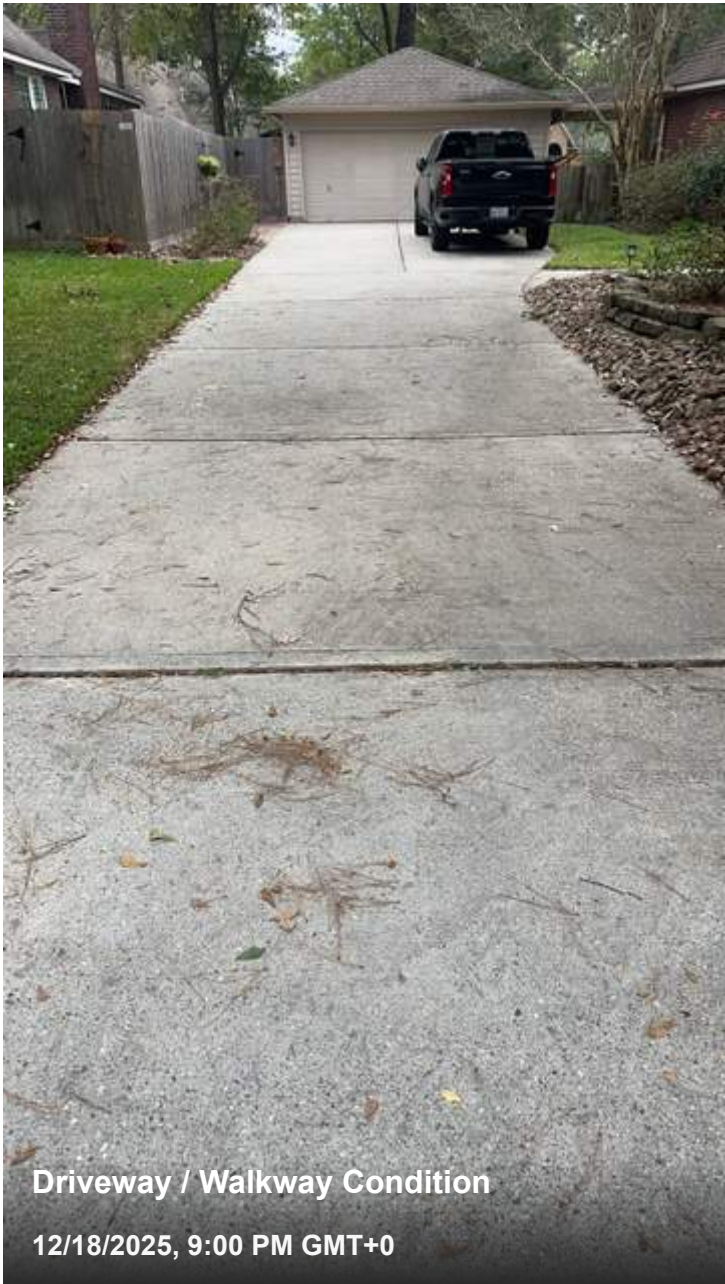
Minor Cracks in the Driveway

The driveway has minor cosmetic cracks. Recommend monitoring this.

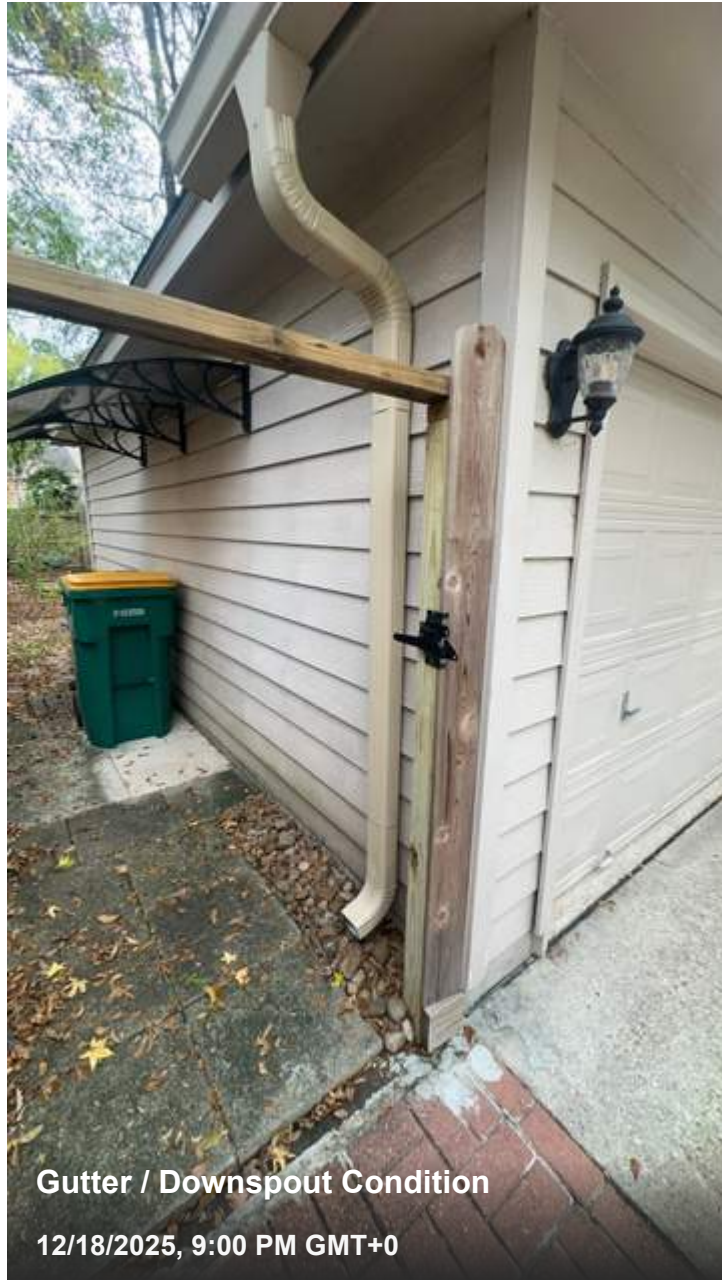
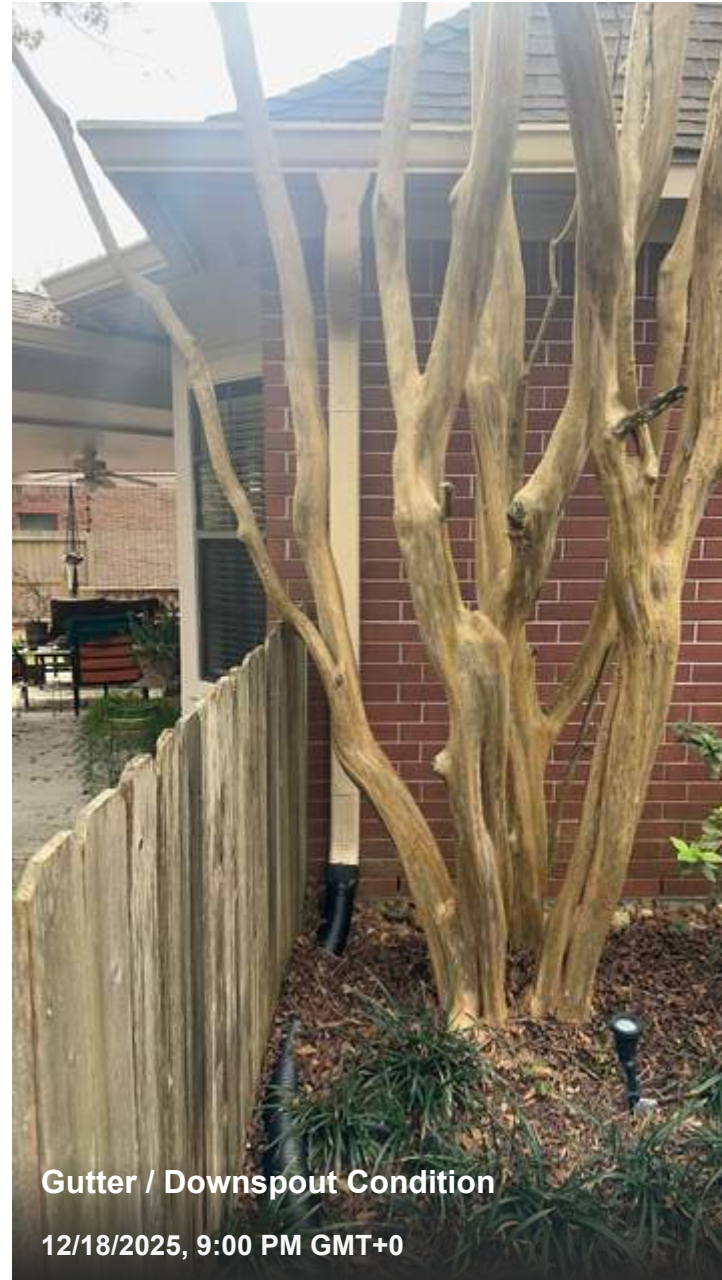
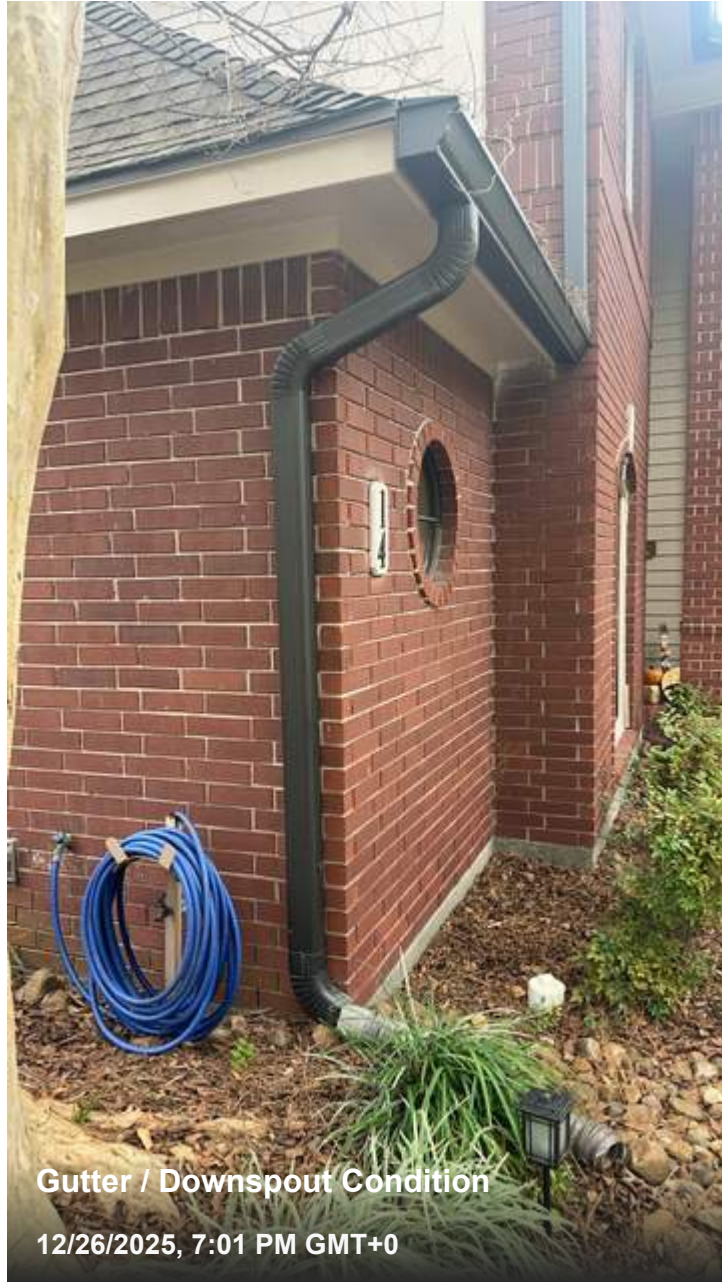
### Damaged Gutters

The gutters are damaged. Recommend repairs or replacing by a qualified professional.

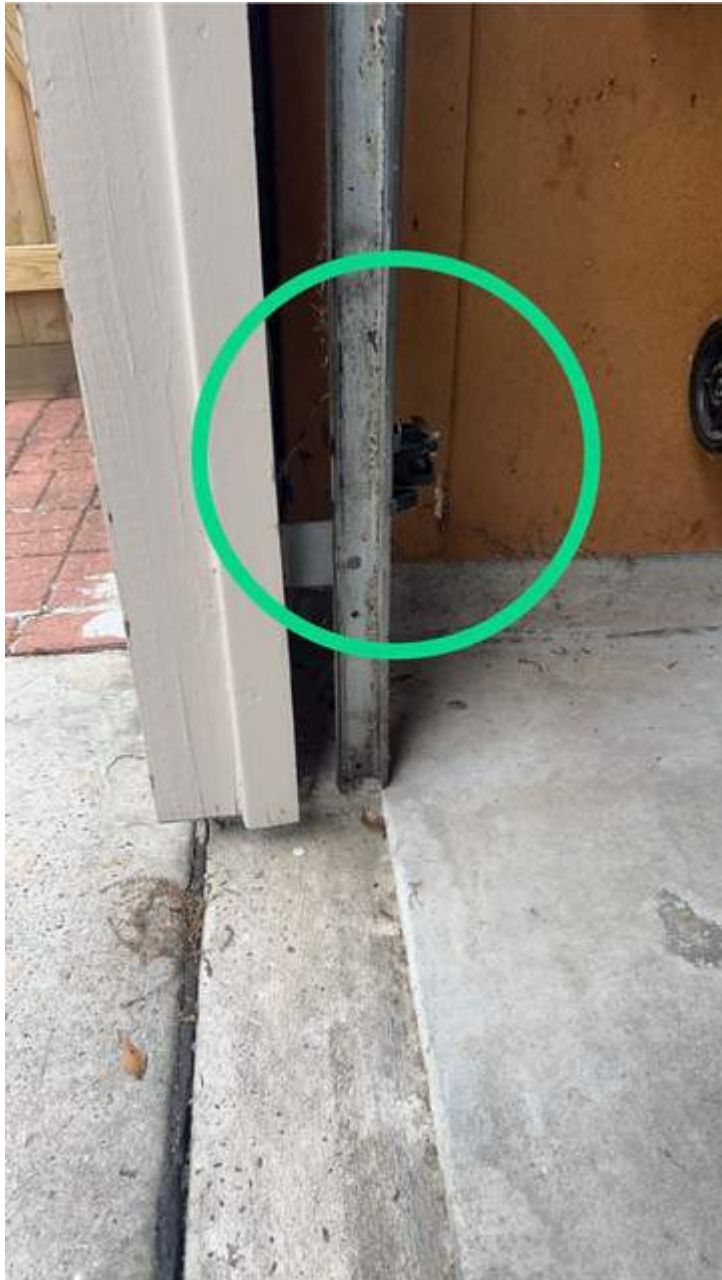
The garage proximity laser is too high off the ground. Recommend repairs or replacing by a qualified professional.

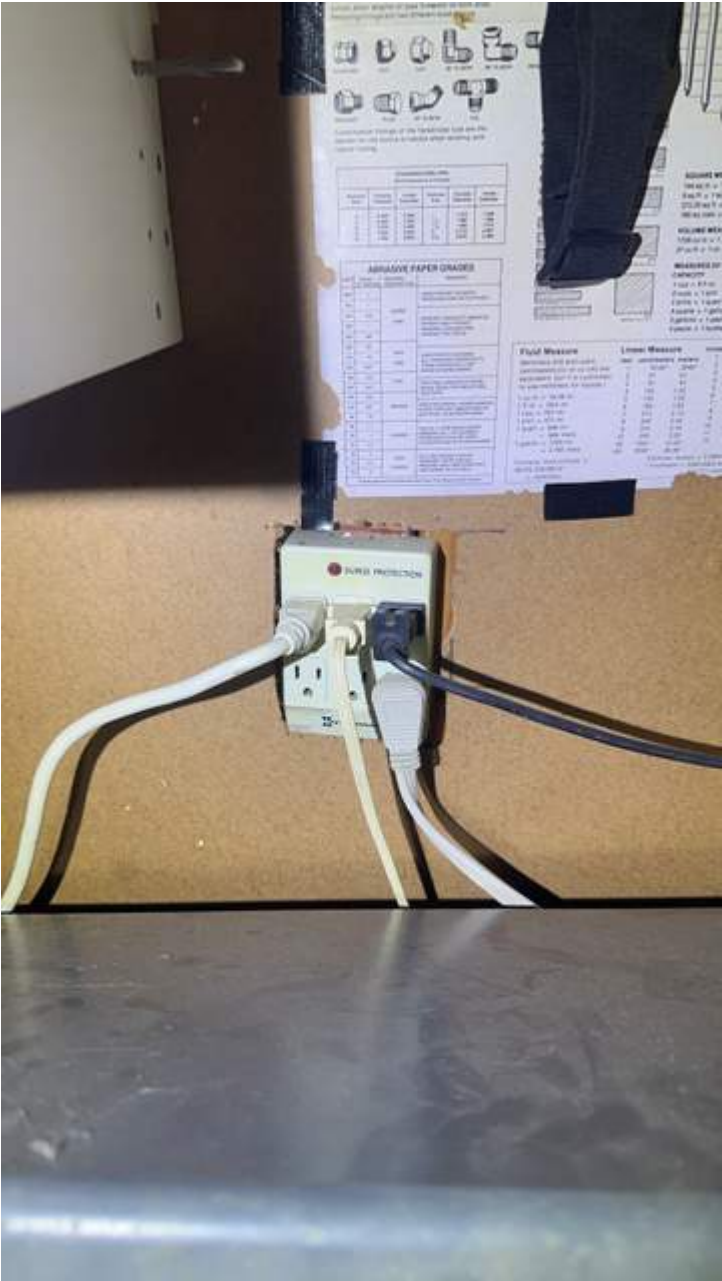
**Missing GFCI**

There is no GFCI (Ground-Fault Circuit Interrupter) protection. Recommend repairs or replacing by a qualified professional.

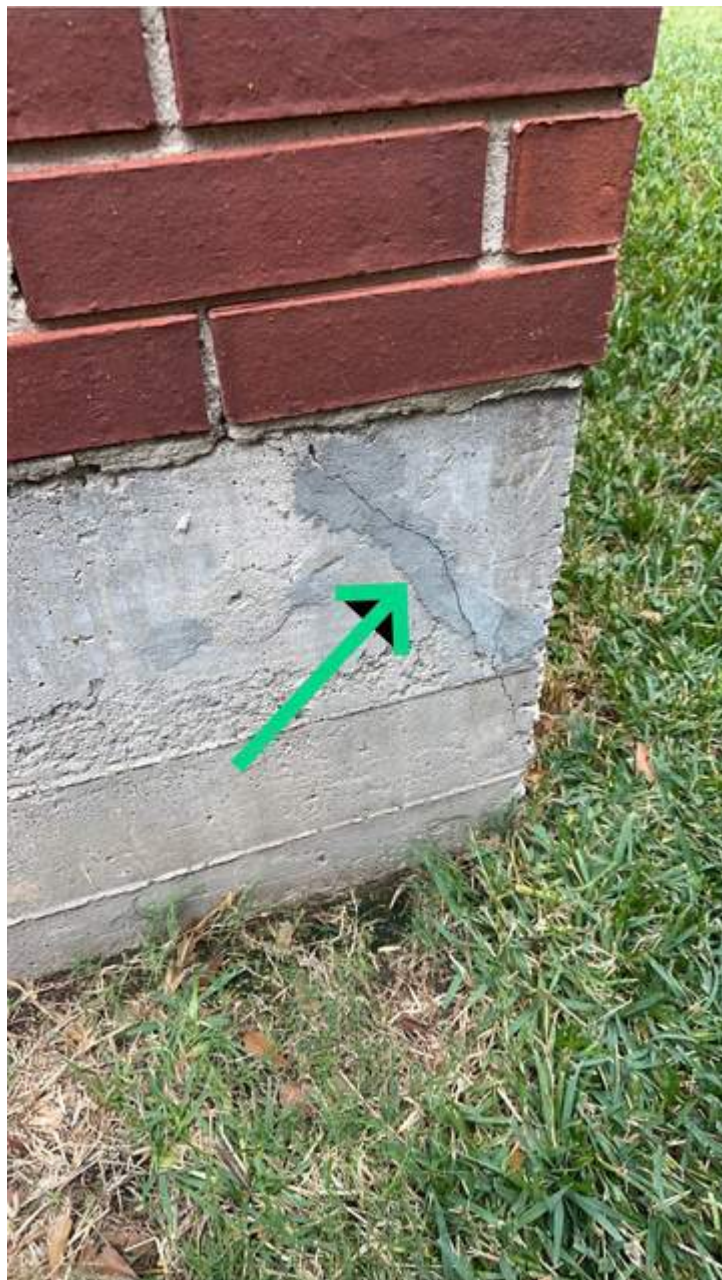
## Minor Corner Cracks

There are minor cracks at the corners of doors / windows / walls. Recommend monitoring this, and further evaluation by a qualified professional.

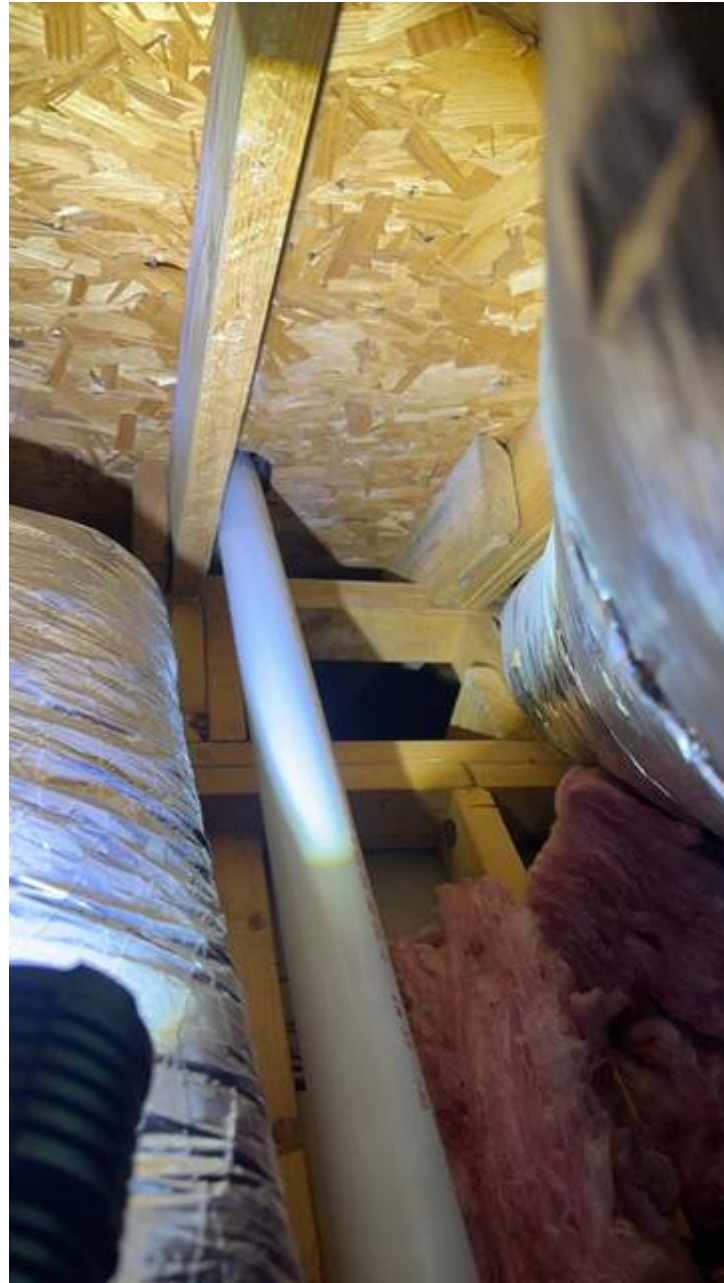
## Leaking Roof

There are indications of a leak from the roof.

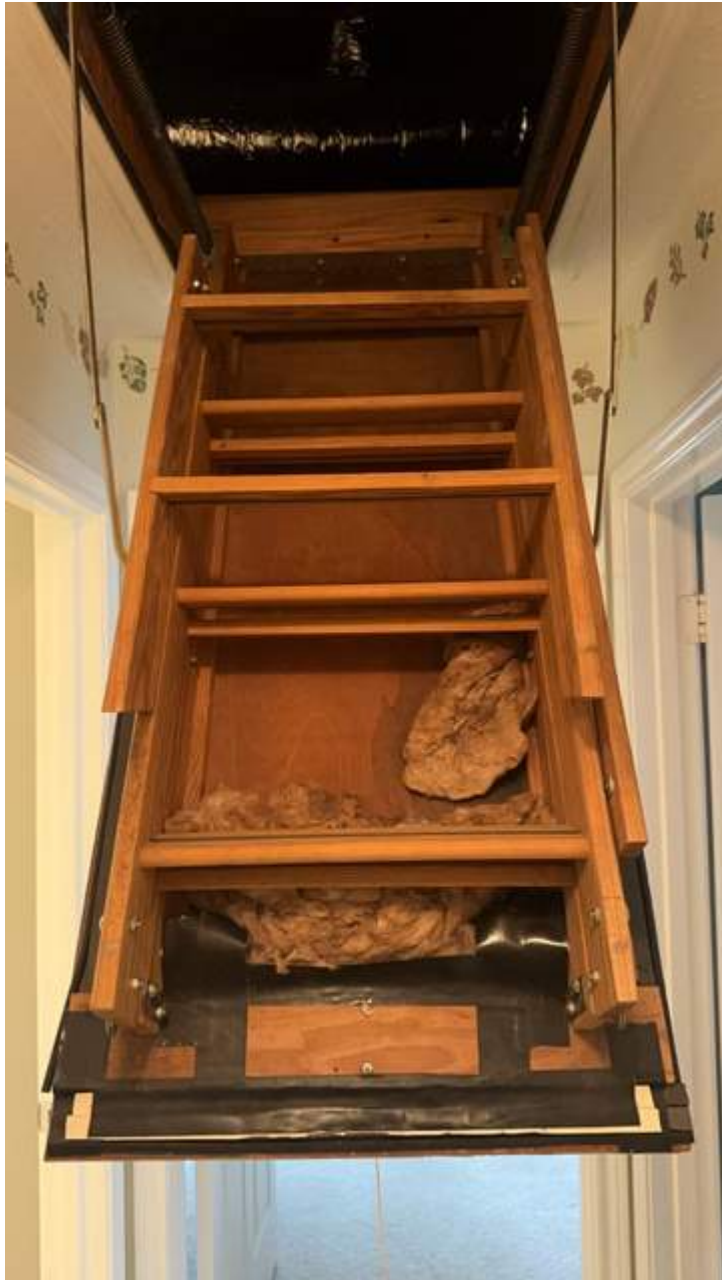
## Missing Attic Hatch Insulation

There is no insulation for the attic access hatches. Recommend repairs or replacing by a qualified professional.

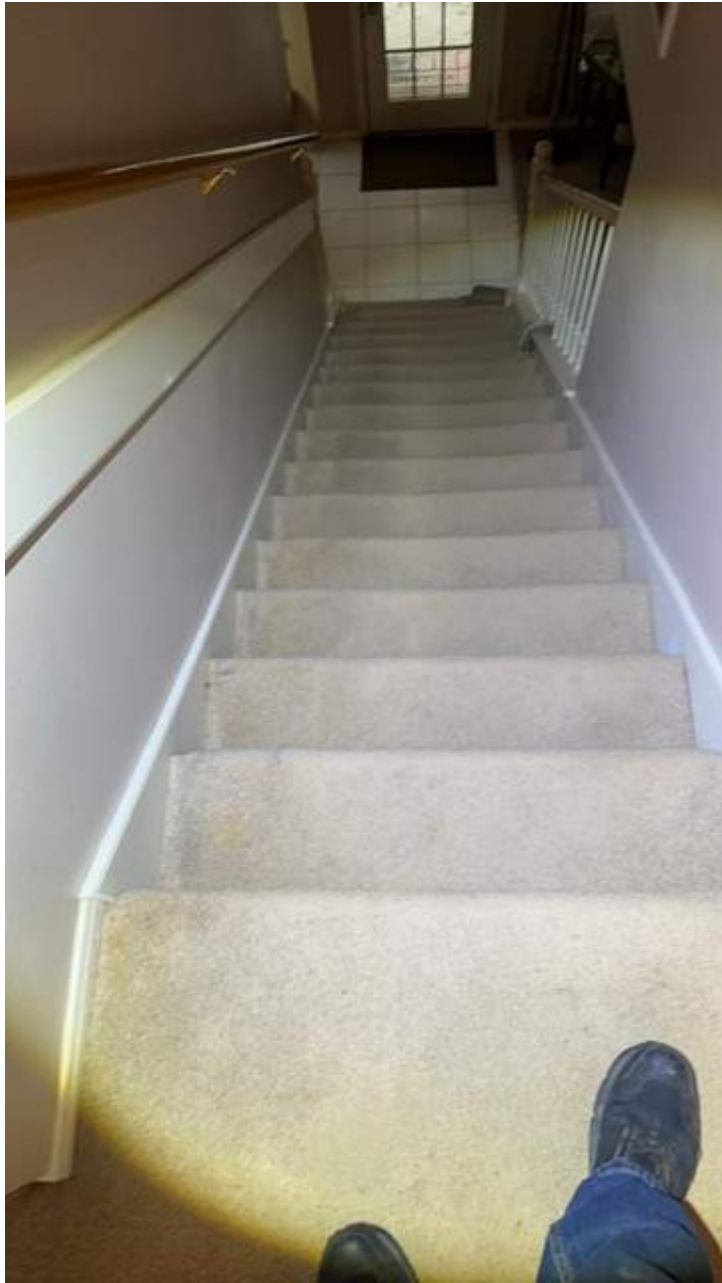
### Stained Carpet

The carpet has areas of staining or discoloration.

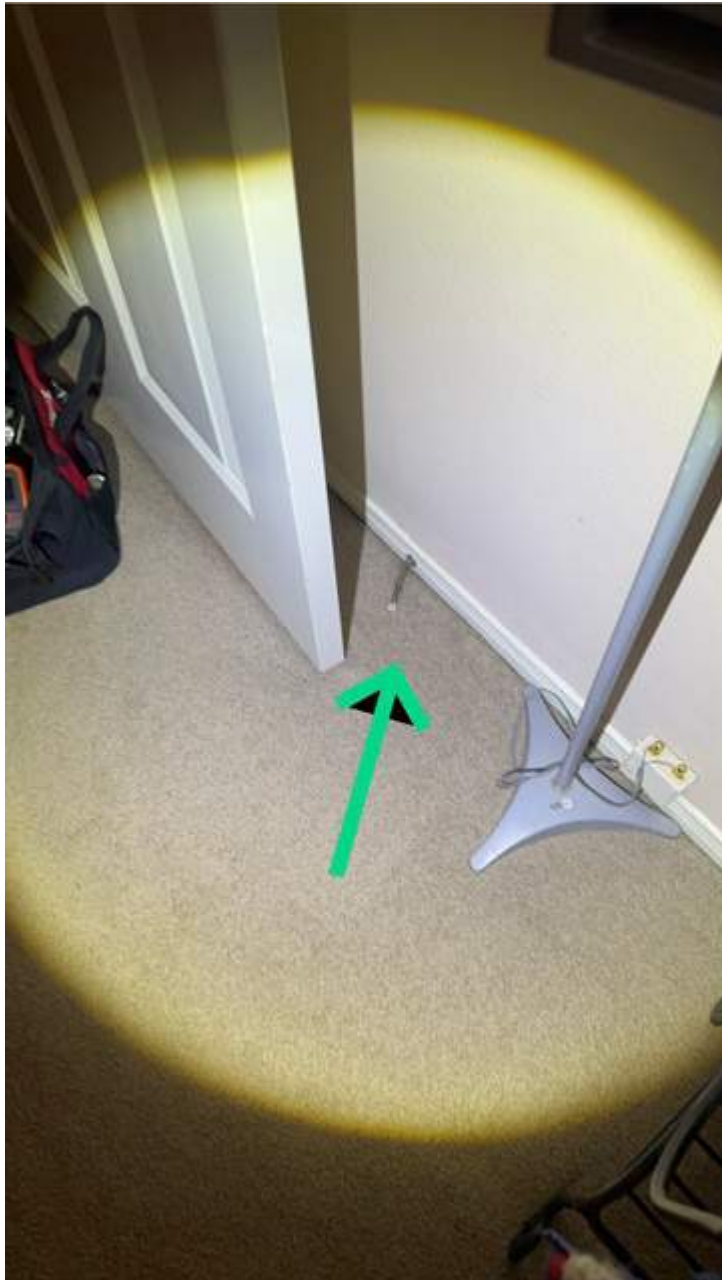
### Missing / Damaged Door Stop(s)

Door stops are missing or damaged for an interior door. Recommend repairs or replacing by a qualified professional.

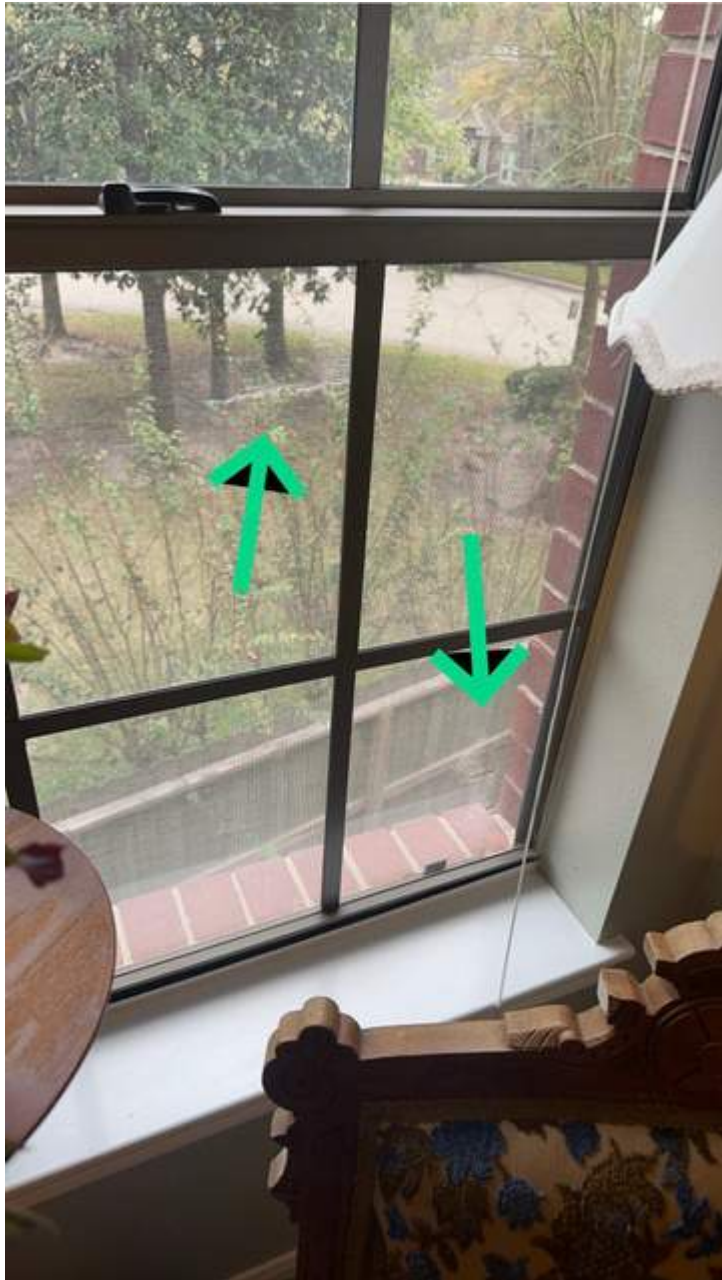
### Damaged Screen

One or more window screens are damaged. Recommend repairs or replacing by a qualified professional.

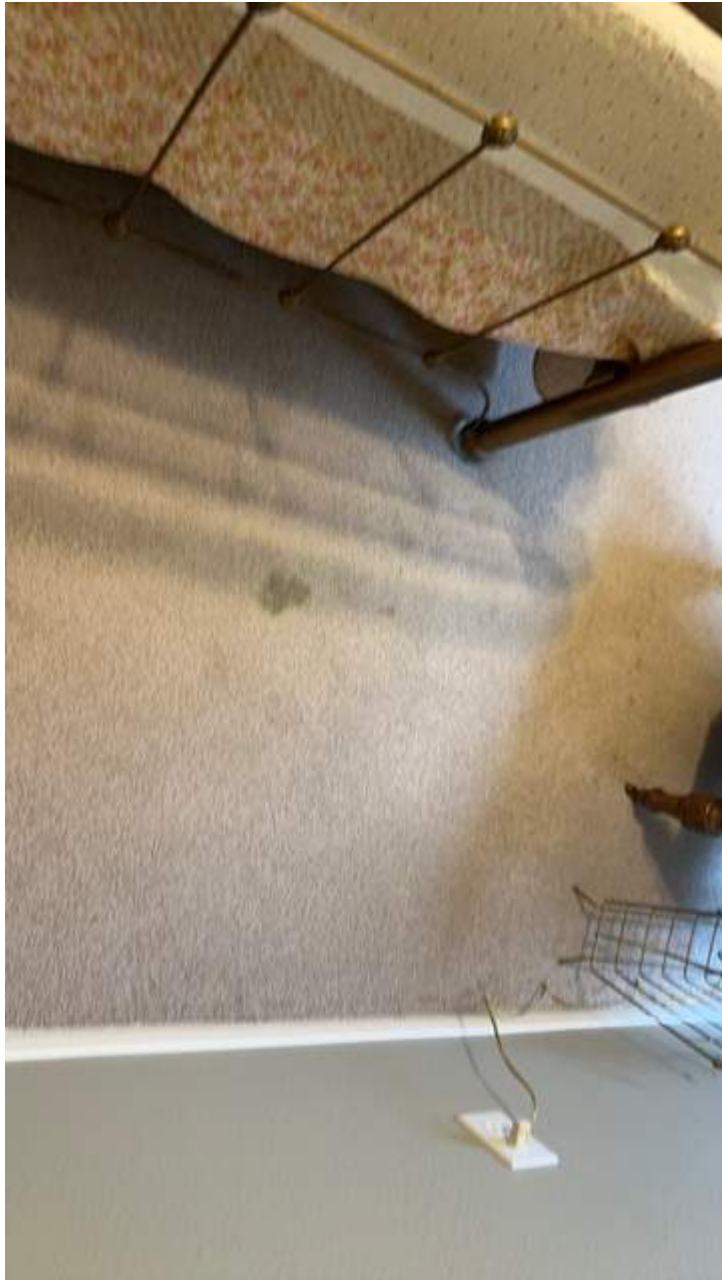
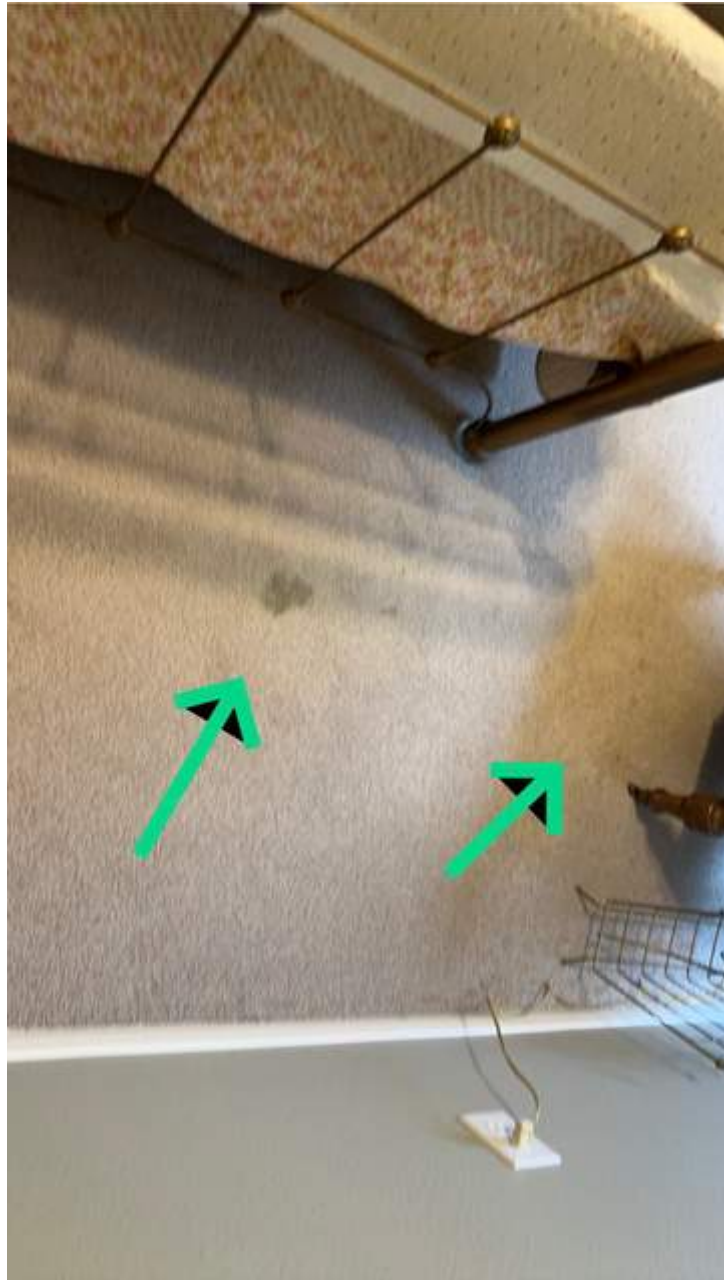
## Stained Carpet

The carpet has areas of staining or discoloration.

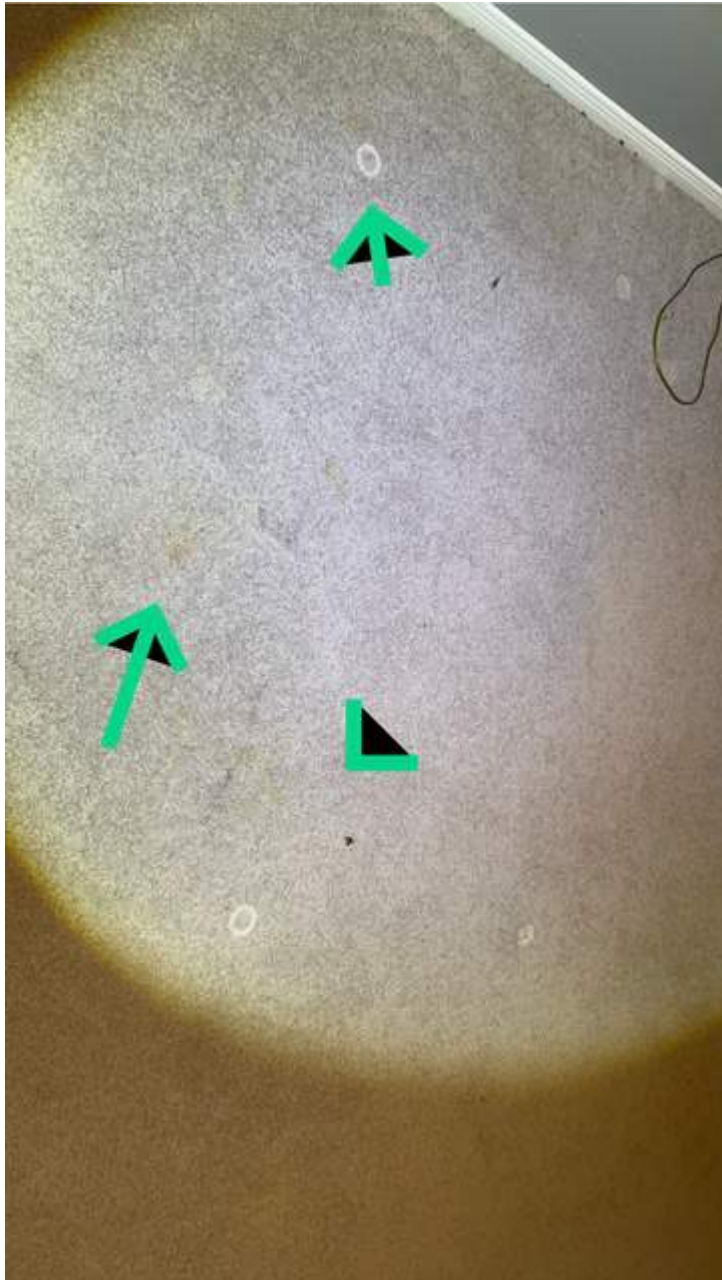
Stained Carpet

The carpet has areas of staining or discoloration. Recommend repairs or replacing by a qualified professional.

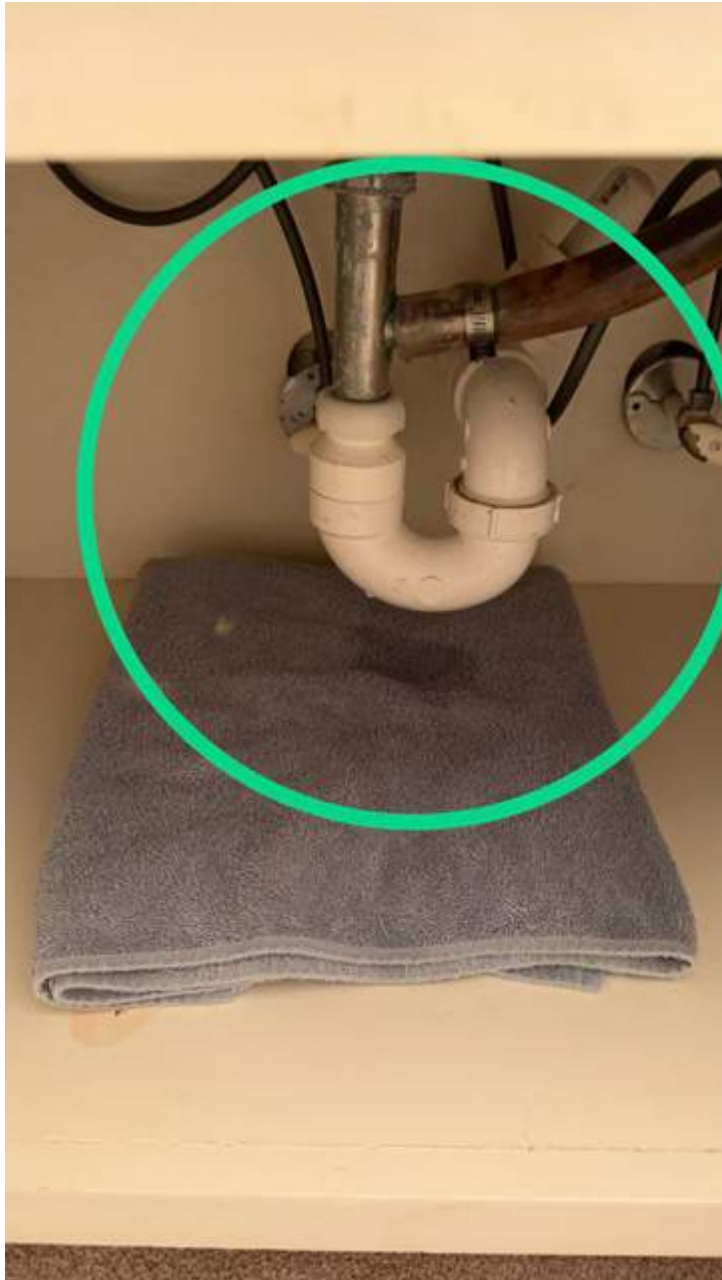
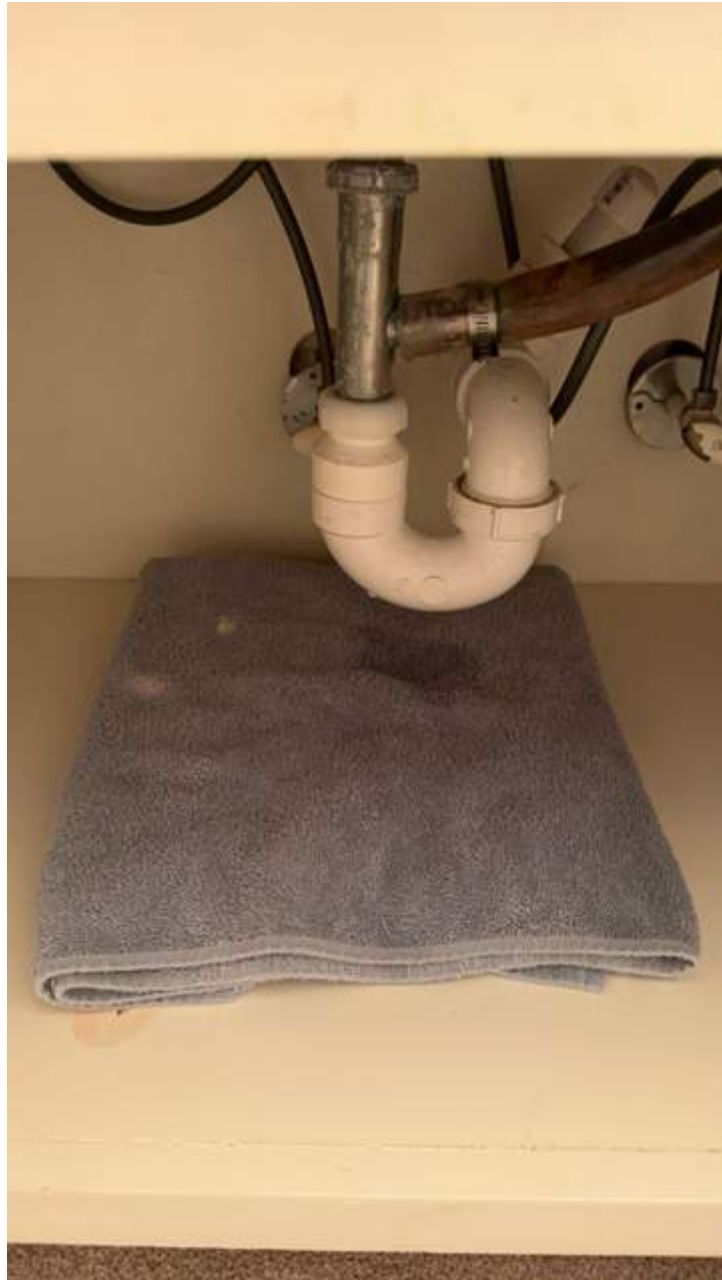
## Leaking Sink

There are signs of a leak from the sink in the cabinet. Recommend repairs or replacing by a qualified professional.

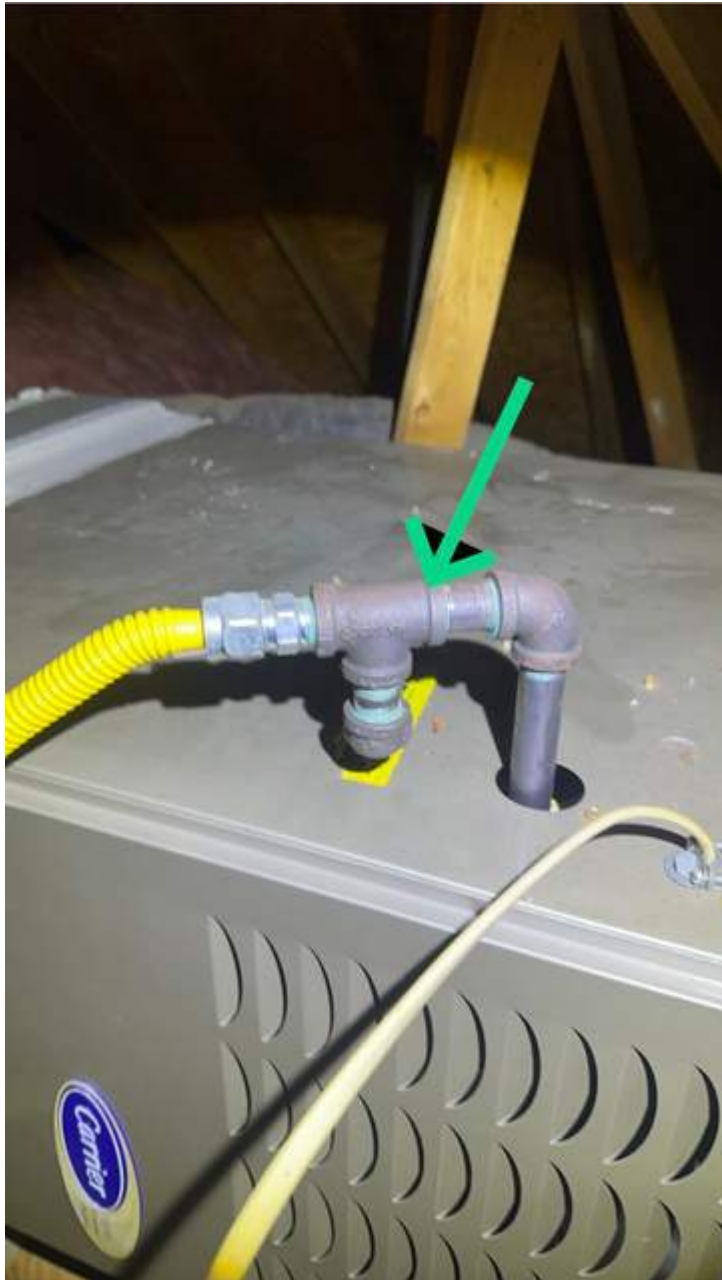
There is no sediment trap on the furnace. Recommend repairs or replacing by a qualified professional.
