March 18, 2026

PROPERTY INSPECTION REPORT FORM

1620 Elgin St. Unit 9, Houston, TX 77004

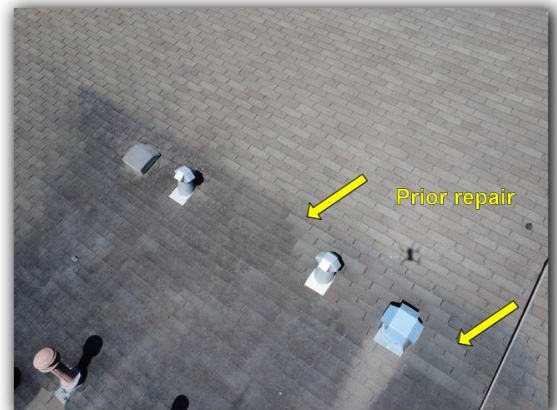
- Missing shingles were observed on the south side of the roof structure. Missing shingles expose the underlayment or decking to the elements, increasing the risk of moisture intrusion and potential damage to the roof structure. Recommend evaluation and repair by a professional roofing contractor to restore missing shingles to ensure proper weather protection.
- The composition roofing material shows granular loss in multiple areas across the roof. Granule loss can reduce the roof's ability to protect against UV damage and water intrusion, potentially shortening its lifespan. Recommend evaluation by a professional roofing contractor to determine the extent of deterioration and necessary repairs or replacement.

You are strongly encouraged to have a professional roofing contractor conduct a physical inspection of the roof prior to the expiration of any time limitations, such as option or warranty periods. This will ensure a complete evaluation of the roofing material's condition. The observations supporting this recommendation include, but are not limited to, the following:

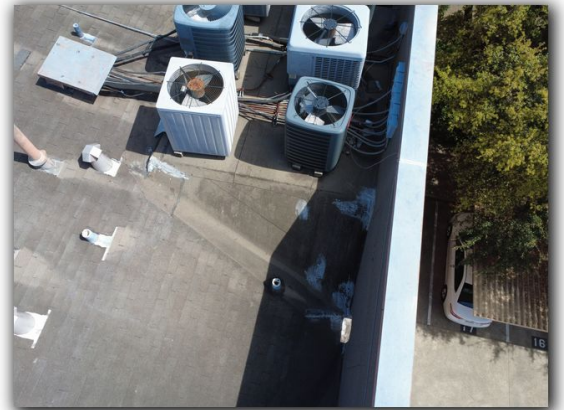
Flashing Details

- It is recommended to paint the flashing to help prevent rust and protect against UV damage. Proper maintenance of flashing can extend its service life and help maintain the roof's overall integrity. Recommend evaluation and painting by a qualified contractor.
- Some metal flashing details were observed to have surface rust. Rust can deteriorate the flashing over time, potentially compromising the roof's watertight integrity. It is recommended to have a professional roofing contractor evaluate the condition and perform necessary maintenance or repairs to prevent further damage.

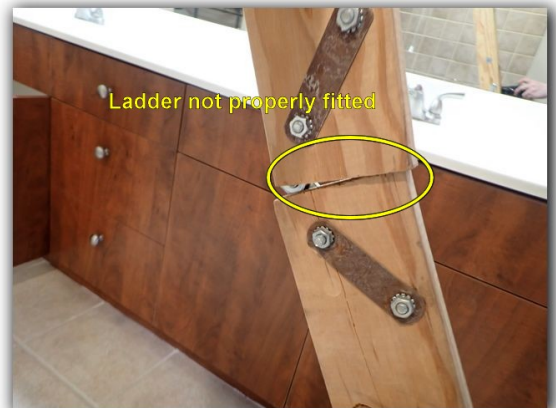
Attic Ladder/Hatch Opening

- The attic ladder does not close completely. The underlying cause should be evaluated and repairs made as necessary to ensure proper operation and safety.
- Surface damage was observed on the face of the attic ladder door.
- Some of the attic ladder nuts and bolts were observed to be loose and/or missing. For safety reasons, it is recommended to secure or replace these fasteners and ensure the attic ladder is properly stabilized.

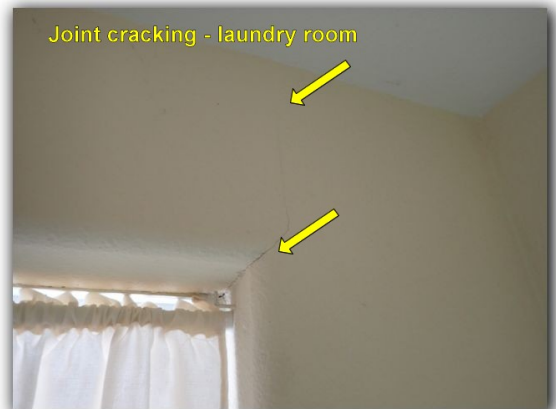
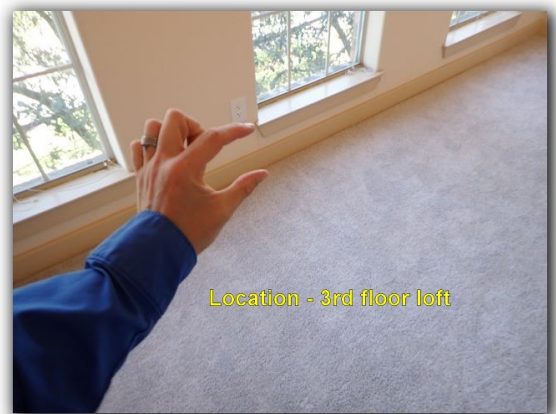
- Joint cracks were observed in the interior walls of several locations throughout the house. These cracks typically indicate normal seasonal expansion and contraction.
- Water staining and/or damage was observed on the baseboards in several locations throughout the house. It is recommended to investigate the cause and address any necessary repairs to prevent further damage.
- Cabinet surface damage was observed in the primary bathroom.
- Stress cracks were observed in the interior walls of the third floor loft area. These cracks may indicate abnormal settling or movement.

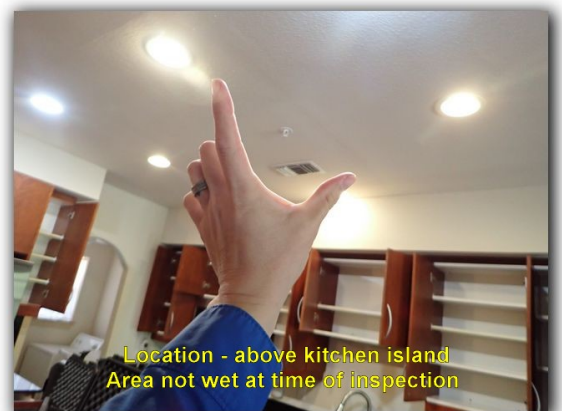
- Water stains were observed on the ceiling(s) in the kitchen, second floor loft area. It is recommended to identify and address the source of moisture (if necessary) to prevent further damage.
- Water stains observed on the ceiling at and/or around the water heater flue area. The sealant at the flue roof level storm collar needs to be further investigated and corrected as necessary.
- Joint cracks were observed in the ceilings of the primary bathroom, second floor loft area. These cracks typically indicate normal seasonal expansion and contraction.

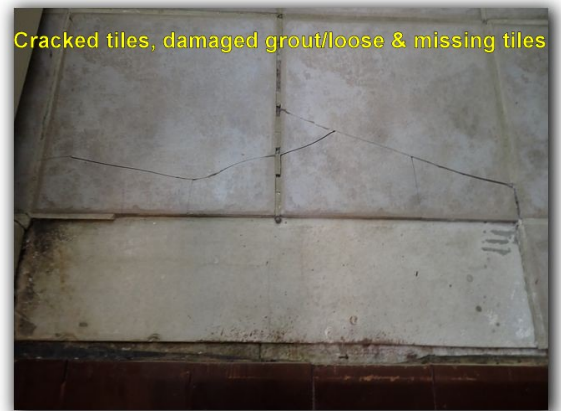
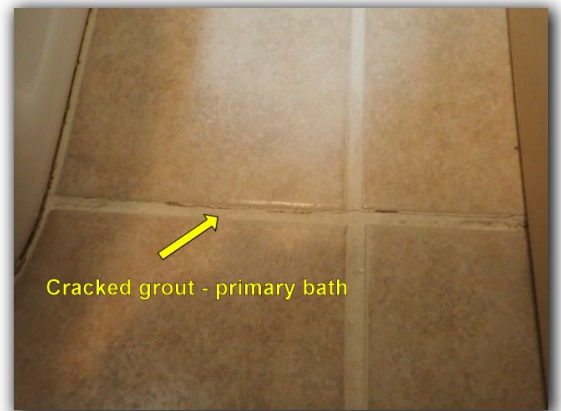
- The floor covering was observed to be damaged in the kitchen.
- The floor tile(s) were observed to be cracked and/or damaged in the laundry room, half bathroom.
- Loose floor tiles were observed in the following area(s): laundry room. This condition may indicate issues with the original installation, such as inadequate adhesive or improper substrate preparation, and can lead to further tile damage or present a tripping hazard. It is recommended to have a qualified flooring contractor assess and properly re-secure or replace the affected tiles to prevent future deterioration.
- The floor tile grout was observed to be damaged and/or missing in the laundry room, primary bathroom.

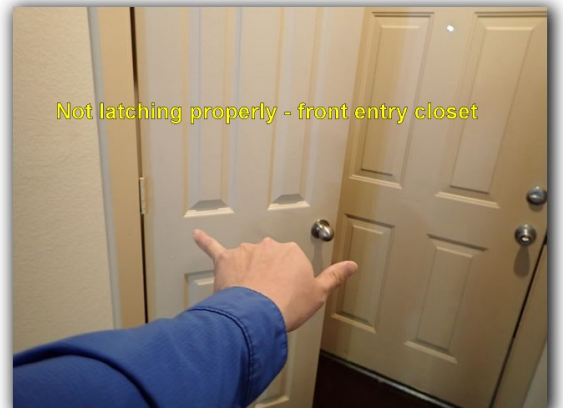
Interior Doors

- The door contacts the floor during operation to the primary bathroom toilet closet. Adjustments are recommended to restore intended operation to the door and prevent floor covering damage.
- The door at the following location(s): front entry closet, is not latching properly. This may be due to misalignment, worn hardware, and/or damage to the latch mechanism, which can affect functionality.

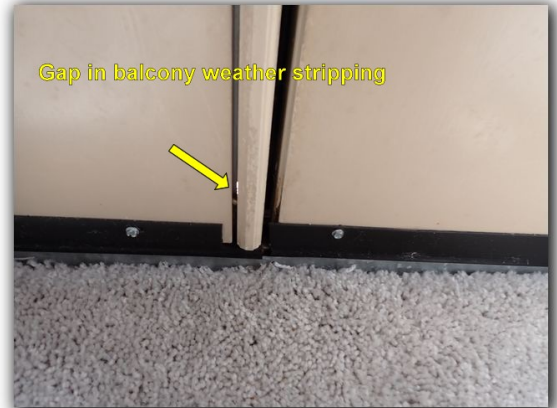
Exterior Doors

- Weather-stripping improvements are recommended for the following exterior door(s): front entry, balcony entry. Upgrading or repairing weather-stripping can help improve energy efficiency by reducing air infiltration and protect against moisture intrusion.
- The door at the following location(s): balcony door, is sticking, making it difficult to open or close smoothly. This issue may be caused by swelling due to moisture, misalignment, or worn hardware.

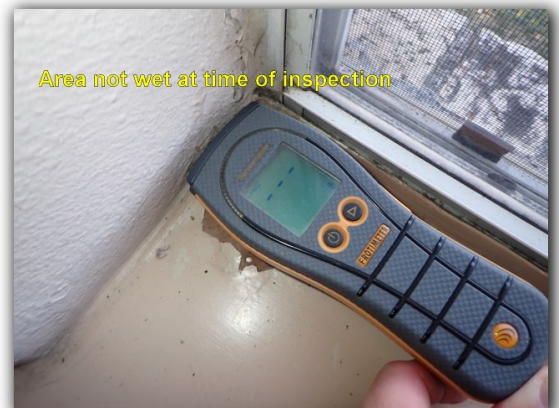
- Water stains were observed at and/or around the window(s) in the following area(s): North side windows. This may indicate past or ongoing moisture intrusion. The source of the staining should be investigated by a qualified professional, and appropriate repairs made to prevent further damage and ensure the area remains dry.

- The window guide is damaged in the following area(s): primary bedroom, third floor loft area, causing the window to not stay in the open position. This condition affects window functionality. It is recommended to have a qualified professional repair or replace the damaged guide to restore proper operation.

- The window sill(s) finish in the following area(s): several locations throughout the house, show signs of deterioration and/or damage. This may be due to moisture intrusion, age, or general wear and tear.

- The weather-stripping is damaged and/or missing at one or more windows. This condition can lead to air/water intrusion and reduced energy efficiency. It is recommended to repair or replace the weather-stripping to improve sealing and overall window performance.

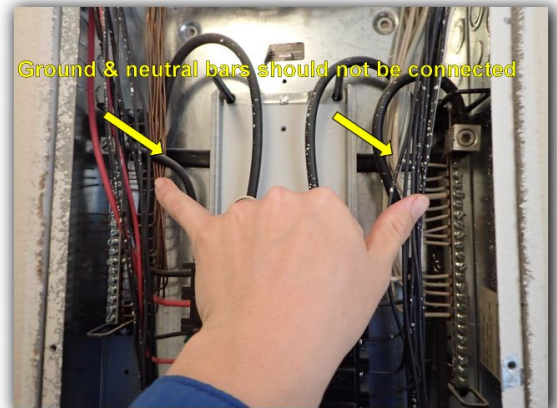
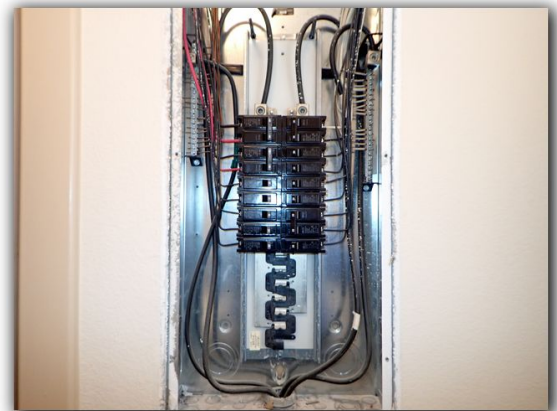
- The electrical cabinet cover plate (dead front) should be secured using blunt-tip screws rather than pointed tip screws to enhance safety and prevent potential damage.
- In the sub-panel electrical cabinet, the ground and neutral wires are not properly separated. According to current National Electrical Code (NEC) standards, neutral conductors in a sub-panel should be isolated on a separate bus bar, while ground conductors should be bonded to the panel cabinet. Although the sub-panel may appear functional, this configuration does not meet current code requirements and should be evaluated and corrected by a licensed electrician.

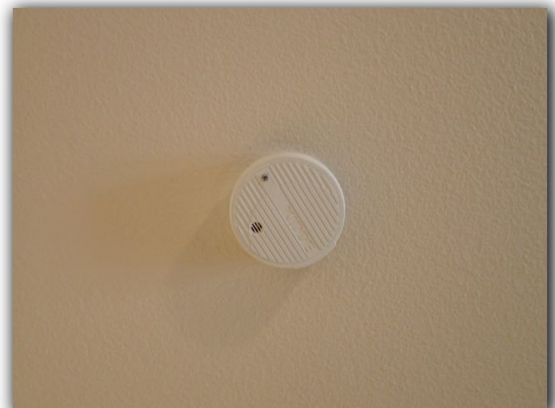
Smoke & Carbon Monoxide Alarms

- I was unable to locate a carbon monoxide alarm in the immediate vicinity of all the bedrooms.
- The smoke alarms present at the time of inspection are older. Most manufacturers recommend replacing smoke alarms every 10 years for safety. It is recommended to replace these alarms to ensure protection.
- One or more smoke alarms are loose at their mounting in the second to third floor stairway. Recommend securing them properly to ensure reliable operation.

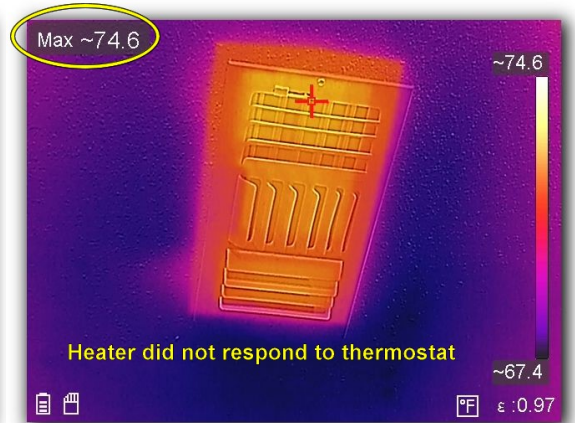
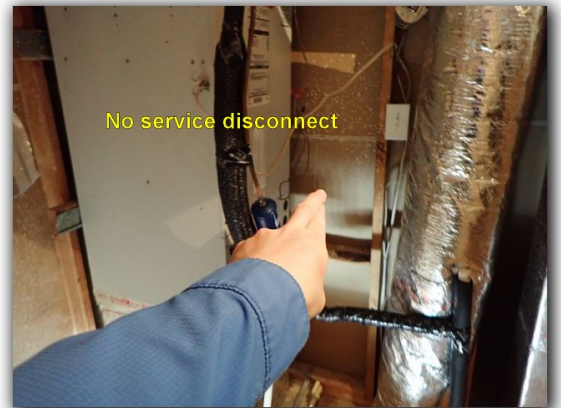
- The heating equipment was found to be inoperative at the time of the inspection. The system did not respond to normal operating controls.
- The air filter is dirty and should be replaced to ensure optimal system performance and air quality.
- A service disconnect was not located or observed at or near the heating unit. Recommend further evaluation and installation of an appropriate disconnect by a qualified electrician or HVAC technician.

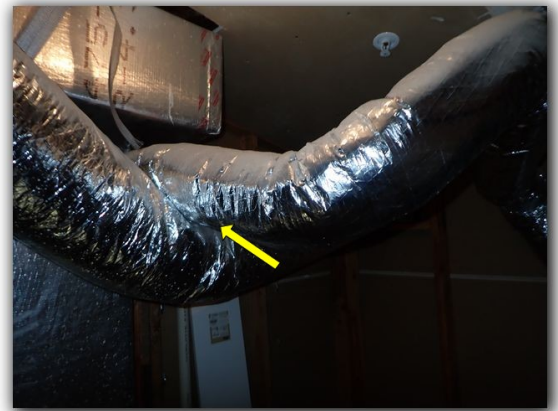
- The duct work in the attic area is not properly separated to help prevent condensation from developing. It is recommended to separate the duct work with a minimum intervals of 1.5-inches.

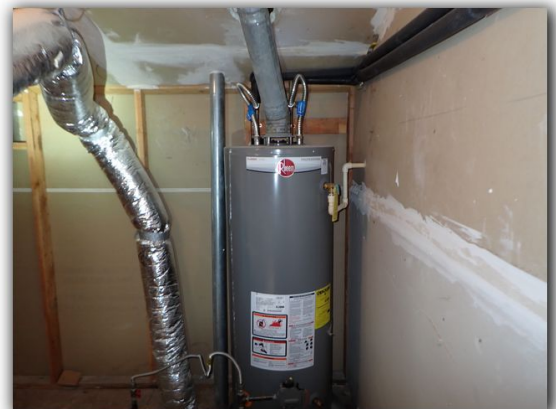
- The water heater flue (vent pipe) does not have adequate clearance from combustible materials. Per current standards, double-walled vent pipes require a minimum 1 inch clearance, and single-walled vent pipes require a minimum 6 inches. Correction by a qualified professional is recommended to ensure safe operation.

- The temperature and pressure (TPR) relief valve discharge pipe runs upward in one or more locations. TPR discharge pipes should slope downward at all points to allow proper gravity drainage. Correction by a qualified professional is recommended.

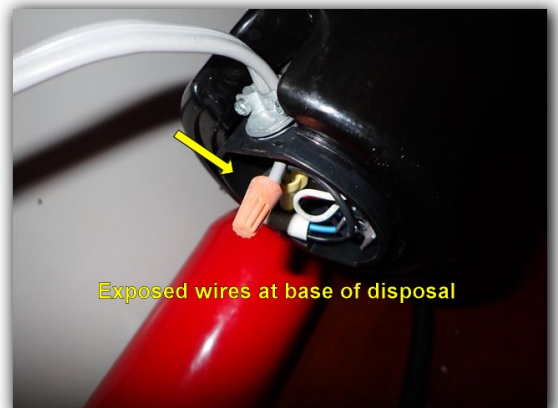
B. Food Waste Disposers

- The food waste disposer was observed to be noisy during operation. This could indicate internal wear, loose components, or debris. Further evaluation and servicing or replacement is recommended to prevent potential failure.
- The spliced wires at the food waste disposer should be properly enclosed in a junction box or appropriate electrical enclosure. This is necessary for safety and to prevent electrical shock or short circuits.

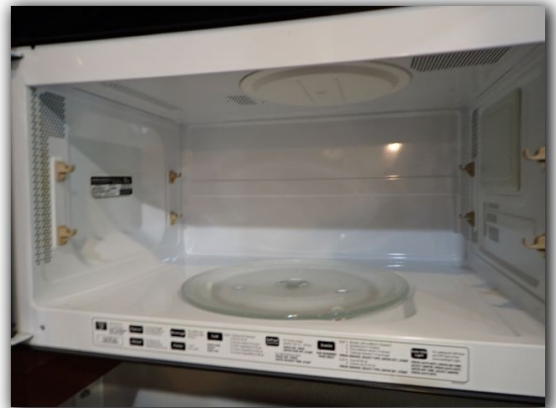
E. Microwave Ovens

- The microwave oven was inoperative at the time of inspection and did not respond to normal user controls. The unit should be further evaluated and repaired or replaced as needed to restore proper function.
