# PROPERTY INSPECTION REPORT FORM

Debra Hosein <i>Name of Client</i>	08/09/2025 <i>Date of Inspection</i>
3206 Watercliff Court , Spring, TX 77388 <i>Address of Inspected Property</i>	
Kevin Akins <i>Name of Inspector</i>	22211 <i>TREC License #</i>
<i>Name of Sponsor (if applicable)</i>	<i>TREC License #</i>

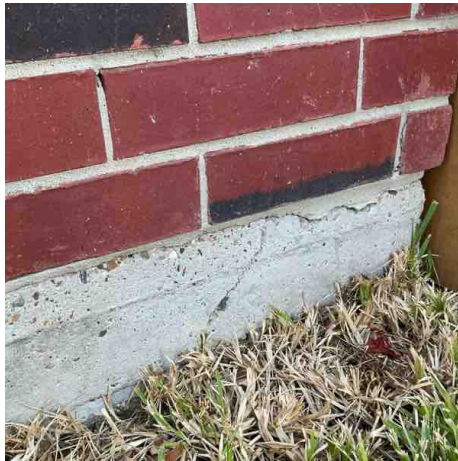
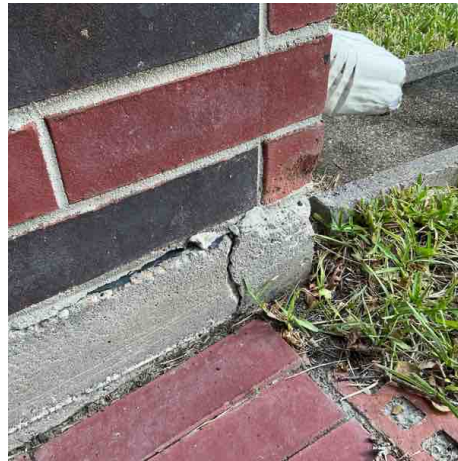
- **Cracks (which are not a structural concern) were observed on the foundation at the corners of the residence commonly called "corner-cracks" (see photos). This type of crack is quite common on foundations of this type. Sealing of cracks will prevent moisture intrusion and the continued deterioration of the area. (Exterior Front)**

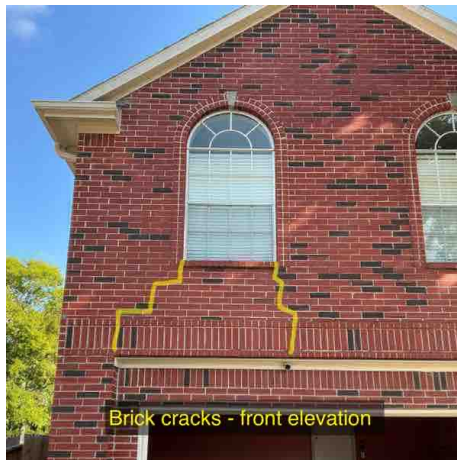
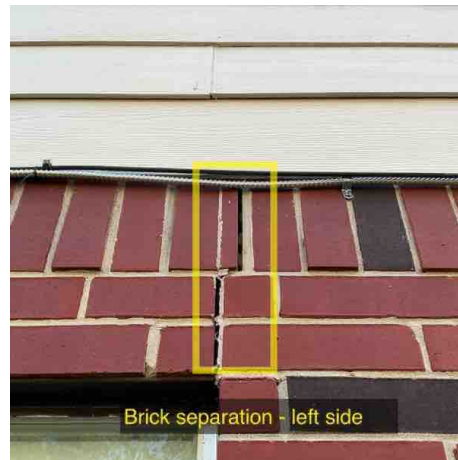
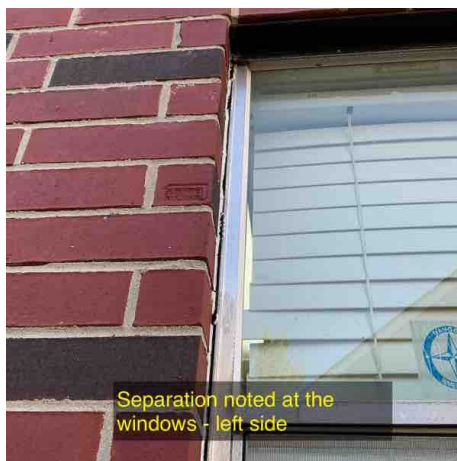
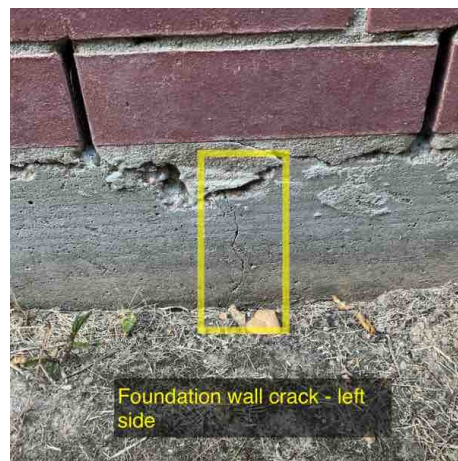
• The foundation appears to have movement that may be beyond normal settling. A Professional Engineer licensed by the State of Texas should be consulted on the current integrity of the foundation and repairs that may be necessary (If Any). The observations made to support the rendering of this opinion are listed but not limited to the following:

1. Cracks at the front elevation, brick veneer.
2. Excessive separation noted at the left side window.
3. Separation noted at the window frames.
4. Foundation wall crack noted on the left side.
5. Crack noted at the garage floor.

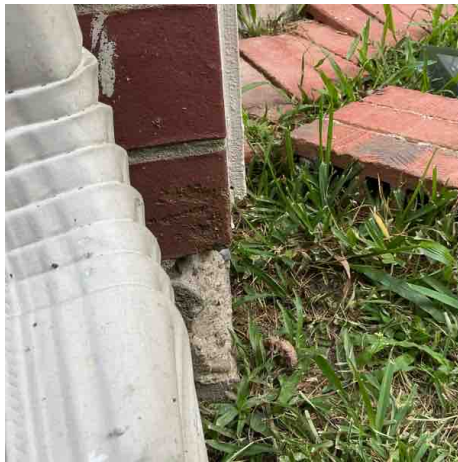
- **The foundation has a corner chip (see photo). Corner should be filled in with cement to prevent further deterioration of the area. (Exterior Rear)**

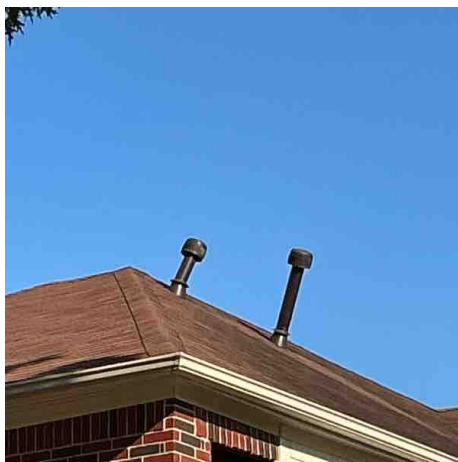
- **The inspector noted the mechanical flue was not in alignment at the roof covering. This condition can cause leaking around the storm collar. Correction should be made by a qualified contractor**

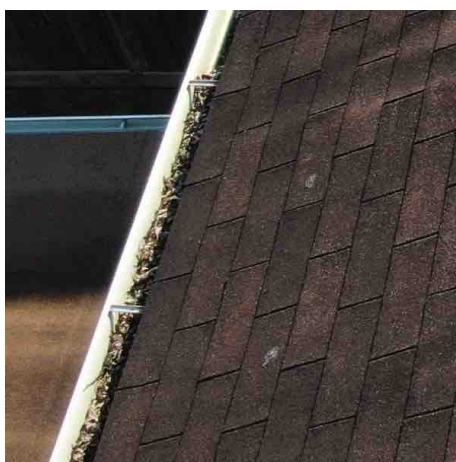
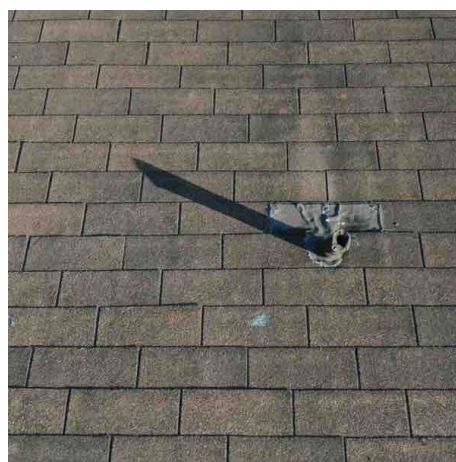
- **Damage, missing and deteriorated shingles observed at the roof covering (see photos below). A qualified roofing contractor should perform all repairs and a complete roof punch.**

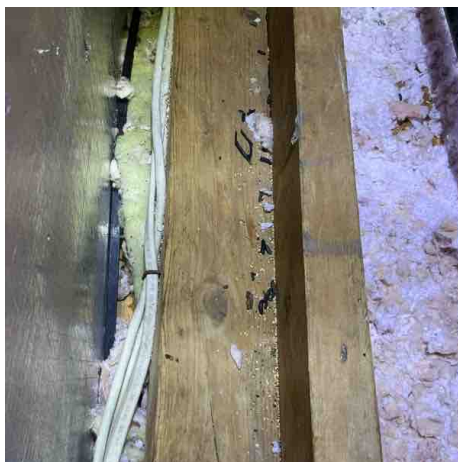
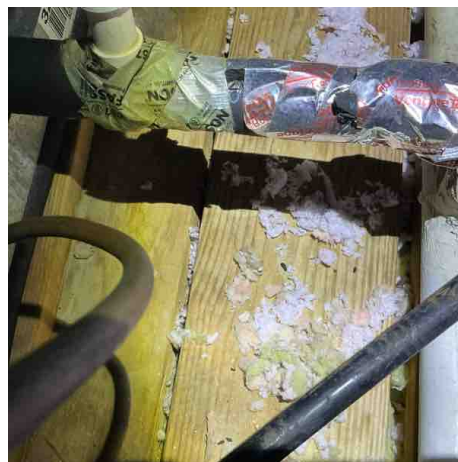
- **Rodent droppings noted in the attic space. Recommend a pest control contractor provide treatment.**

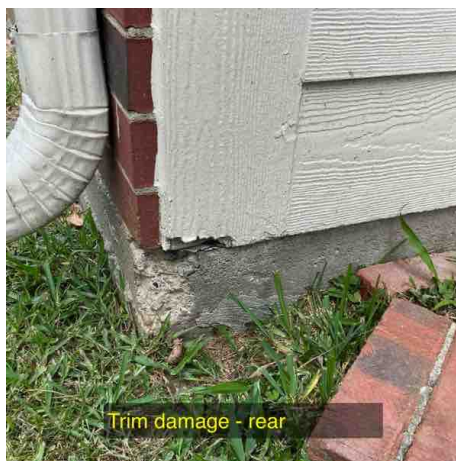
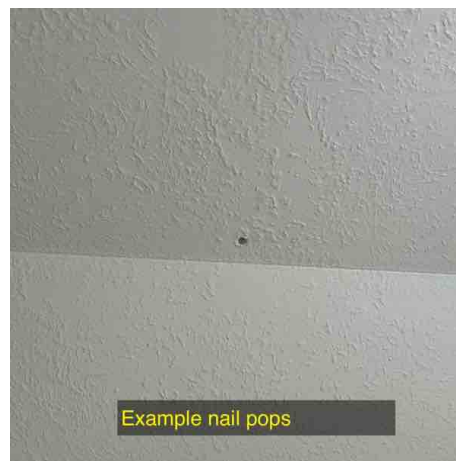
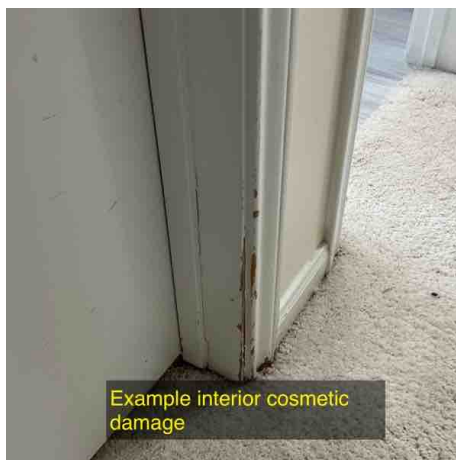
- Observe general painting needs, damage siding, wood rot, gaps and caulking touch-ups around the structure (see a representative number of photos below). Recommend corrective actions by a painting and general contractor as needed.

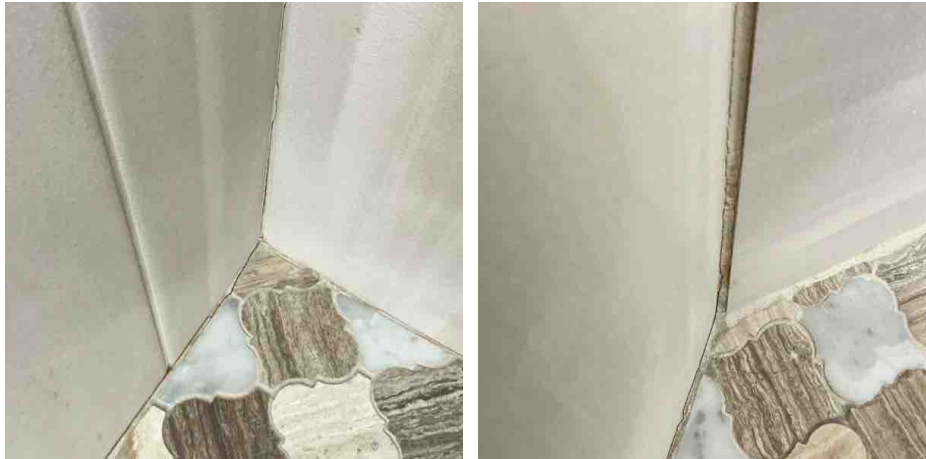
- Shower enclosure has gaps in the grout. Grout should be sealed to prevent shower water from escaping the confines of the shower enclosure. This is especially important when there is a job built shower on the 2nd floor.

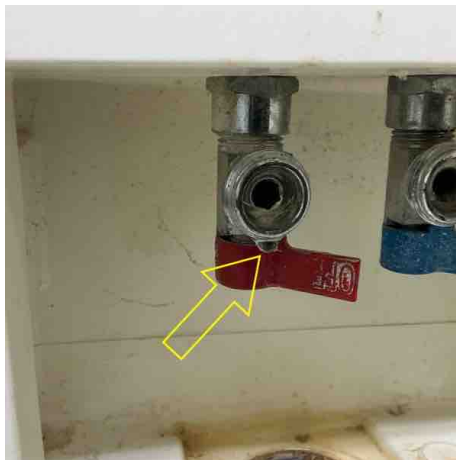
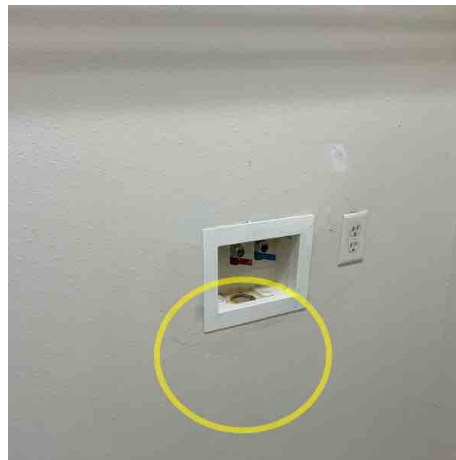
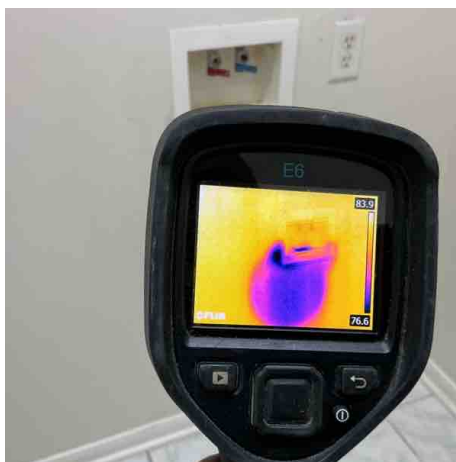
- Leak noted at the washer connection (hot side). This has caused moisture to accumulate on the nearby drywall. Recommend repairs and the water line and remediation at the nearby drywall.

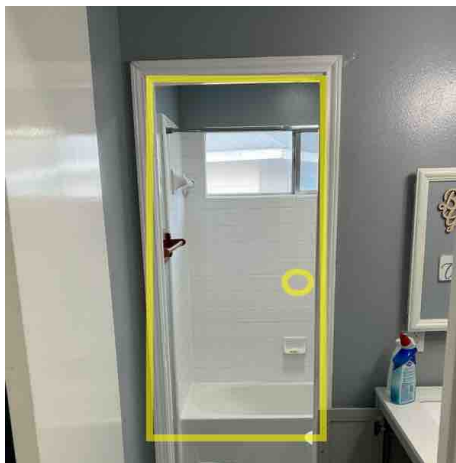
- **Missing door noted. Replacement door should be installed as desired. (Upstairs Hall Bathroom)**

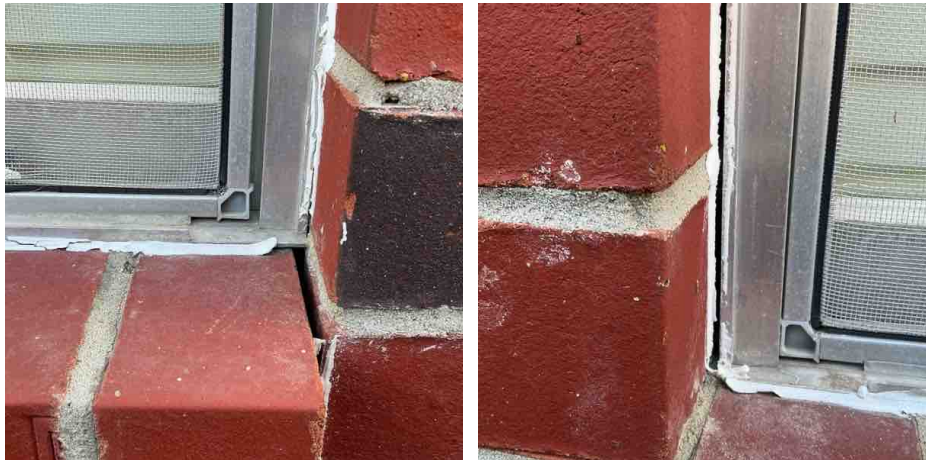
- **Windows around the structure have missing and deteriorated caulking. Caulking windows with a good exterior grade caulking will prevent storm water intrusion.**

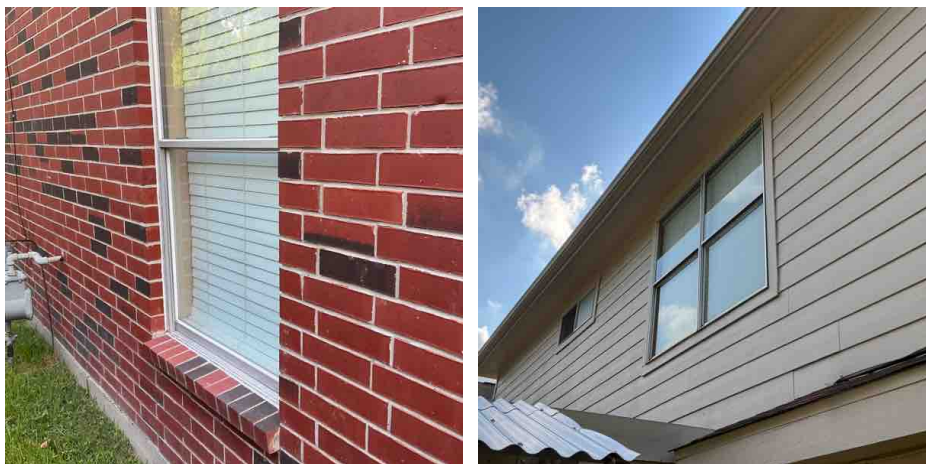
- **Screens missing on venting windows around the perimeter of the residence. Recommend installing new screens on venting units as needed.**

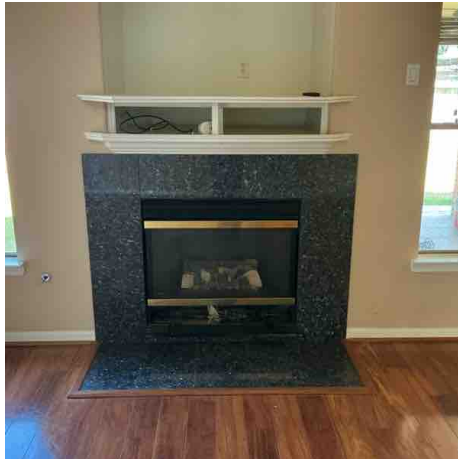
- **Fireplace would not operate at the time of inspection. Repairs should be made by a qualified contractor.**

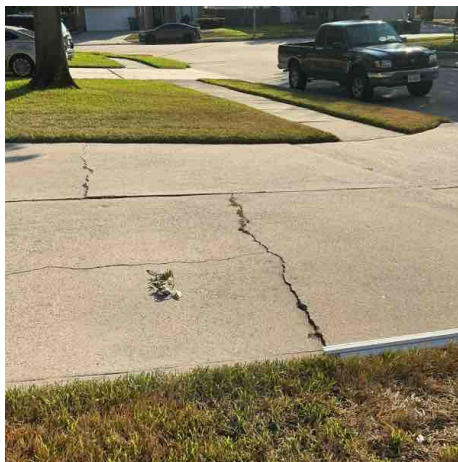
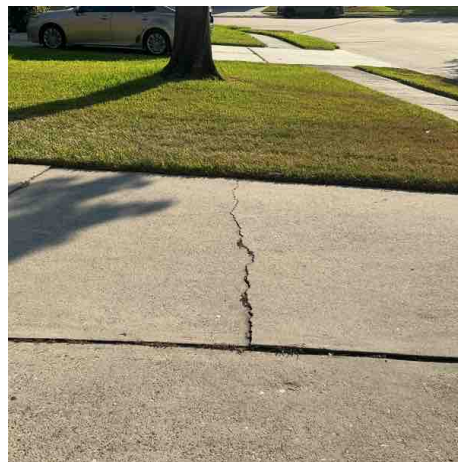
- Ants, other insects and rodents can occupy a home at any time, especially if the home is unoccupied at any point during the transition from the seller to the buyer. Therefore, an initial pest control treatment is recommended.
- **Broken driveway sections noted. Repairs should be made by a qualified concrete contractor as needed.**

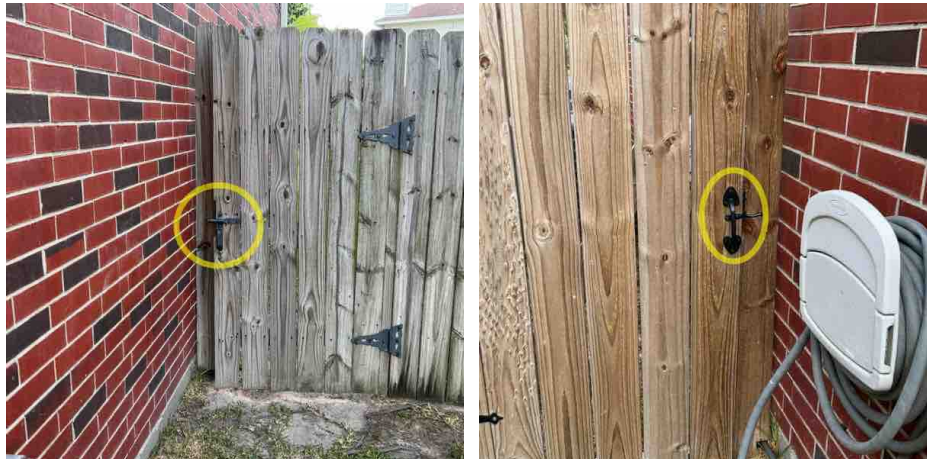
- Exterior fence entrances have difficult to operate latches. Repairs should be made by a qualified contractor. (Exterior Right)

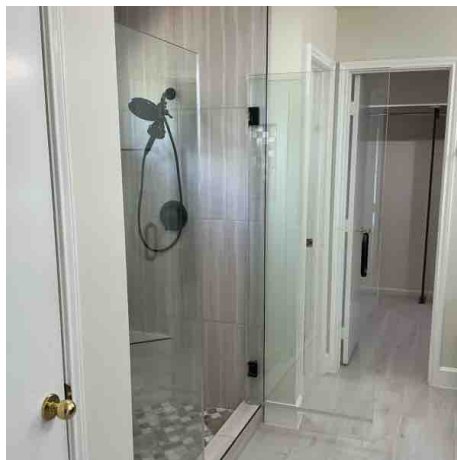
- Shower glass does not appear to be tempered (no stamp located). Corrections is recommended by a qualified contractor. (Master Bathroom)

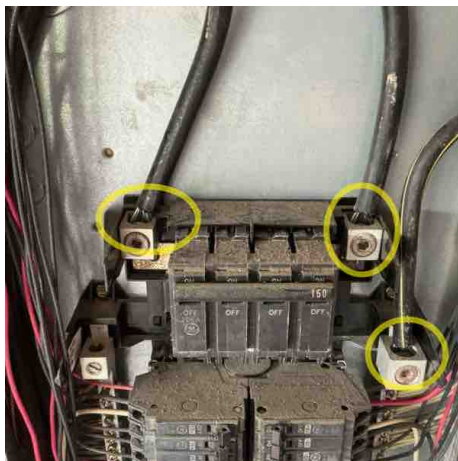
- **Anti-oxidant paste missing at the main aluminum conductor terminals inside the panel (see photo). Wires should be fully dipped in anti-oxidant paste to prevent oxidation from occurring. Recommend having a qualified person or Electrician apply paste as needed.**

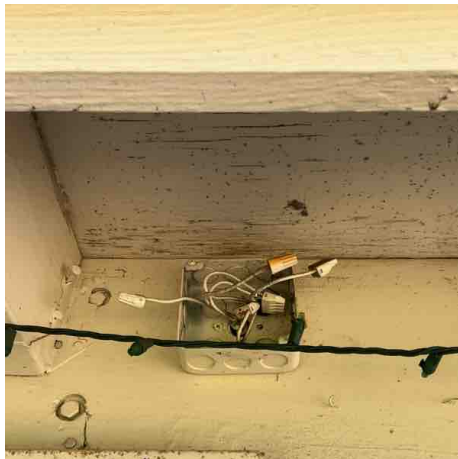
- Branch circuit wiring is copper. All appears to be in good condition. All accessible plugs, lights, ceiling fans, GFCI and smoke alarms were tested.
- **The rear patio has exposed branch wiring. All branch wiring should terminate into a closed junction box.**

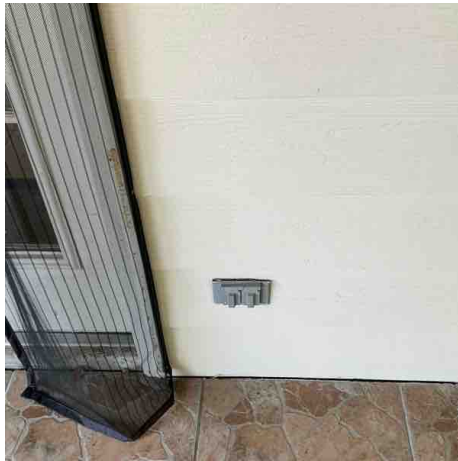
- **Loose rear exterior outlet box noted. A licensed Electrician should perform repairs.**

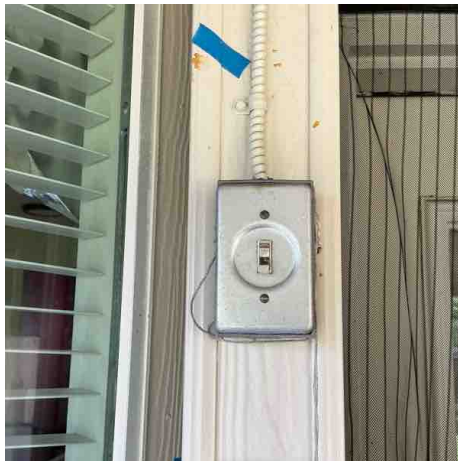
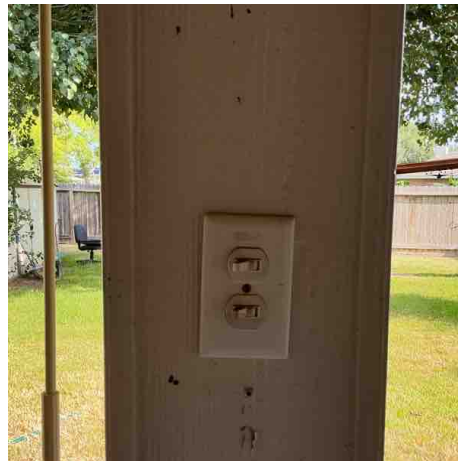
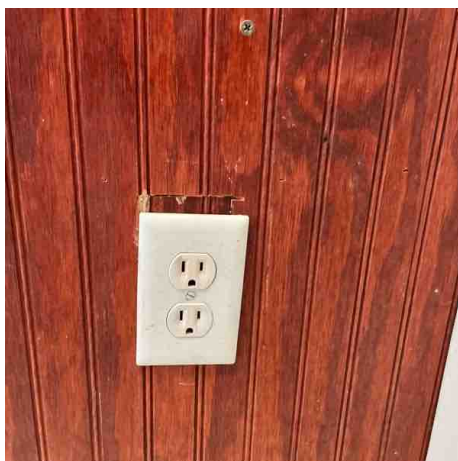
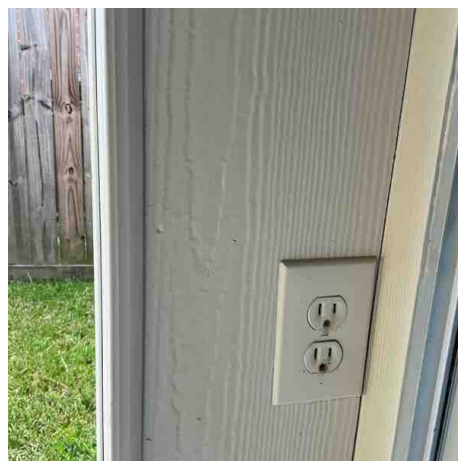
- **Rear patio exterior switch plates and outlets are exposed to moisture. Recommend adding a dome style protective cover as a correction.**

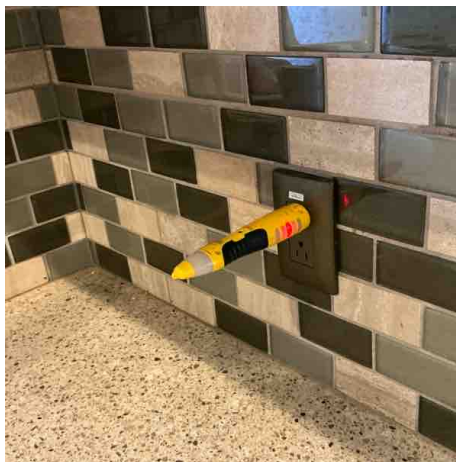
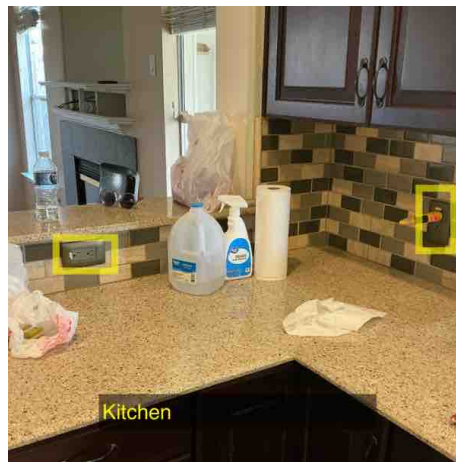
• Electrical outlets have reversed polarity which means the hot and neutral wires are reversed. This could create a safety hazard. Corrective actions should be made by the installation electrical contractor.

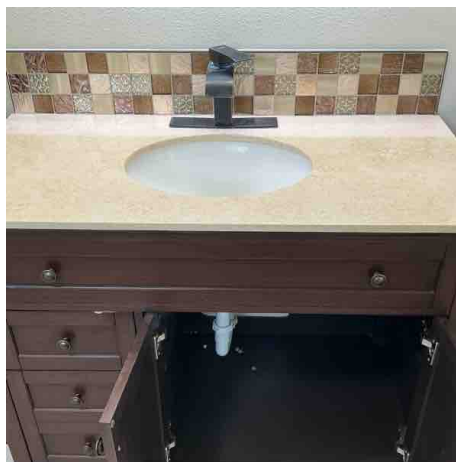
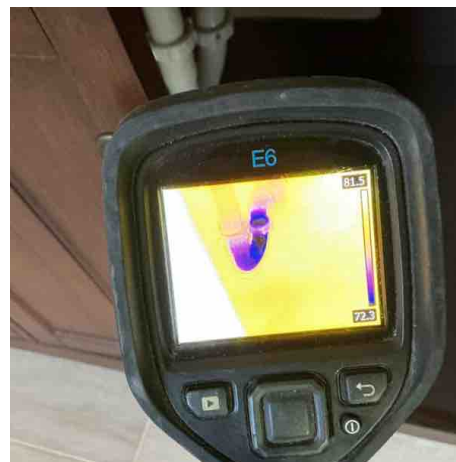
- Gurgling noises heard at the master bathroom sink (this is where the A/C drain line is located). This could be an early sign of a clog. Recommend repairs by a qualified HVAC contractor.

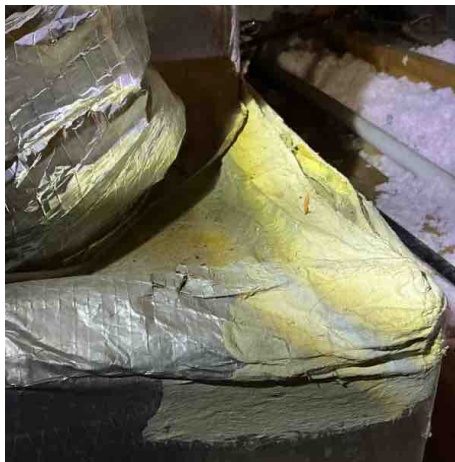
- Gaps noted at the return air box. Correction should be made by an HVAC contractor.

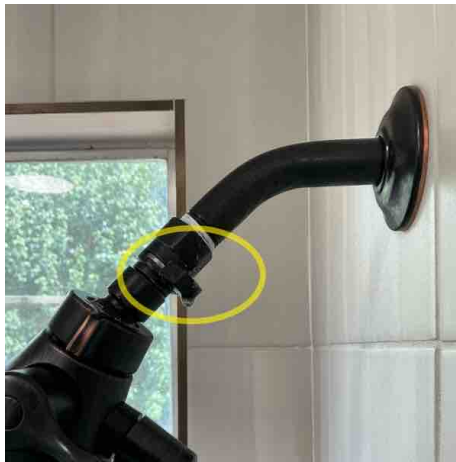
- Leak observed at the shower head (during operation). Recommend corrective actions by a licensed Plumber. (Master Bathroom)

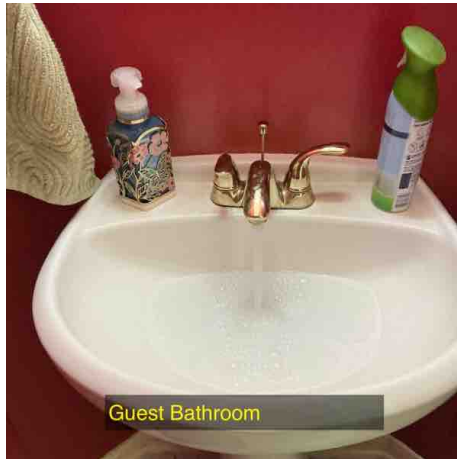
- **Loose faucet noted. Repairs should be performed by a qualified person or plumbing contractor.**

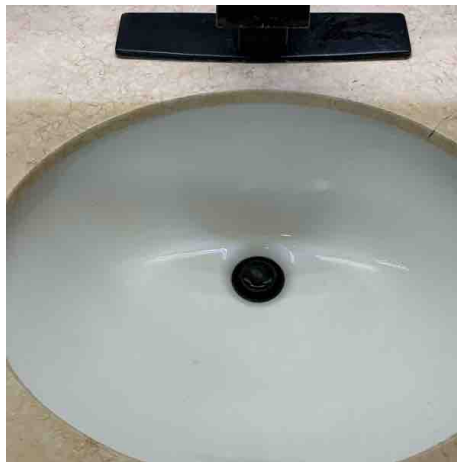
- **Master bath basin has a non-functioning drain stop handle. Recommend a qualified person or Plumber for repairs.**

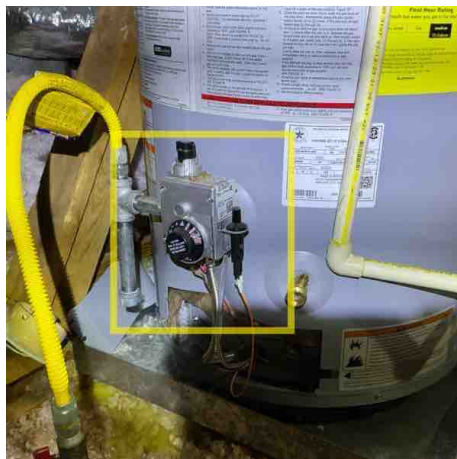
- Raw gas smell noted at the water heater. Further evaluation should be made by a licensed Plumber.

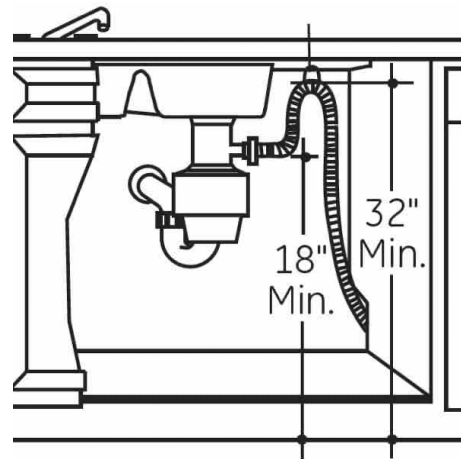
- Drain line for the dishwasher is not "high looped". A licensed Plumber should establish a "high loop" to prevent back-siphoning (which is required when an air gap is not in use).

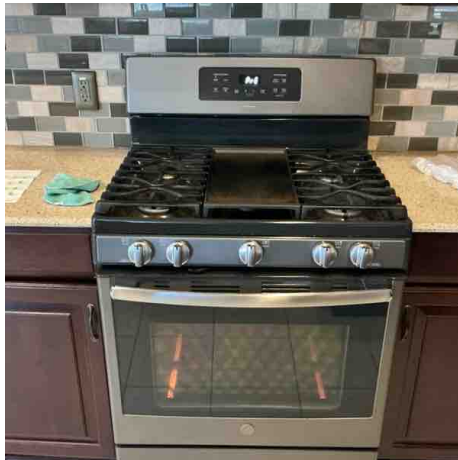
- **Anti-tip mechanism on the range was not performing or not installed which is considered a safety hazard. Recommend a qualified technician for corrections as needed.**
