# 15202 Sunlight Bay Ct

## Cypress, Texas 77429

| Type | Home Inspection and Floor Plan Report - 15202 Sunlight Bay Ct |
| Inspected by | Rio Bravo - Inspectify Pro - Houston |

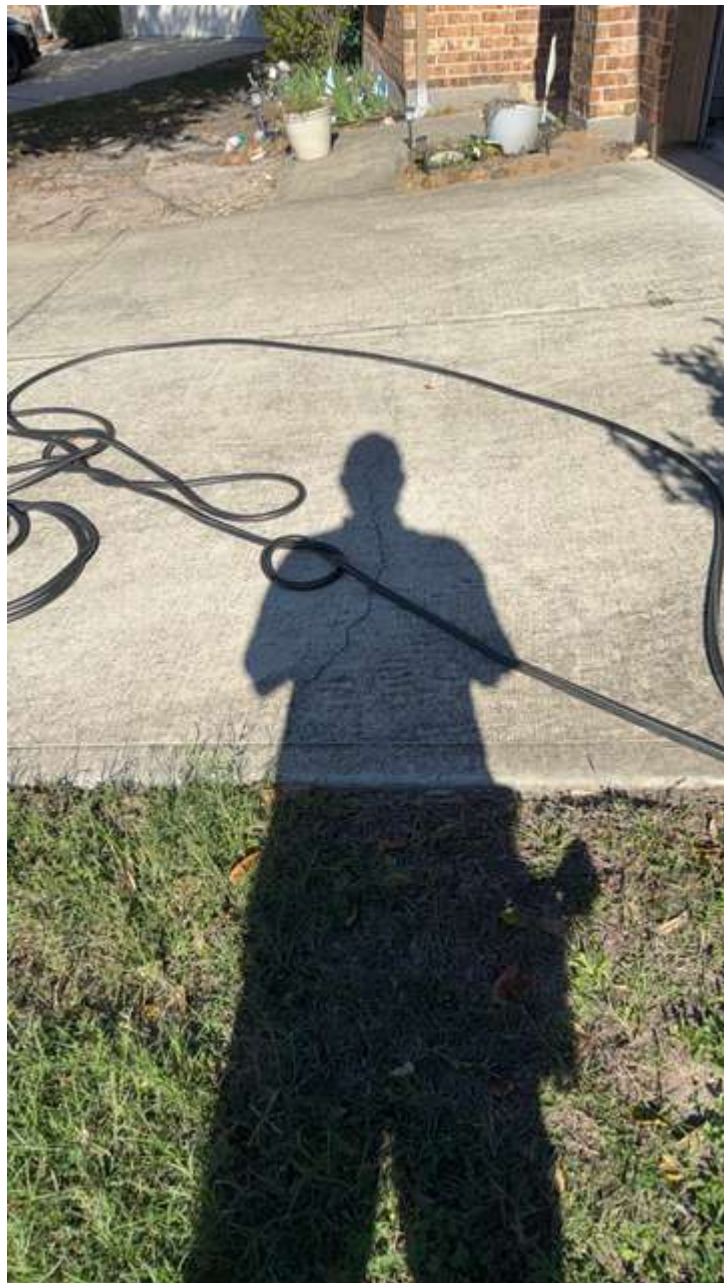
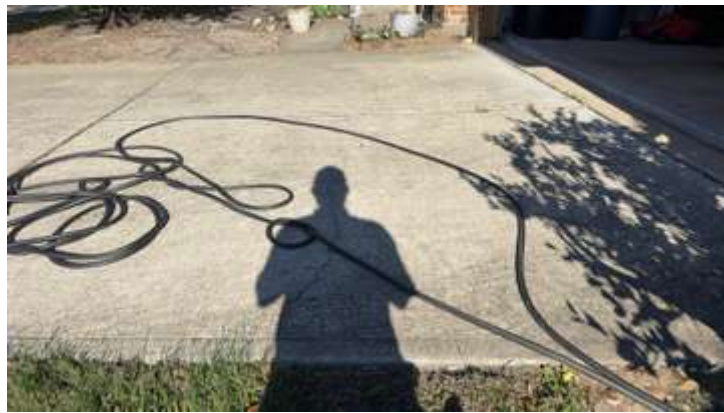
### Minor Cracks in the Driveway

The driveway has minor cosmetic cracks.

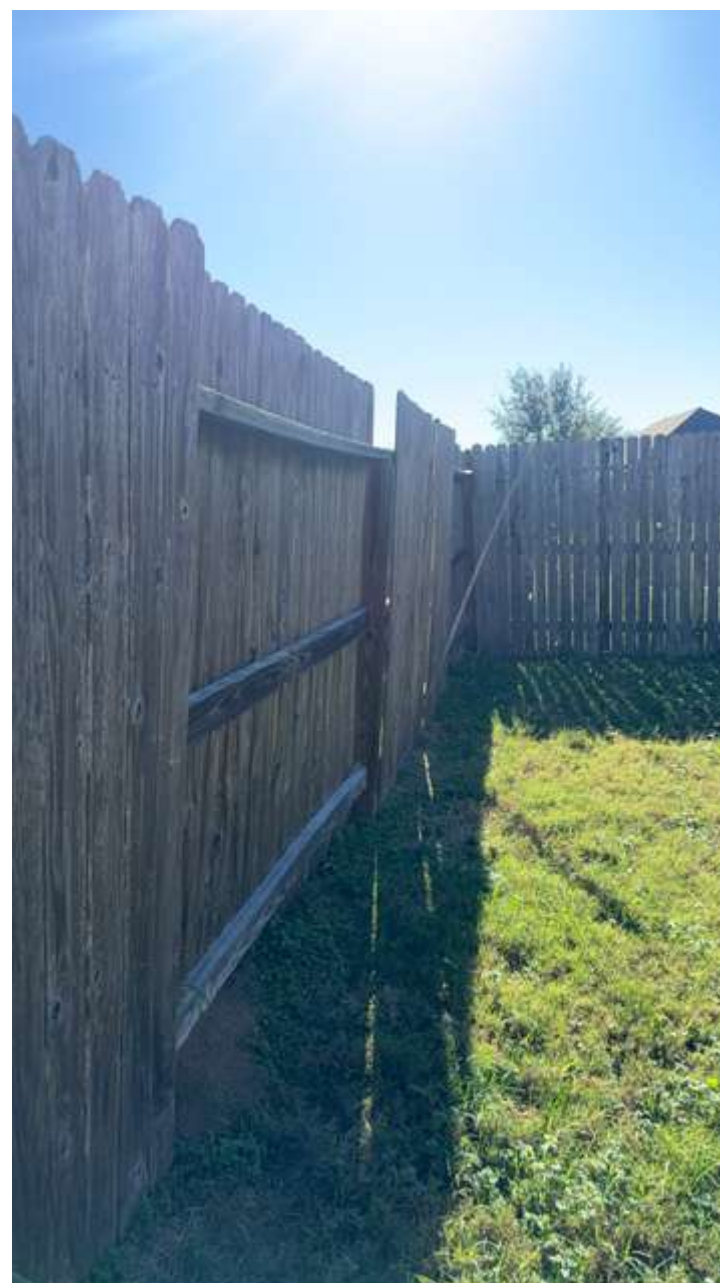
## Leaning Fence

The fence is leaning.

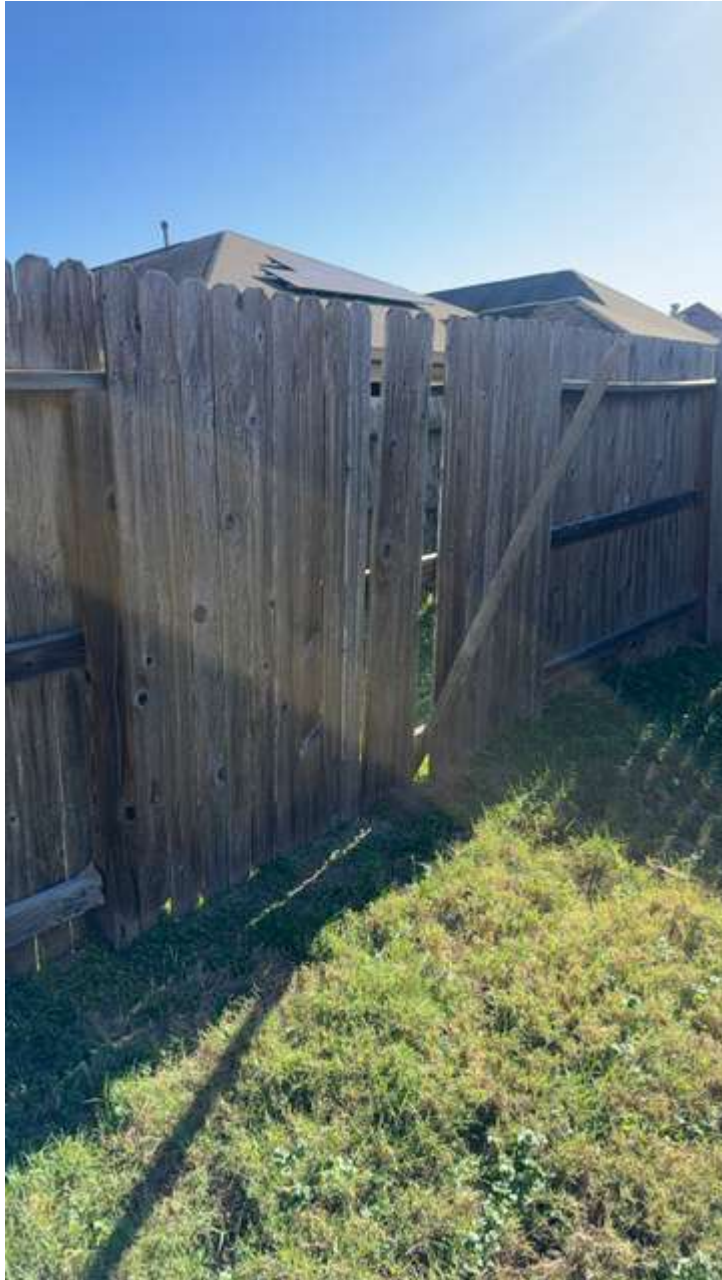
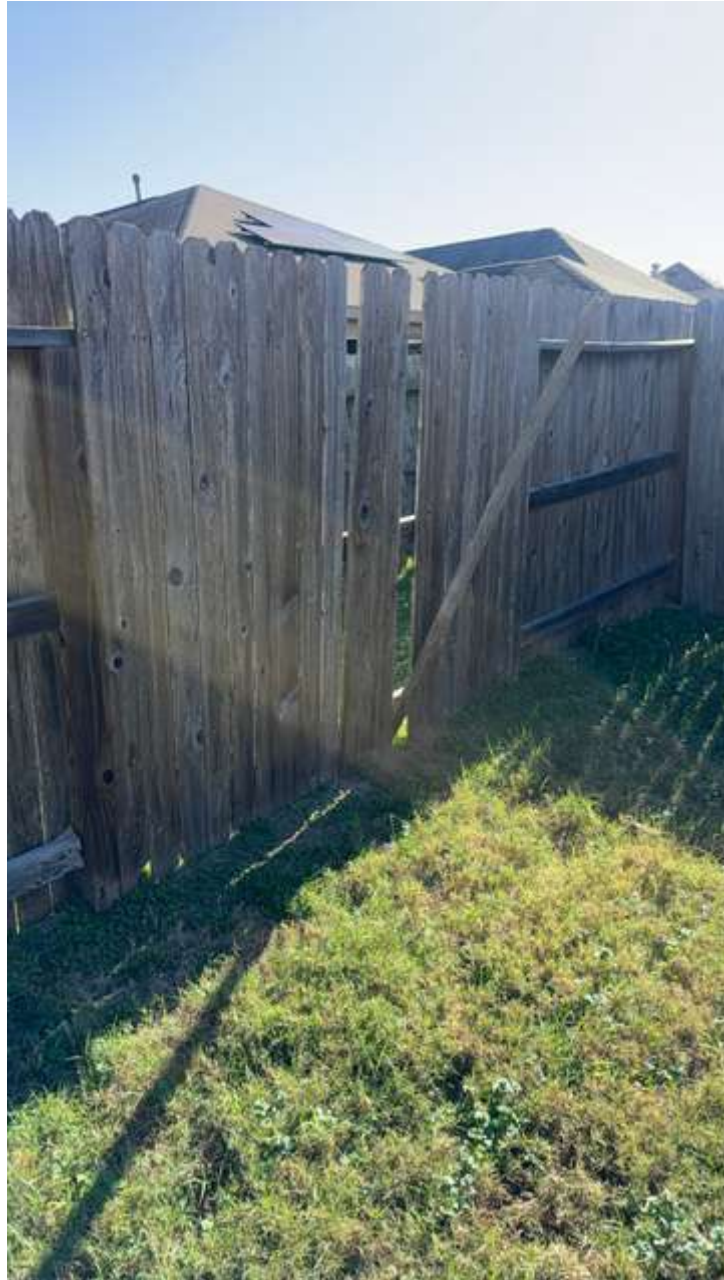
## Damaged / Missing Fence Boards

One or more fence boards are missing or damaged.

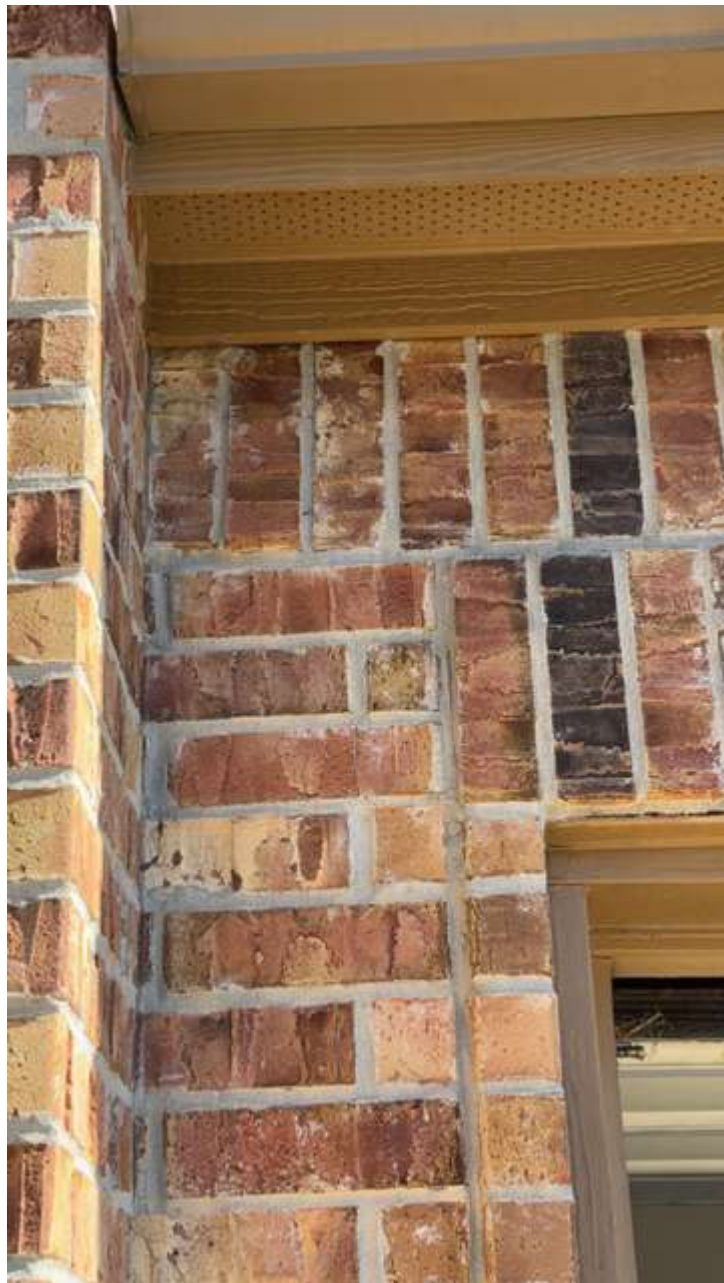
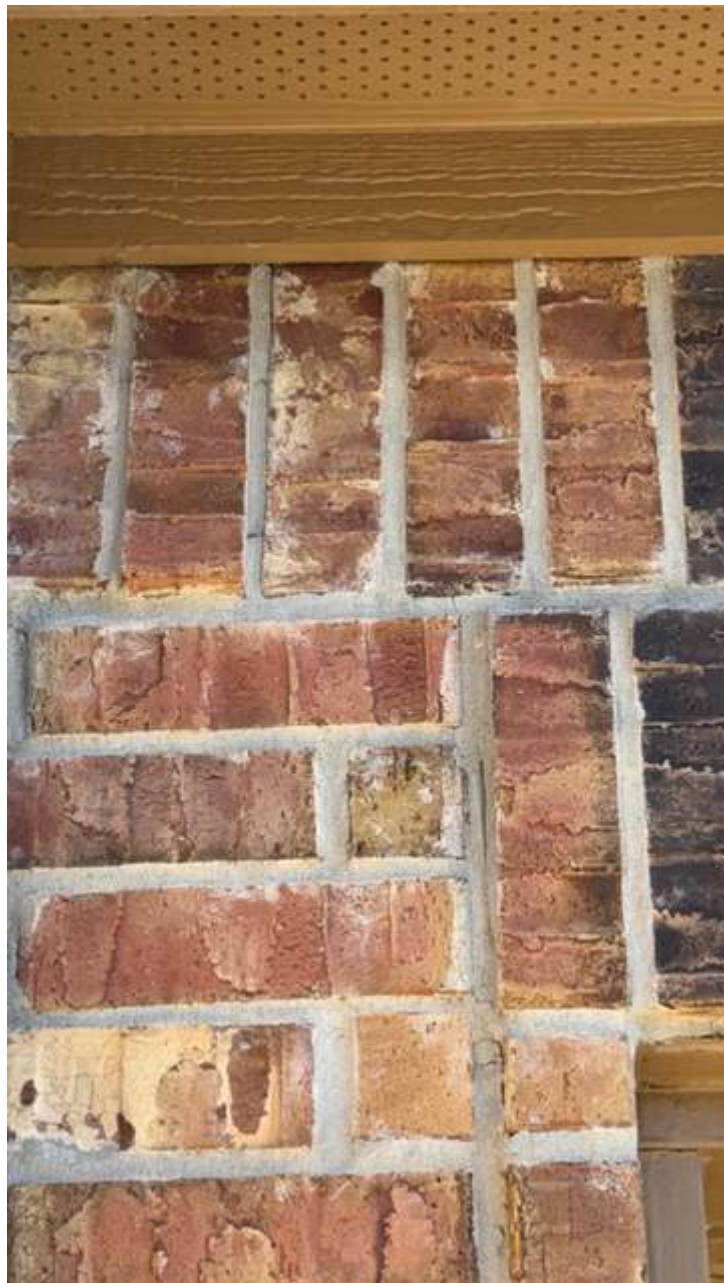
### Minor Exterior Cracks

There are minor cosmetic cracks throughout the exterior.

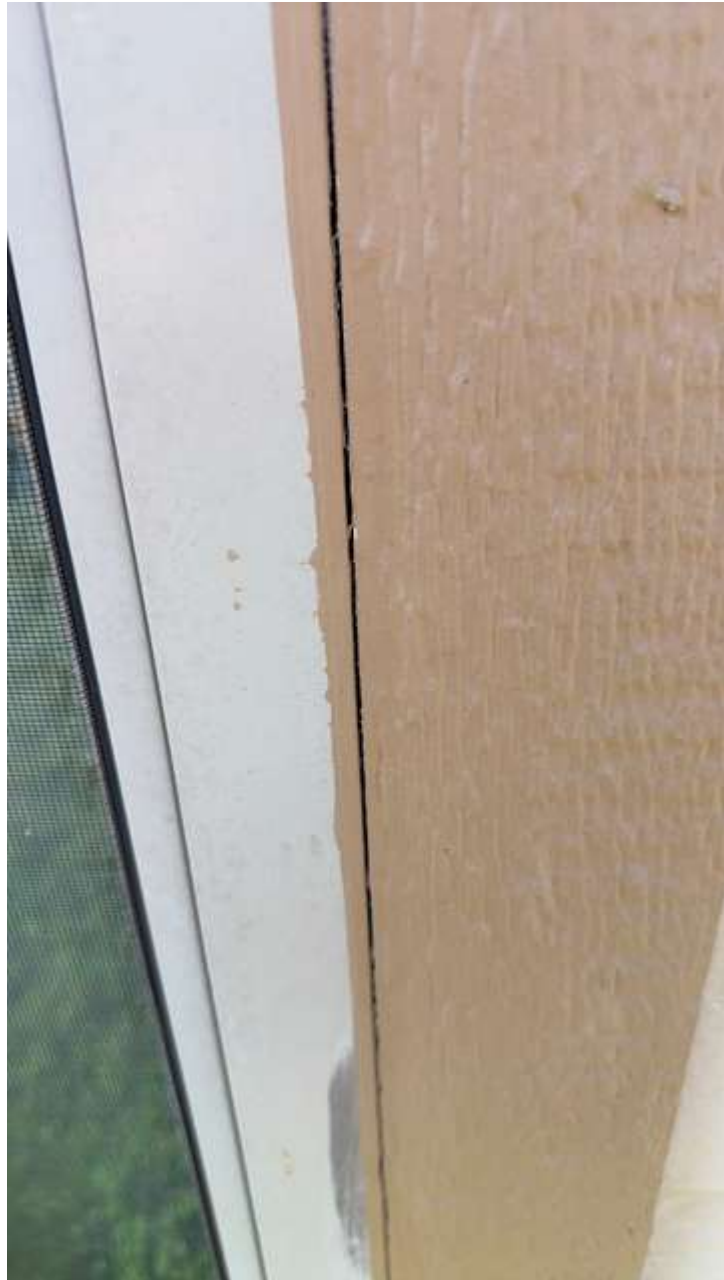
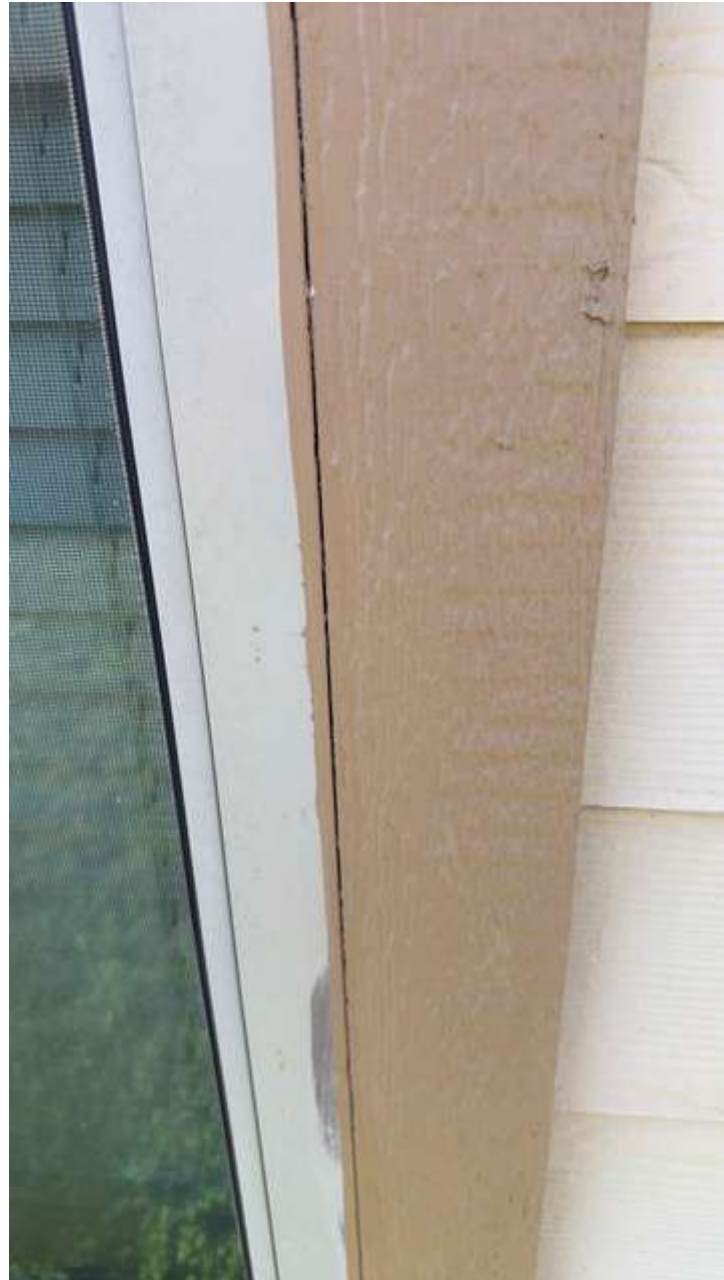
## Window Needs Caulking

One or more windows need caulking.

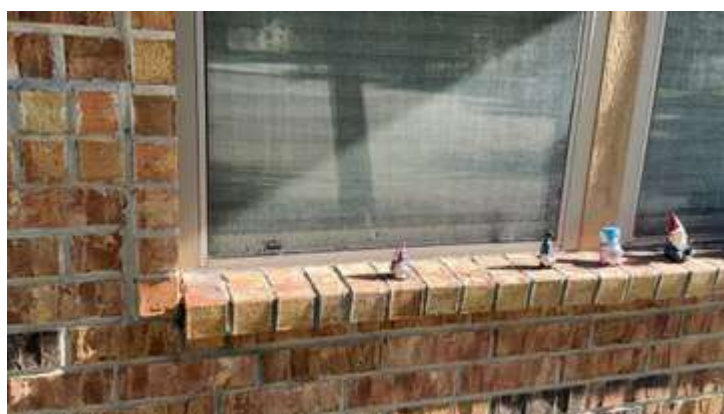
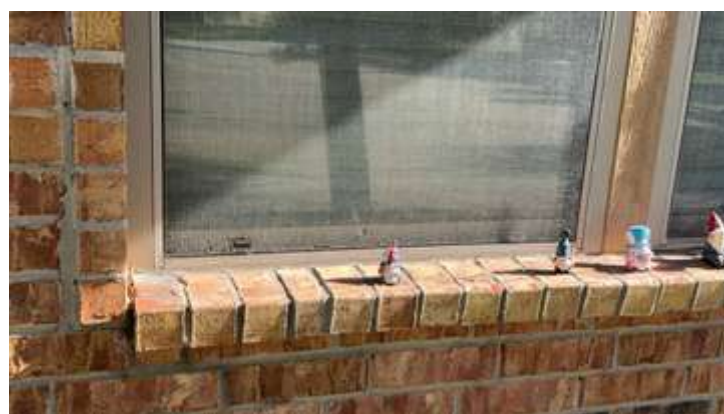
## Damaged Screen

One or more window screens are damaged.

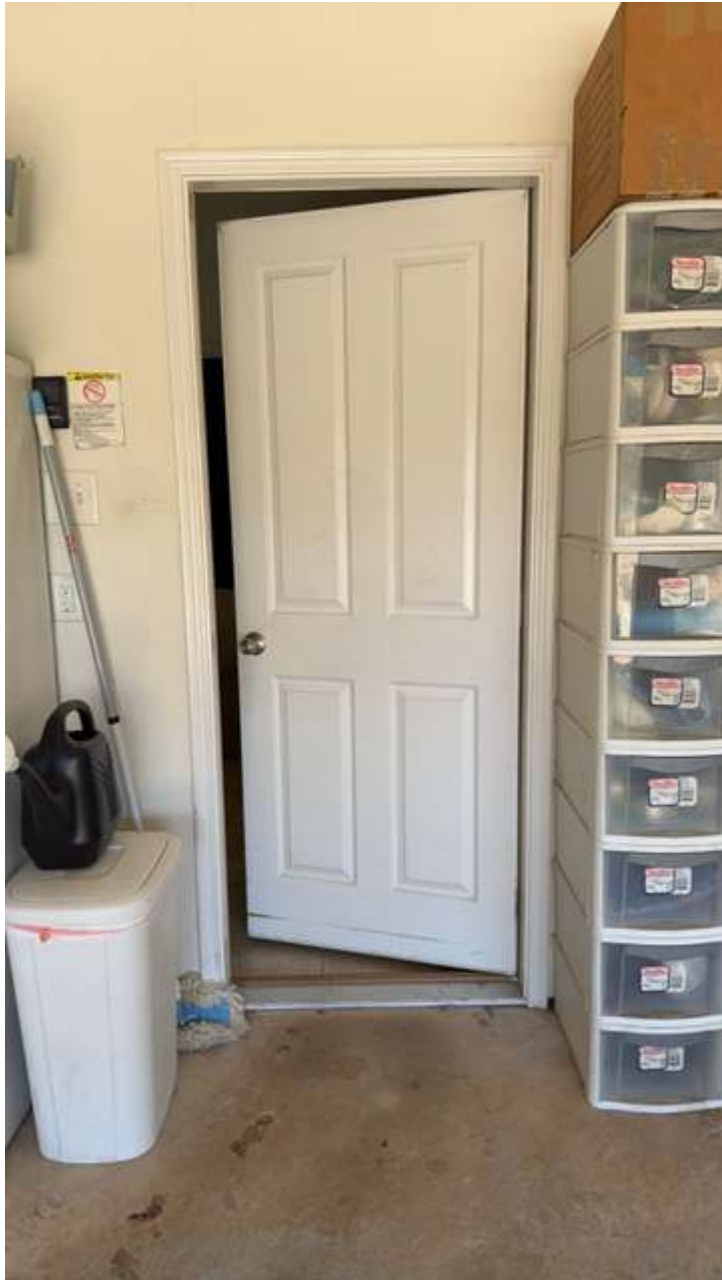
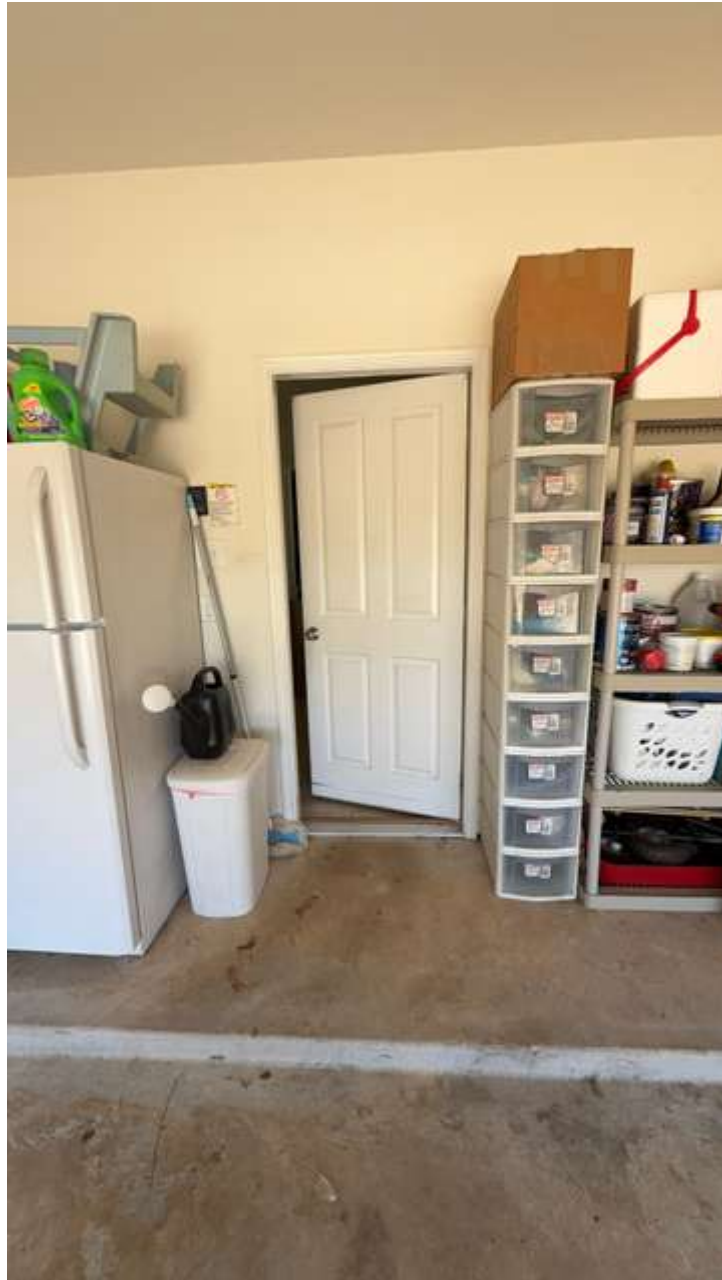
## Missing / Inoperable Self-Closing Door Hinges

The self-closing door hinges are missing / inoperable.

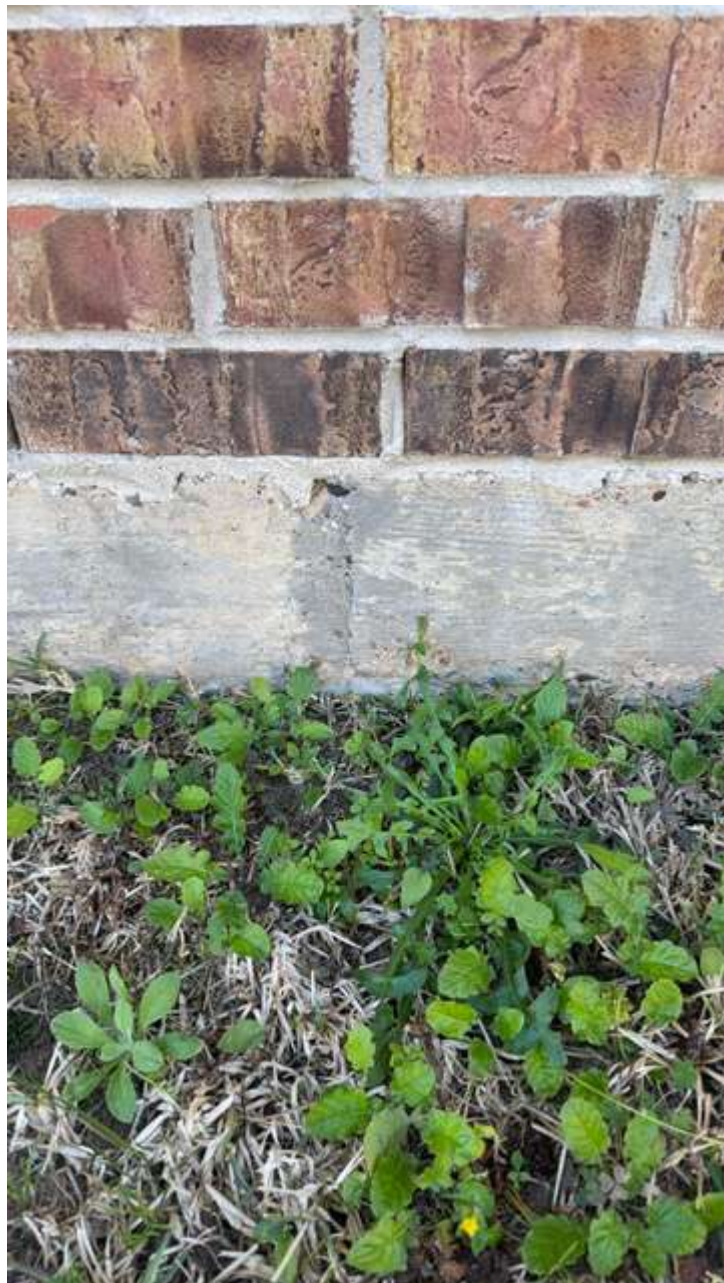
## Minor Foundation Cracks

One or more areas of the foundation have minor cracking.

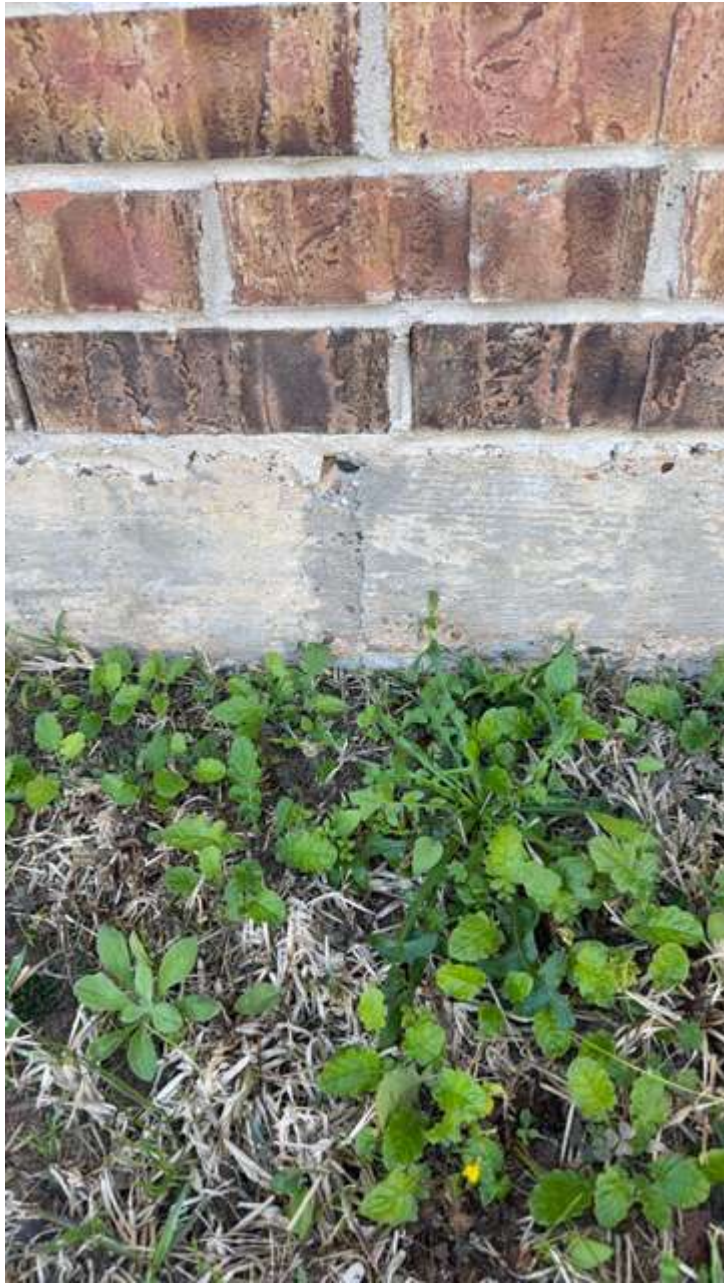
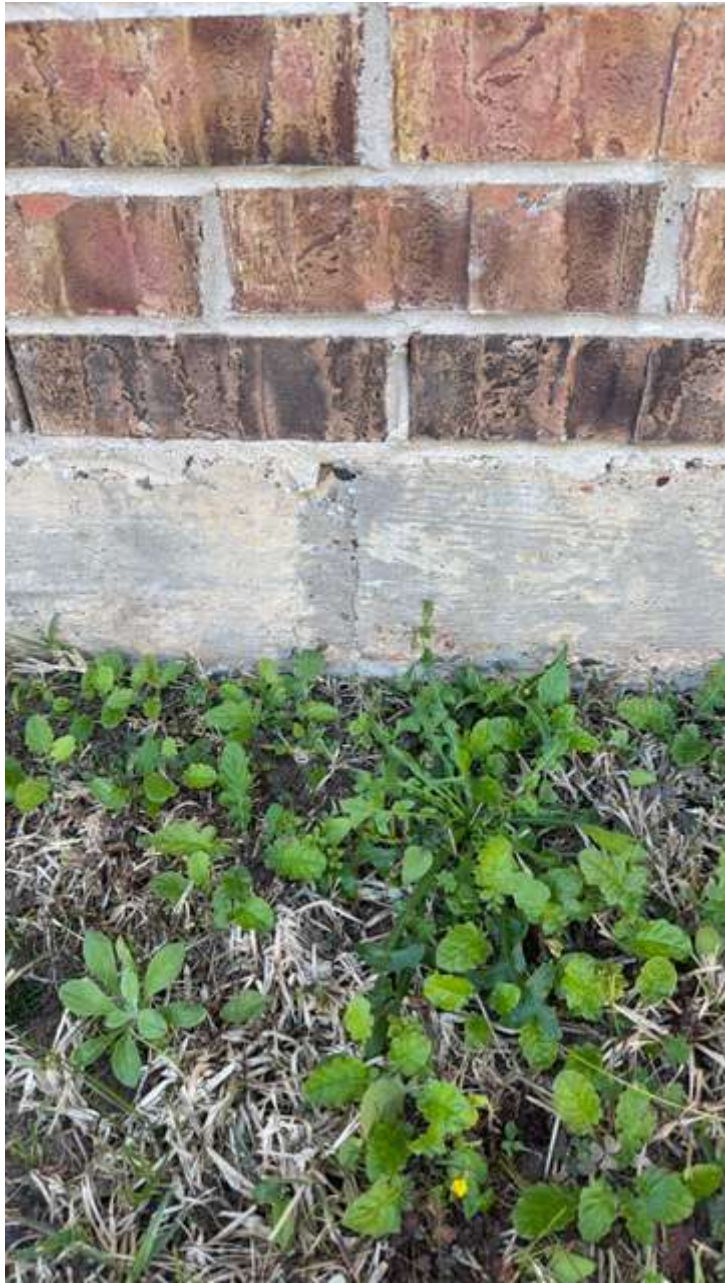
### Minor Foundation Cracks

One or more areas of the foundation have minor cracking.

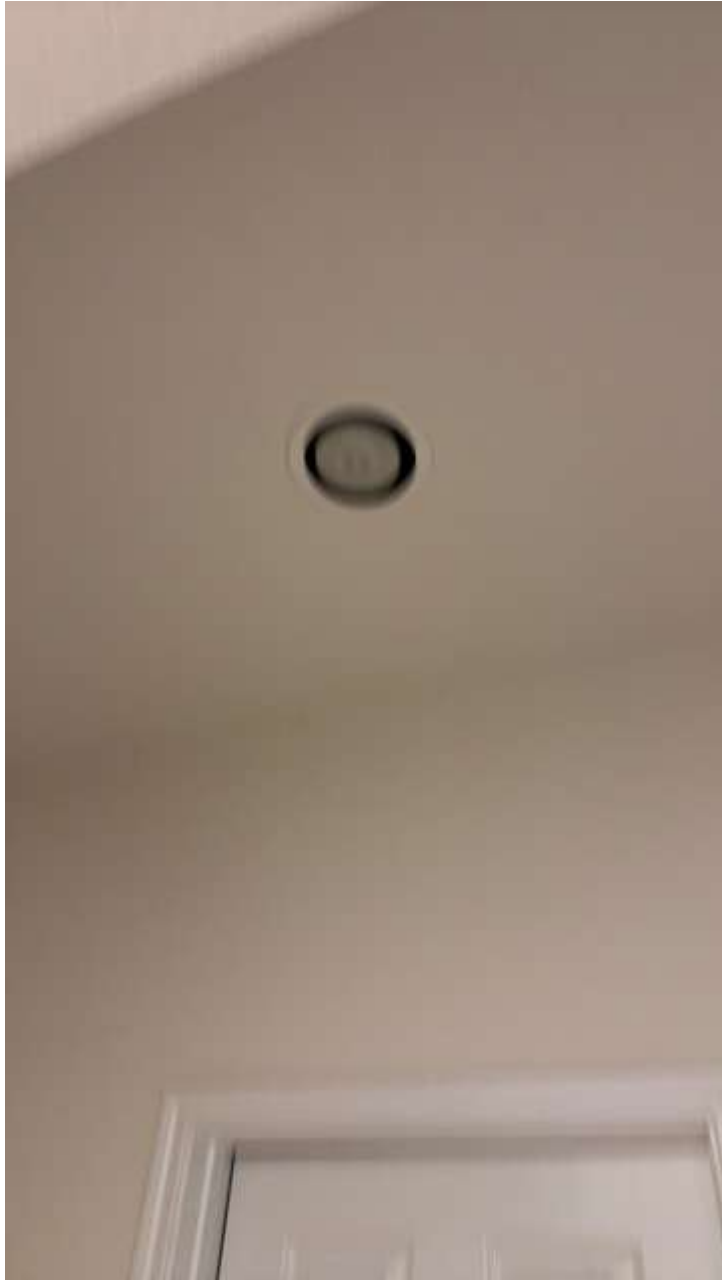
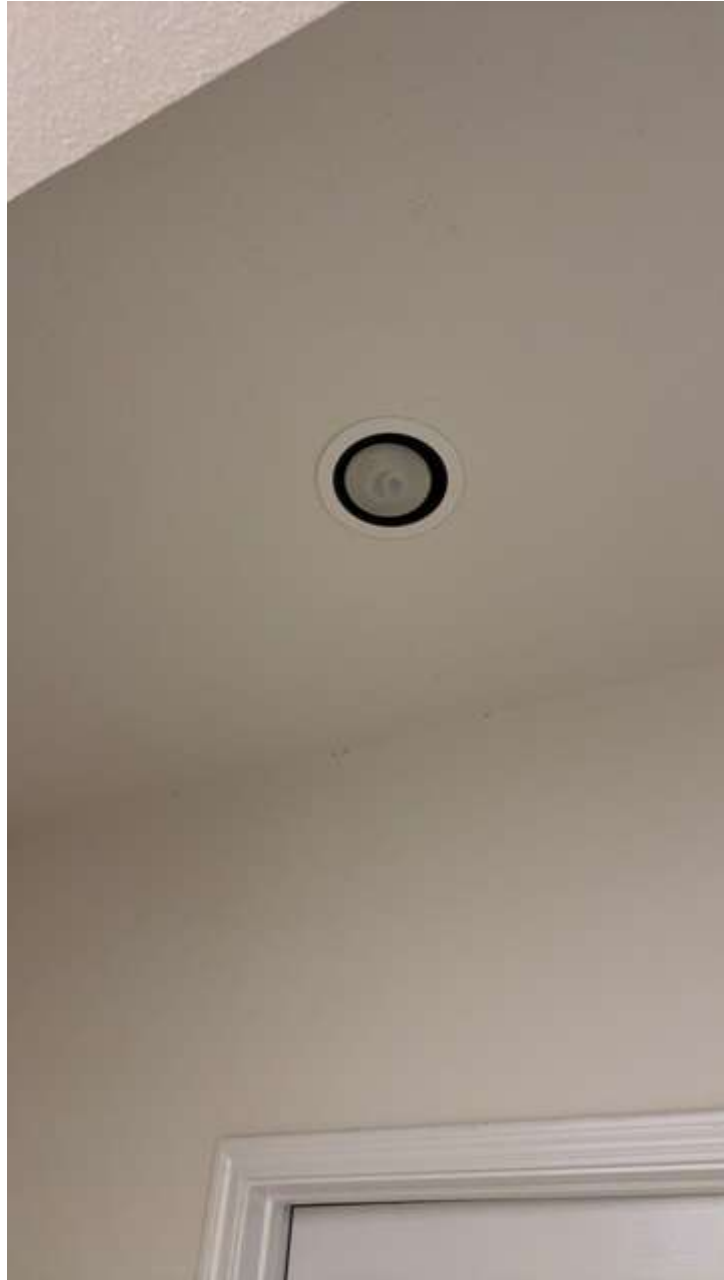
**Monitor deficiency****Inoperable or Missing Light Bulb**

One or more light bulbs have burnt out or are missing.

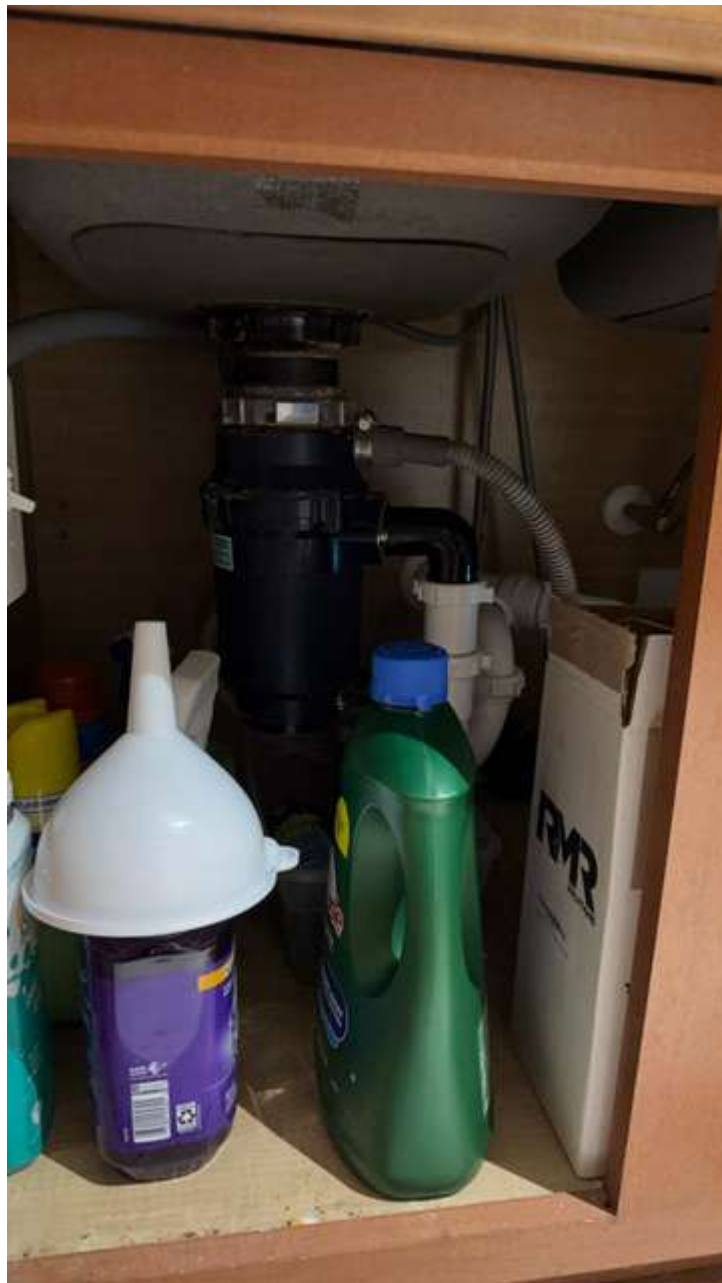
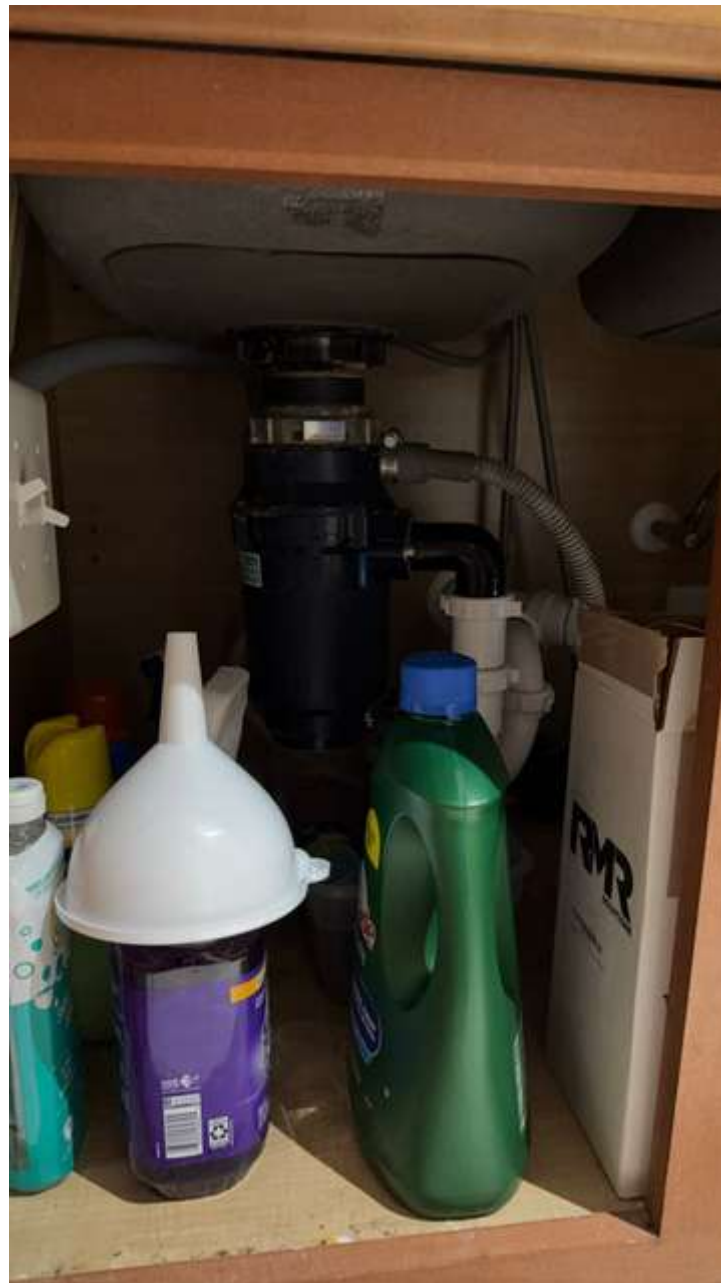
## Missing Dishwasher High Loop

The dishwasher plumbing is missing a high loop.

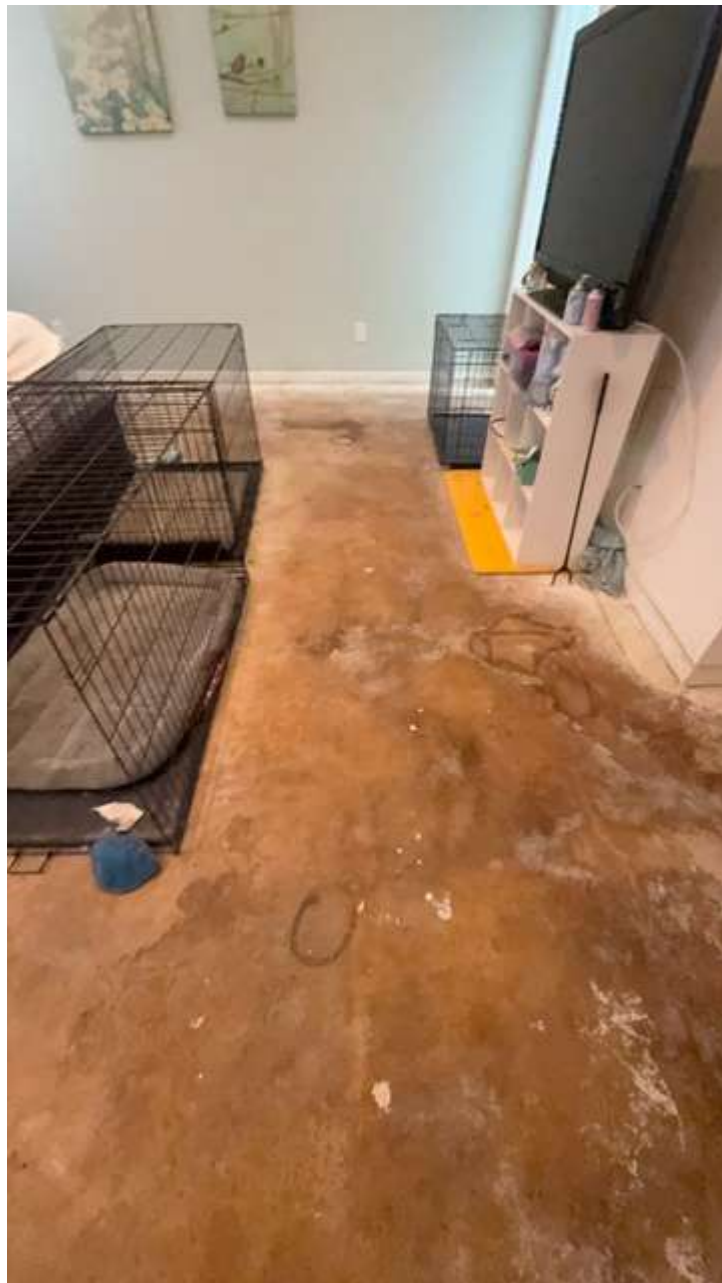
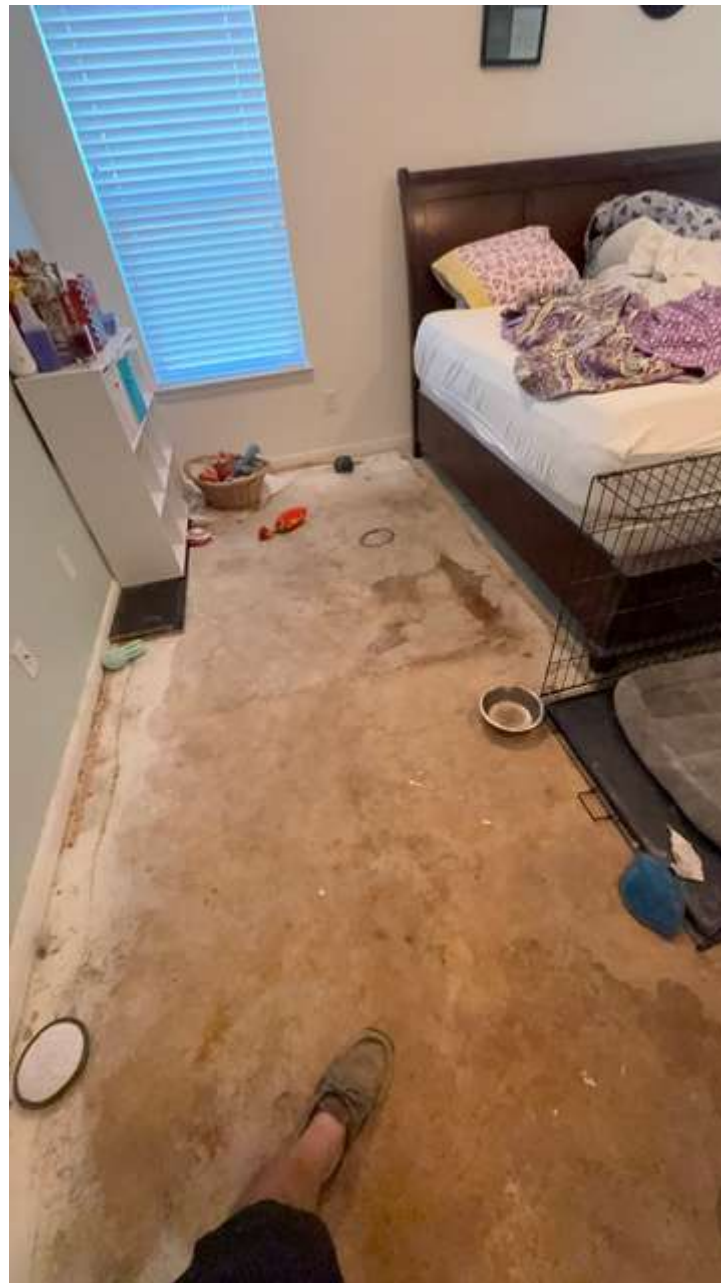
### Damaged or Torn Carpet

The carpet floor is damaged or torn in one or more areas.

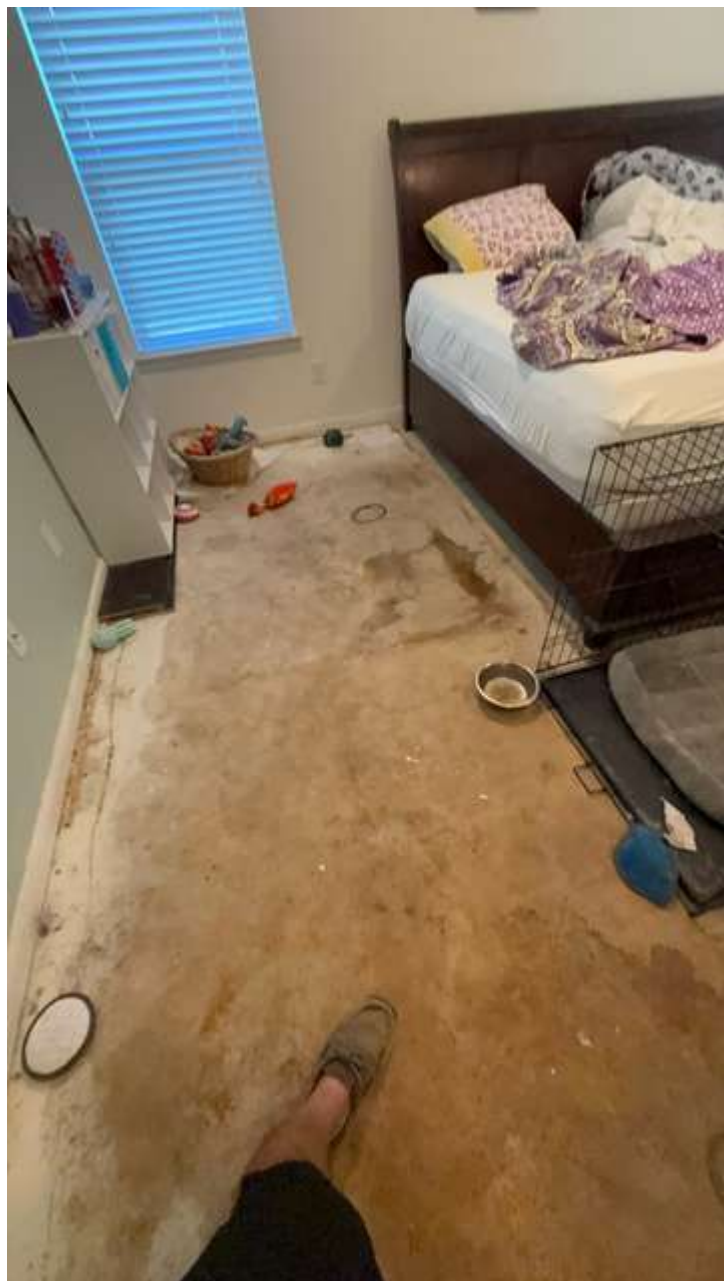
### Flooring Beyond Repair

Flooring Beyond Repair

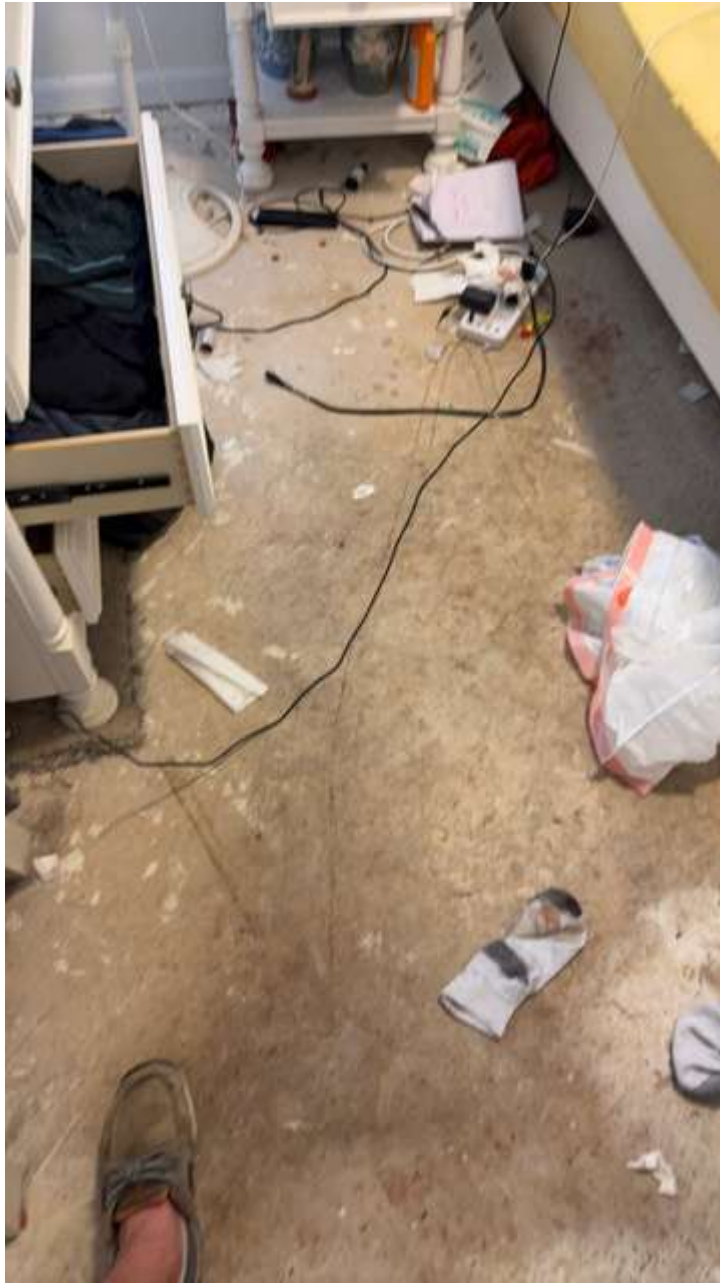
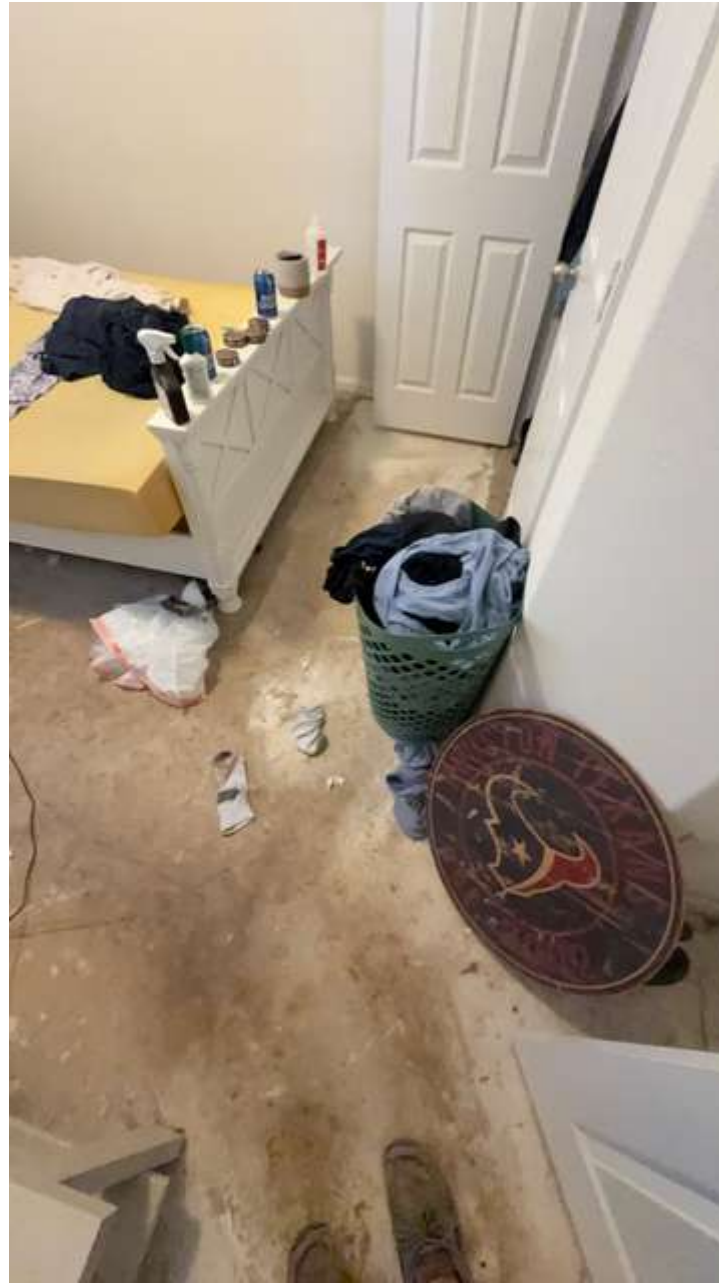
## Damaged or Torn Carpet

The carpet floor is damaged or torn in one or more areas.

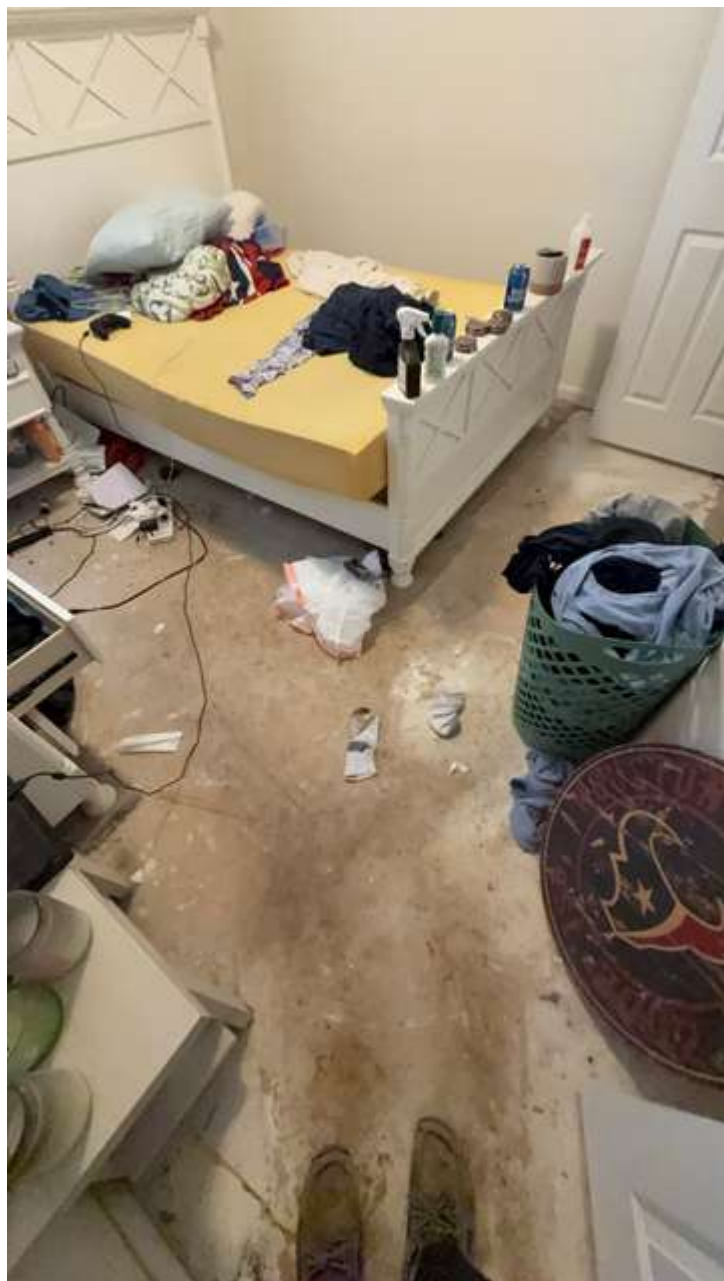
### Flooring Beyond Repair

Flooring Beyond Repair
