# 15202 Sunlight Bay Ct

## Cypress, Texas 77429

| Type | Home Inspection and Floor Plan Report - 15202 Sunlight Bay Ct |
| Inspected by | Rio Bravo - Inspectify Pro - Houston |

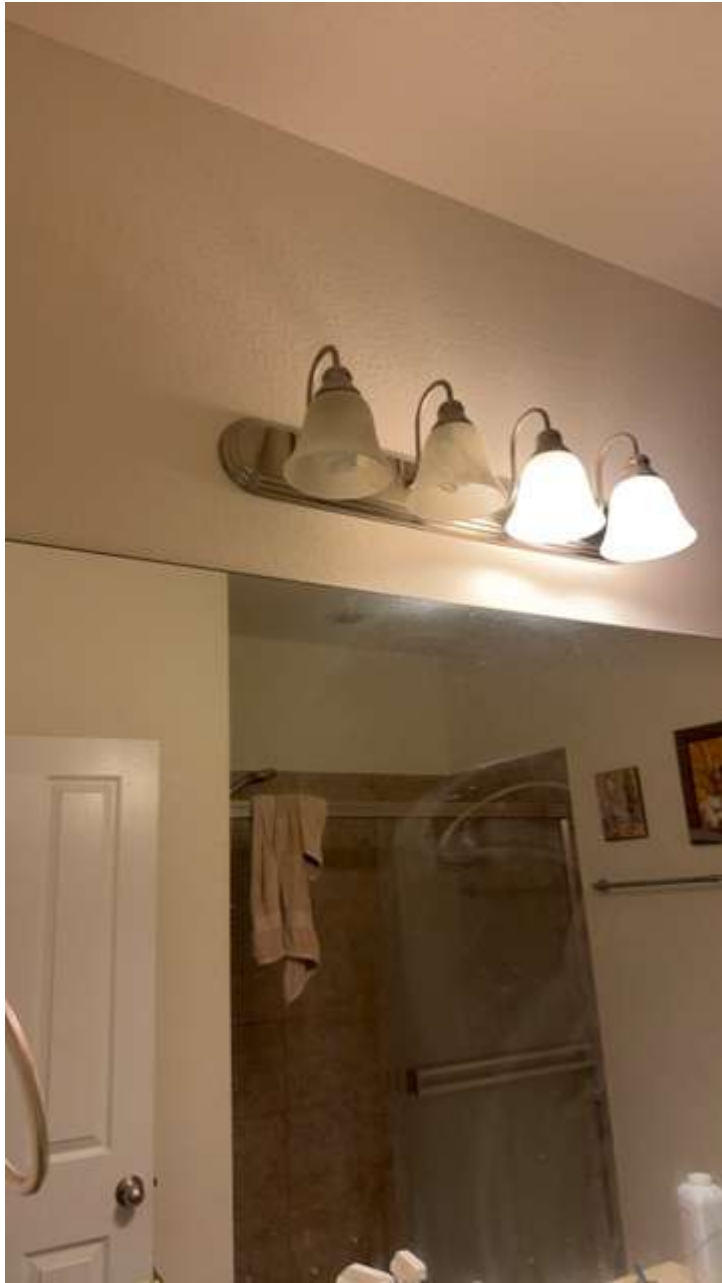
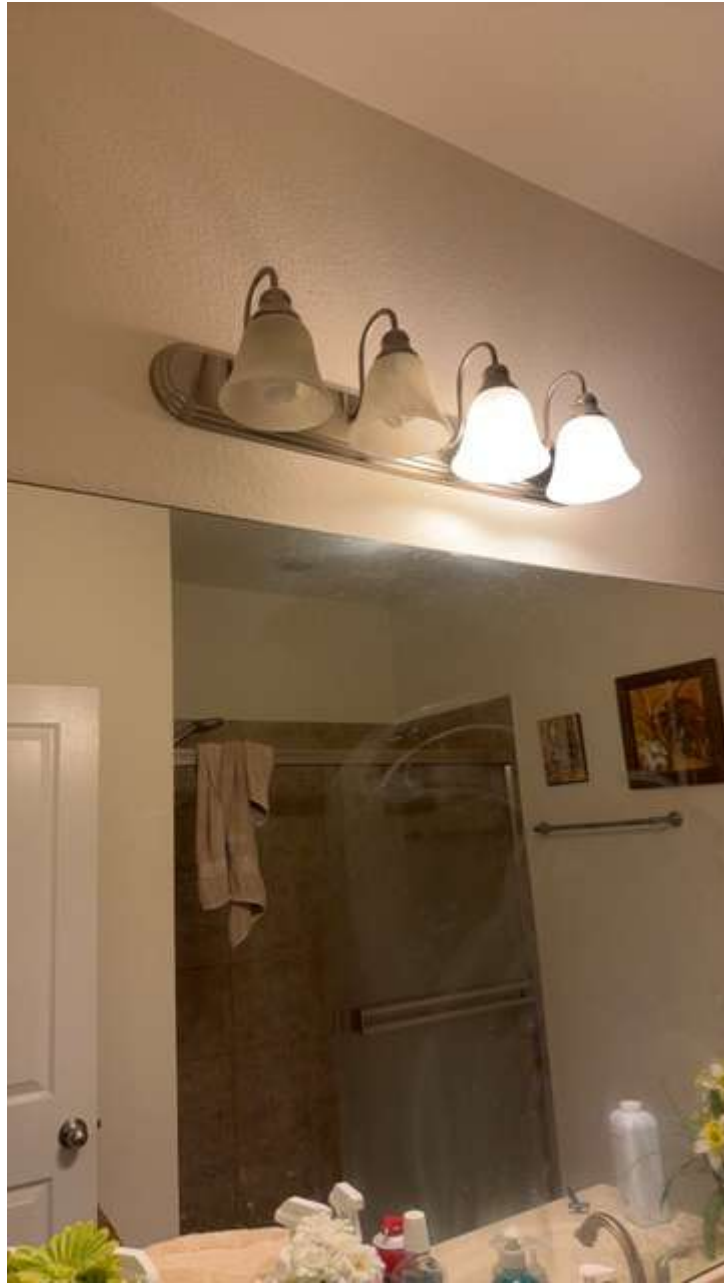
## Inoperable or Missing Light Bulb

One or more light bulbs have burnt out or are missing.

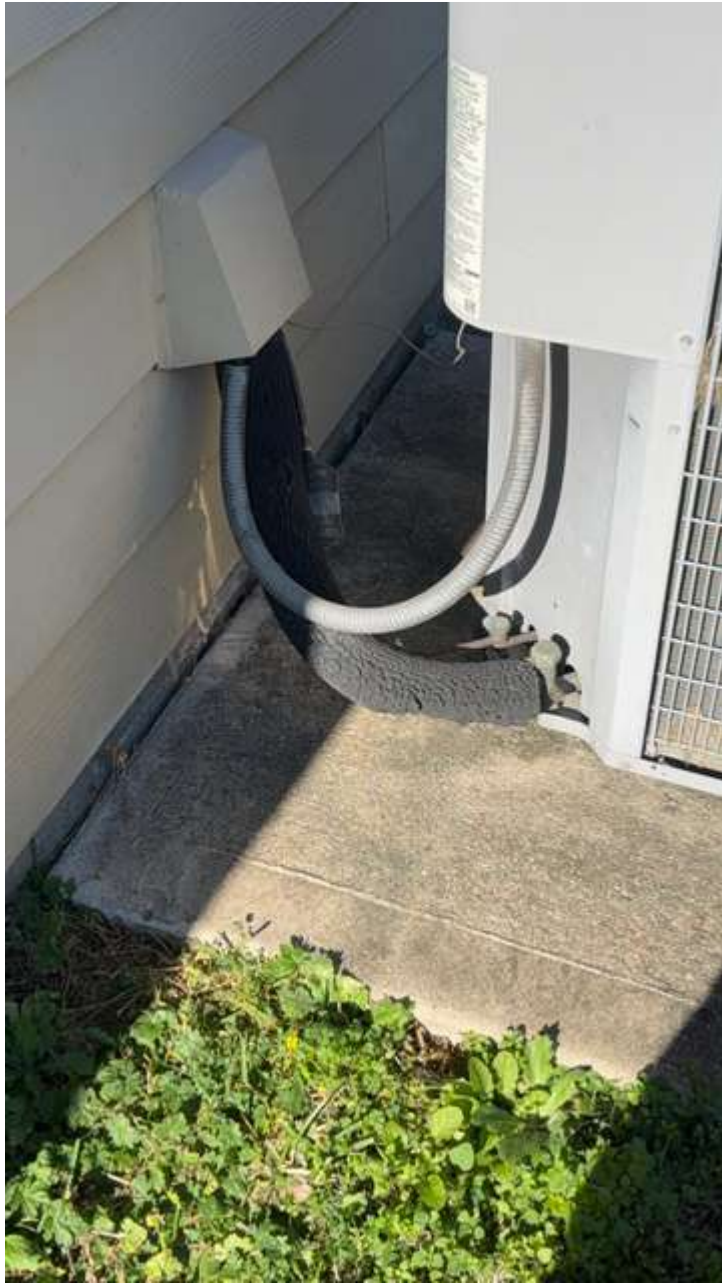
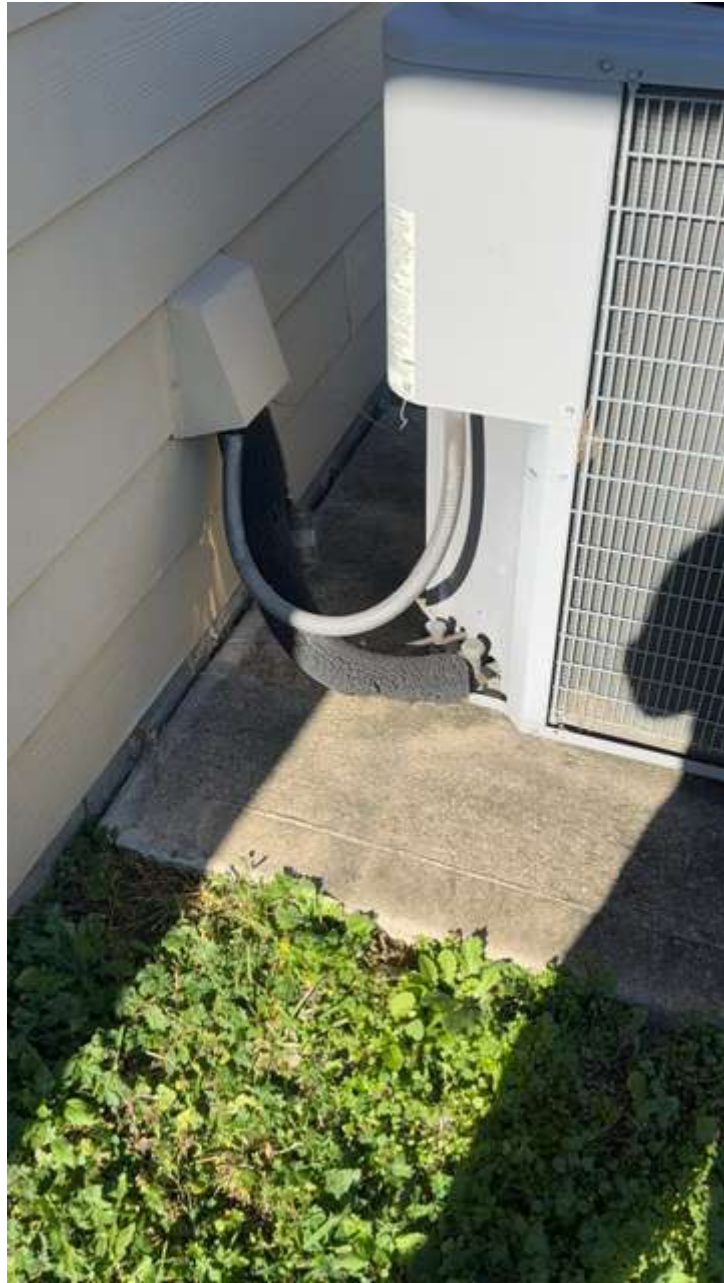
Missing or Damaged HVAC Line Insulation

The refrigerant line insulation is missing or damaged.
