PROPERTY INSPECTION REPORT

Concerning: 16734 Pebbleglen Dr, Houston TX 77095

By: Brett Finch - TREC #22635

05/25/2021 2:00 pm

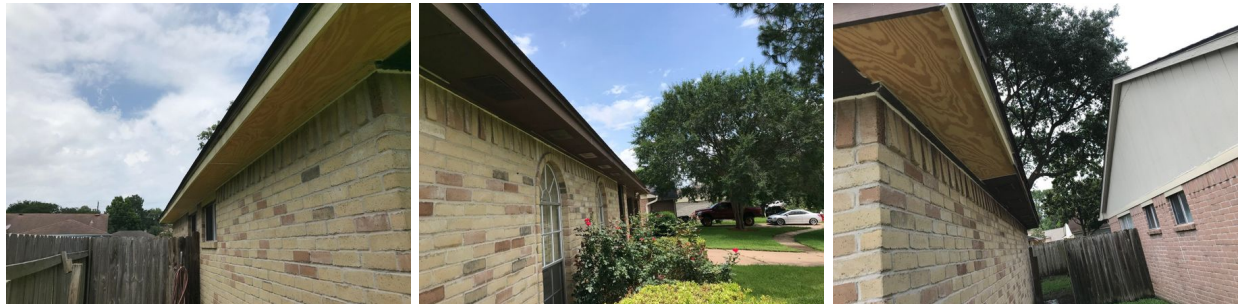
1: Gutters Absent

No gutters were observed to be installed along multiple roof slopes. Installation is highly recommended to prevent further erosion of the soil resulting in standing water near the foundation.

Recommendation: Contact a qualified gutter contractor

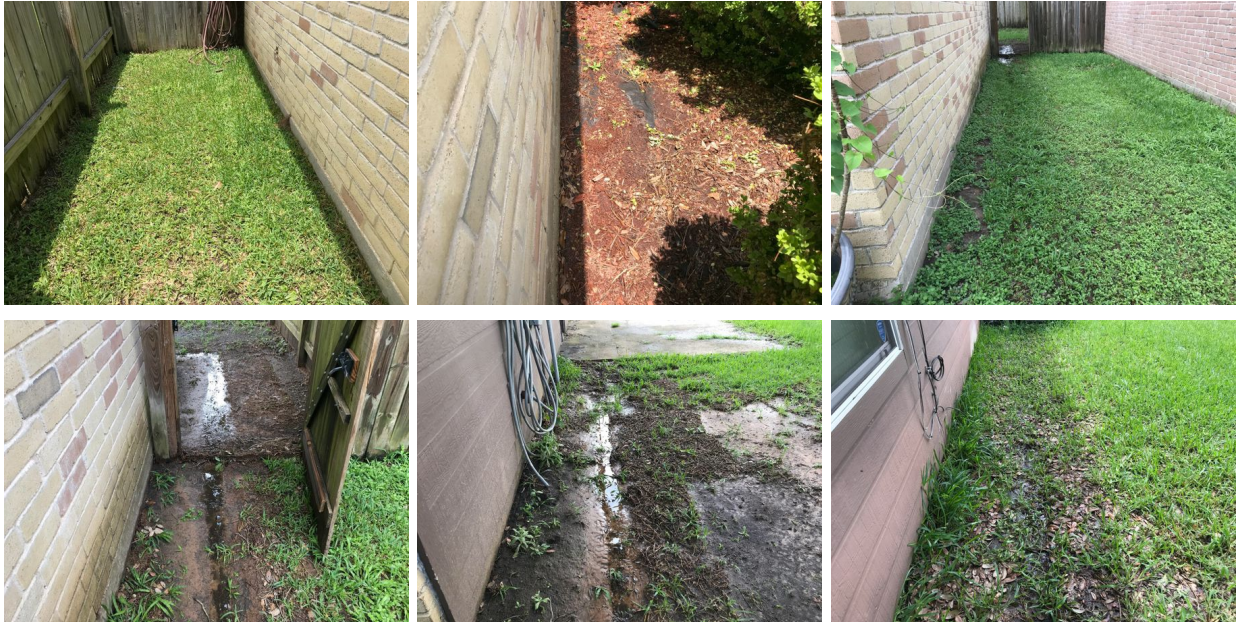
Soil erosion was observed at various locations around the home, likely being contributed to the lack of gutters. This condition can lead to grading issues and standing water. Recommend further evaluation and correction as needed to prevent further erosion and ensure proper drainage conditions.

Recommendation: Contact a qualified landscaping contractor

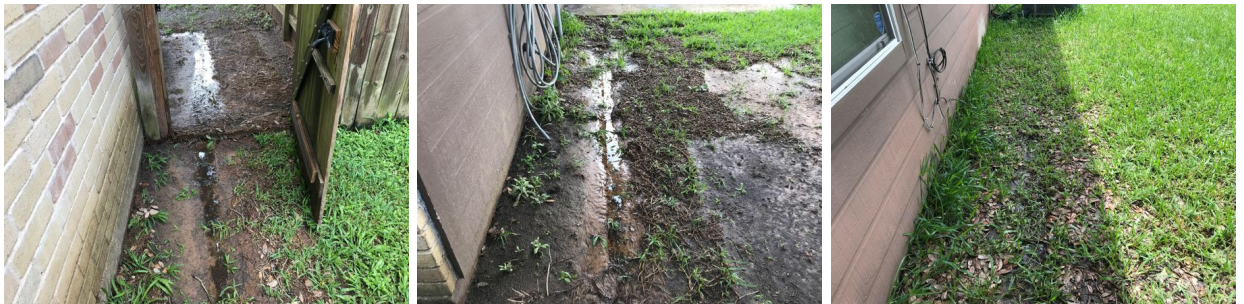
4: Grading and Drainage: Low spots/Standing water

Locations were observed around the property that were low or improperly sloped and likely holding water. Low spots in the grade should be properly repaired to ensure proper drainage and avoid a potential hazard. Recommend consulting with builder to determine the best method of repair. Note: Potential solutions may include the installation of an underground drain system around the property.

Recommendation: Contact a qualified landscaping contractor

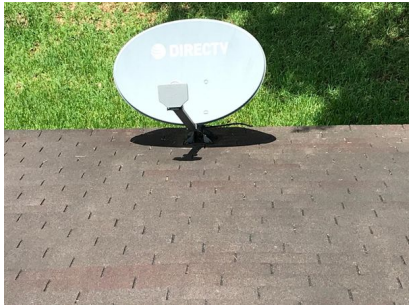
Decking Under Satellite Dish:

The inspector was unable to verify the condition of roof decking material under the mounted satellite dish(es). It is recommended that these dishes be secured to walls or other similar locations, and not secured through the roof covering. Recommend continued monitoring or considering removal/relocation.

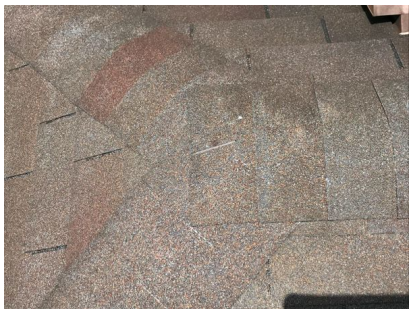
1: Exposed Nails

Several locations where the nail heads are exposed and need sealed. These locations include around vent jacks, flashings, and hip and ridge caps. Recommend correction as needed to prevent moisture penetration over time.

Recommendation: Contact a qualified roofing professional.

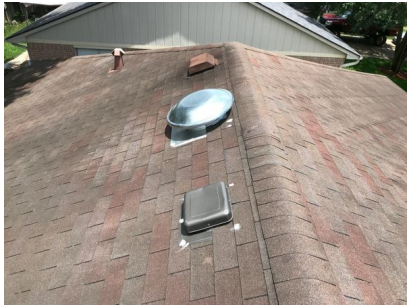
2: Unpainted Materials

Several locations including exposed flashing, vent assemblies, and/or plumbing vents were observed to have not been painted. All areas exposed above the roof line are required to be properly painted to avoid deterioration. Recommend correction.

Recommendation: Contact a qualified roofing professional.

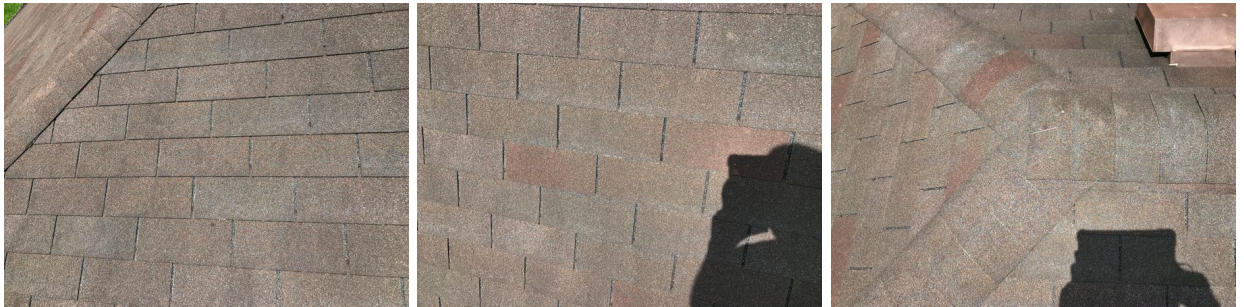
3: Shingles: Granule Loss Noted

Moderate granule loss of the asphalt roofing shingles was observed at some locations. This condition is typical for an aging roof, and does not seem to be affecting the performance of the roof covering at this time. Recommend regular monitoring and inspection of this condition. Consult with roofing contractor if you desire further evaluation of this condition.

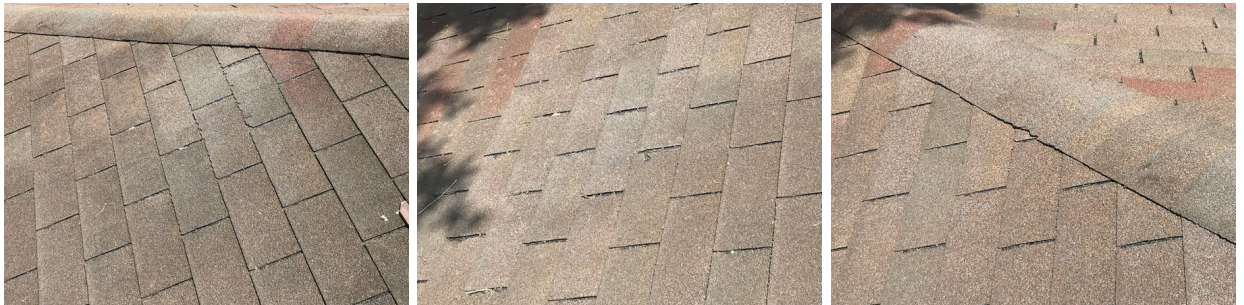
4: Shingles: Damaged/Missing

Damaged/missing shingles were observed on the roof covering. These conditions can compromise the integrity of the roof covering, and I recommend further evaluation by qualified contractor to determine the extent of needed repairs.

Recommendation: Contact a qualified roofing professional.

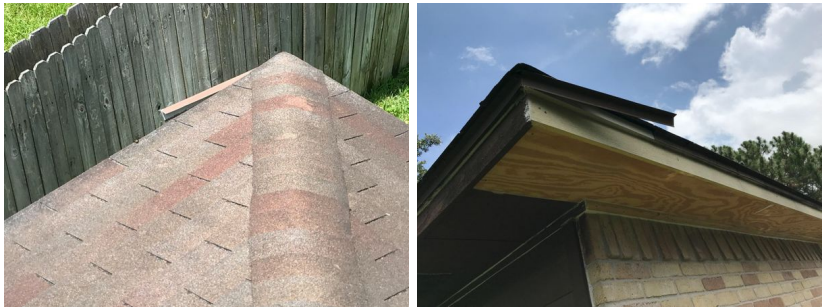
5: Drip Edge: Drip Edge Damaged

Locations were observed where the drip edge flashing was damaged and/or displaced. Recommend further evaluation and correction as needed to avoid potential moisture intrusion issues.

Recommendation: Contact a qualified roofing professional.

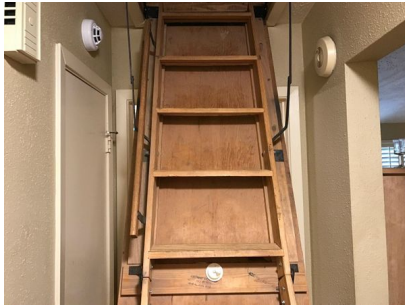
1: Attic Door: Issues Observed

The above stated issues were observed in relation to the attic access door at the time of inspection. Attic access doors are required to be properly insulated, weatherstripped, and seal firmly for energy efficiency reasons. Pull down attic ladders are required to be properly secured to the ceiling framing with appropriate fasteners, the hardware on the doors should be kept in good condition and be regularly serviced for safety reasons. Recommend correction of any above referenced issues to ensure performance and proper installation.

Recommendation: Contact a qualified handyman.

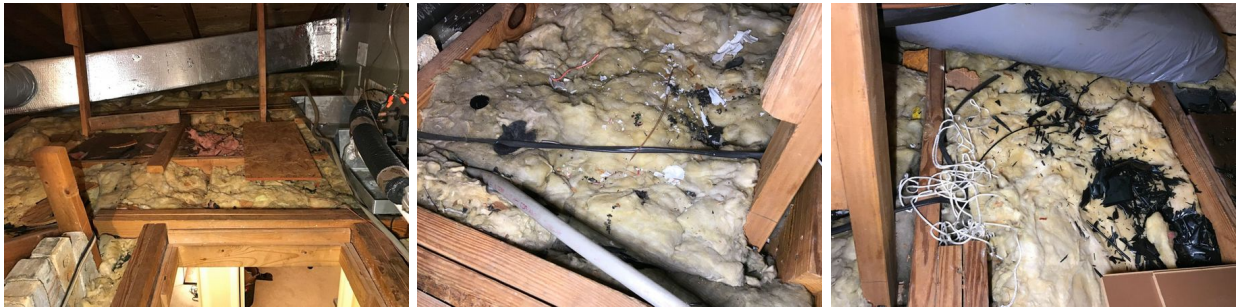
2: Insulation: Low Insulation

Insulation depth was observed to be low. Installation of additional insulation by a qualified insulation contractor is recommended for energy efficiency purposes.

Recommendation: Contact a qualified professional.

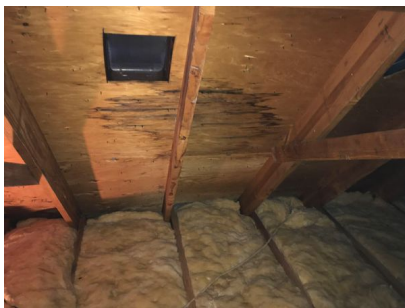
3: Moisture staining on roof decking

Moisture staining on roof decking in the attic. I cleaned up to this area and touched it with my hand and it is not actively moist at this time. I recommend inquiring with seller if any additional damages were caused by this week.

Recommendation: Contact a qualified professional.

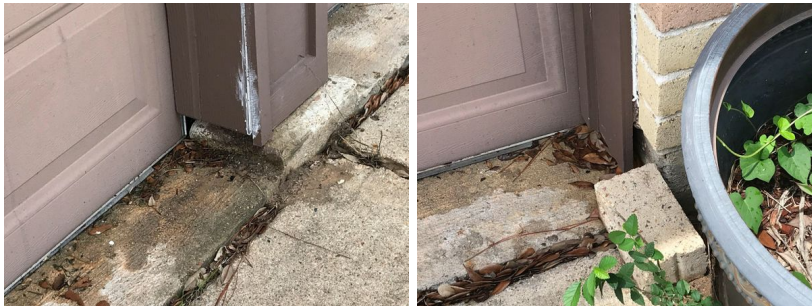
1: Exterior Walls: Seal Openings

The inspector observed one or more excessive gaps or openings in the exterior finishes that could be potential points of pest intrusion. Recommend these locations be properly sealed or that you contact a qualified pest control company to perform a proper exclusion on the property.

Recommendation: Contact a qualified pest control specialist.

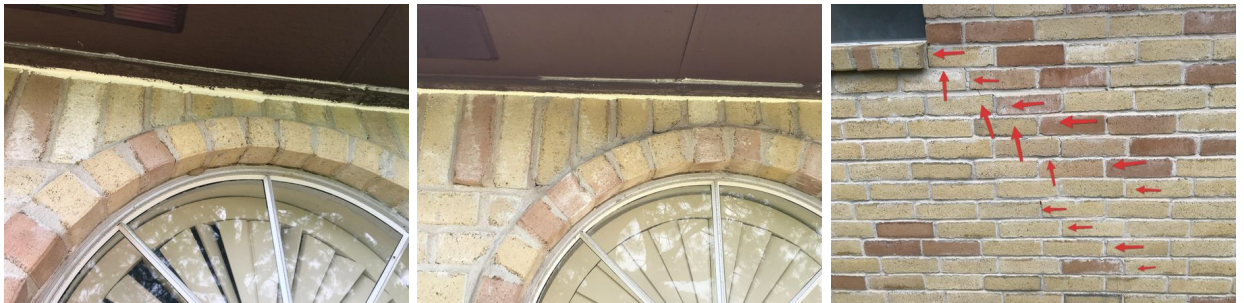
2: Masonry: Minor cracks/Maintenance Recommended

Minor cracks were observed in the masonry walls and/or mortar lines around the home. These conditions appear related to typical or normal settlement. Recommend you consider correction to avoid further deterioration and for cosmetic reasons.

Recommendation: Contact a qualified masonry professional.

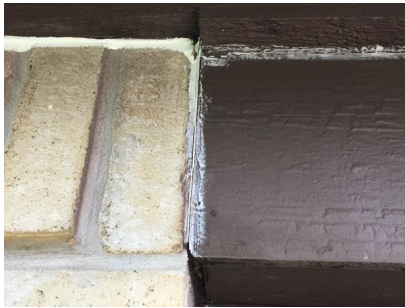
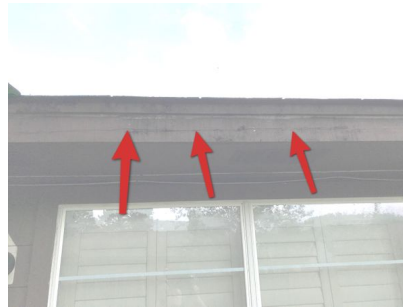
3: Siding: Minor Damage/Maintenance Recommended

The siding displayed sections with minor damage or maintenance issues. Common maintenance items include: minor damage, separation at joints and trim, finishes that are worn, etc. While these conditions do not appear to be contributing to any larger issues, I recommend you consider correction to avoid further deterioration and as apart of normal maintenance.

Recommendation: Contact a qualified handyman.

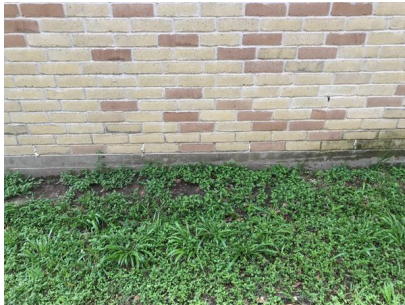
4: Masonry: Weep holes dirty/obstructed

Weep holes in the brick veneer were filled with debris. Weep holes permit moisture to drain from behind the brick and prevent moisture from being trapped within the walls. Recommend further evaluation and repair.

Recommendation: Contact a qualified professional.

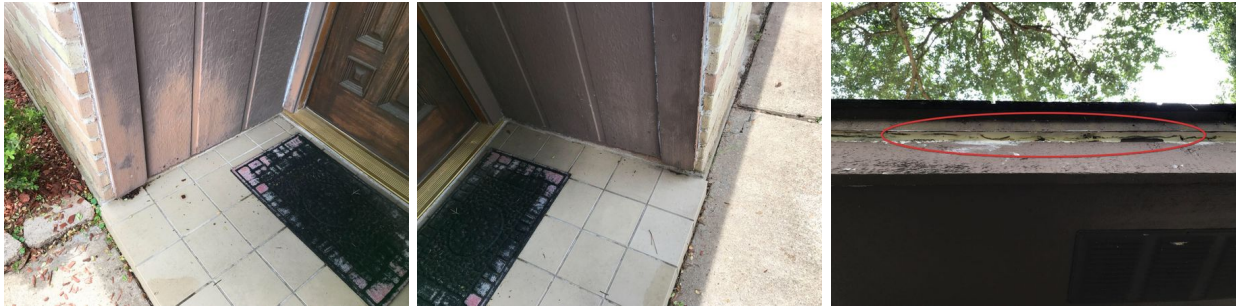
5: Siding: Wood Rot/Moisture Issues

Moisture penetration was observed to the wooden trim, fascia boards and siding at multiple locations around the home. Repair as needed to prevent further deterioration.

Recommendation: Contact a qualified professional.

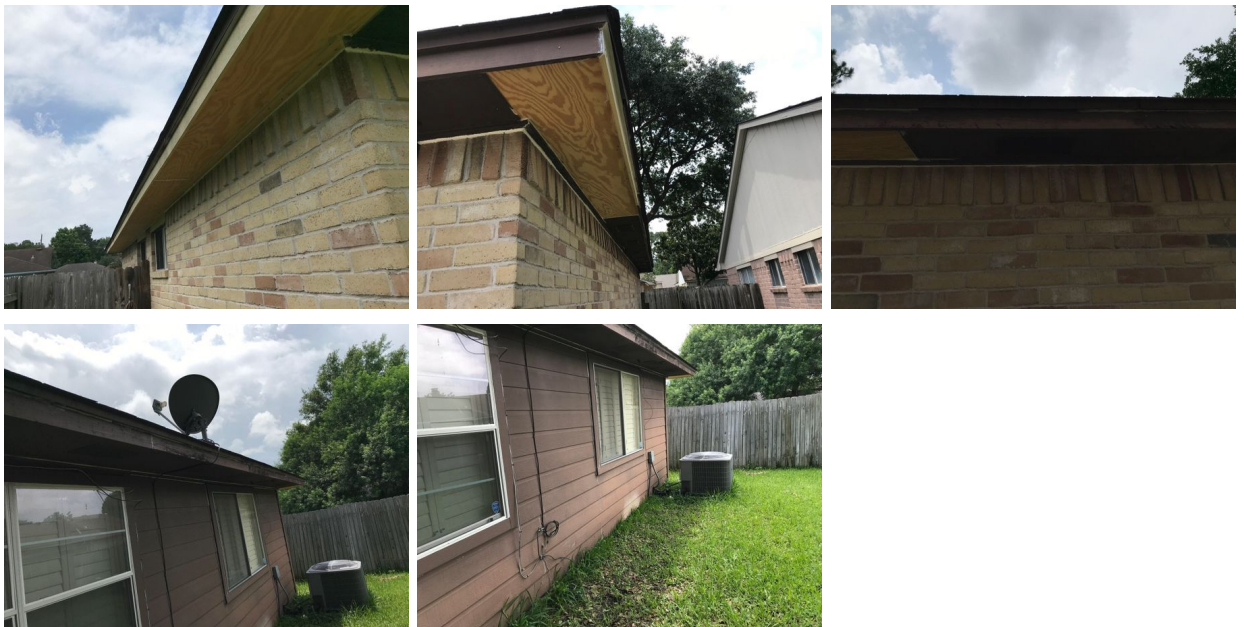
6: Siding: Paint/Finish Issues

There were some areas of the exterior siding or trim that needs painting or staining to prevent premature weathering of building materials. Remedy as needed.

Recommendation: Contact a qualified professional.

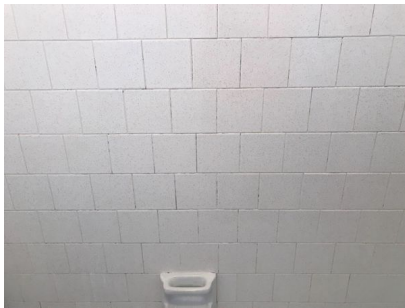
8: Tile wall at bathtub or shower

The tile wall caulking or grout is deteriorated. I recommend repair.

Recommendation: Contact a qualified professional.

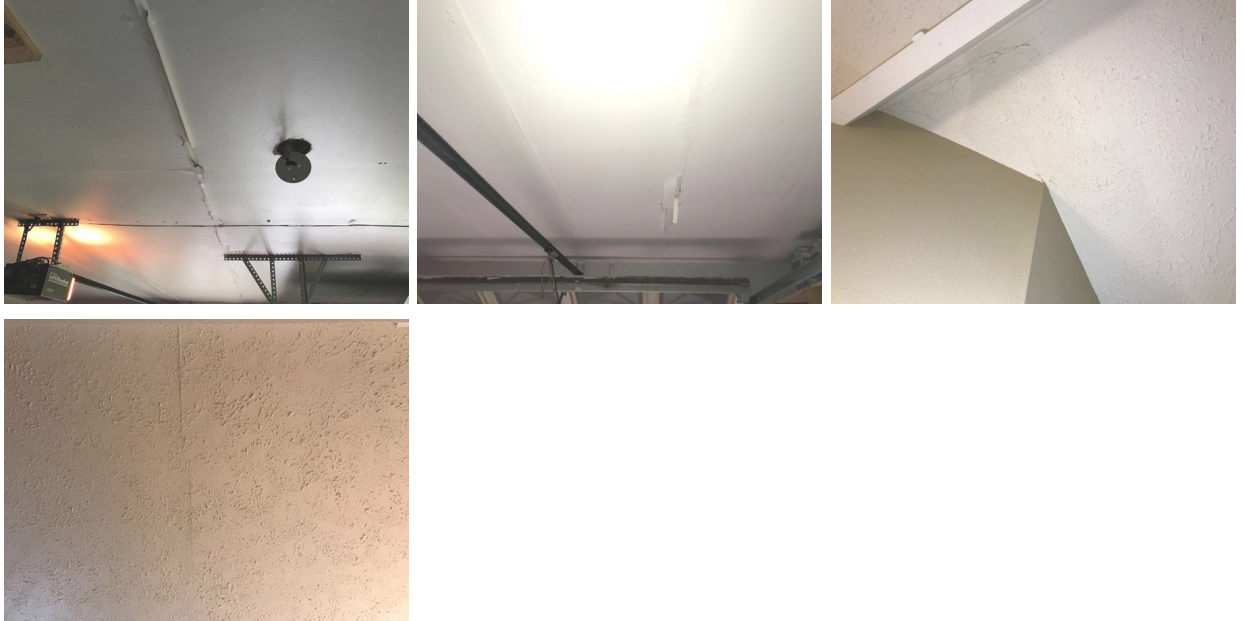
1: Ceiling: Cracked Tape Joints

Cracked taped joints and other cosmetic issues were observed on the ceiling finish at multiple locations. These cracks and cosmetic issues are due to typical settlement of the foundation and recommend repair as needed to prevent further deterioration.

Recommendation: Contact a qualified painting contractor.

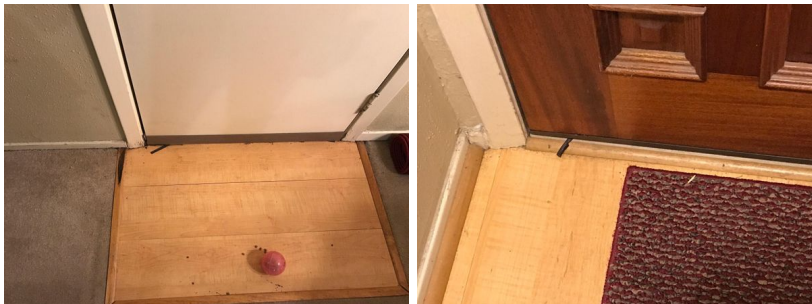
1: Exterior Door: Weatherstripping Missing or Damaged

Multiple exterior doors showed damage or were missing its weatherstripping. Recommend installation or repair of standard weatherstripping to prevent energy loss and/or moisture intrusion.

Recommendation: Contact a qualified professional.

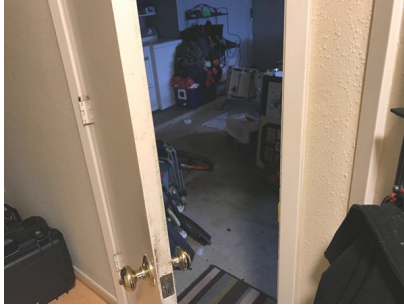
2: Garage Door into Living Space: Self-Closing Mechanism not Present/Operable

The door between the garage and living area does not have an automatic closing function. This may have not been a requirement when the home was originally constructed, but I recommend correction for safety purposes.

Recommendation: Contact a qualified professional.

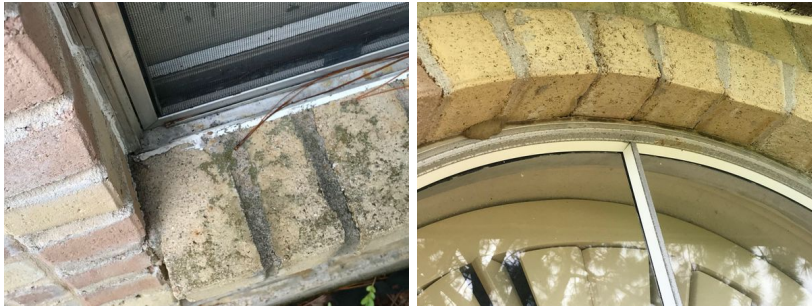
1: Missing/Deteriorated Caulking Exterior Frames

Caulking is missing/deteriorated on the exterior frame. Remedy as needed.

Recommendation: Contact a qualified professional.

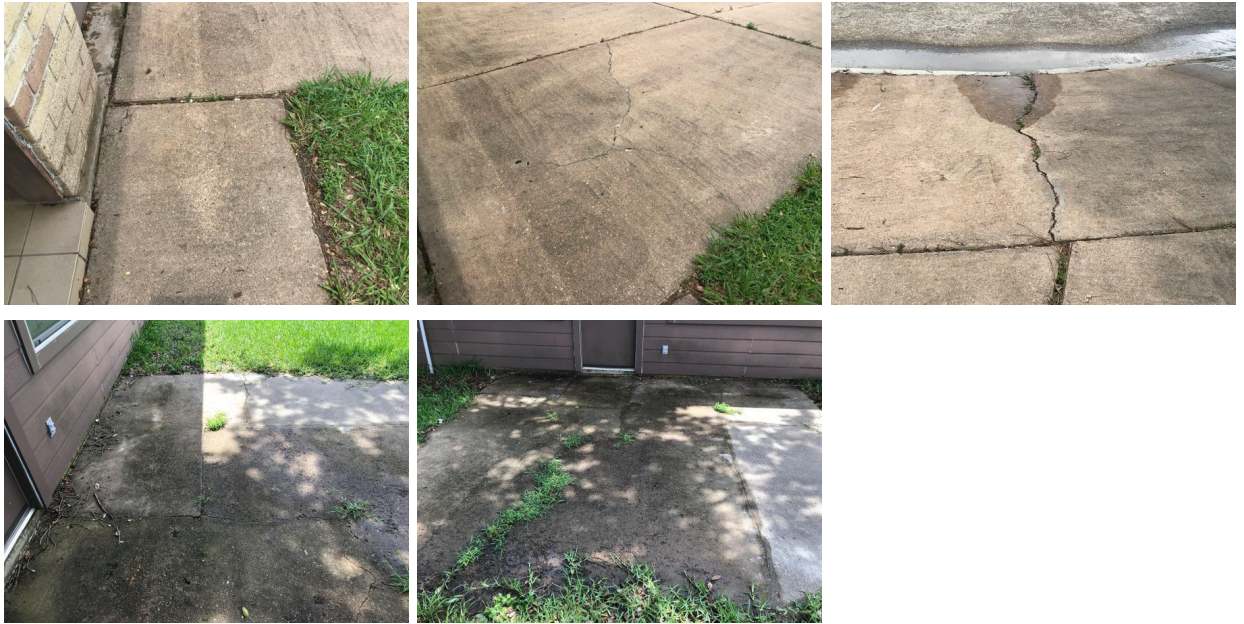
1: Driveway/Walkway - Cracked/Heaved

The driveway/walkway concrete around the property was observed to be cracked/heaved at multiple locations. Recommend consulting with a qualified contractor to evaluate these conditions further and determine the extent of necessary repairs.

Recommendation: Contact a qualified concrete contractor.

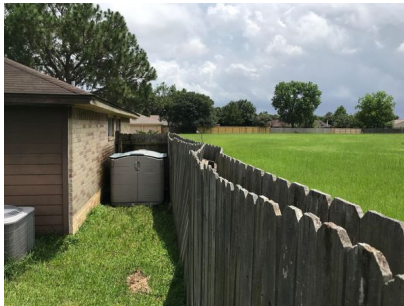
2: Fence: Leaning

The fence was observed to be leaning. Recommend repair to prevent further deterioration.

Recommendation: Contact a qualified professional.

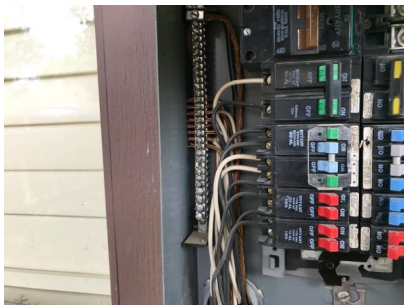
Double lugged neutral wires were on the neutral bus bar inside the distribution panel. One neutral wire per lug is recommended. Remedy as needed.

Recommendation: Contact a qualified electrical contractor.

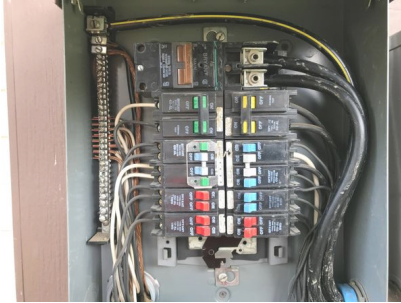
4: Missing Bond Screw/Strap

No bond screw/strap was observed to be in place. Recommend correction to allow the service entrance to be properly bonded

Recommendation: Contact a qualified professional.

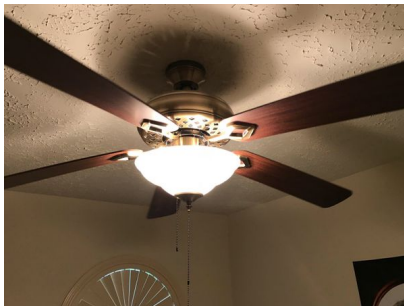
The inspector observed one or more ceiling fans inoperable. Recommend further evaluation by electrician.

Recommendation: Contact a qualified electrical contractor.

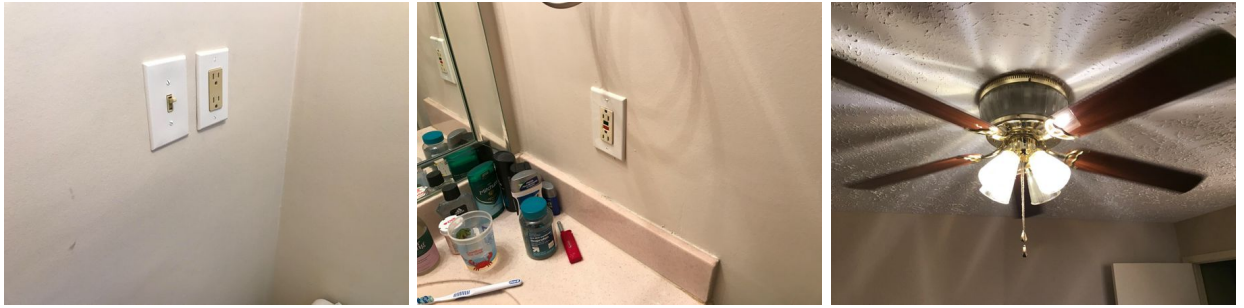
2: Multiple Electrical Fixture Issues

Loose outlets, Flickering light, Appears to only have slow ans off -

The ceiling fan in the master bedroom appears to only have speeds slow and off. When the pool chain is used to change the speed of the fan and the light flickers. I recommend repair.

Recommendation: Contact a qualified professional.

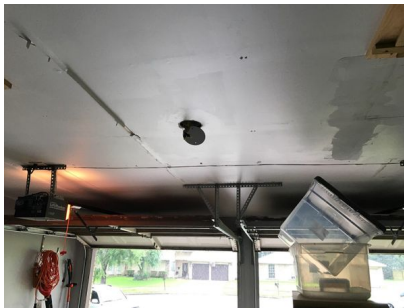
5: Light fixture: missing

The light fixture in the garage is missing. Remedy as noted.

Recommendation: Contact a qualified professional.
