28943 Enchanted Dr

Shenandoah, Texas 77381

Client	--
Reference id	a4xPd000003PxsnIAC
Type	Home Inspection and Floor Plan Report - 28943 Enchanted Dr
Inspected by	Rio Bravo - Inspectify Pro - Houston
State license	TREC 22388
InterNACHI	17031522
Scheduled	January 8, 2026, 11:00 AM CST
Completed	January 8, 2026, 1:19 PM CST

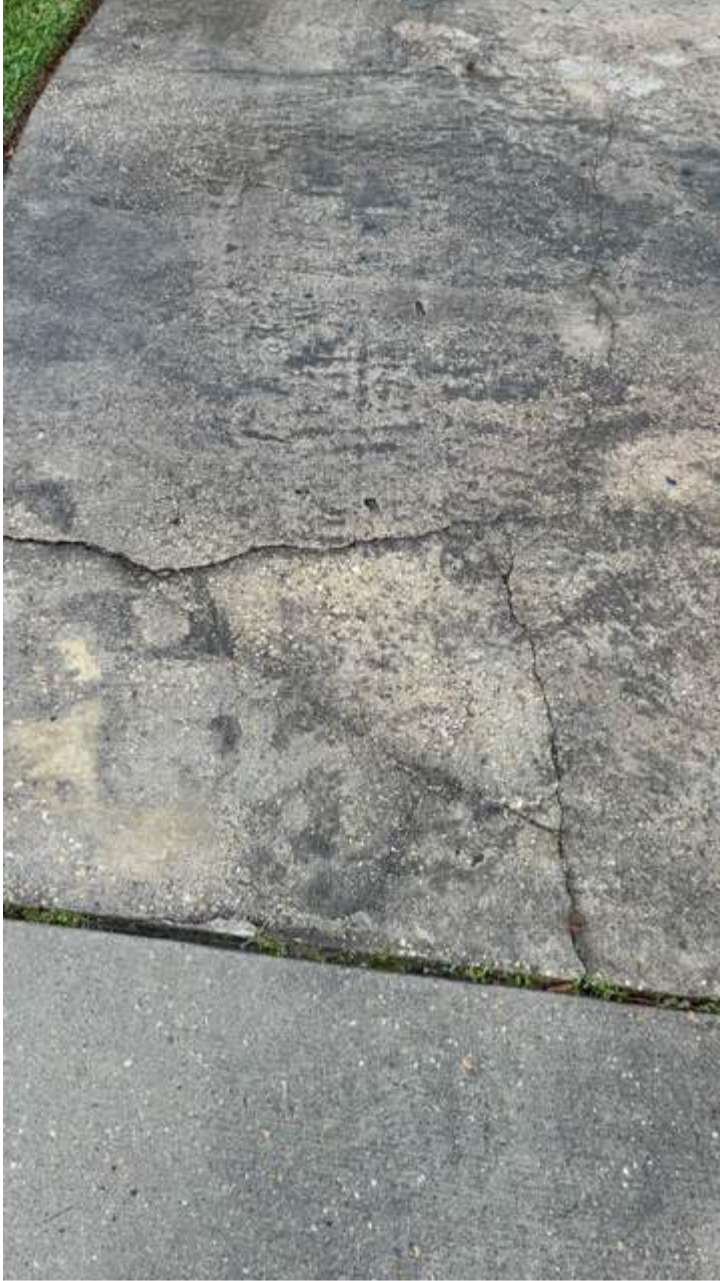
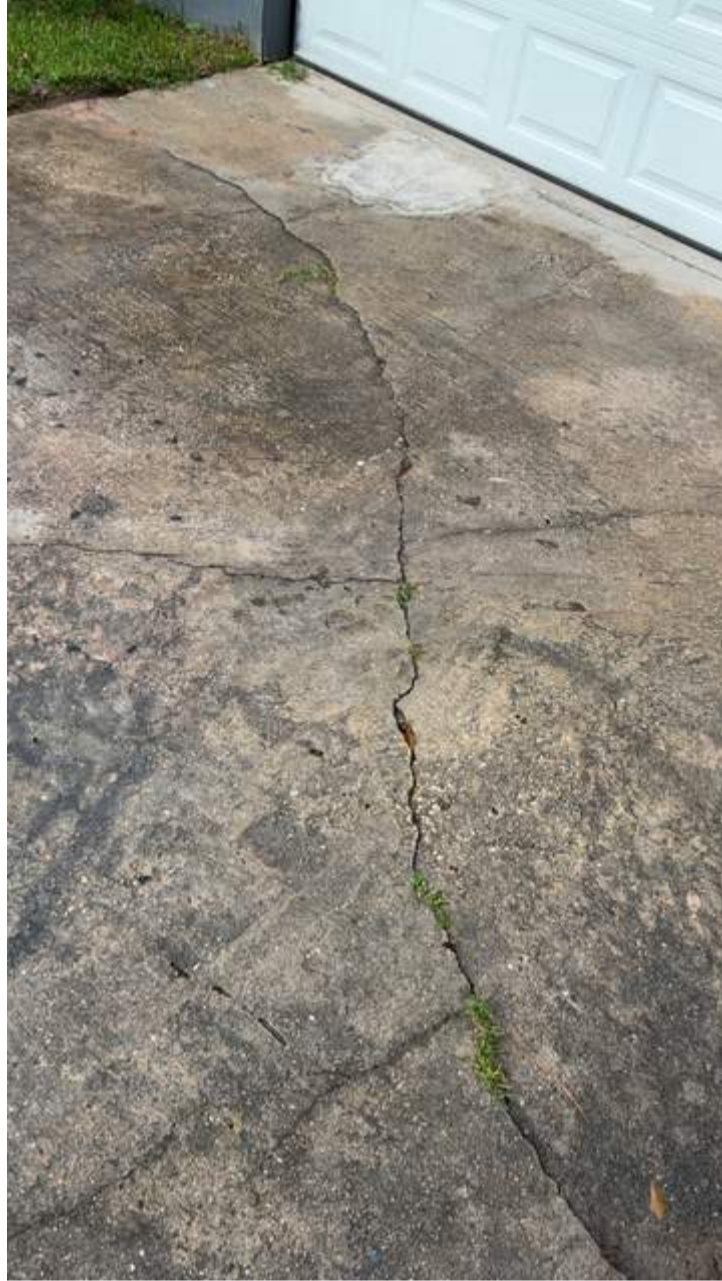
West

Significant Cracks in Driveway

There are one or more significant cracks in the driveway. Recommend repairs or replacing by a qualified professional.

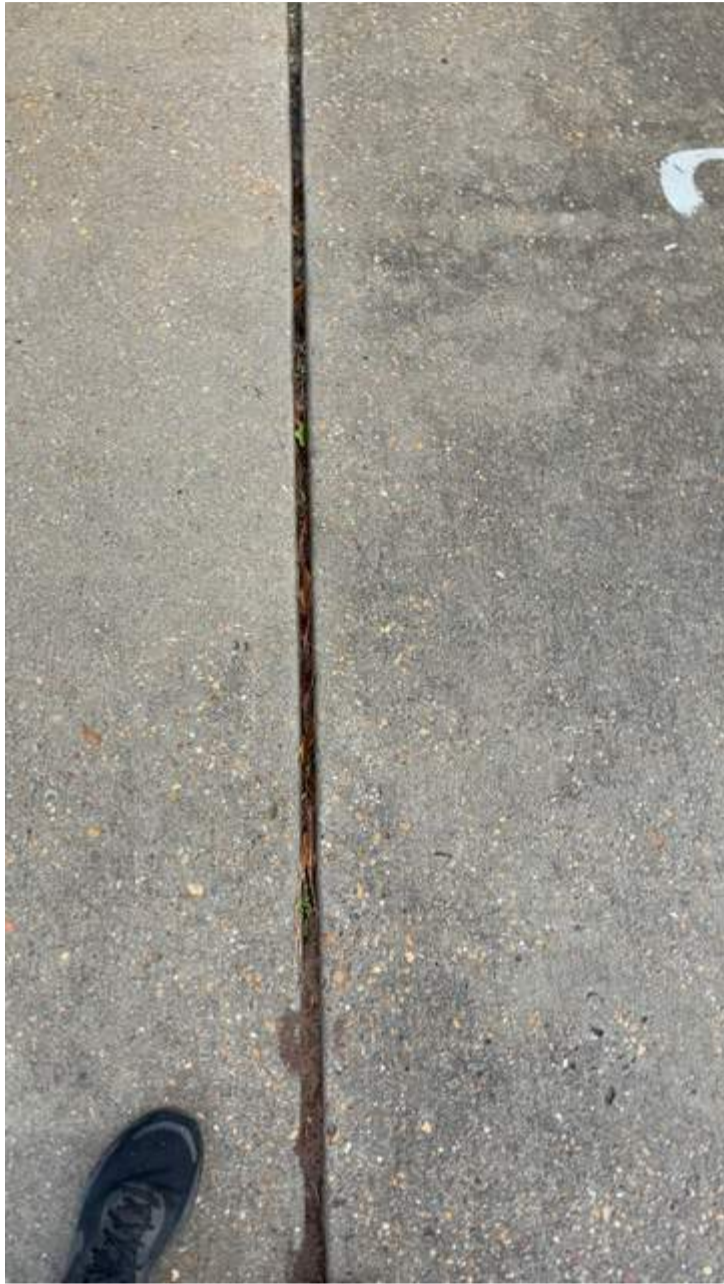
Missing / Deteriorated Expansion Joint Materials

Expansion joint materials are missing / deteriorated. Recommend repairs or replacing by a qualified professional.

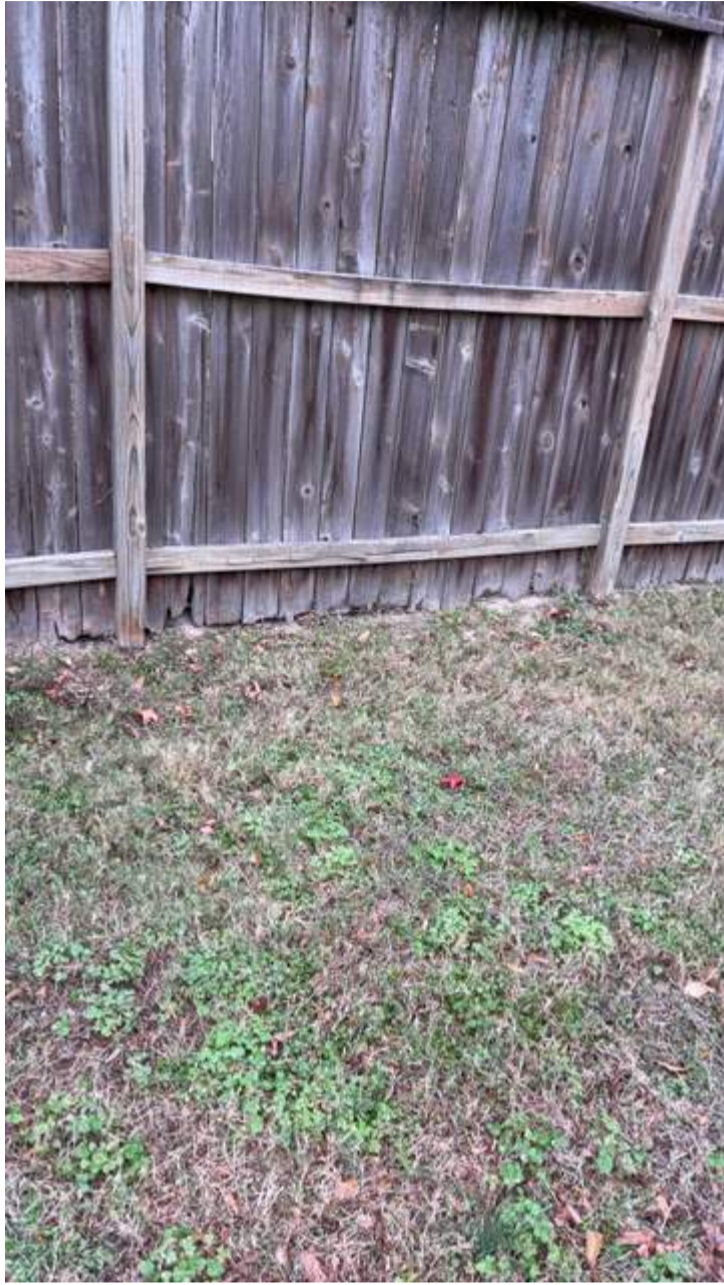
Damaged / Missing Fence Boards

One or more fence boards are missing or damaged.

Large section of fence was missing

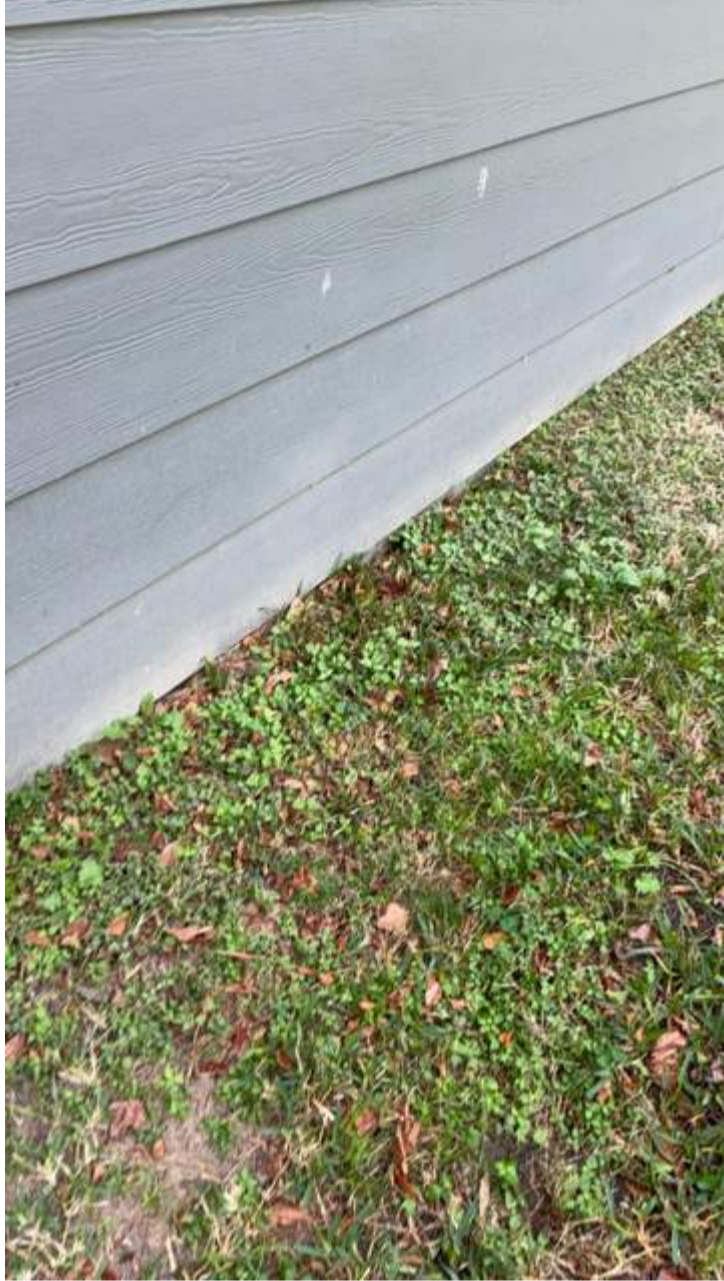
Garage

There are areas of high soil around the foundation.

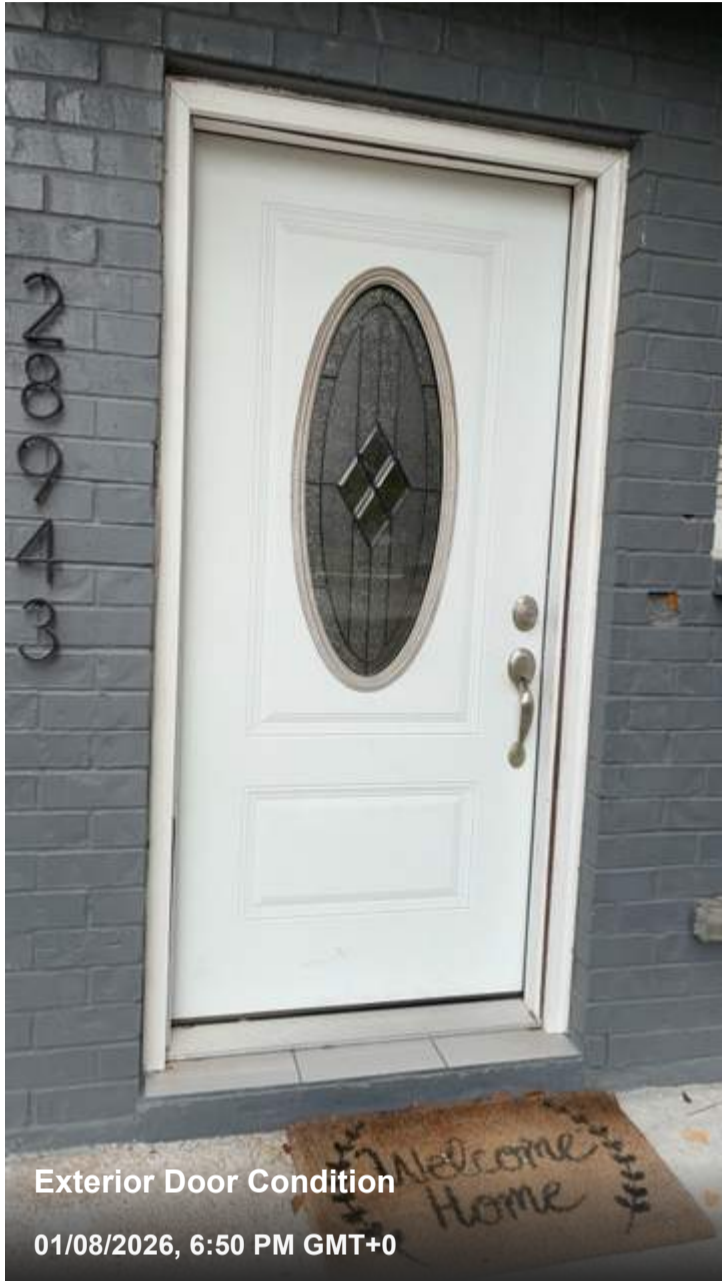
One or more gaps are observed on the exterior door.

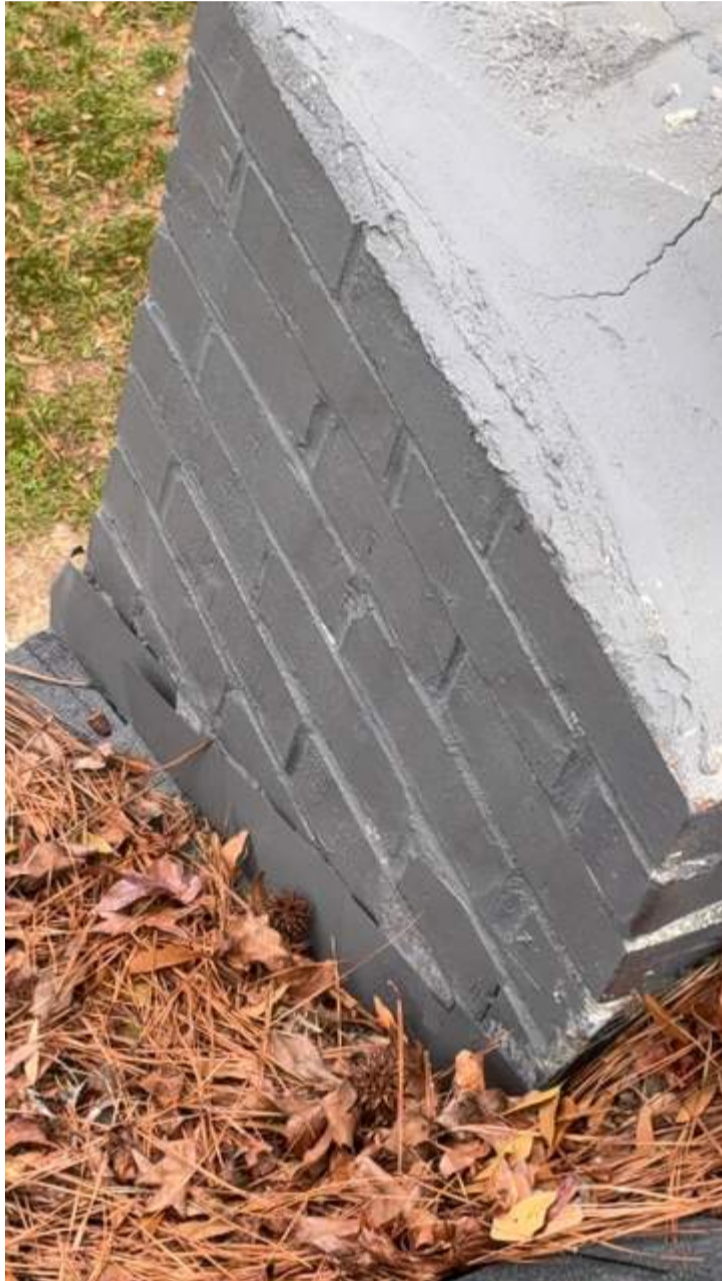
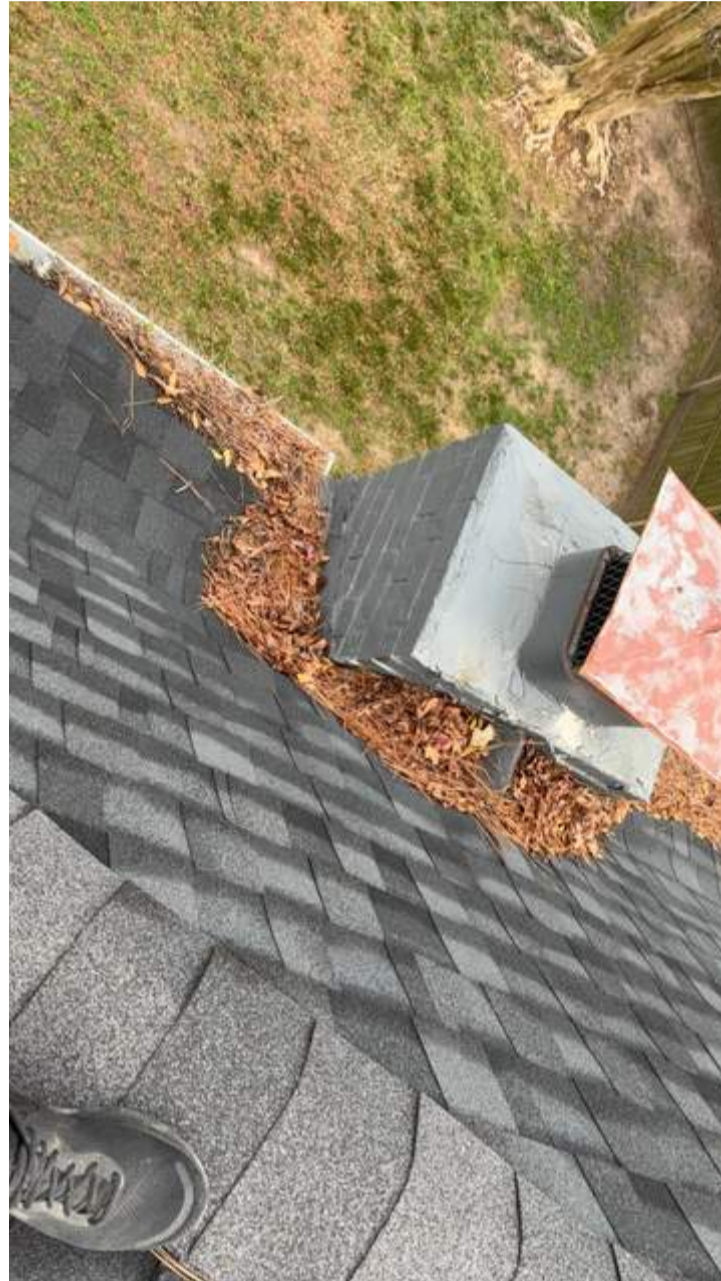
Loose or Separated Flashing

One or more pieces of flashing are loose or separated. Recommend repairs or replacing by a qualified professional.

Loose flashing on chimney

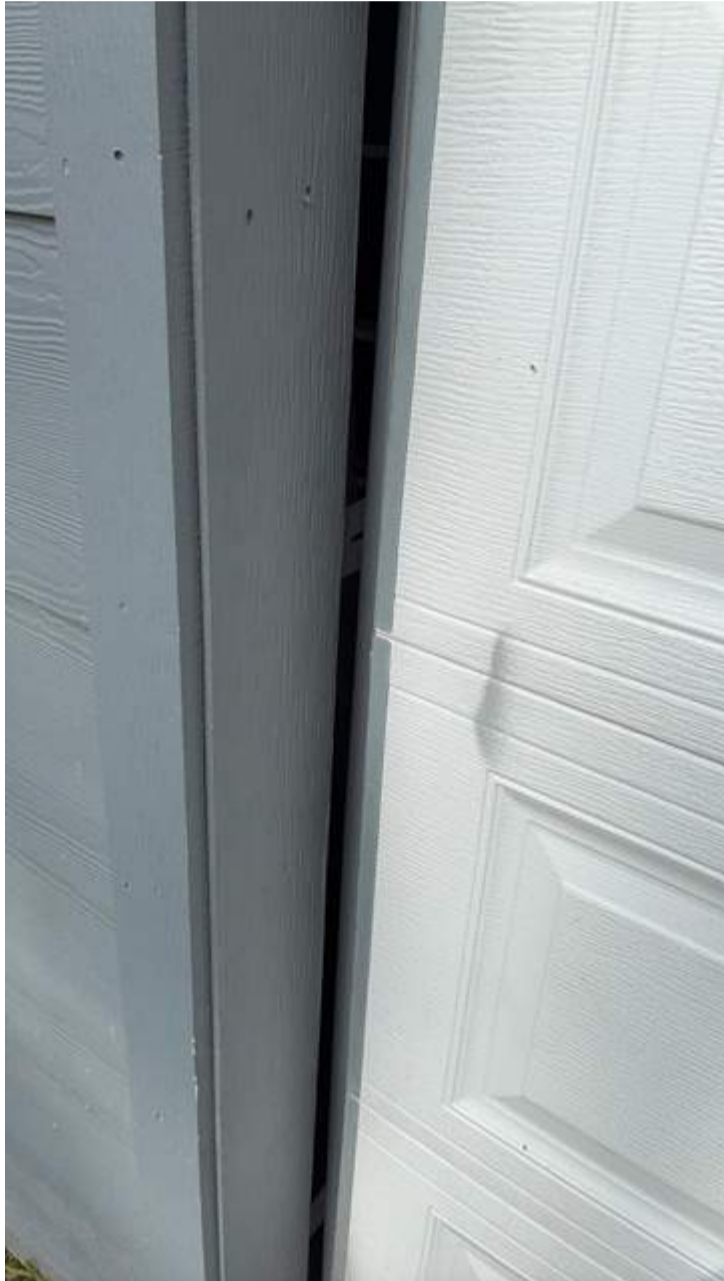
gaps were noted at both sides of garage door

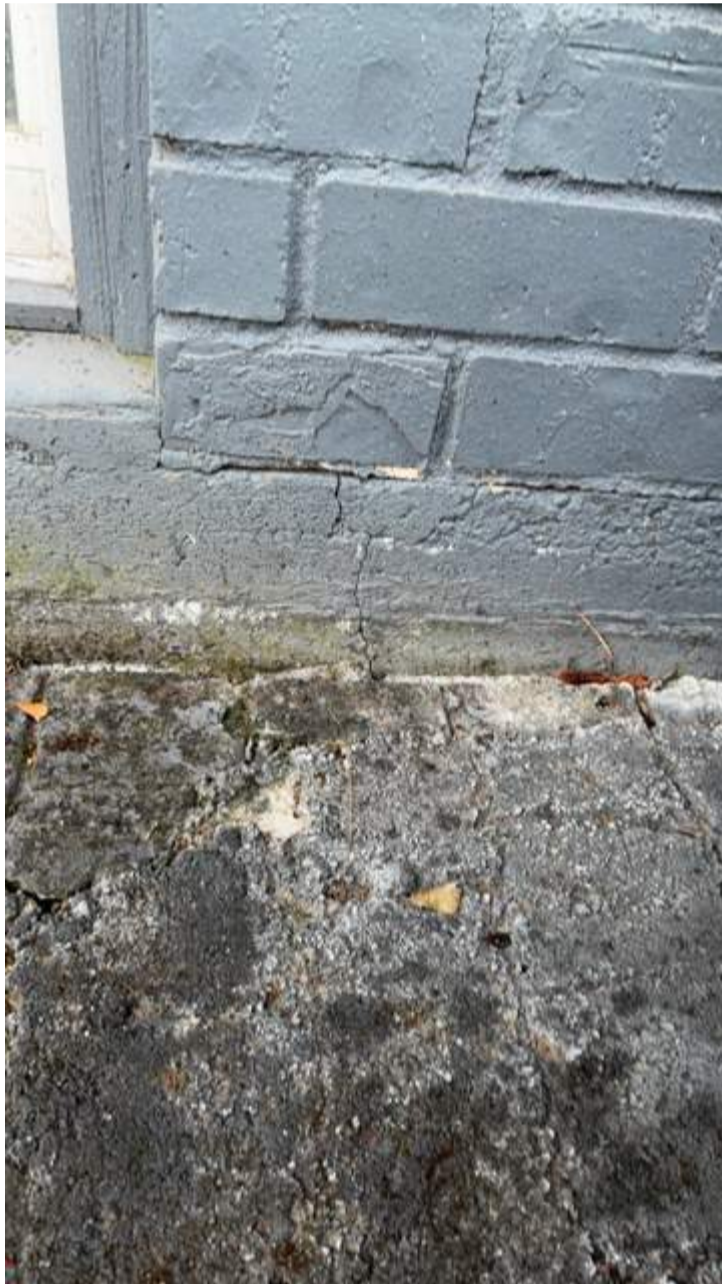
North

Cracks in foundation do not appear severe

Minor Foundation Cracks

One or more areas of the foundation have minor cracking. Recommend further evaluation by a qualified professional.

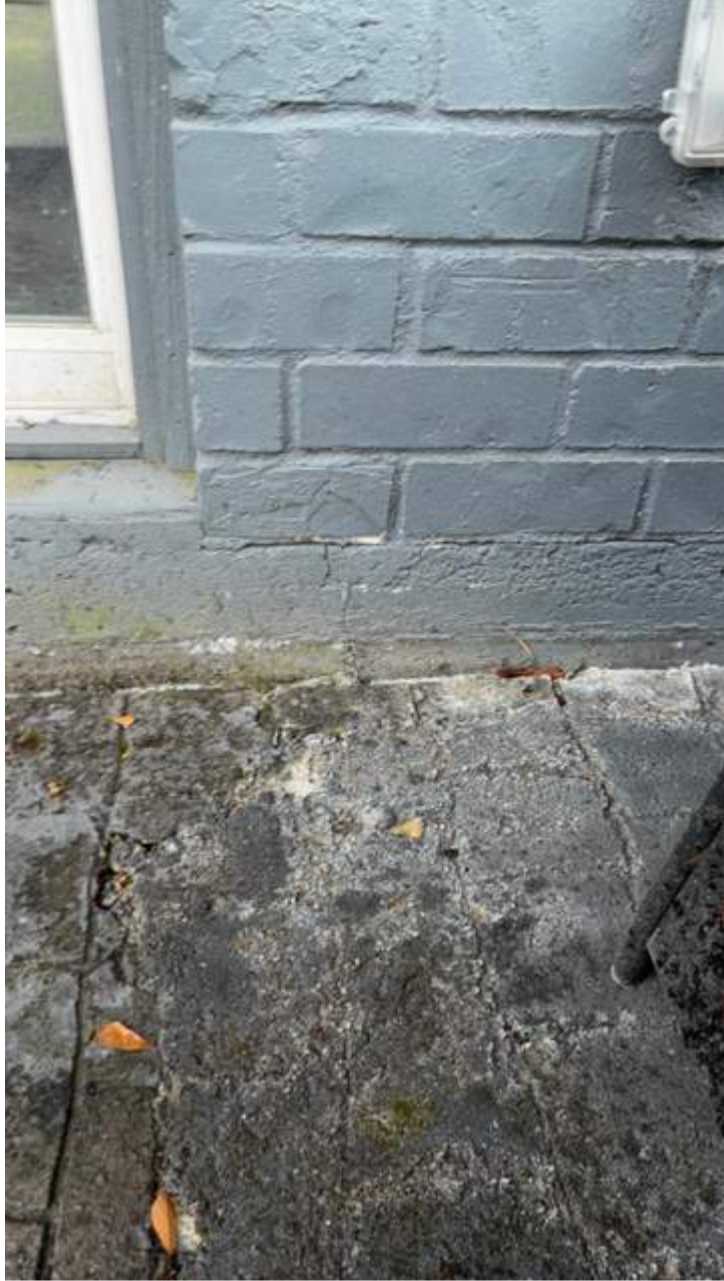
North

Minor Foundation Cracks

One or more areas of the foundation have minor cracking.

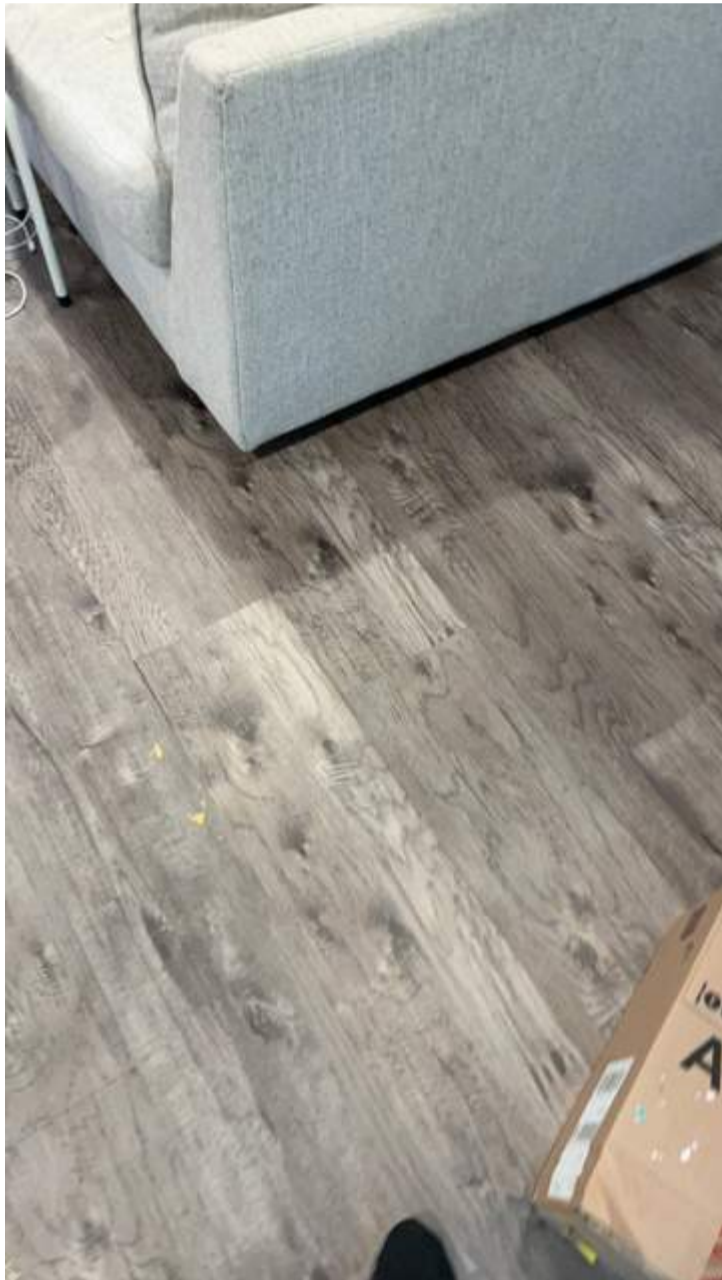
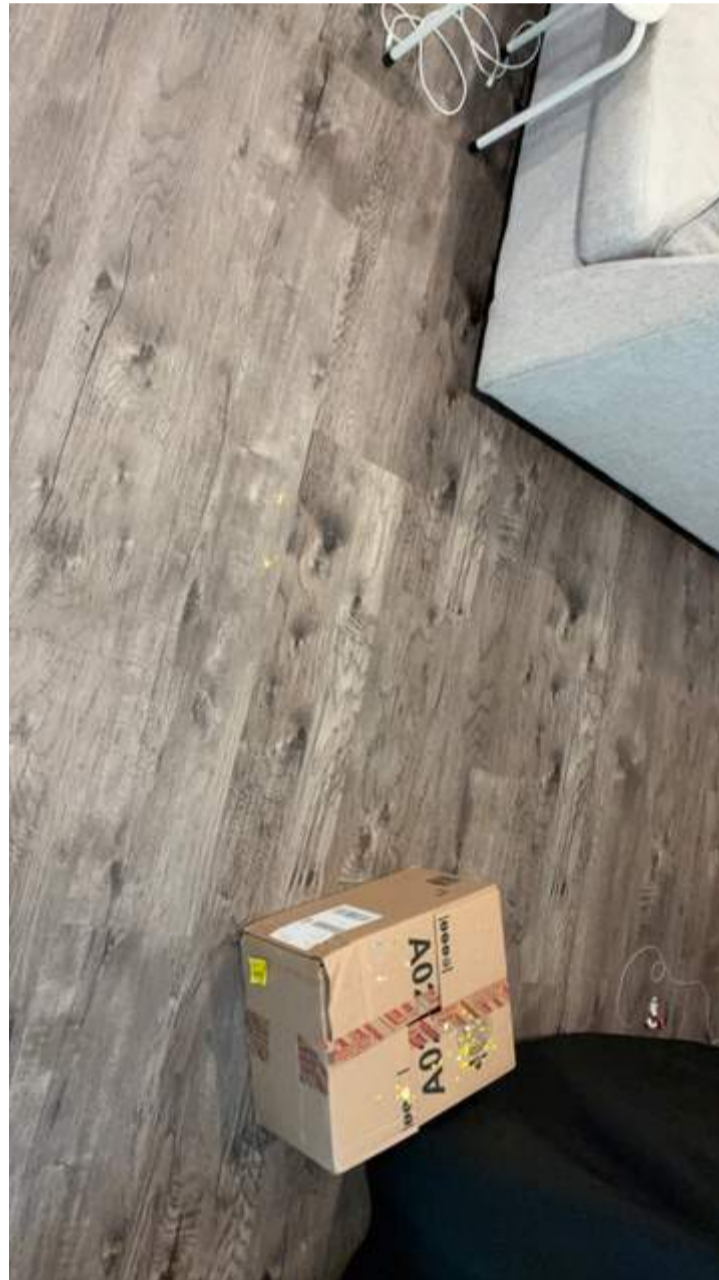
Living Room

Loose flooring

Floor coverings were loose from floor Recommend repairs or replacing by a qualified professional.

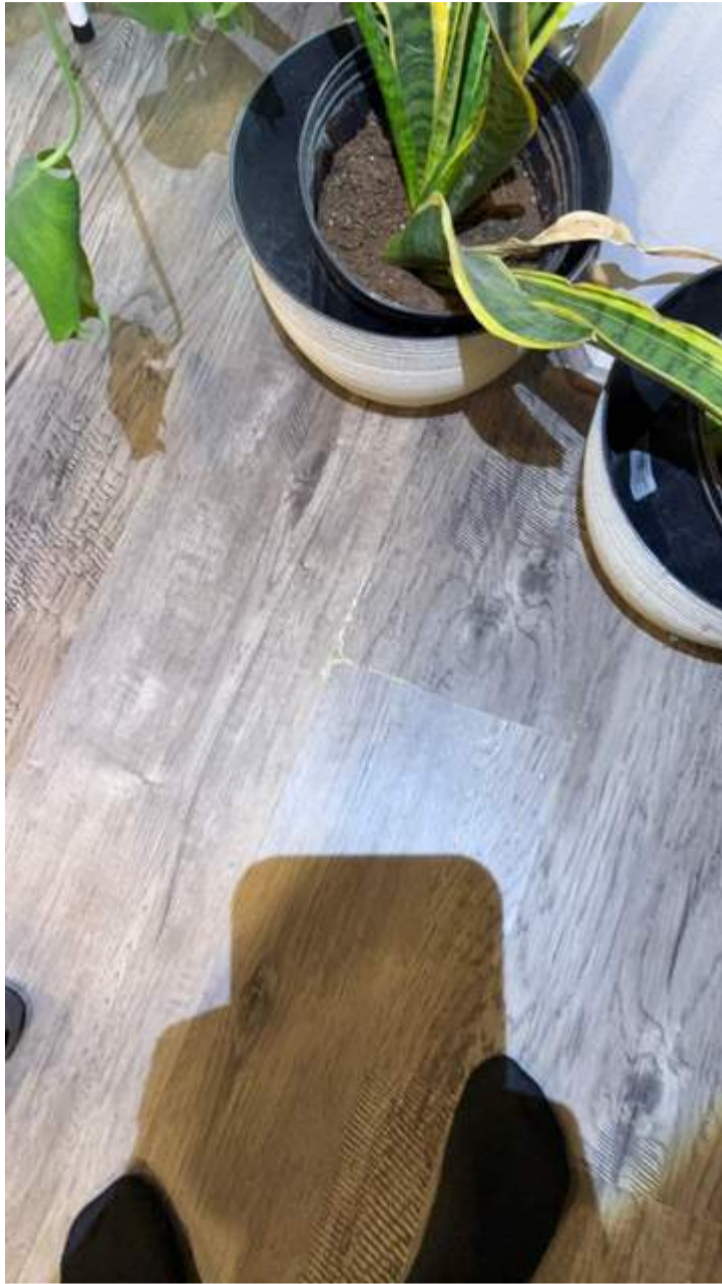
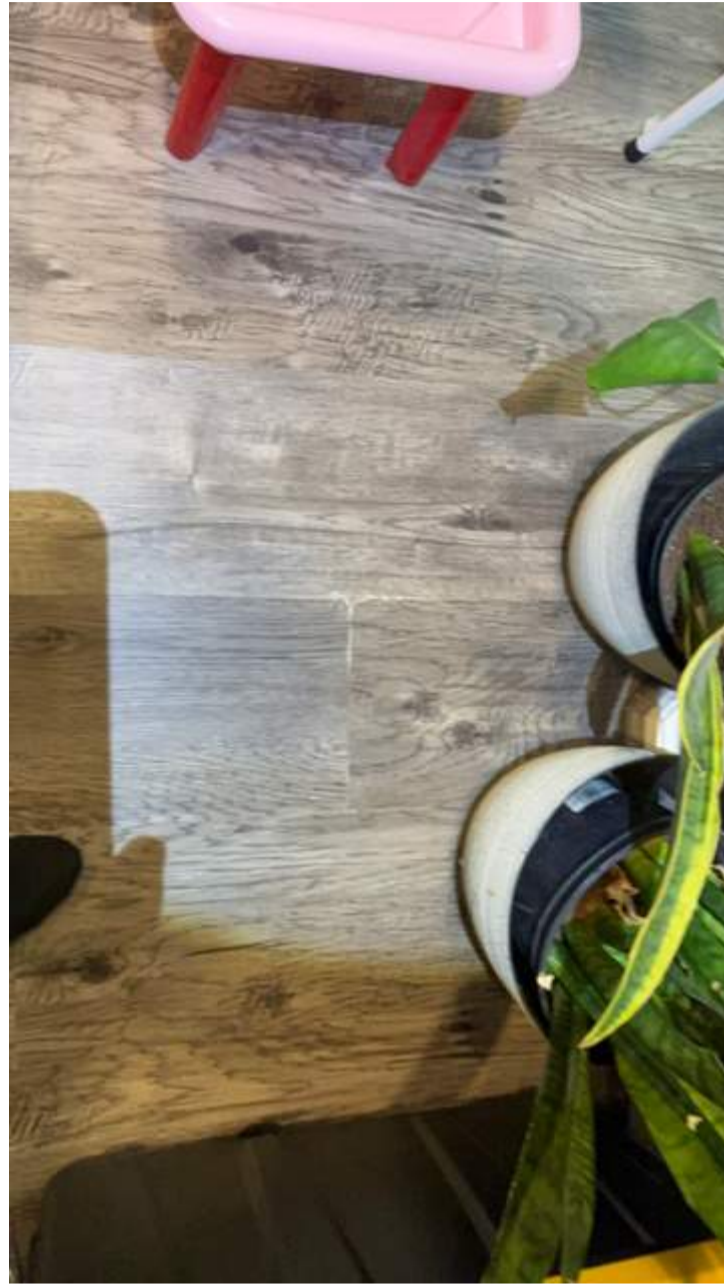
Dining Room

Damaged Flooring

The floors are damaged.

Flooring is also loose

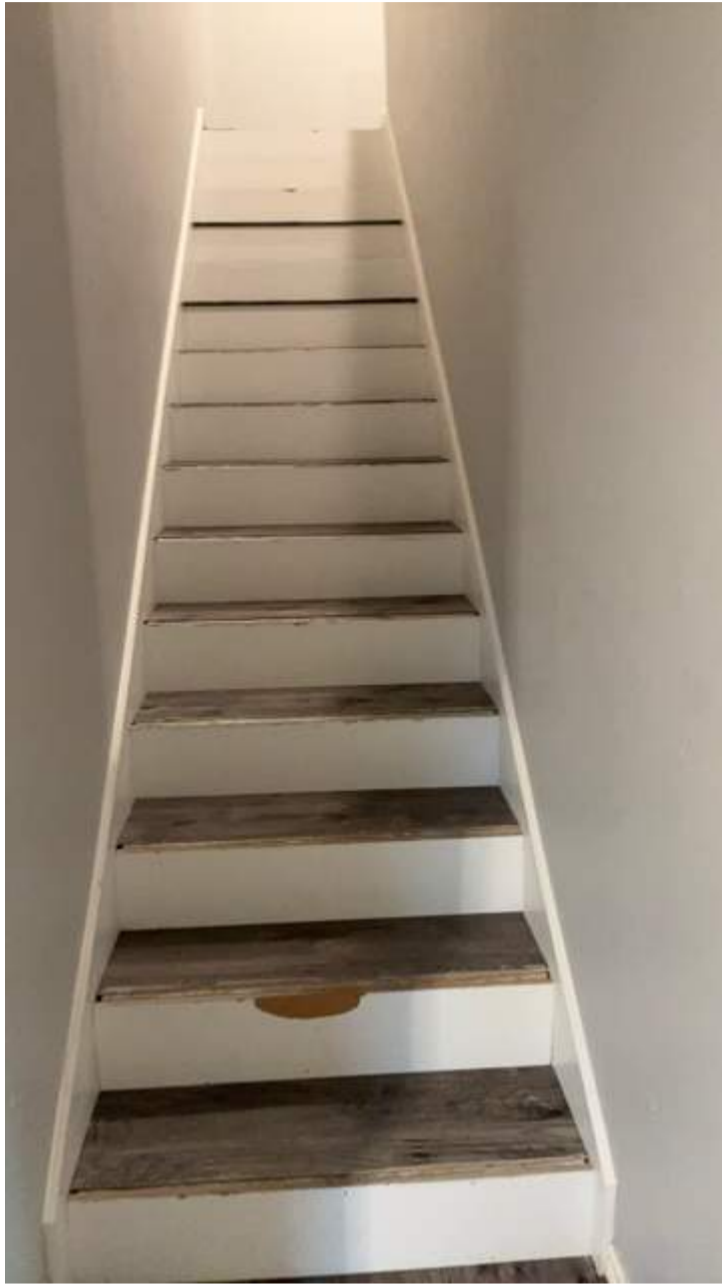
Missing Railing

There is no handrail for the staircase.

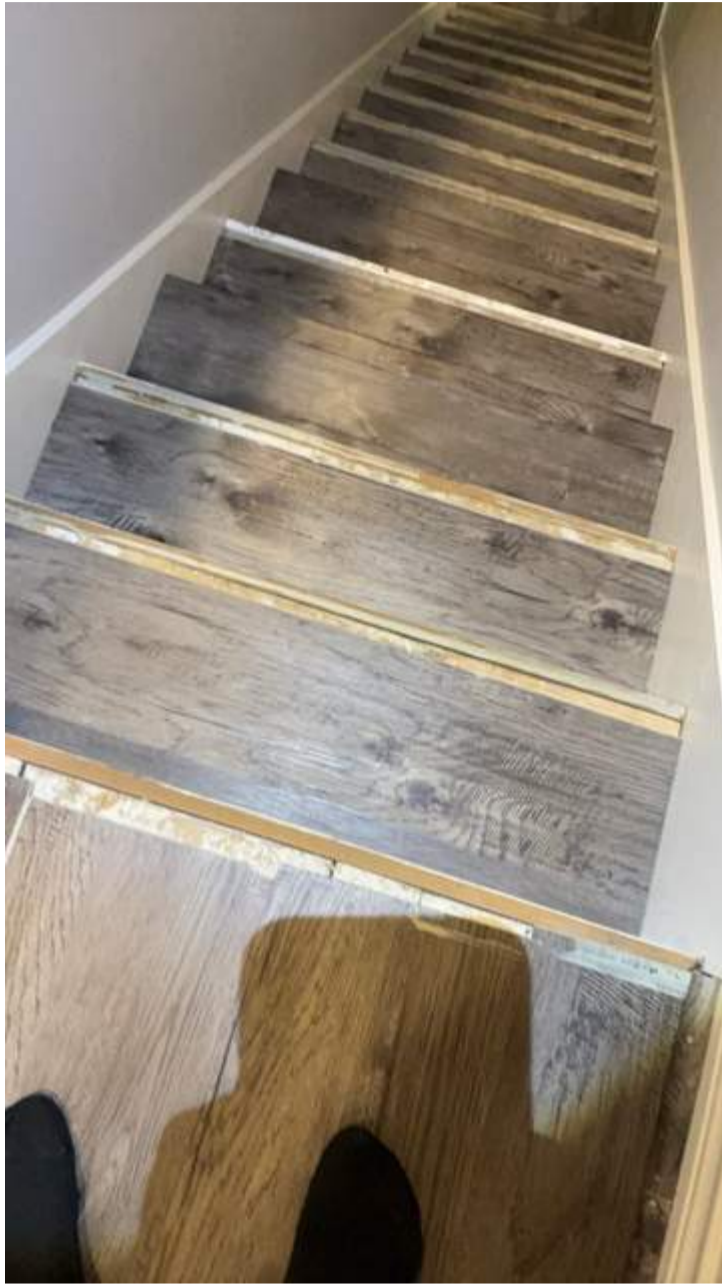
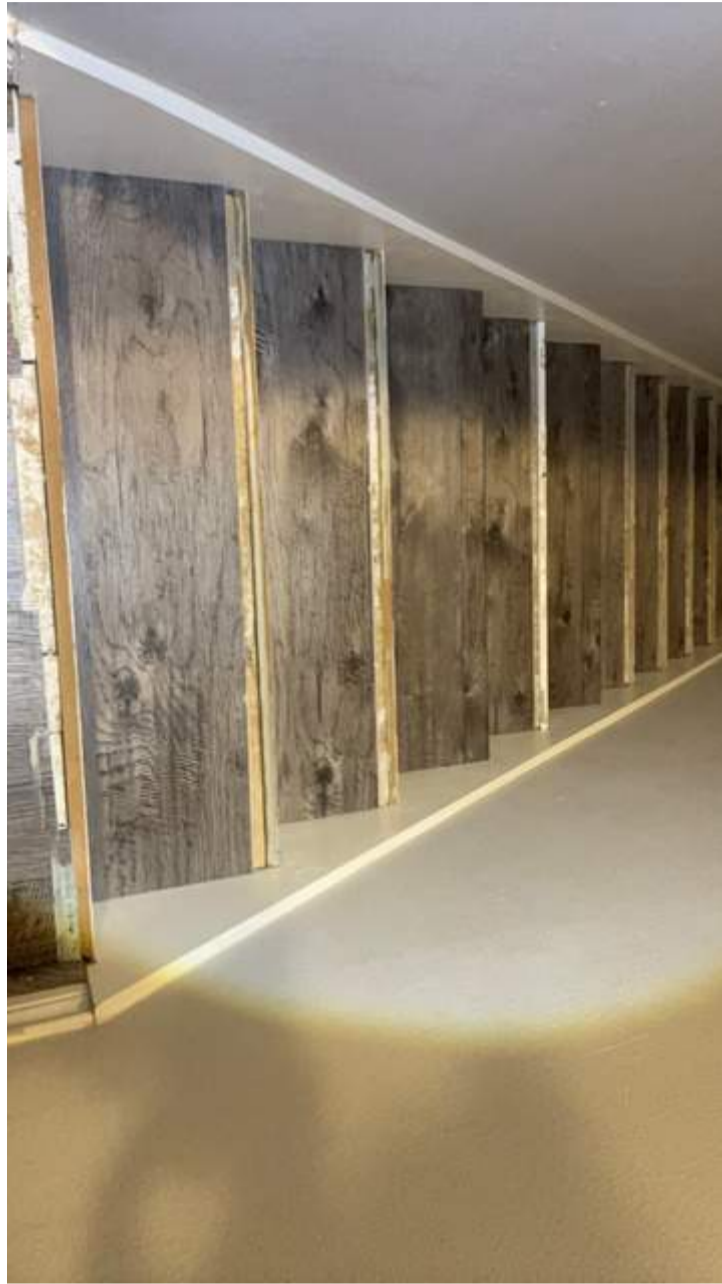
Damaged Flooring

The floors are damaged. Recommend repairs or replacing by a qualified professional.

Missing cover on nosing on all treads

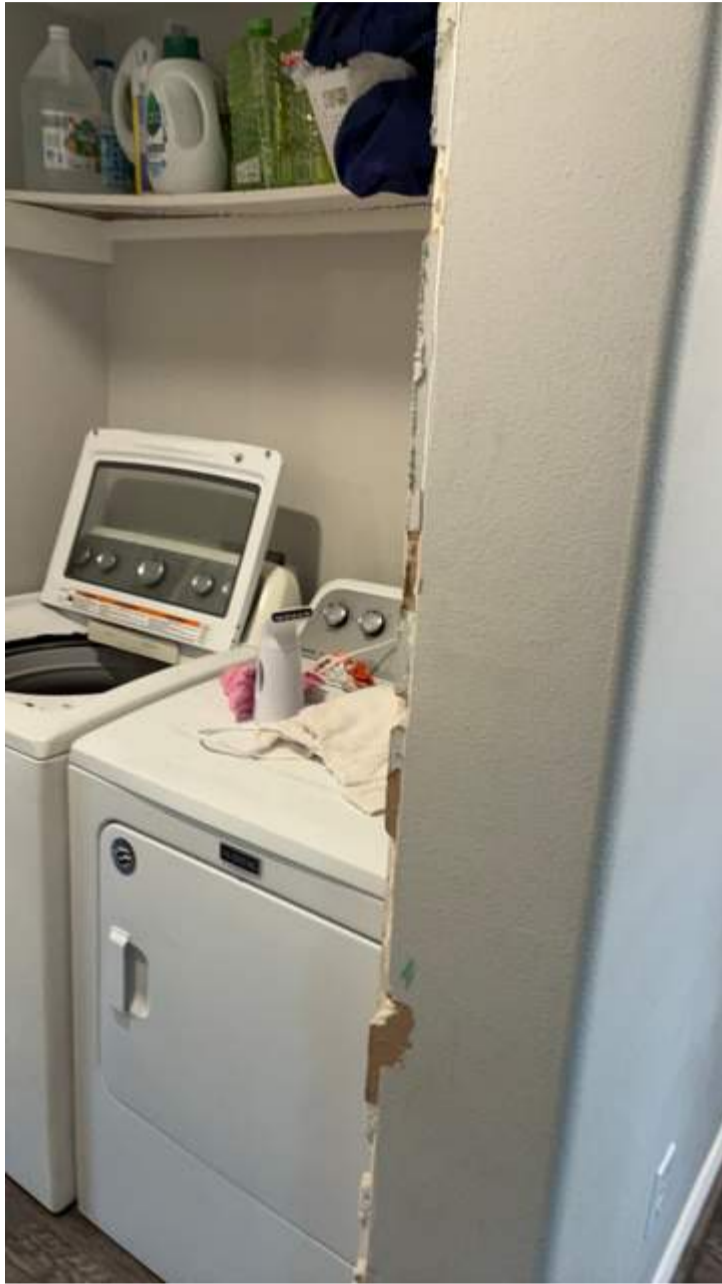
Damaged / Missing Interior Trim

The trim is damaged / missing in one or more spots.

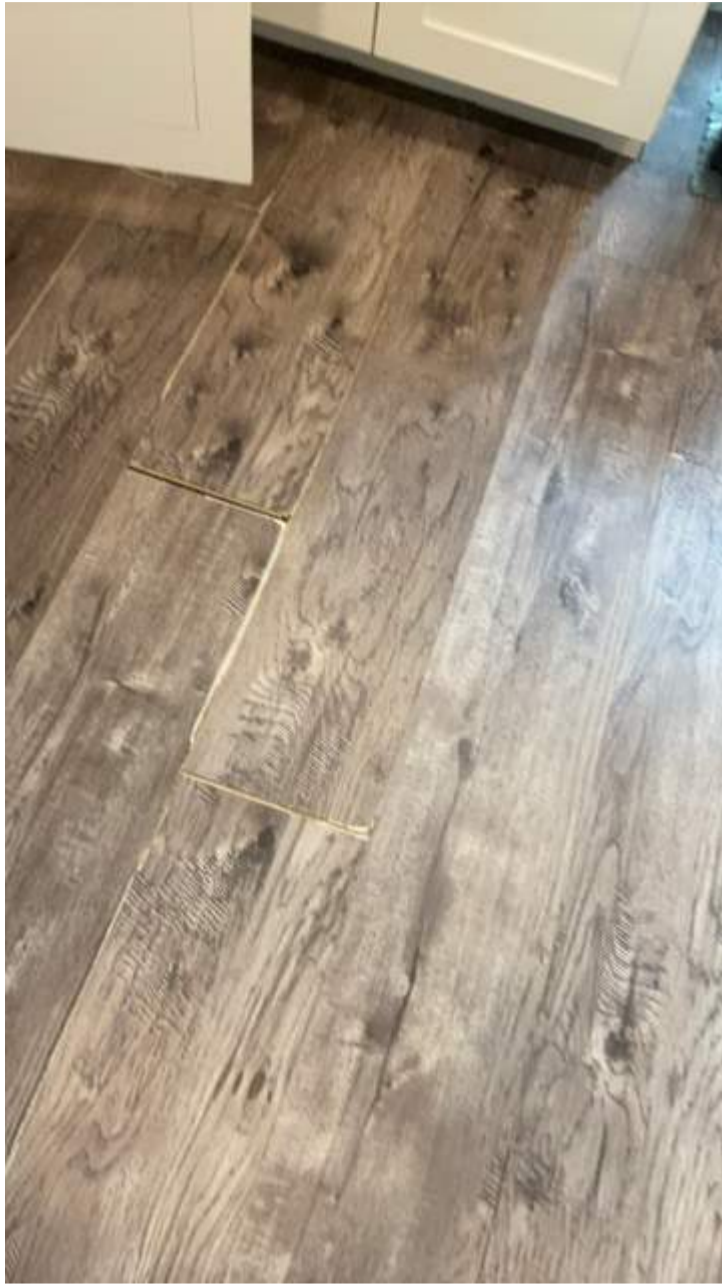
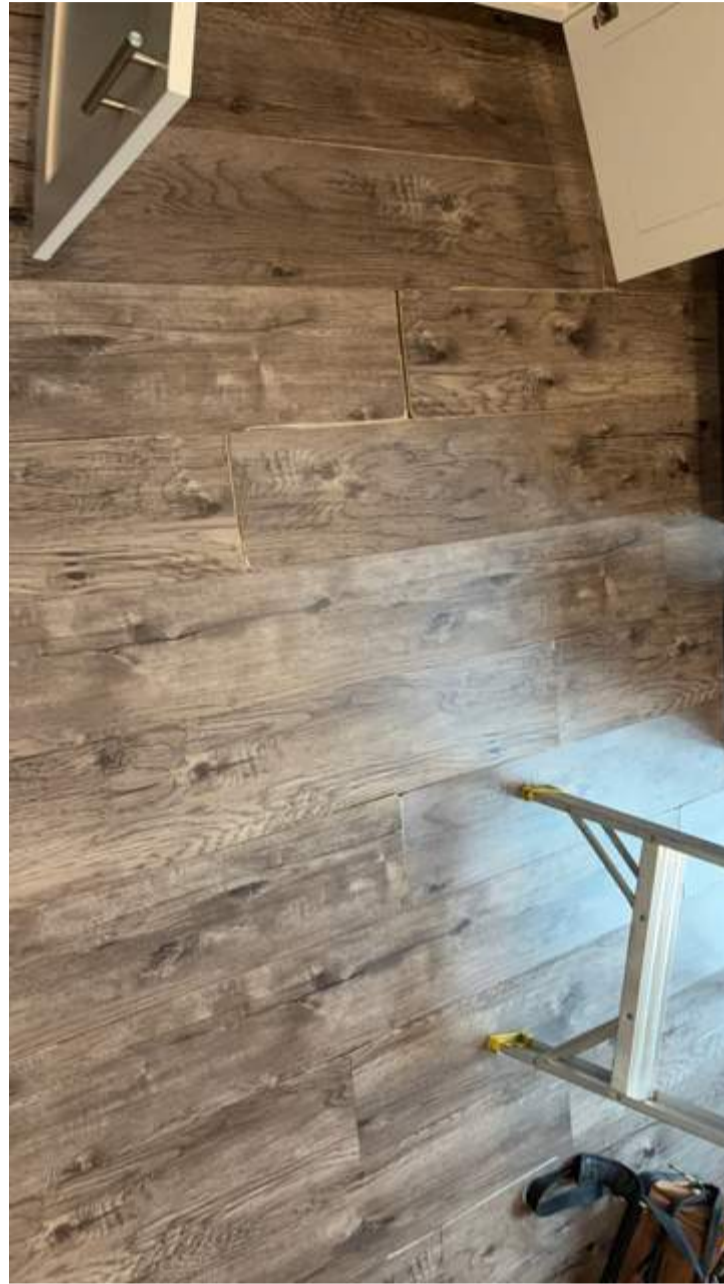
Kitchen

Damaged Flooring

The floors are damaged.

Flooring is loose and slightly damaged

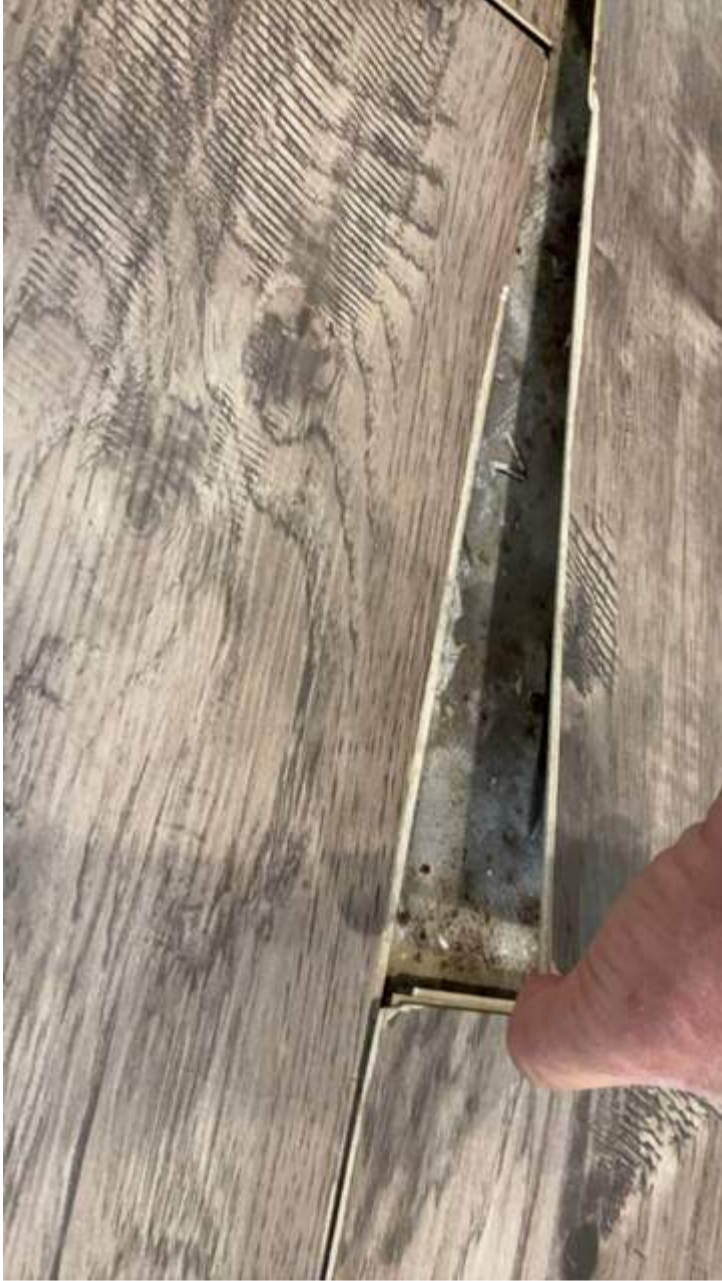
Missing Flooring Vapor Barrier

There is no vapor barrier beneath the flooring.

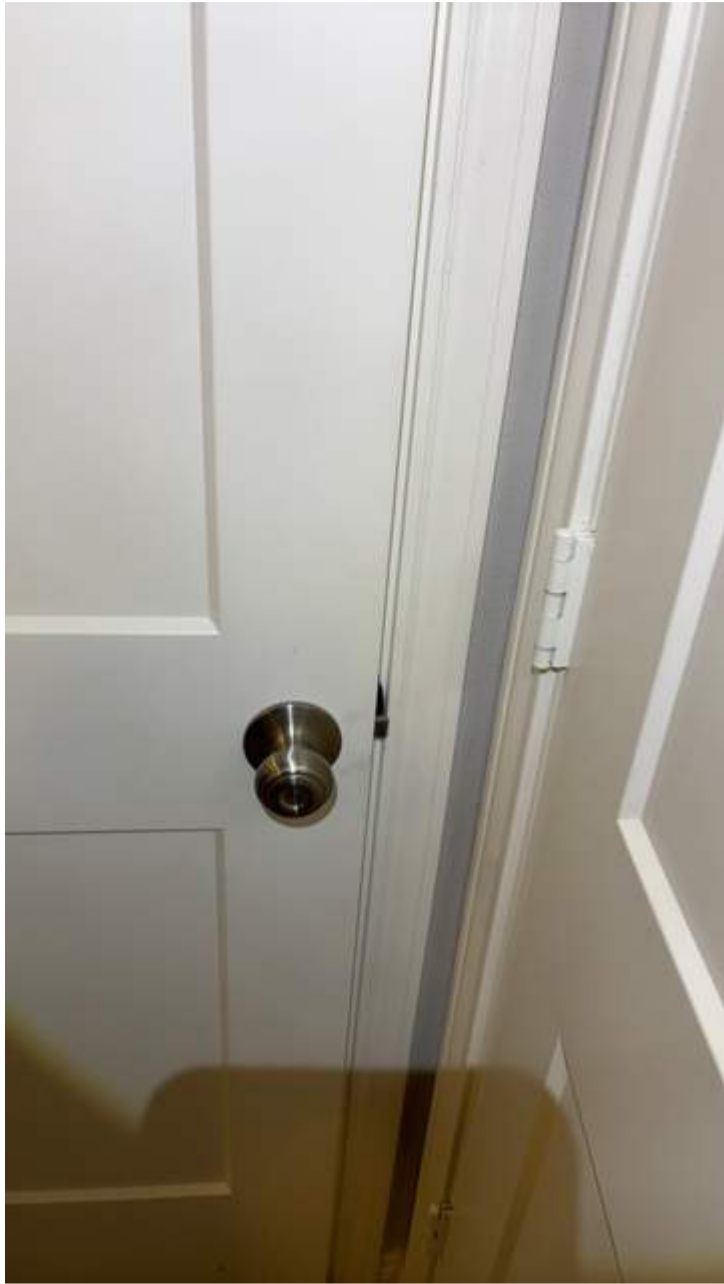
Kitchen

Also missing door stop
