28943 Enchanted Dr

Shenandoah, Texas 77381

Client	--
Reference id	a4xPd000003PxsnIAC
Type	Home Inspection and Floor Plan Report - 28943 Enchanted Dr
Inspected by	Rio Bravo - Inspectify Pro - Houston
State license	TREC 22388
InterNACHI	17031522
Scheduled	January 8, 2026, 11:00 AM CST
Completed	January 8, 2026, 1:19 PM CST

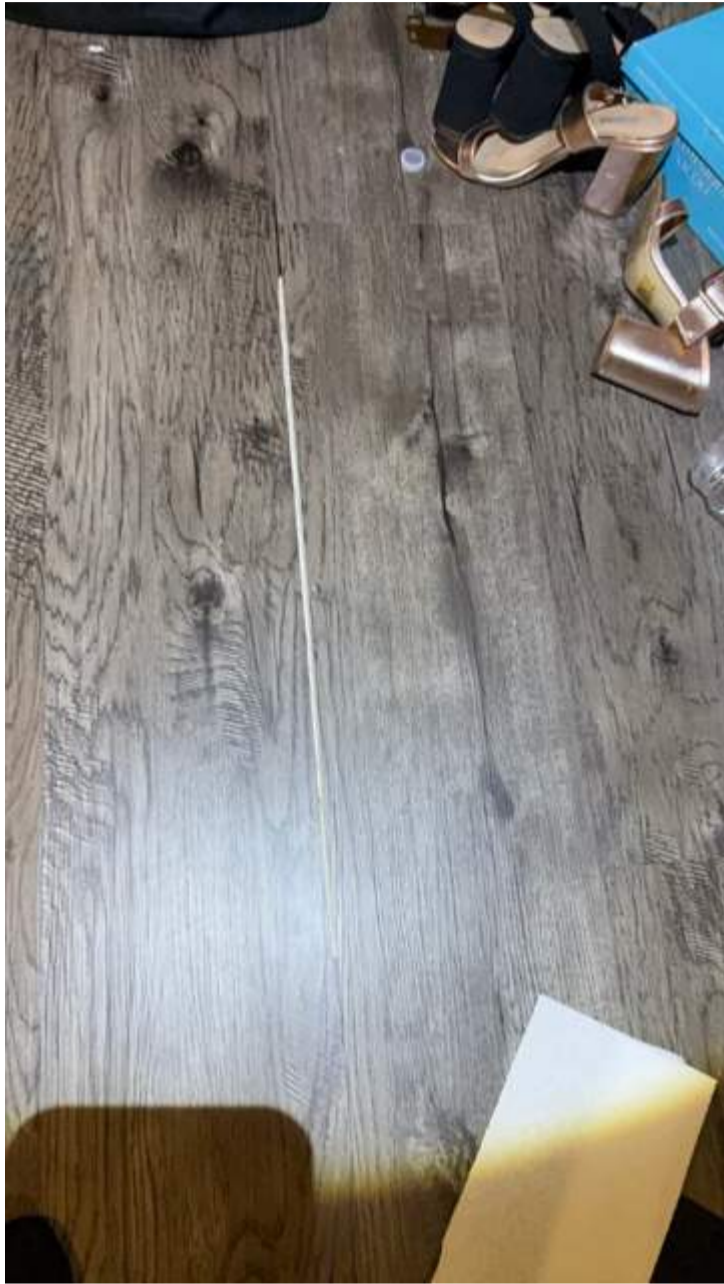
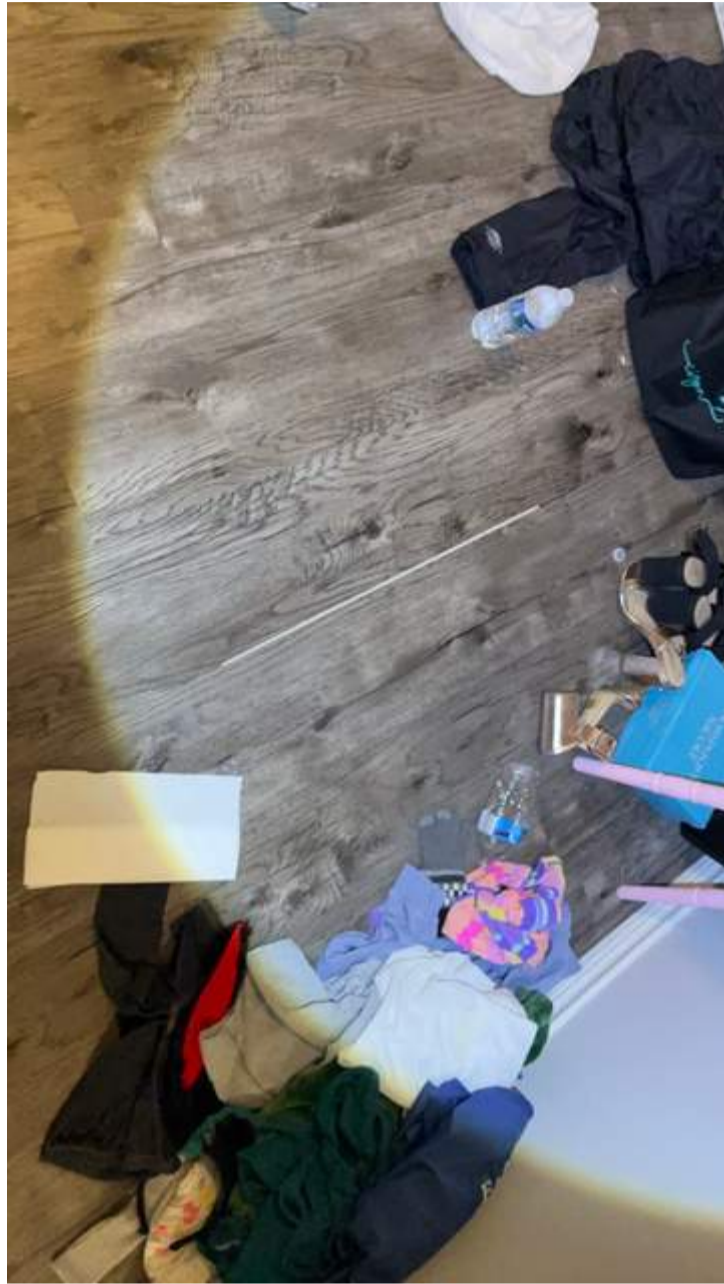
2nd Floor

One or more gaps are present in the flooring. Recommend repairs or replacing by a qualified professional.

Flooring was also loose in some OBJ areas

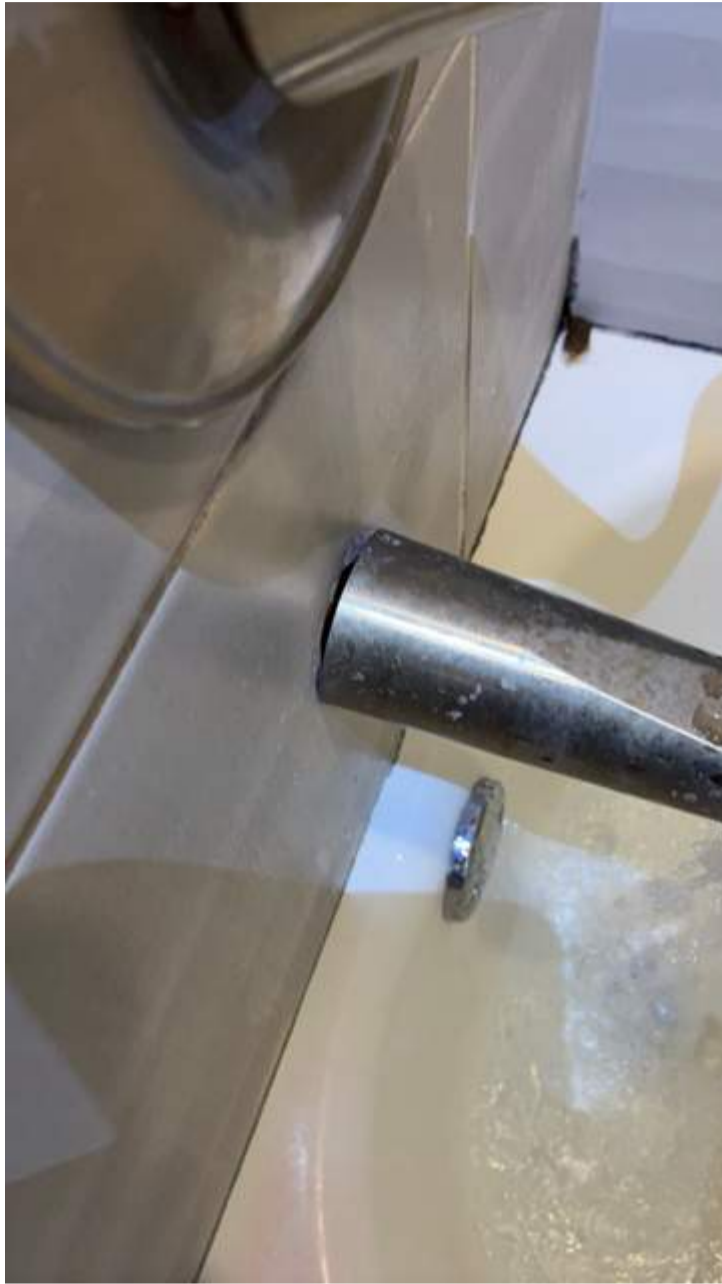
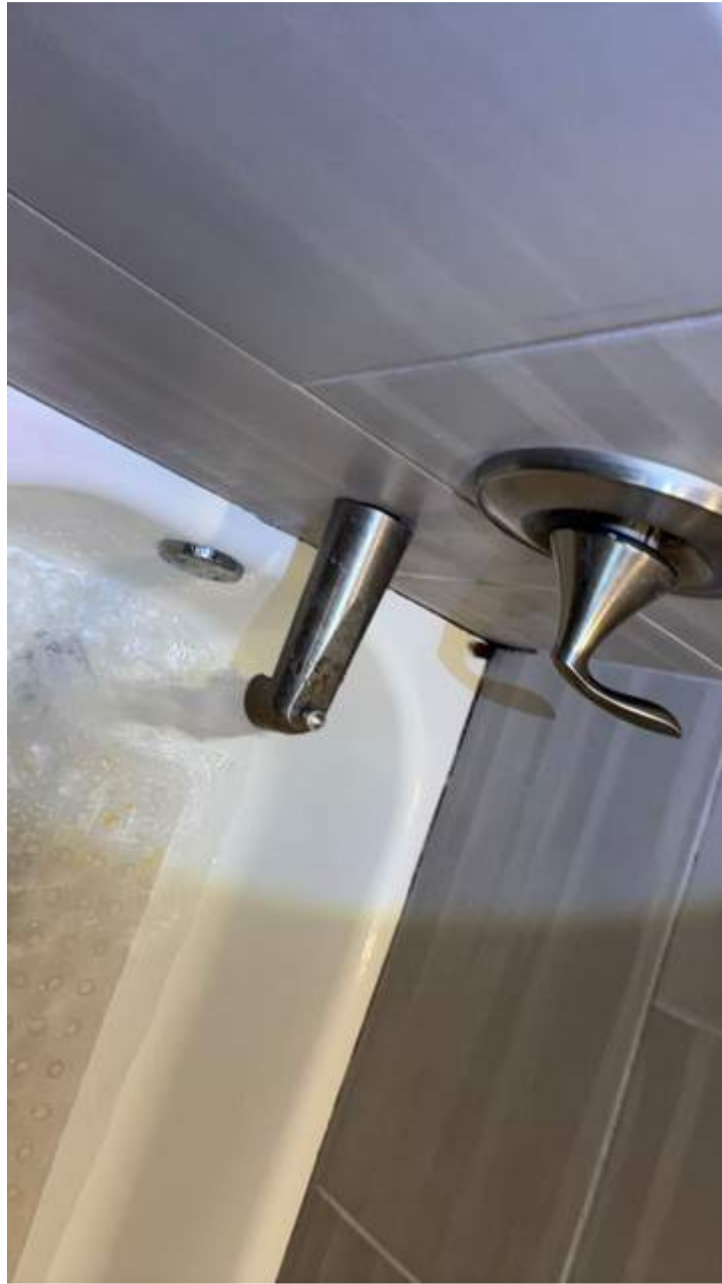
Primary, Bathroom

Inadequate Bathroom Caulking

The caulking between the shower enclosure / tub / floor / wall is inadequate or damaged. Recommend repairs or replacing by a qualified professional.

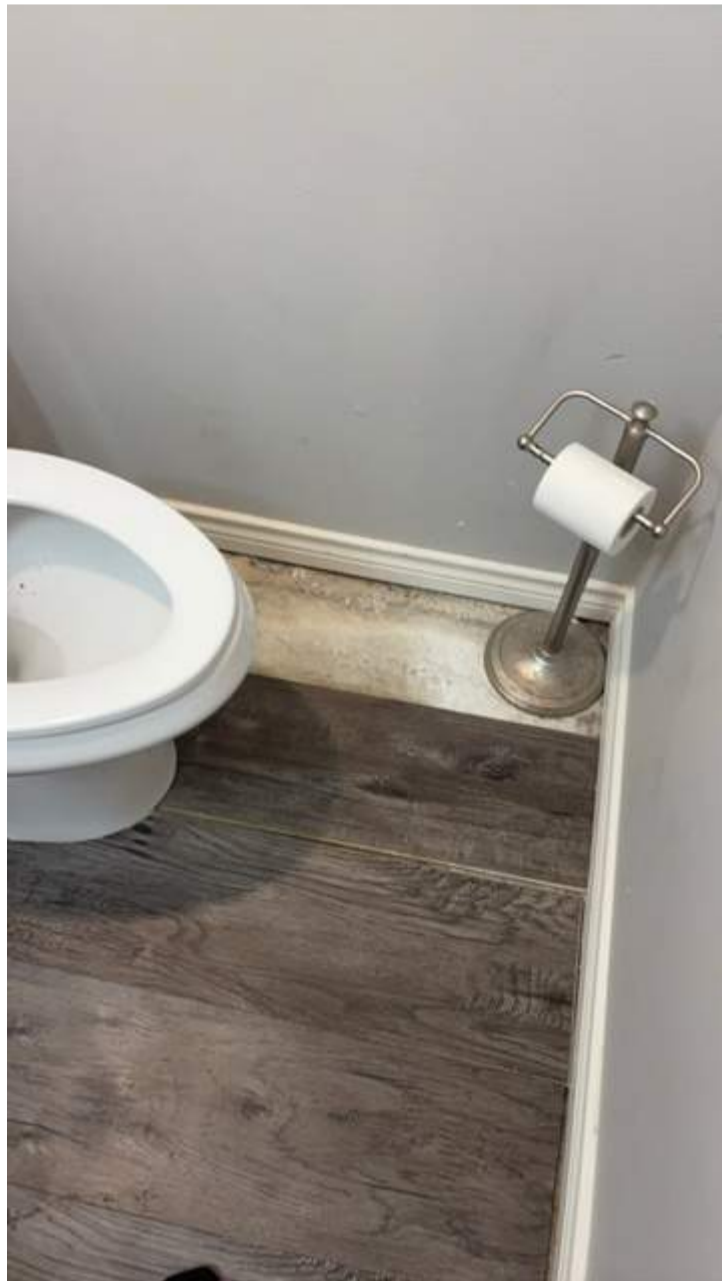
1st Floor, Bathroom

Missing flooring

Flooring was missing in one more areas Recommend further evaluation by a qualified professional.

Flooring was also loose

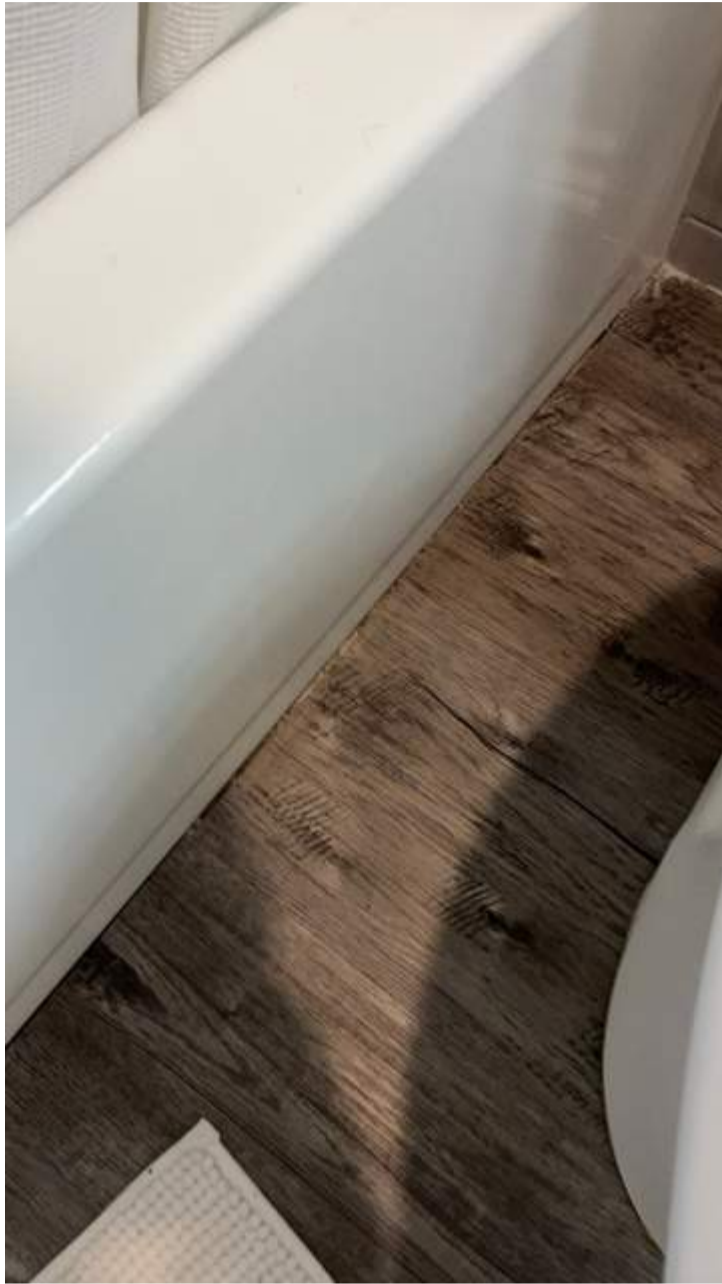
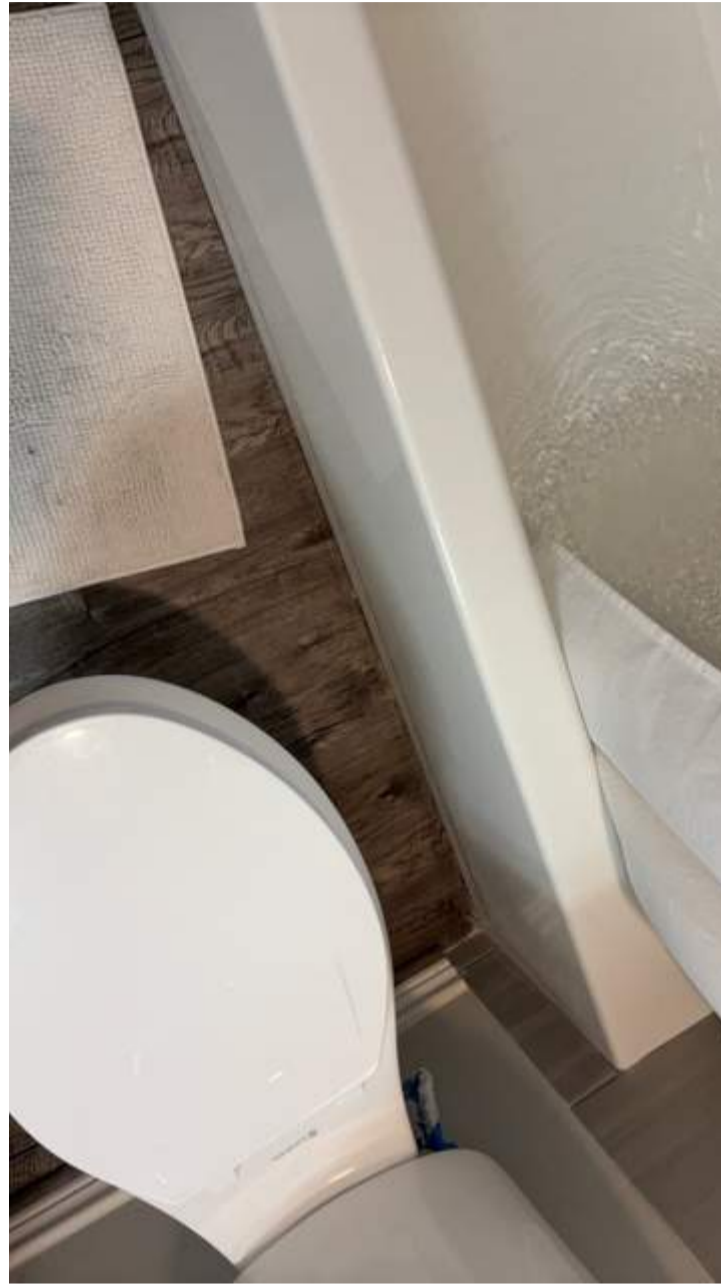
Inadequate Bathroom Caulking

The caulking between the shower enclosure / tub / floor / wall is inadequate or damaged.

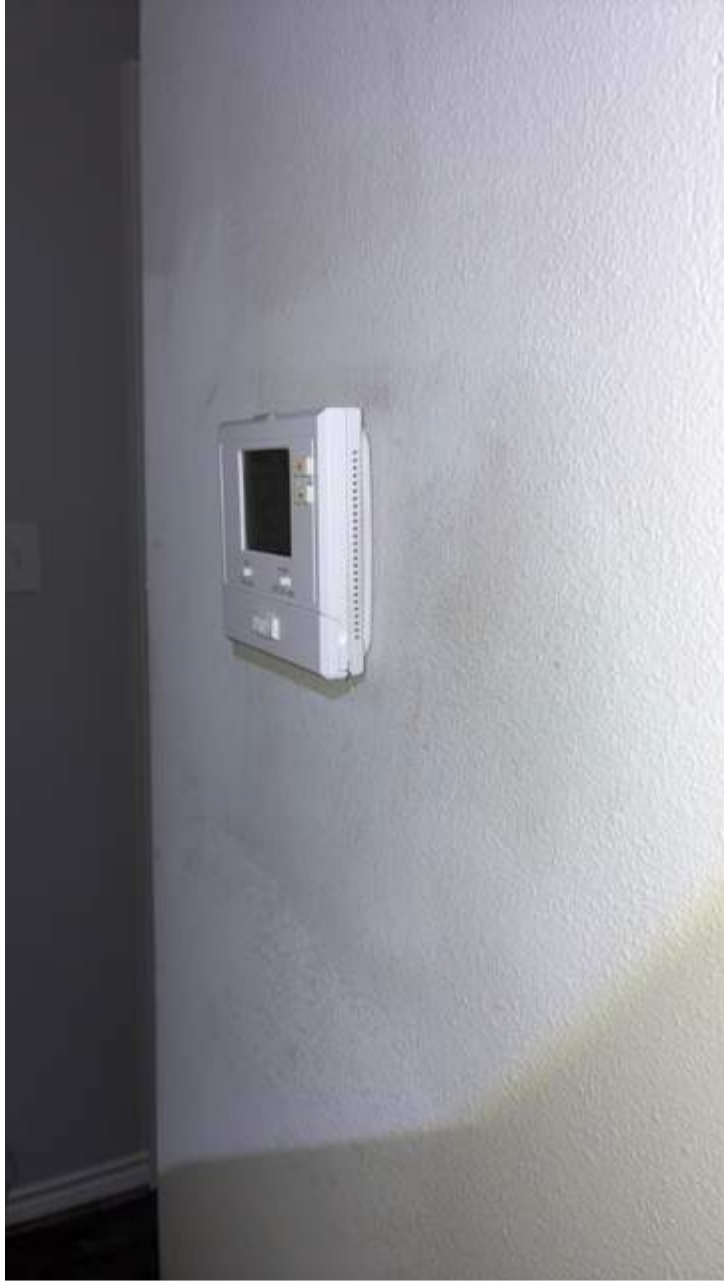
The thermostat is loose.

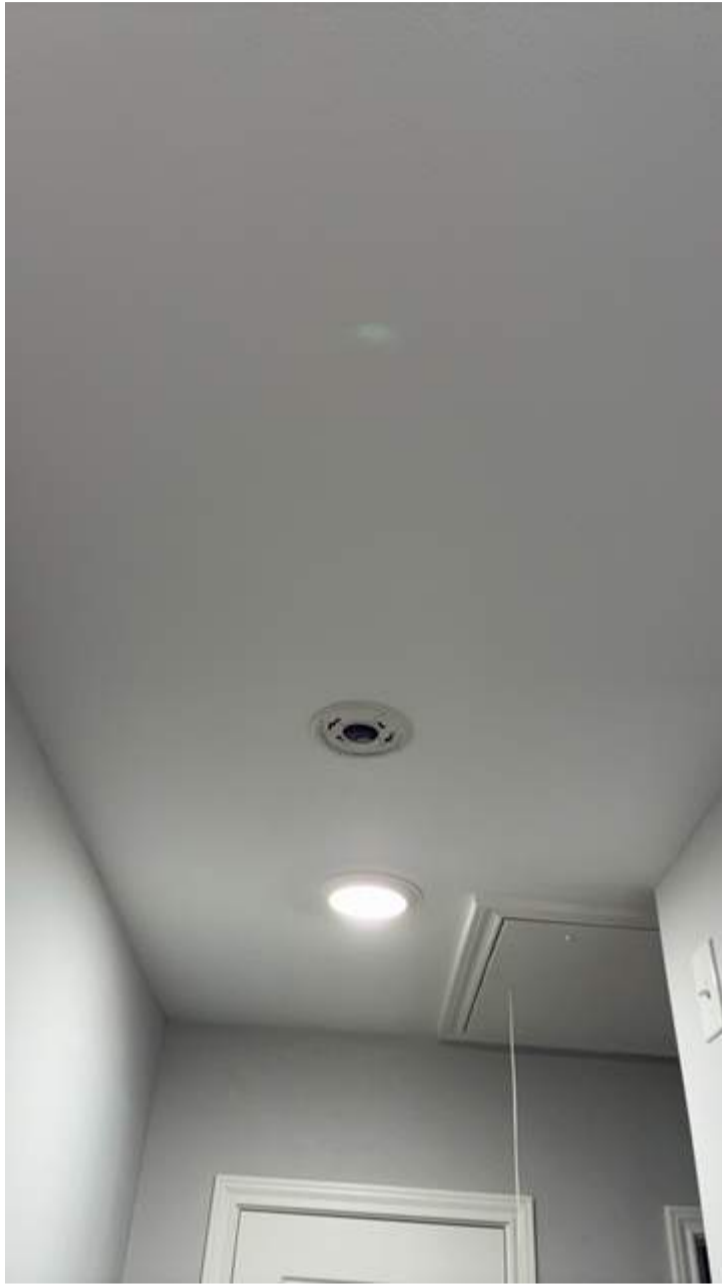
Missing Carbon Monoxide Detector(s)

One or more carbon monoxide detector(s) is missing or not installed. Recommend repairs or replacing by a qualified professional.

Missing outside of sleeping rooms
