# 16870 Blackberry Lily Ln Conroe, Texas 77385

Client	--
Reference id	<b>a4xPd000003NoOziAK</b>
Type	<b>Home Inspection and Floor Plan Report - 16870 Blackberry Lily Ln</b>
Inspected by	<b>HomeTeam Inspection Service - North Houston</b>
State license	<b>TREC 20811</b>
Scheduled	<b>December 24, 2025, 9:00 AM CST</b>
Completed	<b>December 24, 2025, 3:38 PM CST</b>

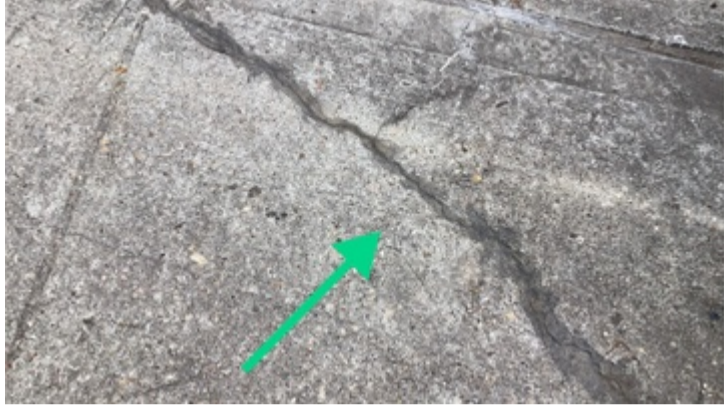
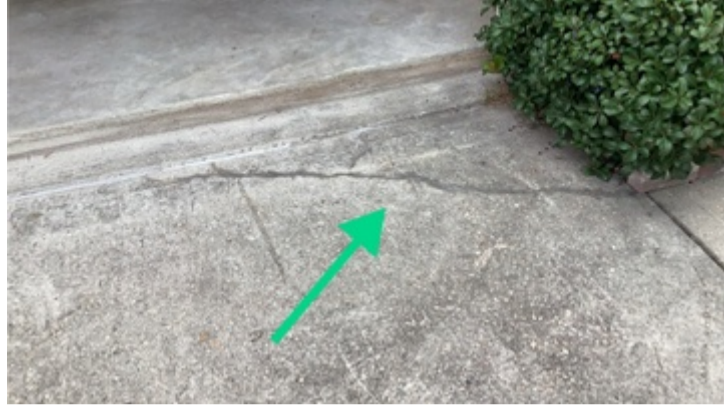
### Minor Cracks in the Driveway

The driveway has minor cosmetic cracks.

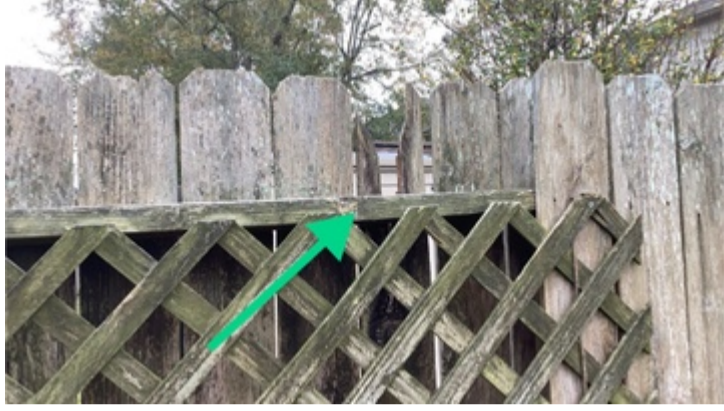
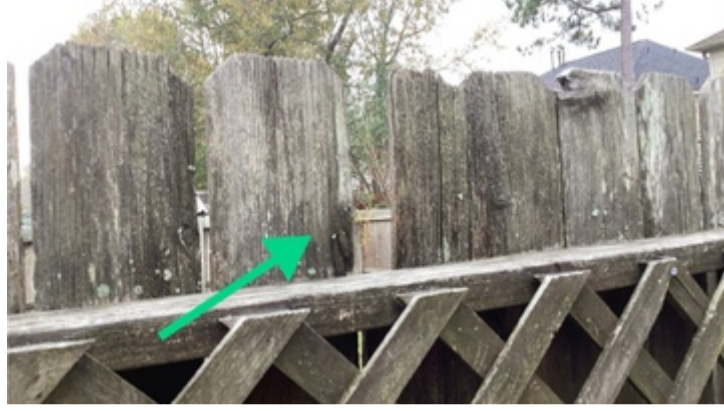
## Damaged / Missing Fence Boards

One or more fence boards are missing or damaged.

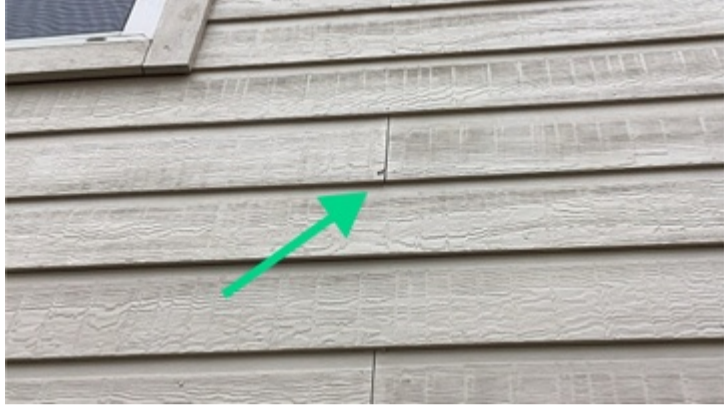
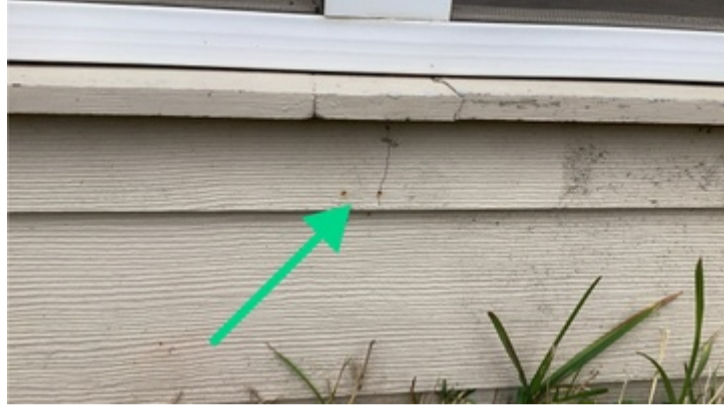
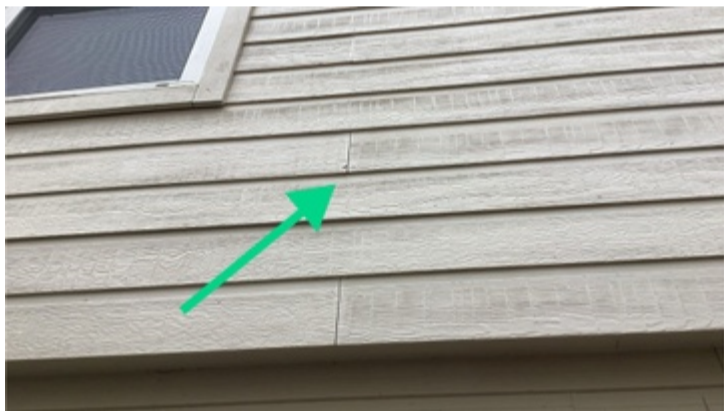
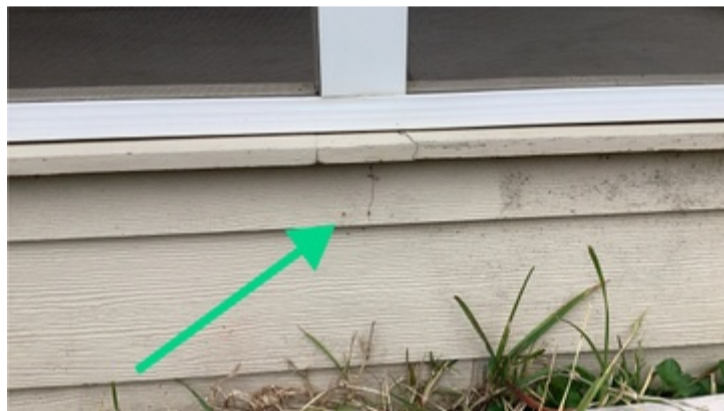
### Damaged Siding

One or more areas of the siding is damaged.

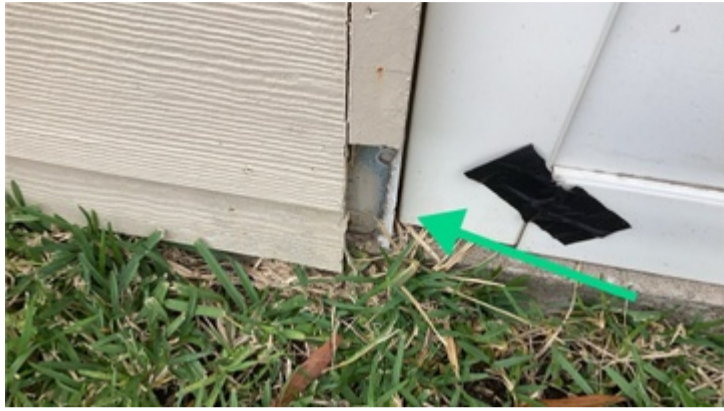
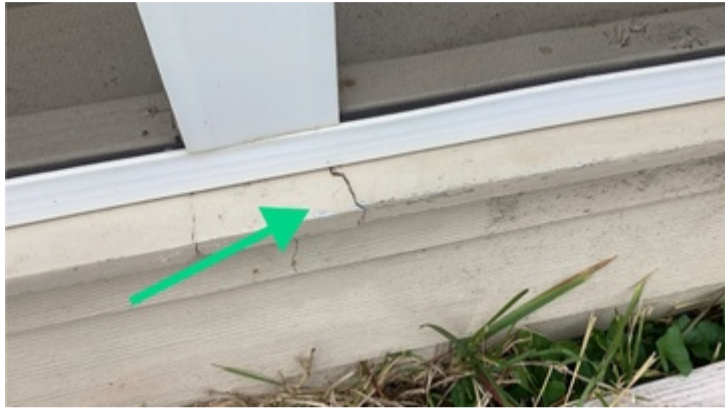
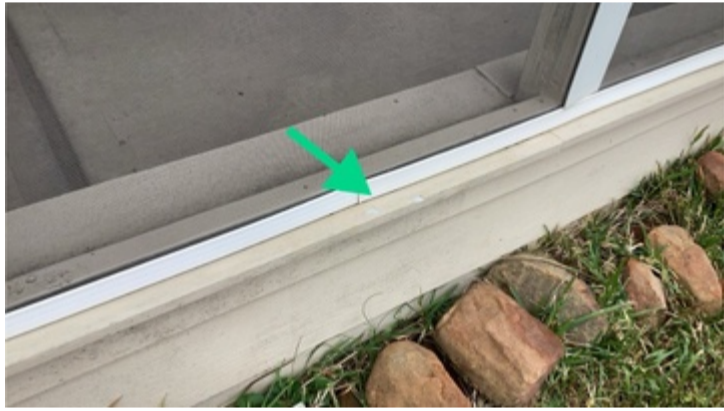
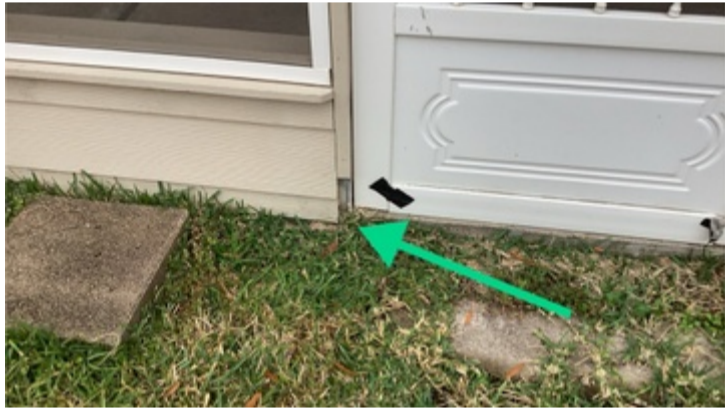
### Damaged Trim

There are signs of damage to the trim.

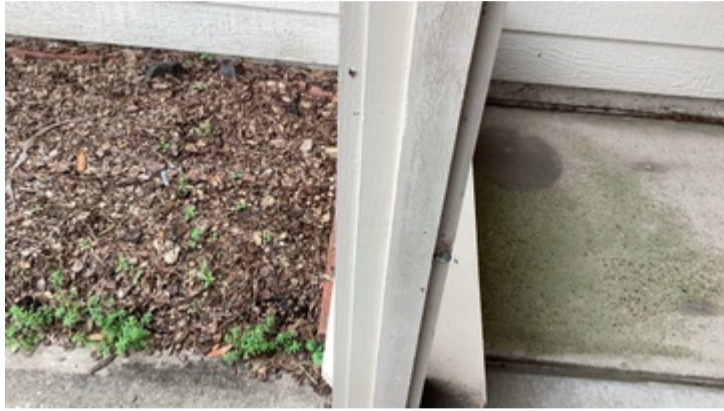
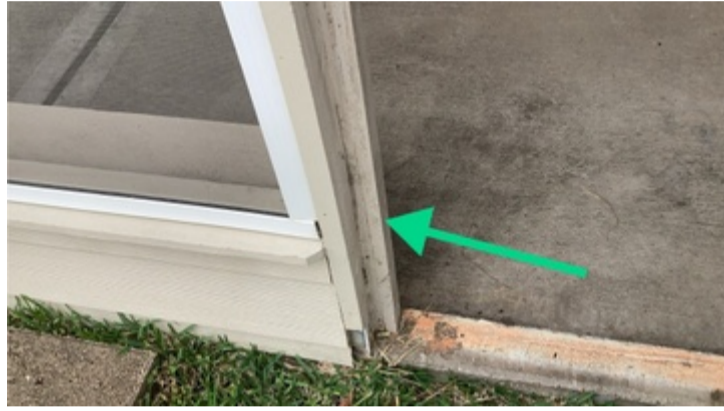
### Damaged or Missing Weatherstripping

The weatherstripping is damaged or missing.

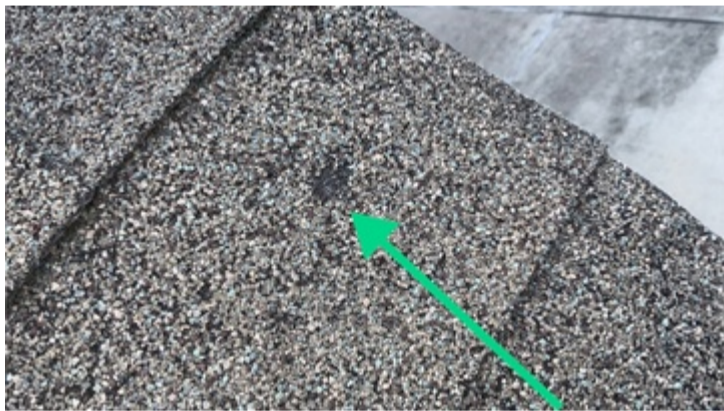
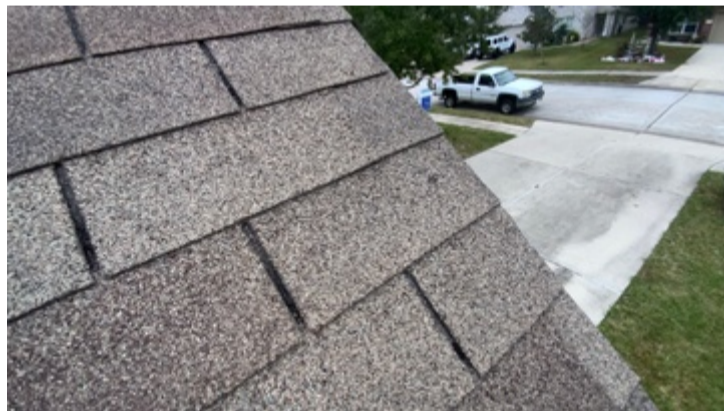
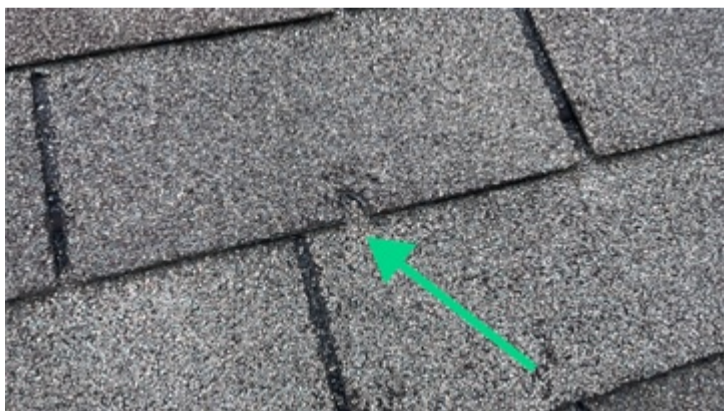
### Damaged Shingles

One or more shingles are cracked or torn. Recommend further evaluation, and repairs or replacing by a qualified professional.

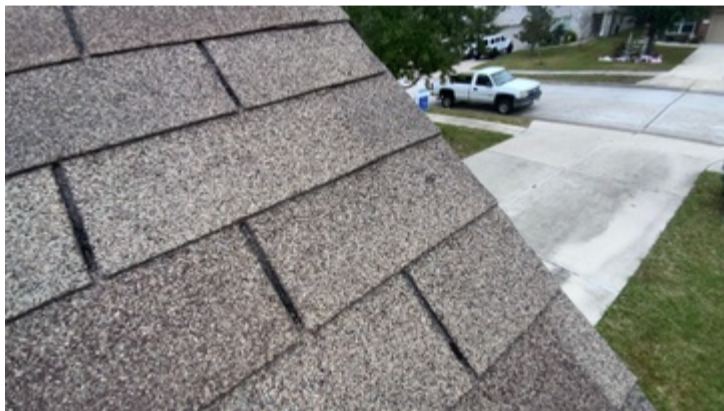
### Damaged Shingles

One or more shingles are cracked or torn.

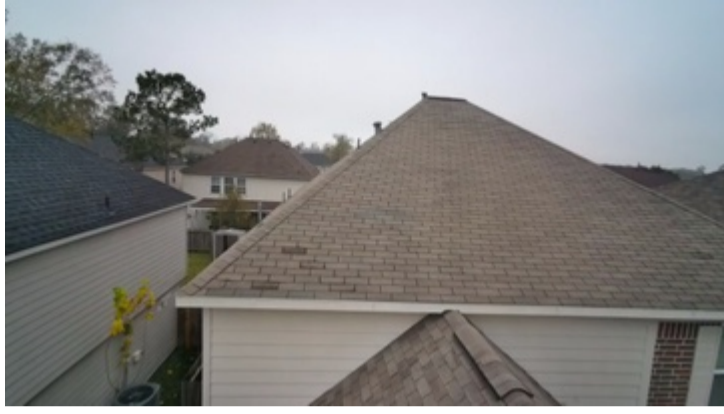
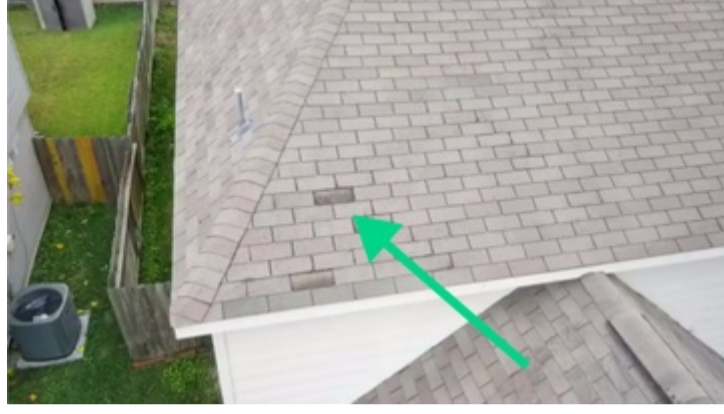
### Roof Missing Shingles

The home is missing roof shingles. Recommend further evaluation, and repairs or replacing by a qualified professional.

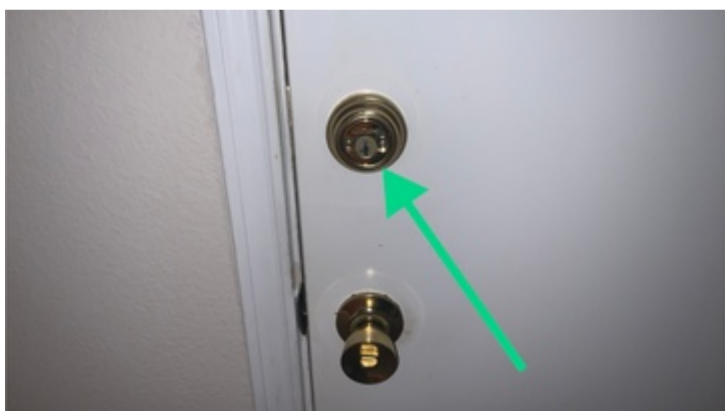
### Unsafe Double-Keyed Lock

A double-keyed lock is a safety hazard.

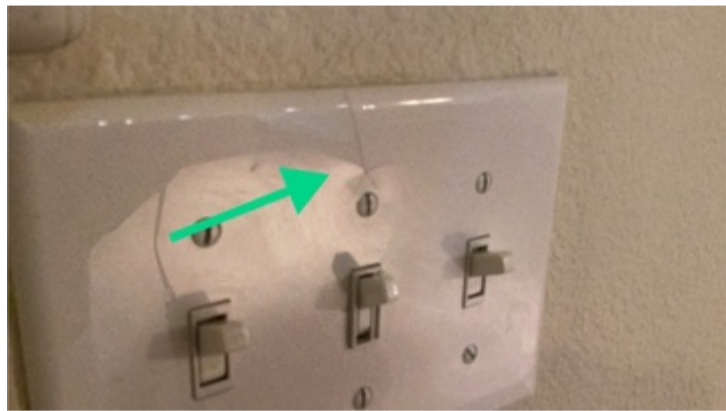
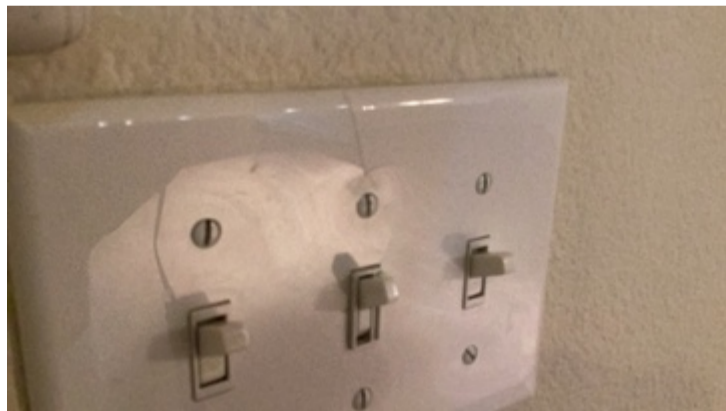
### Damaged Cover Plates

One or more switch / outlet / receptacle cover plates are damaged.

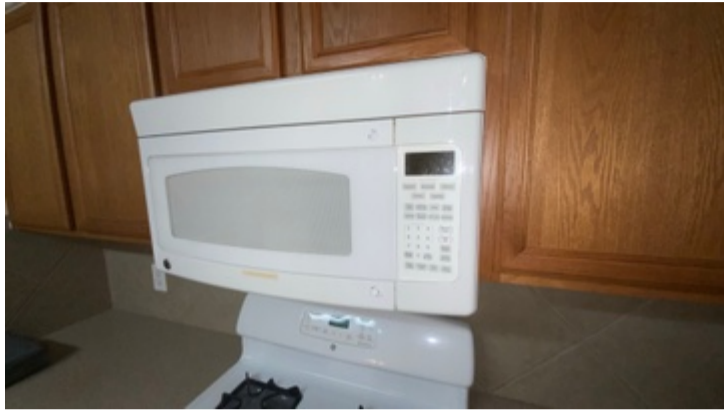
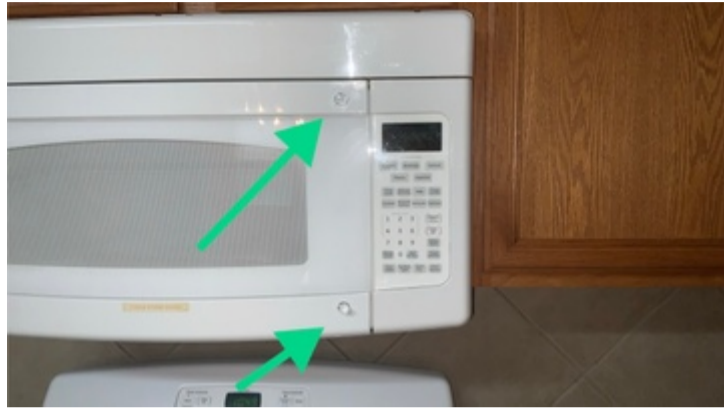
### Loose or Broken Microwave Handle

The microwave handle is loose or broken.

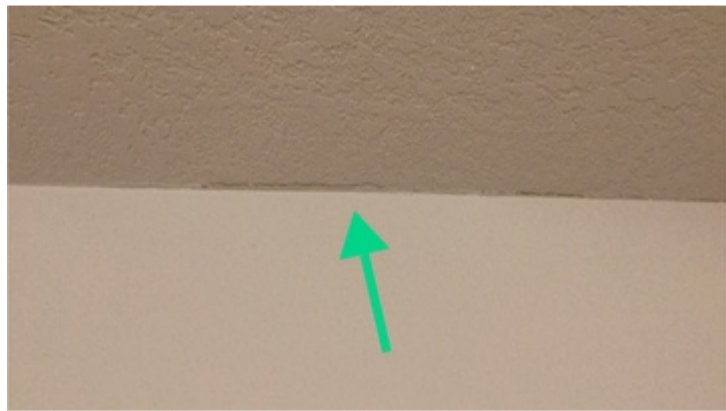
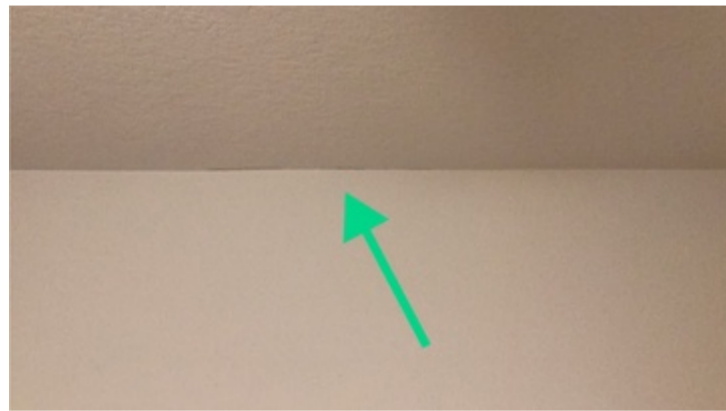
### Minor Wall Cracks

There is minor cracking on the wall / ceiling.

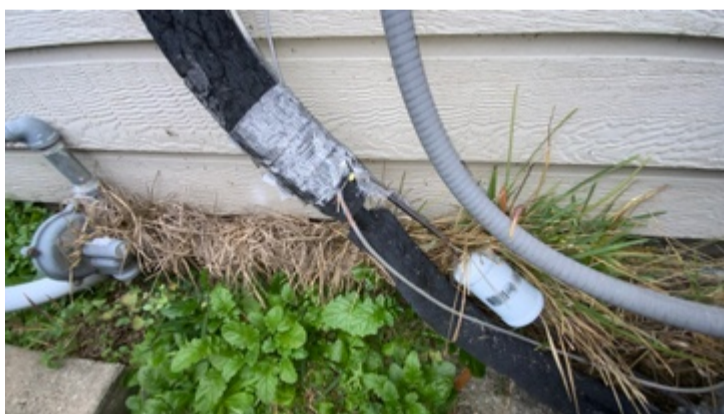
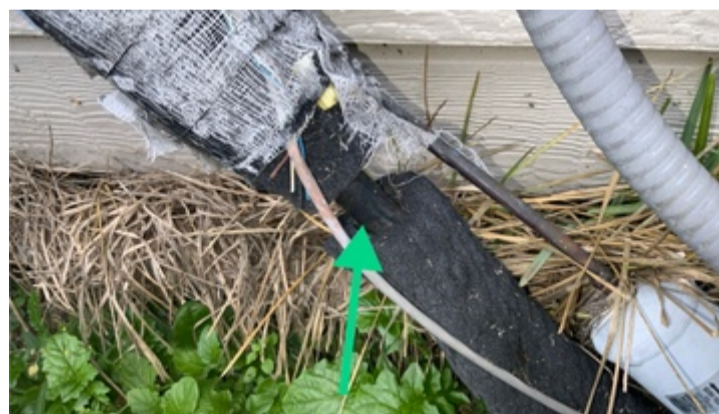
## Missing or Damaged HVAC Line Insulation

The refrigerant line insulation is missing or damaged.

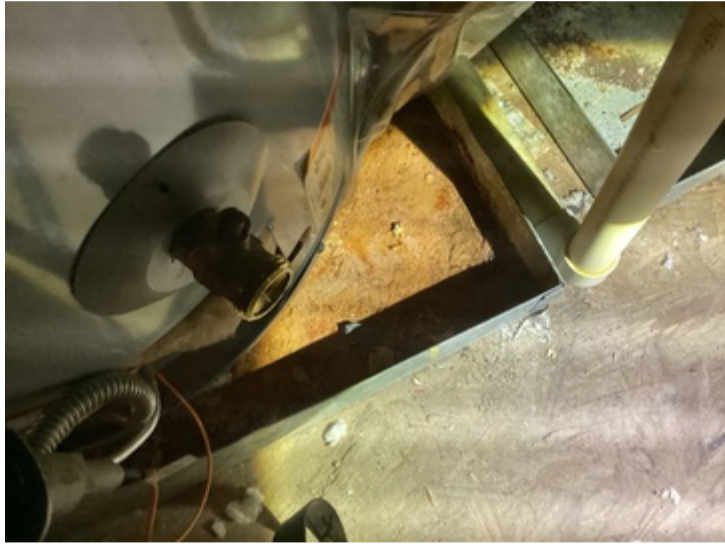
### Rusted water heaters drip pans

Rust in the water heaters drip pans

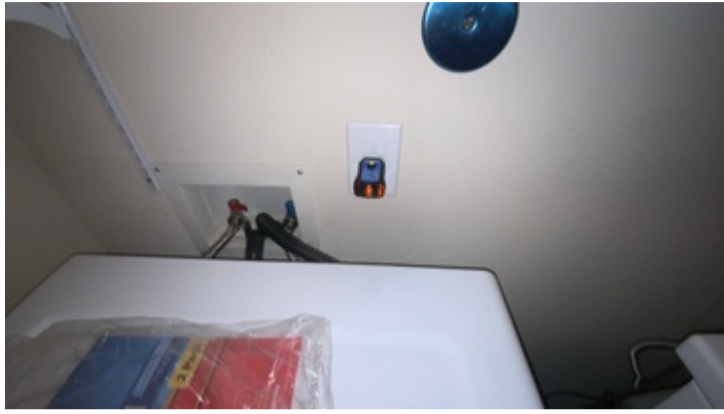
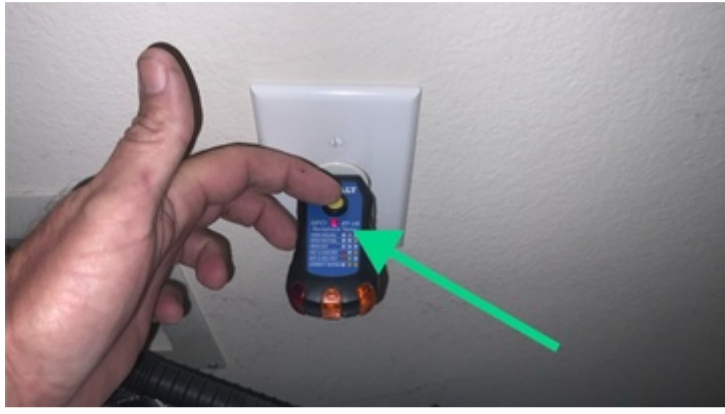
### Missing GFCI

There is no GFCI (Ground-Fault Circuit Interrupter) protection.

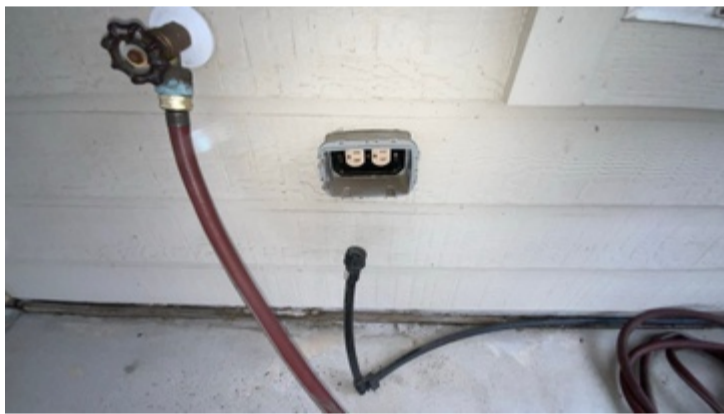
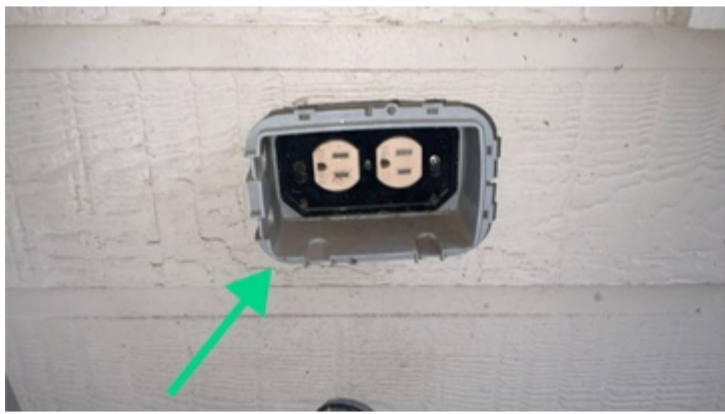
### Missing Weather-Resistant Cover

There should be a water-resistant cover installed.

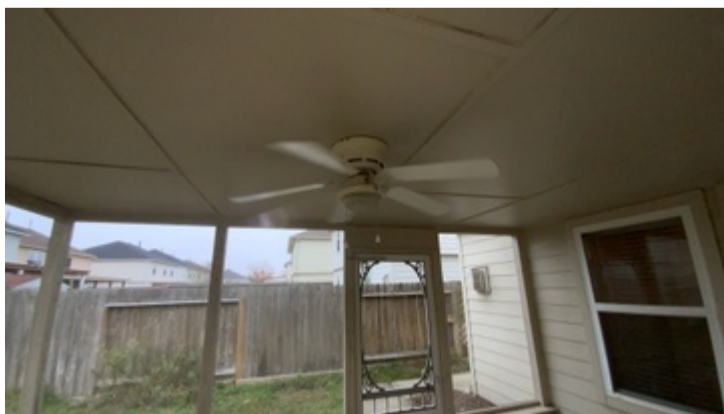
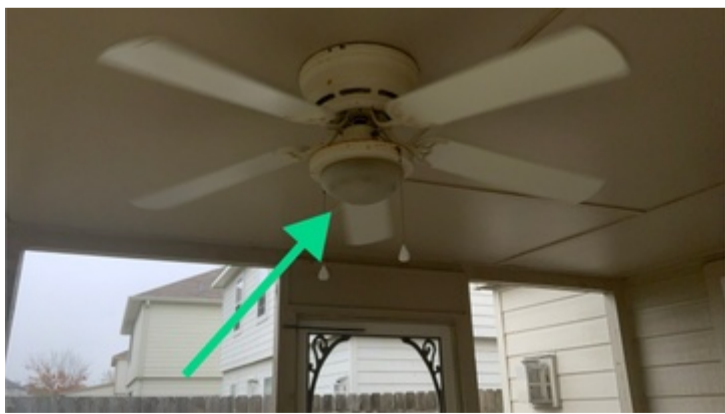
### Inoperable or Missing Light Bulb

One or more light bulbs have burnt out or are missing.
