Confidential Inspection Report

LOCATED AT:
8507 Clarkman Ridge Ln
Cypress, TX 77433

INSPECTED ON:
Tuesday, November 25, 2025

Inspector, Justin Vincent
Texas Prime Inspections

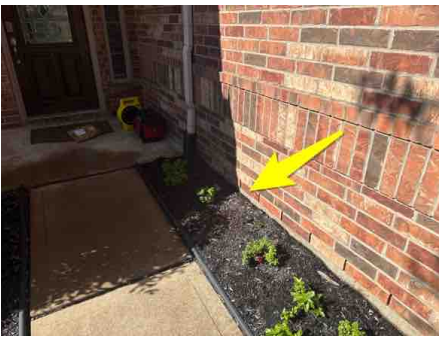
REC 1: High soil was present, which is conducive to wood destroying insect activity, and/or moisture entry. At least 4 inches of clearance should be present between the soil or concrete and the exterior wall surfaces for brick or masonry walls, and 6 inches of clearance should be between the soil and the exterior siding. We recommend these areas be maintained and treated on a routine basis, or adjustments to the soil be made. See IRC R404.1.6

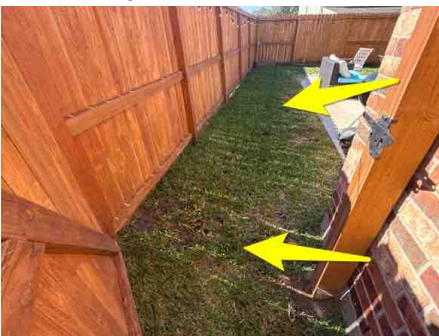
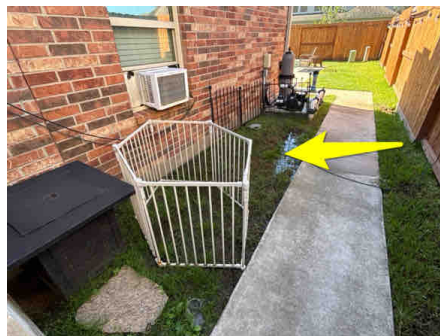
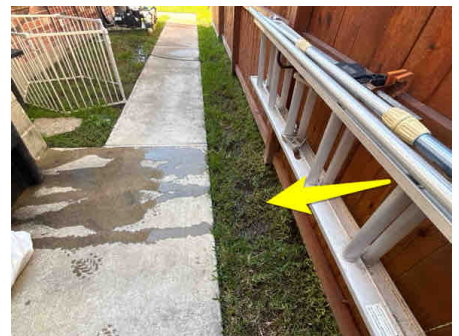
REC 2: There were low areas where water may stand on the lot and/or next to the home. Adjustments to the grading and drainage could be made.

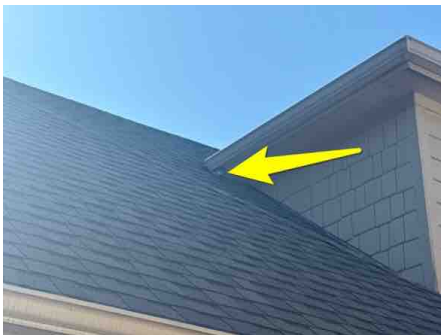
MNT 5: Some of the rain gutters and gutter downspouts terminated at the roof surfaces as is found at many homes of this type. It is recommended that they be extended to the roof edges/lower rain gutters/soil areas, to reduce chances of damage and wear, and leaks at the shingles and flashings. See GAF Technical Bulletin No. TAB-R-2011-150

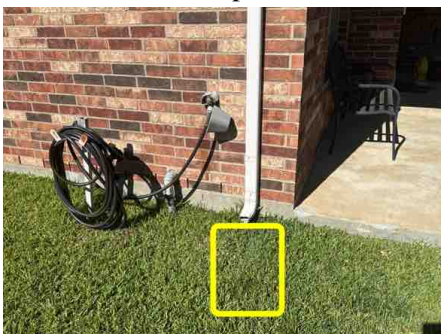
MNT 6: Splash blocks for directing water away from the foundation were not at the base of every downspout. We recommend that a splash block be installed for every downspout.

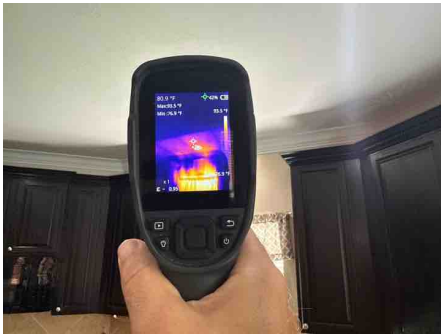
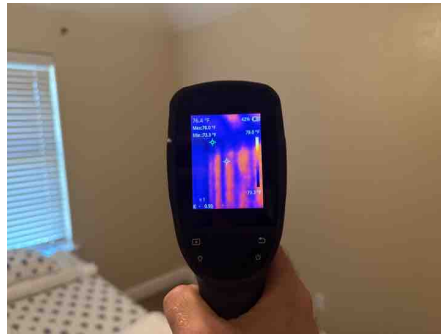
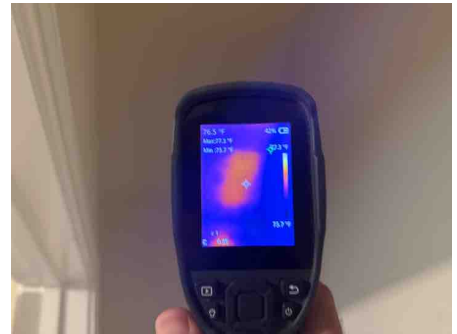
MNT 8: The wall and/or ceiling insulation had limited gaps or thin spots that can be adjusted or repaired to limit energy loss at these areas.

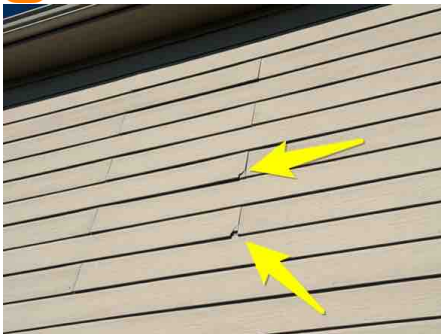
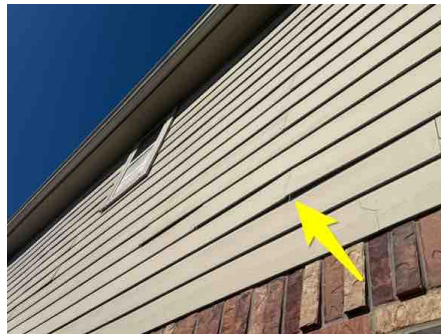
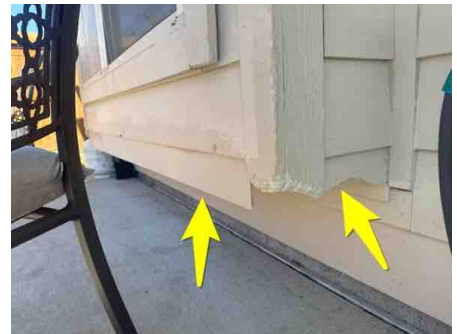
REC 9: The exterior siding and trim had limited gaps and marks/damage that could be repaired.

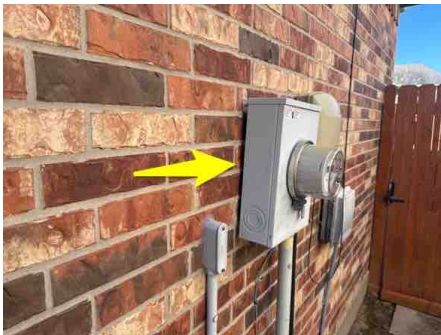
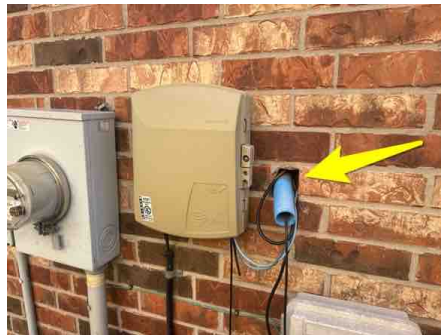
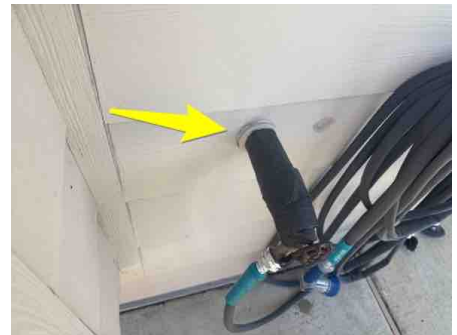
REC 10: There were gaps at the exterior wall surfaces such as around the wall penetrations. This is a common maintenance item found at most homes. The gaps could be repaired with matching caulking/sealant.

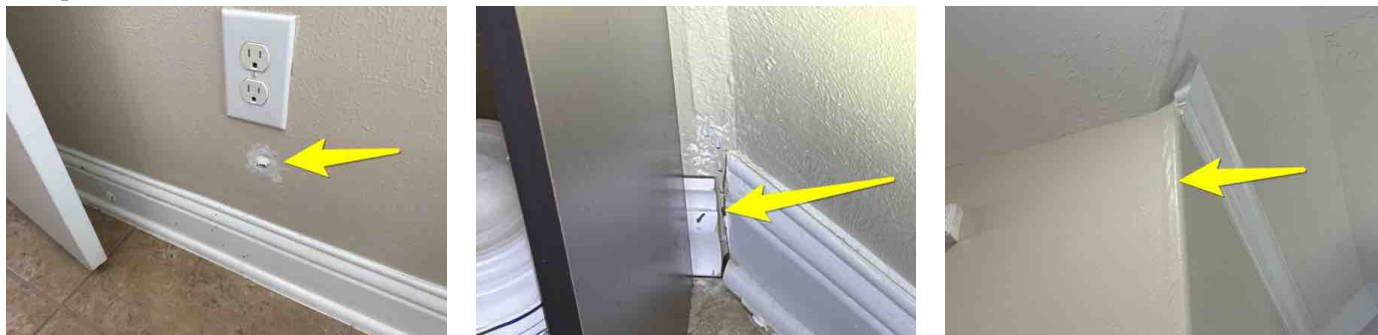
MNT 11: There were limited signs of settling, damages, and gaps at the wall and trim areas that could be touched up or repaired.

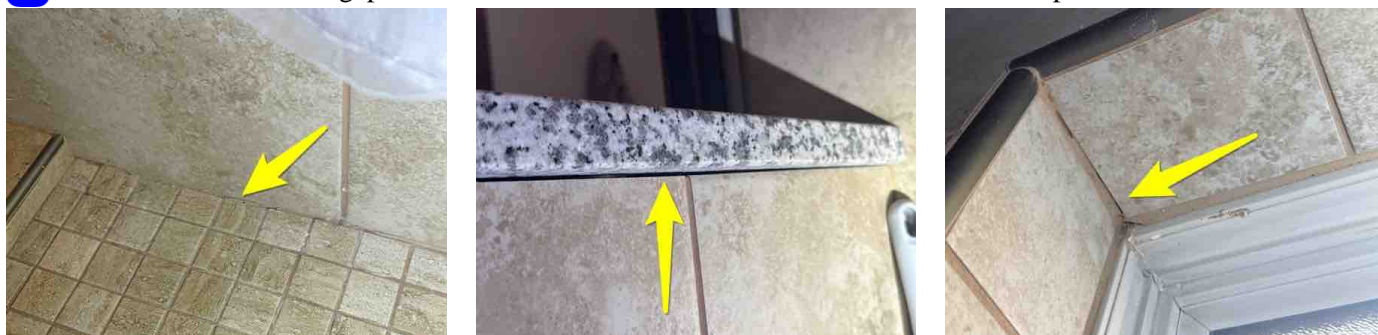
MNT 12: There were limited gaps at the tub and shower walls that should be sealed and repaired.

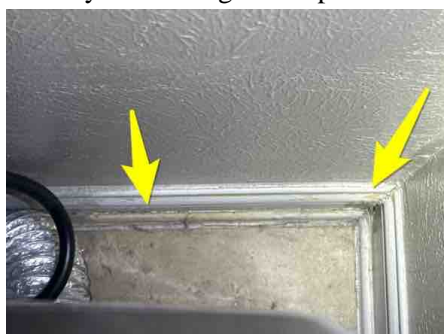
Behind washing machine

EVAL 13: Some of the walls, trim, and adjacent materials had limited signs of water damage. These areas were not actively wet during the inspection. Further evaluation is recommended.

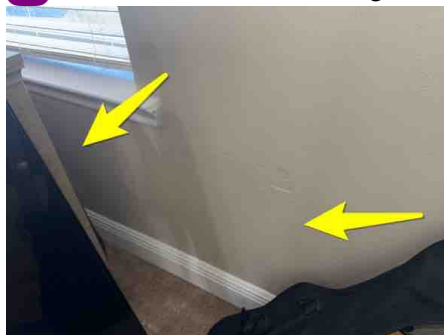
Gameroom, below window

EVAL 14: The walls had some signs of past repairs. The sellers may be able to provide more information about these.

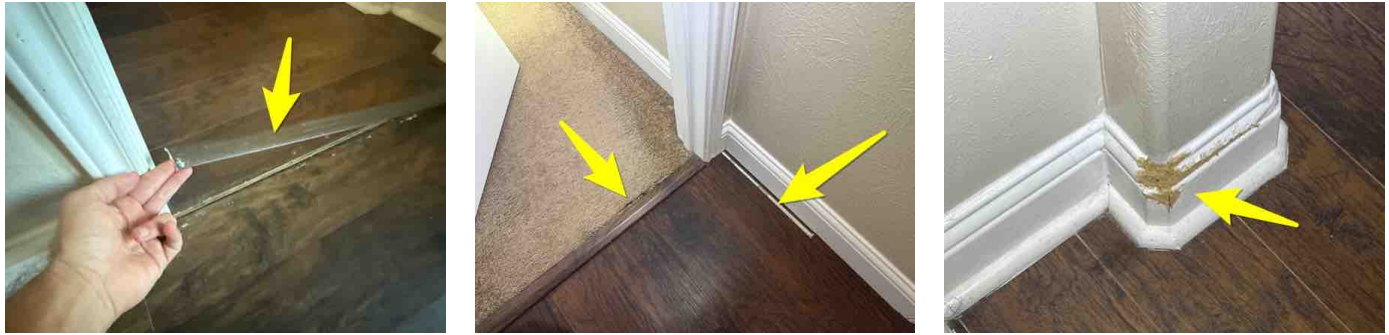
MNT 15: The floor and floor trim parts had limited marks, damage, and loose parts. This is a fairly common condition that could be repaired on a needed basis.

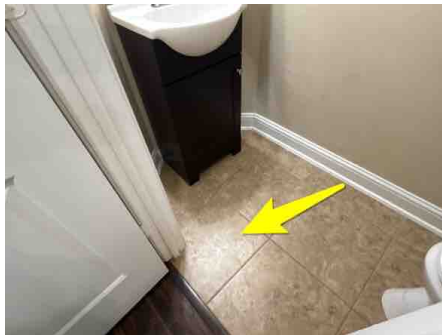
Half bathroom

EVAL 16: Some of the tile floors sounded hollow when they were tapped indicating possible voids under the tiles here. These tiles can be more vulnerable to damages. A budget could be maintained for potential future repair needs.

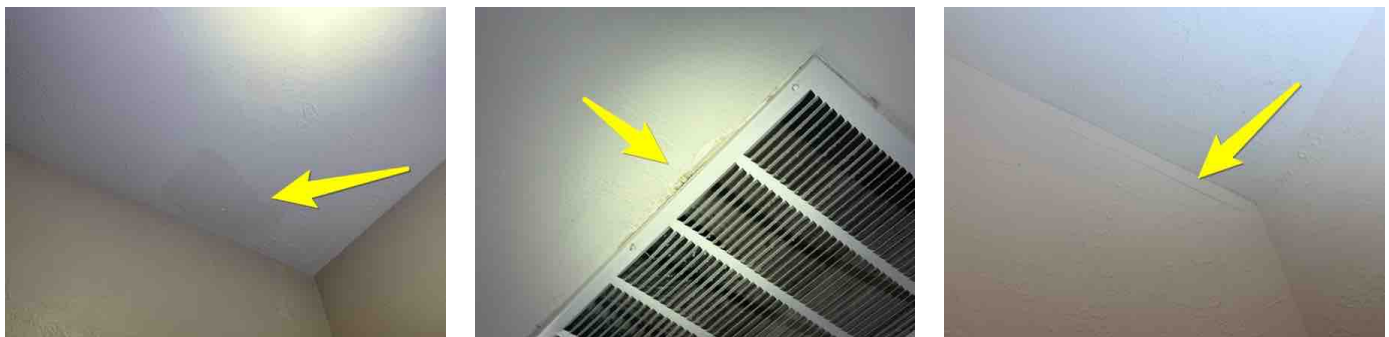
MNT 17: The ceilings had limited signs of settling, marks, and other blemishes that could be repaired or touched up on a needed basis.

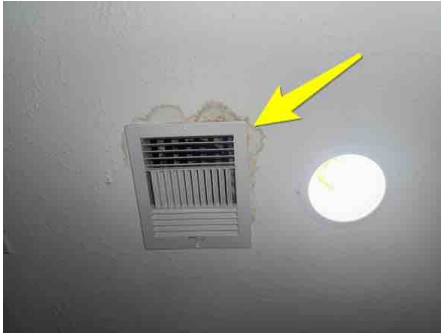
Media room

EVAL 18: The ceilings had limited instances of water stains or damages. The sellers may be able to describe what had caused them. The areas pictured were not actively wet during the inspection. Further evaluation is recommended. (The staining around some of the vent registers could be related to gaps at the ducts.)

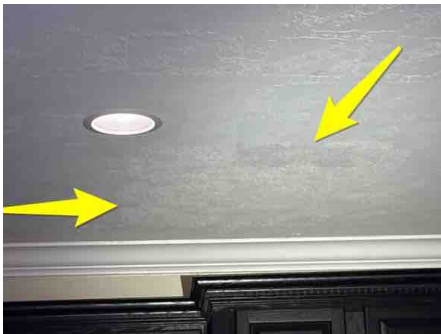
Kitchen

EVAL 19: The ceilings had what appeared to be signs of past repairs. The sellers may be able to describe what had occurred at these areas.

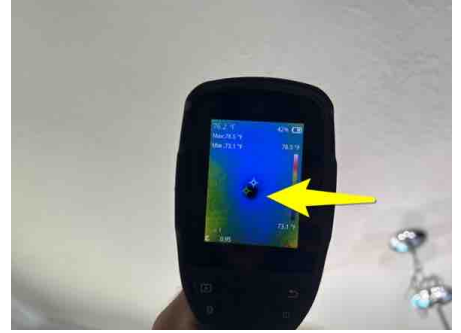
REC 20: Limited moisture was detected at the dining area ceiling. We were unable to determine the source. We recommend this be further evaluated by a qualified contractor and repaired as necessary.

Moisture detected

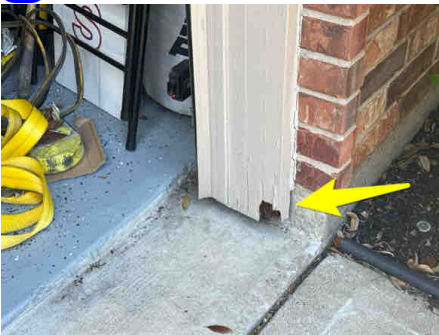
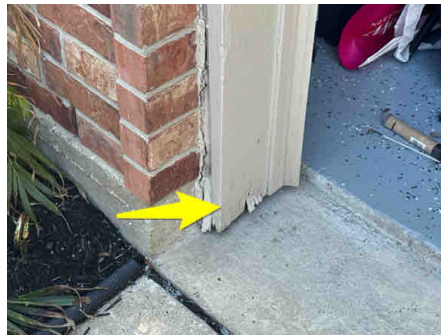
MNT 21: The garage door trim had some damages and deterioration and needs repair.

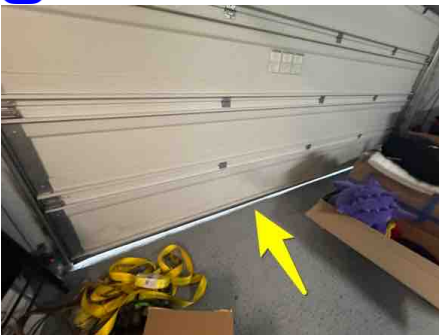
MNT 22: Gaps were present around the perimeter of the garage door. Repairs are recommended.

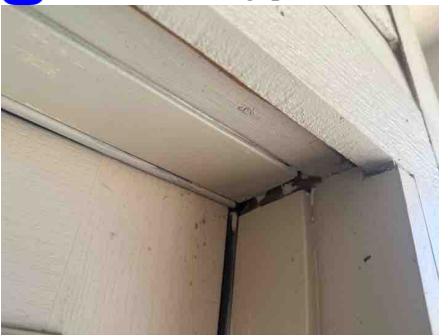
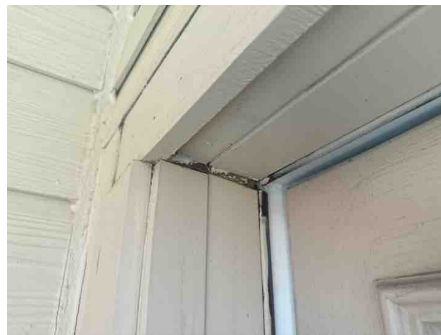
MNT 23: There were gaps around the exterior door trim areas that should be sealed and repaired.

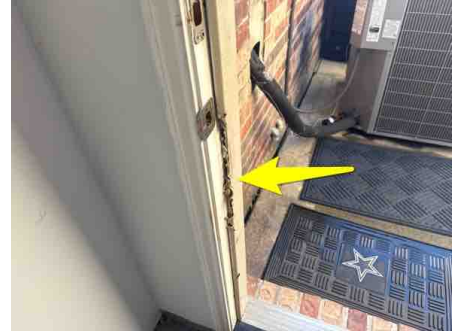
Garage side door

MNT 24: The exterior door weather stripping parts and sweeps had some gaps or damages that could be repaired.

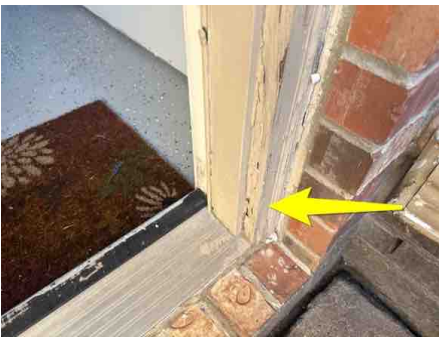
Garage side door

MNT 25: Some of the exterior door trim parts had damages and deterioration present. These parts could be repaired or replaced.

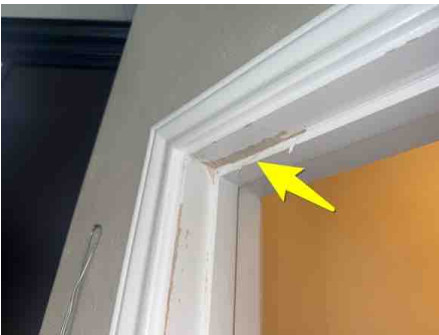
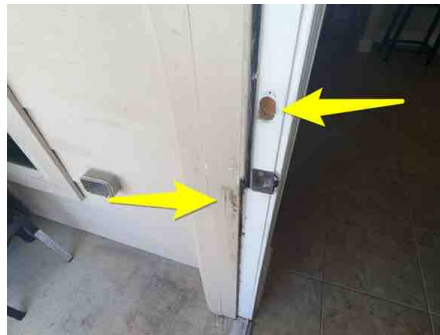
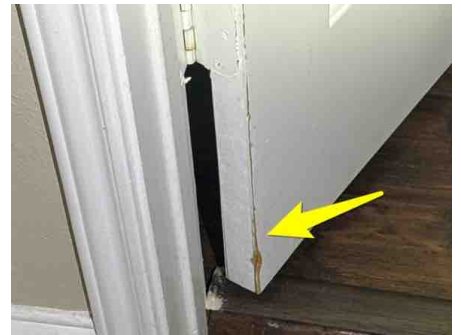
MNT 26: The doors and door trim had limited cosmetic blemishes, damages and/or missing hardware parts that could be repaired.

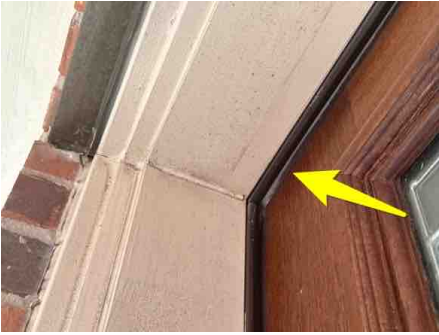
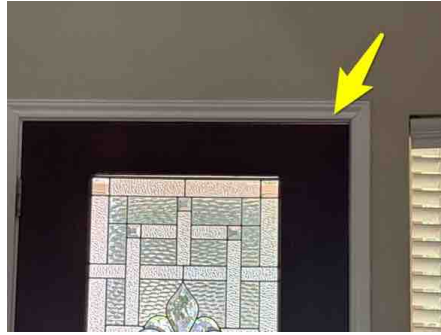
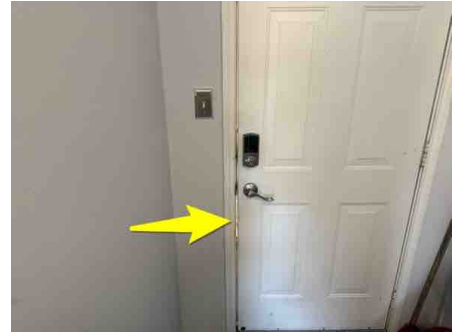
MNT 28: The front door and garage side door were slightly out of alignment and did not close flush when tested. Limited gaps were present around the doors as a result. Adjustments could be made.

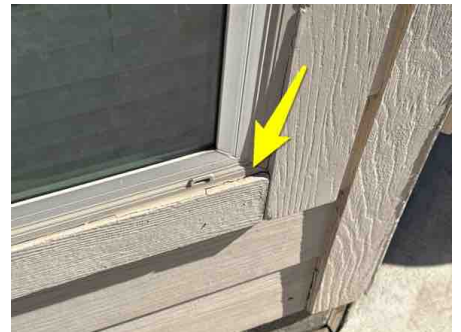
MNT 30: There were gaps around the windows and window trim. This is a common maintenance item. All gaps should be touched up and repaired.

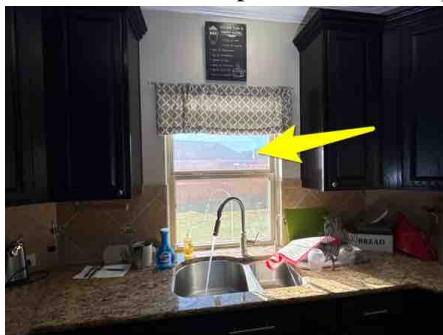
Kitchen

EVAL 32: Some of the windows had surface discoloration. It appeared that the low-e or low emissivity coating that is a surface tint or coating to block some of the light entry had begun to age or the windows had failed seals. The discolored window panes could be replaced.

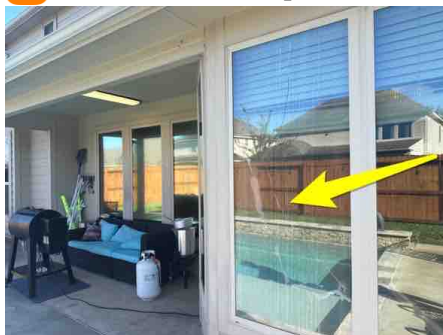
Dining area

REC 33: Some window panes were cracked or damaged and could be replaced.

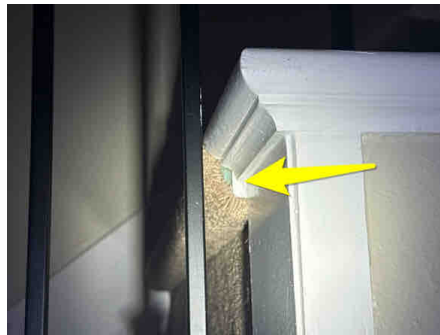
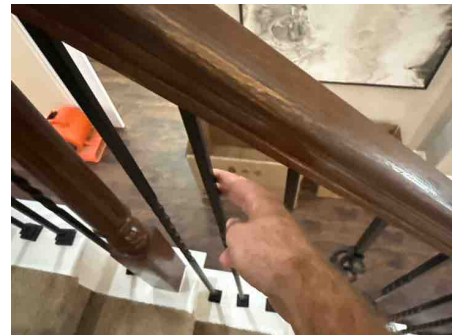
MNT 37: The stairway trim and railings had limited marks, damages, and/or gaps. Repairs are recommended.

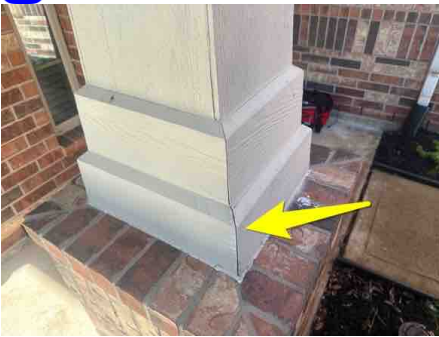
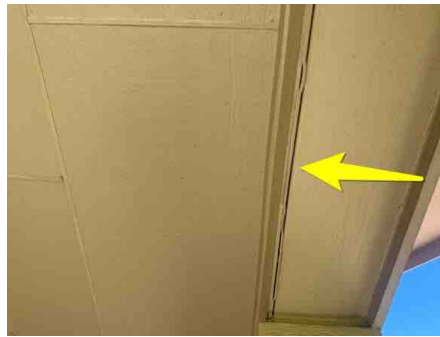
MNT 39: The porch ceilings and trim had limited gaps and irregularities that could be repaired.

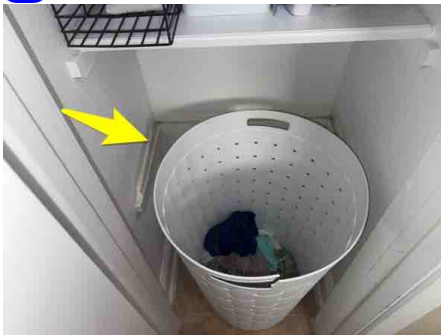
MNT 42: Some of the built in shelving parts were damaged or missing and could be replaced.

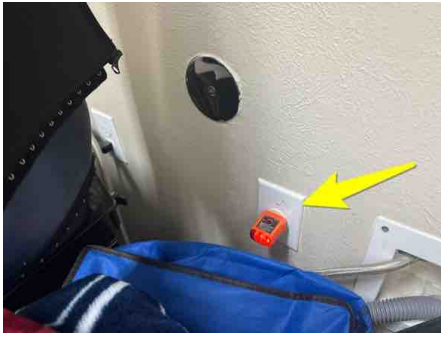
SAFE 48: The laundry room electrical receptacles did not have GFCI protection, which is recommended per current standards and could be installed as a safety precaution.

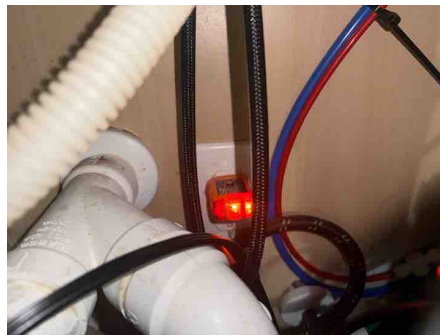
SAFE 49: The electrical receptacle under the kitchen sink did not shut off when tested with a GFCI tester. Per current standards, all electrical receptacles within 6 feet of a sink should have GFCI protection, including those under the sink areas.

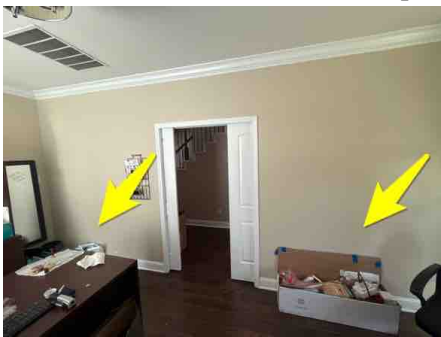
Study

EVAL 50: Some of the wall areas did not have receptacles every 12 feet at the wall areas, which is recommended per current standards. Additional receptacles could be added on a needed basis.

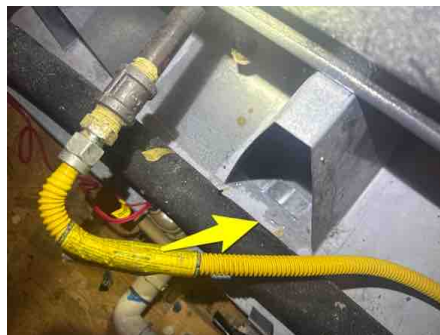
REC 56: There were minor gaps at the air-conditioner unit refrigerant line insulation and/or equipment surfaces that should be repaired, to prevent energy loss and to prevent condensation from dripping from it. Some moisture was present in the drain pan which was most likely related. We recommend the equipment be further evaluated and repaired as necessary.

Limited water in pan

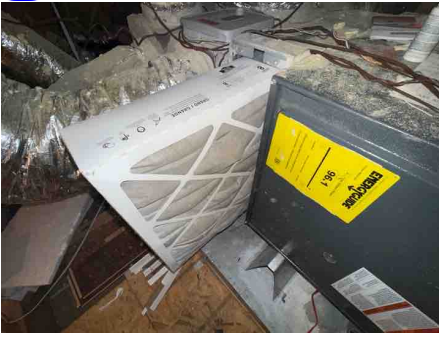
MNT 57: A return air filter was present and could be replaced.

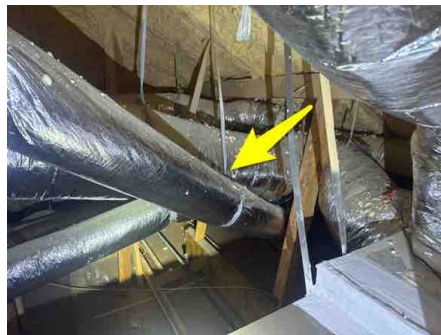
MNT 58: Some of the ducts were in contact with each other, which could lead to condensation formation. It is recommended that the ducts be separated. Repairs can be performed by adding attic insulation between the ducts where they are in contact with each other.

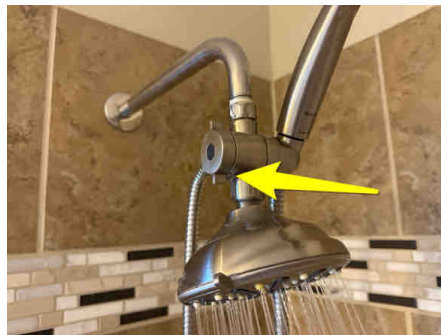
Upstairs back right bathroom

MNT 59: Some of the shower head or hand sprayers had minor leaks when tested and could be repaired.

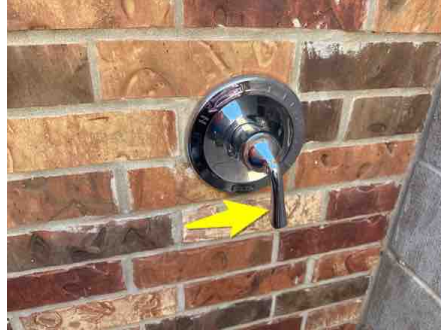
EVAL 60: The outdoor shower operated when tested, however, the handle had a regularities as it could only be turned a quarter of the way. This could be repaired on a needed basis.

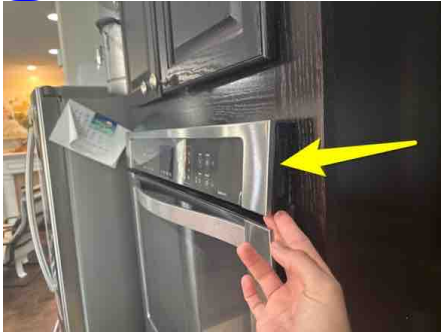
MNT 63: The oven control panel was loose and could be re-secured in place.

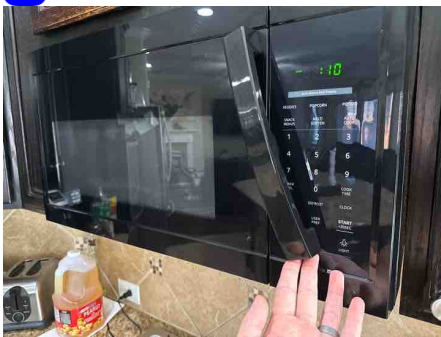
MNT 64: The microwave door handle was loose and could be repaired.

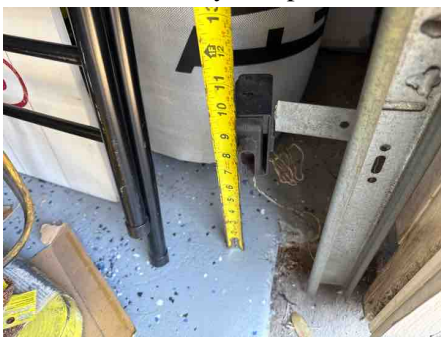
SAFE 65: The garage door opener optical sensors was mounted higher than 6 inches above the garage floor, which is considered a safety risk per current standards. The sensors could be lowered.

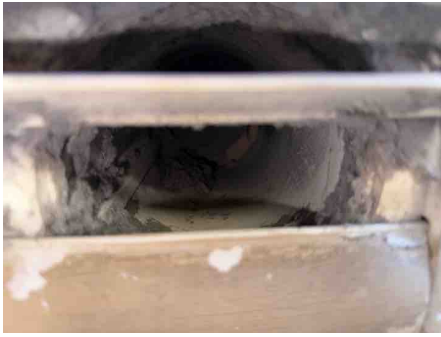
MNT 66: The dryer vent had accumulated some lint and debris. We recommend it be cleaned as part of preventative maintenance.

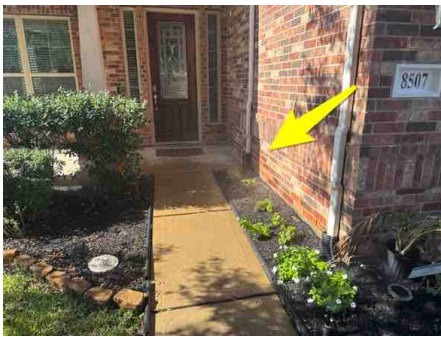
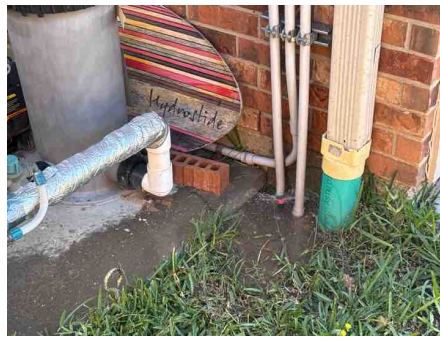
MNT 68: Some of the sprinklers over-sprayed onto the home, flatwork and/or fences. Adjustments to the sprinkle heads could be made.

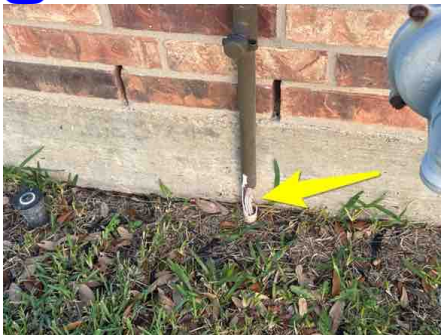
MNT 69: The sprinkler system control wire conduit was damaged and needs to be repaired or replaced.

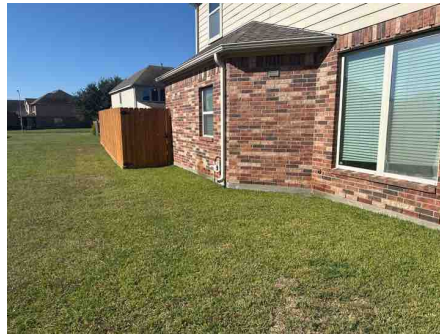
Zone 3

REC 71: Some of the sprinkler zones or heads did not operate properly or had low pressure when tested. Further evaluation and repairs are recommended.

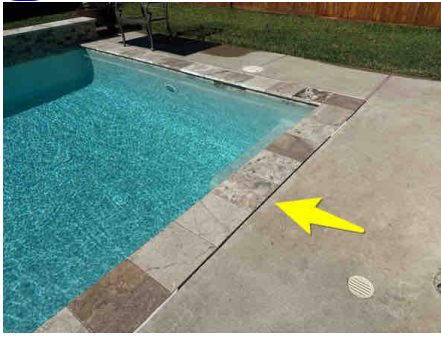
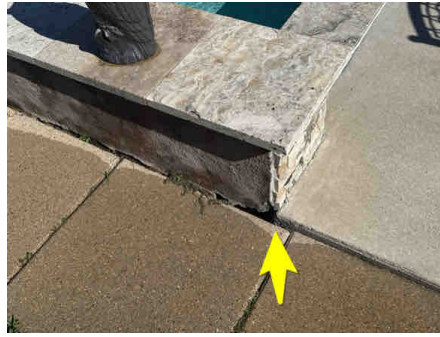
MNT 73: There were gaps, cracks, and irregularities at the flatwork around the pool areas that need to be repaired.

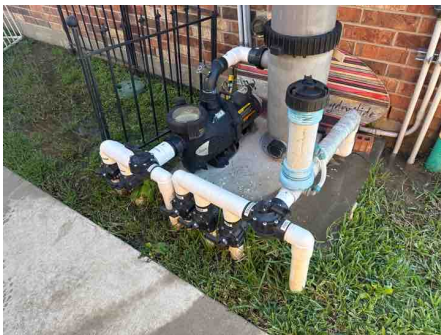
MNT 75: The pool equipment PVC pipes were exposed and should be sheltered or painted with UV resistant paint to prevent premature aging and damage.

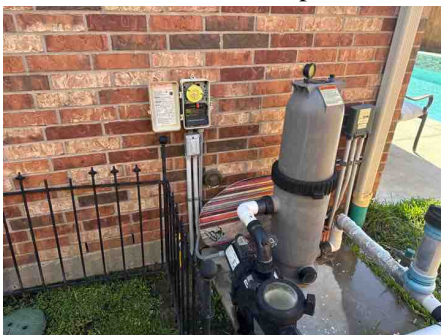
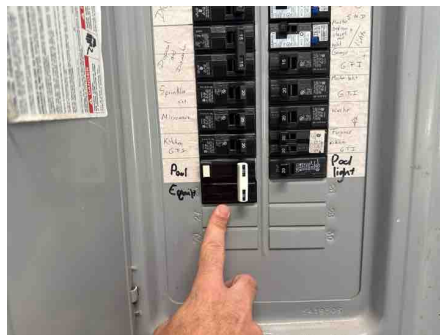
REC 76: The inspection of the pool was limited as the breaker serving the pool equipment popped and sparked when tested using normal controls during the inspection. The pool equipment did not appear to have power as a result. Further evaluation and repairs are needed.
