PROPERTY INSPECTION REPORT FORM

Jose Andres Lopez <i>Name of Client</i>	03/09/2023 <i>Date of Inspection</i>
7600 Emmett F Lowry Expressway #1102, Texas City, TX 77591 <i>Address of Inspected Property</i>	
Tommy Amonette <i>Name of Inspector</i>	TREC 22620 <i>TREC License #</i>
<i>Name of Sponsor (if applicable)</i>	<i>TREC License #</i>

Home Inspection Report

Inspection No. 521274-2025

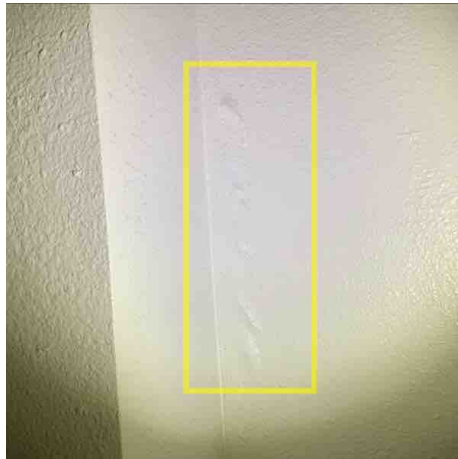
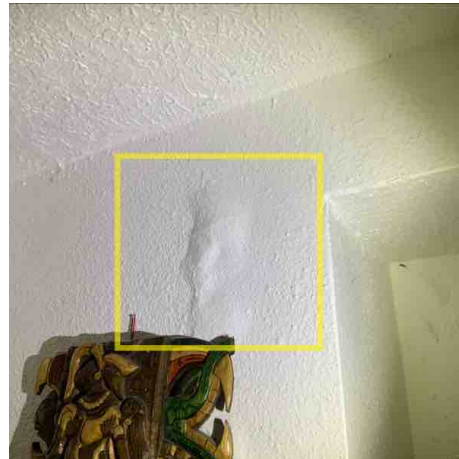
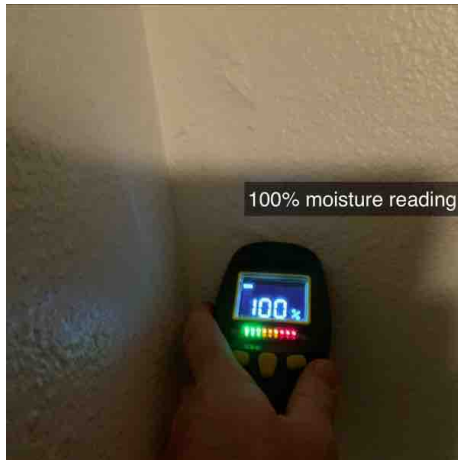
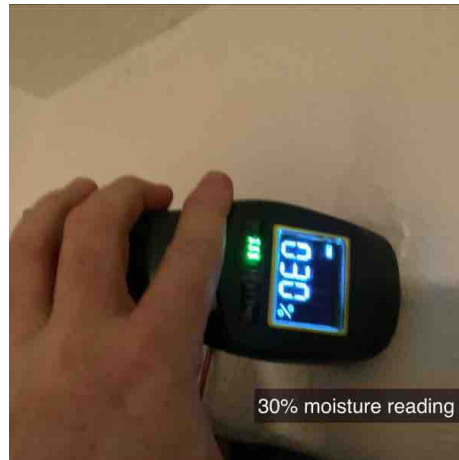
- Multiple areas of damage were noted in the primary bedroom wall to the left of the window. These areas were checked for moisture and moisture WAS detected in multiple areas. Recommend further investigation into the cause of these areas of damage and moisture and make any needed repairs

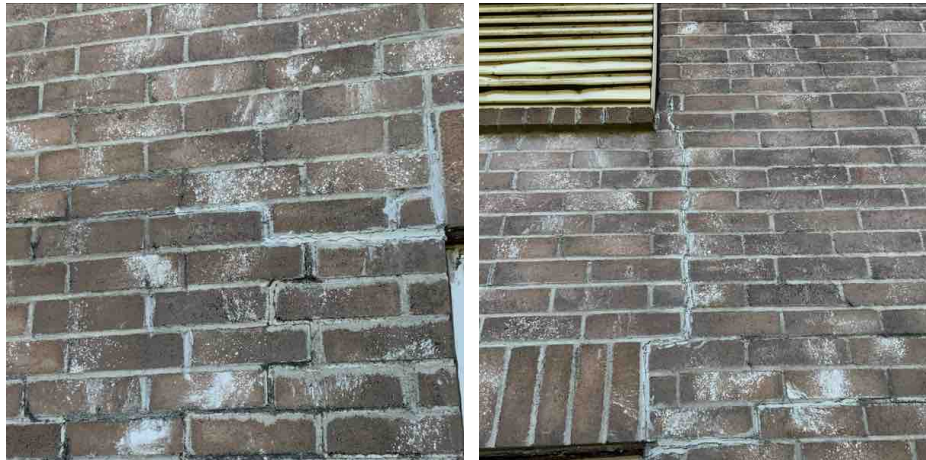
- **Cracking in the brick and mortar was noted in multiple areas around the exterior of the home. It is possible that these may indicate some structural movement and/or foundation settlement. Recommend repairing / resealing to prevent possible moisture penetration, and monitoring for any future movement.**

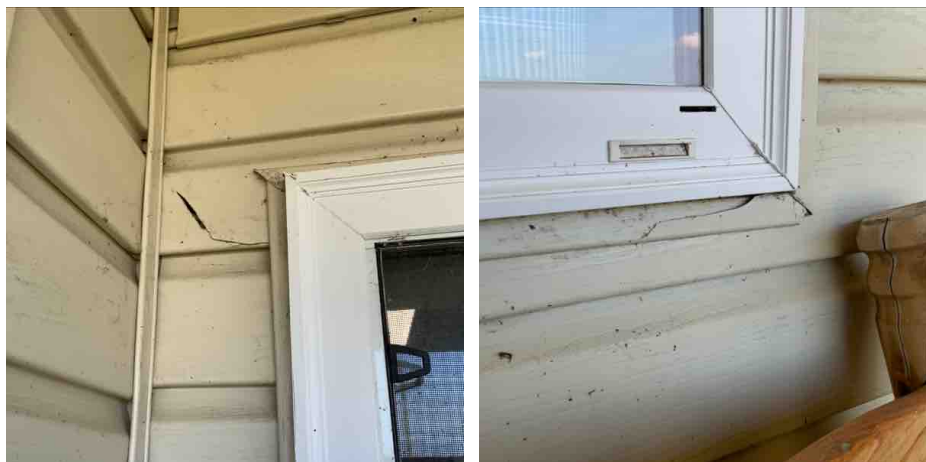
- **Vinyl siding was noted loose and/or damaged in multiple areas around the home. Recommend sealing / repairing these areas to prevent possible pest and / or water penetration into the walls.**

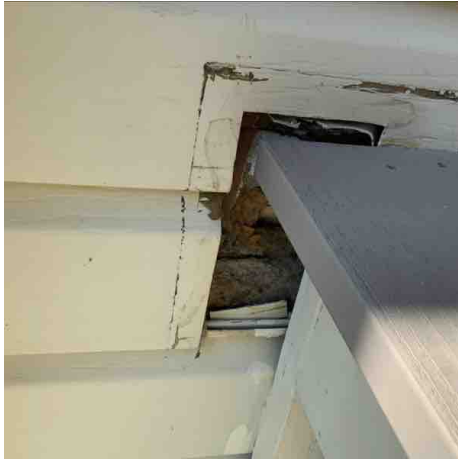
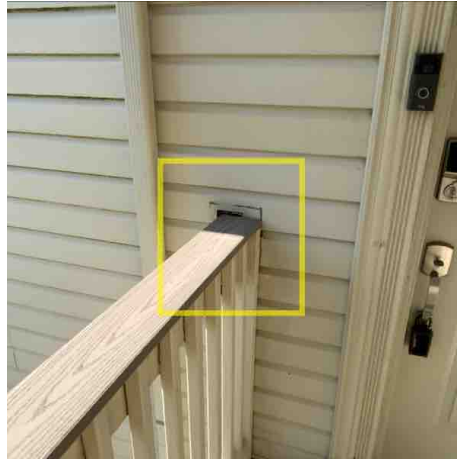
- Damage was noted at the exterior wall at the handrail near the front entry way door. Recommend repairing and sealing this area properly to prevent possible moisture penetration into the wall

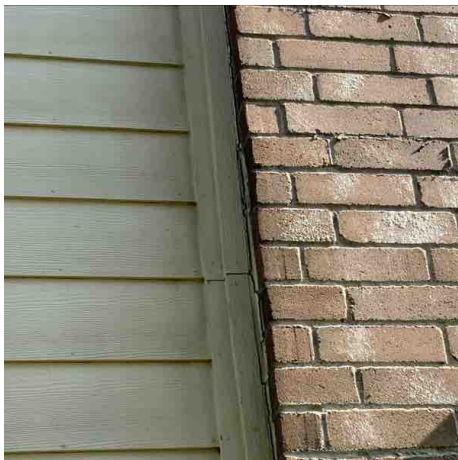
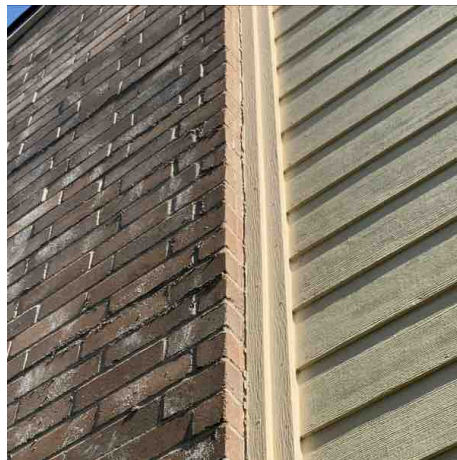
- Sealant was noted deteriorated and/or cracking in multiple areas on the exterior siding and trim. Recommend removing old sealant and resealing to prevent water penetration and possible deterioration.

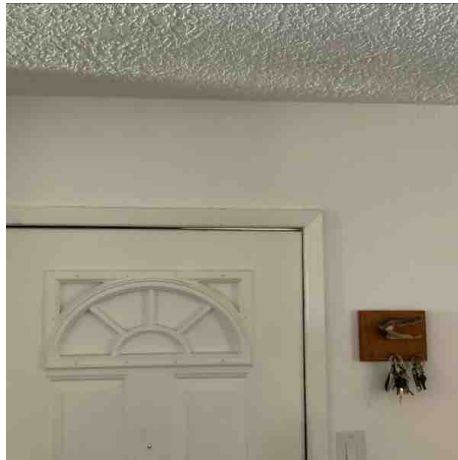
- Daylight observed from around the front entry way door. Recommend repairing the seal to prevent water and/or pest penetration, and promote energy savings.

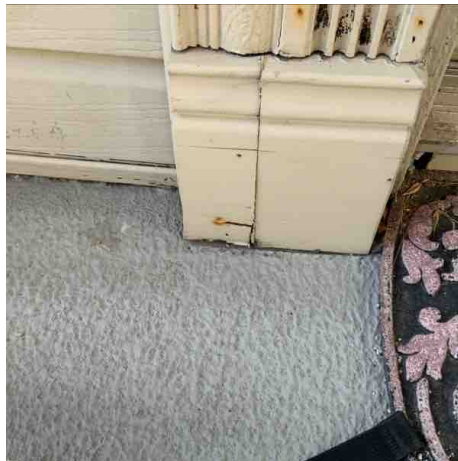
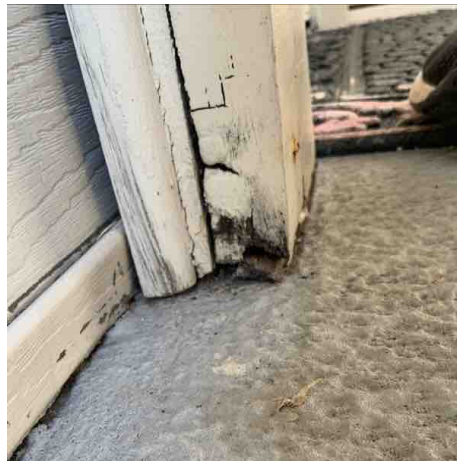
- Trim was noted cracked / deteriorated in areas around the front exterior door of the home. Recommend repairing and sealing to prevent possible further damage from moisture and/or pest penetration.

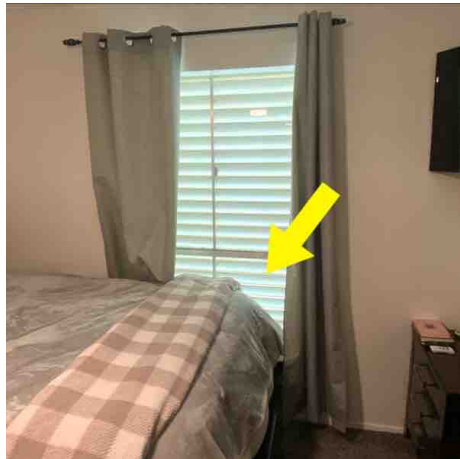
- Window in the back guest bedroom was noted not able to stay open on its own, slamming shut when open and released.

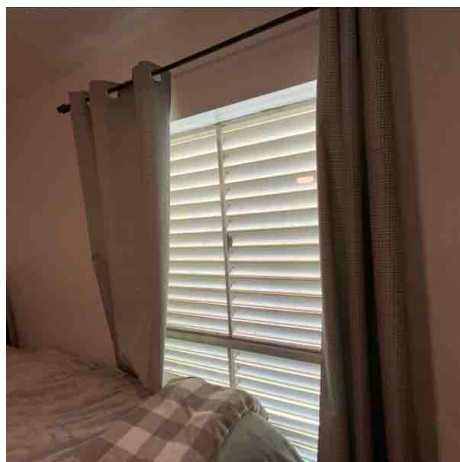
- Hurricane window shutters were noted on bedroom windows in the home. This impedes the egress through these windows. Bedrooms are required to have one egress window that does not require special tools to use, for a emergency exit.

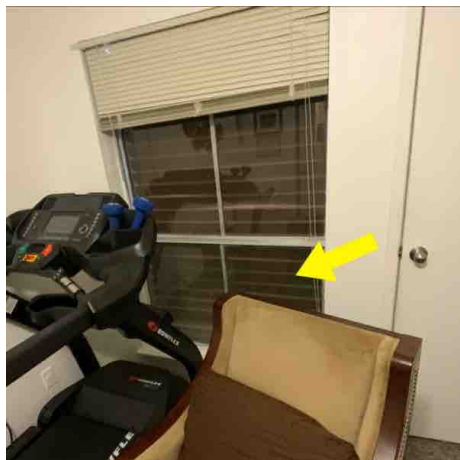
- Window in the front guest bedroom/office was unable to be opened at the time of inspection

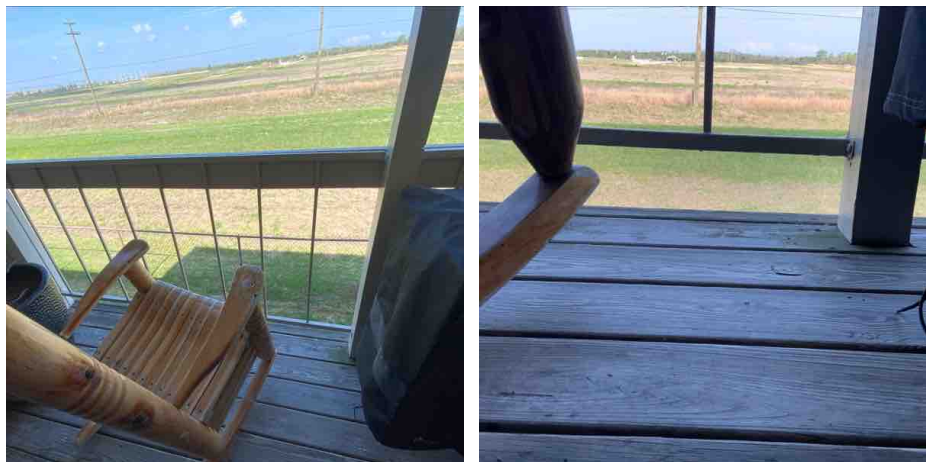
- **Baluster for the balcony guardrail are spaced to far apart, and the bottom of the guardrail opening is too large. The maximum space allowed between balusters and under the guardrail is 4", for child safety.**

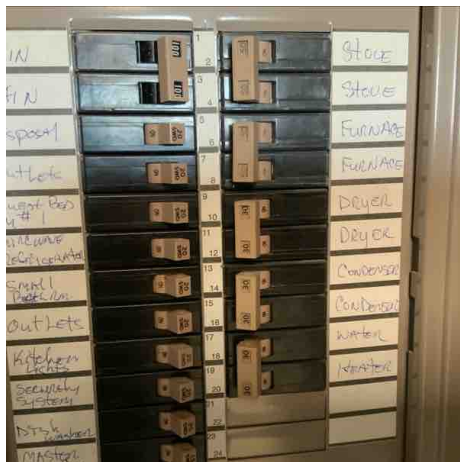
- AFCI breakers are not present in the service panel. AFCI breakers are now required in all habitable areas as a safety measure. This might not have been required at the time of the construction of this home, but is now required in today's safety standards.

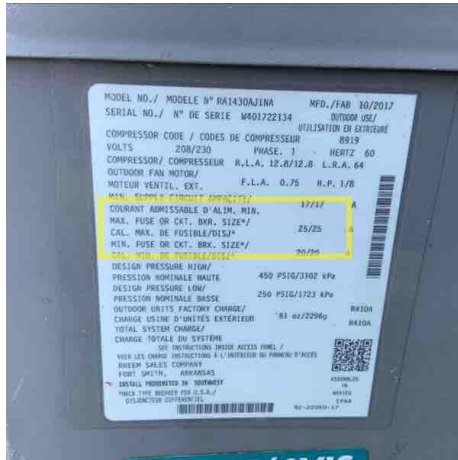
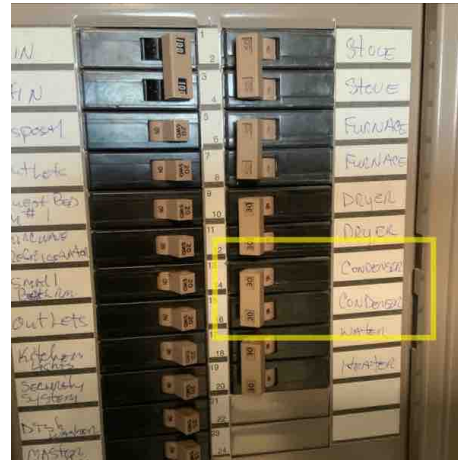
- Breaker protecting the AC condenser circuit is too large for the appliance. The AC condenser certification label state the max breaker sizes to be a 25 Amp breaker and a 30 Amp breaker was observed in the panel. This could allow the compressor to overheat and cause damage to the unit before tripping the breaker.

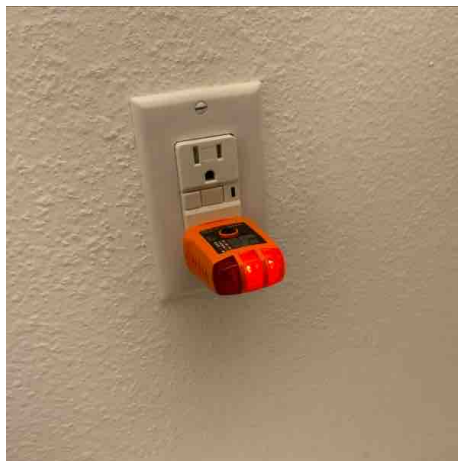
- The hallway bathroom GFCI receptacle was not able to be tripped when tested. Therefore, this receptacle is not functioning safely as a GFCI protected receptacle. All receptacles in wet areas, outside, and in the garage, are required to be GFCI protected. GFCI protected receptacles reduce the risk of electrical shock.

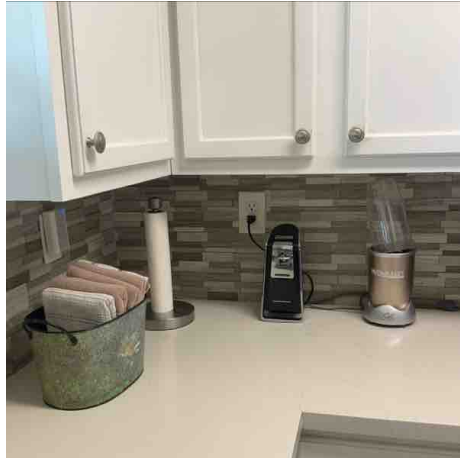
- There are currently no GFCI protected receptacles in the kitchen area. Today's building standards require the kitchen counter receptacles to be on a minimum of 2 circuits, spaced a maximum distance of 24" apart, ALL be GFCI protected, and the refrigerator on a different circuit from the counter receptacles. Recommend making needed repairs to ensure all required areas are GFCI protected for safety.

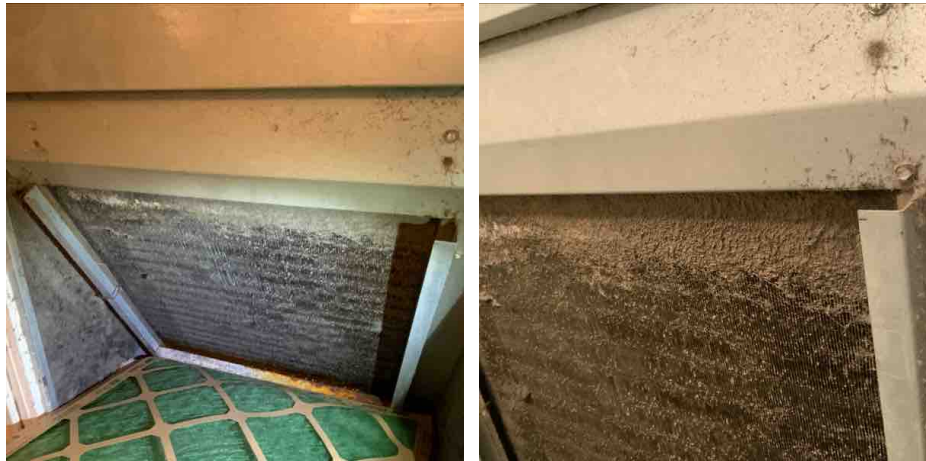
- AC evaporator coils in the attic unit were noted extremely dirty. Recommend cleaning the coils to improve the efficiency of the system.

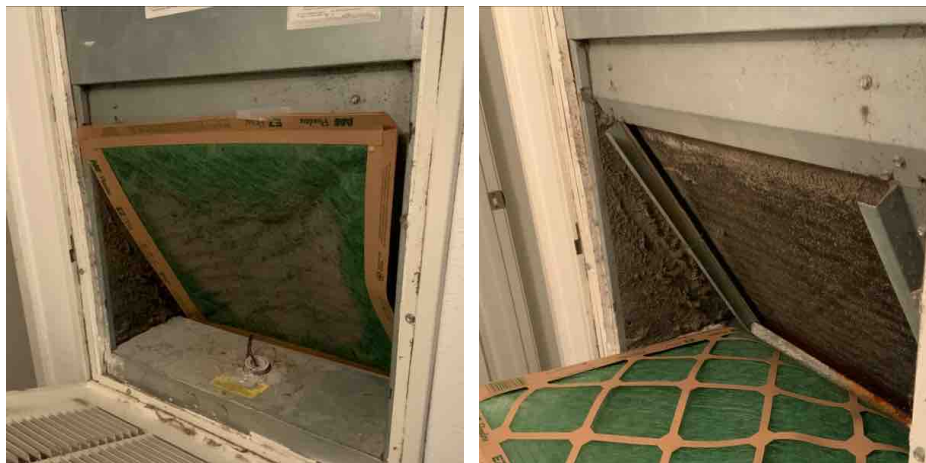
- The current AC filter installed in the unit does not appear to be the correct size filter for the system. Recommend installing the proper size filter in the unit for proper operation

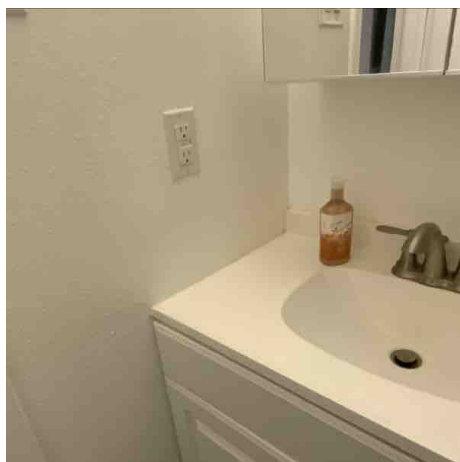
- Side splash piece was noted missing in the hallway bathroom sink. This is required to protect the drywall from moisture damage.

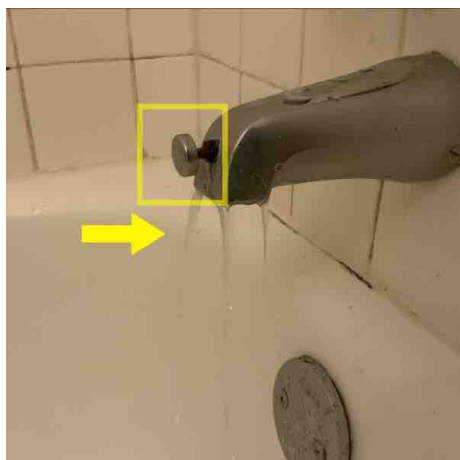
- Water pressure / diverter in the hallway bathtub, does not completely change over to the shower head when adjusted, water continues to come out of the spout while the shower is running.

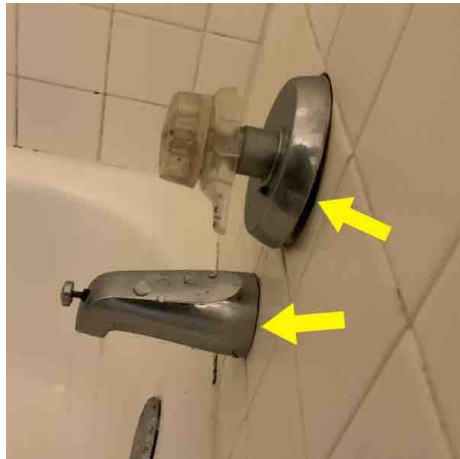
- **Tub spouts / handles in the showers/bathtubs should be sealed to prevent water penetration into the walls.**

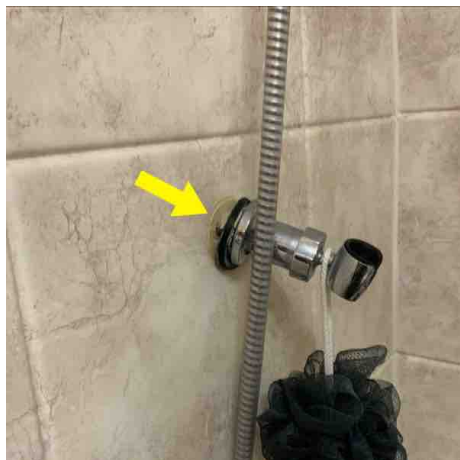
- **Shower control handle holder loose in the primary bath tub/shower wall. Recommend making need repairs to seal this area at the wall properly to prevent possible water penetration**

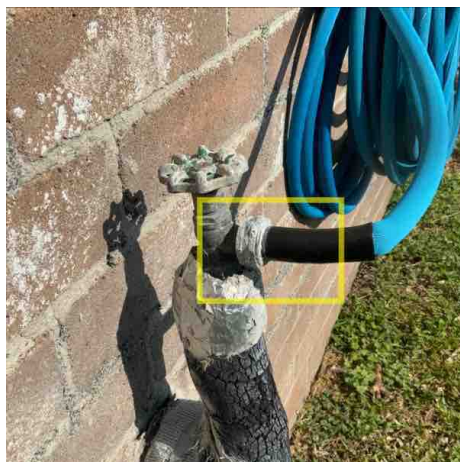
- **Hose bibs are missing the anti-siphon device. Recommend adding these to prevent backsiphonage into the house water supply**

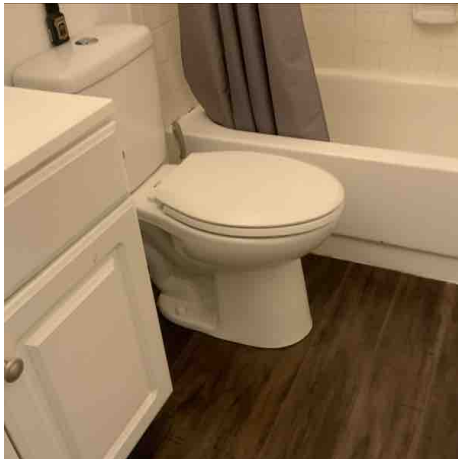
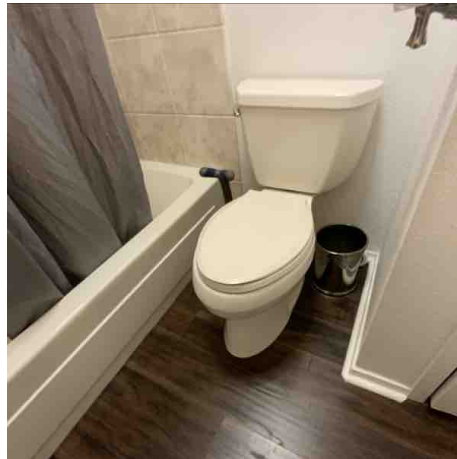
- Main sewer clean out location
- **Both bathroom toilets in the home were noted completely loose at the floor. Recommend securing and sealing at the floor to prevent possible leaks.**

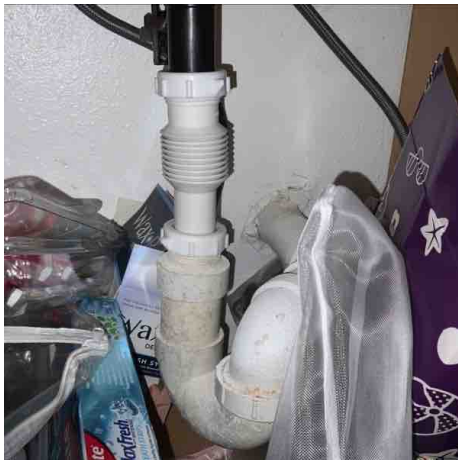
- **Improper plumbing material used to connect tail pipe to trap under the hallway bathroom sink. Material should be smooth walled pipe.**

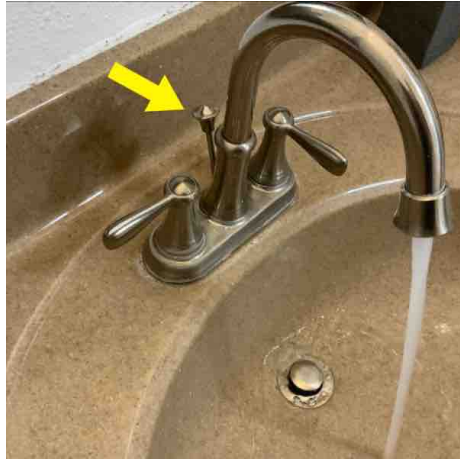
- Pull rod at the primary bathroom sink failed to operate the drain stopper.

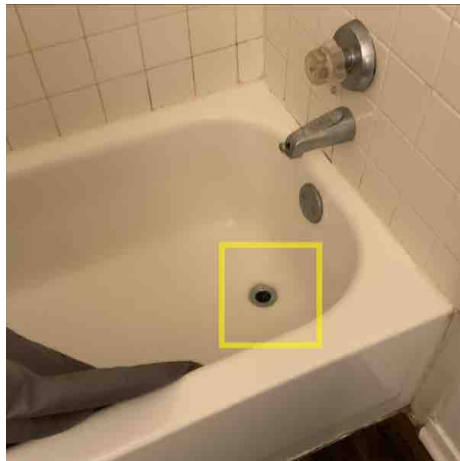
- Both bathtubs in the home are currently missing a drain stopper to properly seal and hold water in the bathtubs.

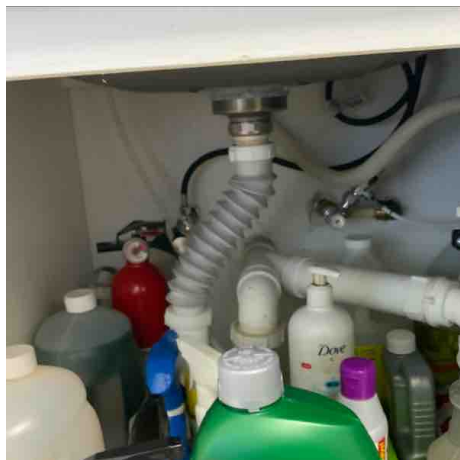
- Improper plumbing material used to connect tail pipe to trap under the kitchen sink. Material should be smooth walled pipe.

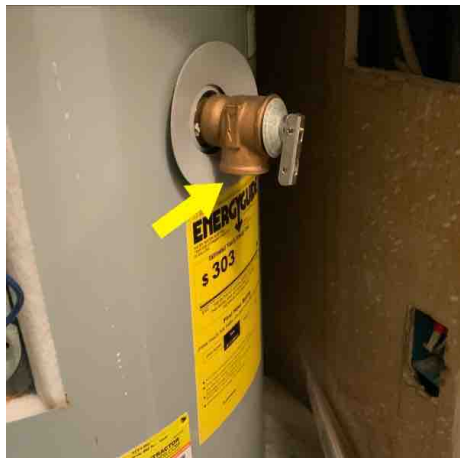
- The TPR valve was noted with no drain line connected to the valve. This should be repaired to ensure proper drainage incase the valve is needed for use. This drain line is required to terminate to the exterior of the home within 6" of grade, due to the high pressure and temperature of the water that will be releasing if this valve is needed for use.

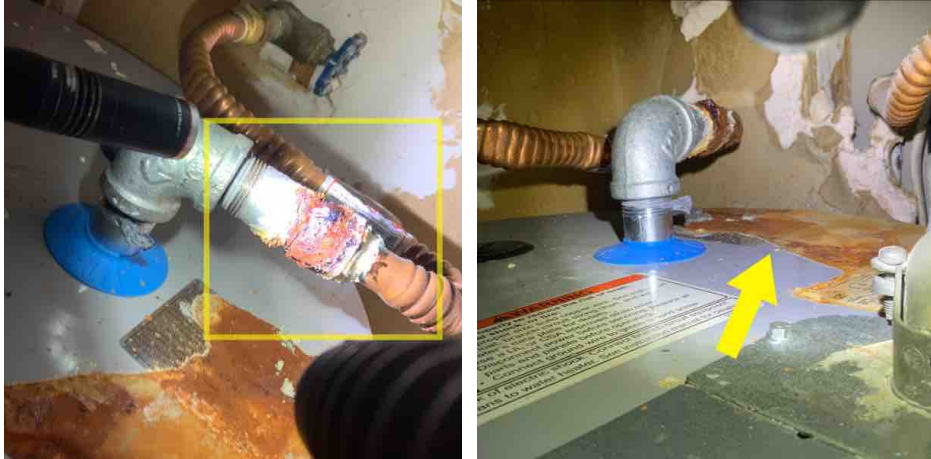
• Galvanic corrosion / major rust observed at the water connection to the unit. This occurs when dissimilar metals are directly connected. This connection should be made with a dielectric union to prevent corrosion. Rust was also noted on the top of the unit under this area.

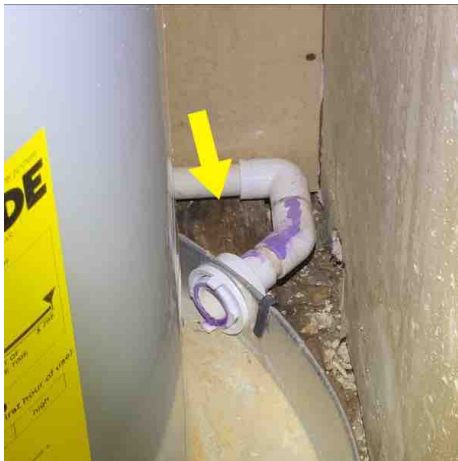
• Possible moisture damage was noted in areas at the back of the water heater closet at the wood flooring. Recommend further investigation into this area to confirm if this is active moisture damage and make any needed repairs.
