# 4650 Axis Trl

## Conroe, Texas 77303

| Type | <b>Home Inspection, Floor Plan and Pool Inspection Report - 4650 Axis Trl</b> |
| Inspected by | <b>Rio Bravo - Inspectify Pro - Houston</b> |

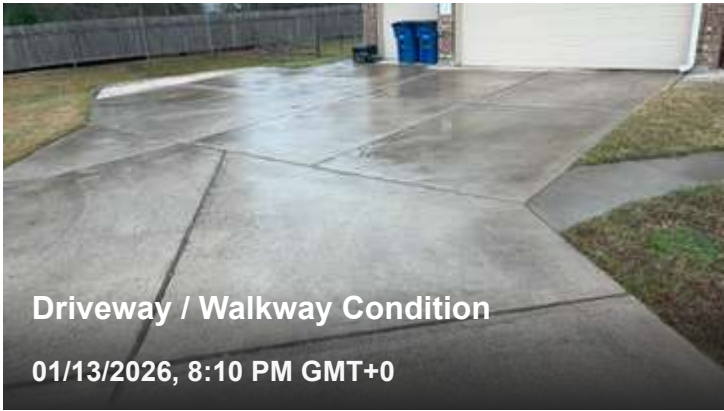
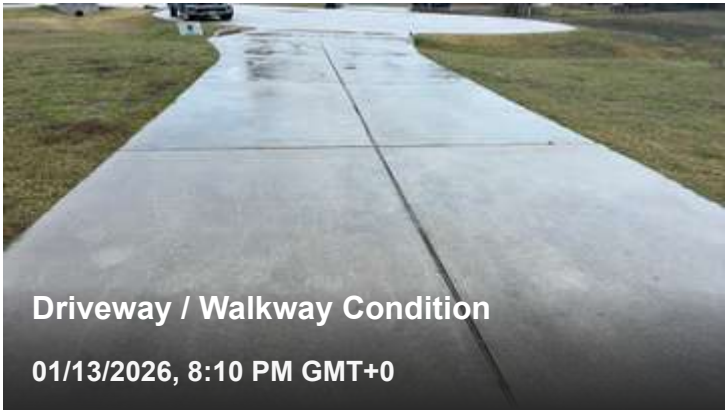
Minor Cracks in the Driveway

The driveway has minor cosmetic cracks. Recommend repairs or replacing by a qualified professional.

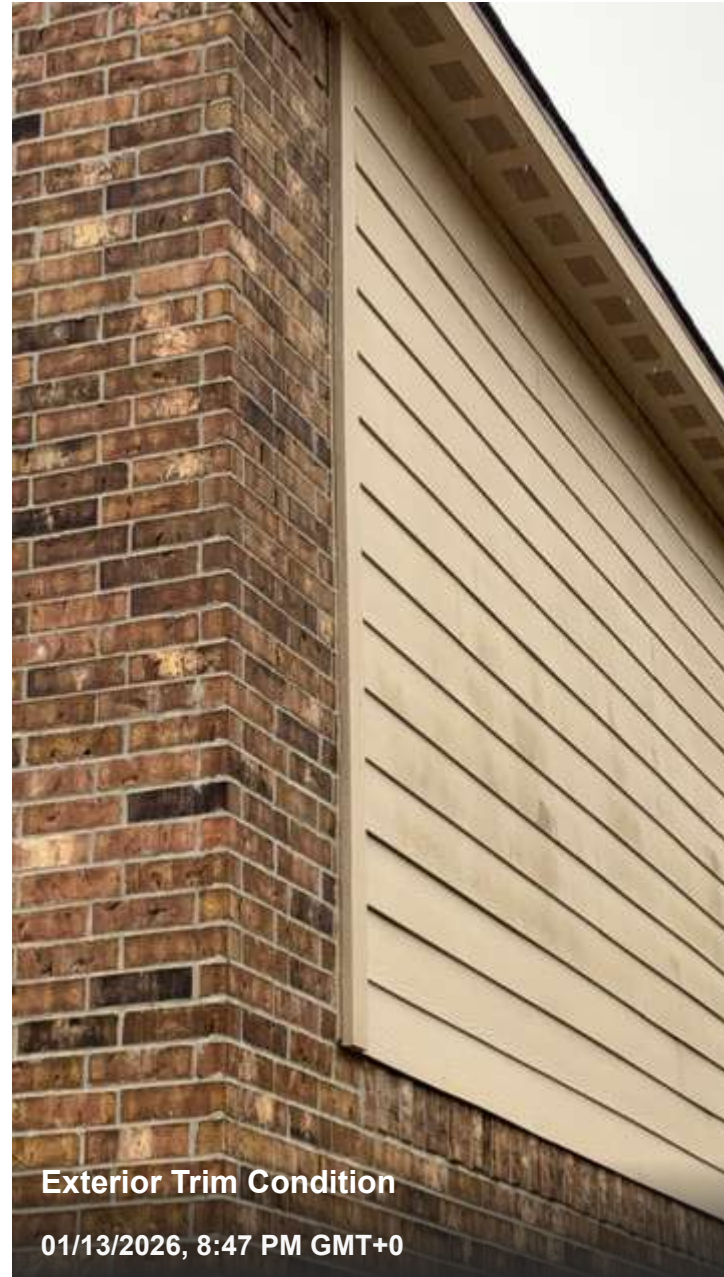
## Missing Exterior Caulk

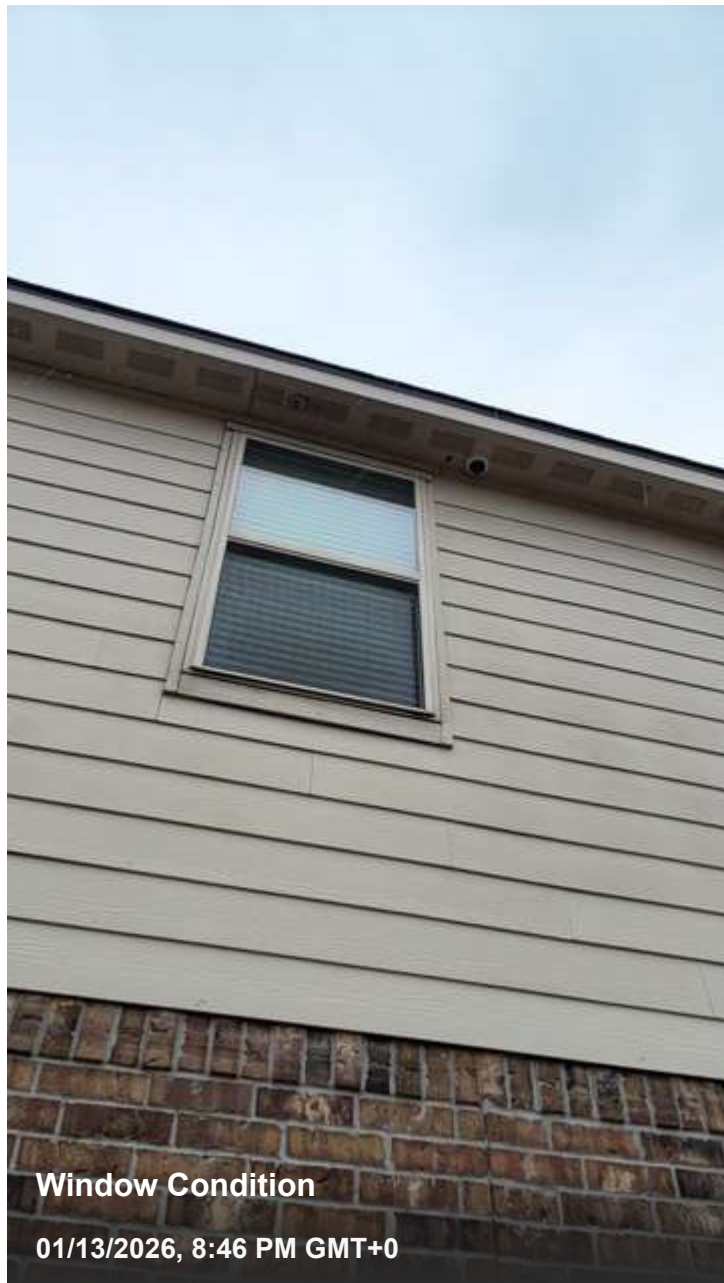
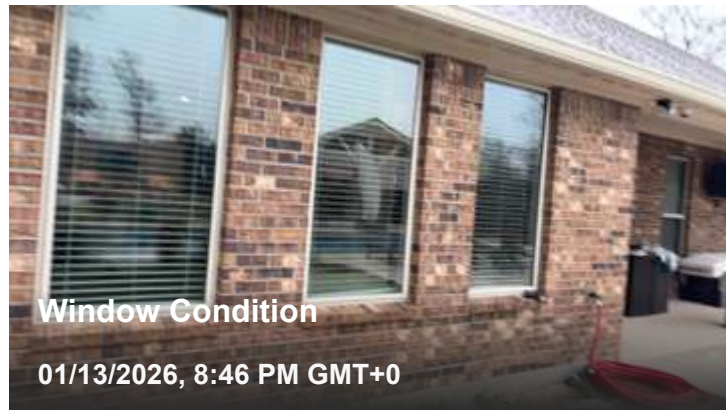
## Missing Window Screen

One or more windows are missing a screen. Recommend repairs or replacing by a qualified professional.

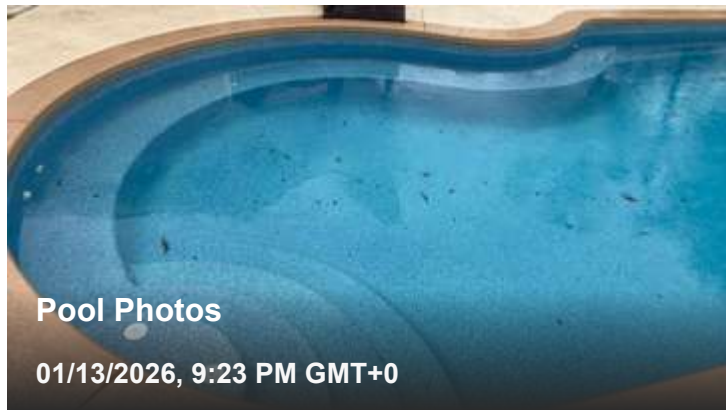
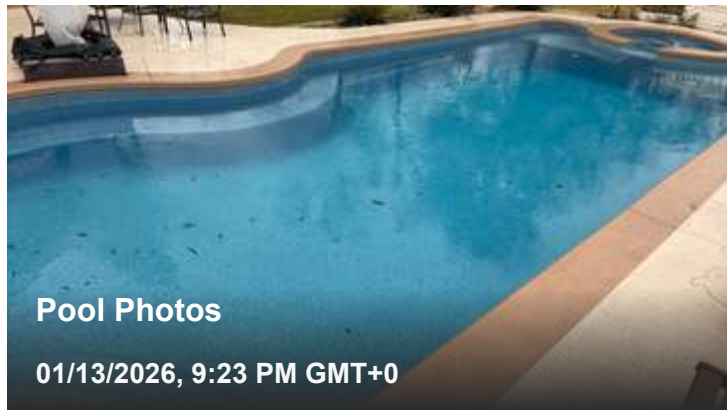
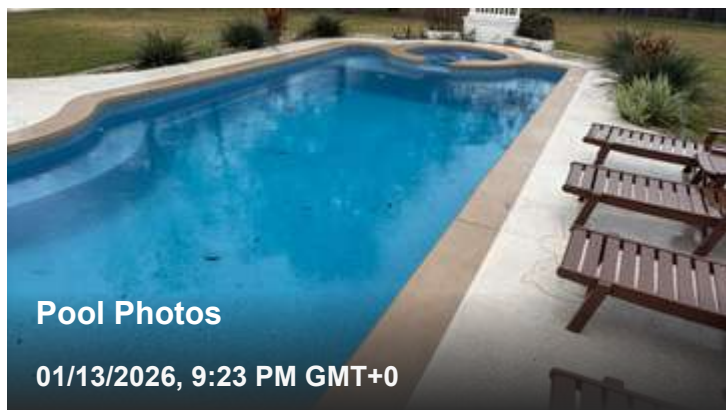
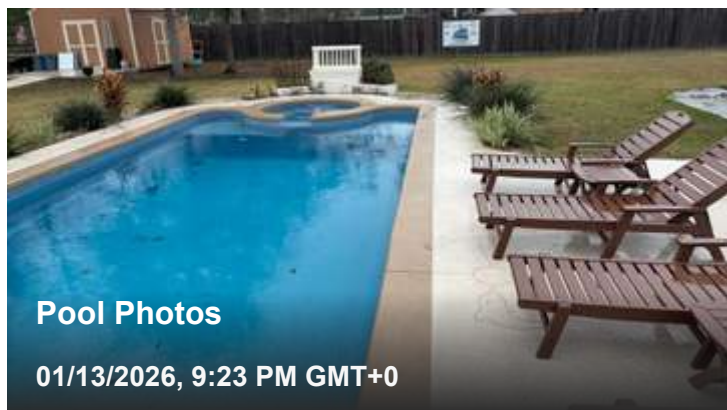
## Inadequate Pool Gate

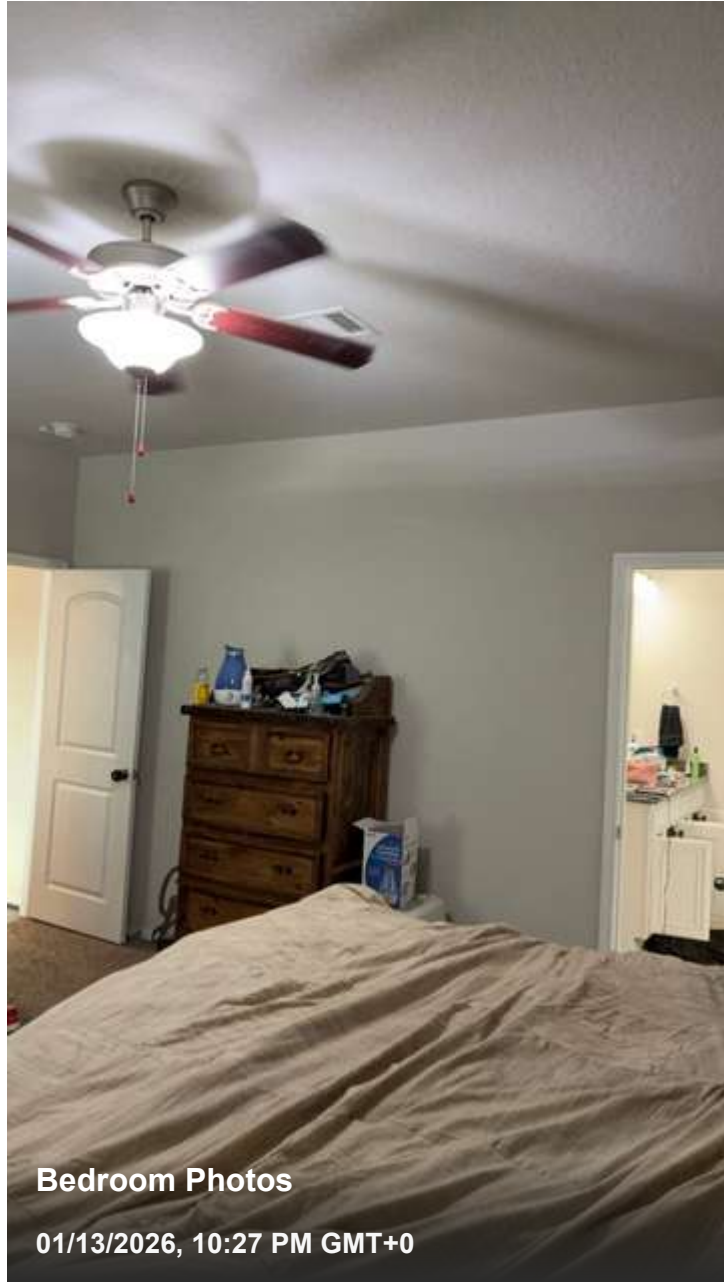
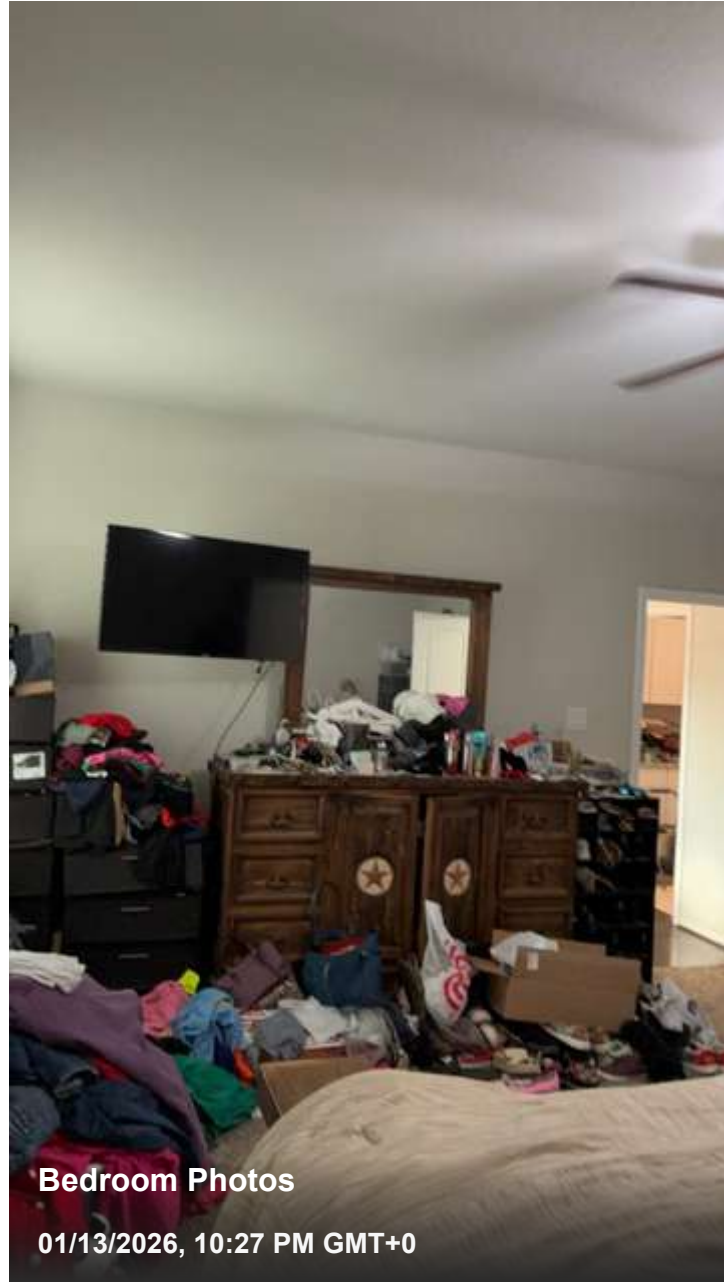
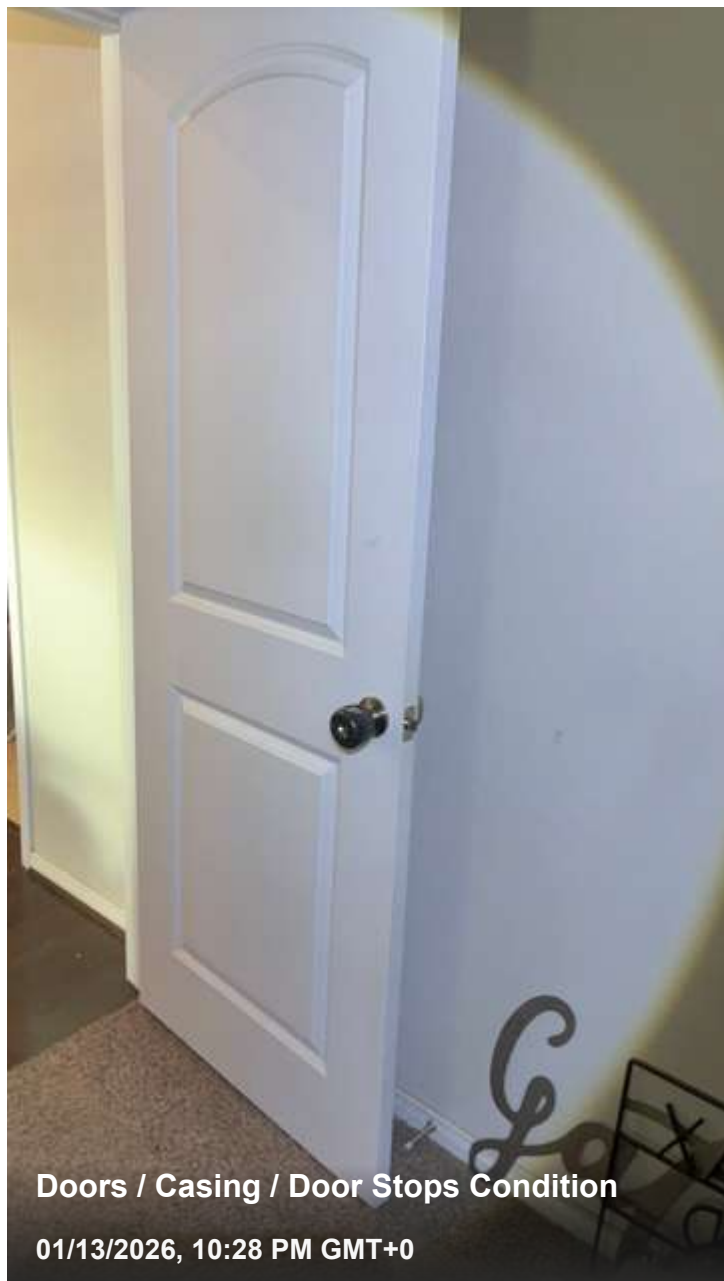
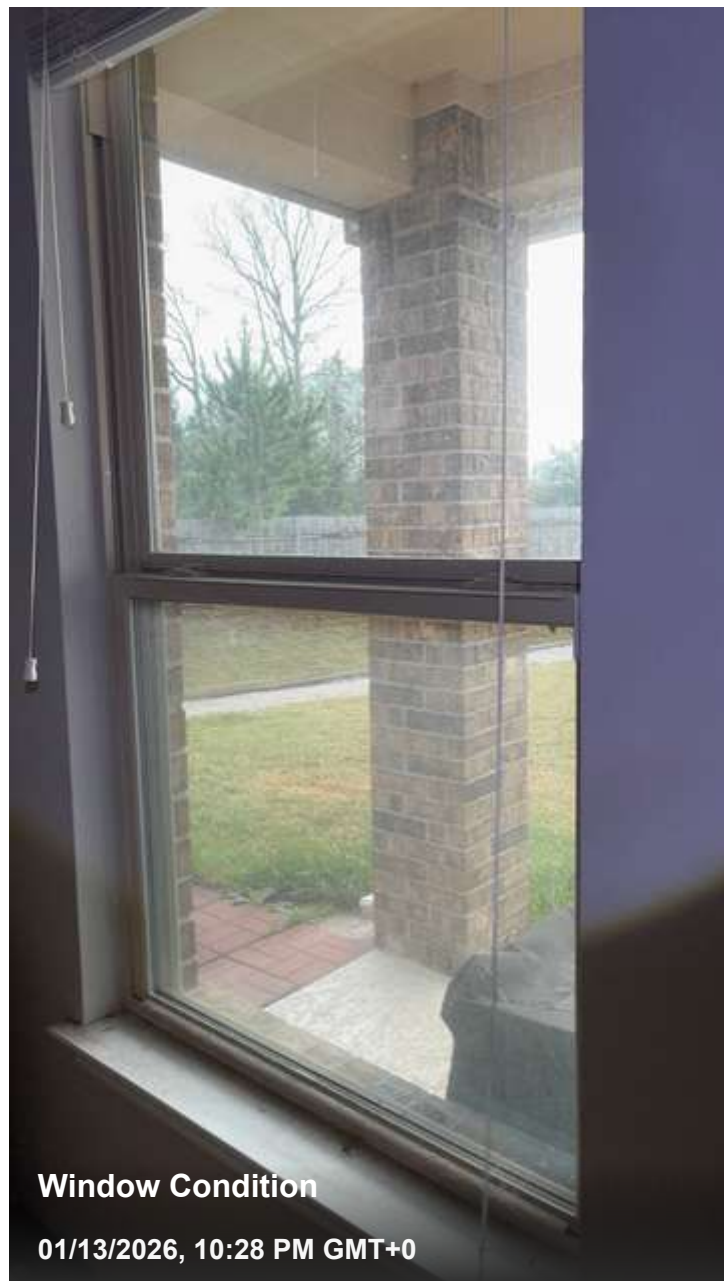
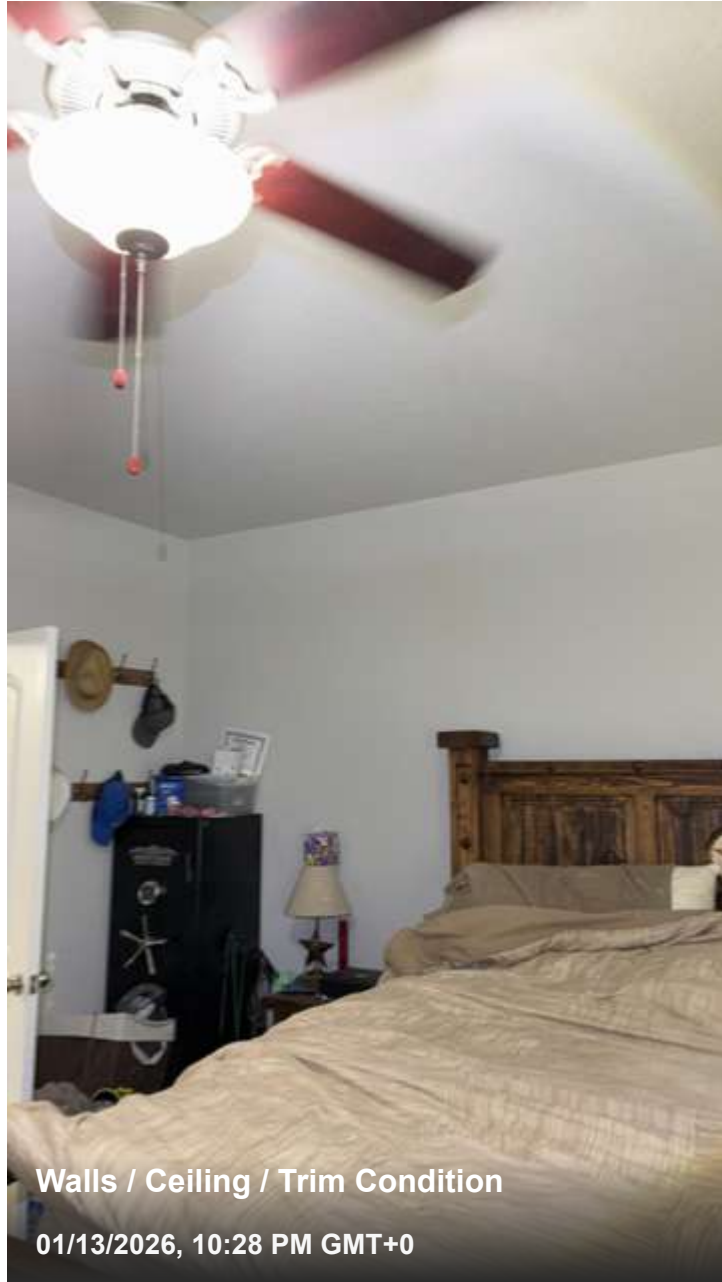
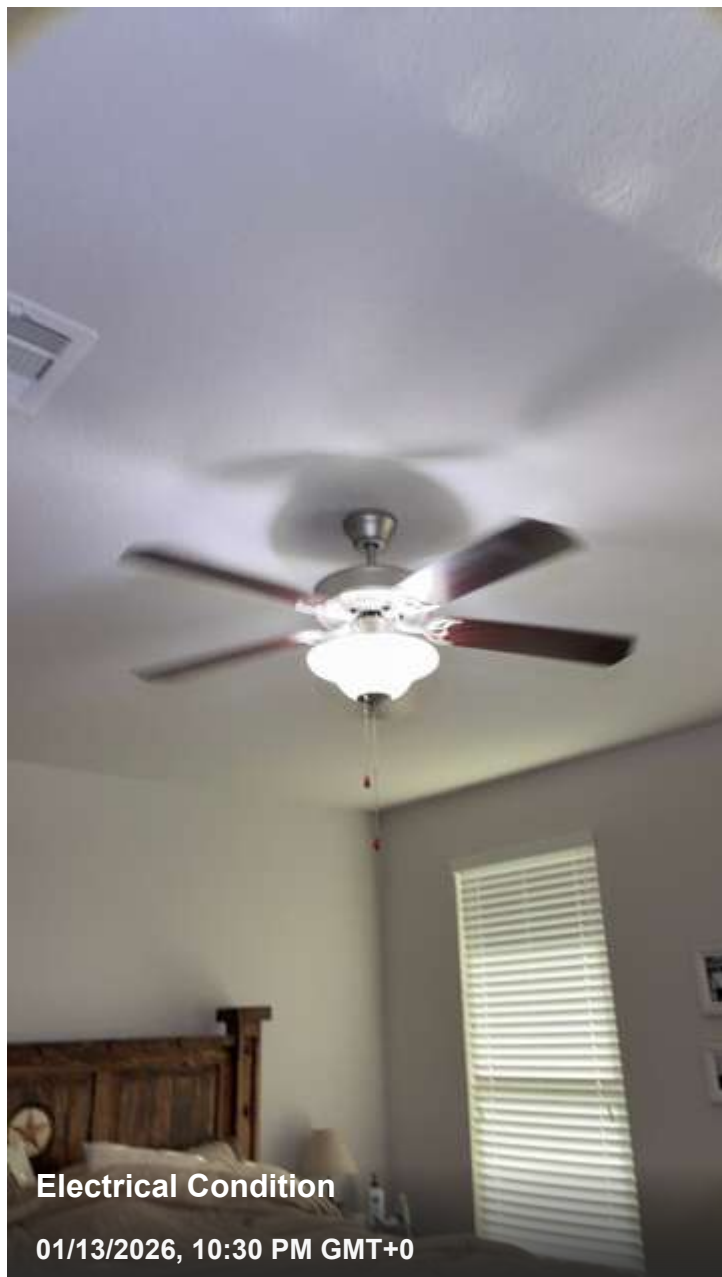
### Damaged door knob

One or more doorknobs are damaged

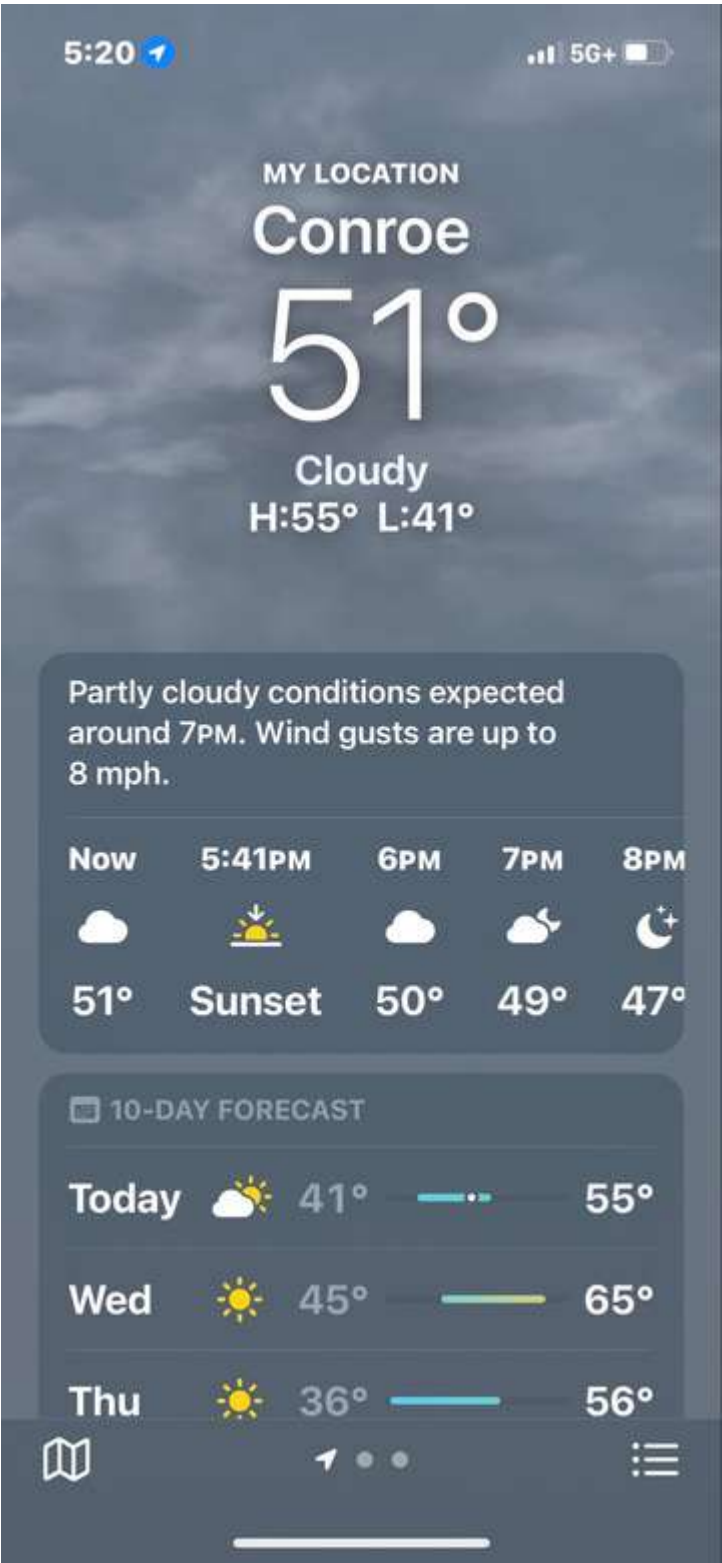
Cooling Equipment Condition: Other

Because the outside temperature was too cool to operate the air conditioner without the possibility of damaging the system, I did not operate the cooling system.

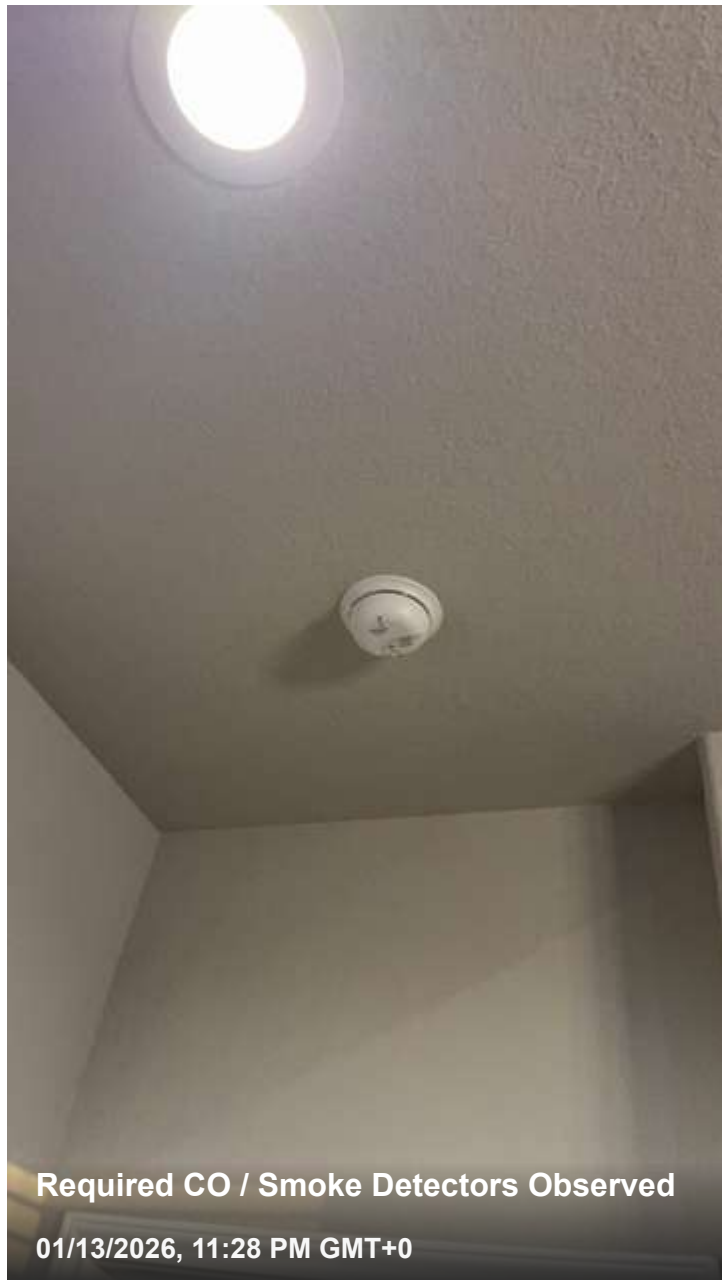
#### Missing Smoke Detector(s)

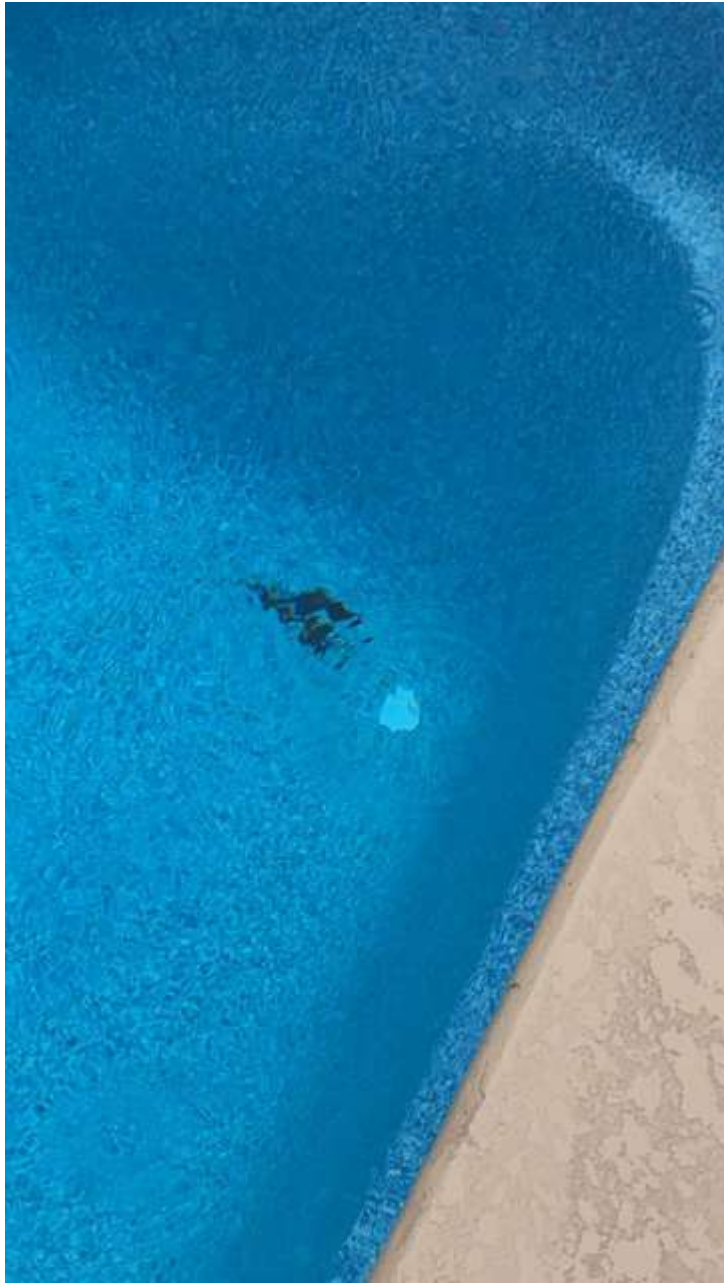
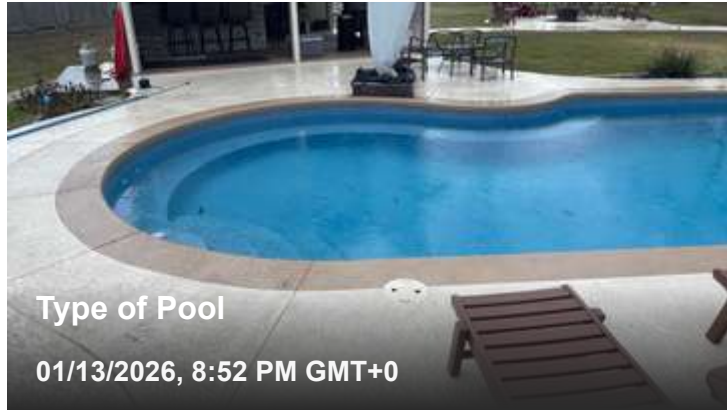
**Patch noted on bottom of pool**
