Job Estimate

Date: March 3, 2026  
To: Linda Mullins  
RE: 2314 Hudly St B Houston, Tx 77019

# Lone Star Stucco, LLC

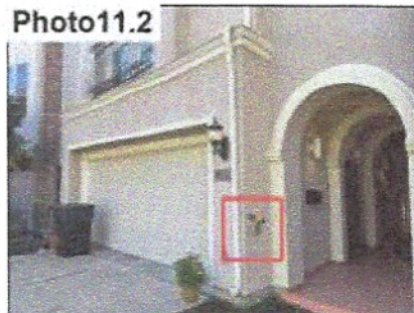
Photo11.2

Substrate Damage / Assess, Repair and Install Proper Relief

Grid Location	Item Description	Moisture Readings	Substrate Condition	Observations
Red Boxes	Damage			Confirmed substrate and potential frame damage is noted at the bottom of the wall. The inspector recommends having a qualified waterproofing contractor further assess the extent of damage, repair as needed and install a proper relief in an effort to prevent moisture intrusion. Please refer to photos #11.2, #11.3, #11.4, #11.5 and #11.6 for more detail.

Remove damaged stucco and sheeting on page 11,16,21,23,24,25,27,33

Install the missing drainage openings on page 11,21,23,24 (Drain Relief)

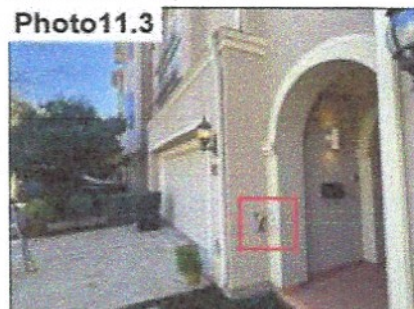
Photo11.3

Substrate Damage / Assess, Repair and Install Proper Relief

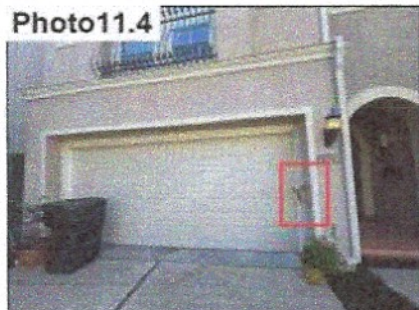
Photo11.4

Substrate Damage / Assess, Repair and Install Proper Relief

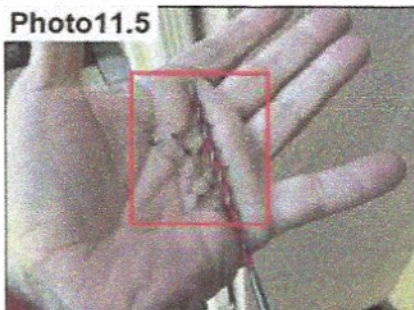
Photo11.5

Substrate Damage / Assess, Repair and Install Proper Relief

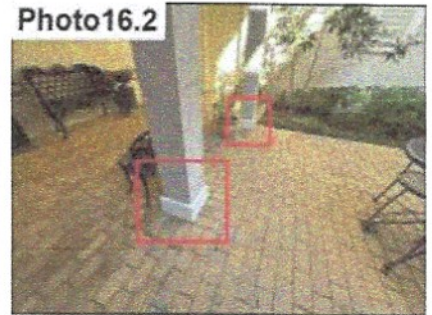
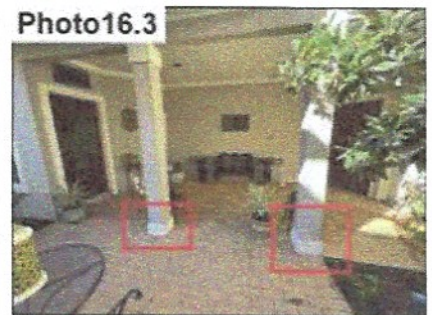
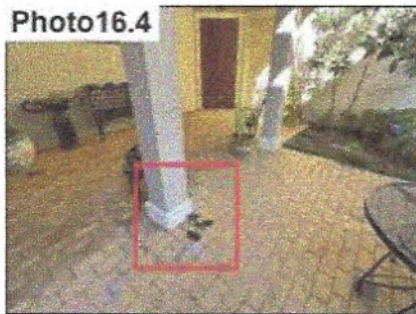
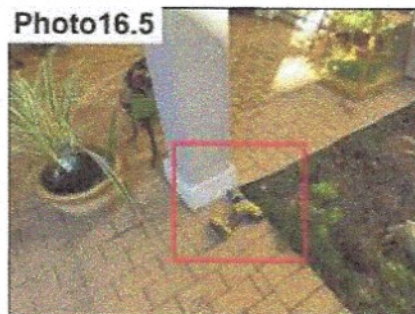
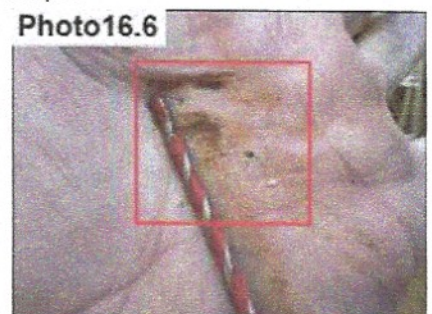
Substrate Damage / Assess & Repair

Grid Location	Item Description	Moisture Readings	Substrate Condition	Observations
Red Boxes	Damage			Confirmed substrate and potential frame damage is noted in the column. The inspector recommends having a qualified waterproofing contractor further assess the extent of damage, repair and modify as needed in an effort to prevent moisture intrusion. Please refer to photos #16.2, #16.3, #16.4, #16.5 and #16.6 for more detail.
D6	Columns		None	A moisture probe was taken at column. No substrate was noted at this time, modify as needed.
F6	Columns		None	A moisture probe was taken at column. No substrate was noted at this time, modify as needed.

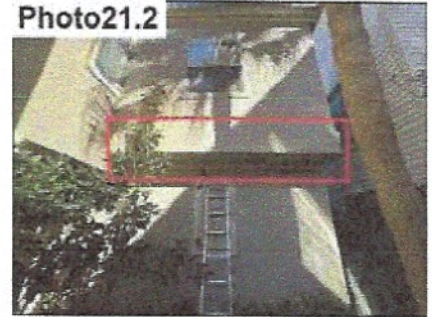
Photo21.2  
Substrate Damage / Assess, Repair and Install Proper Relief

Grid Location	Item Description	Moisture Readings	Substrate Condition	Observations
Red Box	Damage			Confirmed substrate and potential beam damage is noted at the bottom of the wall. The inspector recommends having a qualified waterproofing contractor further assess the extent of damage, repair as needed and install a proper relief in an effort to prevent moisture intrusion. Please refer to photos #21.2, #21.3, #21.4 and #21.5 for more detail.
E5	Bottom Wall		None	A moisture probe was taken at bottom wall. No substrate was noted at this time, modify as needed.
F5	Bottom Wall		None	A moisture probe was taken at bottom wall. No substrate was noted at this time, modify as needed.

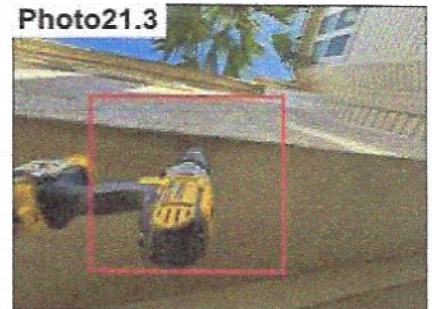
Photo21.3  
Substrate Damage / Assess, Repair and Install Proper Relief

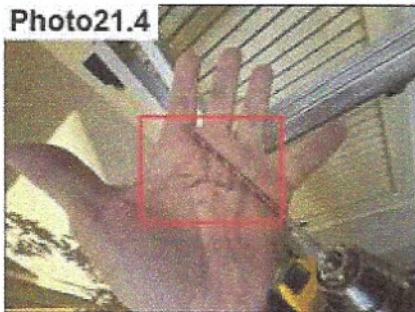
Photo21.4  
Substrate Damage / Assess, Repair and Install Proper Relief

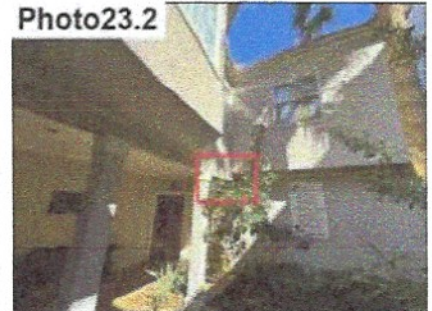
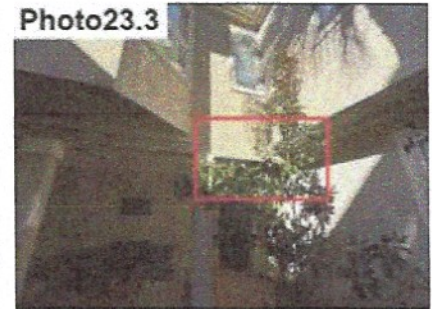
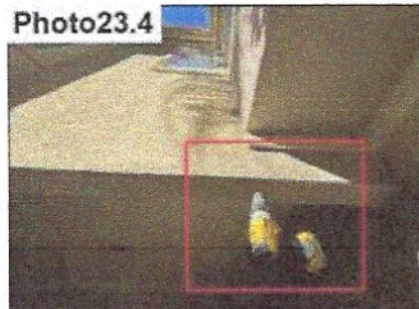
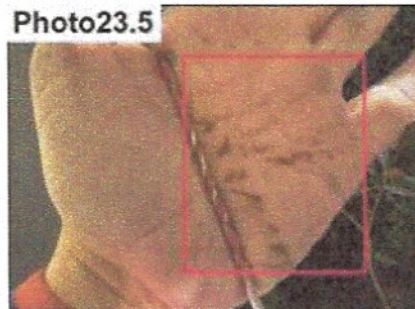
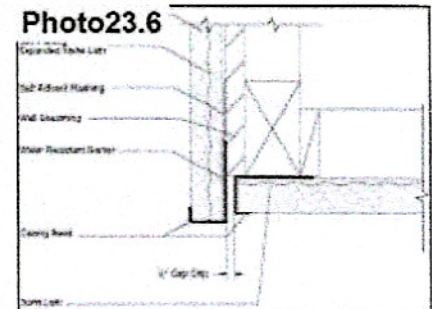
Substrate Damage / Assess, Repair and Install Proper Relief

Grid Location	Item Description	Moisture Readings	Substrate Condition	Observations
Red Box	Damage			Confirmed substrate and potential frame damage is noted at the bottom of the wall. The inspector recommends having a qualified waterproofing contractor further assess the extent of damage, repair as needed and install a proper relief in an effort to prevent moisture intrusion. Please refer to photos #23.2, #23.3, #23.4, #23.5 and #23.6 for more detail.
G4	Bottom Wall		None	A moisture probe was taken at bottom wall. No substrate was noted at this time, modify as needed.
H4	Bottom Wall		None	A moisture probe was taken at bottom wall. No substrate was noted at this time, modify as needed.

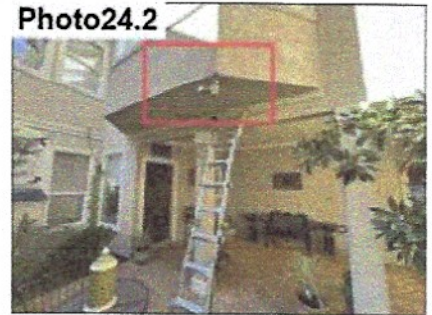
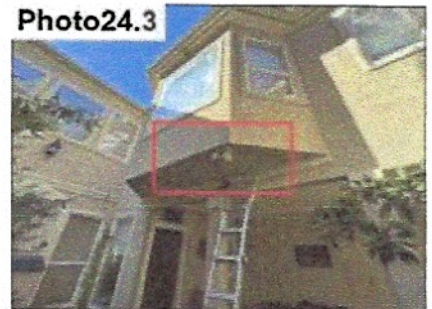
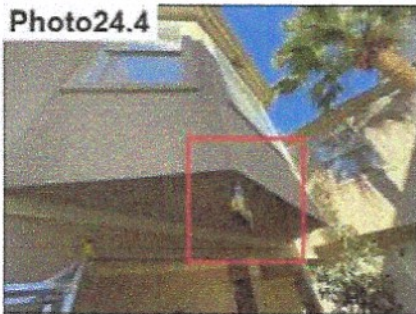
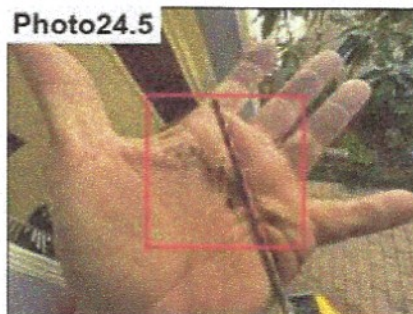
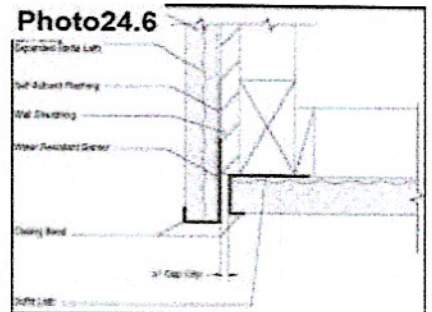
Substrate Damage / Assess, Repair and Install Proper Relief

Grid Location	Item Description	Moisture Readings	Substrate Condition	Observations
Red Box	Damage			Confirmed substrate and potential frame damage is noted at the bottom of the wall. The inspector recommends having a qualified waterproofing contractor further assess the extent of damage, repair as needed and install a proper relief in an effort to prevent moisture intrusion. Please refer to photos #24.2, #24.3, #24.4, #24.5 and #24.6 for more detail.
F4	Bottom Wall		None	A moisture probe was taken at bottom wall. No substrate was noted at this time, modify as needed.
E4	Bottom Wall		None	A moisture probe was taken at bottom wall. No substrate was noted at this time, modify as needed.

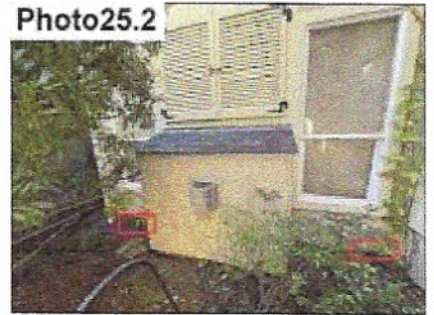
Photo25.2

Wood Rot at Bottom Wall/ Repair

Grid Location	Item Description	Moisture Readings	Substrate Condition	Observations
Red Box	Wood Rot			The bottom of the wall in this area has wood rot. The inspector suggests to have a qualified contractor further assess and repair this area as needed in an effort to prevent moisture intrusion. All wood rot was not necessarily identified in this report. Please refer to photos #25.2, #25.3 and #25.4 for more detail.

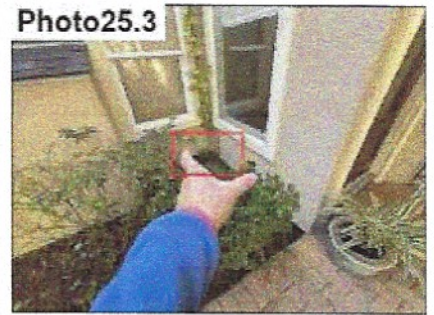
Photo25.3

Wood Rot at Bottom Wall/ Repair

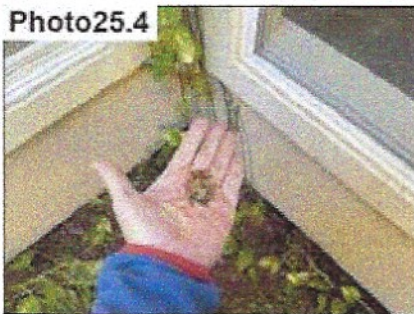
Photo25.4

Wood Rot at Bottom Wall/ Repair

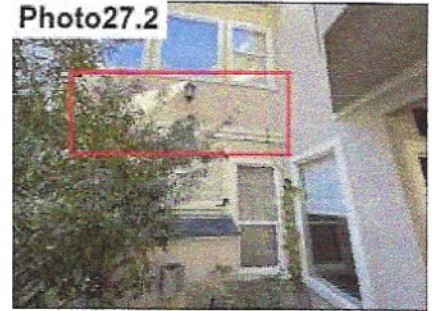
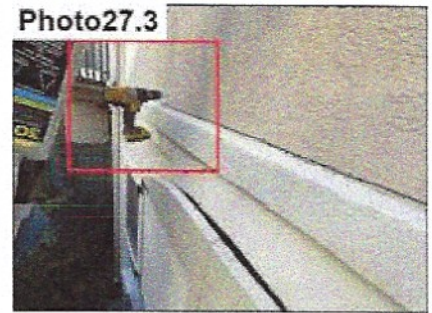
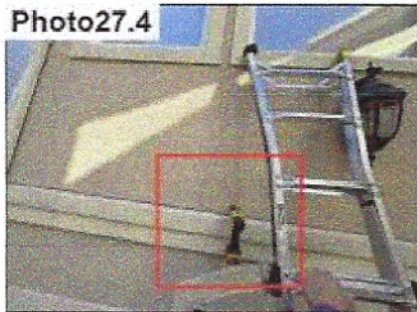
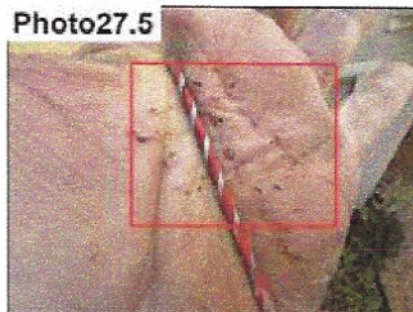
Substrate Damage / Assess & Repair

Grid Location	Item Description	Moisture Readings	Substrate Condition	Observations
Red Box	Damage			Confirmed substrate and potential window header damage noted at this location. The inspector suggests to have a qualified waterproofing contractor further assess the extent of damage, modify this area and install a relief in an effort to prevent moisture intrusion. Please refer to photos #27.2, #27.3, #27.4 and #27.5 for more detail.
B4 (Red)	Window Header		None	A moisture probe was taken at the window header. No substrate was noted at this time, modify as needed.
B4 (Orange)	Window Header		None	A moisture probe was taken at the window header. No substrate was noted at this time, modify as needed.
C4	Window Header	20%	Firm	A moisture probe was taken at window header. An elevated moisture reading was noted with a firm substrate.

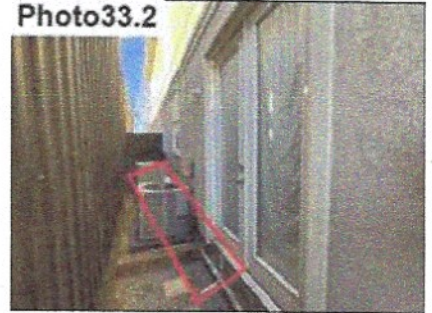
Photo33.2

Substrate Damage / Assess & Repair

Grid Location	Item Description	Moisture Readings	Substrate Condition	Observations
Red Box	Damage			Confirmed substrate and potential frame damage is noted at the bottom of the wall. The inspector recommends having a qualified waterproofing contractor further assess the extent of damage, repair as needed and install a proper relief in an effort to prevent moisture intrusion. Please refer to photos #33.2, #33.3, #33.4, #33.5 and #33.6 for more detail.

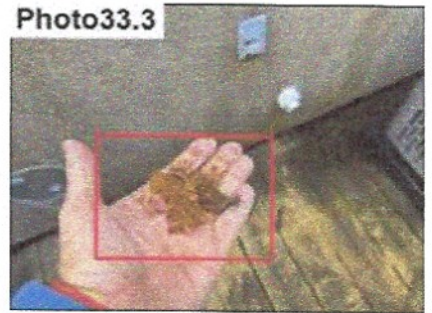
Photo33.3

Substrate Damage / Assess & Repair

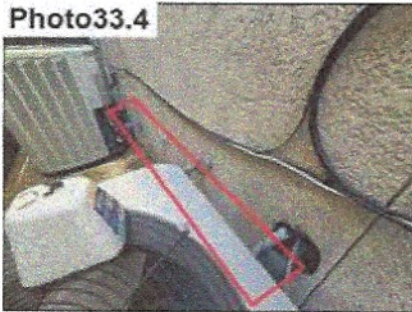
Photo33.4

Substrate Damage / Assess & Repair

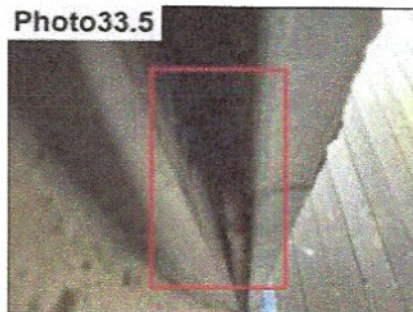
Photo33.5

Substrate Damage / Assess & Repair

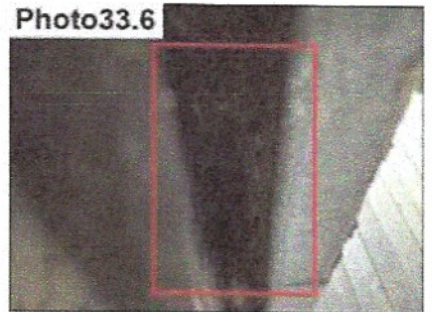
Photo33.6

Substrate Damage / Assess & Repair
