ESTIMATE

FOR: Blake Hillegeist
2314 Huldy St Houston, TX 77019

Lone Star Stucco, LLC

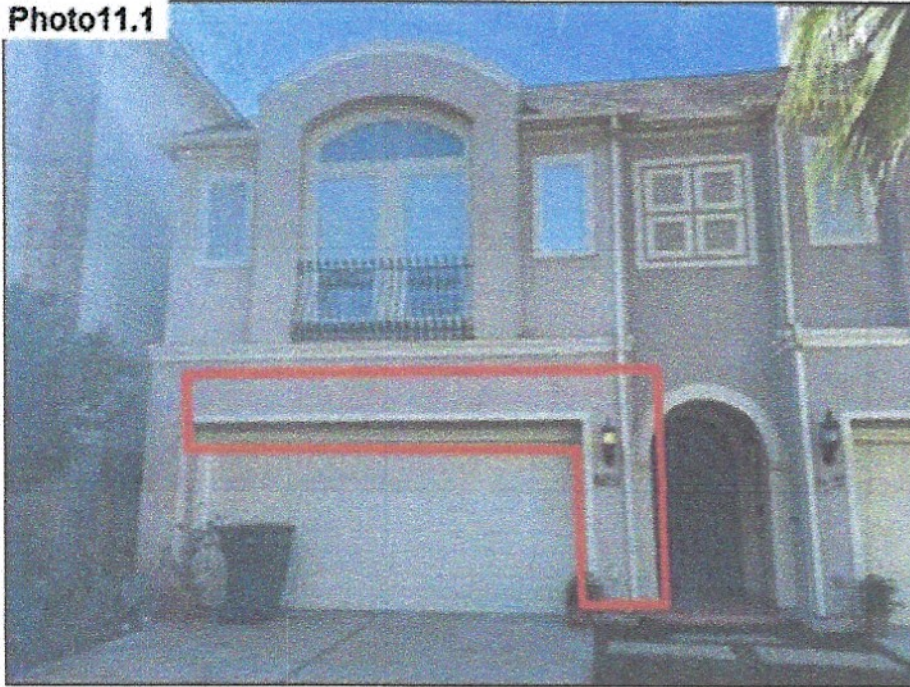
Photo11.1

Grid Location	Item Description	Moisture Readings	Substrate Condition	Observations
Red Boxes	Damage			Confirmed substrate and potential frame damage is noted at the bottom of the wall. The inspector recommends having a qualified waterproofing contractor further assess the extent of damage, repair as needed and install a proper relief in an effort to prevent moisture intrusion. Please refer to photos #11.2, #11.3, #11.4, #11.5 and #11.6 for more detail.

Description	Quantity	Unit price	Amount
Stucco Repair Remove and replace the lower beam liner, and Repair framing members and insulatic designed to facilitate drainage according to the report on page 11 photo 11.1 , 11.2 , 11.3 , 11.4 , 11.5	1	\$6,800.00	\$6,800.00
. Remove and replace the lower corner rner wall and also below the kickout flashing according to the report. on page 13 Repair framing members and insulatic de	1	\$3,500.00	\$3,500.00
. Fix and paint cracks at casing as per report page 15	1	\$100.00	\$100.00
. Remove and replace deteriorated and 2 column as per report page photo 16 Location	1	\$1,200.00	\$1,200.00
. Remove and replace deteriorated sheathing at botton wall as per report page photo 21 ,1 Location E5 F5 repair framing members and insulation if present. Install weep screed to proper relief	1	\$1,600.00	\$1,600.00
. Remove and replace deteriorated sheathing at botton wall as per report page photo 23,1 Location G4 H4 repair framing members and insulation if present. Install weep screed to proper relief	1	\$1,600.00	\$1,600.00

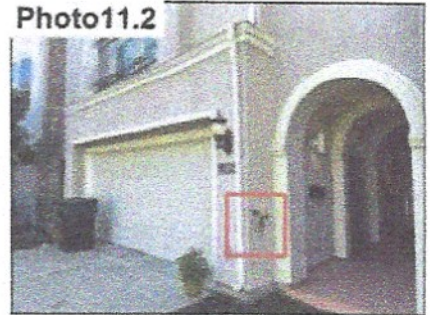
Photo11.2

Substrate Damage / Assess, Repair and Install Proper Relief

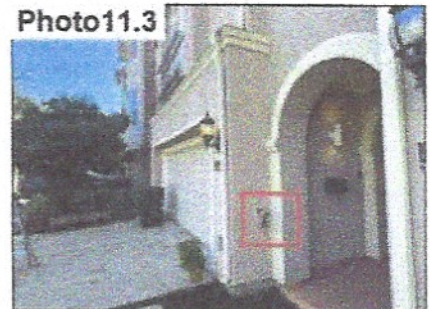
Photo11.3

Substrate Damage / Assess, Repair and Install Proper Relief

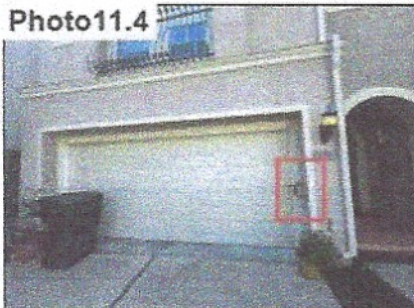
Photo11.4

Substrate Damage / Assess, Repair and Install Proper Relief

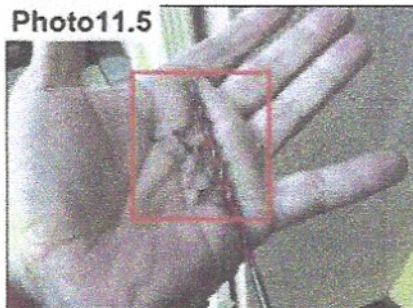
Photo11.5

Substrate Damage / Assess, Repair and Install Proper Relief

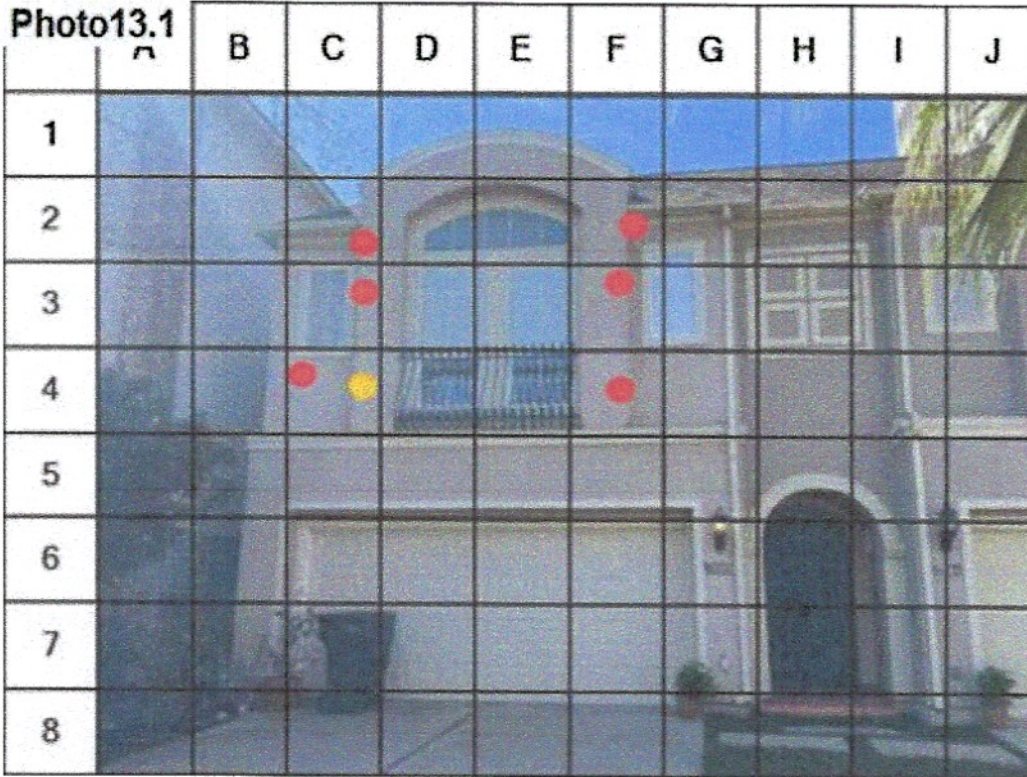
Grid Location	Item Description	Moisture Readings	Substrate Condition	Observations
C4 (Red)	Window Lower Left	23%	Firm	A moisture probe was taken at the window lower left. An elevated moisture reading was noted with a firm substrate.
C4 (Orange)	Corner Wall Below Failing Kickout	22%	Semi-Firm	A moisture probe was taken at corner wall below failing kickout flashing . An elevated moisture reading was noted with a semi-firm substrate.
C3	Corner Wall Below Failing Kickout	21%	Semi-Firm	A moisture probe was taken at corner wall below failing kickout flashing. An elevated moisture reading was noted with a semi-firm substrate.
F4	Corner Wall Below Failing Kickout	20%	Firm	A moisture probe was taken at corner wall below failing kickout flashing. An elevated moisture reading was noted with a firm substrate.
F3	Corner Wall Below Failing Kickout	22%	Firm	A moisture probe was taken at corner wall below failing kickout flashing. An elevated moisture reading was noted with a firm substrate.

C2	Corner Wall Below Failing Kickout		None	A moisture probe was taken at corner wall below failing kickout flashing. No substrate was noted at this time, modify as needed.
F2	Corner Wall Below Failing Kickout		None	A moisture probe was taken below the kickout flashing. No substrate was noted at this time, modify as needed.

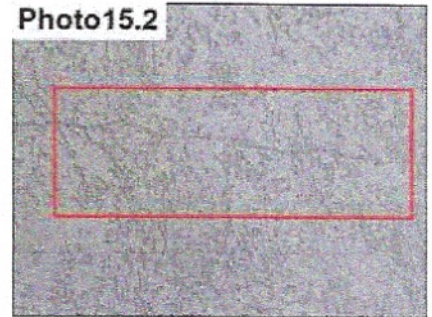
Photo15.2

Cracks / Paint (Aesthetic)

Grid Location	Item Description	Moisture Readings	Substrate Condition	Observations
Red Box	Cracks			Cracks are noted at this location. The inspector suggests to have a qualified waterproofing contractor paint for aesthetic concerns only. All cracking was not necessarily identified in this report. Please refer to photos #15.2, #15.3, #15.4 and #15.5 for more detail.

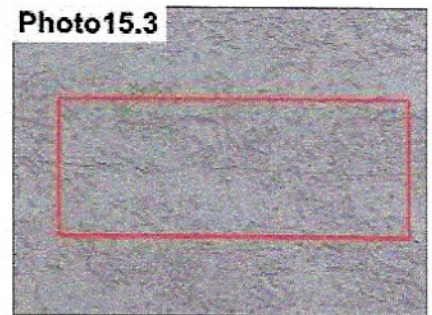
Photo15.3

Cracks / Paint (Aesthetic)

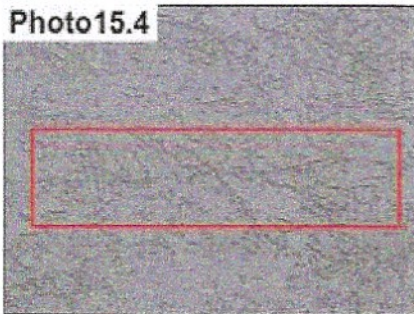
Photo15.4

Cracks / Paint (Aesthetic)

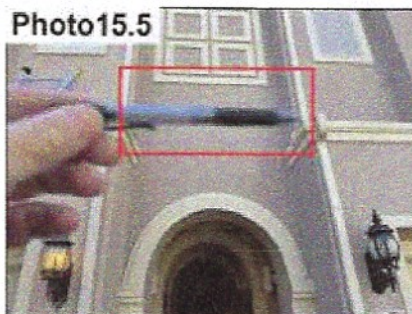
Photo15.5

Cracks / Paint (Aesthetic)

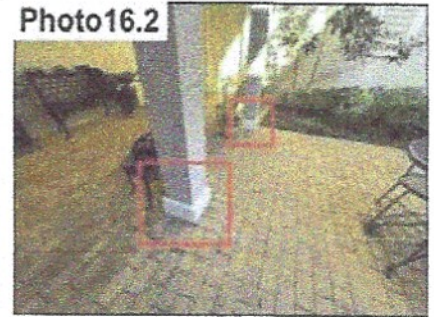
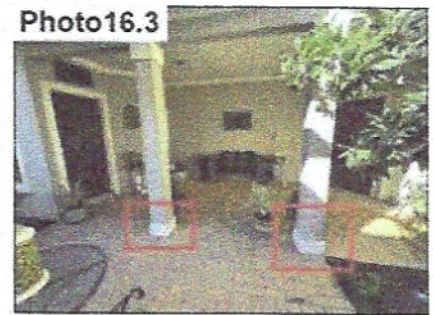
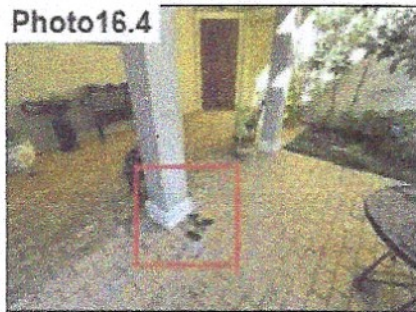
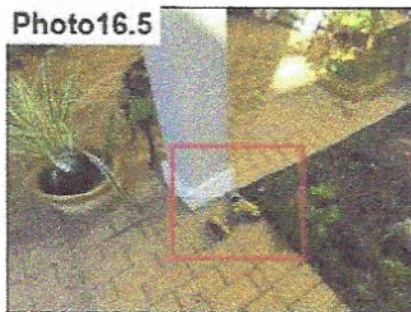
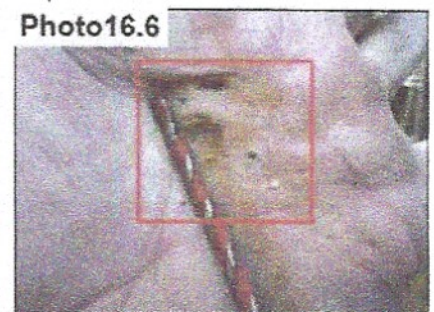
Substrate Damage / Assess & Repair

Grid Location	Item Description	Moisture Readings	Substrate Condition	Observations
Red Boxes	Damage			Confirmed substrate and potential frame damage is noted in the column. The inspector recommends having a qualified waterproofing contractor further assess the extent of damage, repair and modify as needed in an effort to prevent moisture intrusion. Please refer to photos #16.2, #16.3, #16.4, #16.5 and #16.6 for more detail.
D6	Columns		None	A moisture probe was taken at column. No substrate was noted at this time, modify as needed.
F6	Columns		None	A moisture probe was taken at column. No substrate was noted at this time, modify as needed.

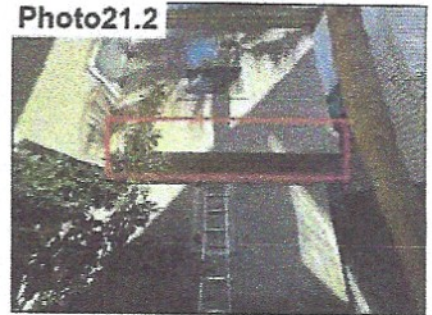
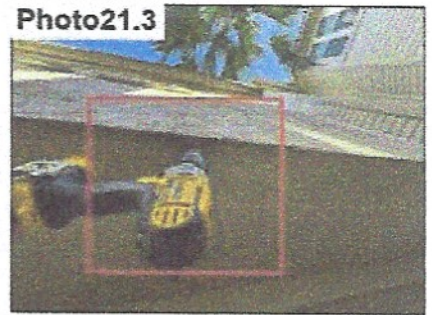
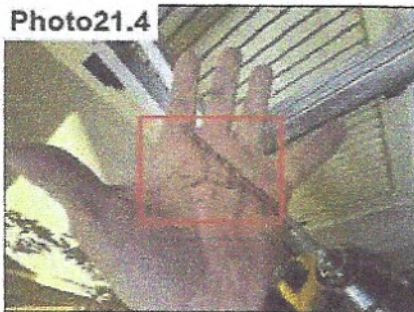
Substrate Damage / Assess, Repair and Install Proper Relief

Grid Location	Item Description	Moisture Readings	Substrate Condition	Observations
Red Box	Damage			Confirmed substrate and potential beam damage is noted at the bottom of the wall. The inspector recommends having a qualified waterproofing contractor further assess the extent of damage, repair as needed and install a proper relief in an effort to prevent moisture intrusion. Please refer to photos #21.2, #21.3, #21.4 and #21.5 for more detail.
E5	Bottom Wall		None	A moisture probe was taken at bottom wall. No substrate was noted at this time, modify as needed.
F5	Bottom Wall		None	A moisture probe was taken at bottom wall. No substrate was noted at this time, modify as needed.

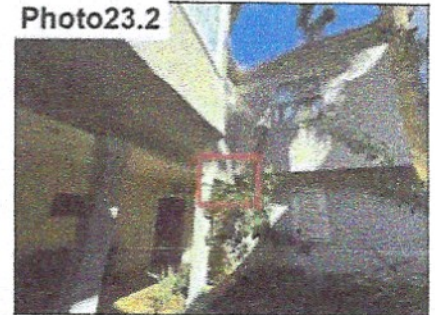
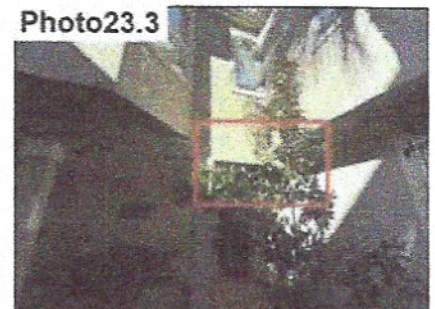
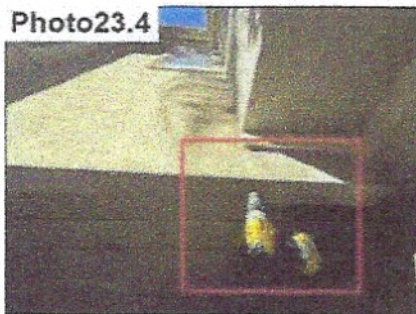
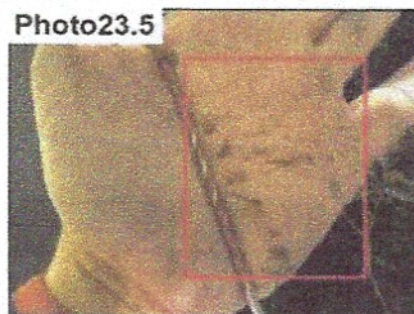
Substrate Damage / Assess, Repair and Install Proper Relief

Grid Location	Item Description	Moisture Readings	Substrate Condition	Observations
Red Box	Damage			Confirmed substrate and potential frame damage is noted at the bottom of the wall. The inspector recommends having a qualified waterproofing contractor further assess the extent of damage, repair as needed and install a proper relief in an effort to prevent moisture intrusion. Please refer to photos #23.2, #23.3, #23.4, #23.5 and #23.6 for more detail.
G4	Bottom Wall		None	A moisture probe was taken at bottom wall. No substrate was noted at this time, modify as needed.
H4	Bottom Wall		None	A moisture probe was taken at bottom wall. No substrate was noted at this time, modify as needed.

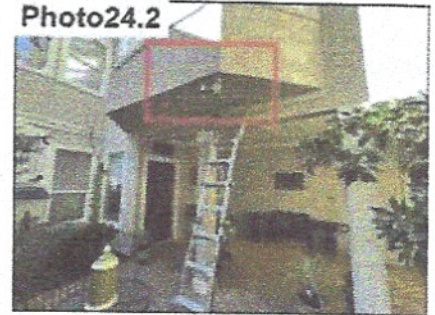
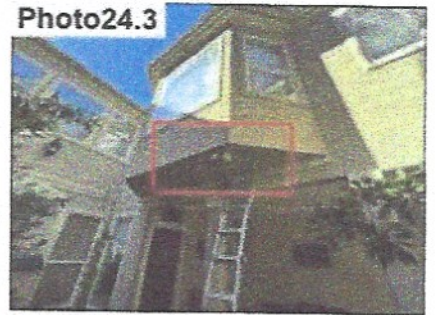
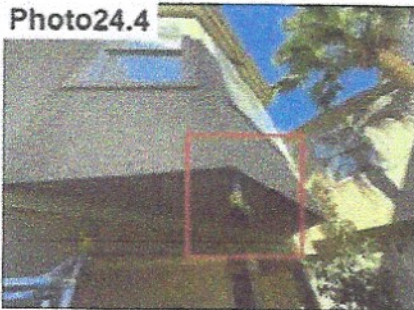
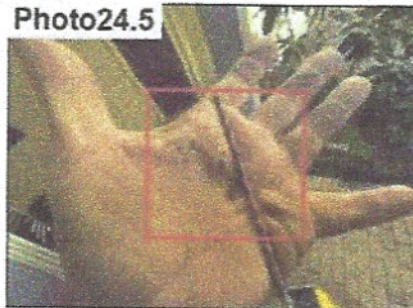
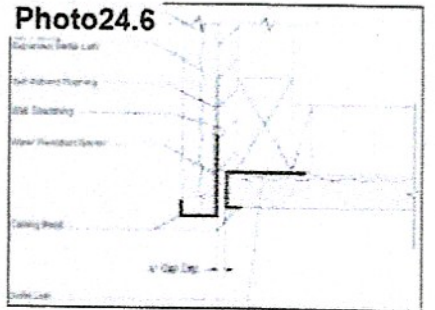
Substrate Damage / Assess, Repair and Install Proper Relief

Grid Location	Item Description	Moisture Readings	Substrate Condition	Observations
Red Box	Damage			Confirmed substrate and potential frame damage is noted at the bottom of the wall. The inspector recommends having a qualified waterproofing contractor further assess the extent of damage, repair as needed and install a proper relief in an effort to prevent moisture intrusion. Please refer to photos #24.2, #24.3, #24.4, #24.5 and #24.6 for more detail.
F4	Bottom Wall		None	A moisture probe was taken at bottom wall. No substrate was noted at this time, modify as needed.
E4	Bottom Wall		None	A moisture probe was taken at bottom wall. No substrate was noted at this time, modify as needed.

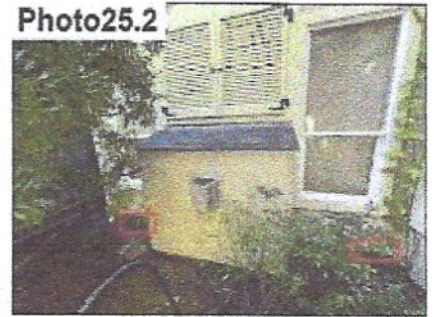
Photo25.2

Wood Rot at Bottom Wall/ Repair

Grid Location	Item Description	Moisture Readings	Substrate Condition	Observations
Red Box	Wood Rot			The bottom of the wall in this area has wood rot. The inspector suggests to have a qualified contractor further assess and repair this area as needed in an effort to prevent moisture intrusion. All wood rot was not necessarily identified in this report. Please refer to photos #25.2, #25.3 and #25.4 for more detail.

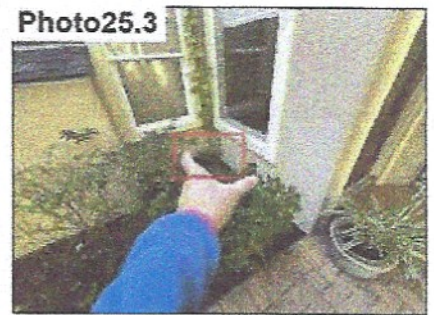
Photo25.3

Wood Rot at Bottom Wall/ Repair

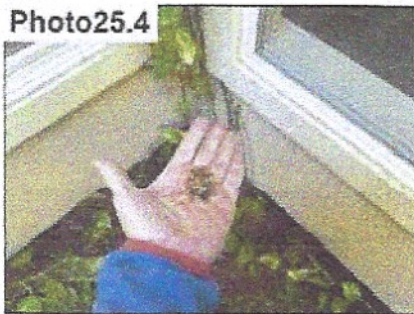
Photo25.4

Wood Rot at Bottom Wall/ Repair

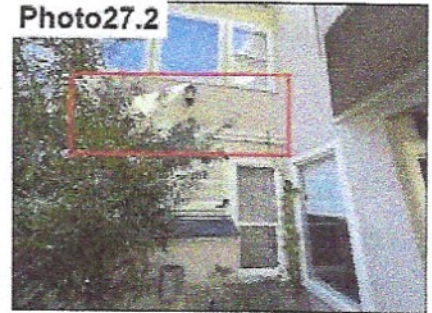
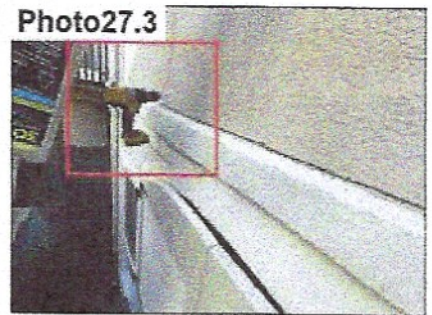
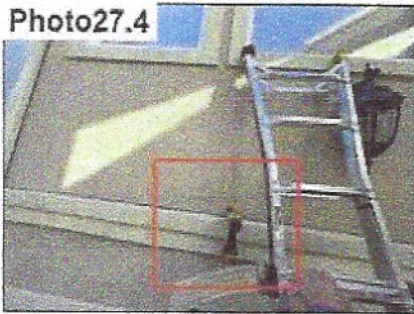
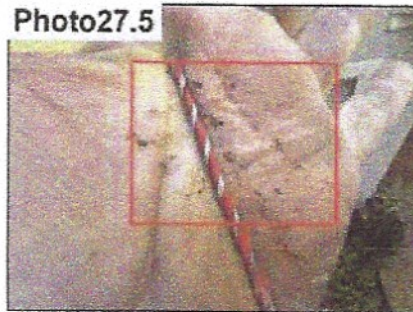
Substrate Damage / Assess & Repair

Grid Location	Item Description	Moisture Readings	Substrate Condition	Observations
Red Box	Damage			Confirmed substrate and potential window header damage noted at this location. The inspector suggests to have a qualified waterproofing contractor further assess the extent of damage, modify this area and install a relief in an effort to prevent moisture intrusion. Please refer to photos #27.2, #27.3, #27.4 and #27.5 for more detail.
B4 (Red)	Window Header		None	A moisture probe was taken at the window header. No substrate was noted at this time, modify as needed.
B4 (Orange)	Window Header		None	A moisture probe was taken at the window header. No substrate was noted at this time, modify as needed.
C4	Window Header	20%	Firm	A moisture probe was taken at window header. An elevated moisture reading was noted with a firm substrate.

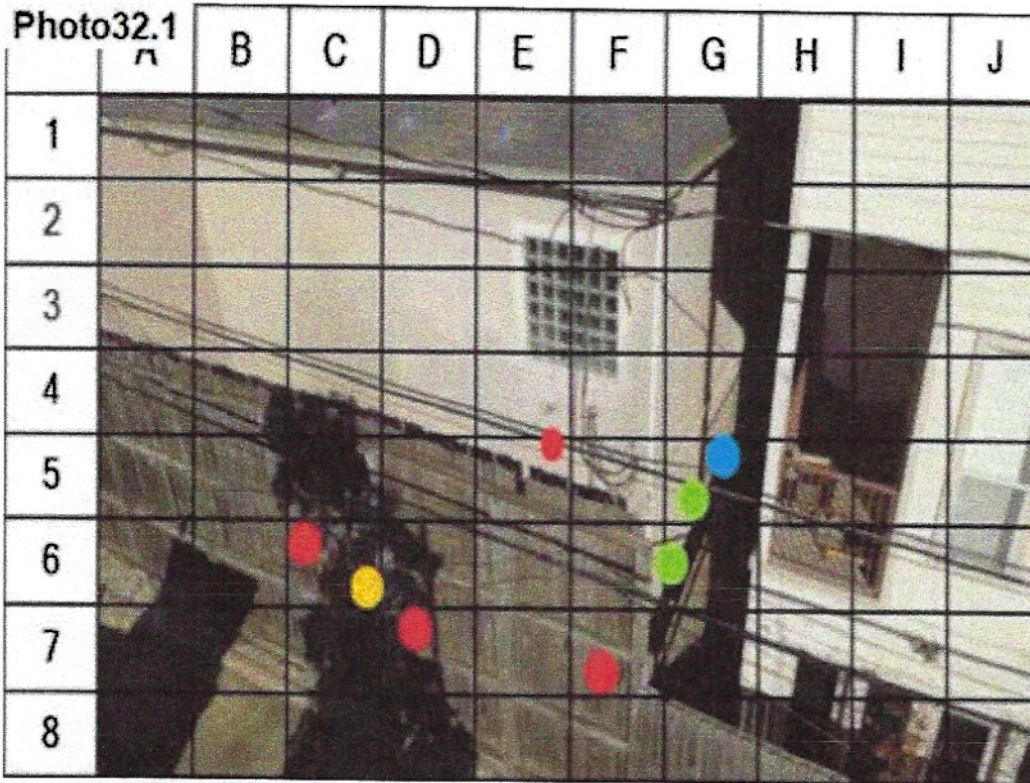
Grid Location	Item Description	Moisture Readings	Substrate Condition	Observations
C6 (Red)	Bottom Wall		None	A moisture probe was taken at bottom wall. No substrate was noted at this time, modify as needed.
C6 (Orange)	Bottom Wall		None	A moisture probe was taken at bottom wall. No substrate was noted at this time, modify as needed.
D7	Bottom Wall		None	A moisture probe was taken at bottom wall. No substrate was noted at this time, modify as needed.
F7	Bottom Wall		None	A moisture probe was taken at bottom wall. No substrate was noted at this time, modify as needed.
G6	Bottom Wall	14%	Firm	A moisture probe was taken at bottom wall. The substrate was firm with no damage noted at this time.
G5 (Green)	Bottom Wall	16%	Firm	A moisture probe was taken at bottom wall. The substrate was firm with no damage noted at this time.
G5 (Blue)	Bottom Wall	16%	Firm	A moisture probe was taken at bottom wall. The substrate was firm with no damage noted at this time.

E5	Door Header	20%	Firm	A moisture probe was taken at door header. An elevated moisture reading was noted with a firm substrate.

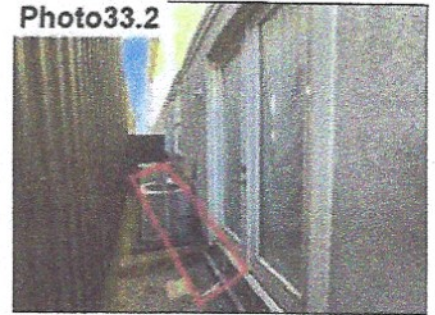
Photo33.2

Substrate Damage / Assess & Repair

Grid Location	Item Description	Moisture Readings	Substrate Condition	Observations
Red Box	Damage			Confirmed substrate and potential frame damage is noted at the bottom of the wall. The Inspector recommends having a qualified waterproofing contractor further assess the extent of damage, repair as needed and install a proper relief in an effort to prevent moisture intrusion. Please refer to photos #33.2, #33.3, #33.4, #33.5 and #33.6 for more detail.

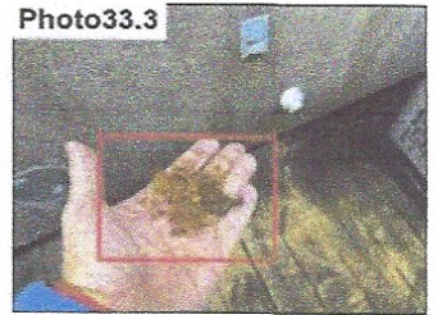
Photo33.3

Substrate Damage / Assess & Repair

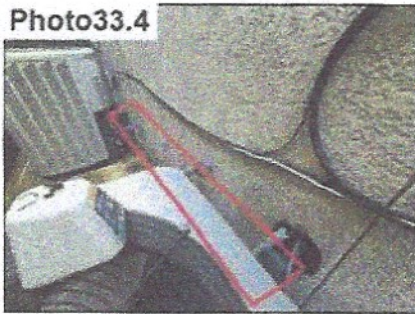
Photo33.4

Substrate Damage / Assess & Repair

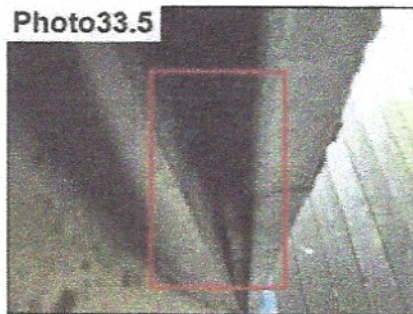
Photo33.5

Substrate Damage / Assess & Repair

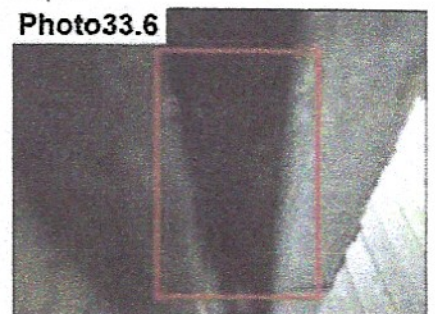
Photo33.6

Substrate Damage / Assess & Repair
