Lone Star Stucco, LLC

Moisture Assessment Report

2314 Hudly St B

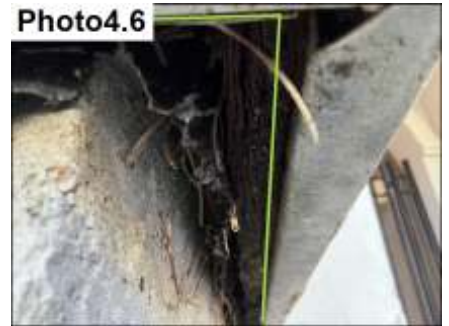
Photo4.6

Proper Grade Termination with Plaster Stop / Positive Detail

Grid Location	Item Description	Moisture Readings	Substrate Condition	Observations
Green Lines	Grade Termination			Stucco appears to be typically detailed at grade for the time of this construction. The inspector suggests that this is a positive detail and recommends no modification at this time but to always keep soil away from the structure. Please refer to photos #4.2, #4.3, #4.4, #4.5 and #4.6 for more detail.

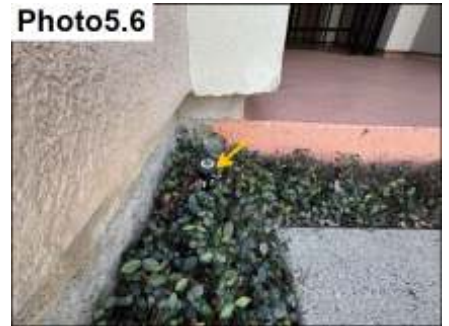
Photo5.6

Sprinklers / Redirect as Needed

Grid Location	Item Description	Moisture Readings	Substrate Condition	Observations
Orange Arrows	Sprinklers			Sprinklers have been noted on this home. The inspector suggests to always redirect sprinkler heads away from the system and windows as needed in an effort to prevent moisture intrusion. Please refer to photos #5.2, #5.3, #5.4, #5.5 and #5.6 for more detail.

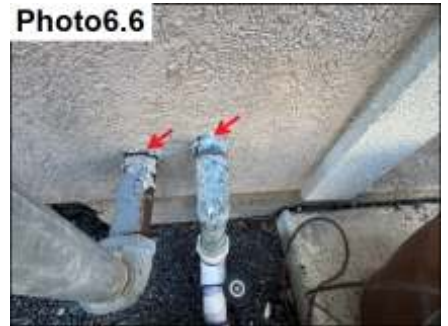
Photo6.6

Penetration Sealants / Seal

Grid Location	Item Description	Moisture Readings	Substrate Condition	Observations
Red Arrows	Penetrations			The penetration sealants are aged in this location. The inspector suggests to have a qualified waterproofing contractor seal this area with a low modulus sealant in an effort to prevent moisture intrusion. These types of sealants are of high quality and compatible with stucco and other termination points. Please refer to photos #6.2, #6.3, #6.4, #6.5 and #6.6 for more detail.

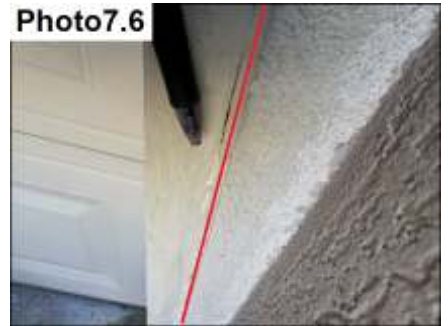
Photo7.6

Garage Door Trim Sealant / Seal

Grid Location	Item Description	Moisture Readings	Substrate Condition	Observations
Red Lines	Garage Doors			The garage door trim sealants are aged at this location. The inspector suggests to have a qualified waterproofing contractor seal this area with a low modulus sealant in an effort to prevent moisture intrusion. These types of sealants are of high quality and compatible with stucco and other termination points. Please refer to photos #7.2, #7.3, #7.4, #7.5 and #7.6 for more detail.

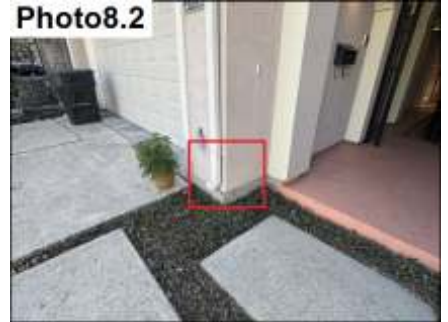
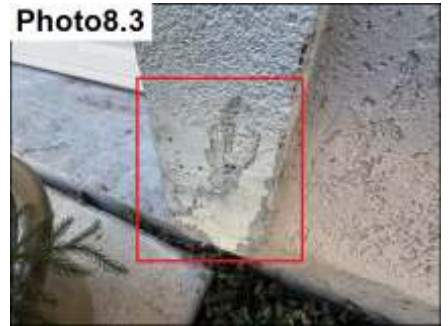
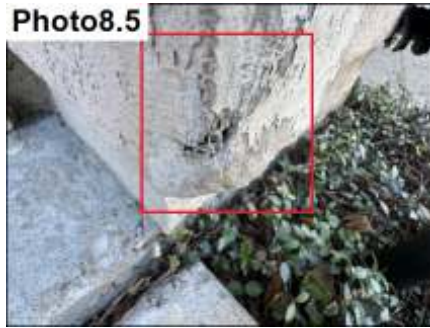
Impact Damage / Repair

Grid Location	Item Description	Moisture Readings	Substrate Condition	Observations
Red Box	Impact Damage			Impact damage noted on foam accent with exposed mesh at these locations. The inspector suggests to have a qualified waterproofing contractor further assess the extent of damage and repair as needed in an effort to prevent moisture intrusion. All impact damage was not necessarily identified in this report. Please refer to photos #8.2, #8.3, #8.4 and #8.5 for more detail.

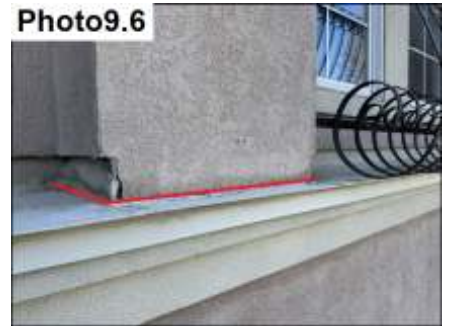
Photo9.6

Metal Cap Termination / Seal

Grid Location	Item Description	Moisture Readings	Substrate Condition	Observations
Red Line	Metal Cap			The metal cap sealants are aged or separated at this location allowing excess moisture into the system below. The inspector suggests to have a qualified waterproofing contractor further assess and seal this area with a low modulus sealant in an effort to prevent moisture intrusion. These types of sealants are of high quality and compatible with stucco and other termination points. Please refer to photos #9.2, #9.3, #9.4, #9.5 and #9.6 for more detail.

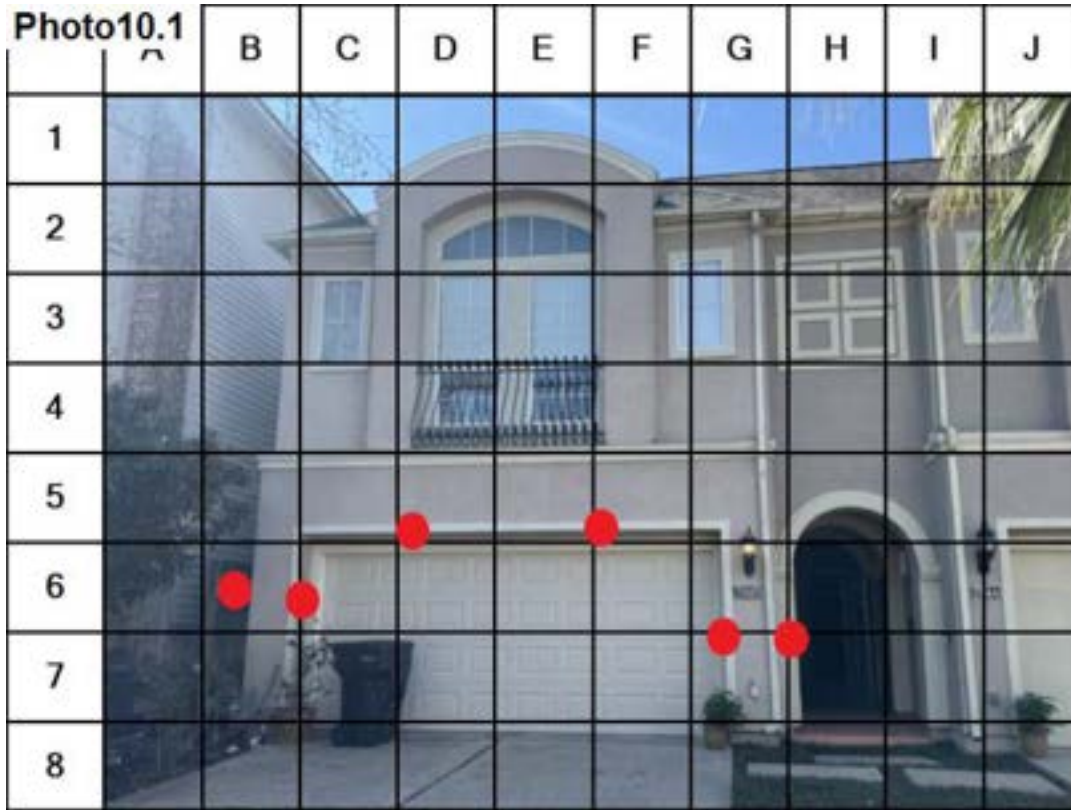
Grid Location	Item Description	Moisture Readings	Substrate Condition	Observations
B6	Corner Wall	20%	Firm	A moisture probe was taken at corner wall. An elevated moisture reading was noted with a firm substrate.
C6	Corner Wall	21%	Firm	A moisture probe was taken at corner wall. An elevated moisture reading was noted with a firm substrate.
D5	Bottom Wall		None	A moisture probe was taken at bottom wall. No substrate was noted at this time, modify as needed.
F5	Bottom Wall		None	A moisture probe was taken at bottom wall. No substrate was noted at this time, modify as needed.
G7	Corner Wall		None	A moisture probe was taken at corner wall. No substrate was noted at this time, modify as needed.
H7	Corner Wall		None	A moisture probe was taken at corner wall. No substrate was noted at this time, modify as needed.

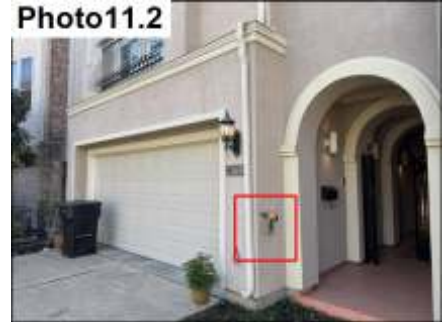
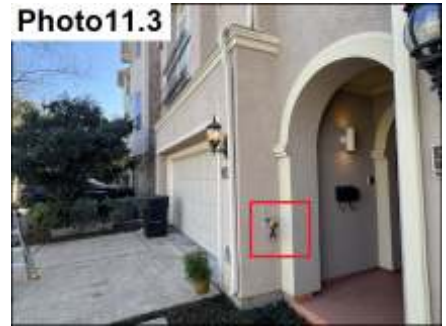
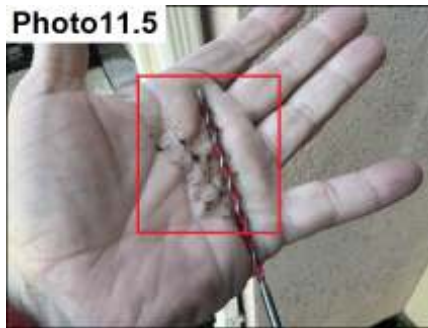
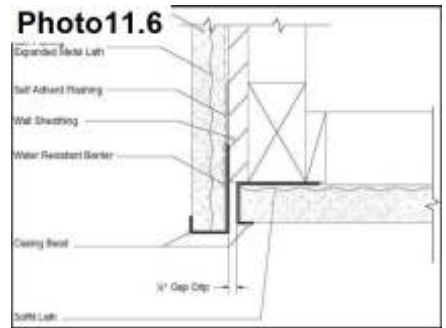
Substrate Damage / Assess, Repair and Install Proper Relief

Grid Location	Item Description	Moisture Readings	Substrate Condition	Observations
Red Boxes	Damage			Confirmed substrate and potential frame damage is noted at the bottom of the wall. The inspector recommends having a qualified waterproofing contractor further assess the extent of damage, repair as needed and install a proper relief in an effort to prevent moisture intrusion. Please refer to photos #11.2, #11.3, #11.4, #11.5 and #11.6 for more detail.

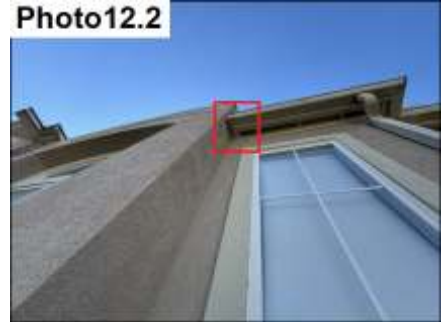
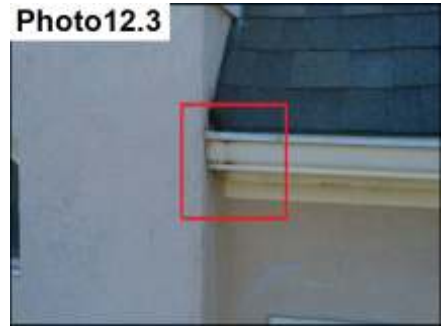
- The fascia at this area has wood rot. The inspector suggests to have a qualified contractor further assess and repair this area as needed in an effort to prevent moisture intrusion. All wood rot was not necessarily identified in this report. Please refer to photos #12.2, #12.3 and #12.4 for more detail.

Wood Rot on Fascia / Repair

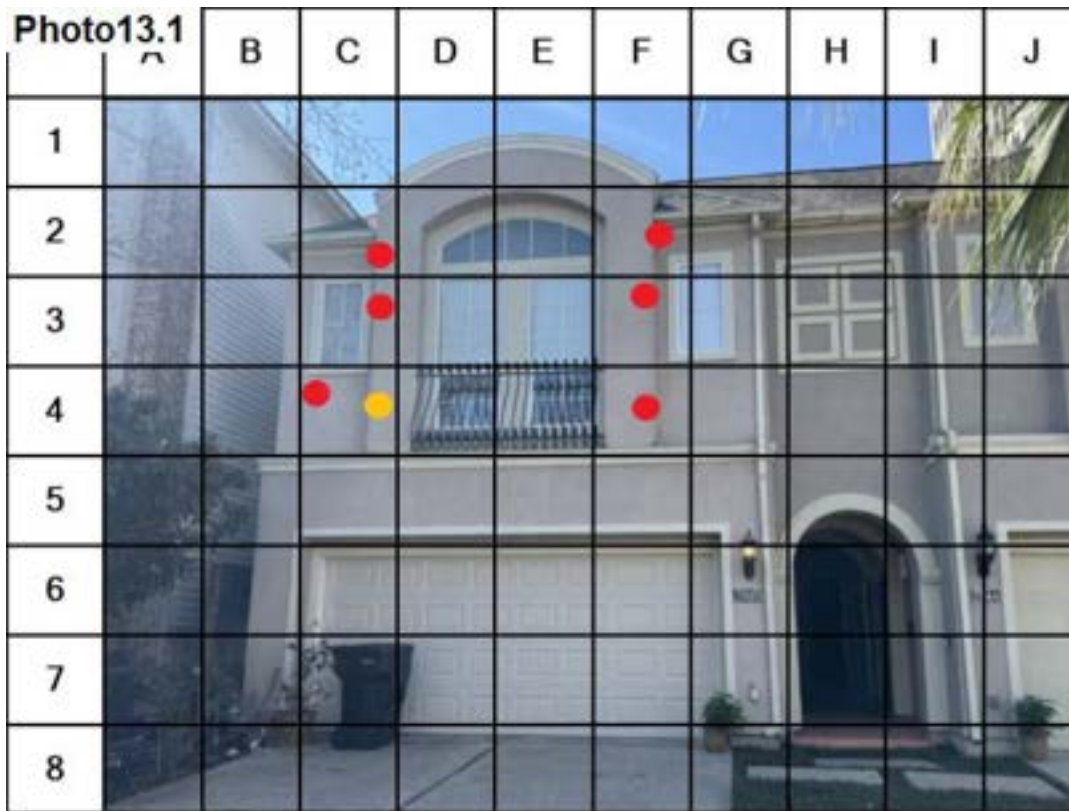
Grid Location	Item Description	Moisture Readings	Substrate Condition	Observations
C4 (Red)	Window Lower Left	23%	Firm	A moisture probe was taken at the window lower left. An elevated moisture reading was noted with a firm substrate.
C4 (Orange)	Corner Wall Below Failing Kickout	22%	Semi-Firm	A moisture probe was taken at corner wall below failing kickout flashing . An elevated moisture reading was noted with a semi-firm substrate.
C3	Corner Wall Below Failing Kickout	21%	Semi-Firm	A moisture probe was taken at corner wall below failing kickout flashing. An elevated moisture reading was noted with a semi-firm substrate.
F4	Corner Wall Below Failing Kickout	20%	Firm	A moisture probe was taken at corner wall below failing kickout flashing. An elevated moisture reading was noted with a firm substrate.
F3	Corner Wall Below Failing Kickout	22%	Firm	A moisture probe was taken at corner wall below failing kickout flashing. An elevated moisture reading was noted with a firm substrate.

C2	Corner Wall Below Failing Kickout		None	A moisture probe was taken at corner wall below failing kickout flashing. No substrate was noted at this time, modify as needed.
F2	Corner Wall Below Failing Kickout		None	A moisture probe was taken below the kickout flashing. No substrate was noted at this time, modify as needed.

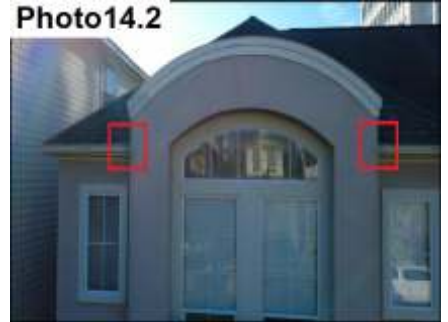
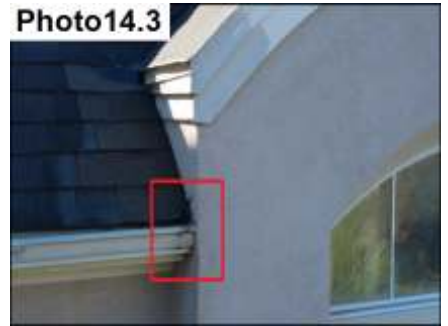
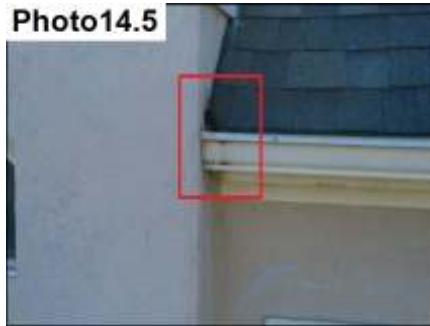
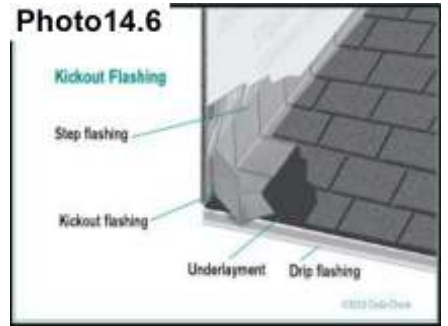
Kickout Flashing Failing/ Modify

Grid Location	Item Description	Moisture Readings	Substrate Condition	Observations
Red Boxes	Kickout			The kickout flashing is failing at this location allowing moisture to penetrate the system causing substrate damage below. The inspector suggests to have a qualified waterproofing contractor further assess and modify this area in an effort to prevent moisture intrusion. Please refer to photos #14.2, #14.3, #14.4, #14.5 and #14.6 for more detail.

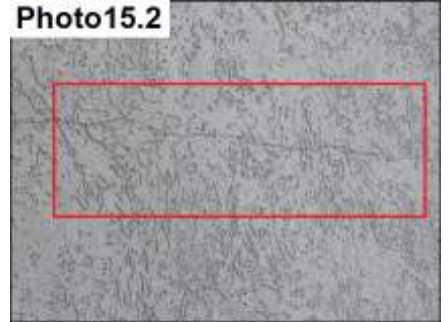
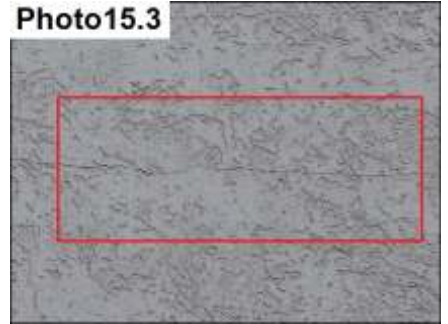
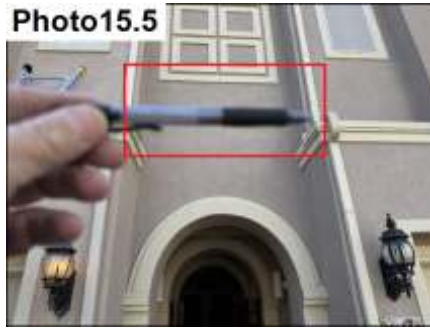
Cracks / Paint (Aesthetic)

Grid Location	Item Description	Moisture Readings	Substrate Condition	Observations
Red Box	Cracks			Cracks are noted at this location. The inspector suggests to have a qualified waterproofing contractor paint for aesthetic concerns only. All cracking was not necessarily identified in this report. Please refer to photos #15.2, #15.3, #15.4 and #15.5 for more detail.

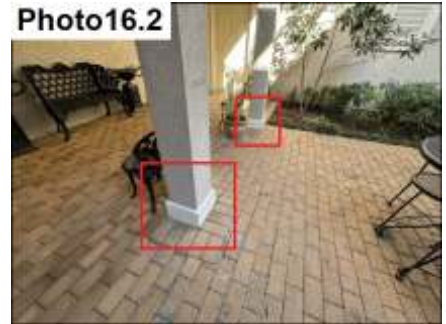
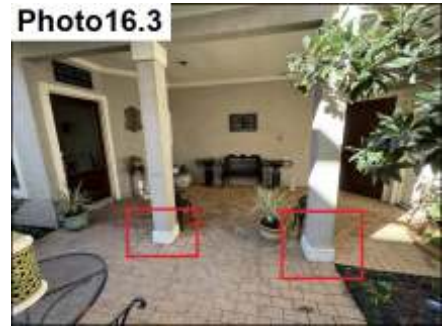
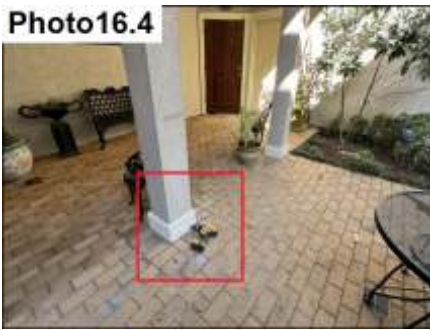
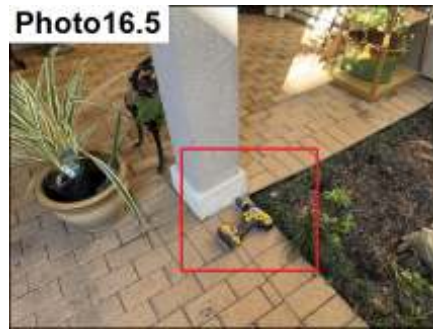
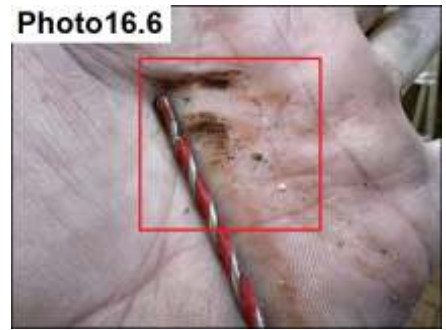
Substrate Damage / Assess & Repair

Grid Location	Item Description	Moisture Readings	Substrate Condition	Observations
Red Boxes	Damage			Confirmed substrate and potential frame damage is noted in the column. The inspector recommends having a qualified waterproofing contractor further assess the extent of damage, repair and modify as needed in an effort to prevent moisture intrusion. Please refer to photos #16.2, #16.3, #16.4, #16.5 and #16.6 for more detail.
D6	Columns		None	A moisture probe was taken at column. No substrate was noted at this time, modify as needed.
F6	Columns		None	A moisture probe was taken at column. No substrate was noted at this time, modify as needed.

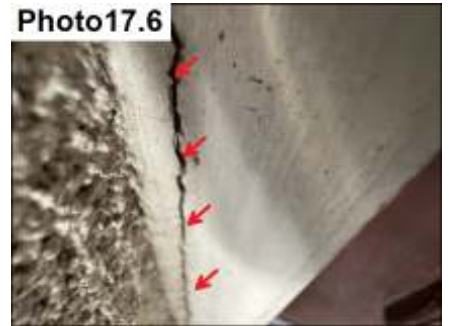
Photo17.6

Door Trim and Miter Sealant / Seal

Grid Location	Item Description	Moisture Readings	Substrate Condition	Observations
Red Arrows	Doors			The door trim and miter sealants are separated or aged at this location. The inspector suggests to have a qualified waterproofing contractor seal this area with a low modulus sealant in an effort to prevent moisture intrusion. These types of sealants are of high quality and compatible with stucco and other termination points. Please refer to photos #17.2, #17.3, #17.4, #17.5 and #17.6 for more detail.

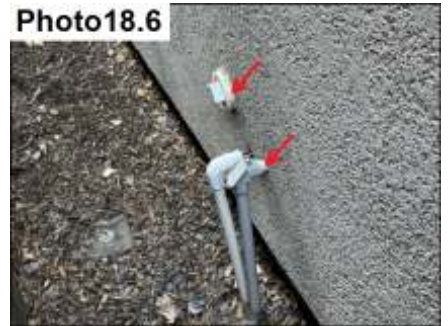
Photo18.6

Penetration Sealants / Seal

Grid Location	Item Description	Moisture Readings	Substrate Condition	Observations
Red Arrows	Penetrations			The penetration sealants are aged in this location. The inspector suggests to have a qualified waterproofing contractor seal this area with a low modulus sealant in an effort to prevent moisture intrusion. These types of sealants are of high quality and compatible with stucco and other termination points. Please refer to photos #18.2, #18.3, #18.4, #18.5 and #18.6 for more detail.

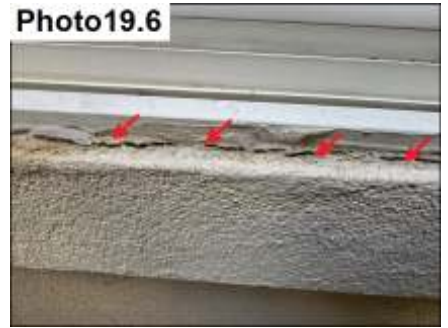
Photo19.6

Window Sealants / Seal

Grid Location	Item Description	Moisture Readings	Substrate Condition	Observations
Red Arrows	Windows			The window sealants are aged or separated. The inspector suggests to have a qualified waterproofing contractor further assess and seal this area with a low modulus sealant in an effort to prevent moisture intrusion. These types of sealants are of high quality and compatible with stucco and other termination points. Please refer to photos #19.2, #19.3, #19.4, #19.5 and #19.6 for more detail.

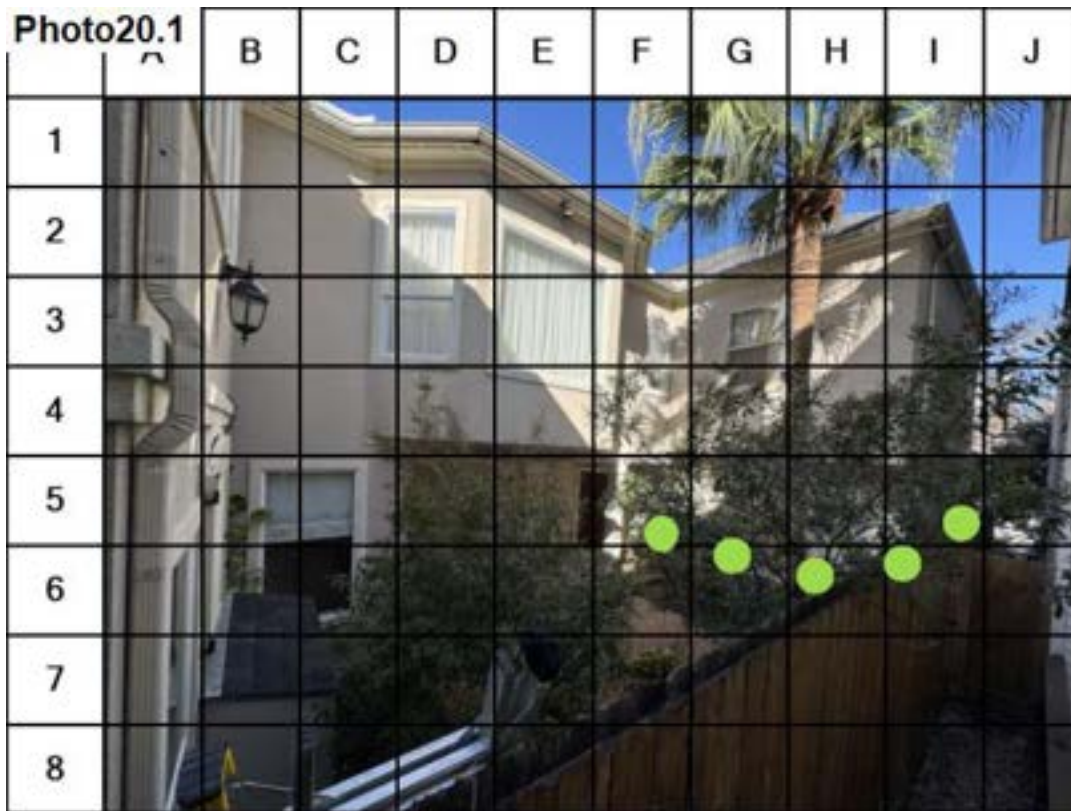
Grid Location	Item Description	Moisture Readings	Substrate Condition	Observations
F5	Bottom Wall	15%	Firm	A moisture probe was taken at bottom wall. The substrate was firm with no damage noted at this time.
G6	Bottom Wall	16%	Firm	A moisture probe was taken at bottom wall. The substrate was firm with no damage noted at this time.
H6	Bottom Wall	15%	Firm	A moisture probe was taken at bottom wall. The substrate was firm with no damage noted at this time.
I6	Bottom Wall	14%	Firm	A moisture probe was taken at bottom wall. The substrate was firm with no damage noted at this time.
I5	Bottom Wall	13%	Firm	A moisture probe was taken at bottom wall. The substrate was firm with no damage noted at this time.

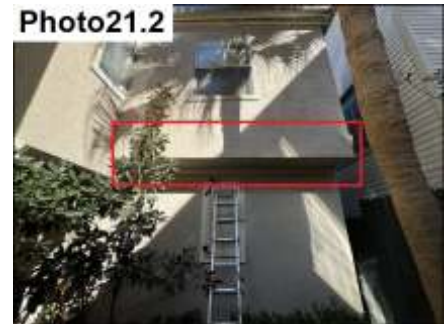
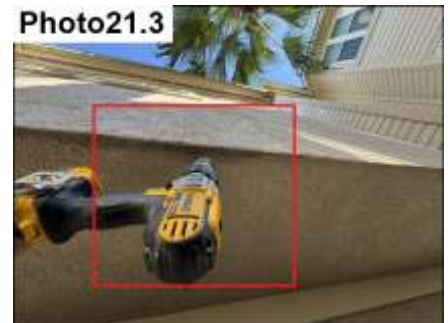
- Confirmed substrate and potential beam damage is noted at the bottom of the wall. The inspector recommends having a qualified waterproofing contractor further assess the extent of damage, repair as needed and install a proper relief in an effort to prevent moisture intrusion. Please refer to photos #21.2, #21.3, #21.4 and #21.5 for more detail.

Photo21.2
Substrate Damage / Assess, Repair and Install Proper Relief

Photo21.3
Substrate Damage / Assess, Repair and Install Proper Relief

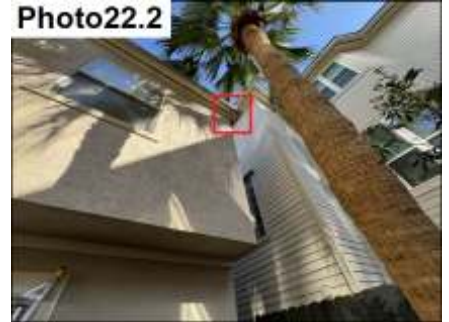
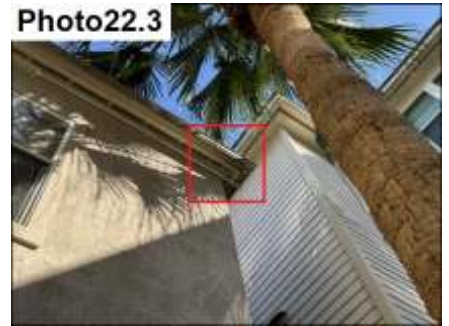
- The fascia at this area has wood rot. The inspector suggests to have a qualified contractor further assess and repair this area as needed in an effort to prevent moisture intrusion. All wood rot was not necessarily identified in this report. Please refer to photos #22.2, #22.3 and #22.4 for more detail.

Wood Rot on Fascia / Repair

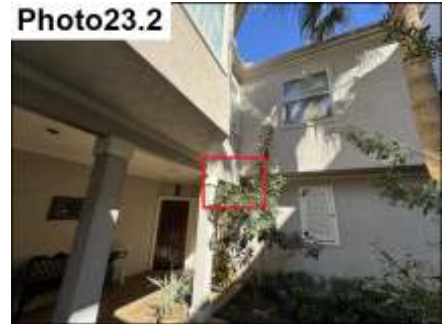
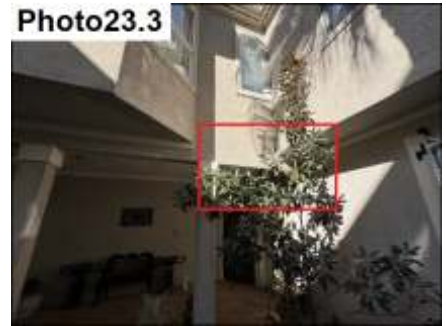
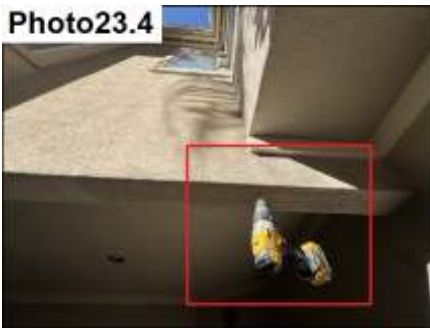
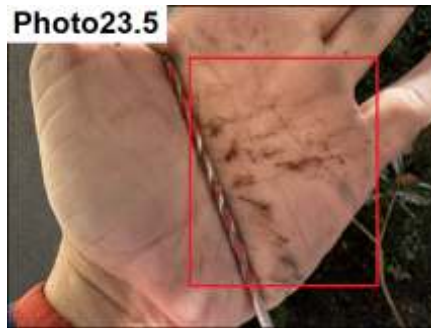
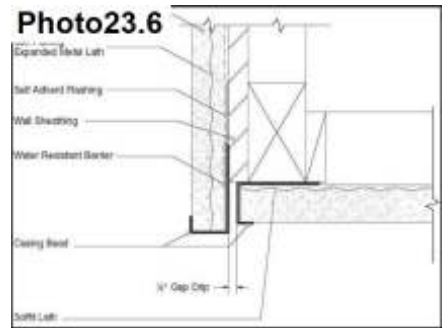
Photo23.2
Substrate Damage / Assess, Repair and Install Proper Relief

Grid Location	Item Description	Moisture Readings	Substrate Condition	Observations
Red Box	Damage			Confirmed substrate and potential frame damage is noted at the bottom of the wall. The inspector recommends having a qualified waterproofing contractor further assess the extent of damage, repair as needed and install a proper relief in an effort to prevent moisture intrusion. Please refer to photos #23.2, #23.3, #23.4, #23.5 and #23.6 for more detail.
G4	Bottom Wall		None	A moisture probe was taken at bottom wall. No substrate was noted at this time, modify as needed.
H4	Bottom Wall		None	A moisture probe was taken at bottom wall. No substrate was noted at this time, modify as needed.

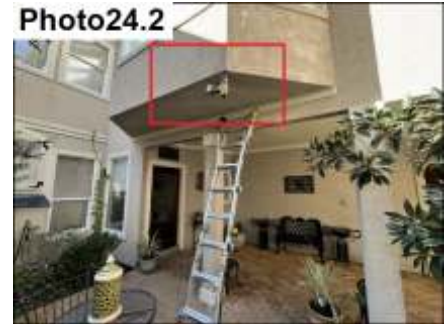
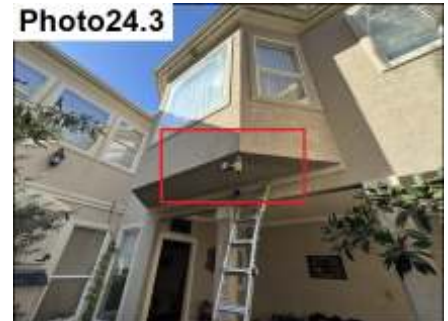
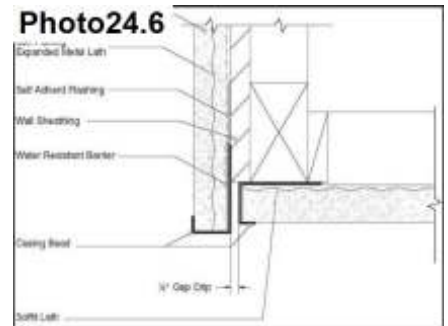
Photo24.2
Substrate Damage / Assess, Repair and Install Proper Relief

Grid Location	Item Description	Moisture Readings	Substrate Condition	Observations
Red Box	Damage			Confirmed substrate and potential frame damage is noted at the bottom of the wall. The inspector recommends having a qualified waterproofing contractor further assess the extent of damage, repair as needed and install a proper relief in an effort to prevent moisture intrusion. Please refer to photos #24.2, #24.3, #24.4, #24.5 and #24.6 for more detail.
F4	Bottom Wall		None	A moisture probe was taken at bottom wall. No substrate was noted at this time, modify as needed.
E4	Bottom Wall		None	A moisture probe was taken at bottom wall. No substrate was noted at this time, modify as needed.

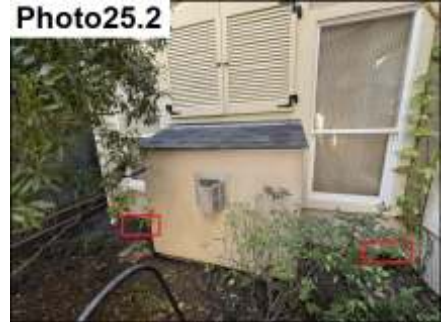
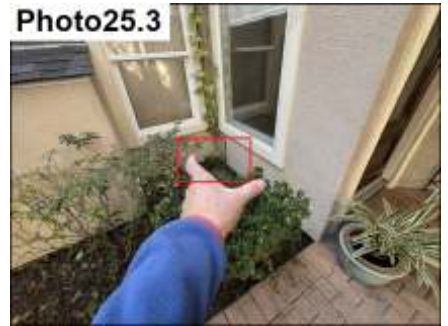
- The bottom of the wall in this area has wood rot. The inspector suggests to have a qualified contractor further assess and repair this area as needed in an effort to prevent moisture intrusion. All wood rot was not necessarily identified in this report. Please refer to photos #25.2, #25.3 and #25.4 for more detail.

Wood Rot at Bottom Wall/ Repair

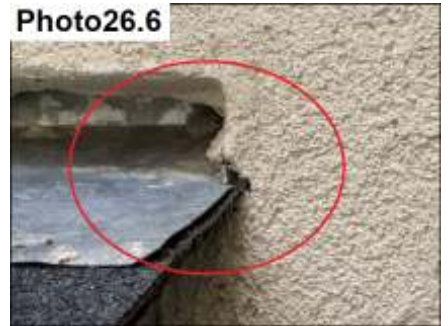
Photo26.6

Roof Diverter Flashing Sealants / Seal

Grid Location	Item Description	Moisture Readings	Substrate Condition	Observations
Red Circle	Flashing			The roof diverter flashing sealants are aged at this location. The inspector suggests to have a qualified waterproofing contractor further assess and seal this area with a low modulus sealant in an effort to prevent moisture intrusion. These types of sealants are of high quality and compatible with stucco and other termination points. Please refer to photos #26.2, #26.3, #26.4, #26.5 and #26.6 for more detail.

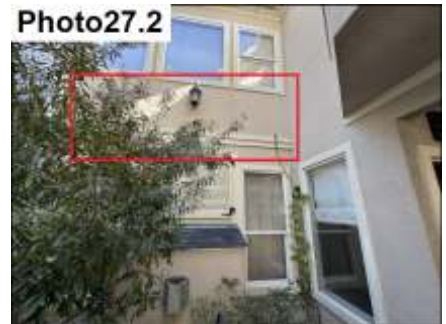
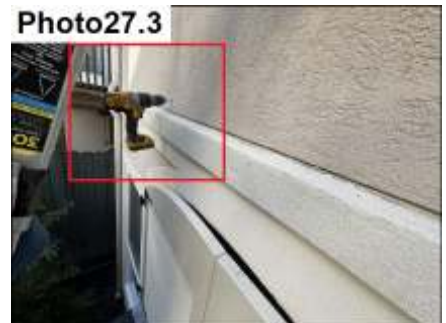
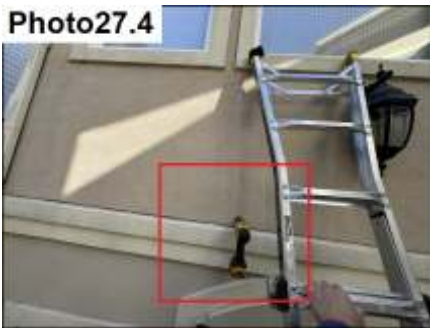
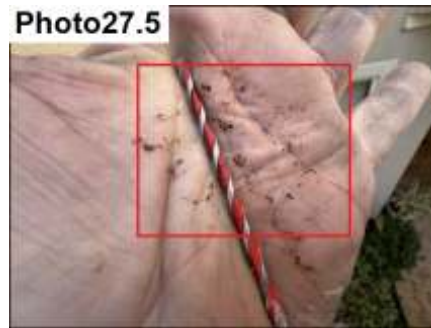
Substrate Damage / Assess & Repair

Grid Location	Item Description	Moisture Readings	Substrate Condition	Observations
Red Box	Damage			Confirmed substrate and potential window header damage noted at this location. The inspector suggests to have a qualified waterproofing contractor further assess the extent of damage, modify this area and install a relief in an effort to prevent moisture intrusion. Please refer to photos #27.2, #27.3, #27.4 and #27.5 for more detail.
B4 (Red)	Window Header		None	A moisture probe was taken at the window header. No substrate was noted at this time, modify as needed.
B4 (Orange)	Window Header		None	A moisture probe was taken at the window header. No substrate was noted at this time, modify as needed.
C4	Window Header	20%	Firm	A moisture probe was taken at window header. An elevated moisture reading was noted with a firm substrate.

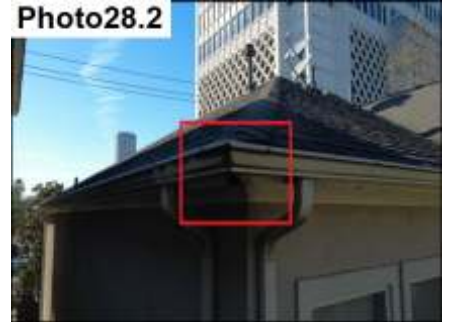
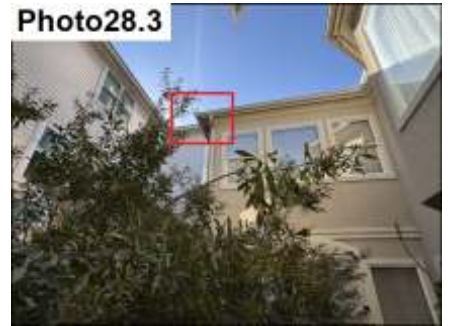
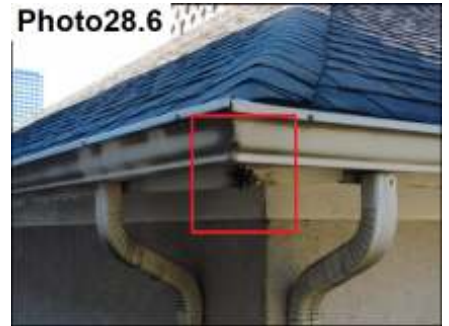
Wood Rot on Fascia / Repair

Grid Location	Item Description	Moisture Readings	Substrate Condition	Observations
Red Box	Wood Rot			The fascia at this area has wood rot. The inspector suggests to have a qualified contractor further assess and repair this area as needed in an effort to prevent moisture intrusion. All wood rot was not necessarily identified in this report. Please refer to photos #28.2, #28.3, #28.4, #28.5 and #28.6 for more detail.

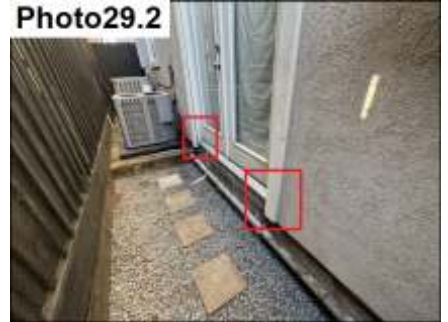
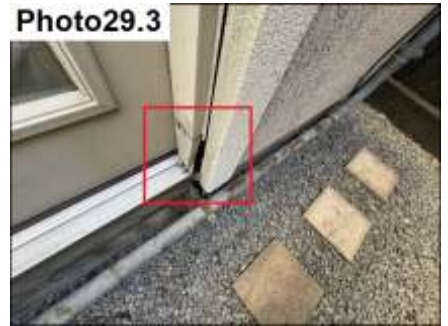
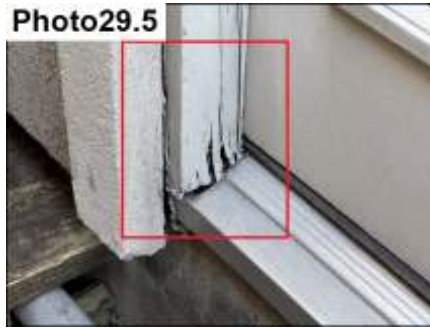
Wood Rot on Door Trim / Repair

Grid Location	Item Description	Moisture Readings	Substrate Condition	Observations
Red Box	Wood Rot			The door trim at this area has wood rot. The inspector suggests to have a qualified contractor further assess and repair this area as needed in an effort to prevent moisture intrusion. All wood rot was not necessarily identified in this report. Please refer to photos #29.2, #29.3, #29.4 and #29.5 for more detail.

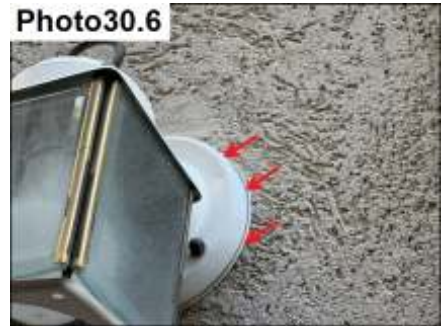
Photo30.6

Penetration Sealants / Seal

Grid Location	Item Description	Moisture Readings	Substrate Condition	Observations
Red Arrows	Penetrations			The penetration sealants are aged in this location. The inspector suggests to have a qualified waterproofing contractor seal this area with a low modulus sealant in an effort to prevent moisture intrusion. These types of sealants are of high quality and compatible with stucco and other termination points. Please refer to photos #30.2, #30.3, #30.4, #30.5 and #30.6 for more detail.

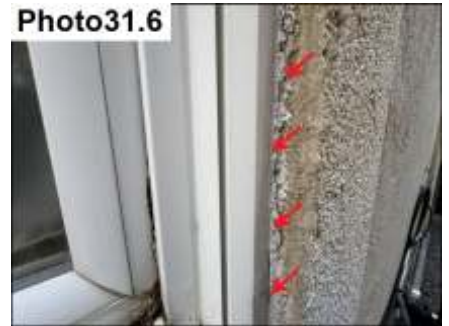
Photo31.6

Window Sealants / Seal

Grid Location	Item Description	Moisture Readings	Substrate Condition	Observations
Red Arrows	Windows			The window sealants are aged. The inspector suggests to have a qualified waterproofing contractor further assess and seal this area with a low modulus sealant in an effort to prevent moisture intrusion. These types of sealants are of high quality and compatible with stucco and other termination points. Please refer to photos #31.2, #31.3, #31.4, #31.5 and #31.6 for more detail.

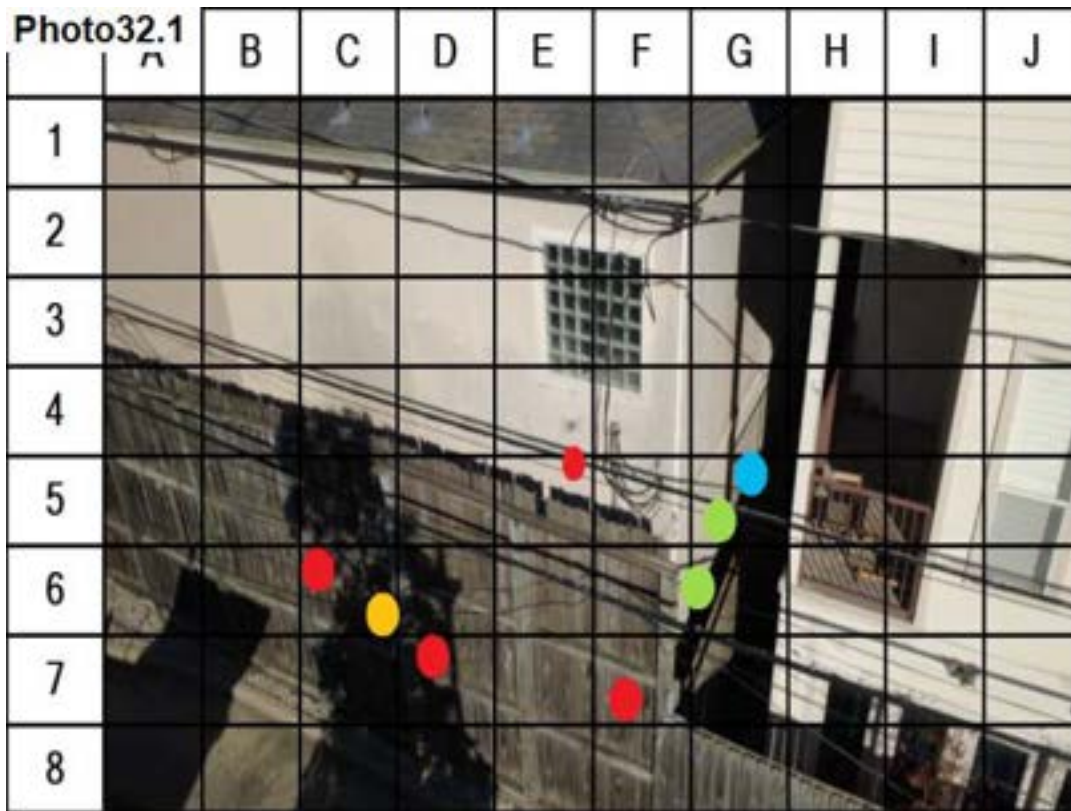
Grid Location	Item Description	Moisture Readings	Substrate Condition	Observations
C6 (Red)	Bottom Wall		None	A moisture probe was taken at bottom wall. No substrate was noted at this time, modify as needed.
C6 (Orange)	Bottom Wall		None	A moisture probe was taken at bottom wall. No substrate was noted at this time, modify as needed.
D7	Bottom Wall		None	A moisture probe was taken at bottom wall. No substrate was noted at this time, modify as needed.
F7	Bottom Wall		None	A moisture probe was taken at bottom wall. No substrate was noted at this time, modify as needed.
G6	Bottom Wall	14%	Firm	A moisture probe was taken at bottom wall. The substrate was firm with no damage noted at this time.
G5 (Green)	Bottom Wall	16%	Firm	A moisture probe was taken at bottom wall. The substrate was firm with no damage noted at this time.
G5 (Blue)	Bottom Wall	16%	Firm	A moisture probe was taken at bottom wall. The substrate was firm with no damage noted at this time.

E5	Door Header	20%	Firm	A moisture probe was taken at door header. An elevated moisture reading was noted with a firm substrate.

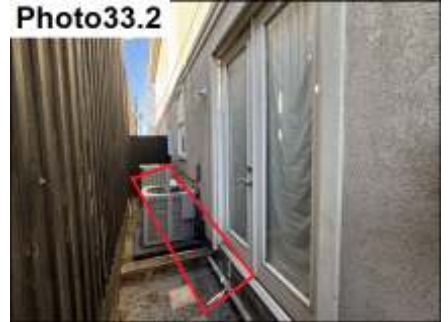
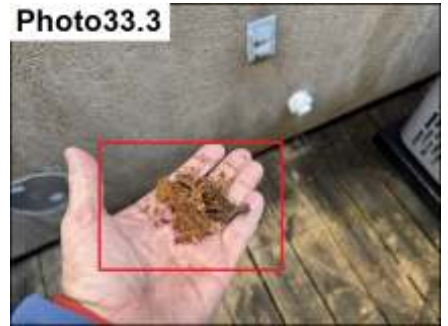
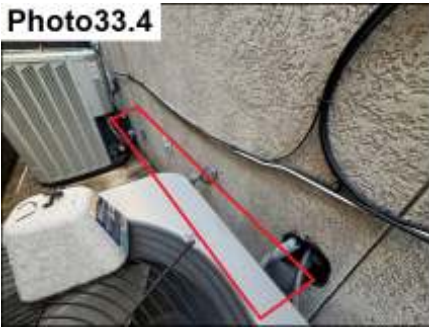
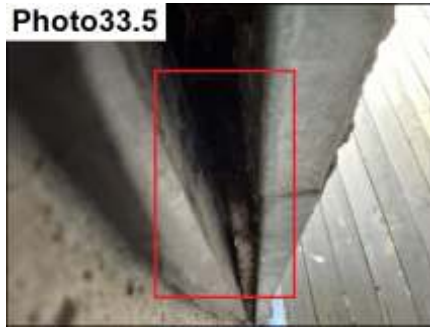
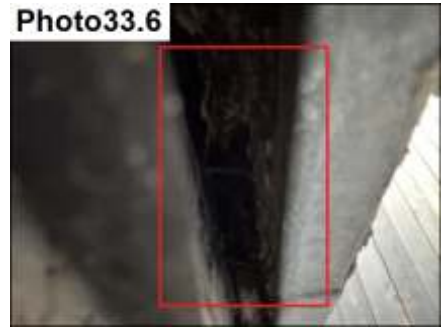
Substrate Damage / Assess & Repair

Grid Location	Item Description	Moisture Readings	Substrate Condition	Observations
Red Box	Damage			Confirmed substrate and potential frame damage is noted at the bottom of the wall. The inspector recommends having a qualified waterproofing contractor further assess the extent of damage, repair as needed and install a proper relief in an effort to prevent moisture intrusion. Please refer to photos #33.2, #33.3, #33.4, #33.5 and #33.6 for more detail.
