2911 Royal Oaks Grv

Client	--
Reference id	a4xPd000003XGcDIAW
Type	Home Inspection and Floor Plan Report - 2911 Royal Oaks Grv
Inspected by	Rio Bravo - Inspectify Pro - Houston
State license	TREC 22388
InterNACHI	17031522
Scheduled	January 29, 2026, 12:45 PM CST
Completed	January 29, 2026, 5:34 PM CST

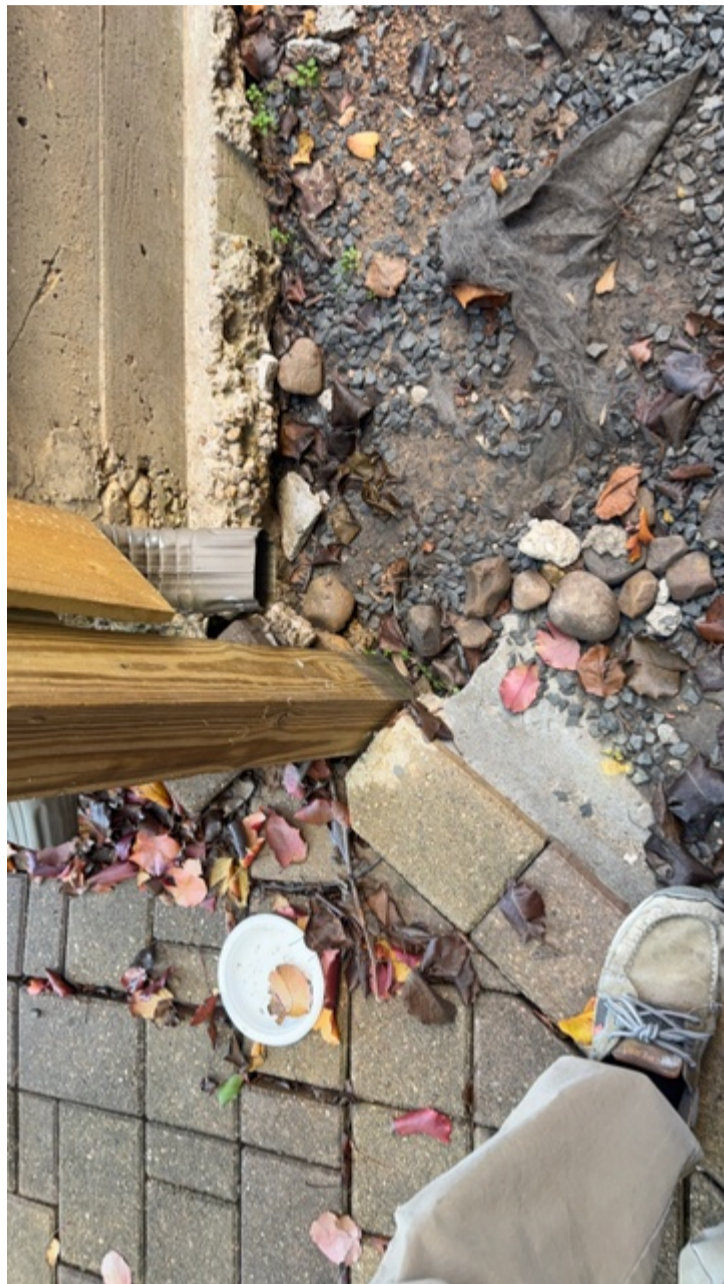
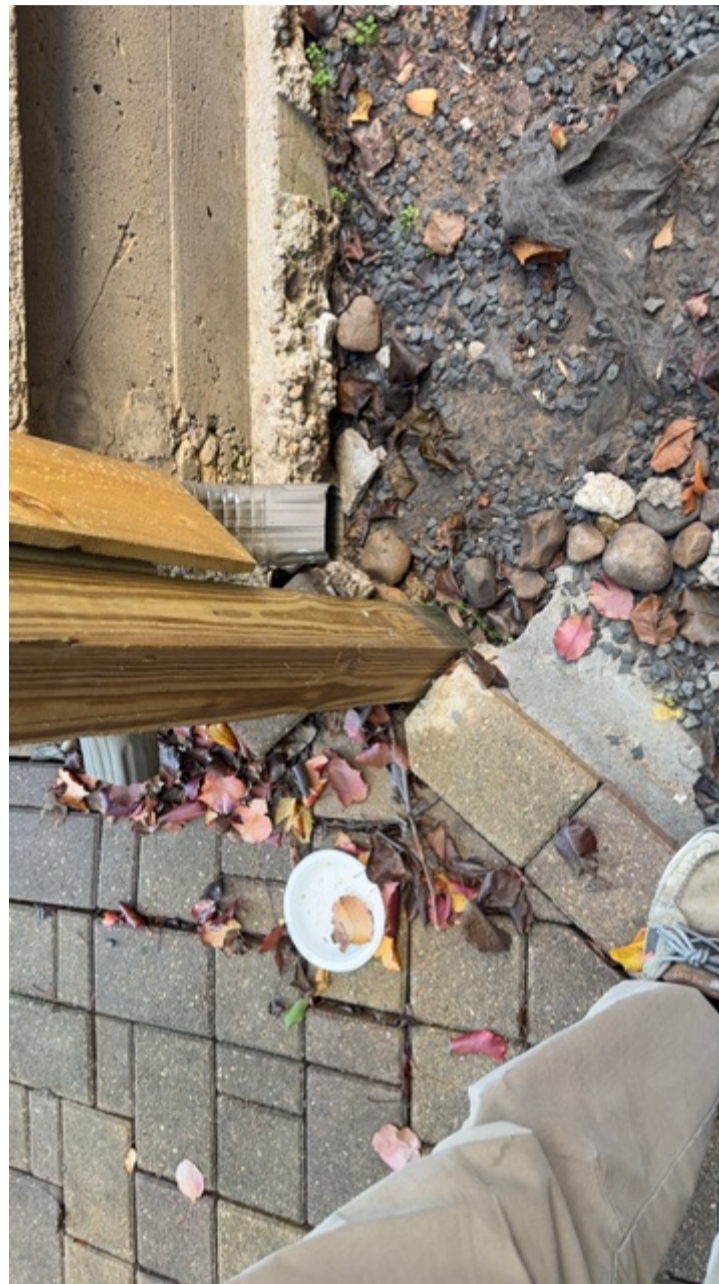
Downspouts Drain Near House

One or more downspouts / downspout extensions drain too close to the property's foundation.

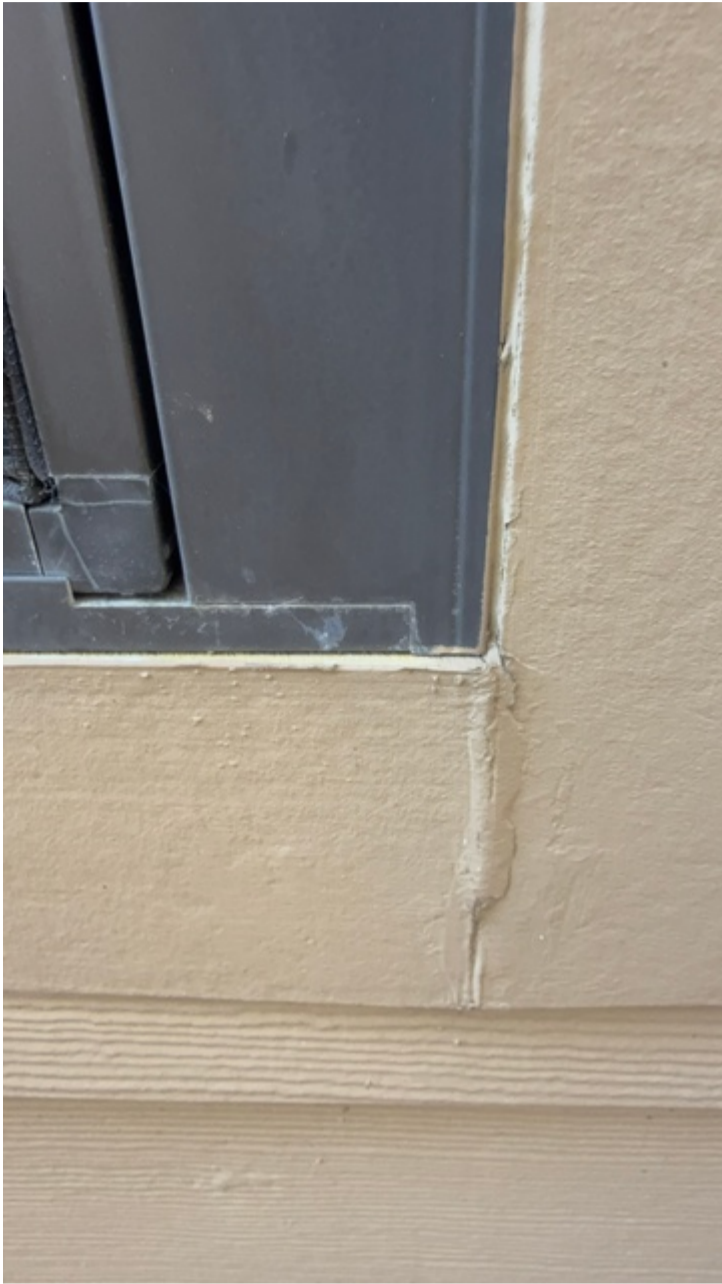
Window Needs Caulking

One or more windows need caulking.

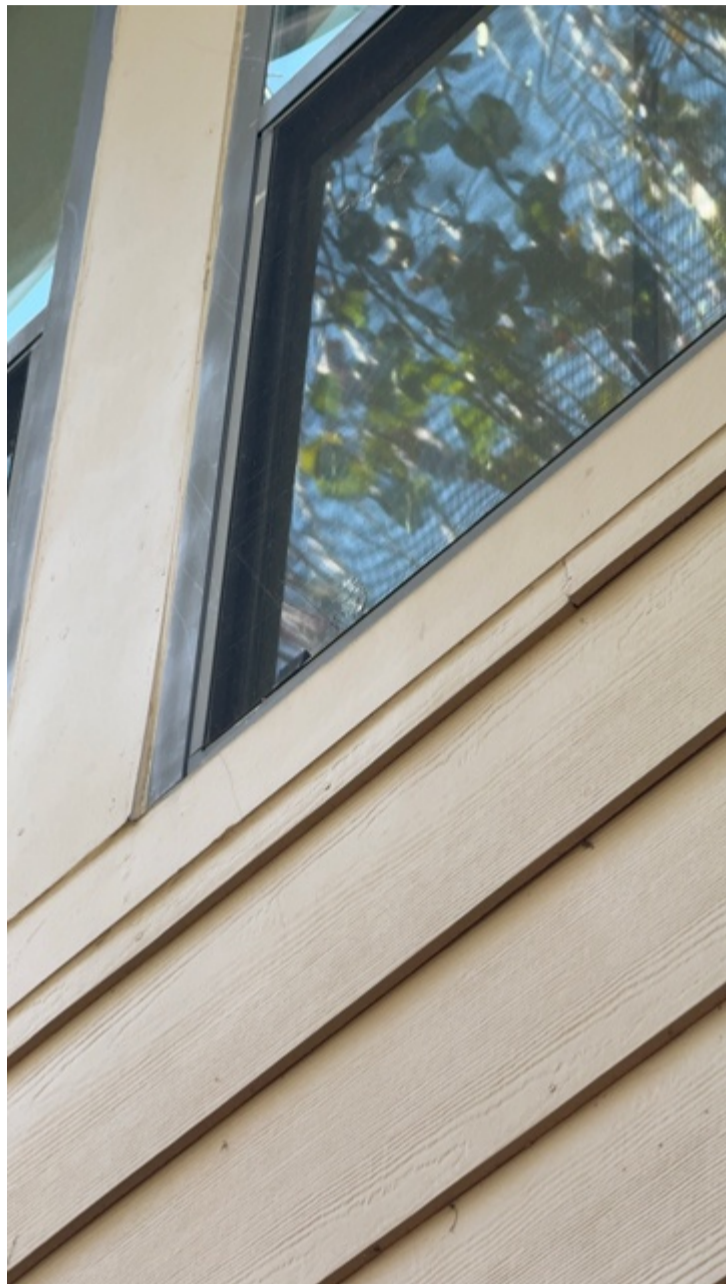
Damaged Screen

One or more window screens are damaged.

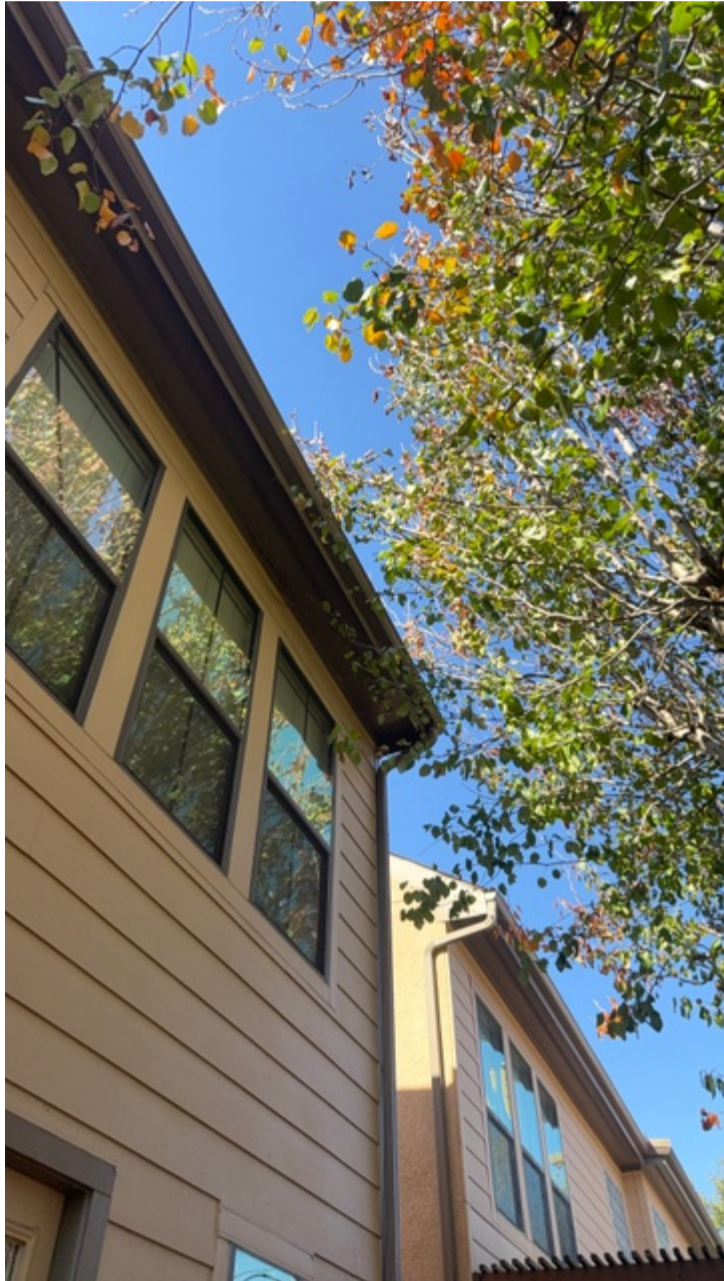
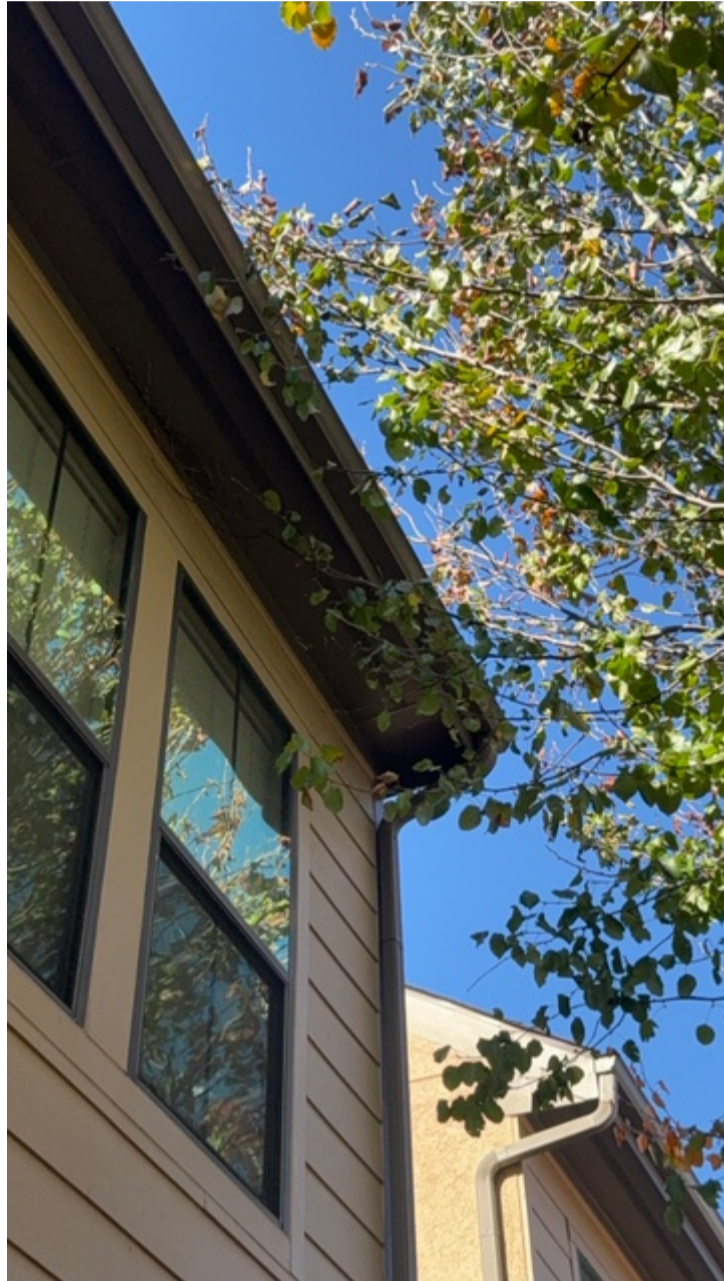
Tree Overhanging the Roof

One or more tree branches(s) are overhanging the roof.

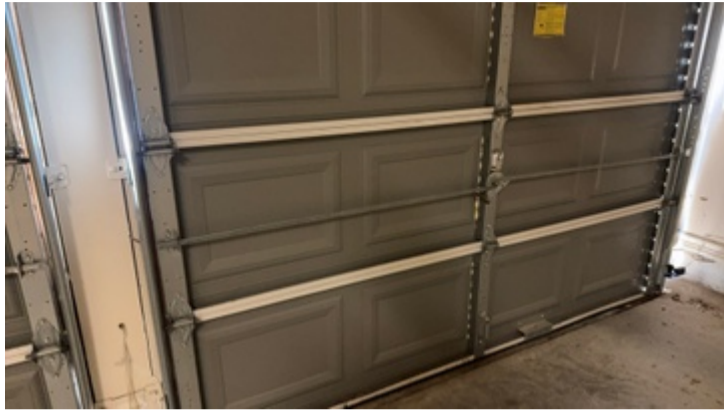
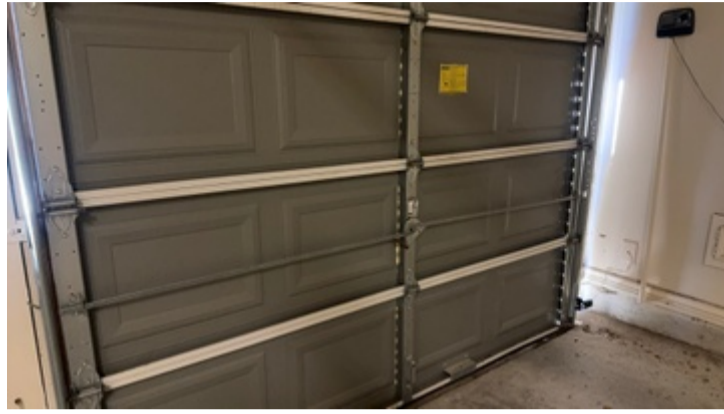
The garage door manual lock was not disabled.

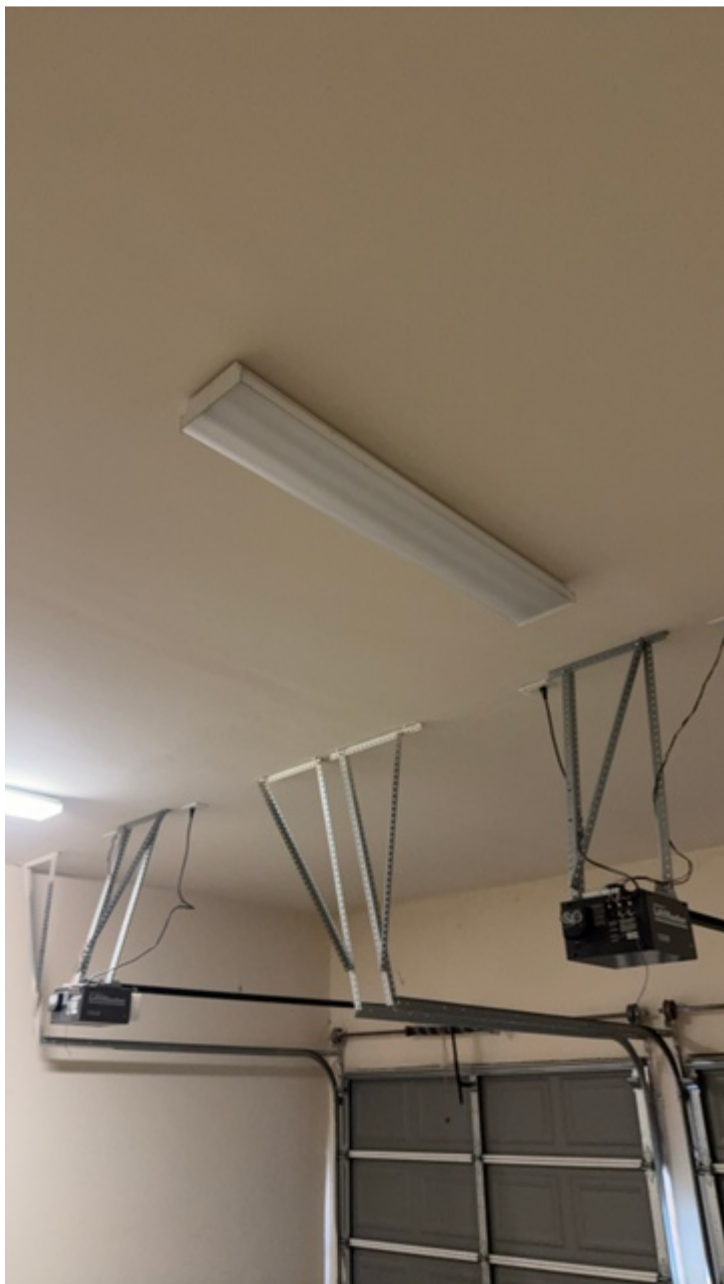
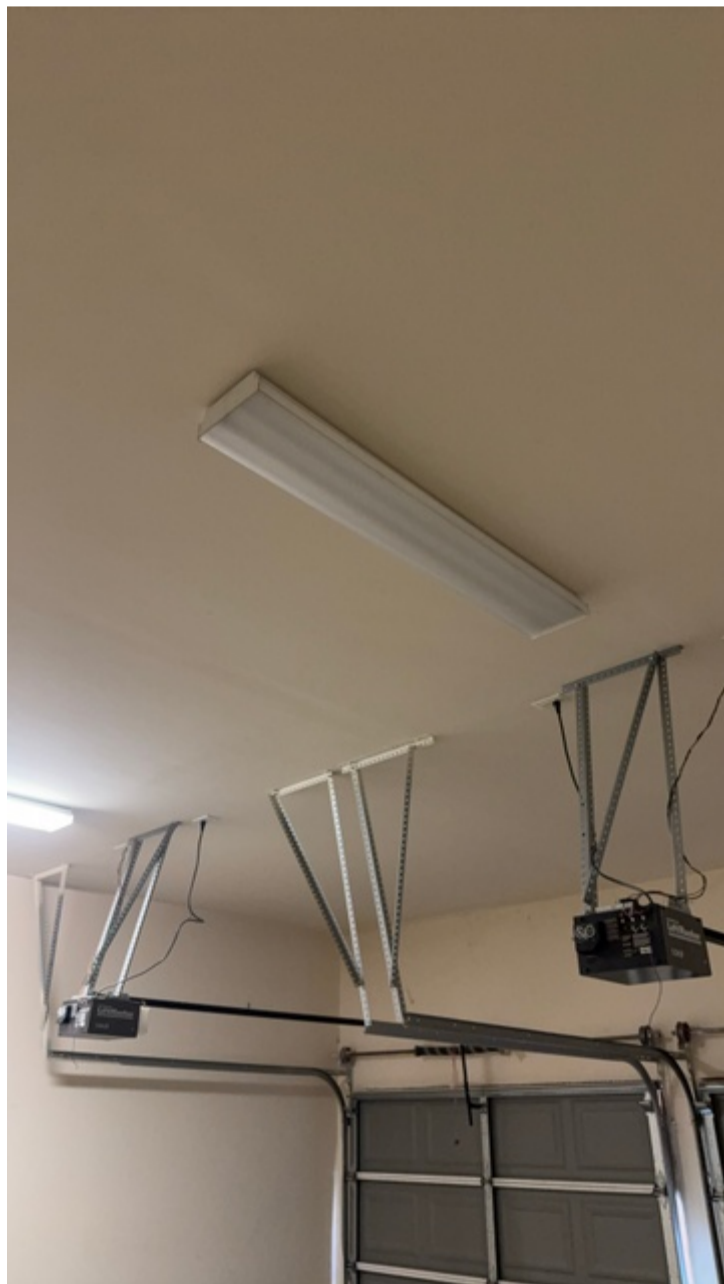
Inoperable or Missing Light Bulb

One or more light bulbs have burnt out or are missing.

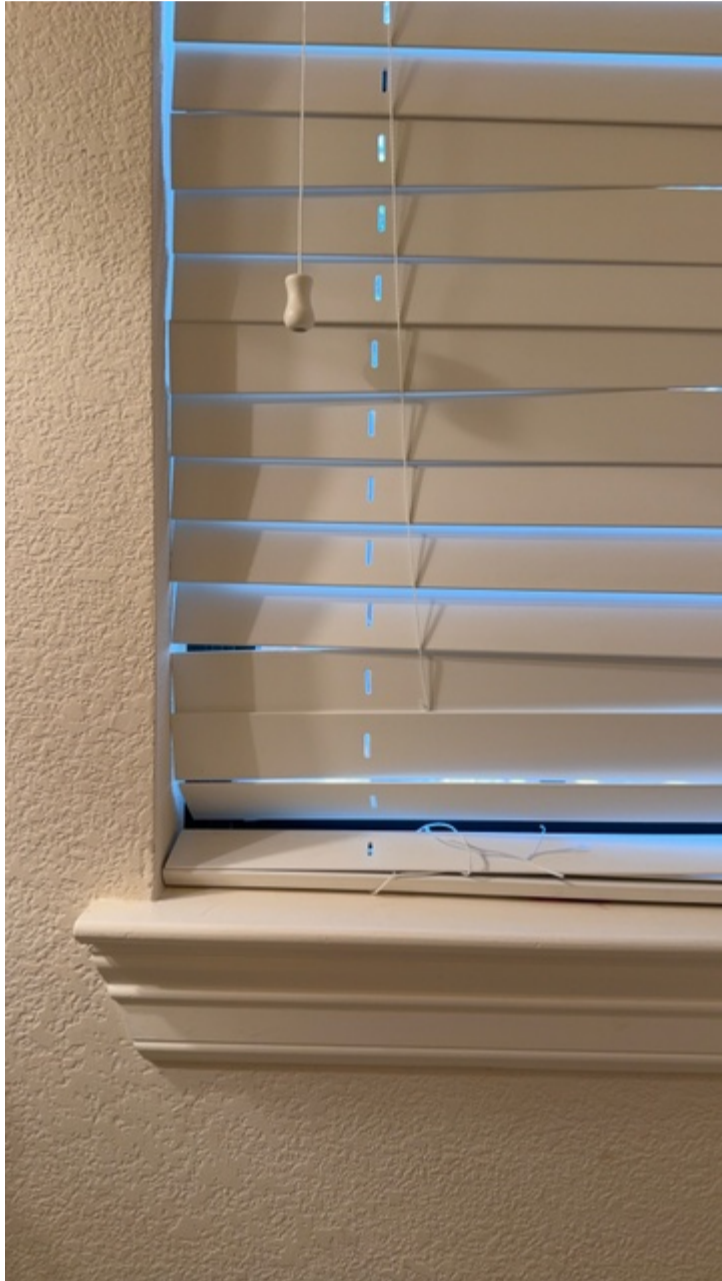
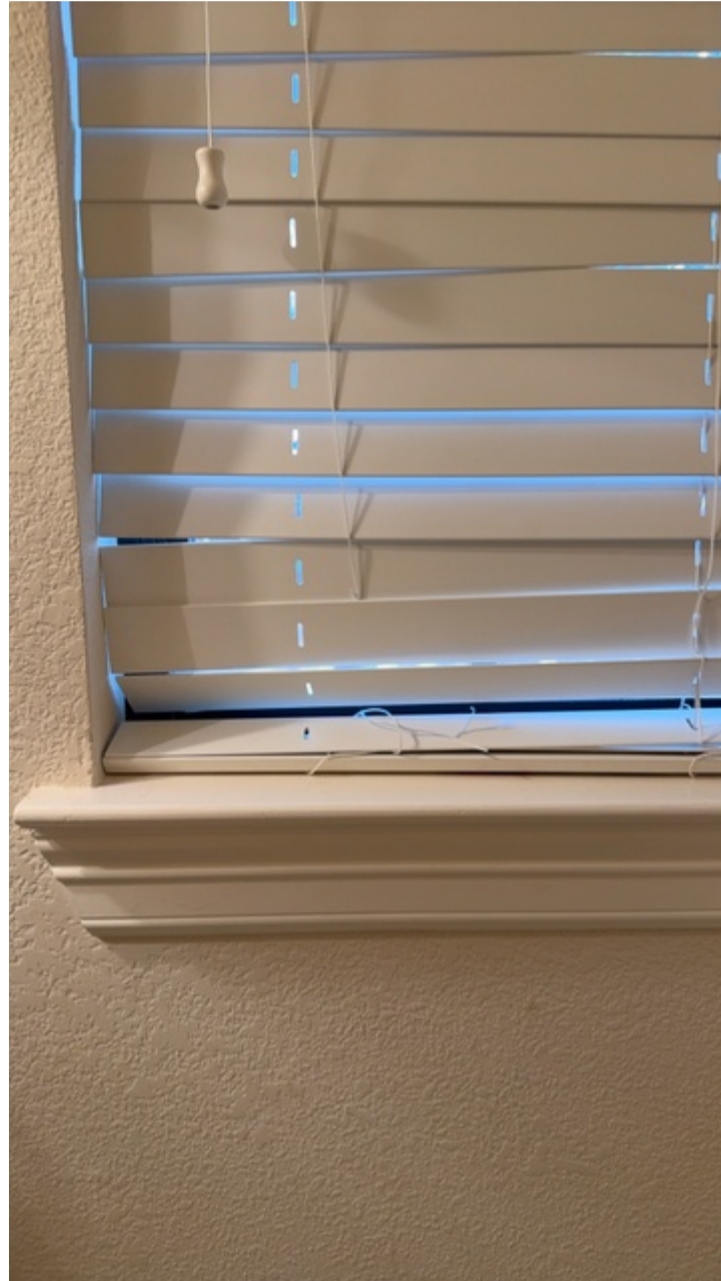
Damaged Blinds

One or more blind slats are damaged.

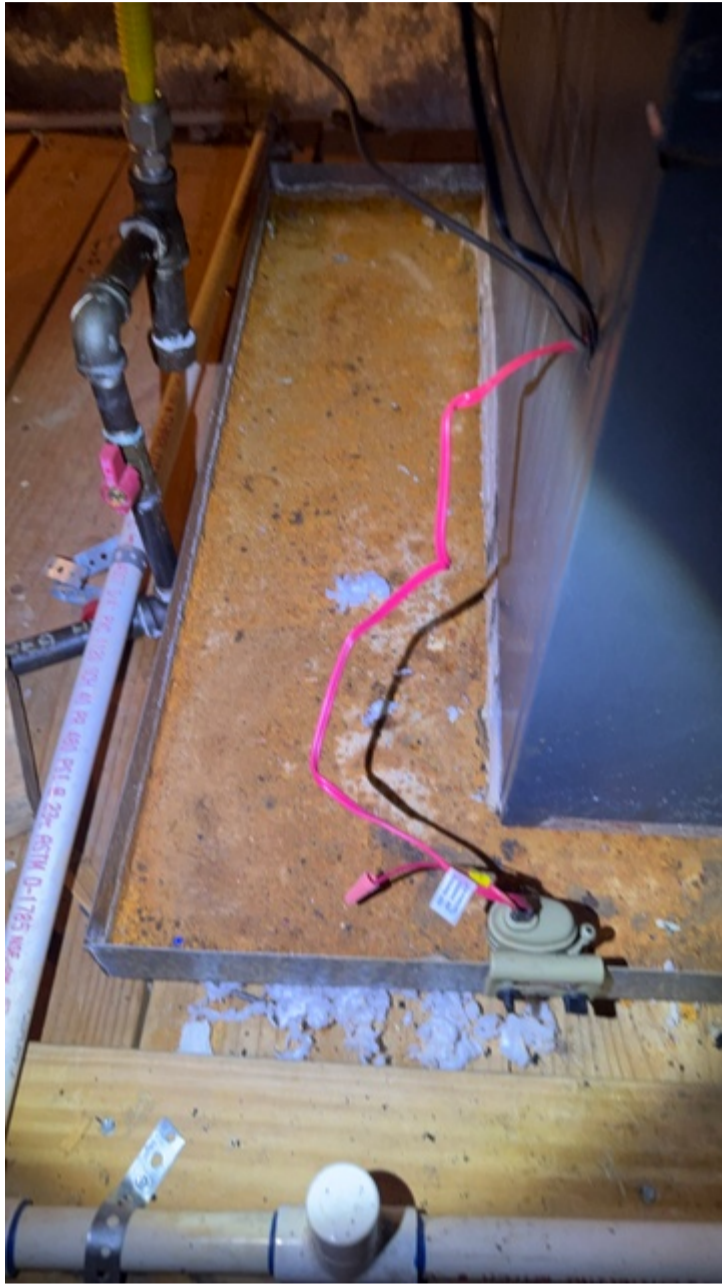
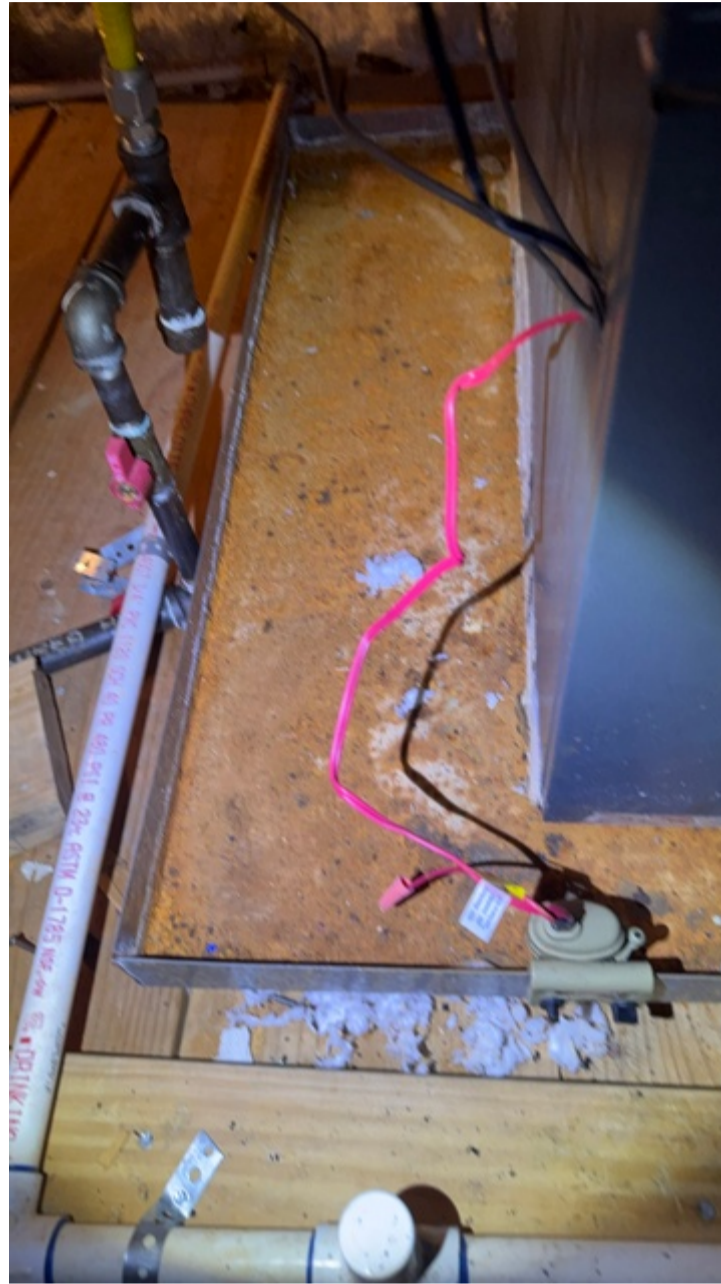
Rusting or Damaged HVAC Drip Pan

The drip pan below the air conditioning unit is rusting or damaged.

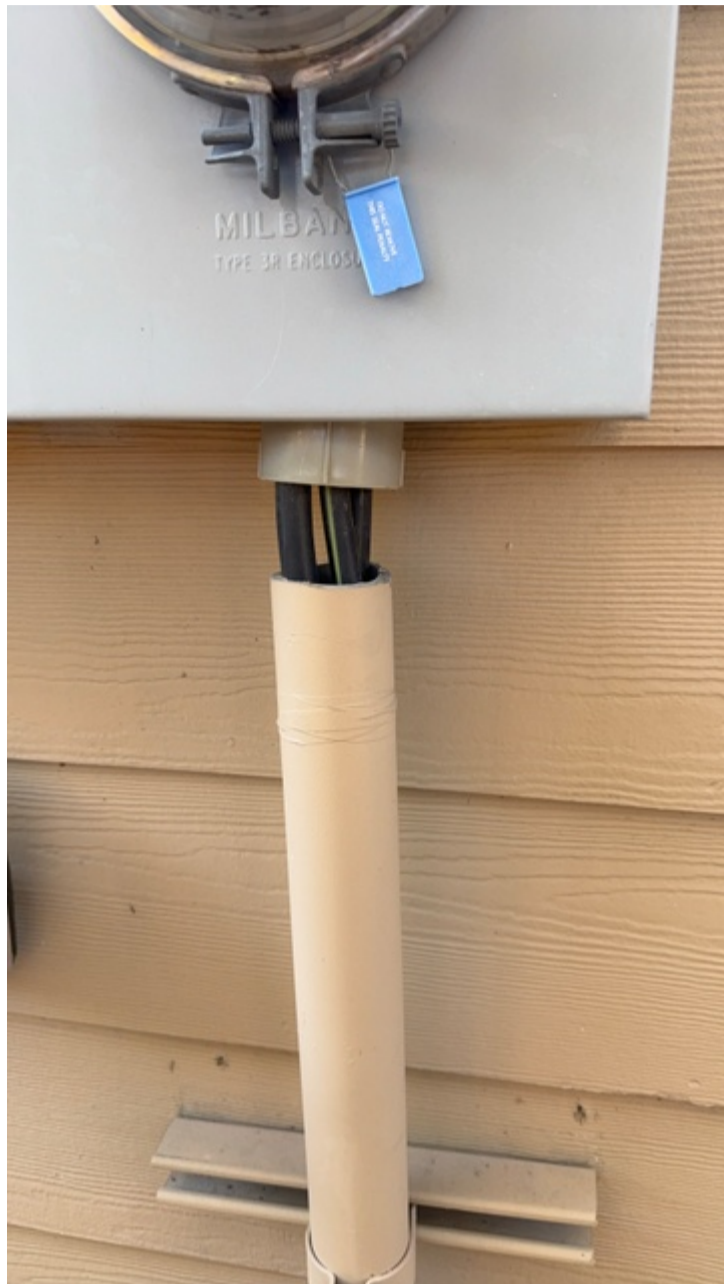
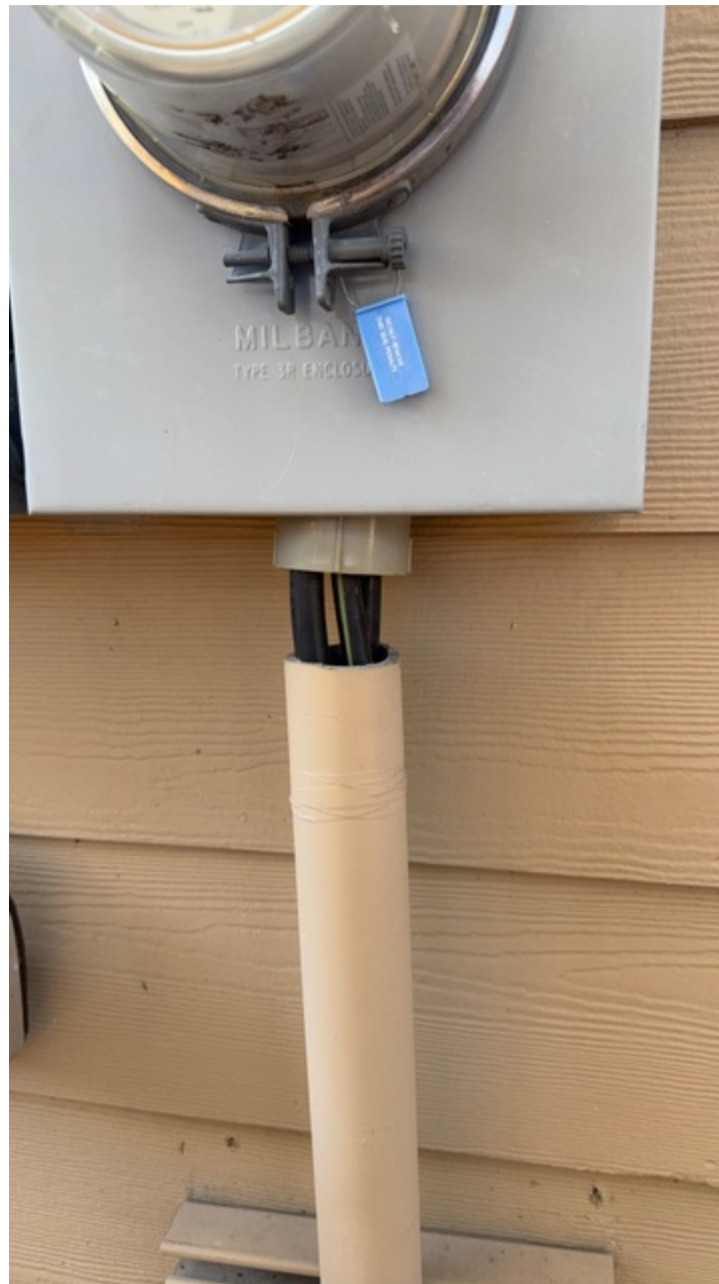
Disconnected or Damaged Conduit

The conduit is disconnected or damaged.
