RCI PROFESSIONAL INSPECTIONS

RESIDENTIAL INSPECTION

17707 Champion Forest Dr
Spring, TX 77379

PROPERTY INSPECTION REPORT FORM

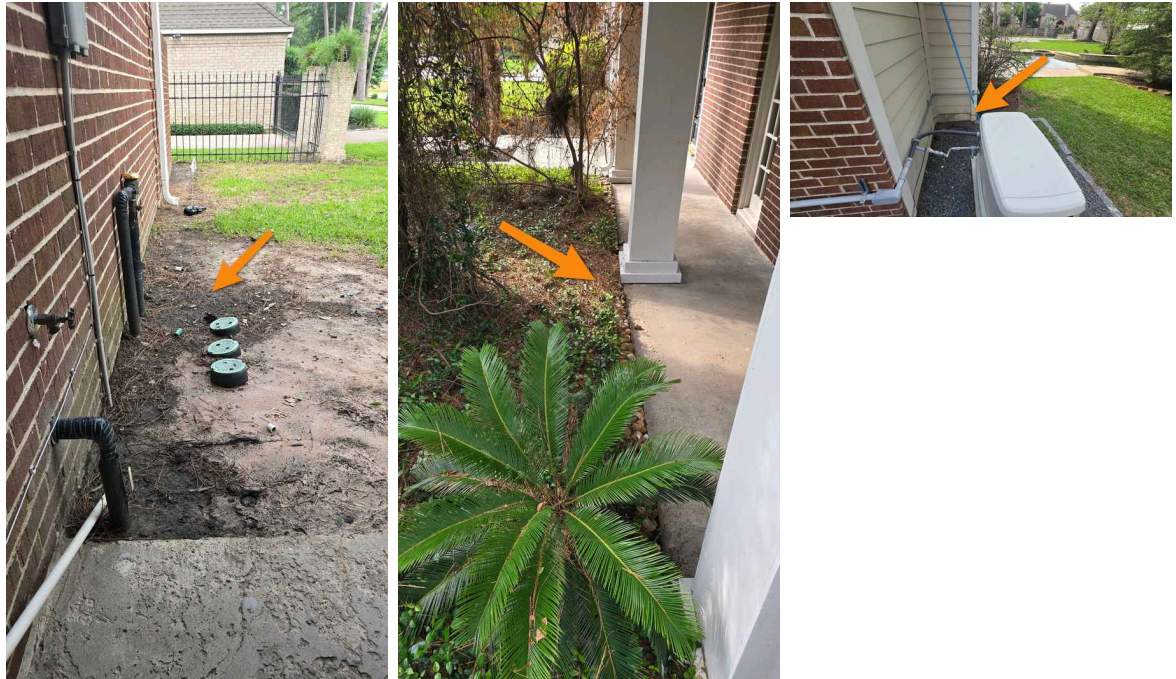
1: Improper grade slope

Front Right, Front, Rear

Requirements for proper drainage from a foundation calls for a minimum 6" slope for the first 10 feet of grading. Drainage should be improved to prevent foundation movement.

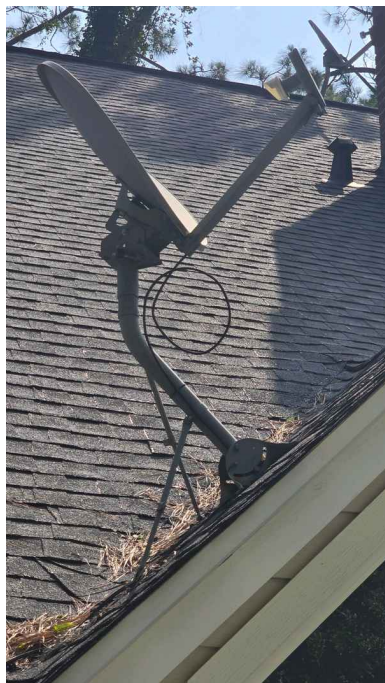
Satellite dish:

Satellite dish is attached to the roof by screwing the bracket directly through shingles and into the roof sheathing. This type of attachments is known to cause leaks if the sealant around the screws are not maintained. Recommend re-sealing as a preventative measure.

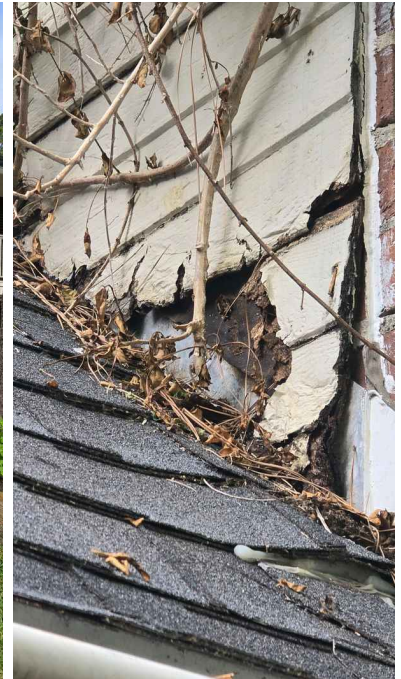
2: Wood Deterioration

Front, Rear

All damaged areas should be repaired, as needed.

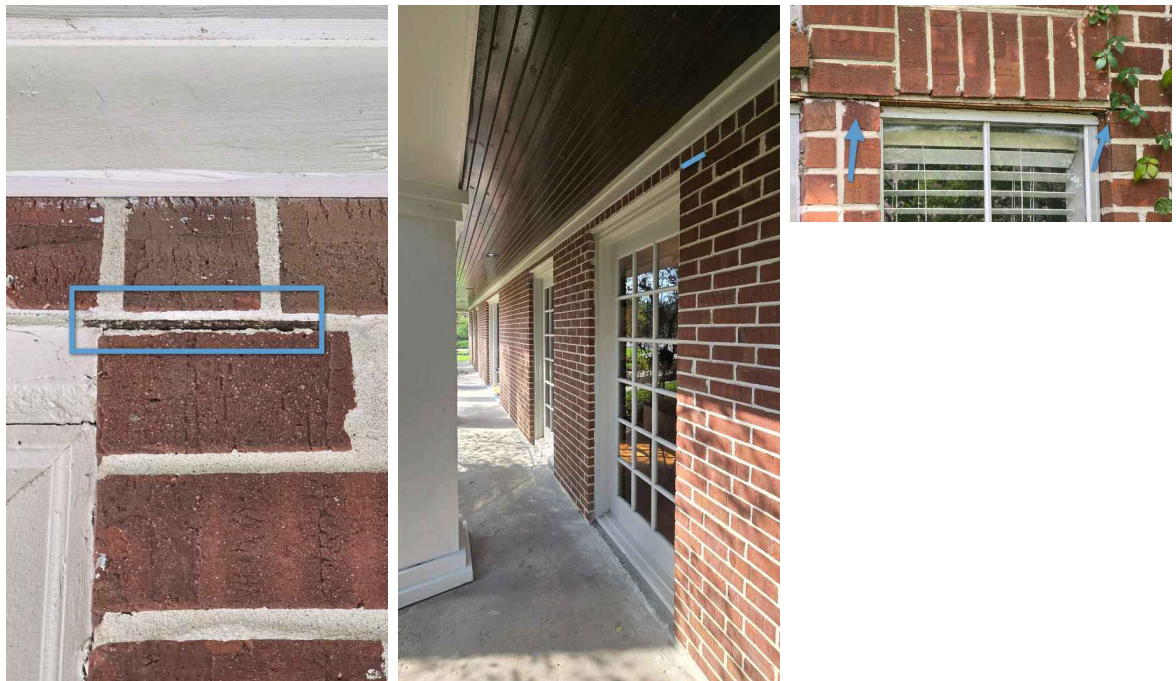
4: Exposed lintel

Front

Exposed lintel (supports for the masonry) should be sealed/patched over to prevent corrosion.

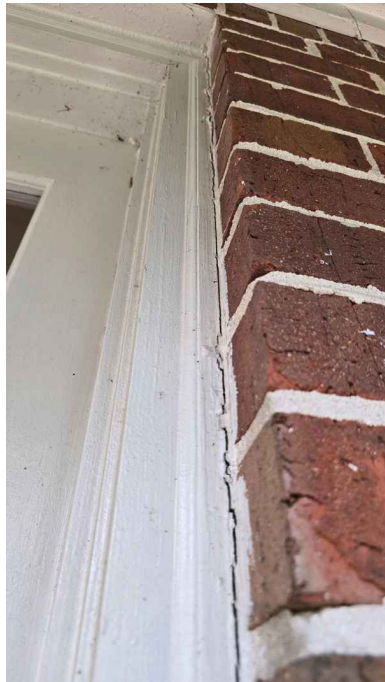
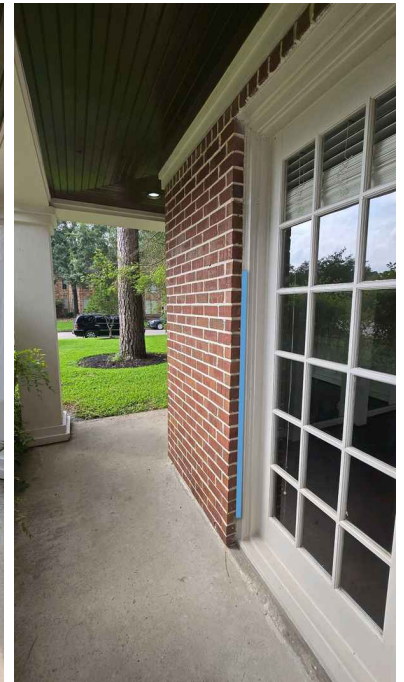
9: Caulking repairs at siding

Front

Seal siding/trim at separations or where missing.

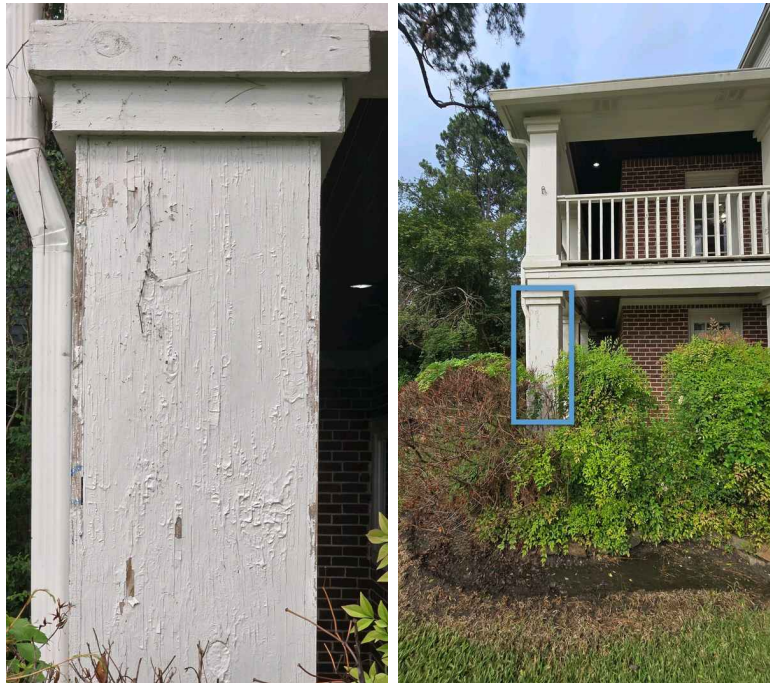
10: Painting repairs needed

Front

Siding needs to be painted where exposed to prevent deterioration.

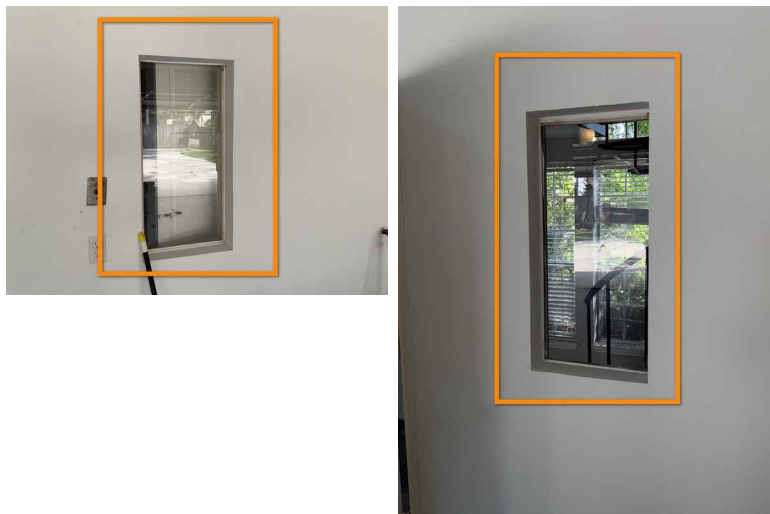
11: Missing firewall in garage

Garage

Area of garage wall is missing required fireblocking protection.

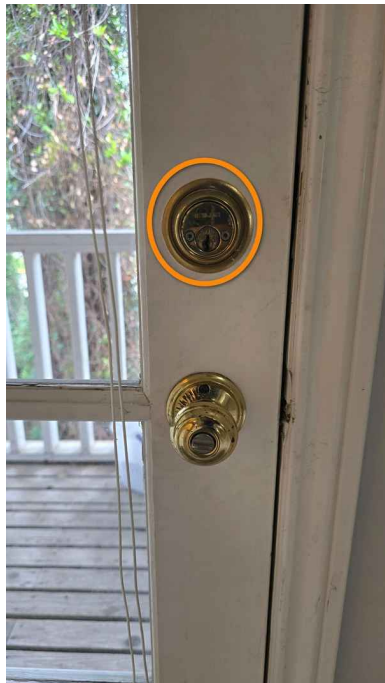
2: Double key deadbolt

2nd Level Front Patio Doors

Double key deadbolt locks are considered an impediment to emergency egress for fire safety and/or escape. Recommend replacing it with single cylinder deadbolt.

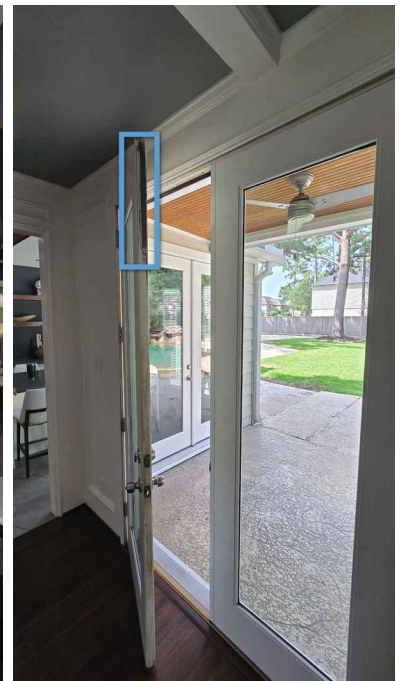
4: Binding door

Breakfast Area Exterior, Rear Exterior, Living Room, Balcony, Front Left Bedroom, 2nd Level Left Bathroom

Adjust and/or repair door to align and not bind.

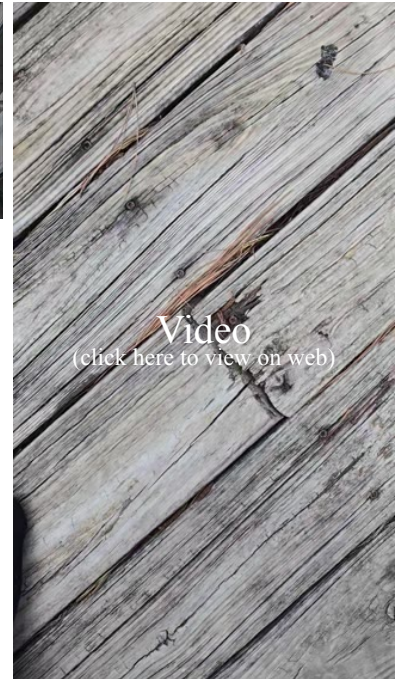
1: Loose step board

Front balcony, Rear balcony

Any loose step boards should be repaired for safety.

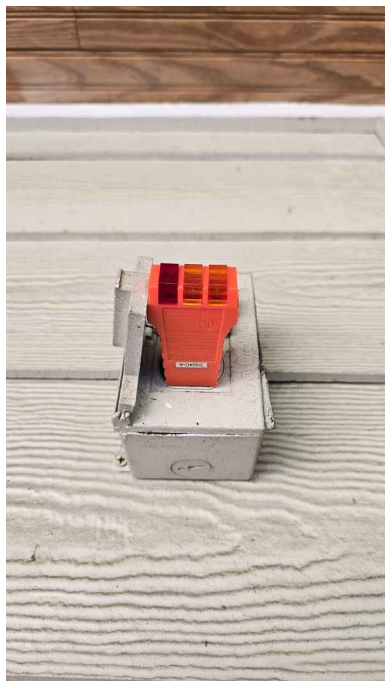
Rear, 2nd Level Front Right Bedroom

Receptacle outlet was not operable and in need of repair/replacement.

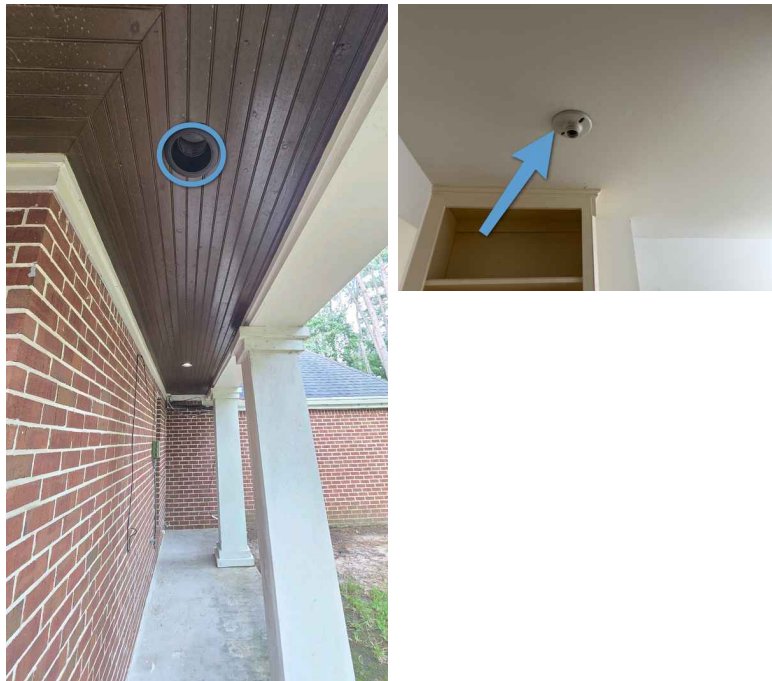
Bathroom Closet

Install light bulb at fixture where missing.

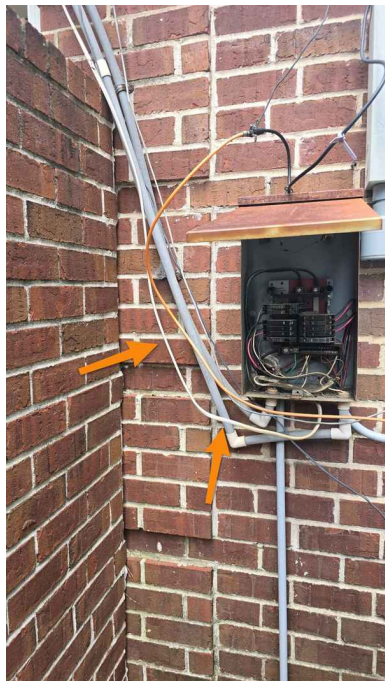
10: Missing conduit

Right Exterior

Conduit is missing at wiring to protect from damage and elements.

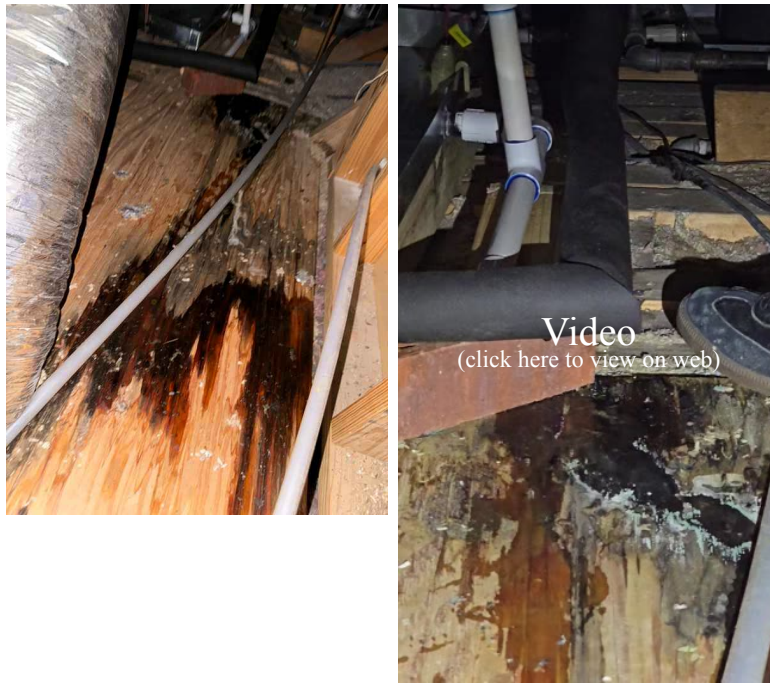
The exposed main condensation drain line in attic space has condensation and causing water damage. Repairs are needed.

Recommendation: Contact a qualified HVAC professional.

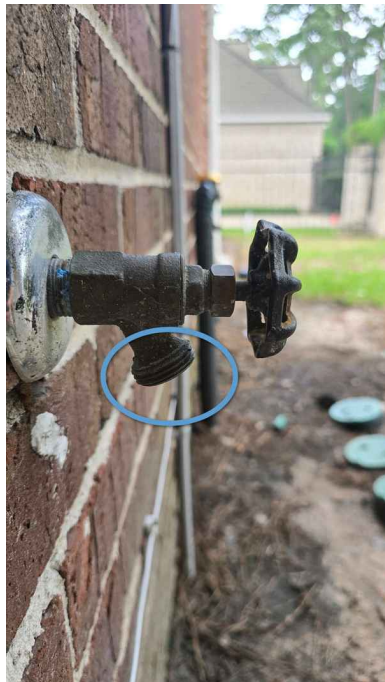
5: Missing Anti-siphon valve(s)

Anti-siphon valves are required at the hose bibs.

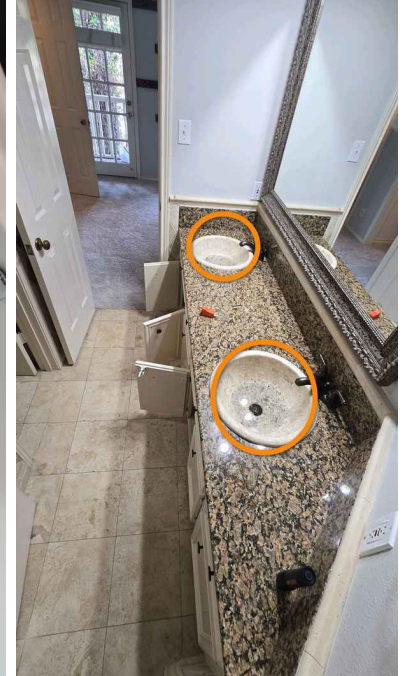
Primary Bathroom, 2nd Level Right Bedroom Bathroom

Slow drain was observed and repairs are needed for proper drainage.
