RESIDENTIAL INSPECTION

17707 Champion Forest Dr
Spring, TX 77379

PROPERTY INSPECTION REPORT FORM

Will Washington <i>Name of Client</i>	05/15/2025 9:00 am <i>Date of Inspection</i>
17707 Champion Forest Dr, Spring, TX 77379 <i>Address of Inspected Property</i>	
Tyler Roberts, Andrew Gordon <i>Name of Inspector</i>	TREC #24422, TREC #26487 <i>TREC License #</i>
Leslie Brush # <i>Name of Sponsor (if applicable)</i>	21684 <i>TREC License #</i>

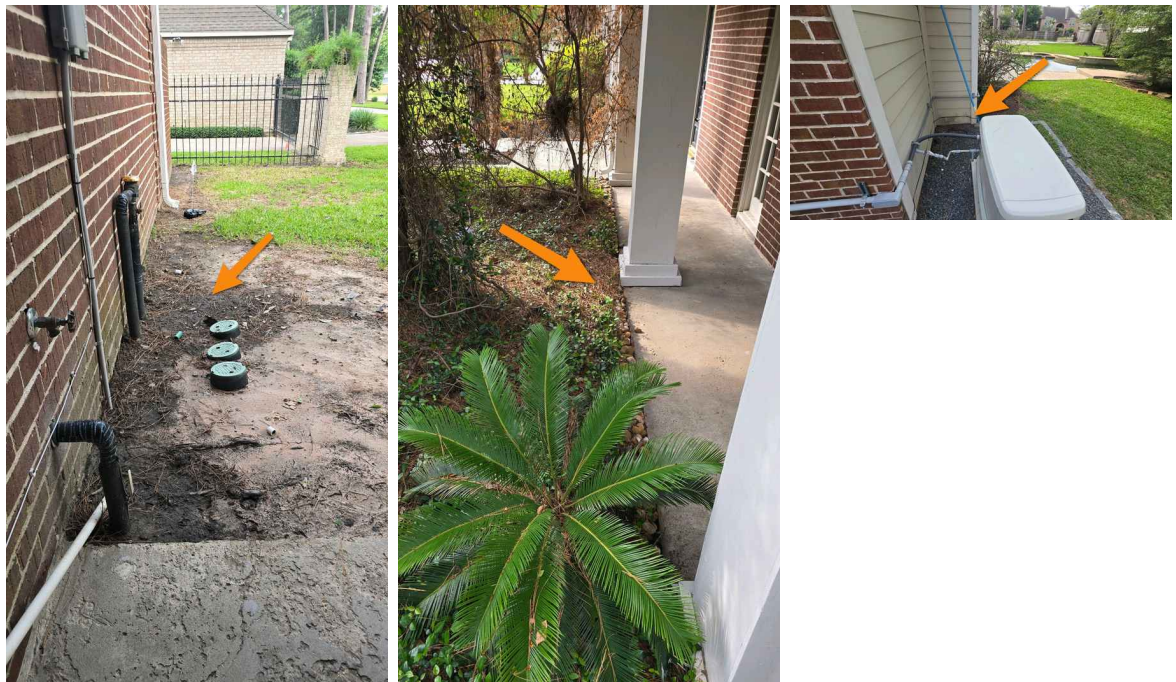
1: Improper grade slope

Front Right, Front, Rear

Requirements for proper drainage from a foundation calls for a minimum 6" slope for the first 10 feet of grading. Drainage should be improved to prevent foundation movement.

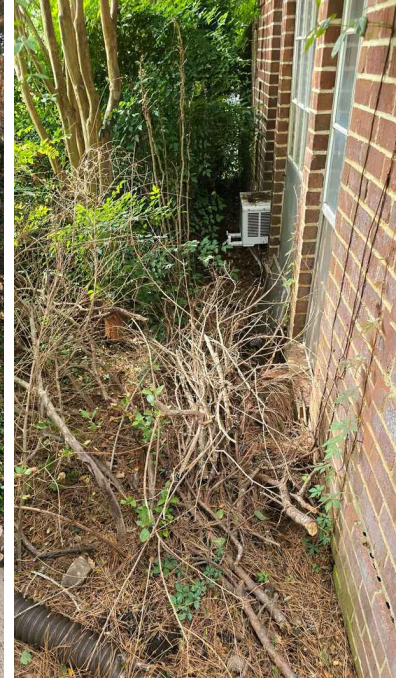
2: Heavy vegetation/overgrowth

Excess overgrowth of vegetation can obstruct the drainage of water away from the home. Drainage around the home should be improved to prevent foundation movement.

Recommendation: Contact a qualified landscaping contractor

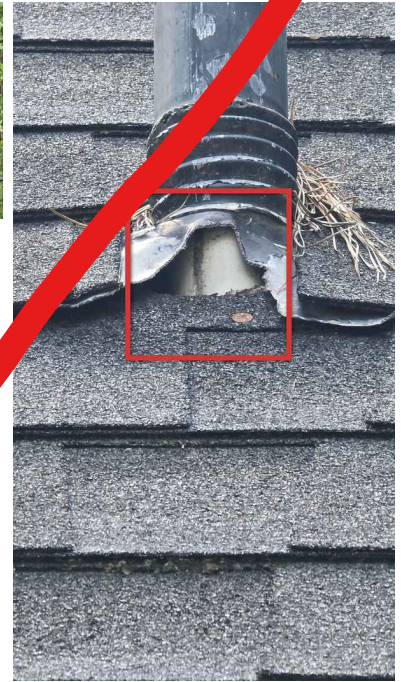
1: Poor condition- needs further review

Roof covering exhibited damage that will affect performance. A qualified roofer is needed for further evaluation and estimate for repairs/replacement.

- Multiple areas of damaged shingles.
- Excessive granule loss at the shingles was observed.
- Multiple plumbing boots were observed damaged, with related water damage in the primary bathroom.
- Heavy tree presence along the left side of the home with evidence of damage at the shingles.

Recommendation: Contact a qualified roofing professional.

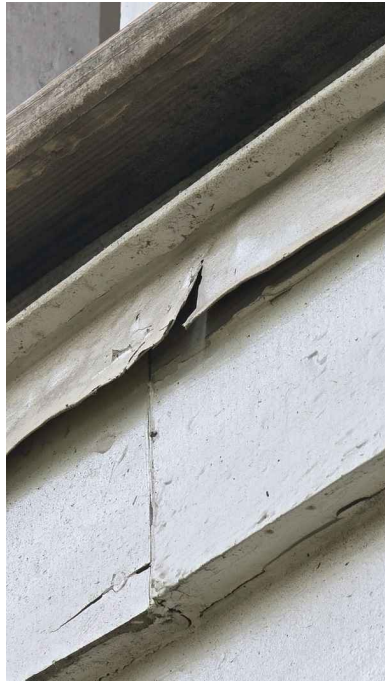
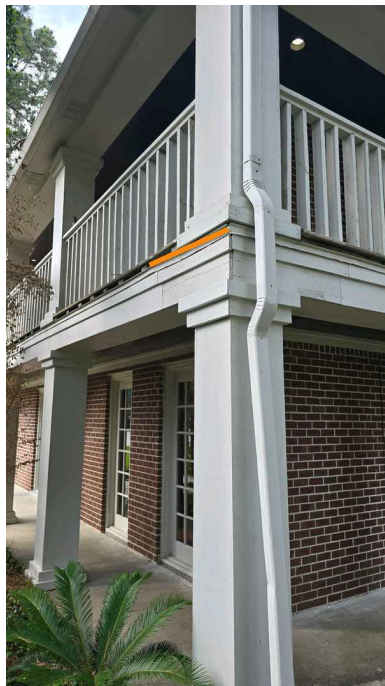
2: Damaged flashing

Flashing should be free of any damage and repaired to lie flat.

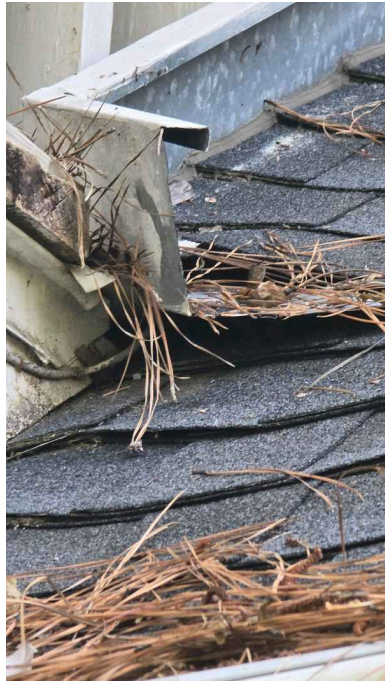
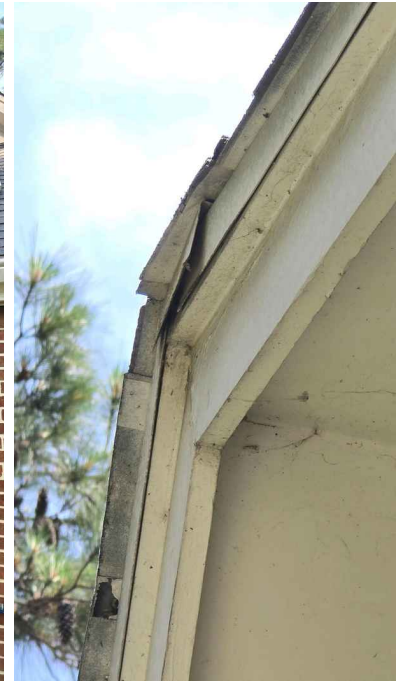
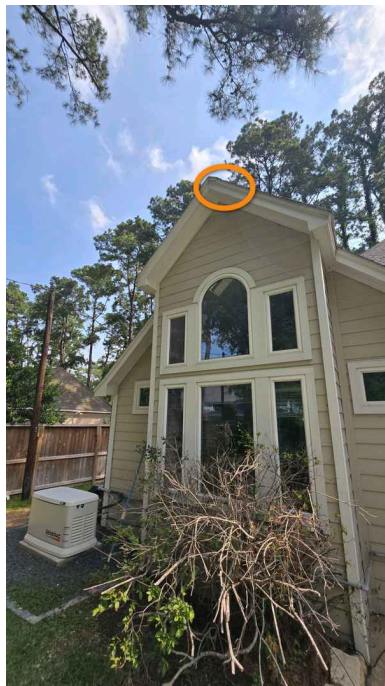
3: Lifted flashing

Any areas of lifted flashing should be repaired to lie flat.

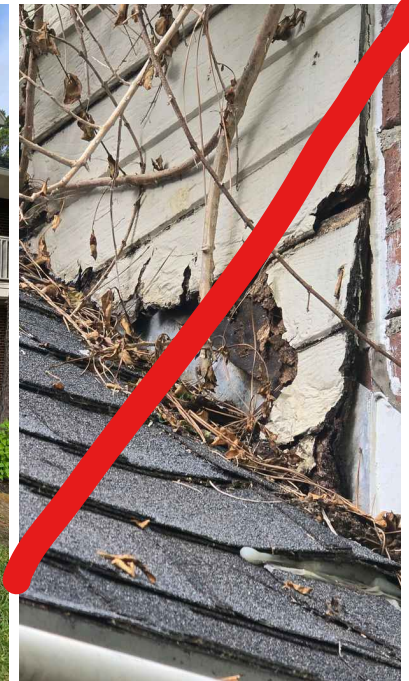
2: Wood Deterioration

Front, Rear

All damaged areas should be repaired, as needed.

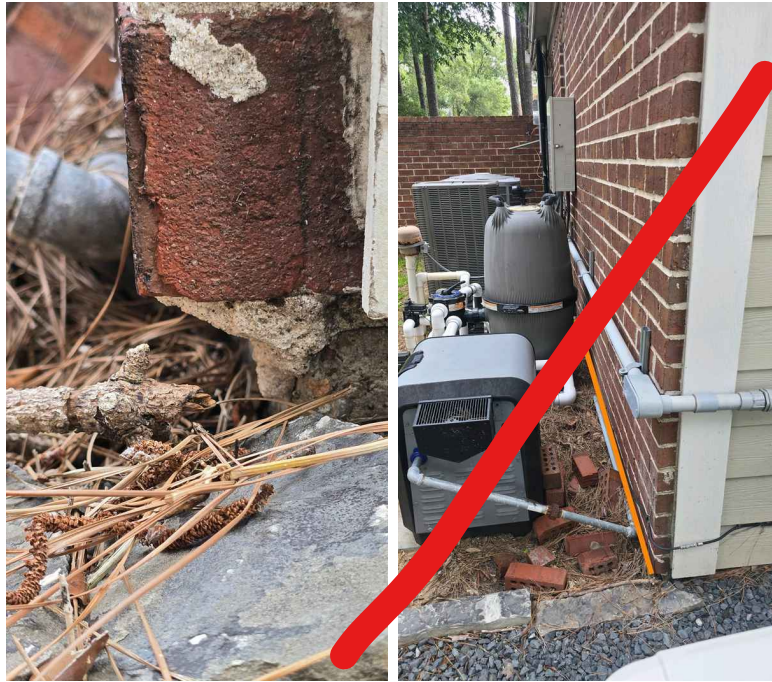
3: Missing brick support

Brick wall projects over the foundation. If the brick over hangs by more than 1/3 the width of the brick, additional support under the brick is necessary.

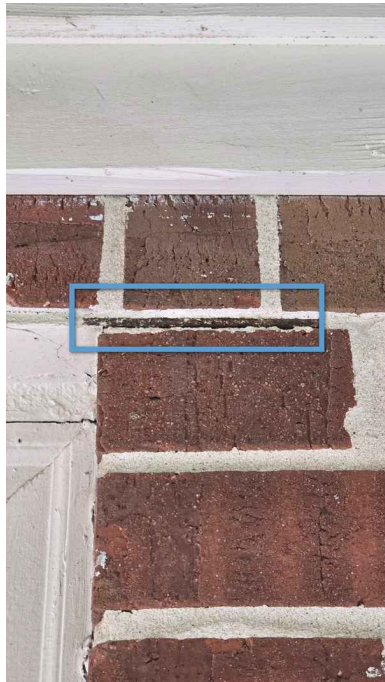
4: Exposed lintel

Front

Exposed lintel (supports for the masonry) should be sealed/patched over to prevent corrosion.

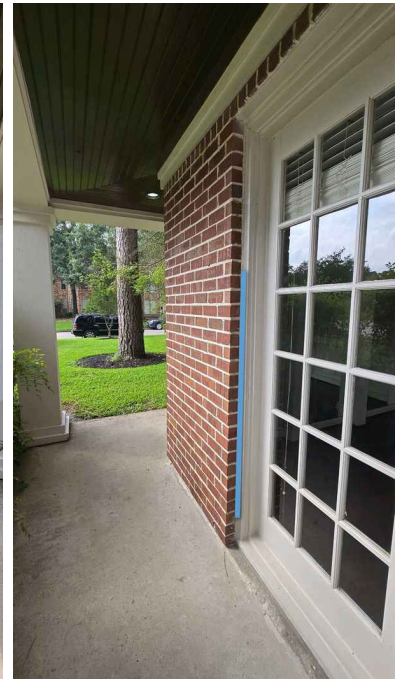
9: Caulking repairs at siding

Front

Seal siding/trim at separations or where missing.

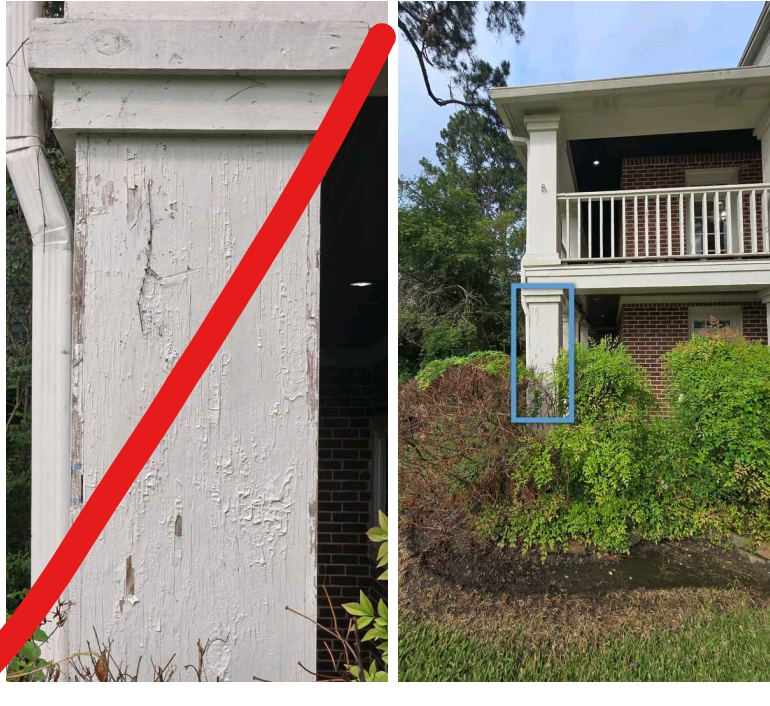
10: Painting repairs needed

Front

Siding needs to be painted where exposed to prevent deterioration.

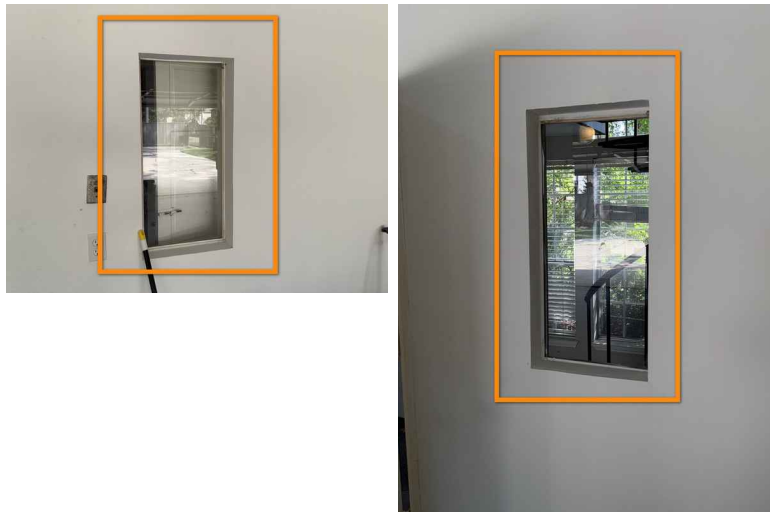
11: Missing firewall in garage

Garage

Area of garage wall is missing required fireblocking protection.

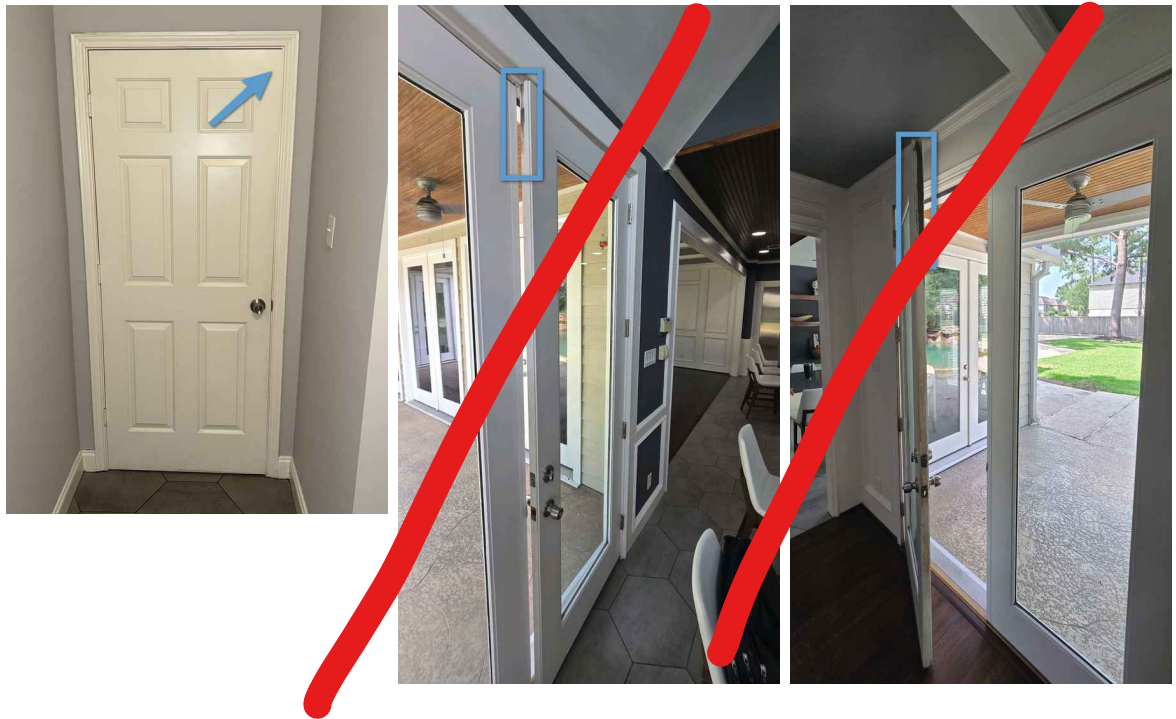
4: Binding door

Breakfast Area Exterior, Rear Exterior, Living Room, Balcony, Front Left Bedroom, 2nd Level Left Bathroom

Adjust and/or repair door to align and not bind.

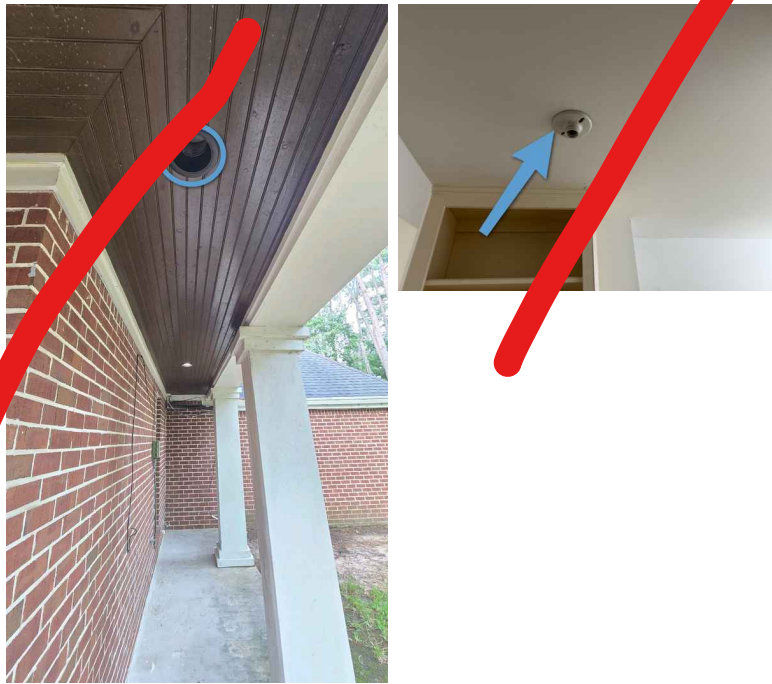
Bathroom Closet

Install light bulb at fixture where missing.

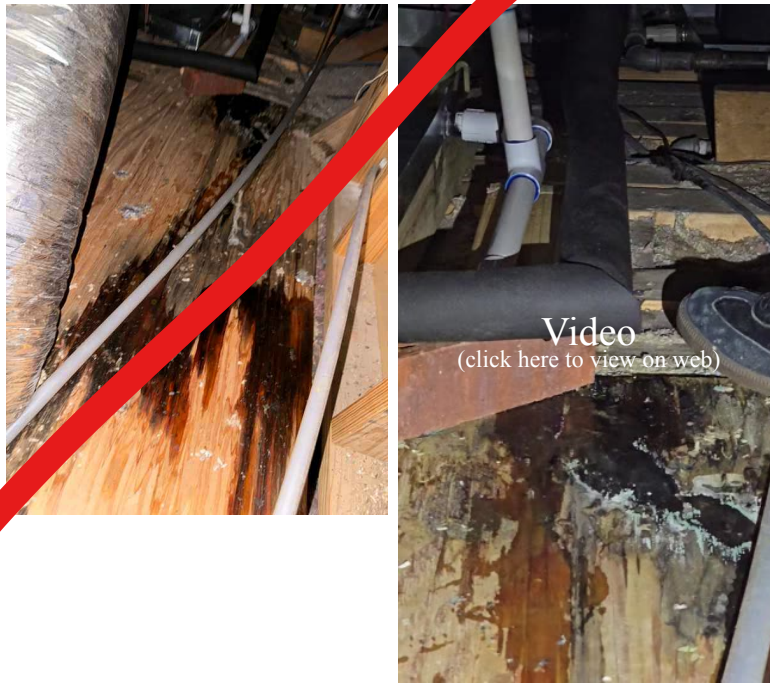
The exposed main condensation drain line in attic space has condensation and causing water damage. Repairs are needed.

Recommendation: Contact a qualified HVAC professional.

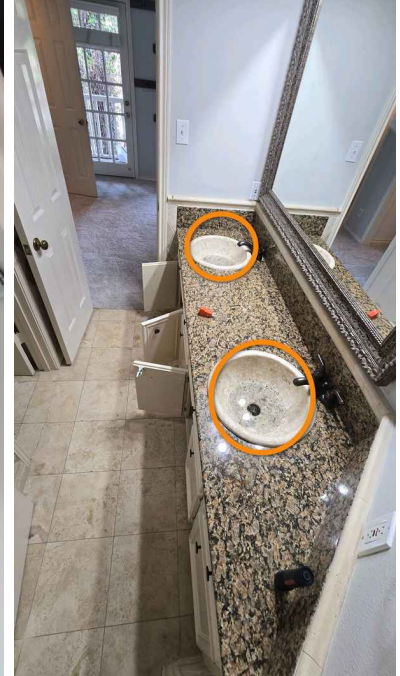
Primary Bathroom, 2nd Level Right Bedroom Bathroom

Slow drain was observed and repairs are needed for proper drainage.

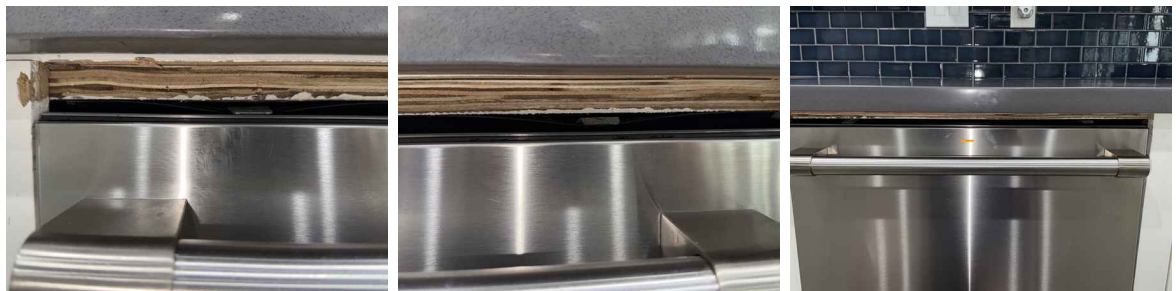
Unit is not anchored/mounted in cabinet and needs to be secured to prevent possible leaks.
