HEDDERMAN SERVICES

MECHANICAL INSPECTION

1119 Del Norte St
Houston, TX 77018

PROPERTY INSPECTION REPORT FORM

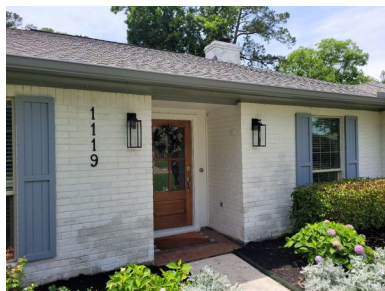
1: GFCI - Missing at outlet

Kitchen counter tops, Exterior north, Utility room, Washing machine, Kitchen island -

A GFCI device was not installed at one or more locations that are currently required to have GFCI protection. It is recommended that an electrician install GFCI devices at all of the currently required locations.

Recommendation: Contact a qualified professional.

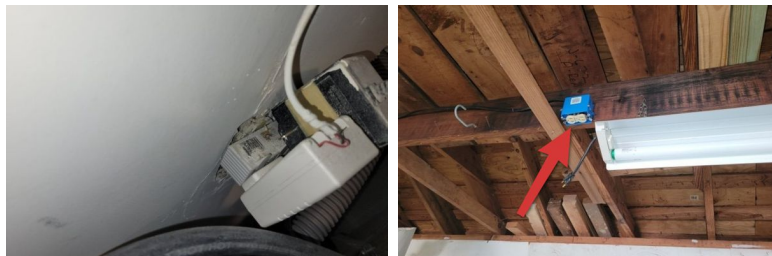
2: Cover Plate - Damaged/Missing

A missing or damaged cover plate was observed.

Obtain Cost Estimate

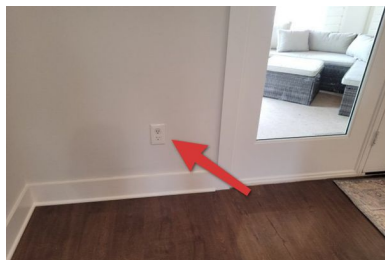
3: Outlet - Loose in wall

Family Room

An outlet was loose on the wall and needs to be secured.

Obtain Cost Estimate

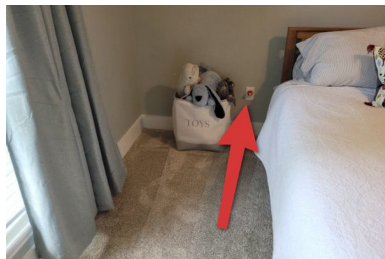
4: Outlet - Ungrounded

Northeast Bedroom

A three prong outlet that was not grounded properly and needs to be repaired. It is recommended that an electrician be contacted, and the necessary repairs made to the outlet.

Obtain Cost Estimate

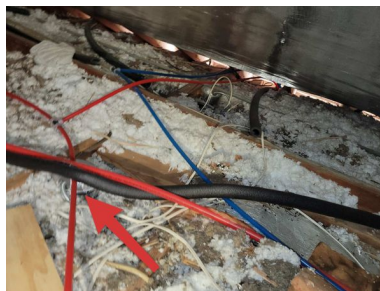
5: Recessed lights - In contact with insulation

The insulation was in contact with the recessed lights, which can be a fire hazard and shorten the life of the light bulbs. It is recommended that the insulation be pulled back to provide a three inch air space.

Obtain Cost Estimate

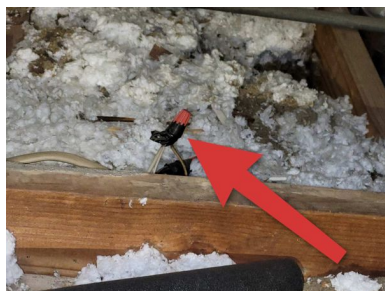
8: Unprotected wire splice

In Attic Above Kitchen Area

Wiring that was spliced and not enclosed in a junction box was observed.

Obtain Cost Estimate

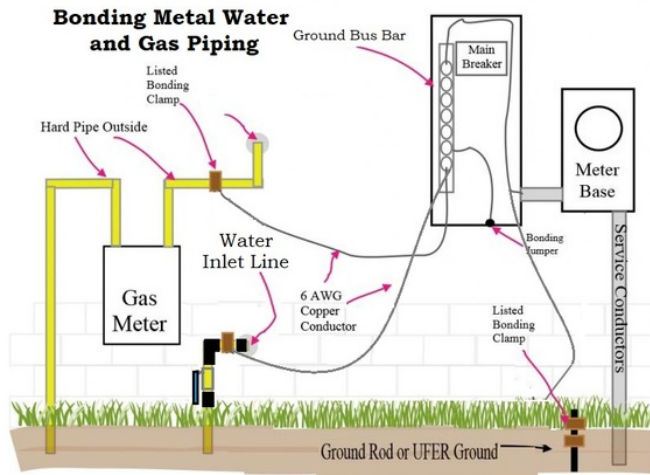
9: Gas and/or Water Piping - Bonding Not visible

The location(s) where the water supply piping and/or gas supply piping were bonded together and/or back to the electrical ground system were not visible at the time of the inspection. It is recommended that an electrician be contacted to determine if the plumbing in the house is properly bonded and to make any needed repairs.

Obtain Cost Estimate

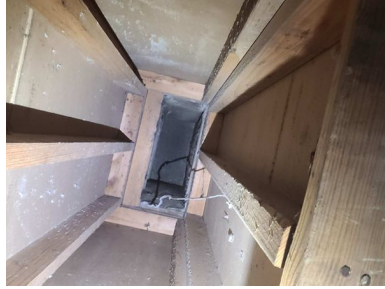
2: Return Air - Not sealed

The chase was not sealed properly and was drawing unconditioned air from the floor and/or wall cavities into the system. Have the chase sealed against air leaks.

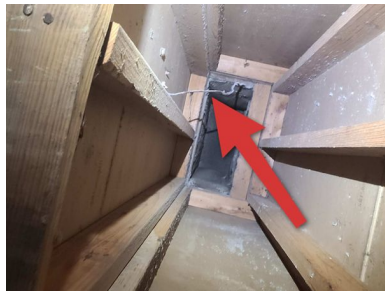
3: Return Air - Minimal size

The return air chase appeared to be minimally sized. Typically, at least one square foot of return air surface space for each ton of air conditioning capacity to allow for proper air circulation through the system. Further investigation with an air conditioning company is recommended, who should provide a cost estimate for repairs.

Obtain Cost Estimate

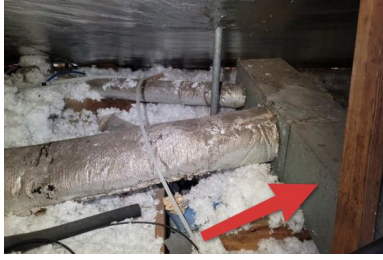
5: Metal Ducts - Not insulated

We observed Un-insulated metal trunk ductwork in the attic. Some square metal ductwork is equipped with interior insulation and the exterior does not require insulation. We could not verify that the metal ducts were lined with insulation and it is recommended that you contact an HVAC contractor to determine if the metal trunk ducts are acceptable for the application.

Further investigation is recommended.

Recommendation: Contact a qualified professional.

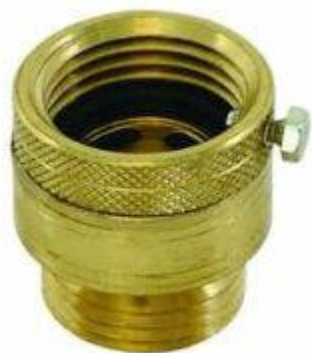
2: Vacuum Breaker - Missing

The atmospheric vacuum breaker devices were missing at one or more of the hose bibbs, and it is recommended that they be installed to prevent cross connections, which can allow contaminated water to enter the potable water supply.

Obtain Cost Estimate

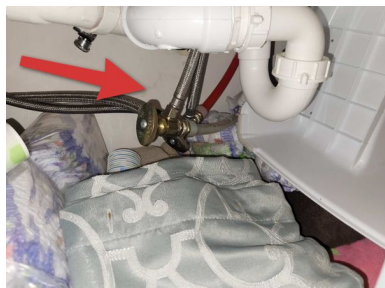
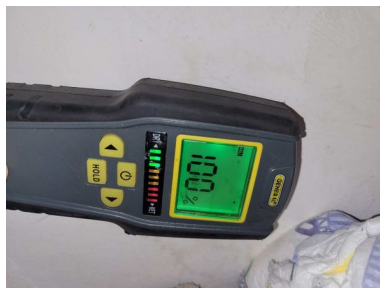
3: Water Stains - High moisture detected

Hall Bath at right sink cabinet

Recommendation: Contact a qualified professional.

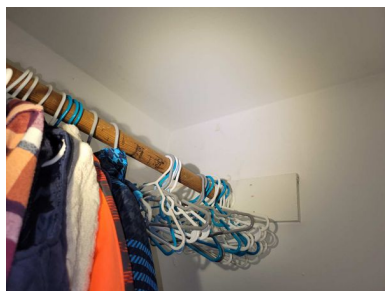
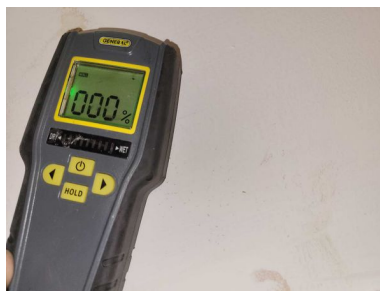
4: Water Stains/Damage Observed

Water stain

Recommendation: Contact a qualified professional.

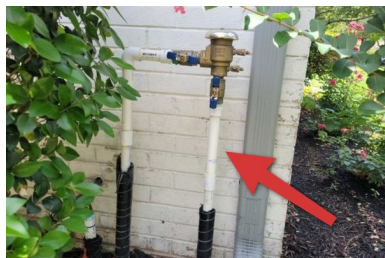
5: Insulate Exterior Water Piping

Sprinkler system backflow preventer

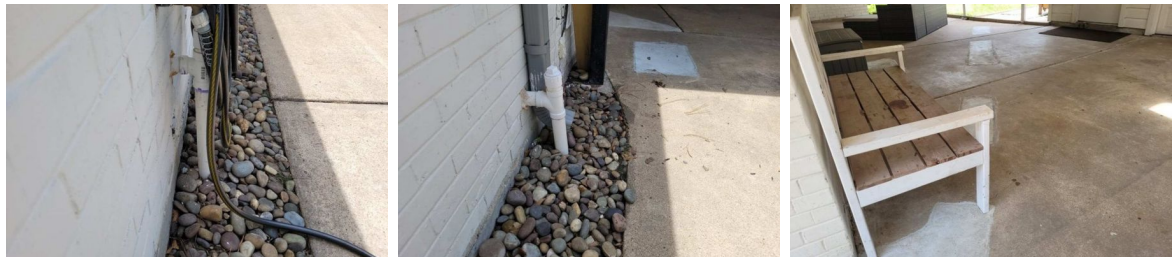
Sewer Piping - Evidence of repairs observed: PVC clean out present, PVC drain(s) extended through wall and rerouted, Concrete patched inline with sewer system -

Evidences of sewer line repairs and/or replacement were observed. It is noted that we could not determine the extent of the repairs to the sewer system or if any of the original cast iron piping is still active. Further investigation is recommended with the owner and/or a service company to determine the extent of the repairs and to determine if any further repairs are needed. A sewer inspection with a plumber to verify the extent of the repairs and the condition of the sewer piping and the repairs is recommended. The plumber should also determine if the washing machine drain riser is adequately sized to accommodate a modern washing machine.

Further investigation is recommended

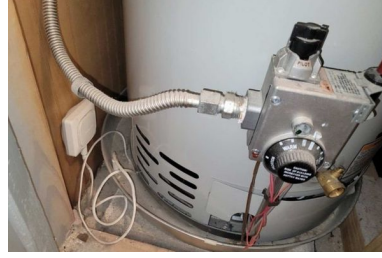
1: Sediment Trap - Missing

Sediment traps were not installed at the gas supply lines for one or more of the gas fired equipment. A sediment trap is intended to catch sediment/moisture/debris in a gas supply line before it can enter into the gas equipment.

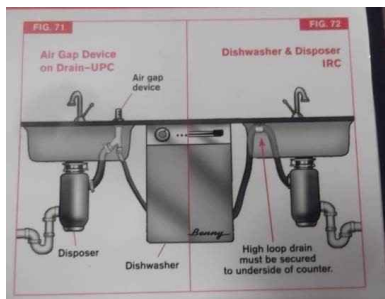
1: No Anti-Siphon

The drain line under the sink was not equipped with an anti-siphon device, nor was it looped up so that the top of the loop is at least six inches above the entrance of the drain line into the disposal. It is recommended at least that the drain line be looped to prevent the water from the garbage disposal from siphoning back into the dishwasher, or an anti-siphon device installed.

Obtain Cost Estimate

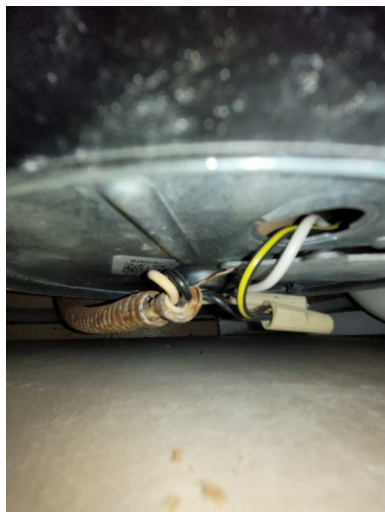
2: Loose in Cabinet

The dishwasher was loose in the cabinet and needs to be properly secured.

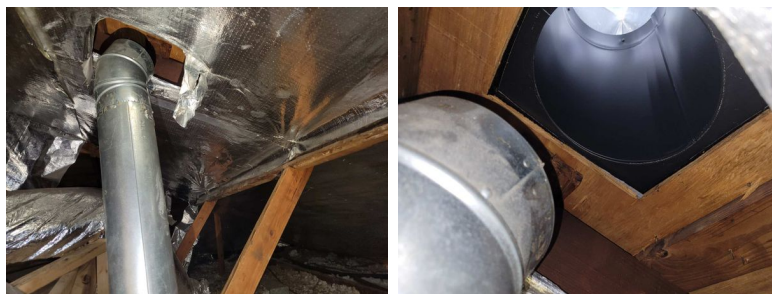
1: Vent Pipe - not secured to roof jack

The end of the vent pipe in the attic was not secured into the roof jack and was discharging air into the attic. The vent pipe needs to be repositioned into the roof jack to discharge to the outside.

Obtain Cost Estimate

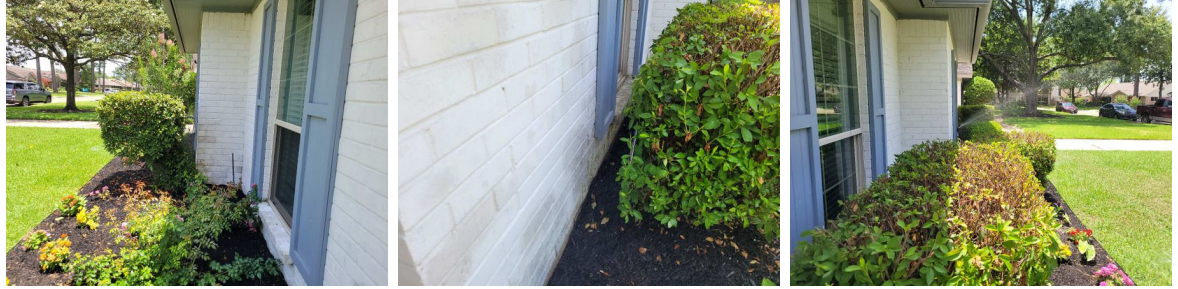
1: Adjust sprinkler head spray

Zone 1
