STRUCTURAL INSPECTION

1119 Del Norte St
Houston, TX 77018

MAY 25, 2022

REF: CONDITION OF PROPERTY SURVEY

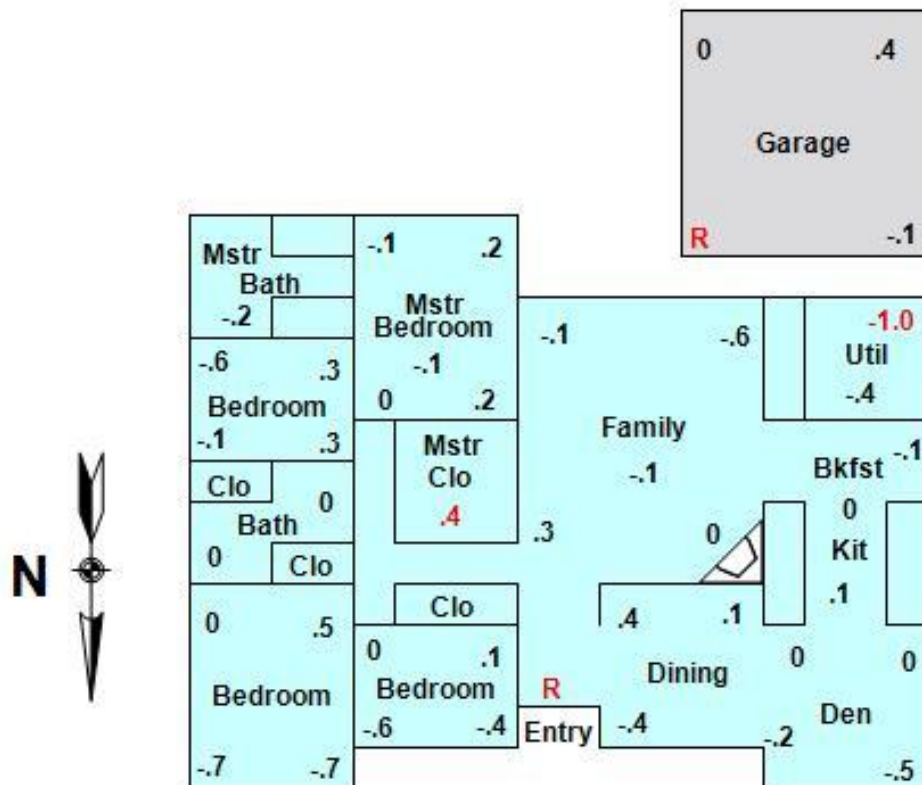
Elevation Readings 1119 Del Norte St

The floors were checked with an electronic level, and were observed to be acceptably level throughout the house. The difference in elevation between the high point and low point was 1.4 inches. The high point was located at the master closet, and the low point was located at the utility room. The unlevelness takes place over a horizontal distance of approximately 35-45 feet.

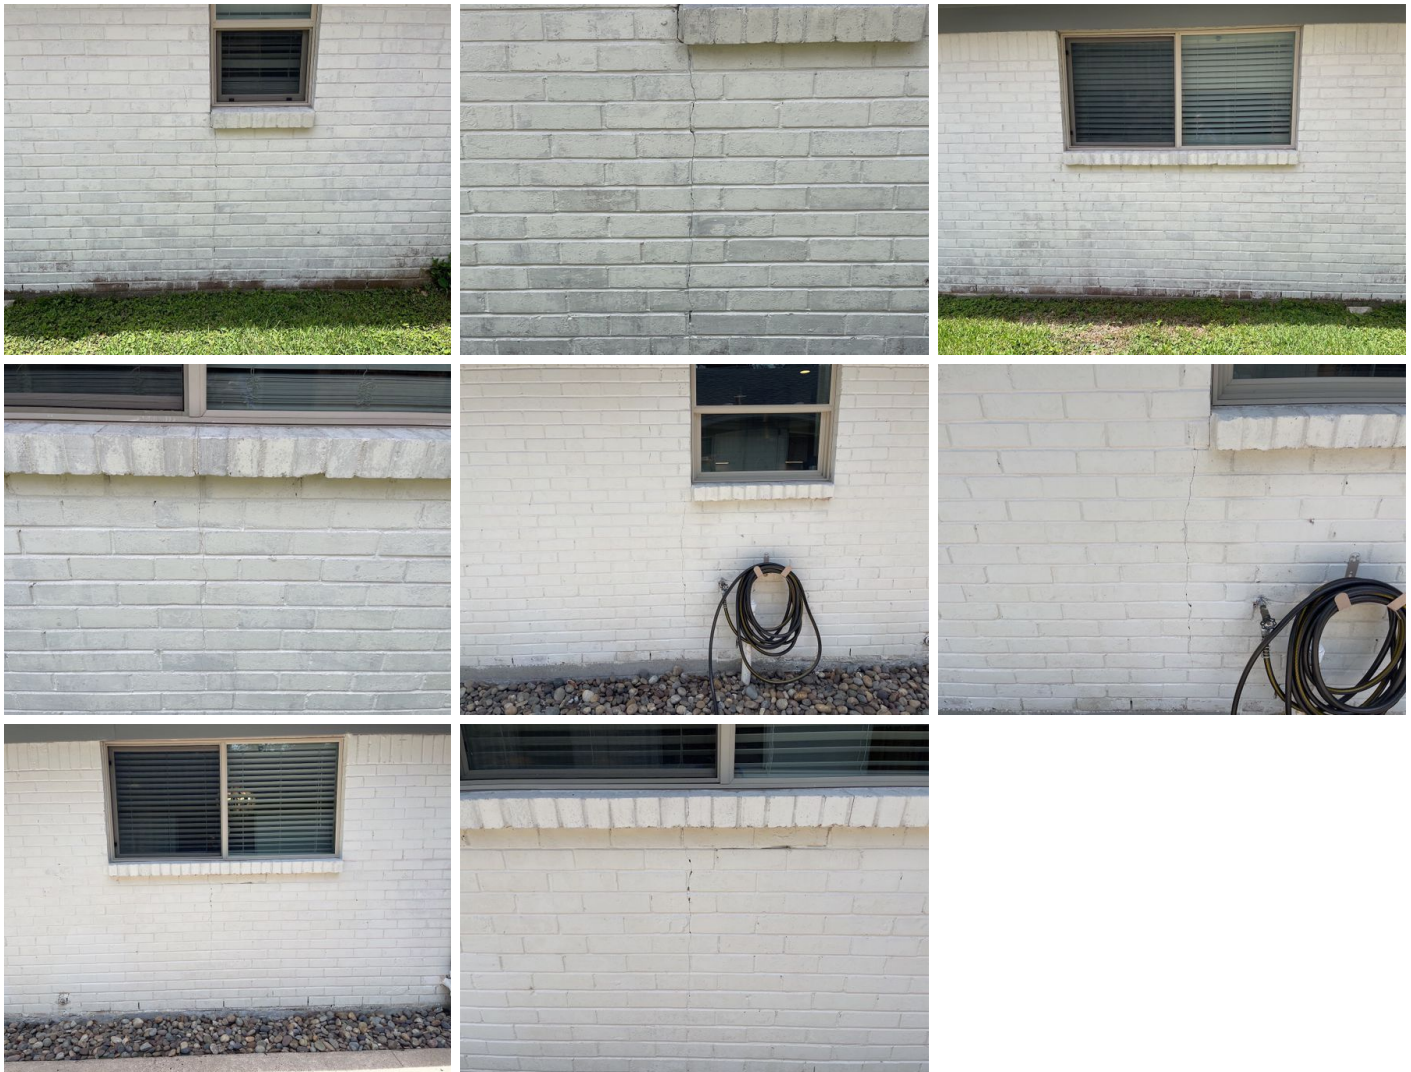
Veneer - Cracks/Patches

Cracks and/or patches were observed in the exterior veneer at the time of the inspection, including at the locations shown in the photos. It is recommended that the cracks be repaired for cosmetic purposes.

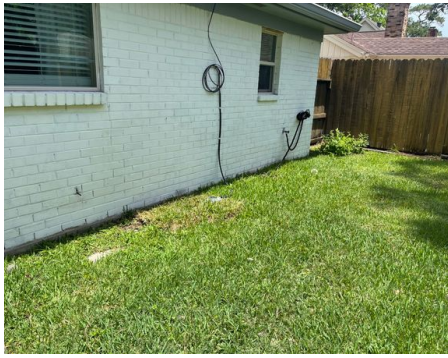
It is pointed out that a portion of the foundation concrete could not be viewed due to soil that was graded near or above the top of the foundation and/or heavy foliage growing against the house. The soil and/or foliage should be

removed, and 3-4 inches of foundation concrete exposed.

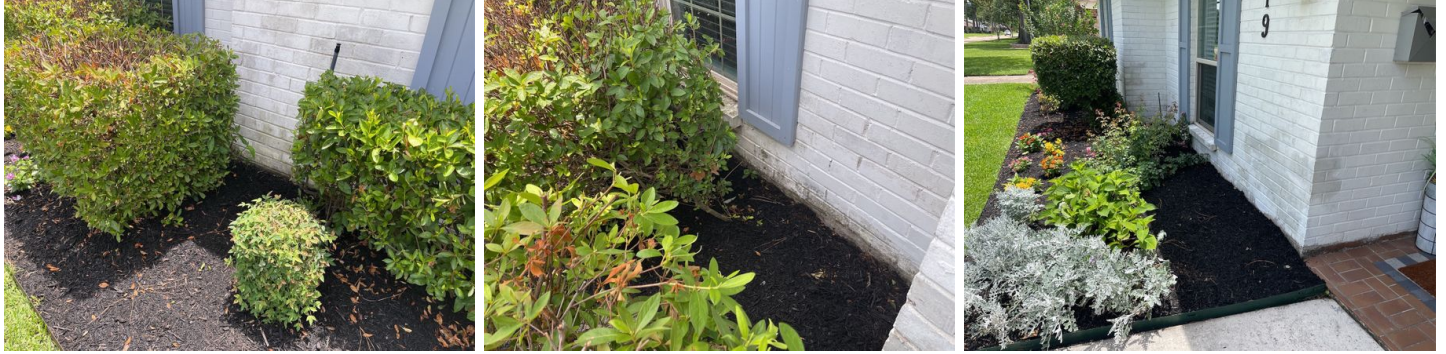
The perimeter grading and/or flower beds was too high at some areas, and was graded near or above the top of the foundation. It is recommended that the beds/soil be regraded as needed to prevent water penetration into the house, and to allow for proper drainage.

R401.3

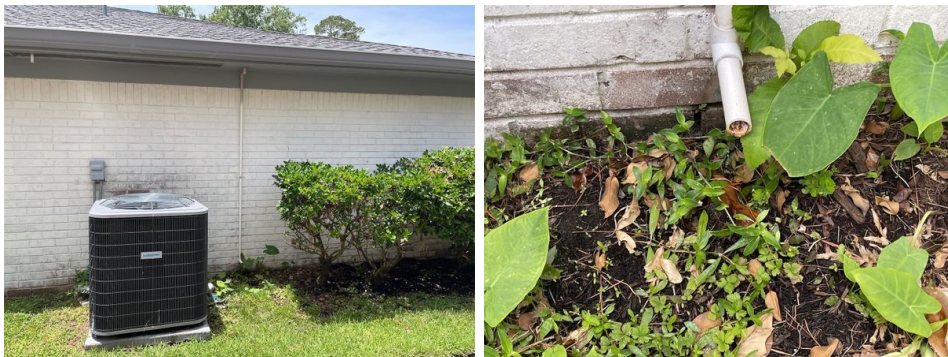
4.6.2 Perimeter Grading/Drainage

CONDENSATE DRAIN LINE

The primary condensate drain line from the air conditioning unit was emptying its water next to the foundation. This can cause the soil in that area to stay saturated, and contribute to differential foundation movement. It is recommended that the drain line be routed to a bathroom sink drain line.

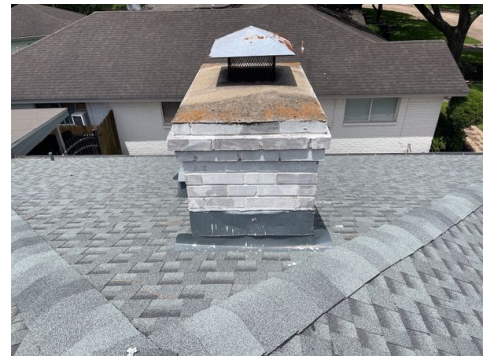
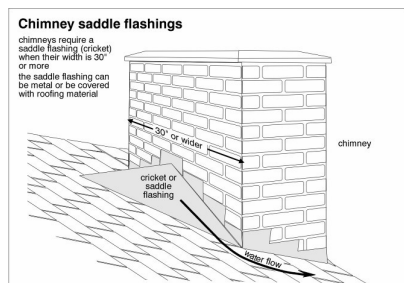
5.8.2 Roof Details

NO CRICKET

No cricket has been installed behind the chimney to divert the roof runoff around the chimney. Since the chimney is more than 30 inches wide, it is recommended that a cricket be installed.

903.2.2

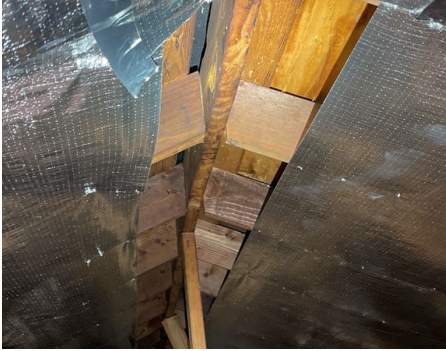
Ridge Beam: Undersized but functional

The ridge beam was undersized for the miter cut on the ends of the rafters. Although the rafters were not braced against the ridge beam for the full length of the miter cut, the consequences of this condition were minimal at this time, and, in our opinion, repairs are not required. Both the ridge beam and rafters are performing their intended function at the time of the inspection, and have been since the house was built. If you are concerned about the condition, it is recommended that consideration be given to a make up piece of lumber being installed along the bottom edge of the ridge beam so that the rafters are bearing against the ridge for the full length of the miter cut on the rafters.

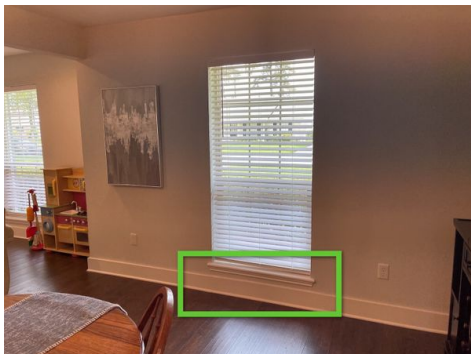
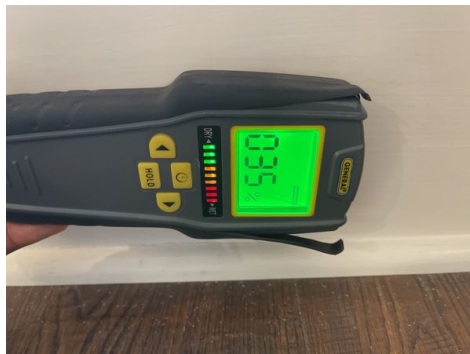
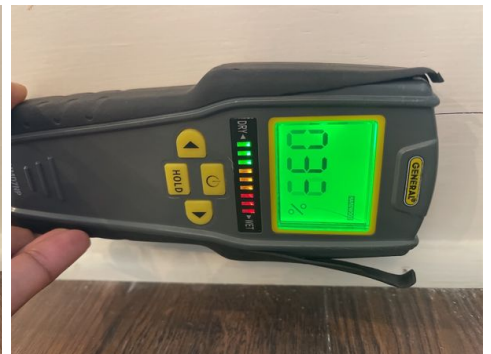
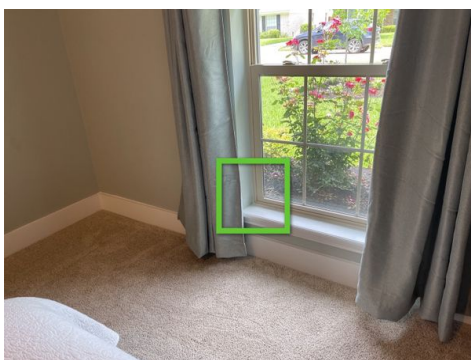
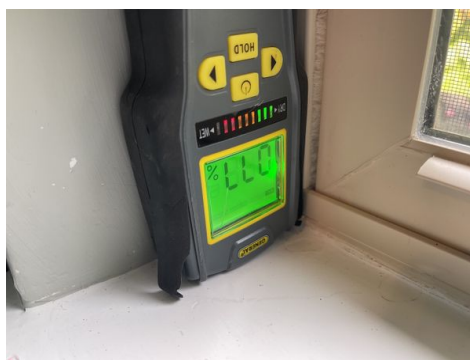
MOISTURE METER - HIGH READING

Evidences of water penetration to the interior of the structure were observed, including the following conditions and locations shown below. Further investigation is recommended with service companies to determine the source(s) of the water penetration along with any secondary damages, and also to provide a cost estimate for any needed repairs.

Our moisture meter showed a higher than normal reading.

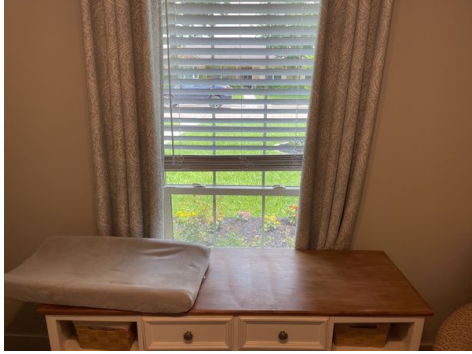
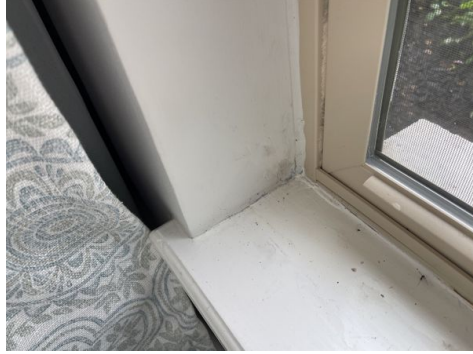
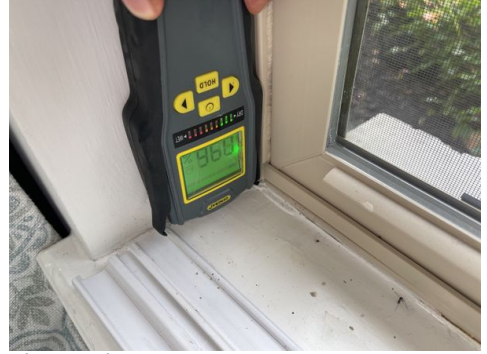
7.1.2 Water Penetration

WATER STAINS/WATER DAMAGE

Evidences of water penetration to the interior of the structure were observed, including water stains/water damaged materials. Further investigation is recommended with service companies to determine the source(s) of the water penetration along with any secondary damages, and also to provide a cost estimate for any needed repairs.

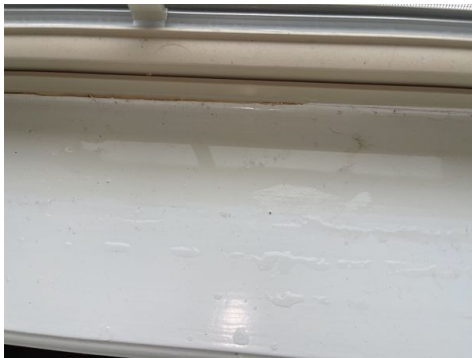
Elevated moisture.

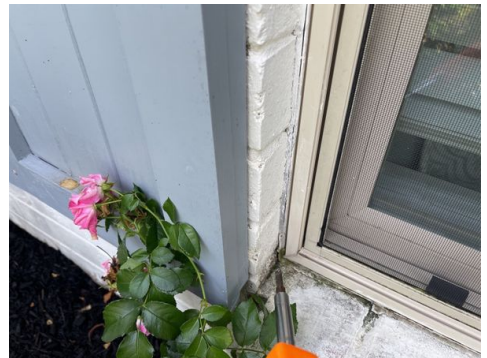
Pooling water.

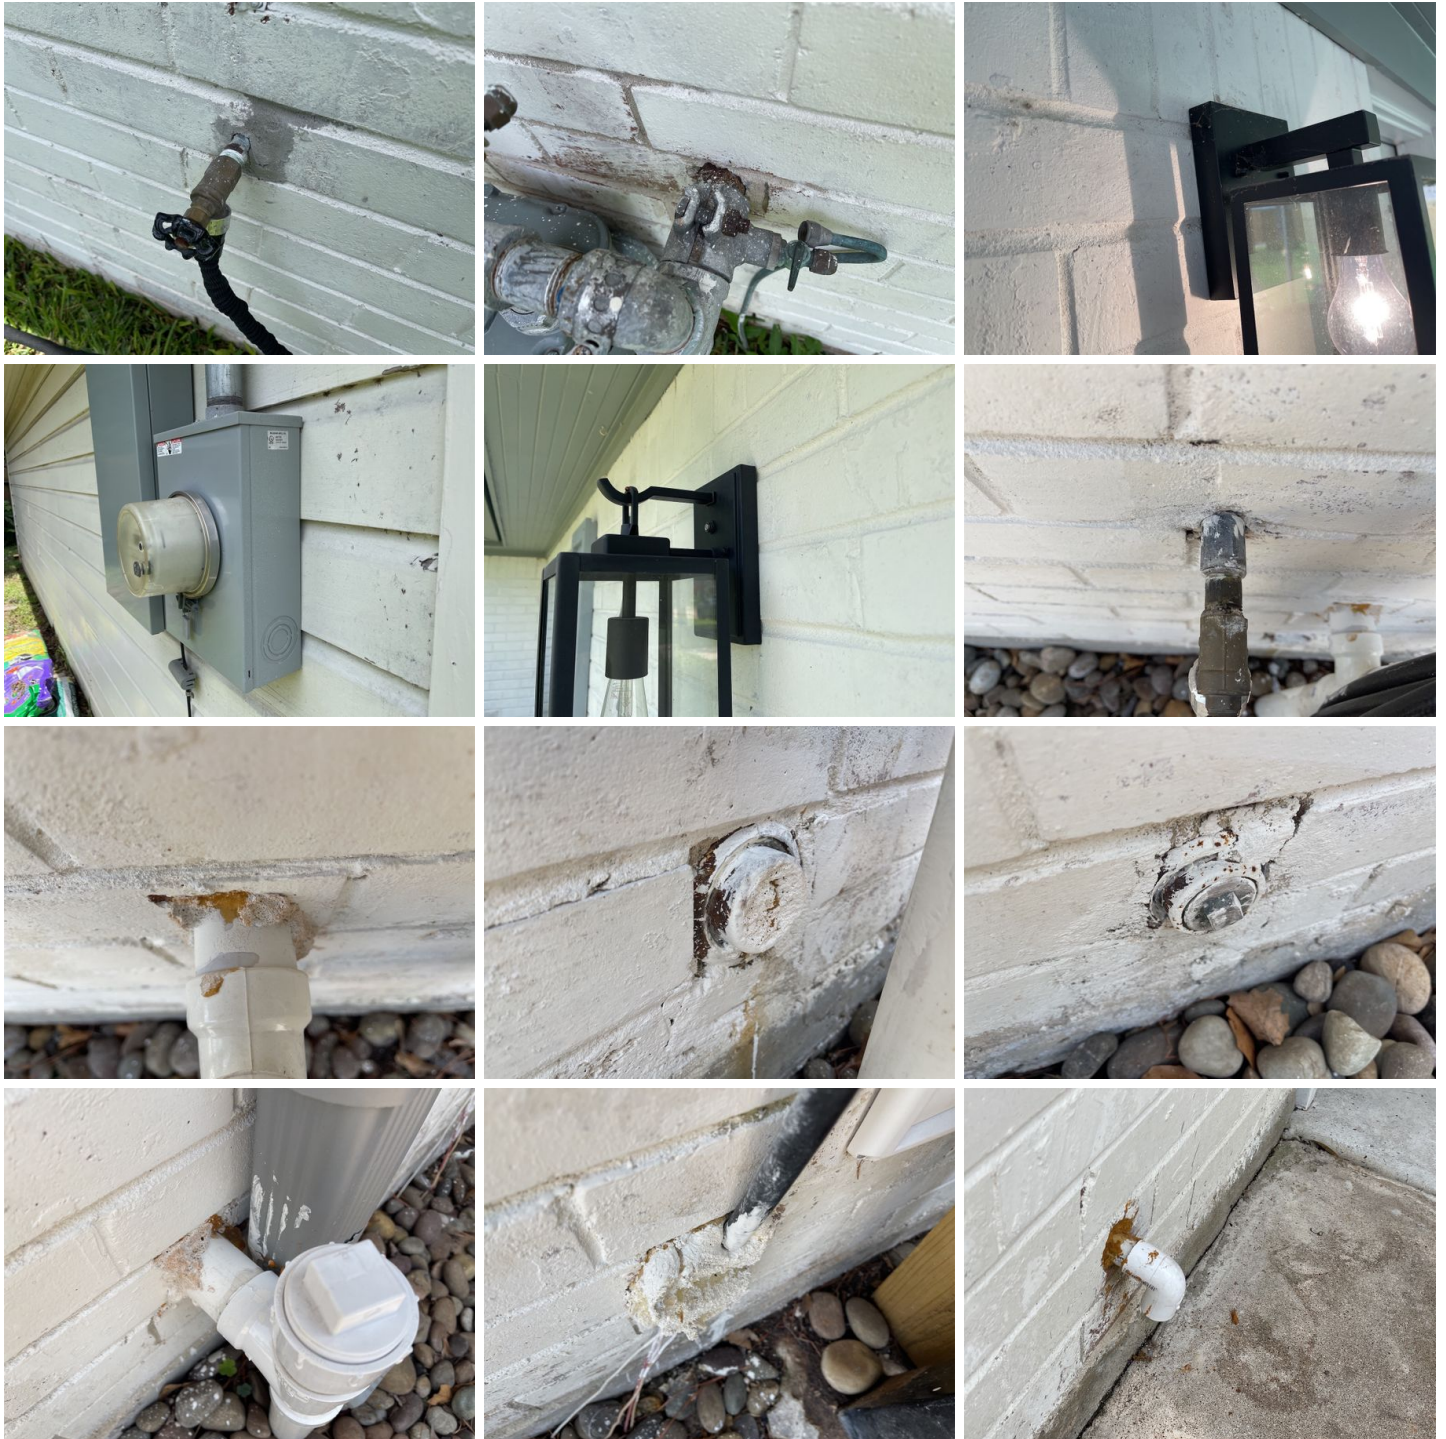
7.1.3 Water Penetration

Sealants deteriorated/missing, Hose Bibb, Light Fixtures, Electrical Wiring, Electrical Box, Electric outlet, Window sealants

A substantial vulnerability to water penetration was observed at penetrations/openings through the exterior building envelope, and it is recommended that all penetrations/openings be sealed against water penetration. Typical examples on a structure may include light fixtures, air conditioning refrigerant lines, water piping, gas piping, vent caps, windows, doors, expansion joints, etc. Below is a representative sample of locations and/or photographs showing some, but not necessarily all, locations where there is a vulnerability to water penetration. Have a contractor provide a cost estimate to seal all vulnerable areas on the exterior building envelope against water penetration and/or open up any clogged weepholes in the veneer.

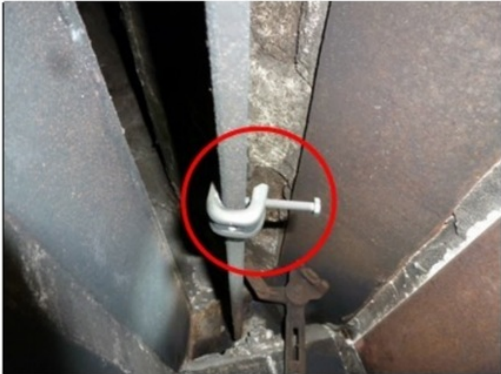
DAMPER - C CLAMP MISSING

The damper was not equipped with a C-Clamp device to prevent closing the damper completely to allow the hazardous combustion gases a path to escape up the chimney.

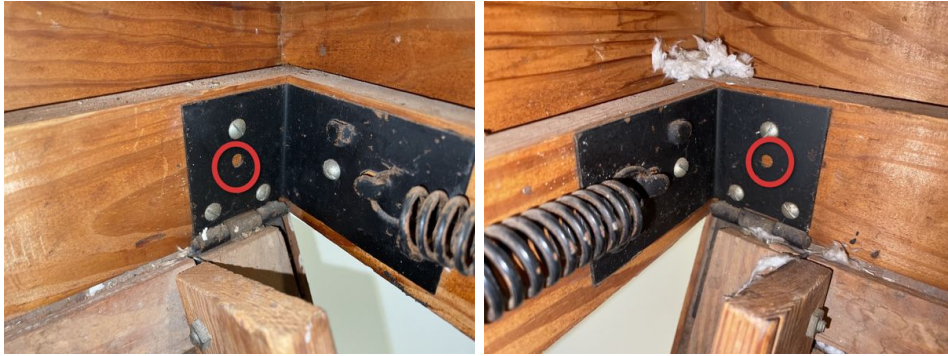
LADDER ATTACHMENT IMPROPER

Nail(s) missing in corner bracket(s)

The stair assembly was not properly installed or secured to the framing members, and repair is needed for safety purposes. The condition(s) can be a safety hazard, and repair is needed, as an improperly installed stair assembly can possibly collapse.

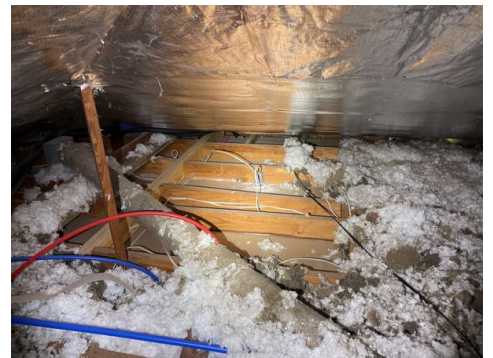
9.4.1 Insulation

INSULATION MISSING - BETWEEN JOISTS

The insulation in the attic was missing from between some of the joists. Have a service company provide a cost estimate for repairs.

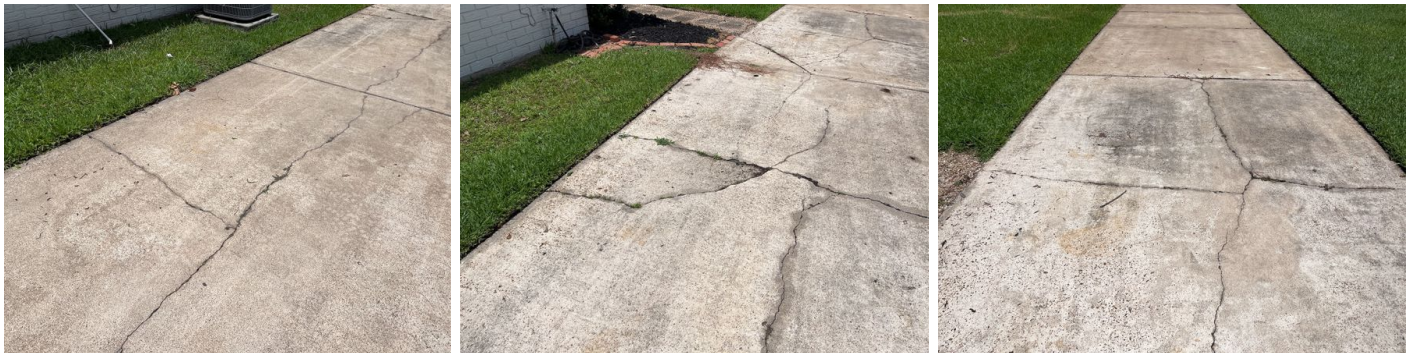
Flatwork Concrete/Patios/Walkways: Cracks Driveway

Cracks and some separations were observed in the driveway concrete. In our opinion, the driveway is still in serviceable condition at this time.

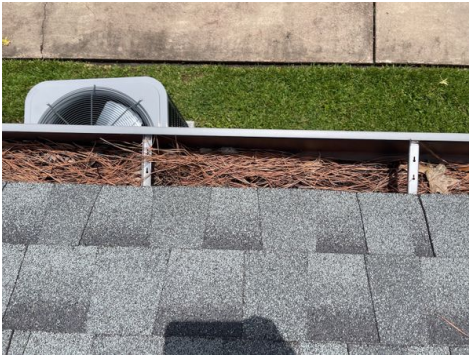
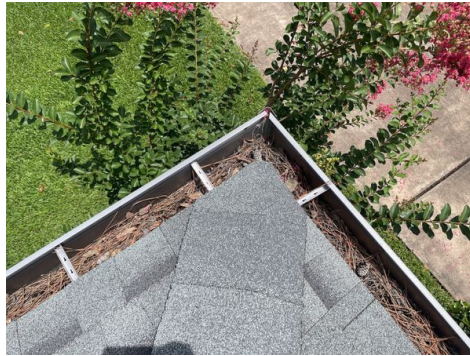
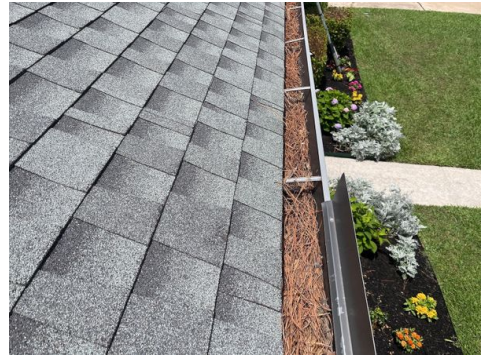
11.2.1 Gutters and Downspouts

The gutters were observed to have debris in them and are in need of cleaning.

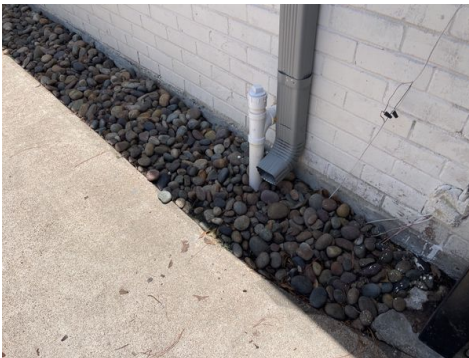
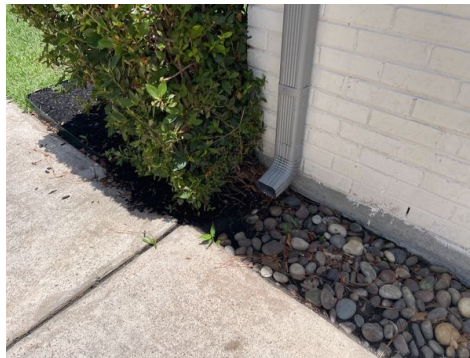
11.2.2 Gutters and Downspouts

DS SPLASH BLOCK

The downspout was missing a splash block.

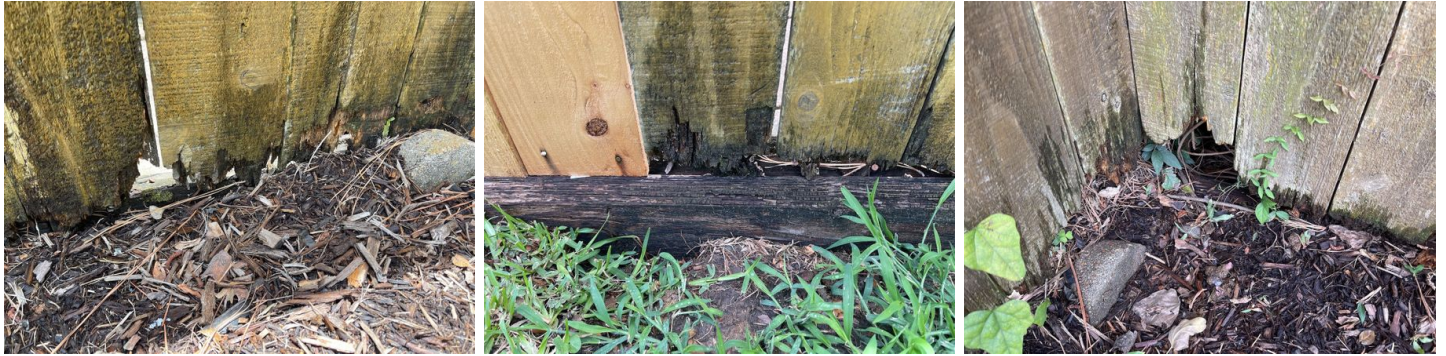
11.3.1 Gates and Fences

WOOD FENCE

Damaged, Starting to rot

The wood fence was in need of some repairs.

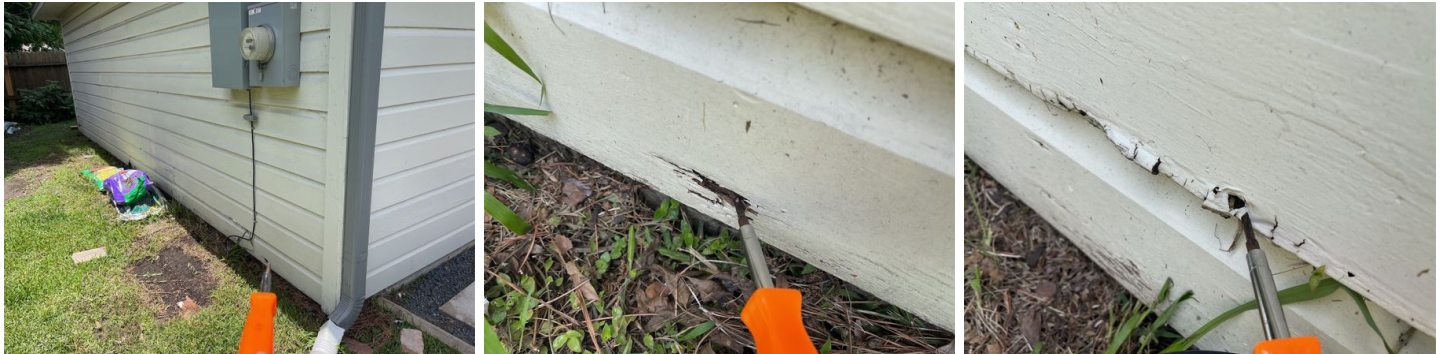
11.4.1 Wood Rot

WOOD ROT

We observed evidences of wood rot and it is recommended that all rotted wood be replaced. Have a contractor provide a cost estimate to determine the entire scope of the wood rot, and provide a cost estimate to replace all rotted wood in the house.

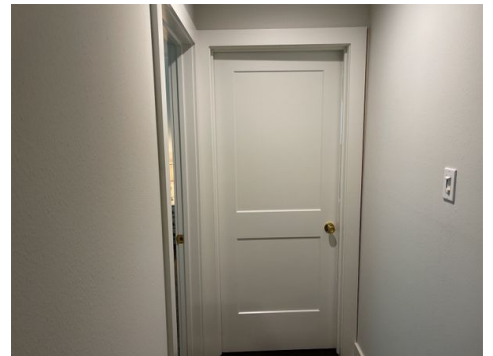
Doors were observed that were sticking and are in need of adjustment. Contact a service company to make the needed repairs.

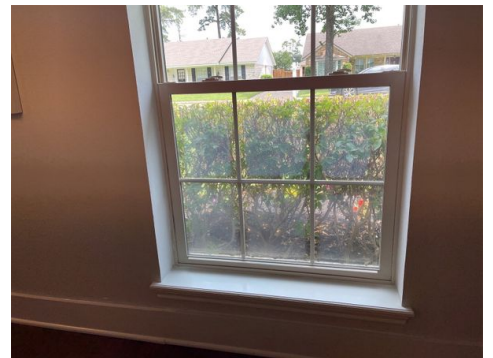
12.2.1 Windows

DOUBLE PANE WINDOW SEAL DAMAGED

One or more double pane windows were observed where the seal has been compromised and allowed moisture between the two panes. It is pointed out that we were not able to view every window under differing lighting conditions at different times of the day, and we may not be able to see discoloration that may become visible under different lighting and/or weather conditions, other than at the locations listed below. Further investigation with a window specialist is recommended concerning the windows to determine the extent of the condition throughout the house, and to make all needed repairs.

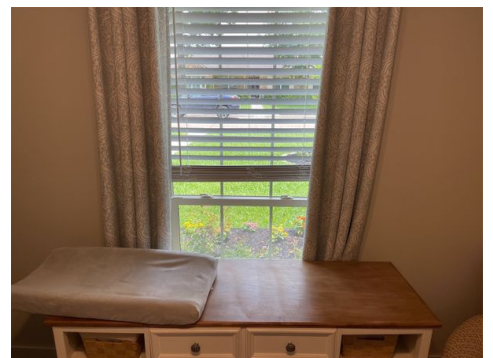
12.2.2 Windows

WINDOWS STUCK-HARD TO OPEN

Windows that were stuck and hard to open were observed.

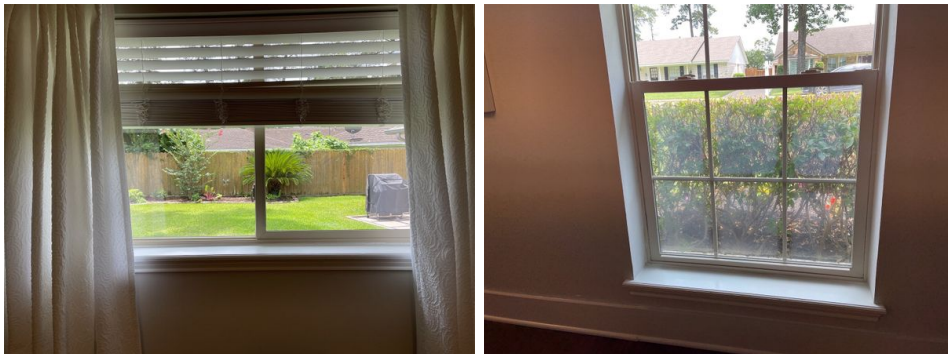
12.2.3 Windows

WINDOW SCREENS MISSING

Window screens were observed to be missing.

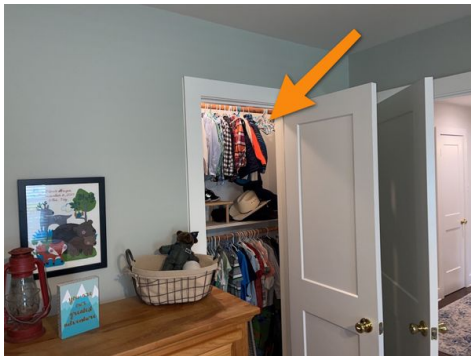
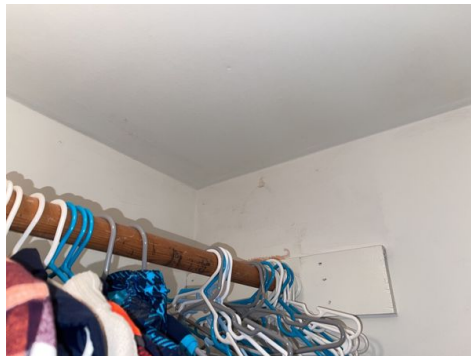
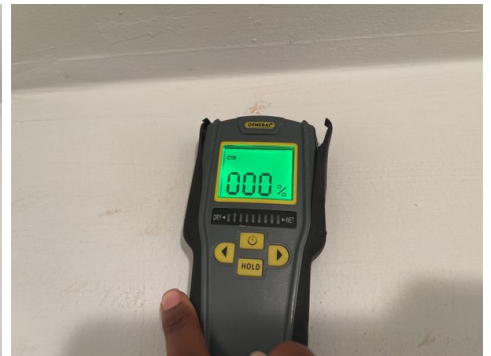
WATER STAINS - SOURCE UNKNOWN-DRY

Water stains were observed on the sheetrock at the above location(s). The source(s) of the water stains could not be determined at the time of the inspection, but possible sources include roof leaks, plumbing leaks in the bathrooms located above the stained areas, or possibly some other source. Have a service company determine the source of the water stains, and provide a cost estimate for any necessary repairs. We checked the stain(s) with a moisture meter, and the stain(s) was dry at the time of the inspection.
