## **Moisture Assessment Report**

2006 N. Memorial Way  
Houston, TX 77007  
02/02/2026

## Project Information

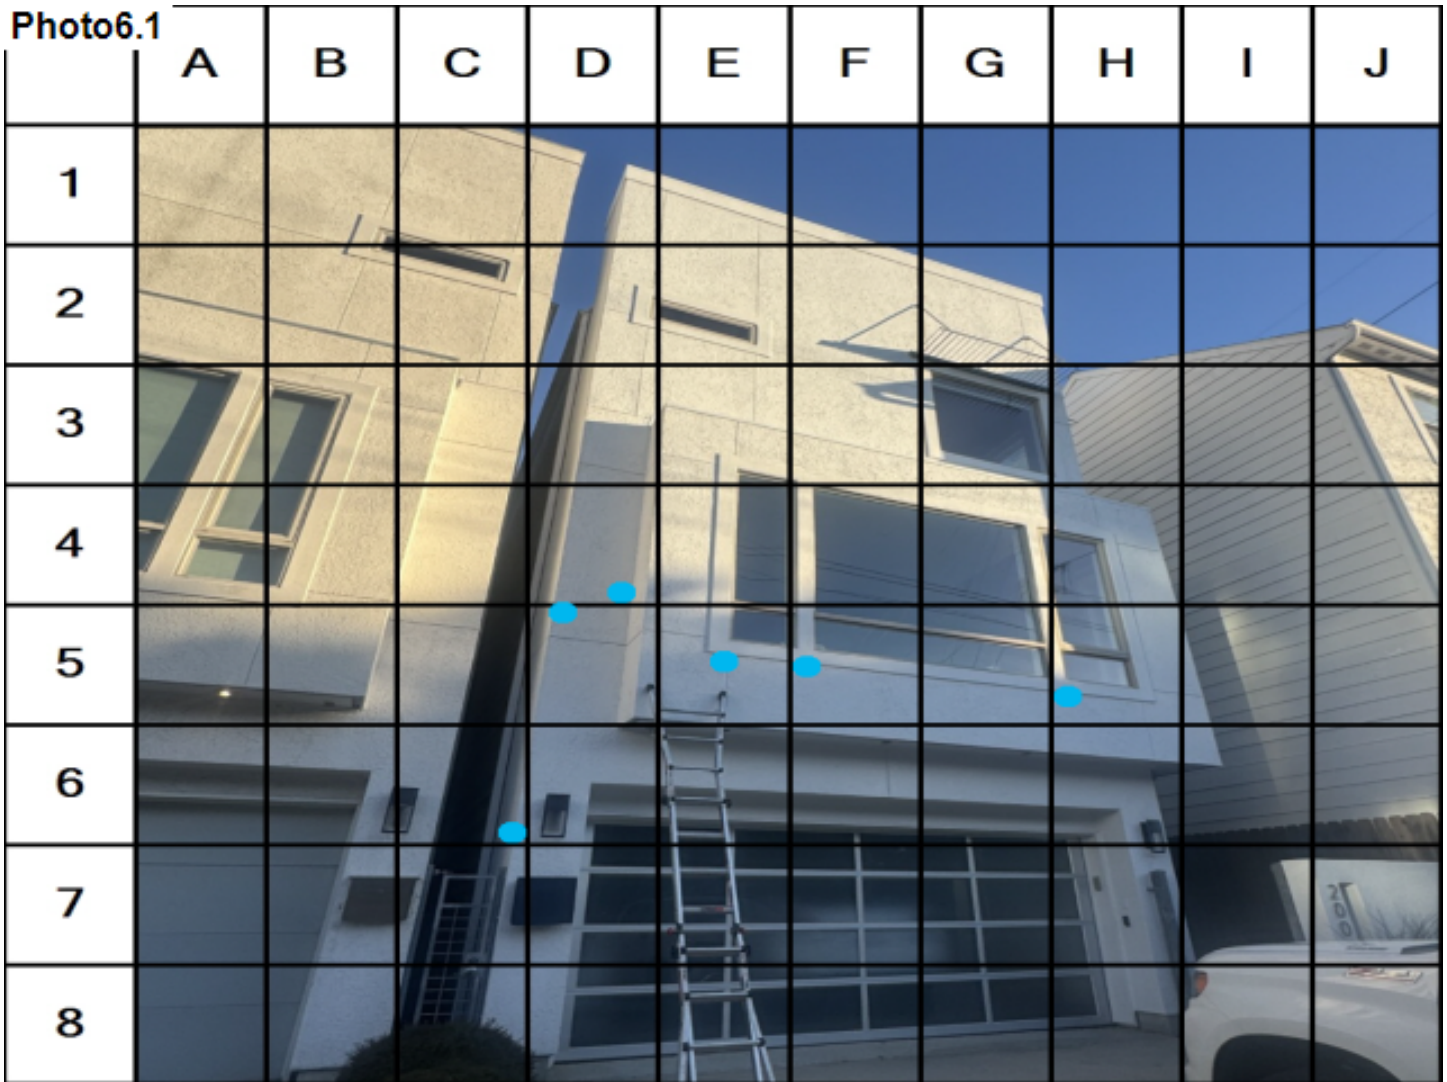
**Photo6.1**

Grid Location	Item Description	Moisture Readings	Substrate Condition	Observations-Photo #6.1	Chapter Reference
				Always maintain sealants at all windows, doors, flashing terminations and penetrations.	Ch 3.1,3.2
D4	Below Metal Cap Termination	11%	Firm	Moisture reading was made below metal cap termination.	
D5	Outside Corner	18%	Firm	Moisture reading was made at outside corner.	
C6	Outside Corner	15%	Firm		
E5	Window Lower Left	18%	Firm	Moisture reading was made at window lower left.	
F5	Below Windows	21%	Firm	Slightly elevated moisture reading was made below windows.	
H5	Below Windows	25%	Firm	Elevated moisture reading was made below windows.

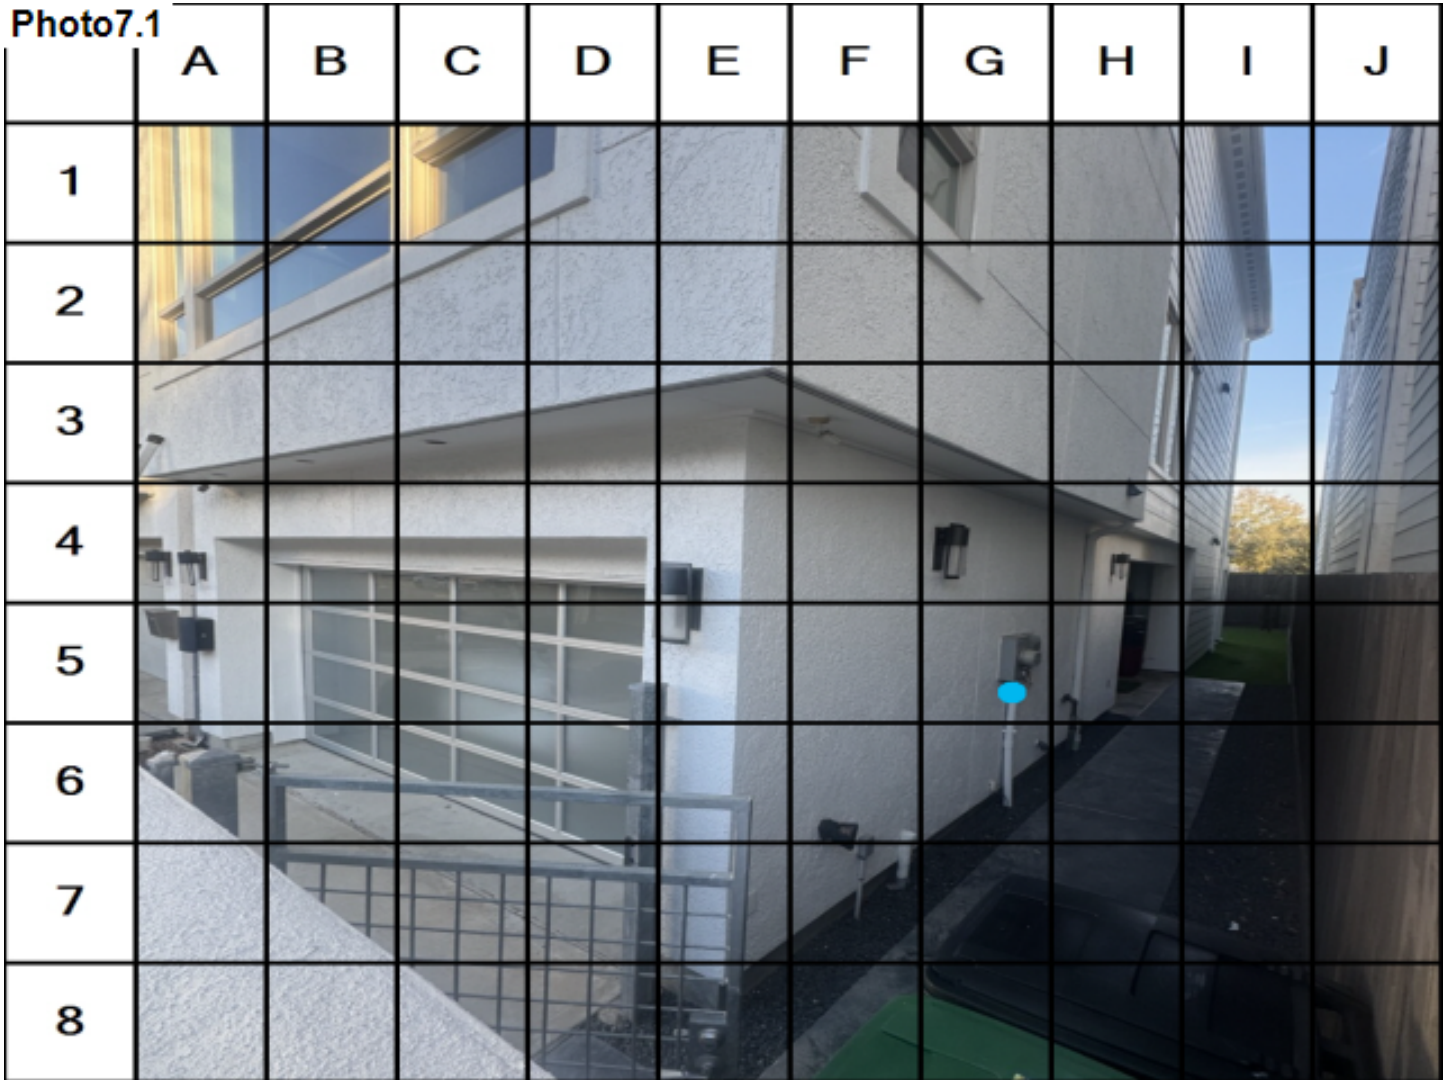
Photo7.1

Grid Location	Item Description	Moisture Readings	Substrate Condition	Observations-Photo #7.1	Chapter Reference
				Always maintain sealants at all windows, doors, flashing terminations and penetrations.	Ch 3.1.3.2
G5	Below Penetrations	14%	Firm	Moisture reading was made below penetrations.

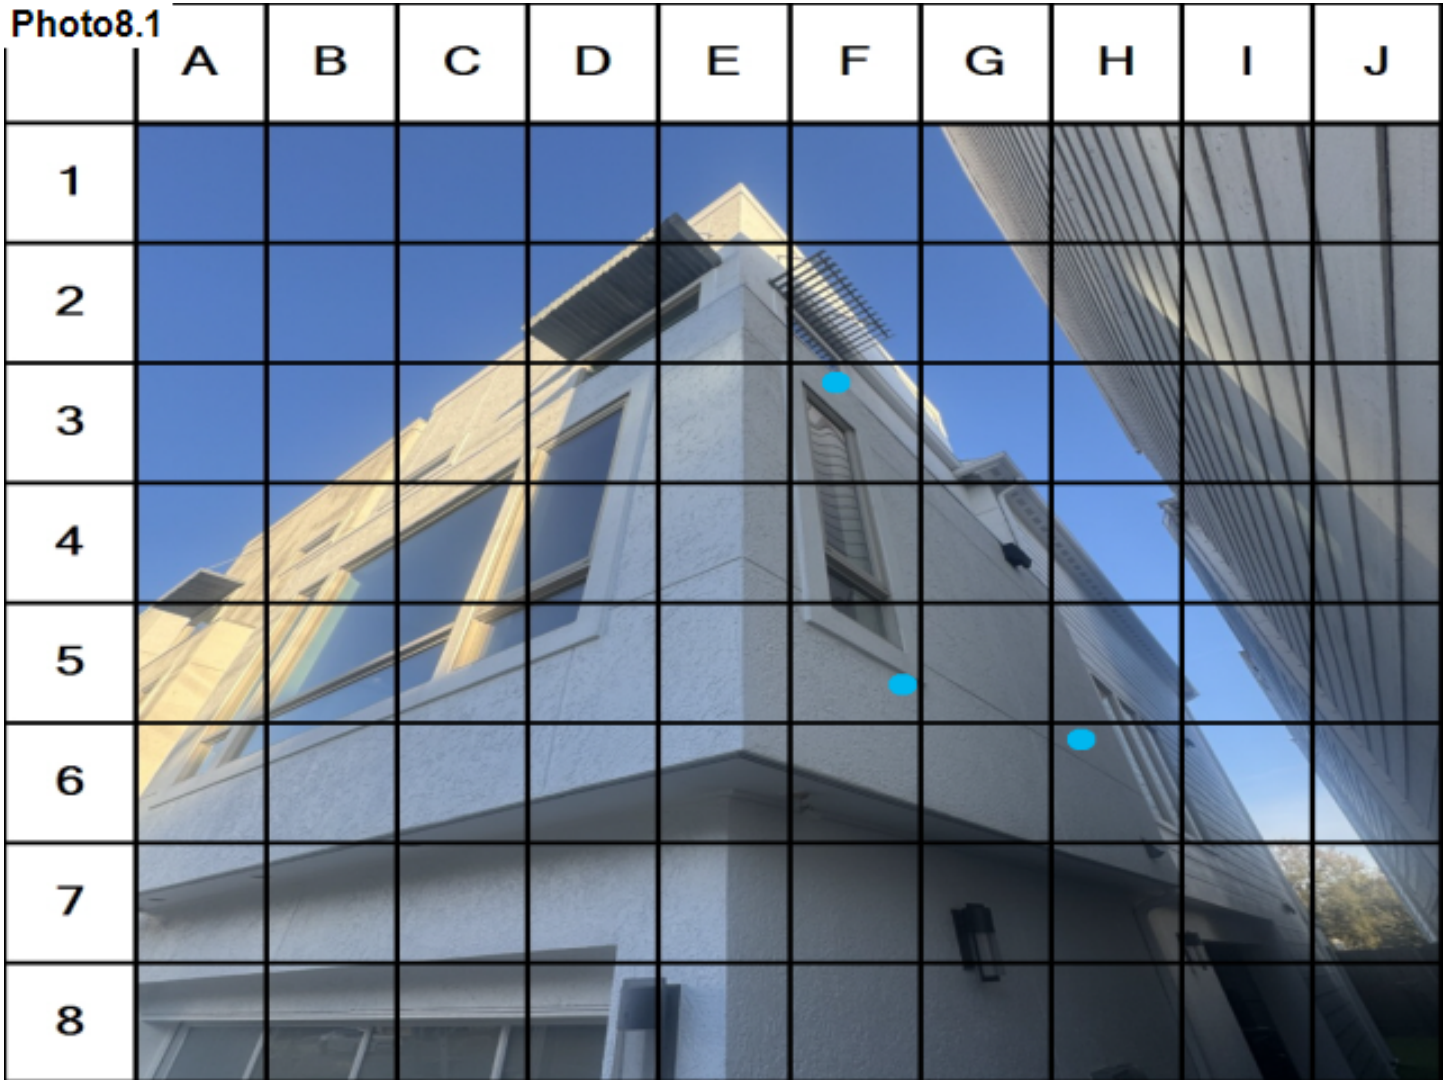
**Photo8.1**

<u>Grid Location</u>	<u>Item Description</u>	<u>Moisture Readings</u>	<u>Substrate Condition</u>	<u>Observations-Photo #8.1</u>	<u>Chapter Reference</u>
				Always maintain sealants at all windows, doors, flashing terminations and penetrations.	Ch 3.1,3.2
F3	Window Lower Right	29%	Firm	Elevated moisture reading was made at window lower right	
F5	Window Lower Right	16%	Firm	Moisture reading was made at window lower right	
H6	Wall Below Vent	15%	Firm	Moisture reading was made at wall below vent penetration.

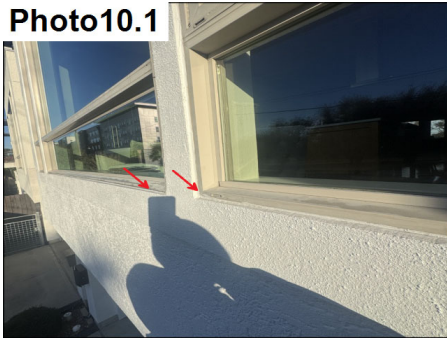
**Photo10.1**

Sealant separation noted at windows in stucco and siding. Reseal all windows.

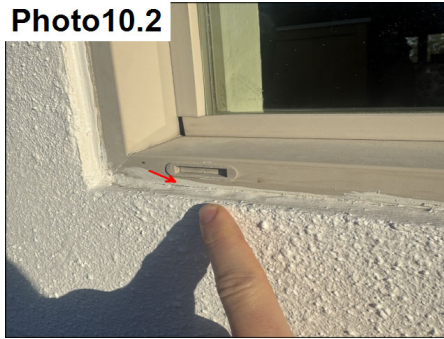
**Photo10.2**

Sealant separation noted at windows in stucco and siding. Reseal all windows.

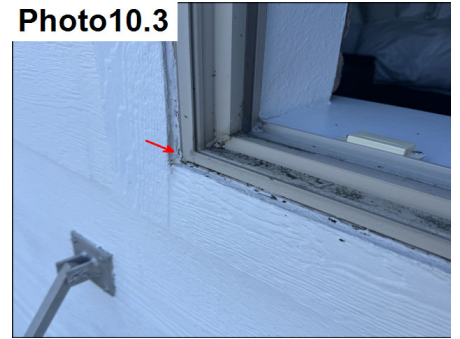
**Photo10.3**

Sealant separation noted at windows in stucco and siding. Reseal all windows.

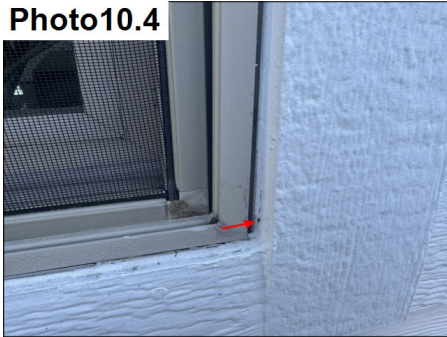
**Photo10.4**

Sealant separation noted at windows in stucco and siding. Reseal all windows.

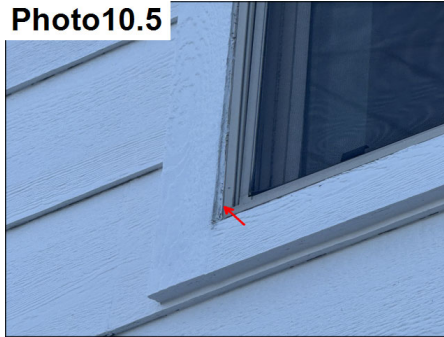
**Photo10.5**

Sealant separation noted at windows in stucco and siding. Reseal all windows.

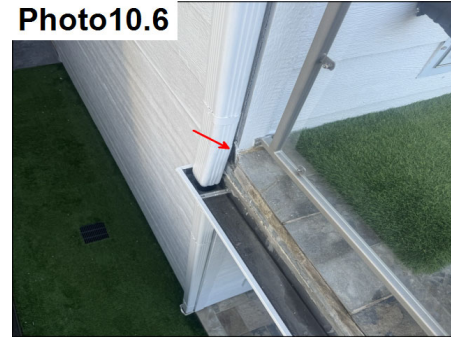
**Photo10.6**

Sealant separation noted at balcony terminations. Reseal all balcony terminations.

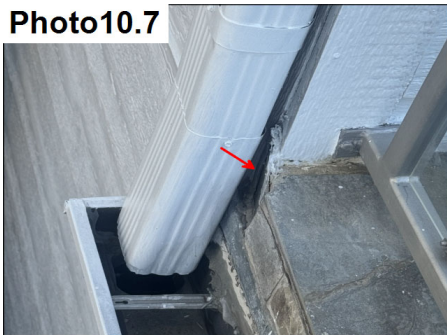
**Photo10.7**

Sealant separation noted at balcony terminations. Reseal all balcony terminations.

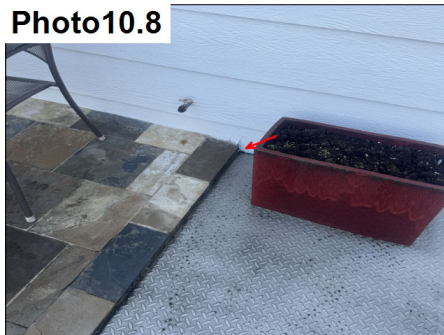
**Photo10.8**

Sealant separation noted at balcony terminations. Reseal all balcony terminations.

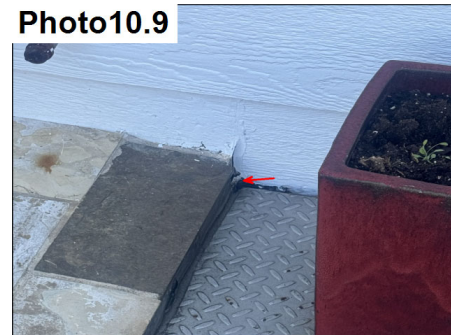
**Photo10.9**

Sealant separation noted at balcony terminations. Reseal all balcony terminations.

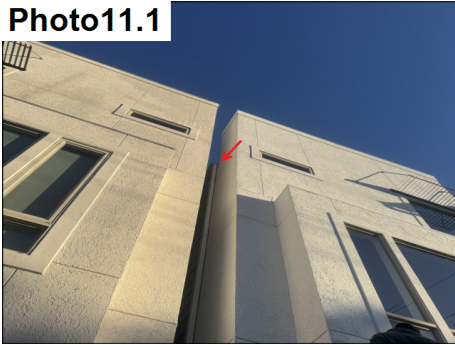
**Photo11.1**

Separation noted at roof termination. Assess and thoroughly seal all roof terminations.

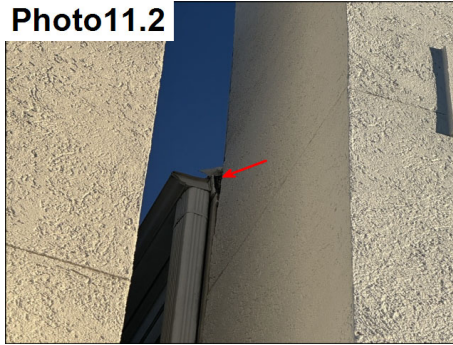
**Photo11.2**

Separation noted at roof termination. Assess and thoroughly seal all roof terminations.

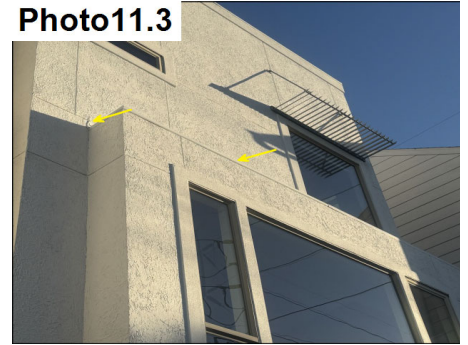
**Photo11.3**

Proper metal caps are present at flat areas. Assess and reseal all metal cap terminations and transitions.

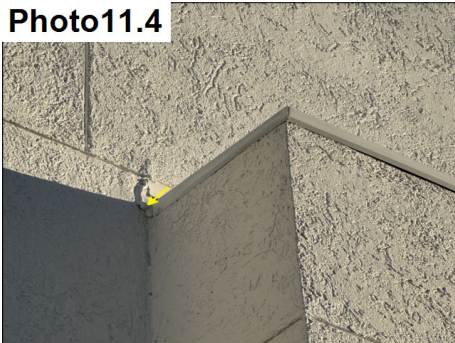
**Photo11.4**

Proper metal caps are present at flat areas. Assess and reseal all metal cap terminations and transitions.

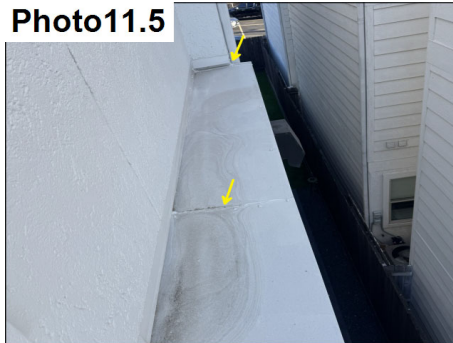
**Photo11.5**

Proper metal caps are present at flat areas. Assess and reseal all metal cap terminations and transitions.

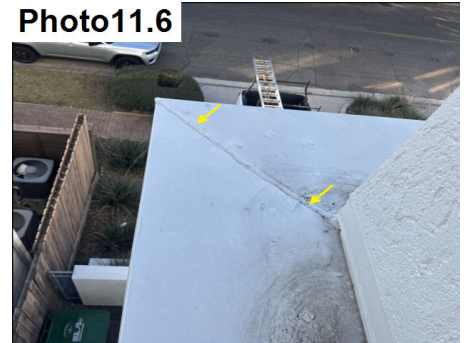
**Photo11.6**

Proper metal caps are present at flat areas. Assess and reseal all metal cap terminations and transitions.

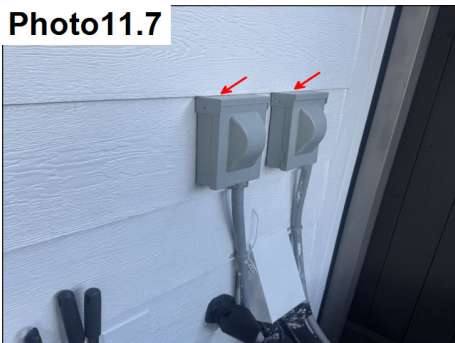
**Photo11.7**

Some penetrations lack sealants. Seal all penetrations.

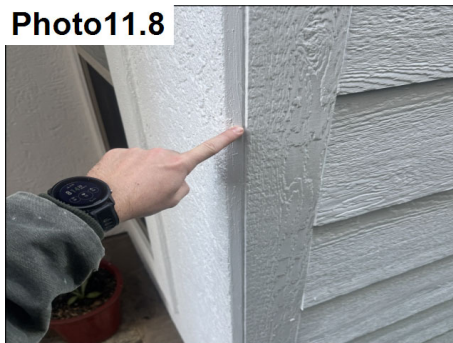
**Photo11.8**

Siding transitions are sealed. Always maintain sealants.

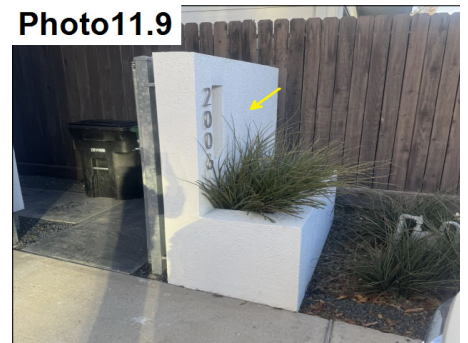
**Photo11.9**

Privacy wall is CMU construction. This is a proper detail.

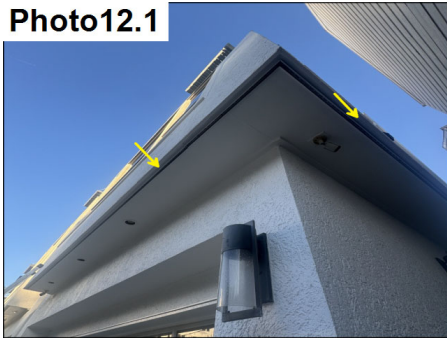
Photo12.1

Proper weep relief is present at bottom of wall.

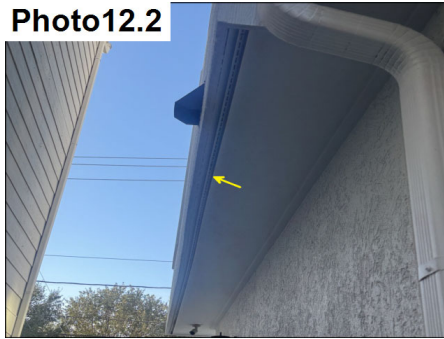
Photo12.2

Proper weep relief is present at bottom of wall.

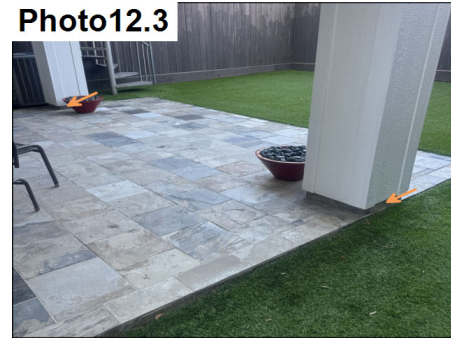
Photo12.3

Column bases are elevated on concrete footers. This is a proper detail.

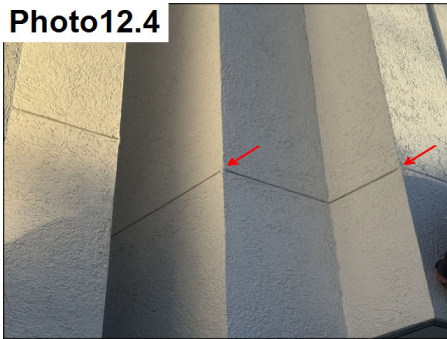
Photo12.4

Cracks noted at outside corners. Seal all outside corners as needed.

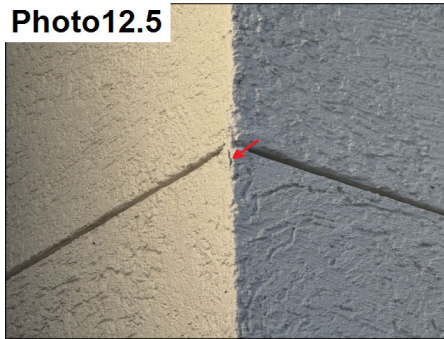
Photo12.5

Cracks noted at outside corners. Seal all outside corners as needed.

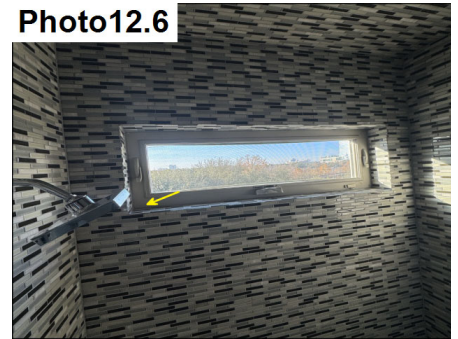
Photo12.6

Interior shower window noted. Assess and reseat the interior of the window to minimize moisture intrusion.

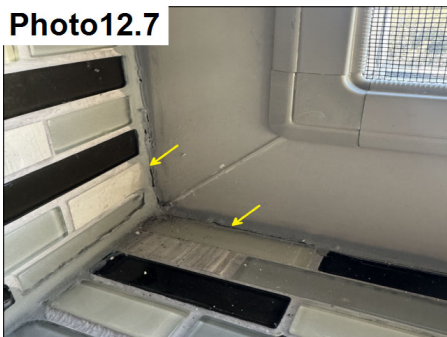
Photo12.7

Interior shower window noted. Assess and reseat the interior of the window to minimize moisture intrusion.

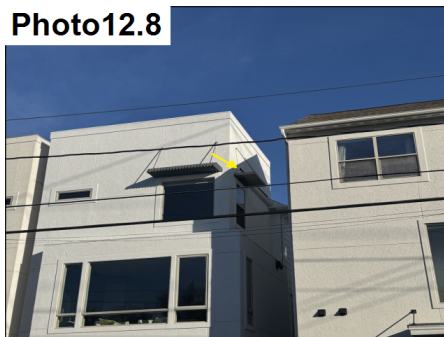
Photo12.8

Large roof scupper flashings noted. Assess and reseat all flashing terminations.

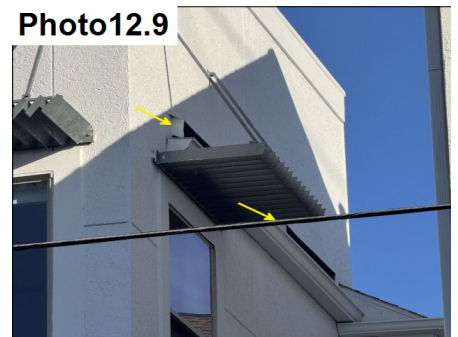
Photo12.9

Large roof scupper flashings noted. Assess and reseat all flashing terminations.

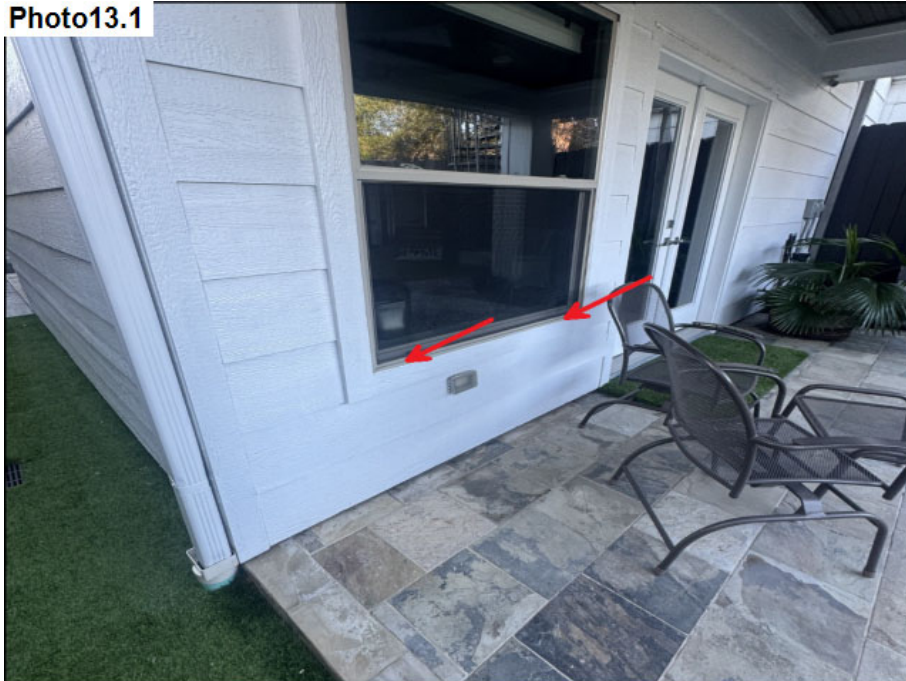
**Photo13.1**

The weep holes at this window appear to be caulked over. Assess and clear out weep holes at window to allow for proper drainage of moisture.

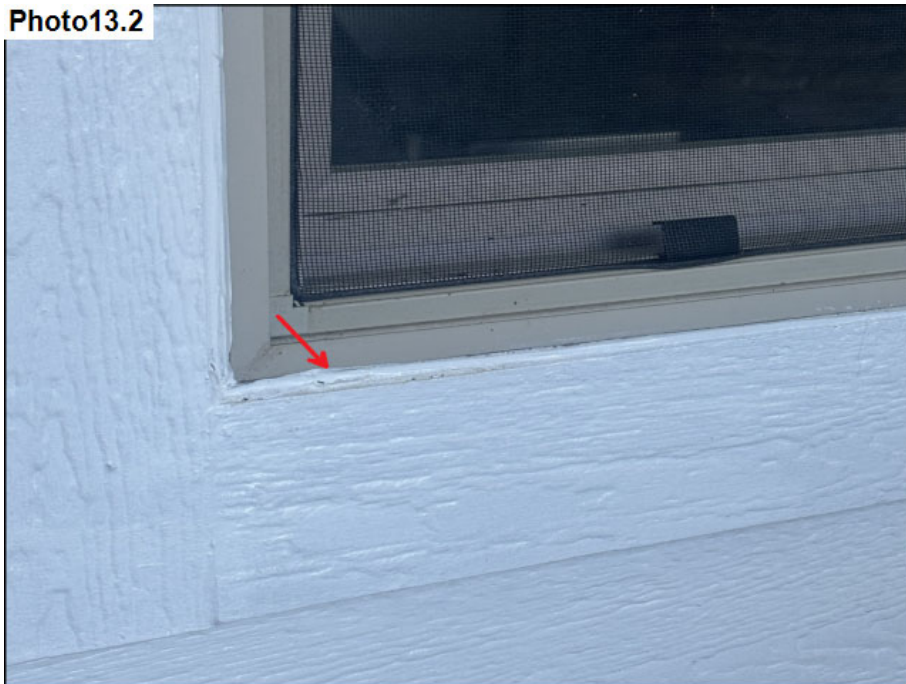
**Photo13.2**

The weep holes at this window appear to be caulked over. Assess and clear out weep holes at window to allow for proper drainage of moisture.
