Transferee Name:	<u>Mingzhe Yu</u>	Street Address:	<u>3923 Birch Vale Ln</u>
City:	<u>Sugar Land</u>	State / Zip Code:	<u>TX / 77479</u>
Customer:	<u>Graebel Companies – CO</u>	File Number:	<u>APROA649919</u>
Customer Contact:	<u>Rachel Case</u>	Inspection / Report Date:	<u>2-26-2026 / 2-27-2026</u>

# Structural Evaluation Report Structural Inspection

**Shadow Glen At Riverstone Sec 5, Block 1, Lot 19  
3923 Birch Vale Lane  
Sugar Land, Texas 77479**

Walk-Through Survey performed February 20, 2026  
*Submitted February 25, 2026*  
CYE Job. No. 2026046N

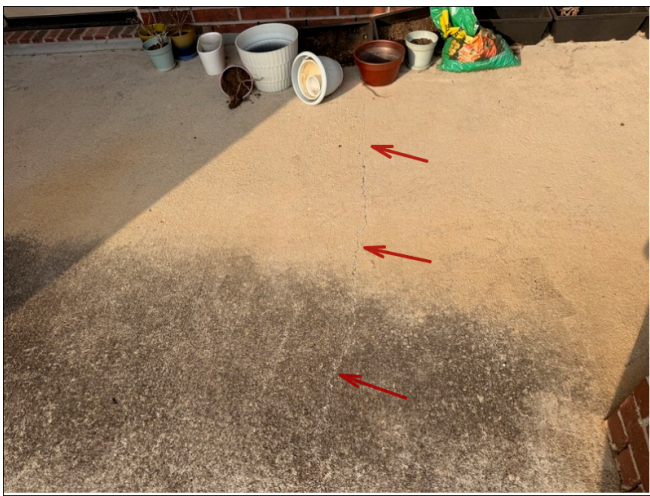
Surface crack in the patio floor (typical)

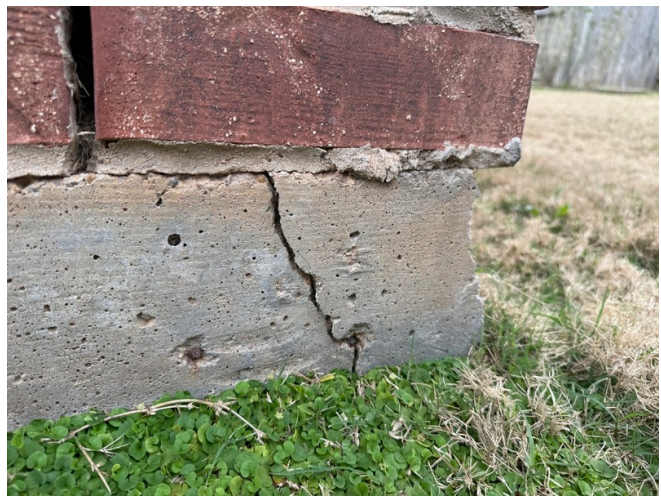
- The concrete slab foundation was spalled at the front left and rear (left and right) corners. This is typically caused by structural or masonry movement. These are common occurrences and are not considered significant structural defects.
- We observed typical levels of cracking in the surface of the patio concrete slab. There was no apparent recent shearing movement along the cracks and the width of the cracking is not structurally significant. It should be noted that many slab foundations develop cracks. Further, the degree of visible cracking does not indicate a major structural defect. No repair is recommended to address the cracking.
- There was minor honeycombing damage on the foundation at the left elevation. This condition appears to be cosmetic and does not affect the structural integrity.

Spalled foundation grade beam resulting in wedge-crack (typical)

- The spalled and cracked foundation corners should be sealed with a high-strength structural epoxy to avert further deterioration and further damaging the brick veneer.

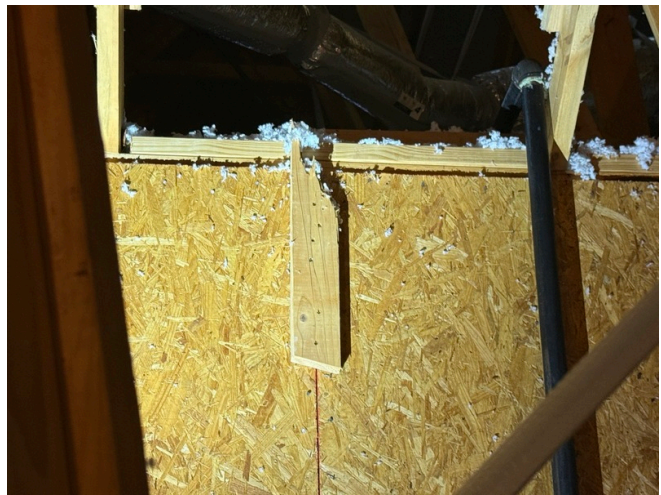
- The home inspection report cited a cracked framing member in the walk-in attic. We located the piece of lumber and have determined it was temporary framing used in construction of the residence. The lumber has been abandoned in place in its current state and is not part of the home's framing system. The member does not affect the structural integrity of the home and no repair is required.

Non-structural broken piece of wood observed at walk-in attic

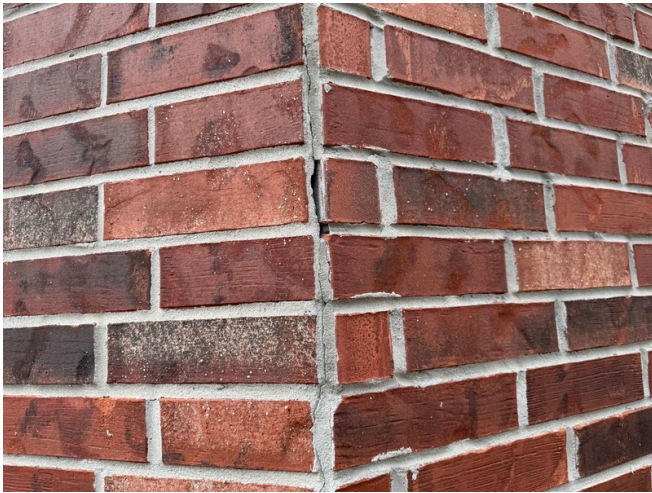
- We observed some cracking of the brick veneer near the corners of windows along the right elevation, rear elevation, and the left rear corner. The cracks on the right elevation around the window are due to the rusting lintel, while the other cracks appear to be related to a degree of differential movement of the structure.
- We observed some cracking of the brick veneer at the rear elevation at the right side of the patio. The crack appears to be related to a degree of movement in the beam that spans the rear patio roof.
- We observed some brick spalling on the porte-cochere column at the front elevation. This damage is related to the rusting lintel.

Mortar crack along corner at rear left corner

- Cracks and spalling mortar in the brick veneer should be sealed to help prevent moisture and insect intrusion.
- Sealant at all expansion joints should be replaced to limit moisture and insect intrusion.
- Rusted lintels should be wire brushed and painted with a rust inhibitor to prevent further deterioration and damage to the brick veneer.
- While the fiber-cement siding is dense and tough, it is vulnerable to moisture penetration. It should be kept well-maintained and, in particular, all joints and edges should be kept well caulked to minimize moisture penetration.
- Sealant around windows and doors that have deteriorated due to structural movement should be sealed to limit moisture intrusion.

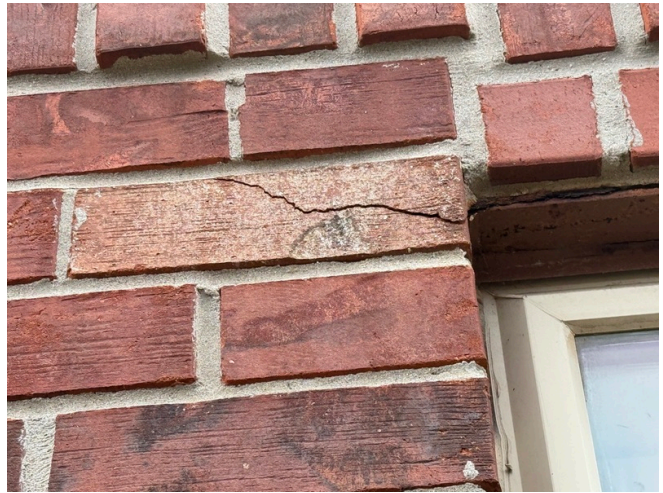
Brick crack at top left corner of bathroom window (right elevation)

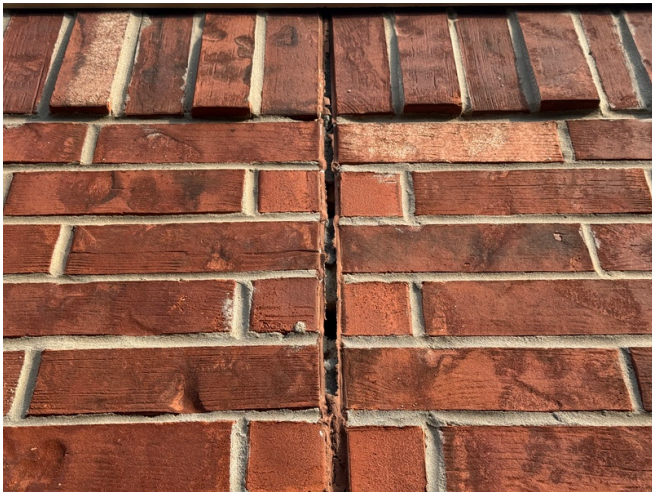
- We observed that the sealant at all expansion joints has deteriorated exposing the backer rod. In some locations, the backer rod is damaged and missing allowing an opening into the wall cavity and framing members. Repair is needed at all expansion joints to help keep moisture and insects from infiltrating the wall cavities.

Expansion joint sealant deterioration at right elevation with openings to the wall cavity (typical)

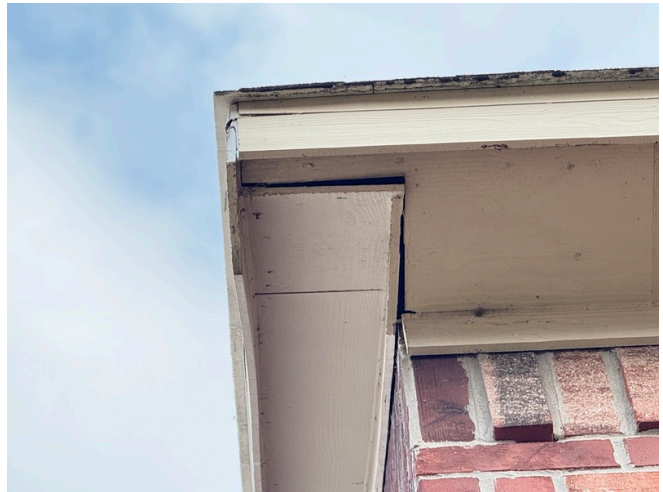
- We observed separation in initially tight trim joints on the soffit and frieze board. This condition is apparent on the front and right elevations.
- The vertical siding trim has separated from the brick veneer and from the siding joints on the left and right elevations of the home.
- Trim separation was noted along the right and left jamb of the garage door.

Soffit and trim separation at front right corner

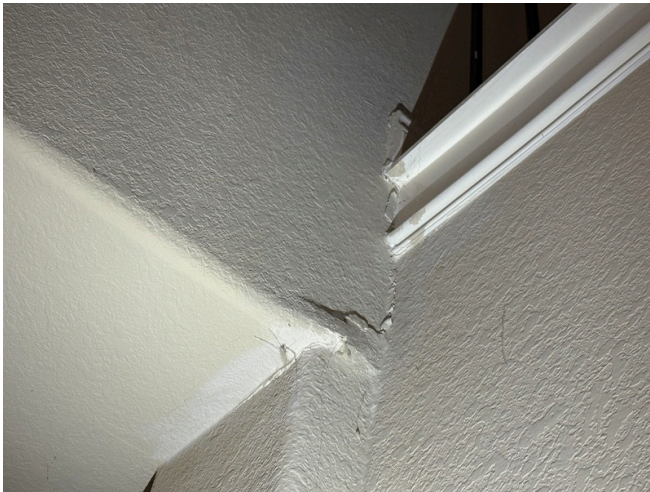
Drywall cracking visible at floor to column transition above the kitchen

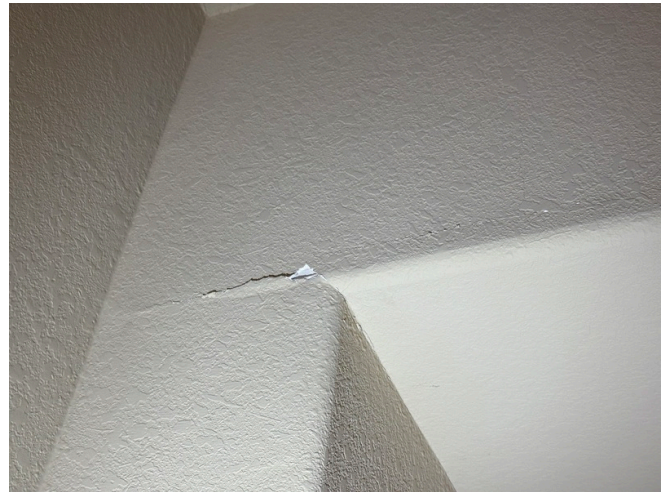
Drywall cracking visible at floor to column transition on the catwalk

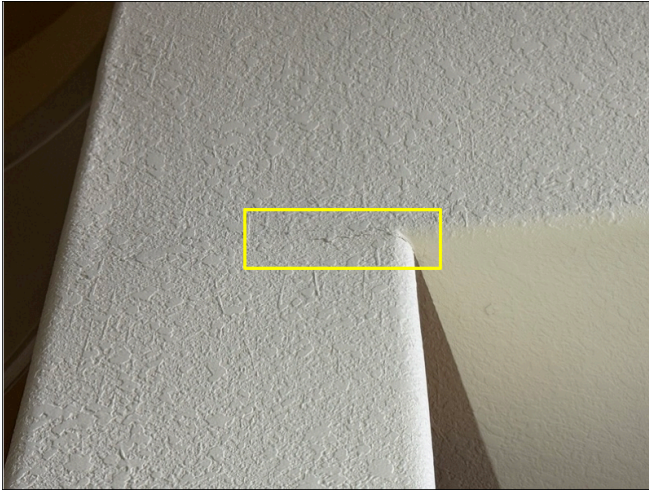
Drywall crack at the floor to column transition at the corner of the staircase in the foyer

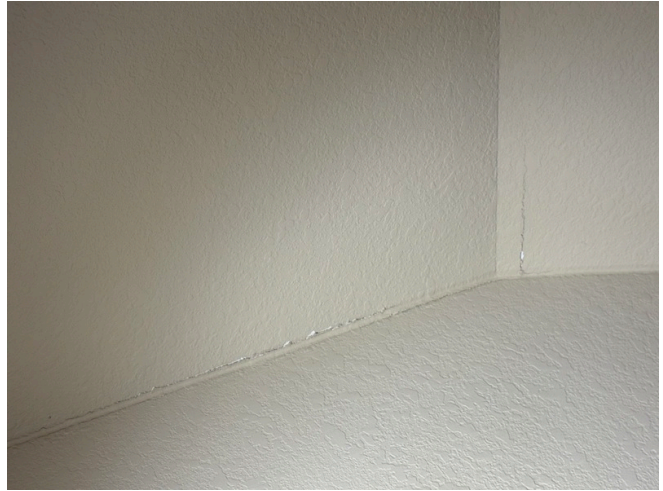
Ceiling drywall and tape seam separation in game room ceiling

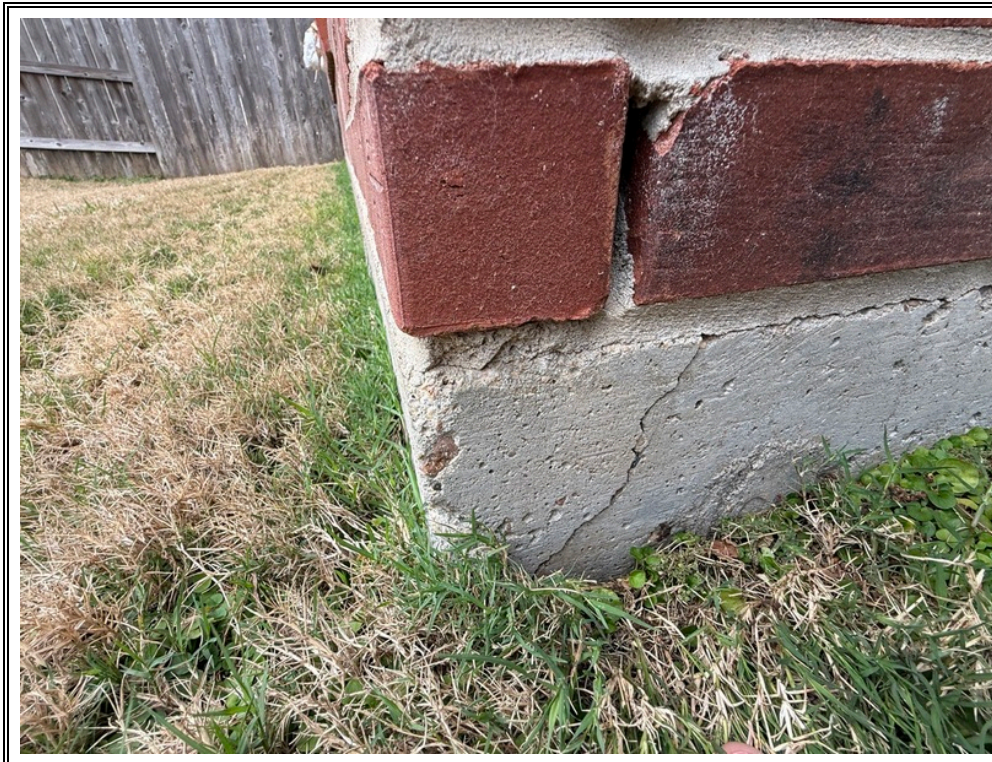
**5**

Spalled foundation grade beam at rear elevation (left corner of bedroom #2)

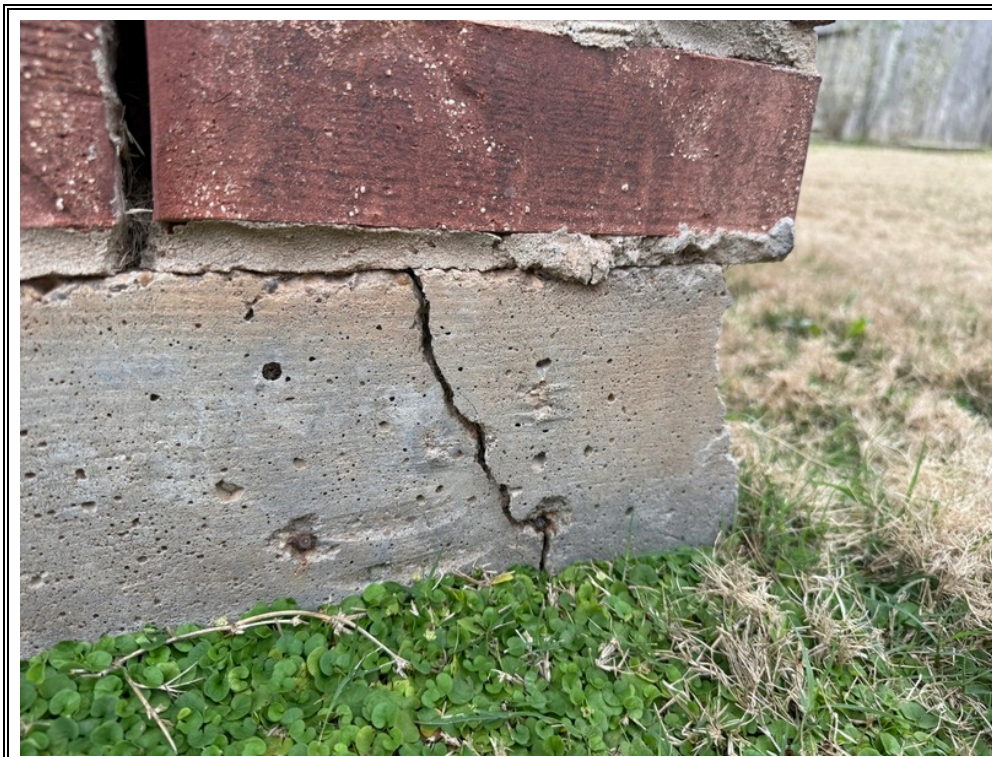
Spalled foundation grade beam at rear elevation (right corner of bedroom #2)

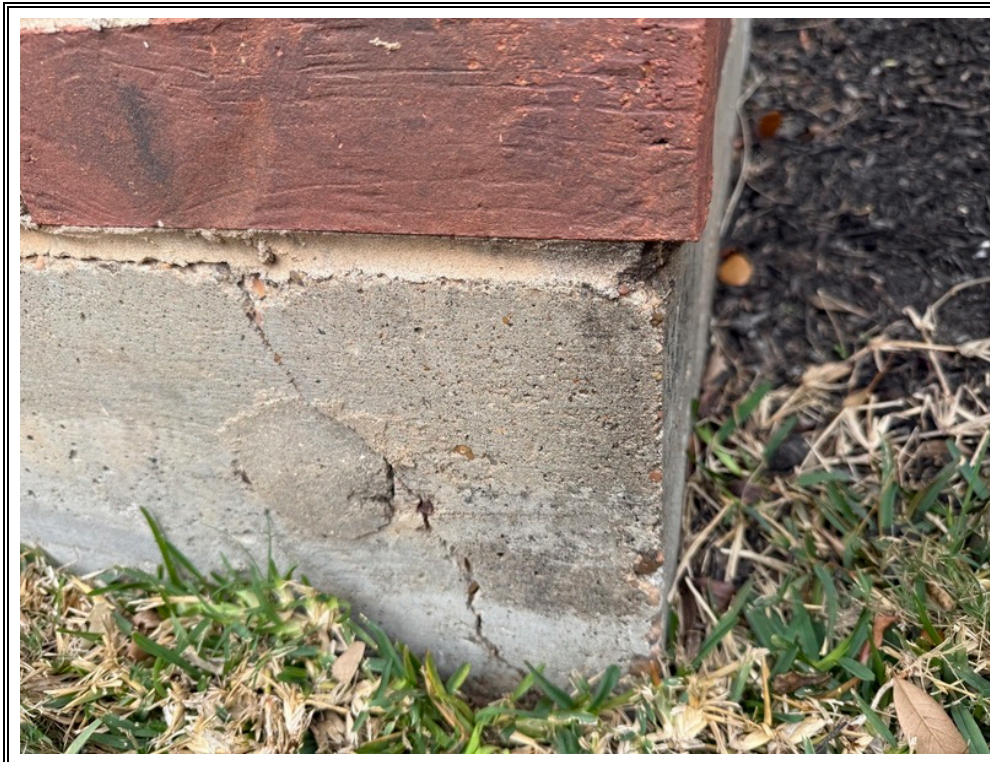
**Photo Number**  
**7**

**Description:**  
Spalled foundation grade  
beam at the front left  
corner

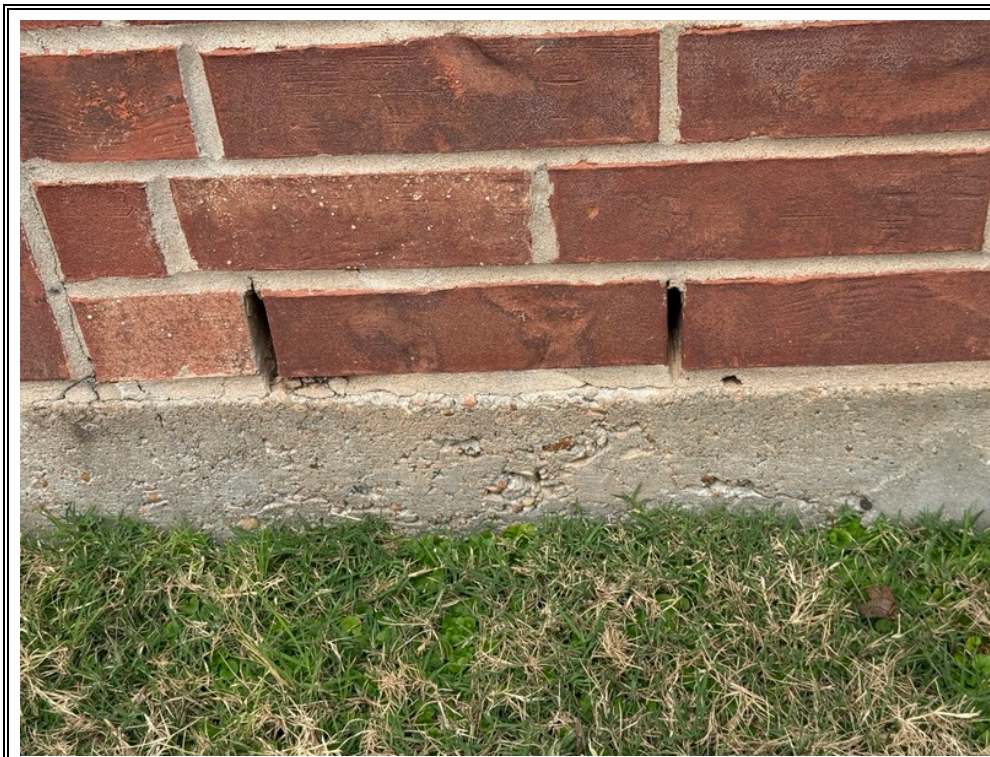
**Photo Number**  
**8**

**Description:**  
Honeycombing on  
foundation along the left  
elevation

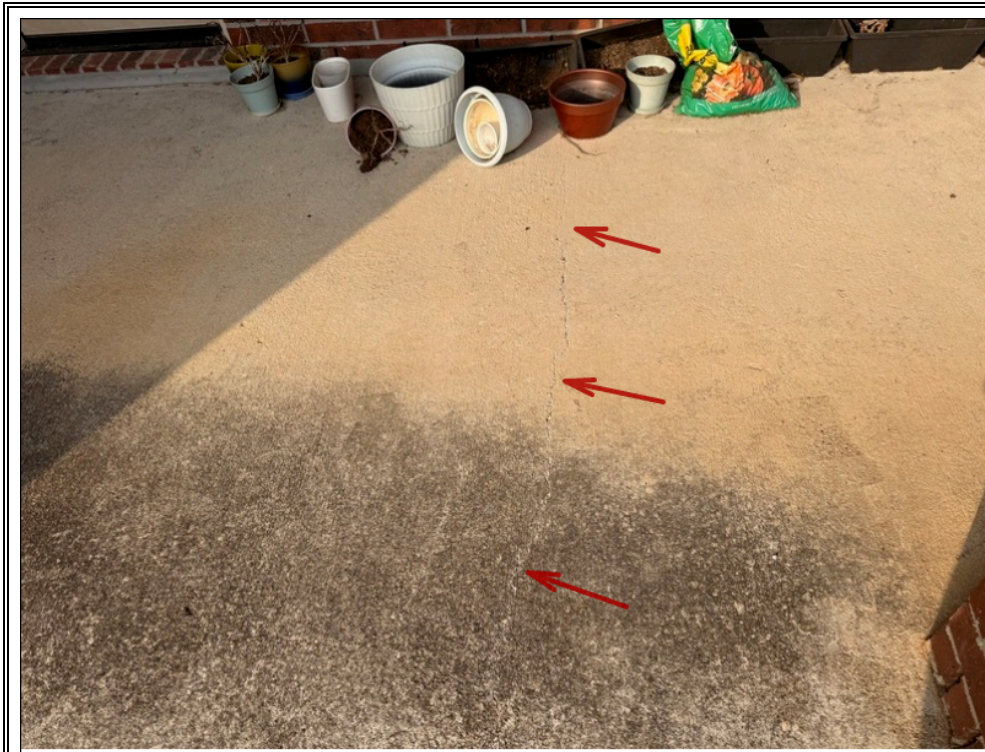
**Photo Number**  
**9**

**Description:**  
Surface crack in the patio  
floor (typical)

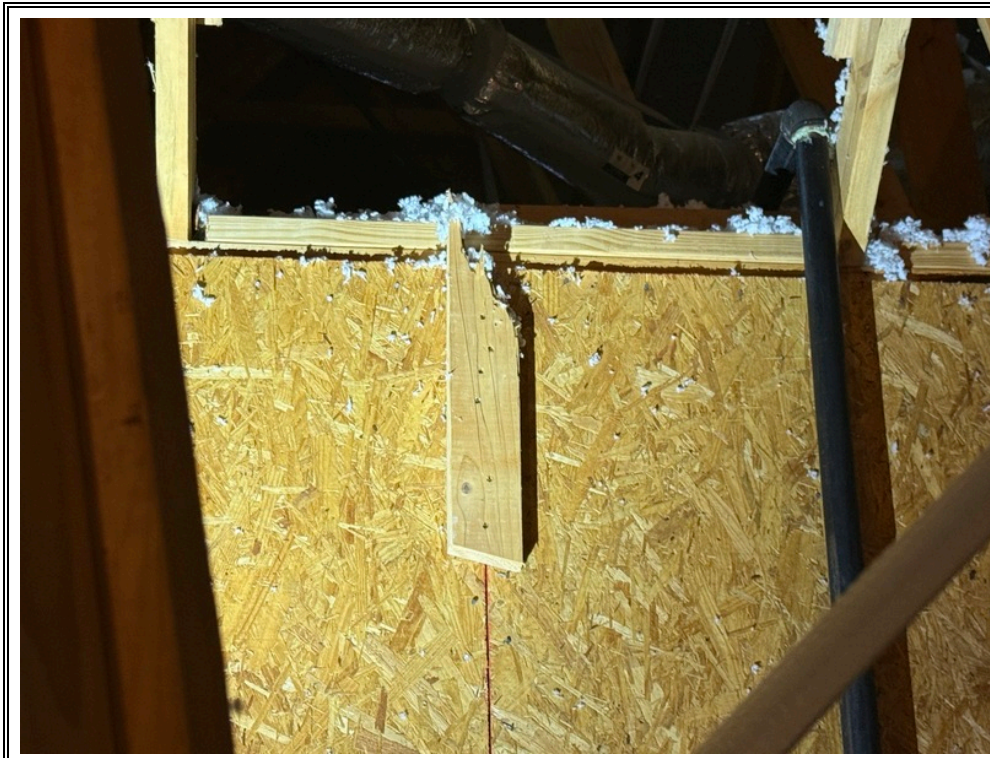
**11**

**Description:**  
Non-structural broken  
piece of wood observed at  
walk-in attic

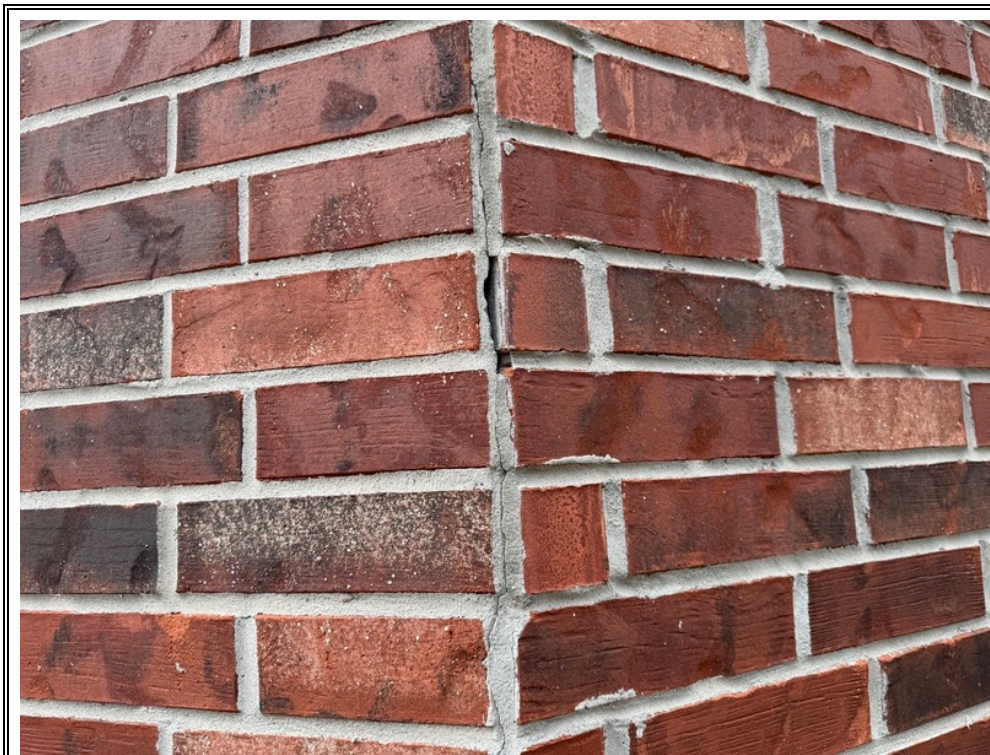
**Description:**  
Mortar crack along corner  
at rear left corner

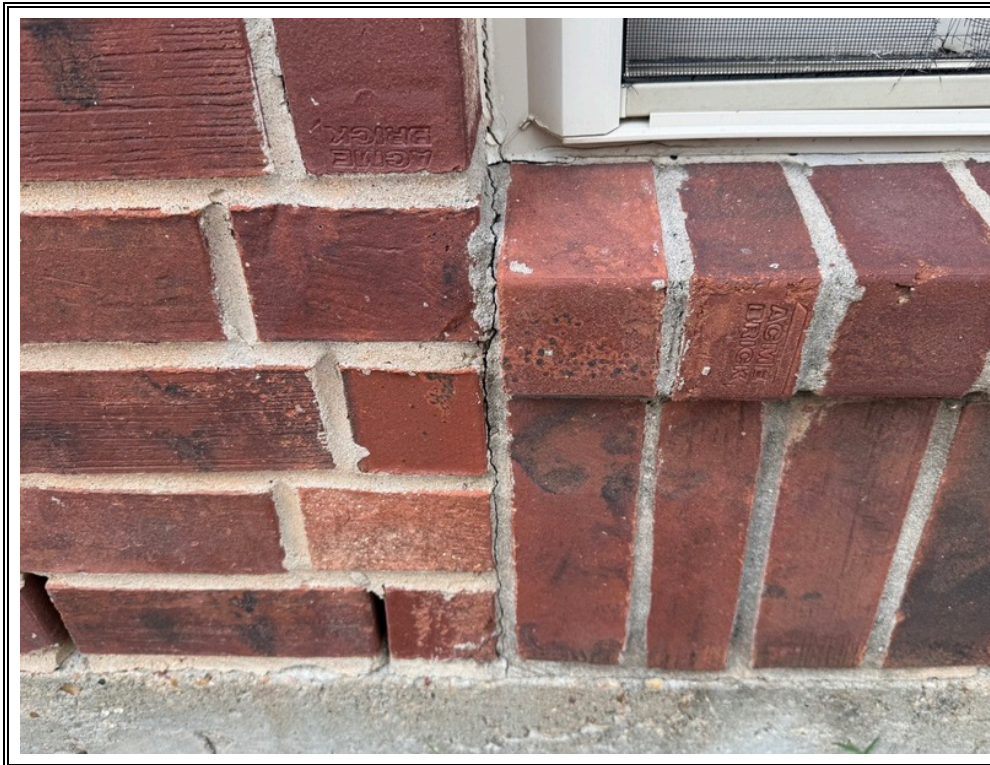
**13**

Mortar crack at window sill  
of bedroom 2 at rear  
elevation

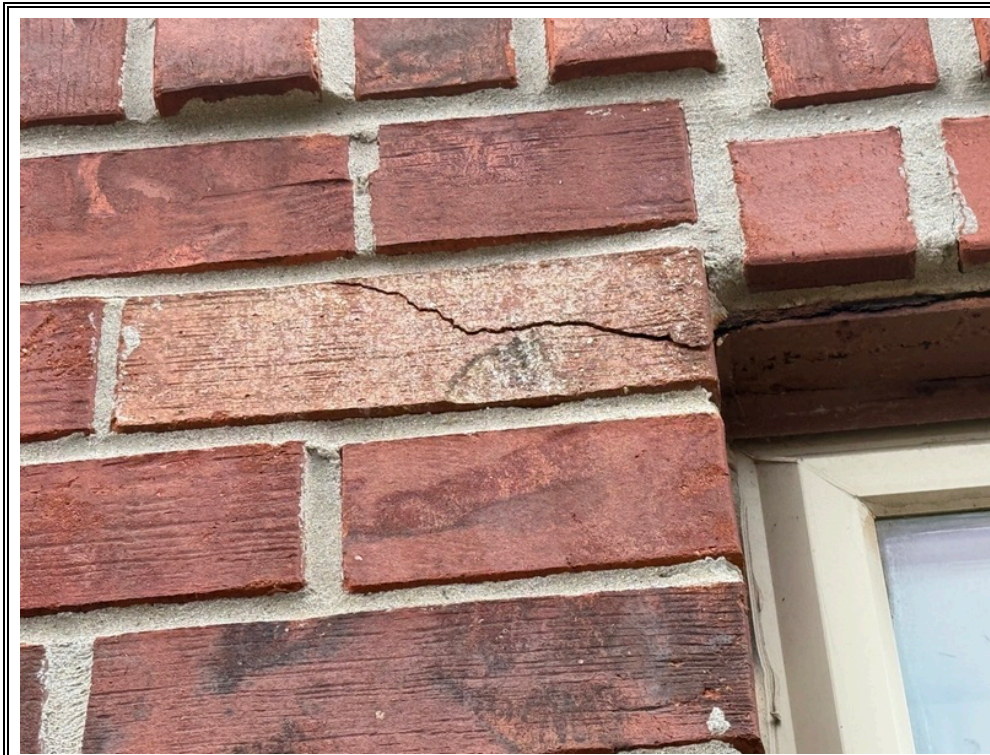
Brick crack at top left  
corner of bathroom  
window (right elevation)

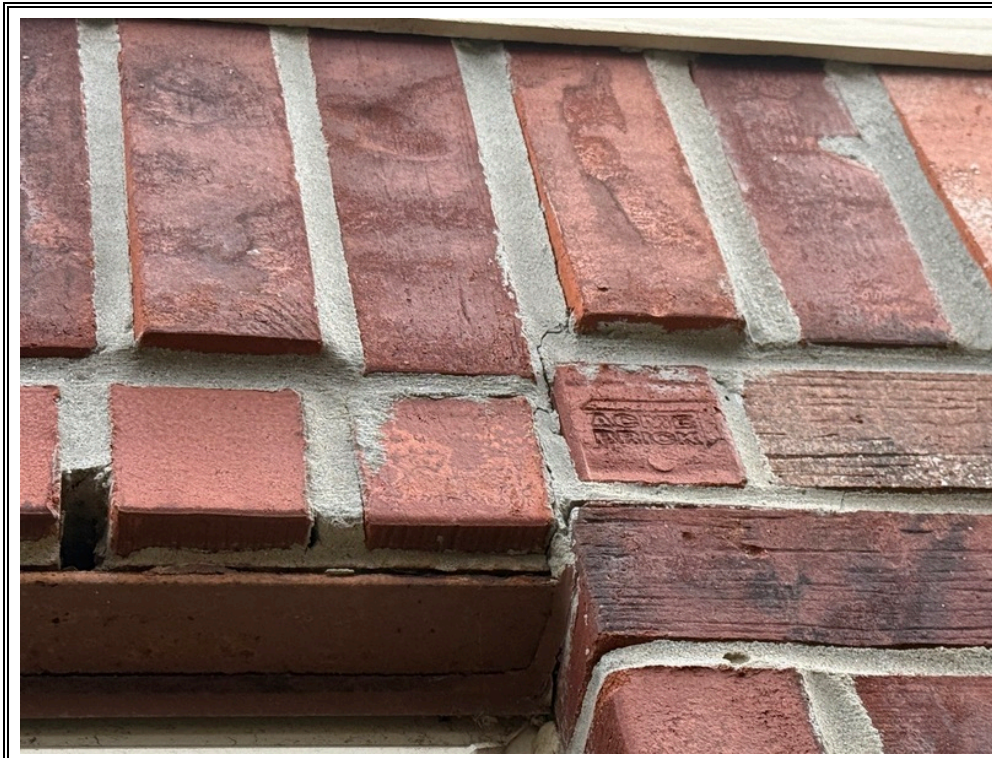
**Photo Number**  
**15**

**Description:**  
Brick crack at top right  
corner of bathroom  
window (right elevation)

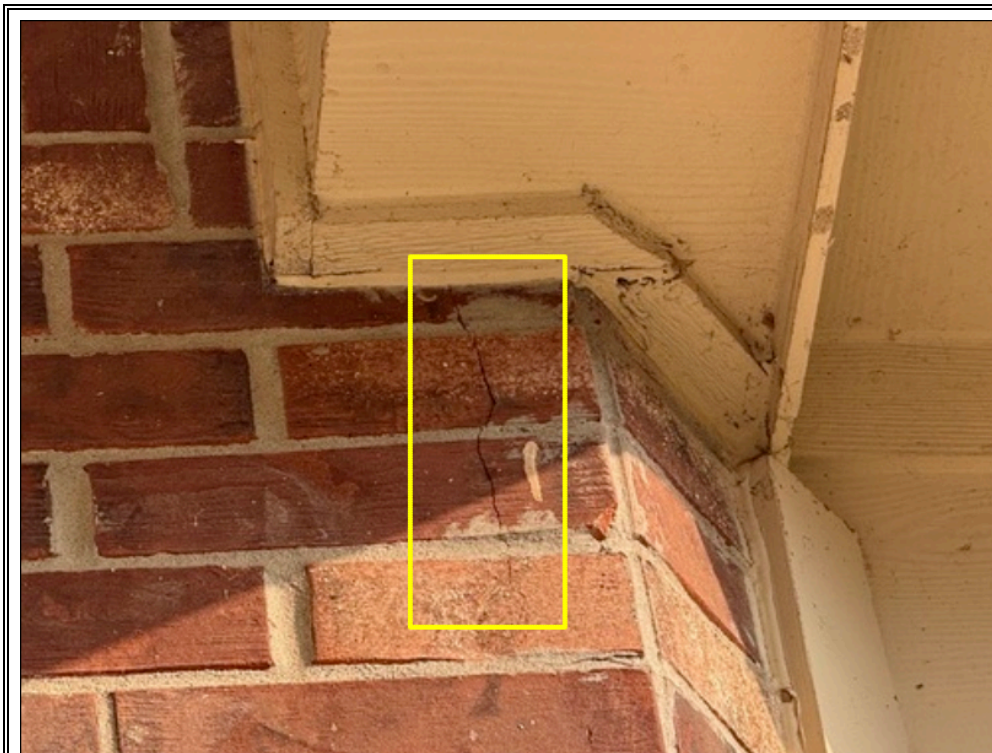
**Photo Number**  
**16**

**Description:**  
Brick cracking visible at  
rear elevation under the  
patio soffit

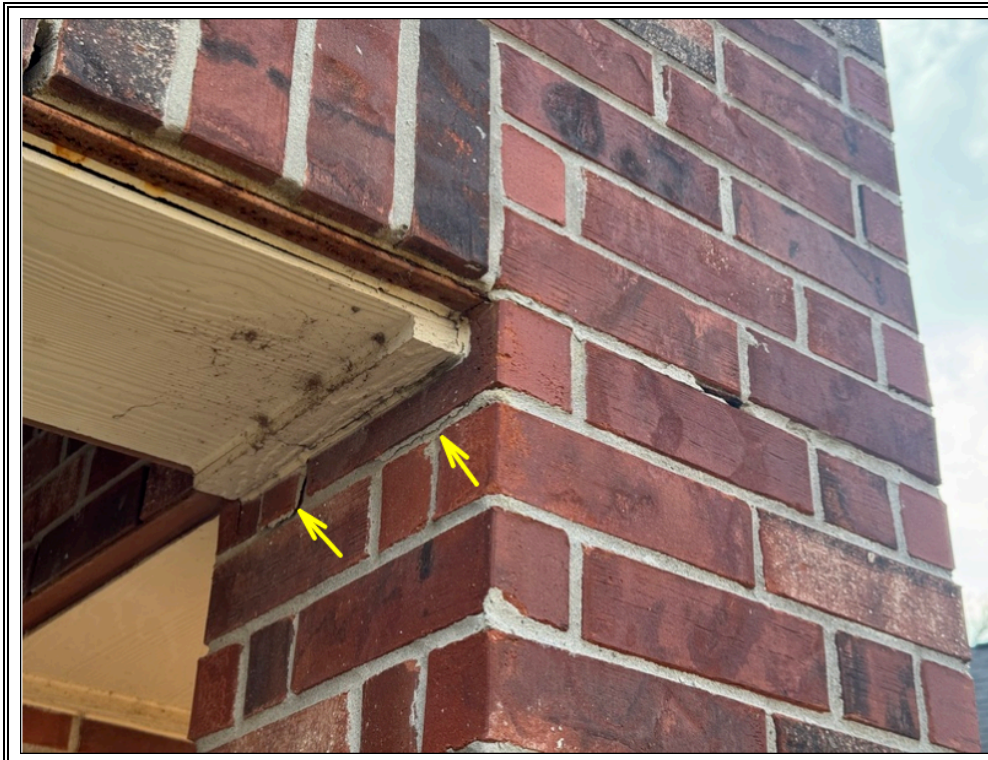
**17**

Brick spalling visible on porte-cochere column at front elevation

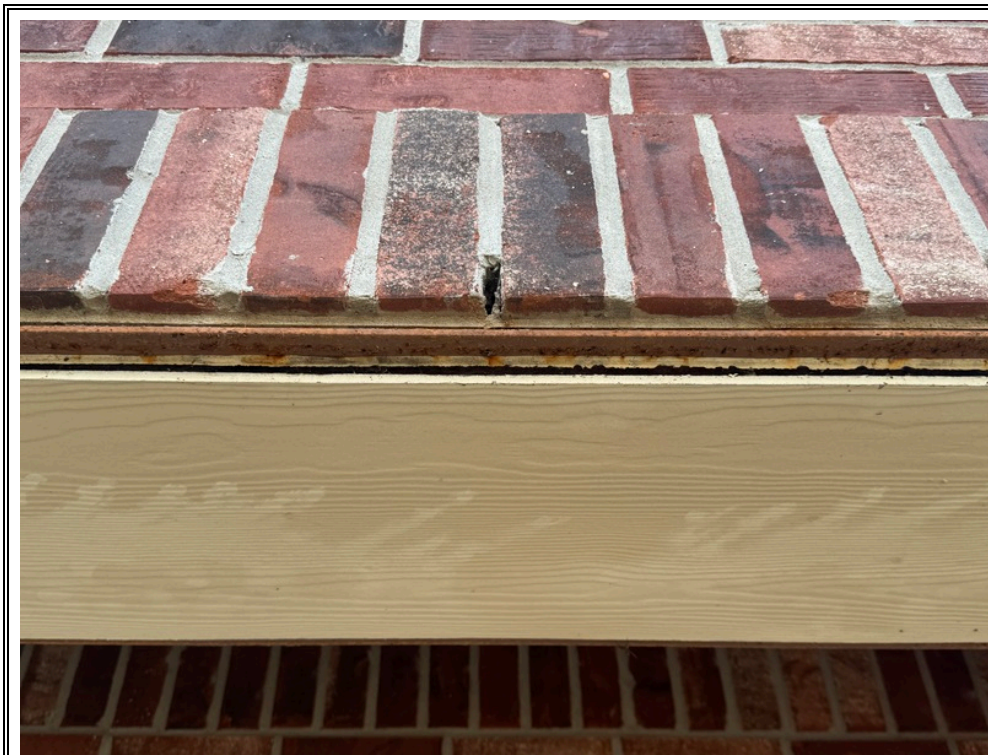
Moderate surface corrosion and material separation on the lintel across the porté-cocheré

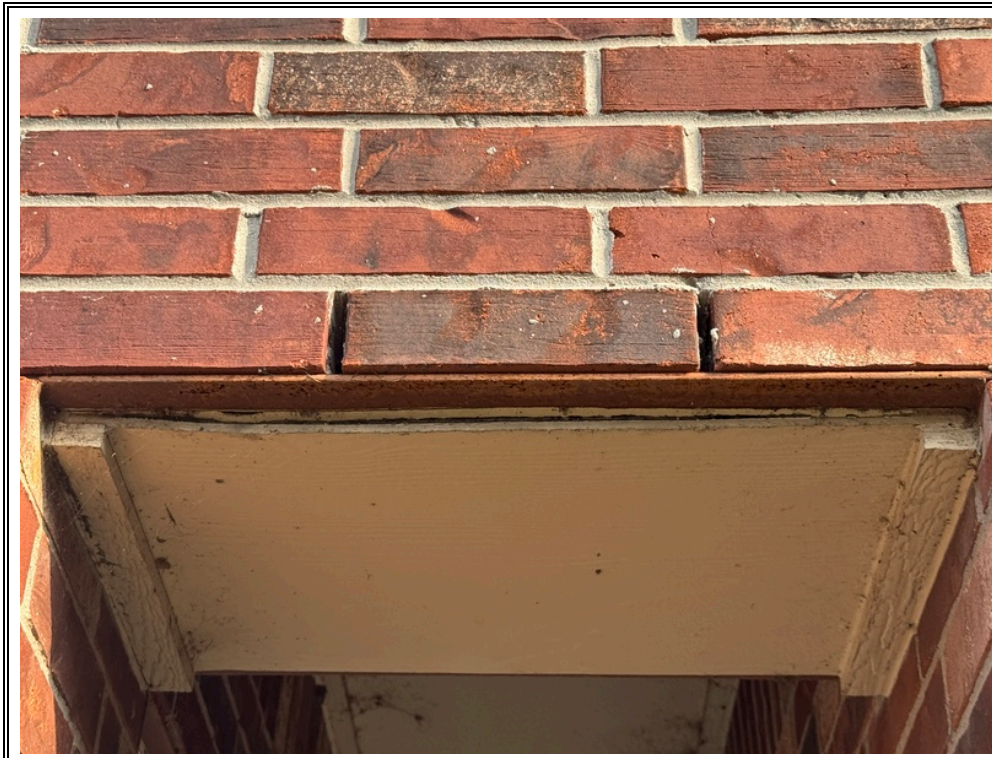
**Photo Number**  
**19**

**Description:**  
Surface corrosion on the  
portè-cochere  
lintel accompanied  
by sealant separation

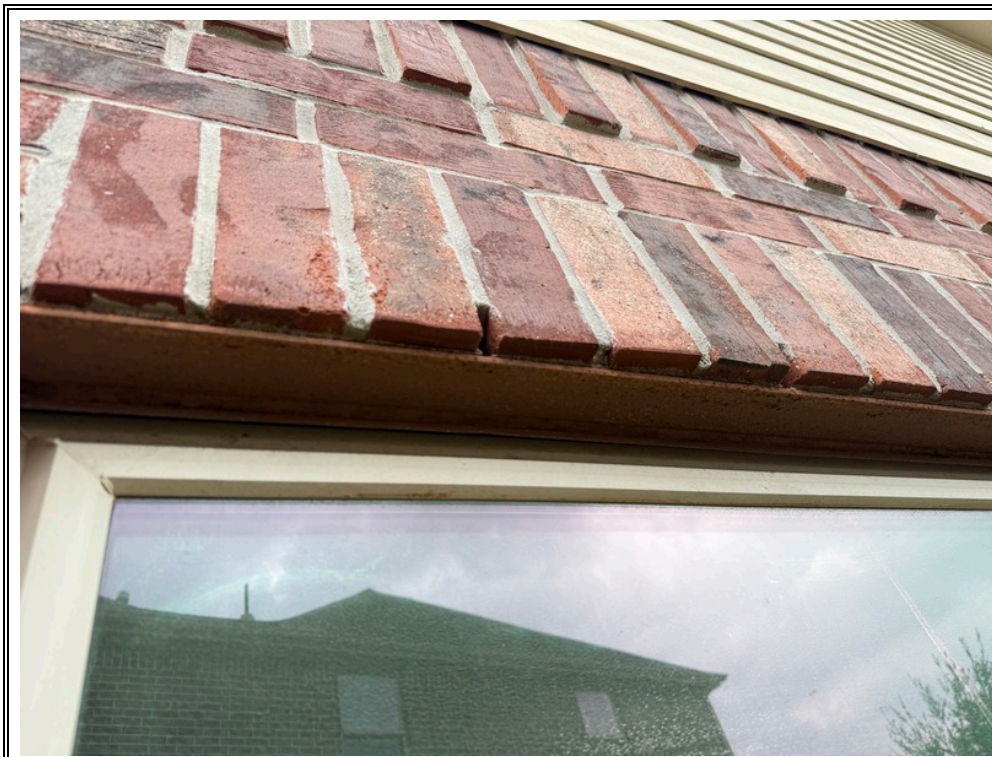
**Photo Number**  
**20**

**Description:**  
Lintel rusting at primary  
bathroom window on left  
elevation

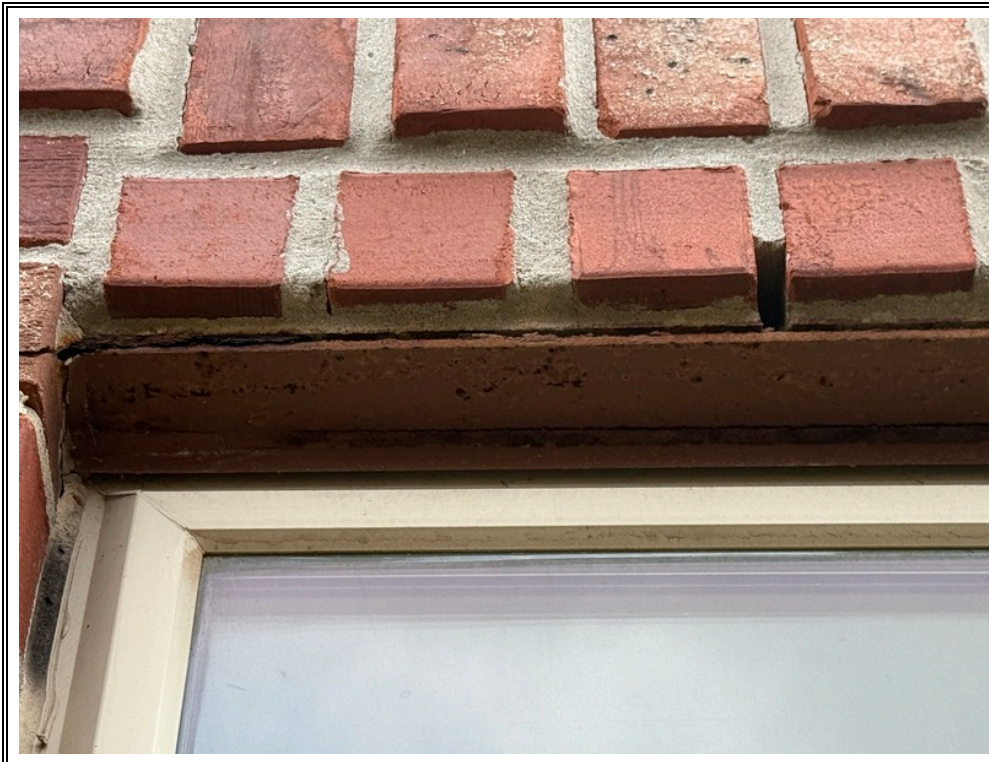
**21**

Lintel rusting accompanied by brick damage on the bathroom window (right elevation)

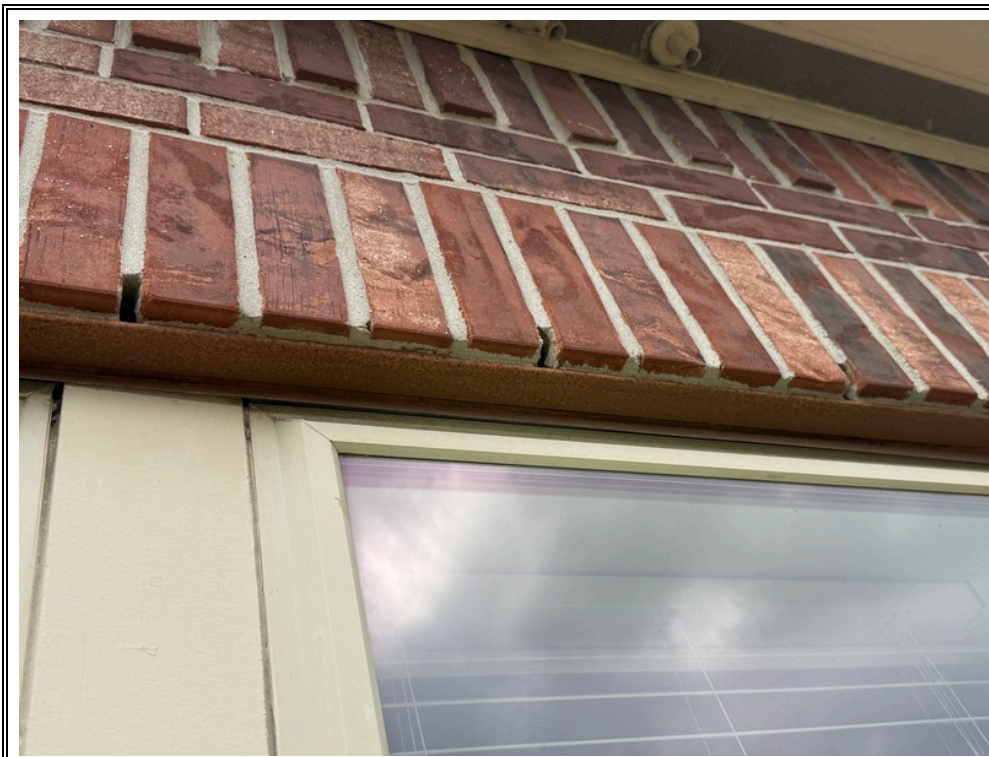
Lintel corrosion at bedroom window at the rear elevation (typical)

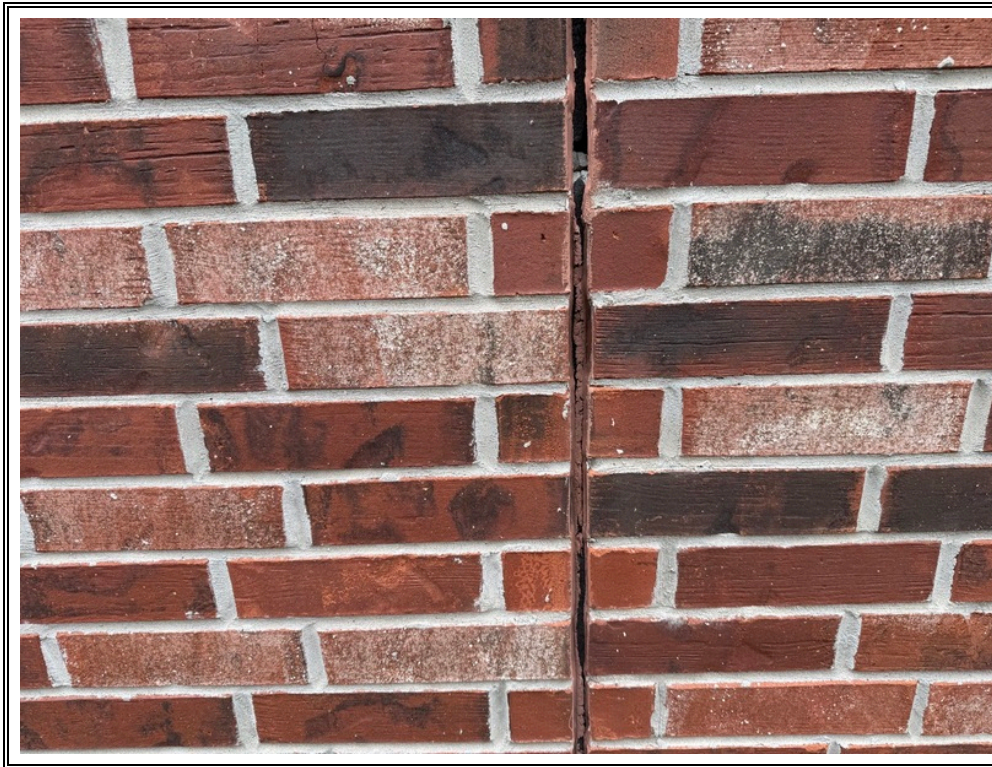
**Photo Number**  
**23**

**Description:**  
Expansion joint sealant  
deterioration at left  
elevation with openings to  
the wall cavity (typical)

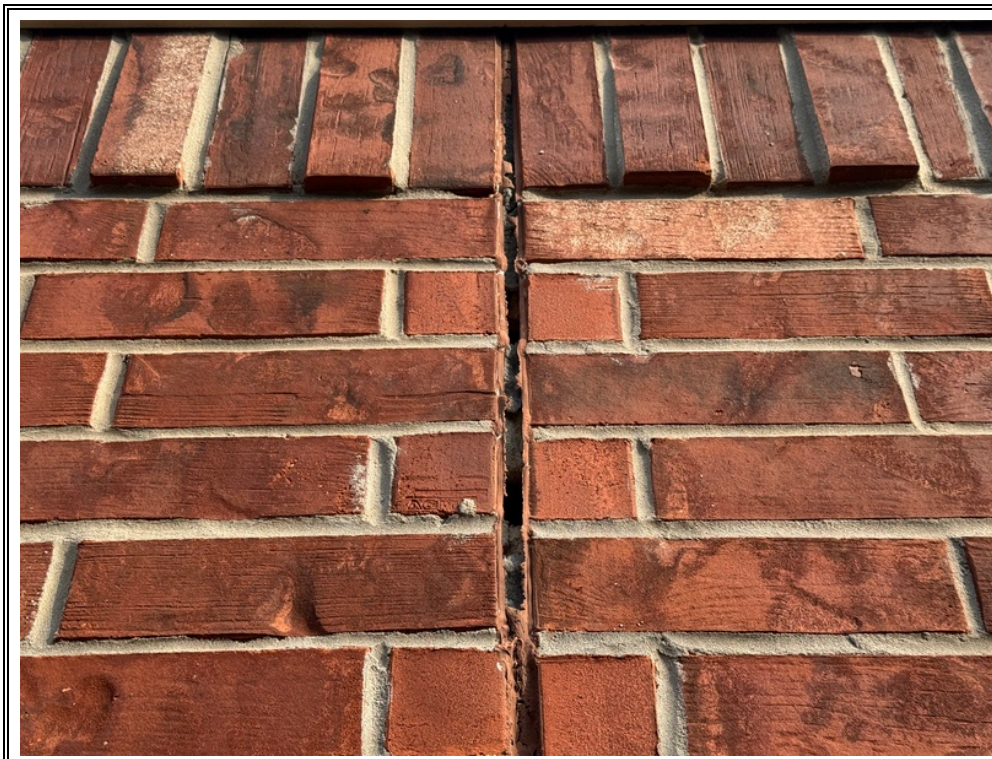
**Photo Number**  
**24**

**Description:**  
Expansion joint sealant  
deterioration at right  
elevation with openings to  
the wall cavity (typical)

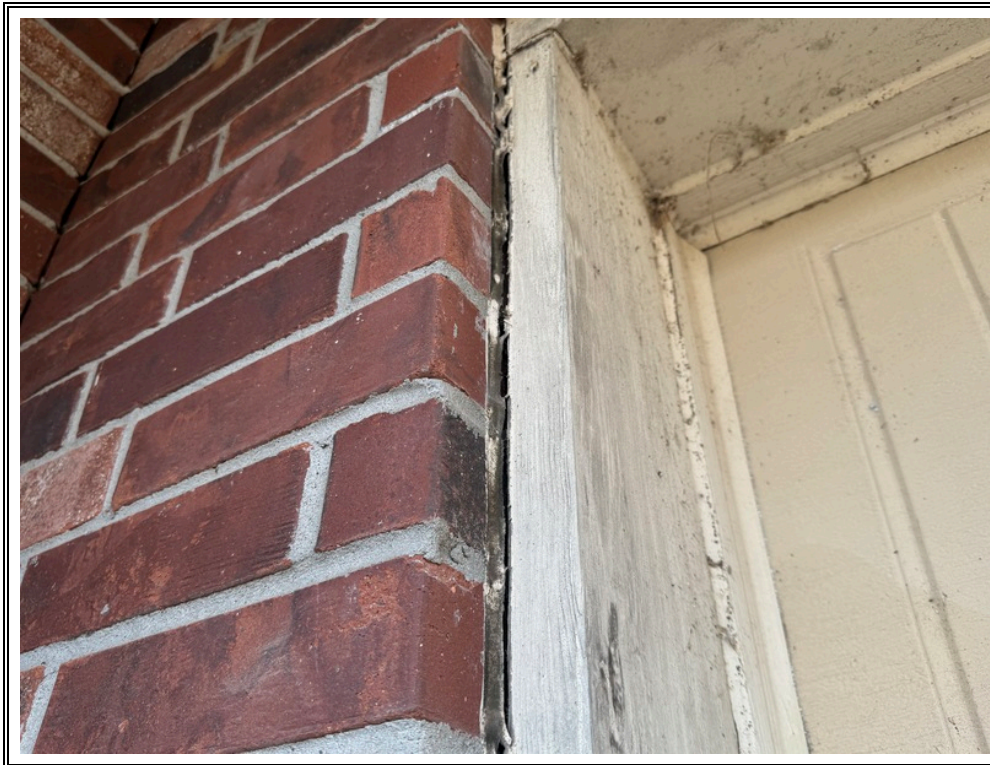
**25**

Trim separation along the garage jamba (typical)

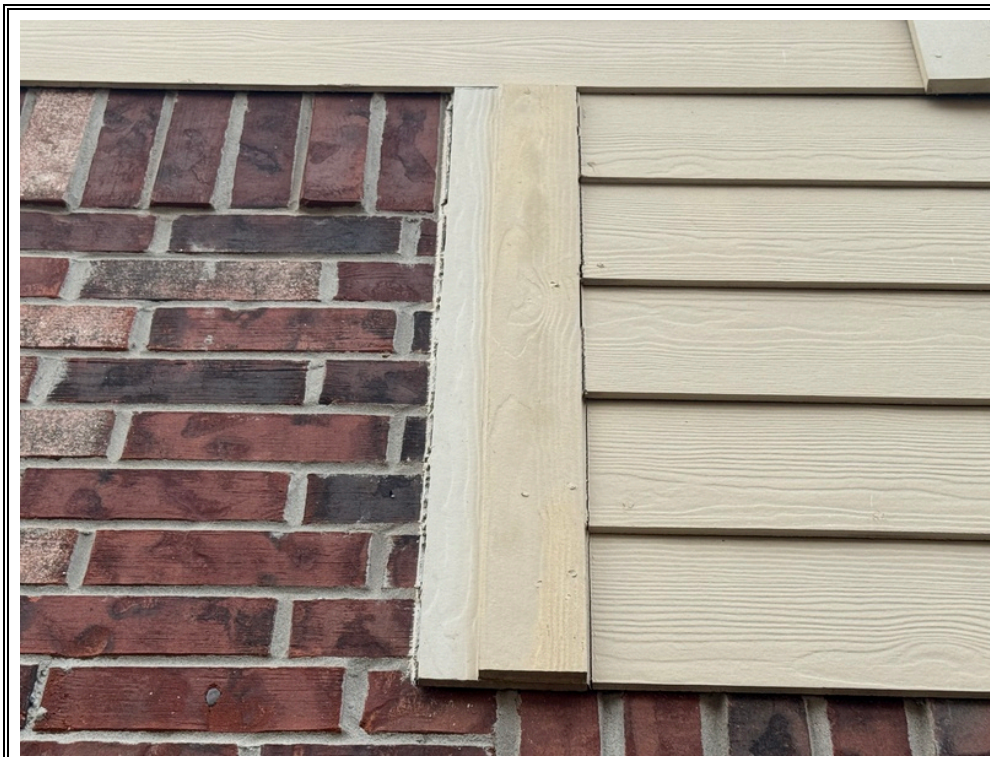
Trim separation along the brick and siding joints at left elevation

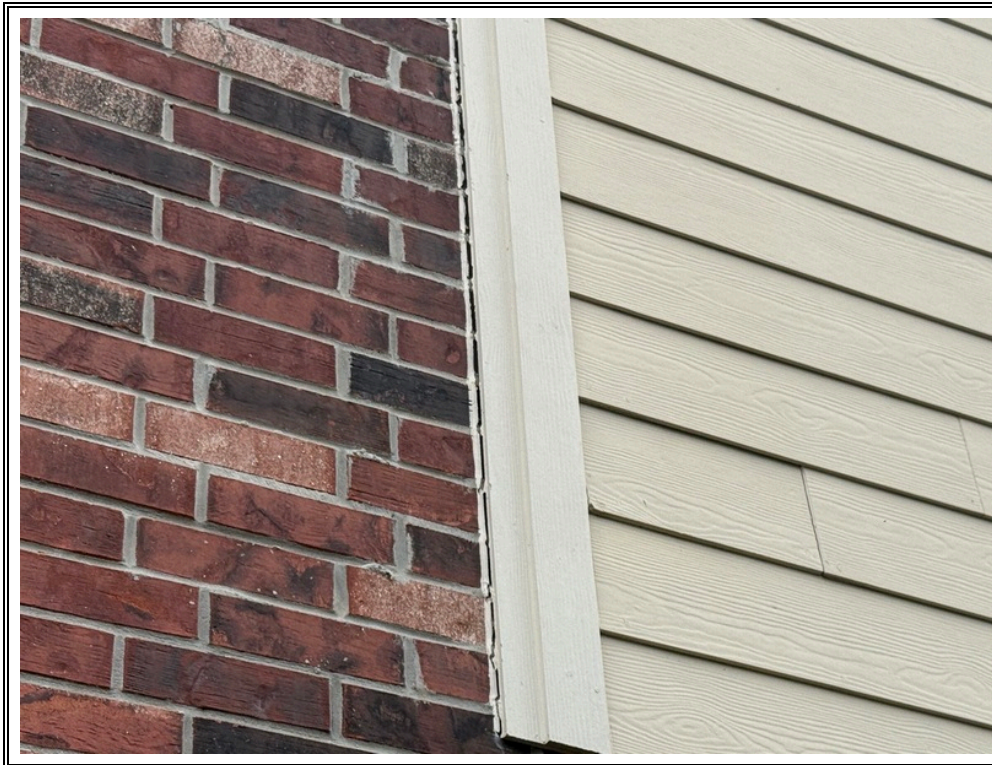
**Photo Number**  
**27**

**Description:**  
Trim separation at right  
elevation

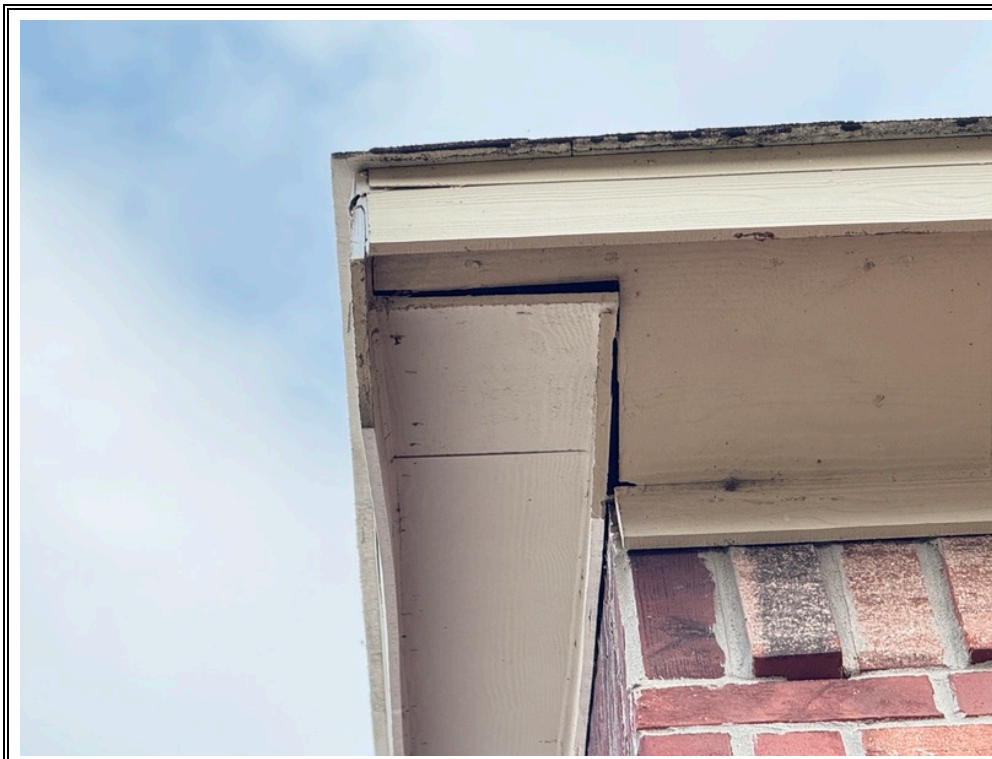
**Photo Number**  
**28**

**Description:**  
Soffit and trim separation  
at front right corner
