Transferee Name:	<u>Mingzhe Yu</u>	Street Address:	<u>3923 Birch Vale Ln</u>
City:	<u>Sugar Land</u>	State / Zip Code:	<u>TX / 77479</u>
Customer:	<u>Graebel Companies – CO</u>	File Number:	<u>APROA649919</u>
Customer Contact:	<u>Rachel Case</u>	Inspection / Report Date:	<u>2-26-2026 / 2-27-2026</u>

# Structural Evaluation Report Structural Inspection

**Shadow Glen At Riverstone Sec 5, Block 1, Lot 19  
3923 Birch Vale Lane  
Sugar Land, Texas 77479**

Walk-Through Survey performed February 20, 2026  
*Submitted February 25, 2026*  
CYE Job. No. 2026046N

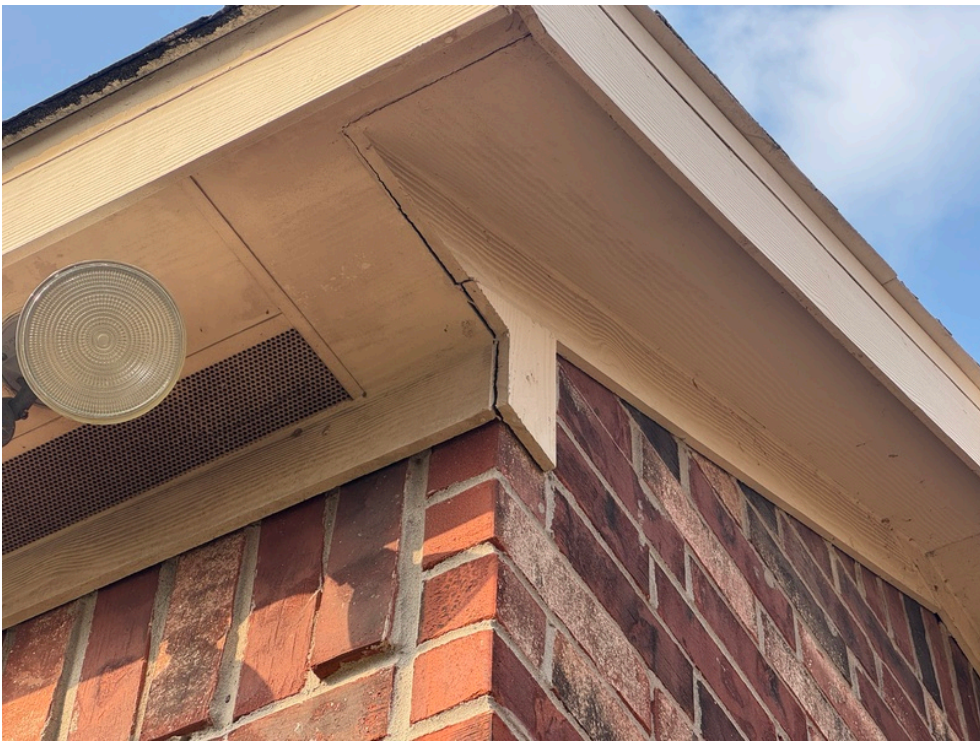
**Photo Number**  
**30**

**Description:**  
Soffit and trim separation  
at rear corner of bedroom  
2 (right corner)

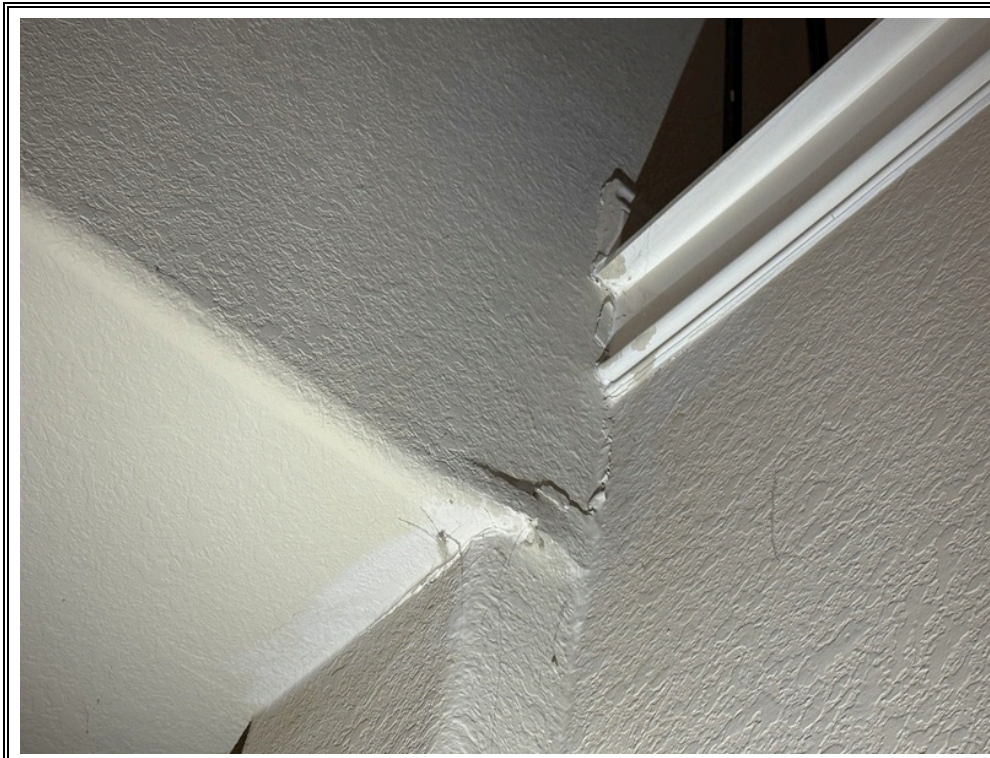
**Photo Number**  
**31**

**Description:**  
Drywall cracking visible at  
floor to column transition  
above the kitchen

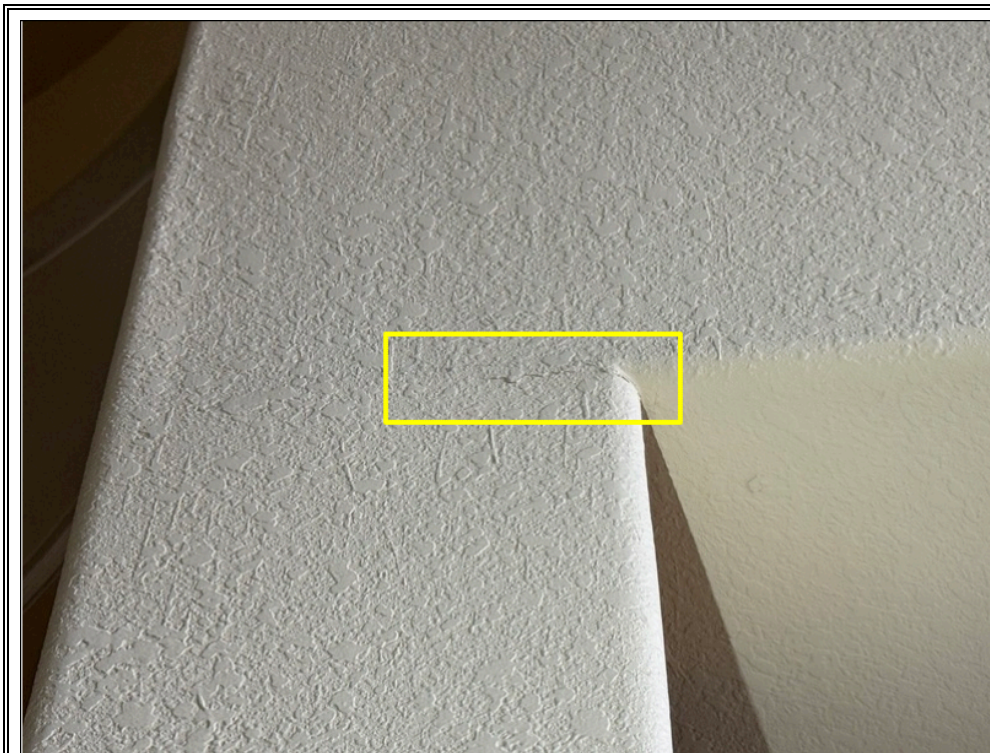
**Photo Number**  
**32**

**Description:**  
Drywall crack at the floor  
to column transition at the  
corner of the staircase in  
the foyer

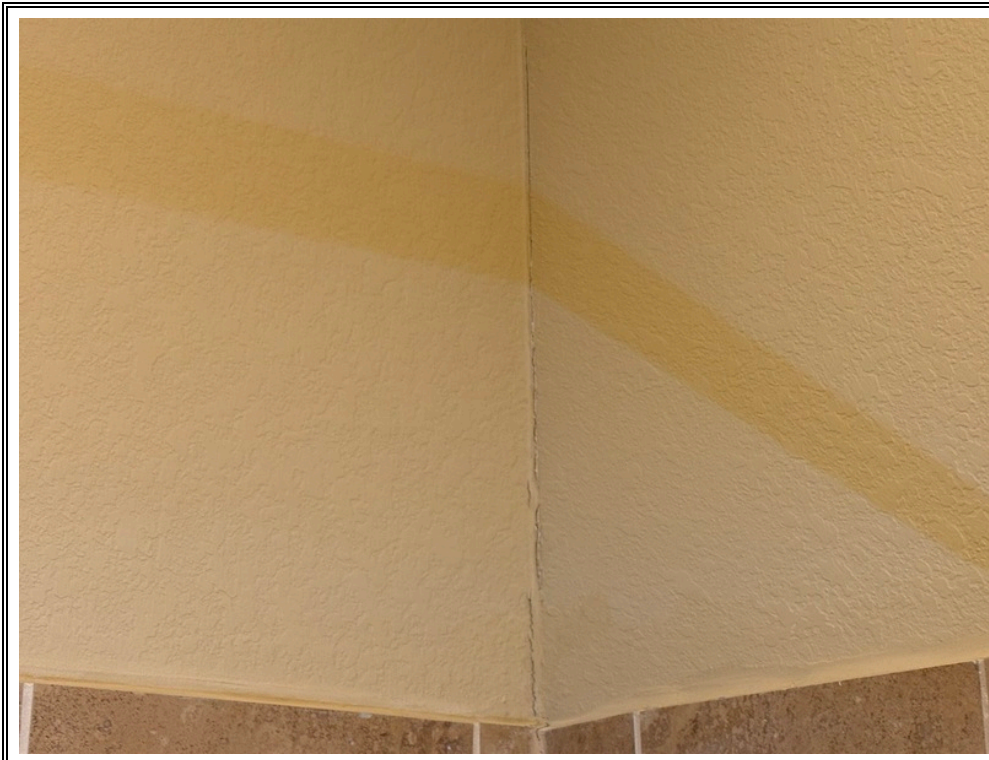
**37**

Drywall separation at the back corner above the tub shower tile (typical to bathrooms up and downstairs)

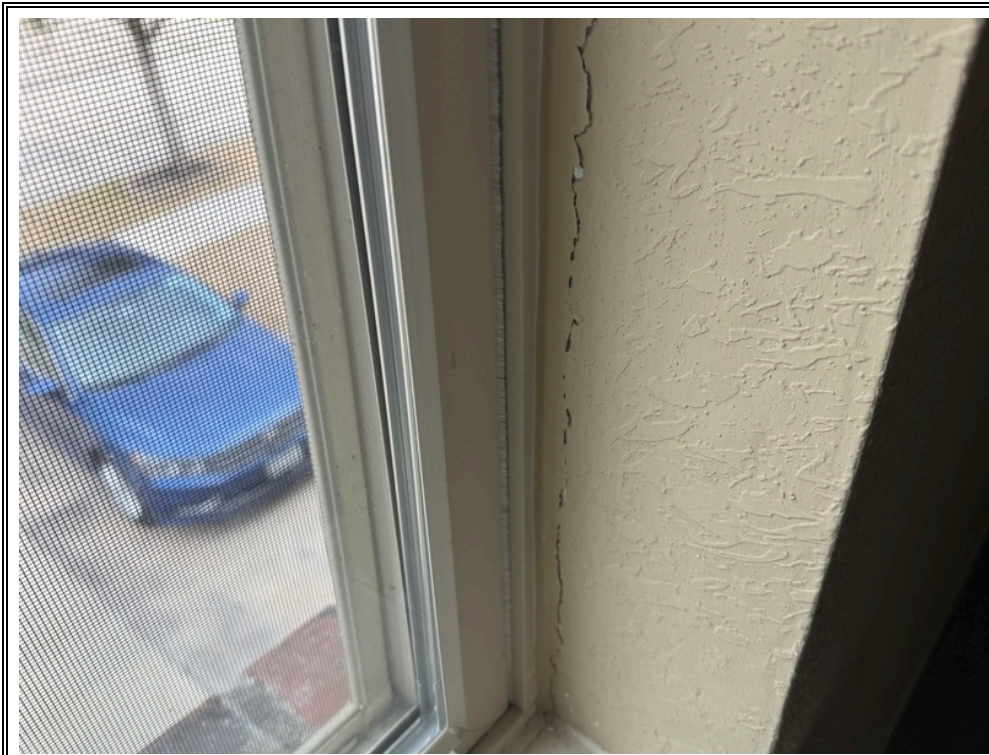
Sealant separation from the window frame along the game room's right jamb

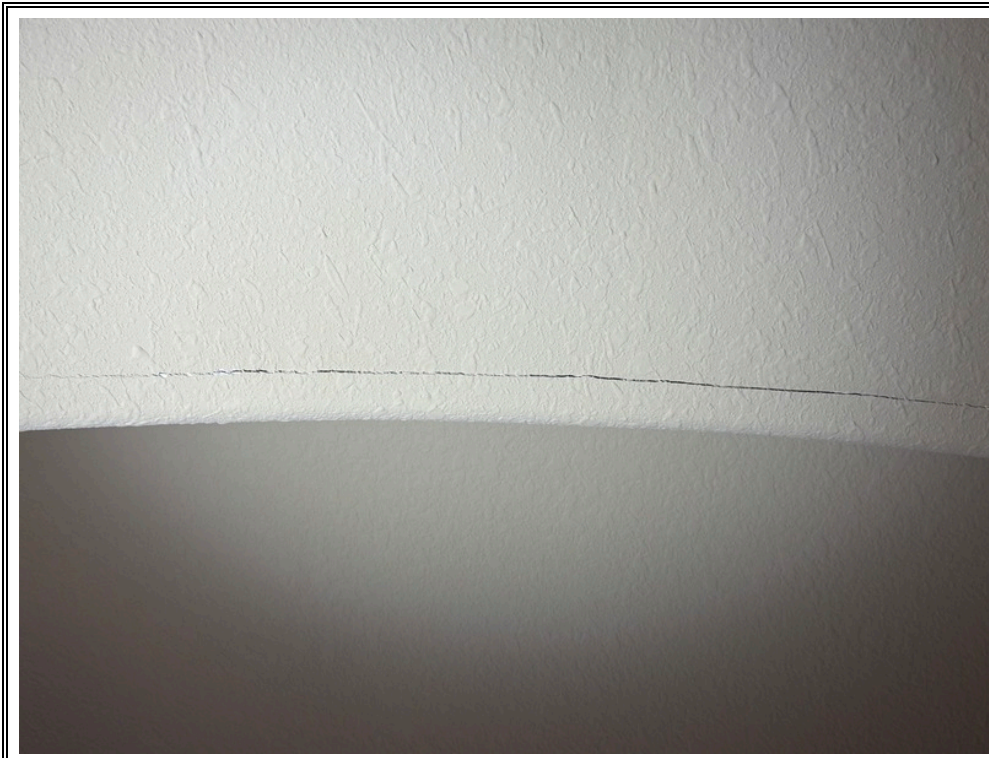
**39**

Drywall crack along the edge of the corner bead trim on the game room arched opening

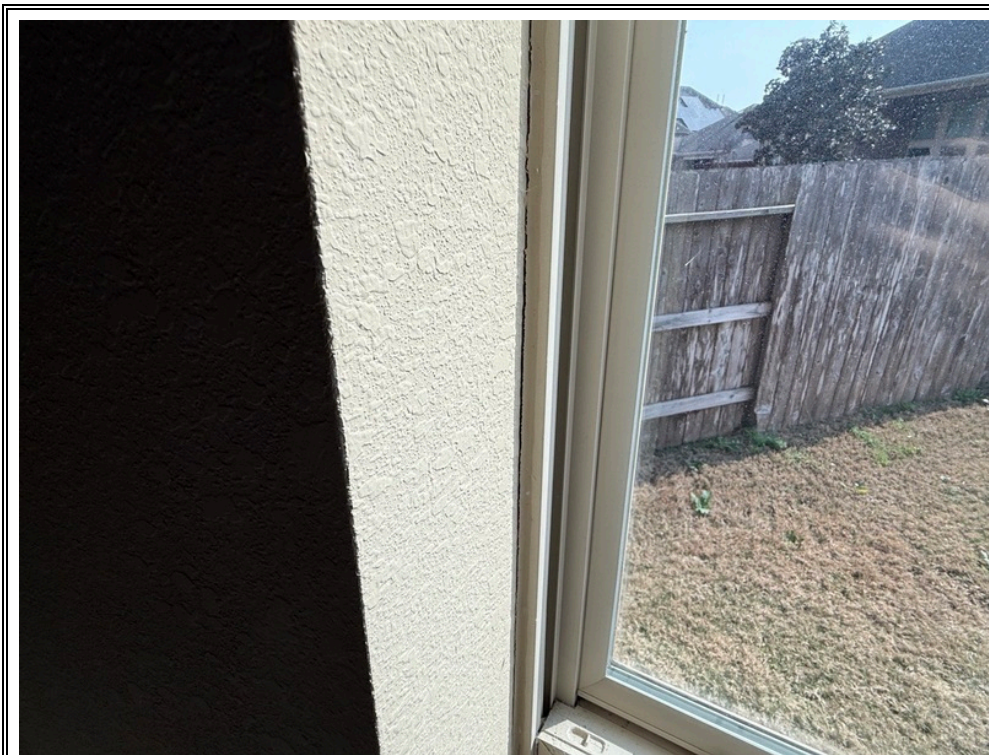
Sealant separation along primary bedroom window jamb

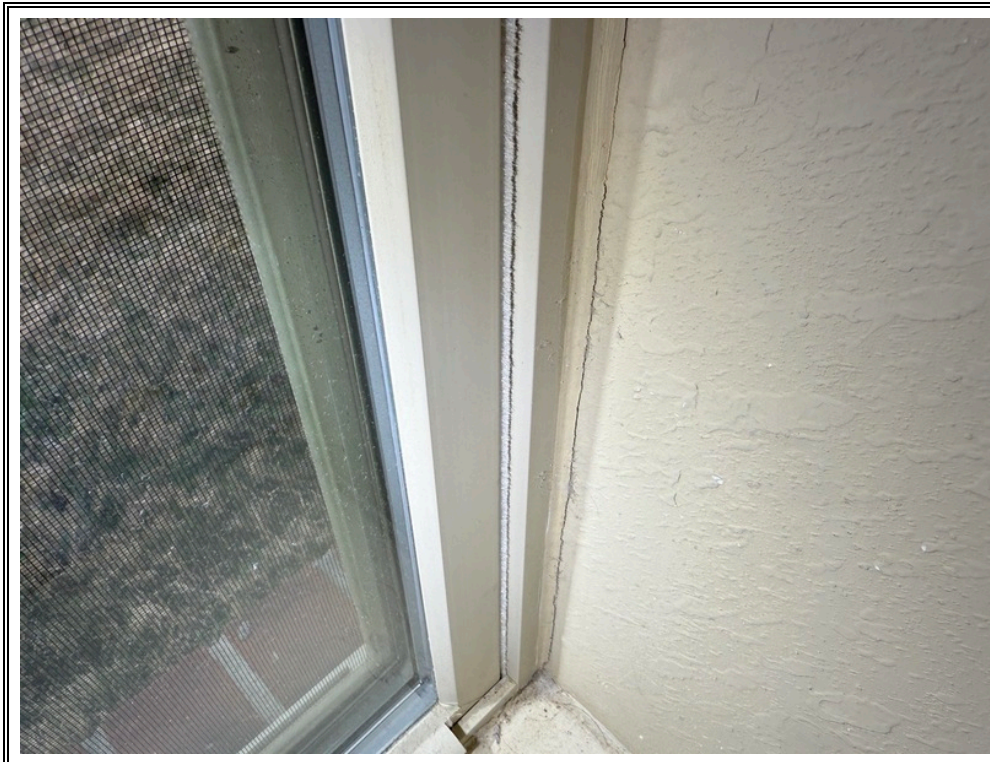
**41**

Sealant separation from the frame along the family room's right window jamb

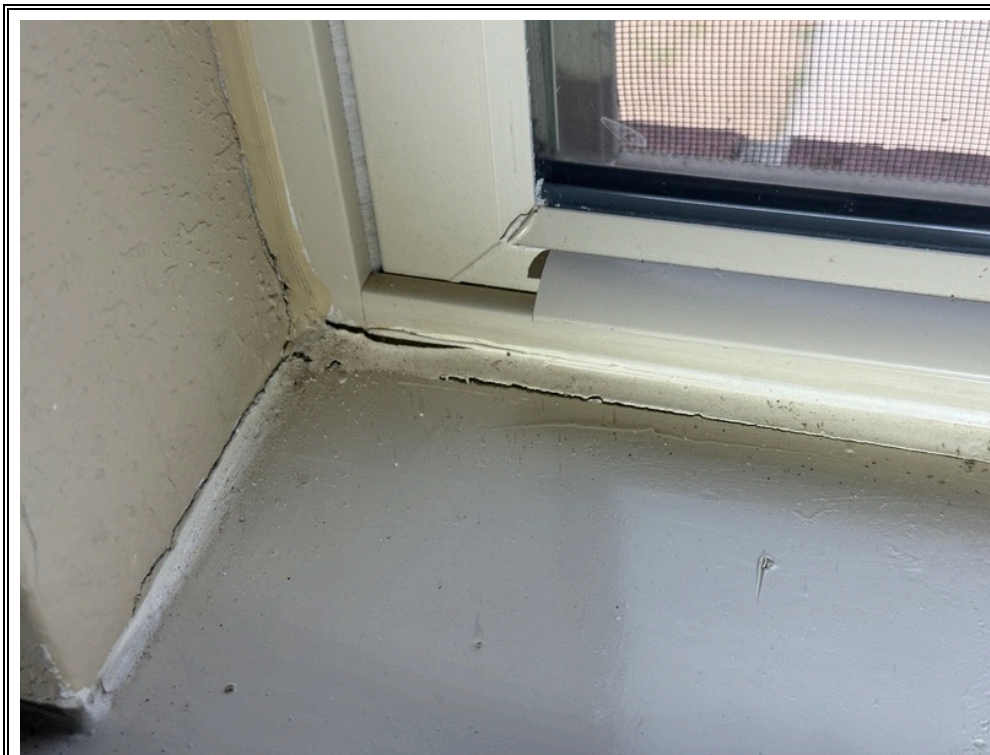
Sealant separation along game room window sill
