Home Inspection - TREC

Inspection Completed for: Graebel Companies - CO
(770) 325-4790
16346 Airport Circle
Aurora, CO 80011
APROA649919

Transferee / Property Information: Mingzhe Yu
3923 Birch Vale Ln
Sugar Land, TX 77479

PROPERTY INSPECTION REPORT FORM

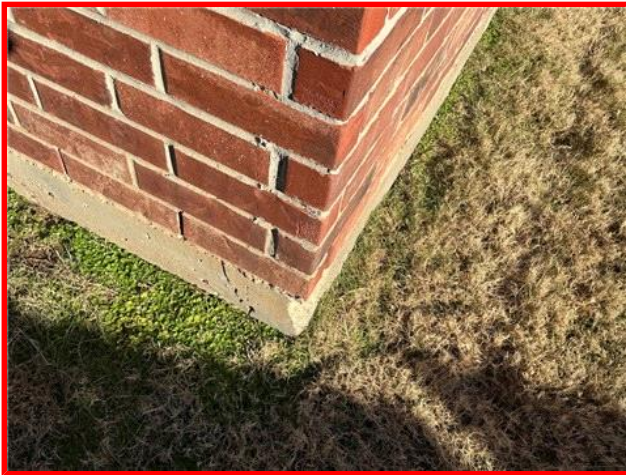
Crack at Right Rear Corner

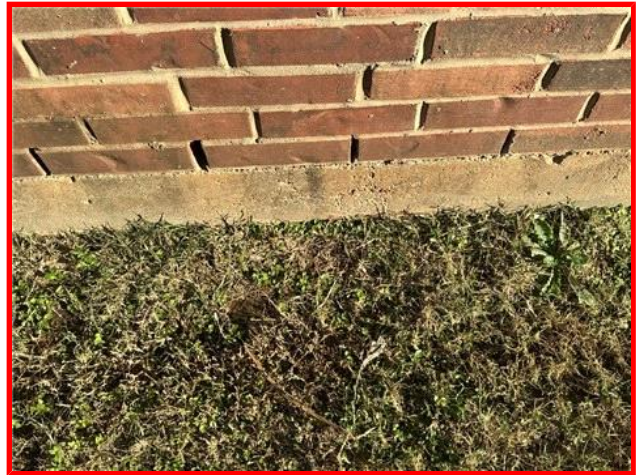
Spalling at Left

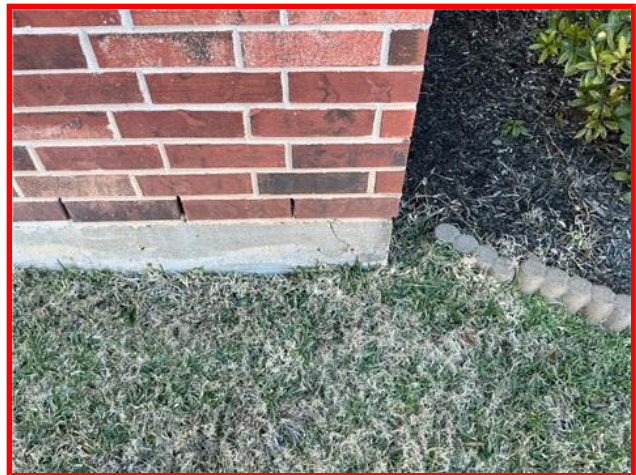
Crack at Front Left Corner

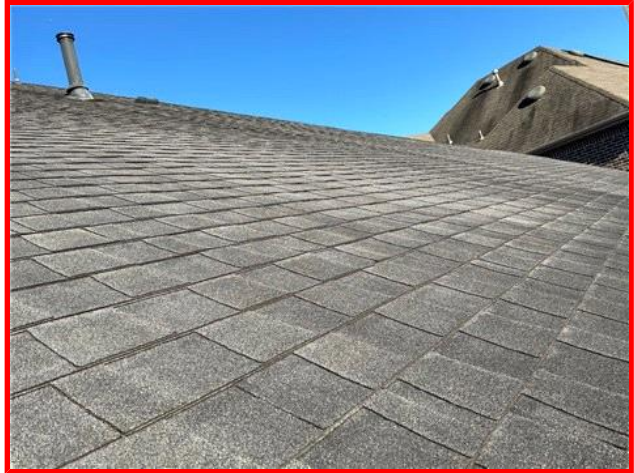
Roof - Granular Loss

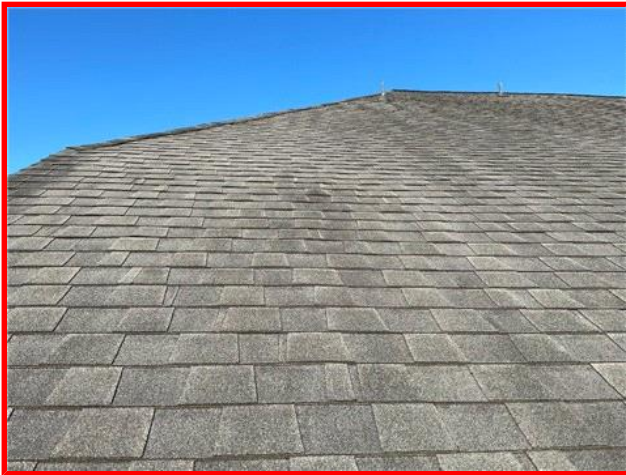
Granular Loss & Raised Vent Boot

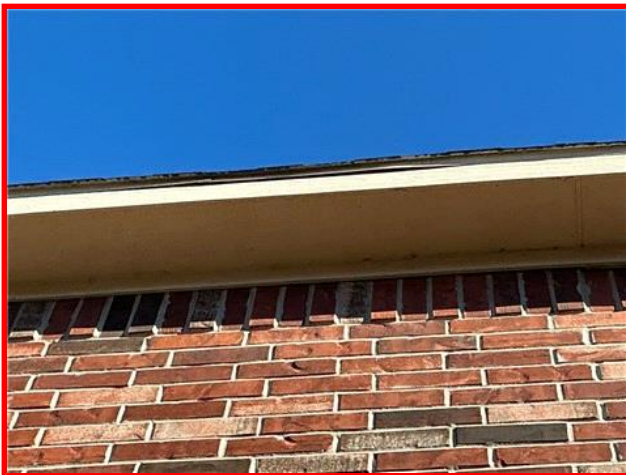
Damaged Flashing at Left

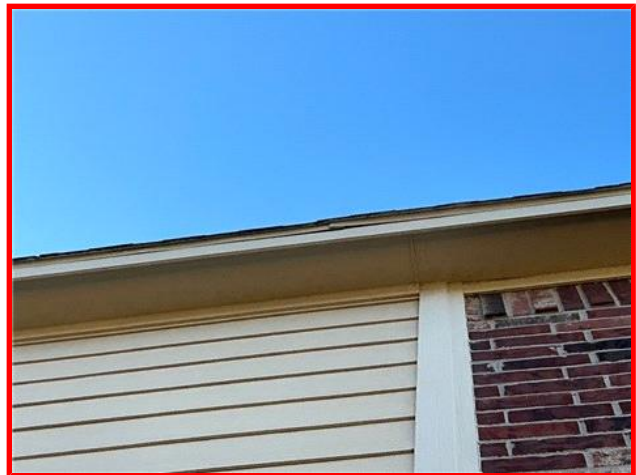
Fascia Board Separating at Left

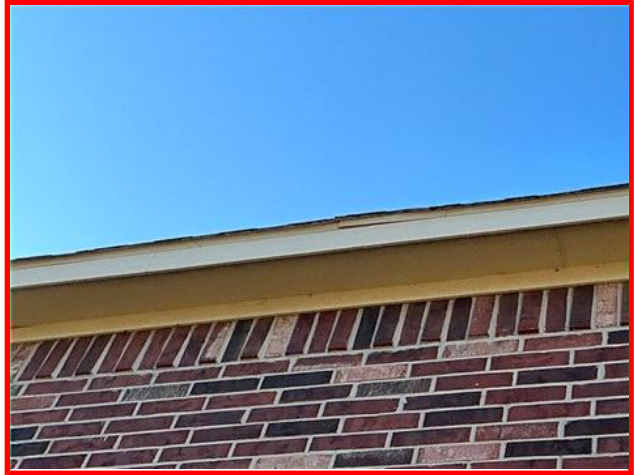
Damaged Drip Edge Flashing at Left

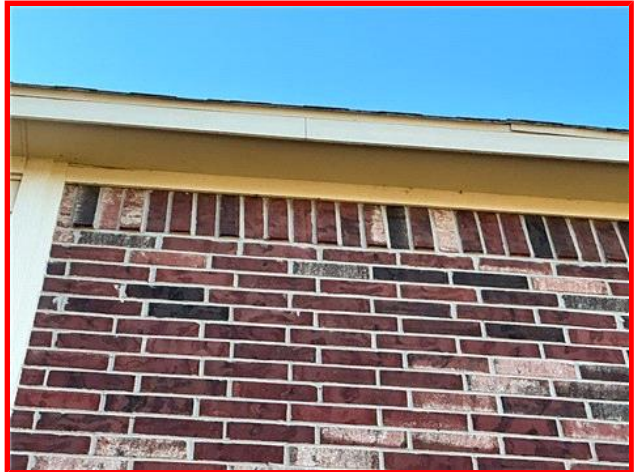
Damaged Drip Edge Flashing at Left

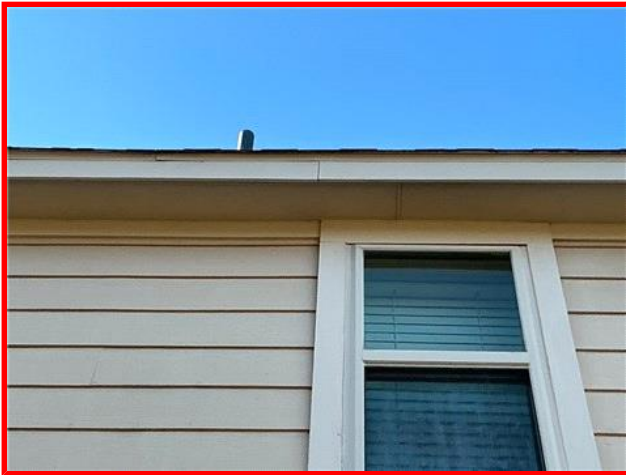
Separated Fascia at Left

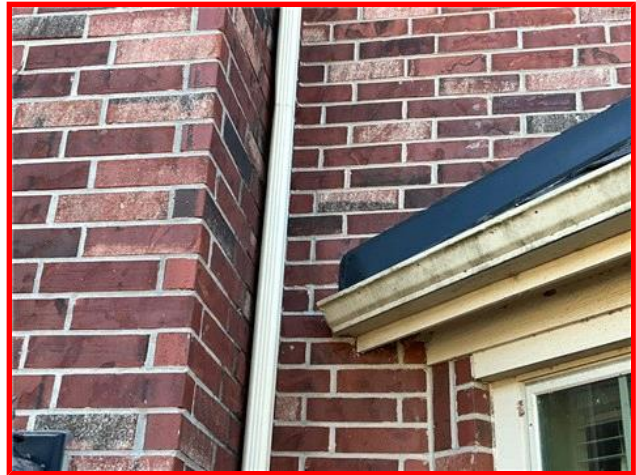
Missing Kickout Flashing at Front

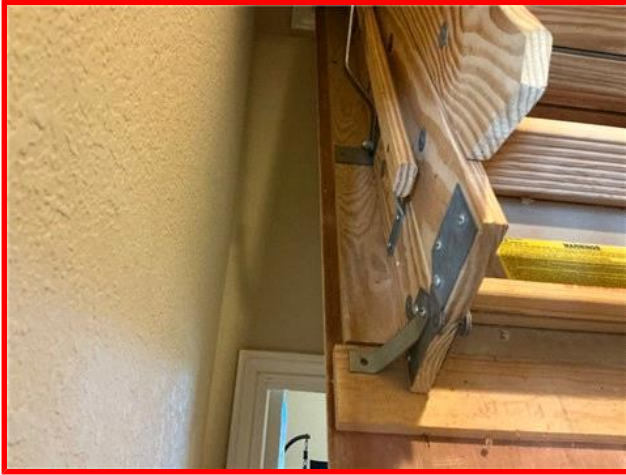
Loose Hardware at Attic Ladder

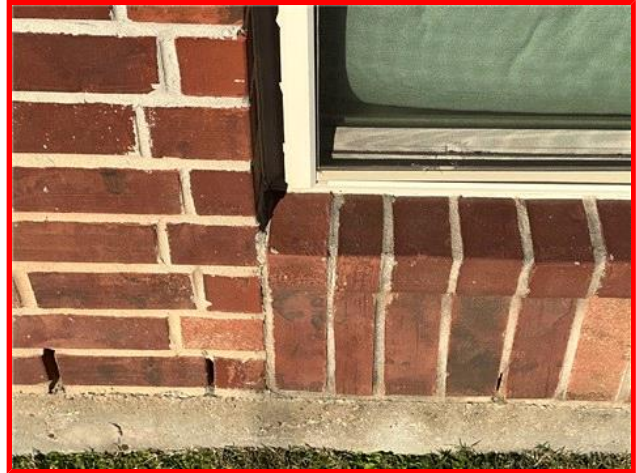
Crack in Mortar at Left

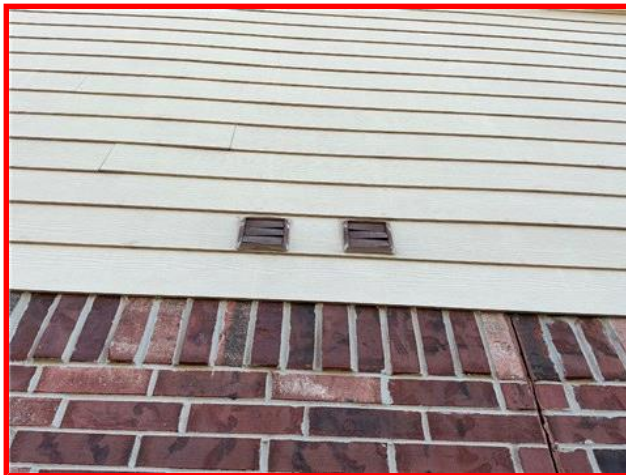
Damaged Vent Covers

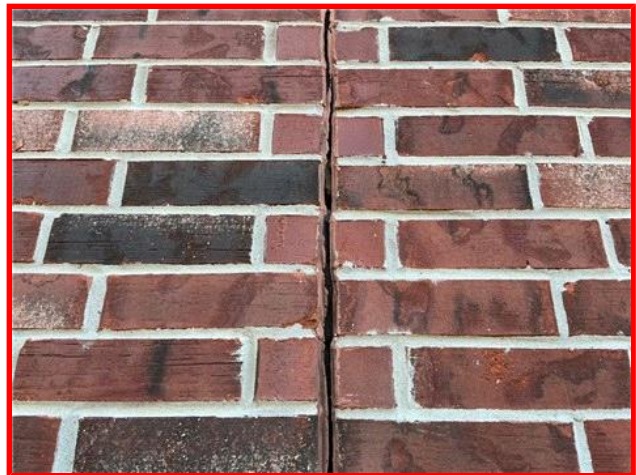
Missing Mortar at Left Expansion Joint

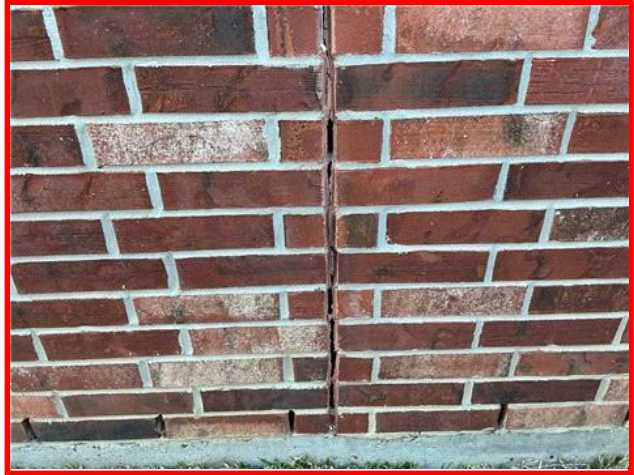
Missing Mortar at Left Expansion Joint

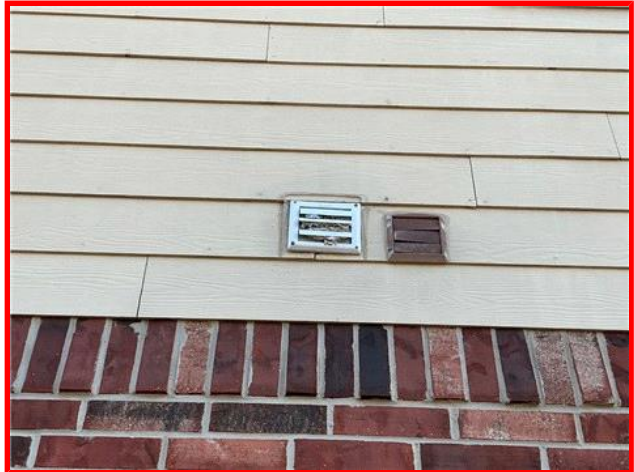
Damage & Debris at Wall Vent

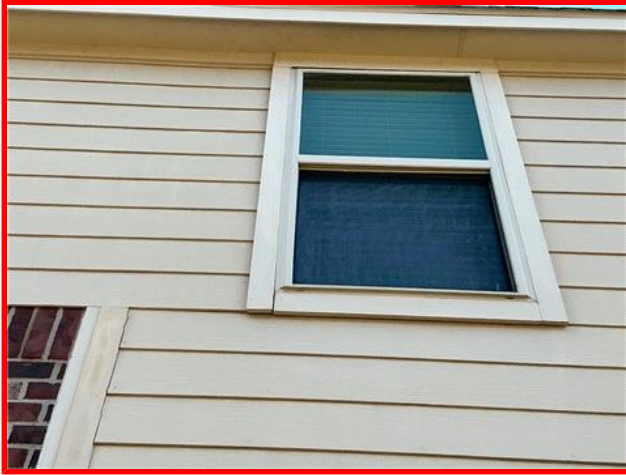
Trim Separation at Left

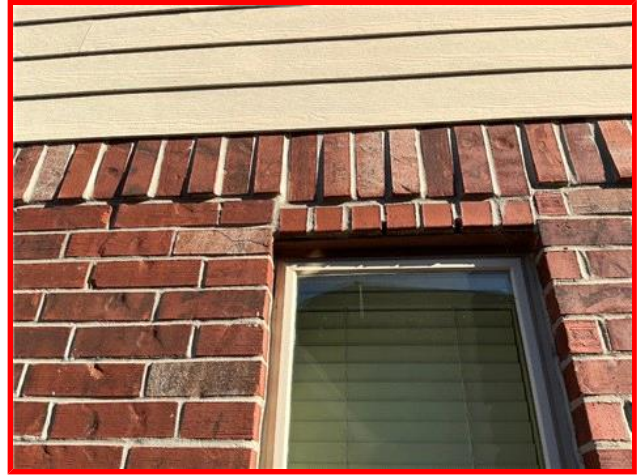
Crack in Brick at Right

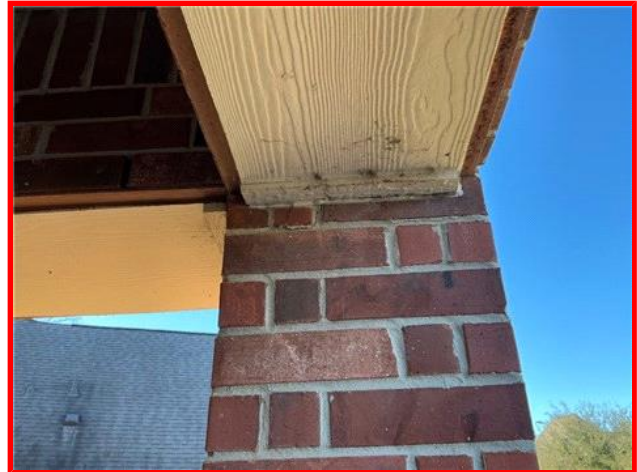
Damaged Brick at Garage

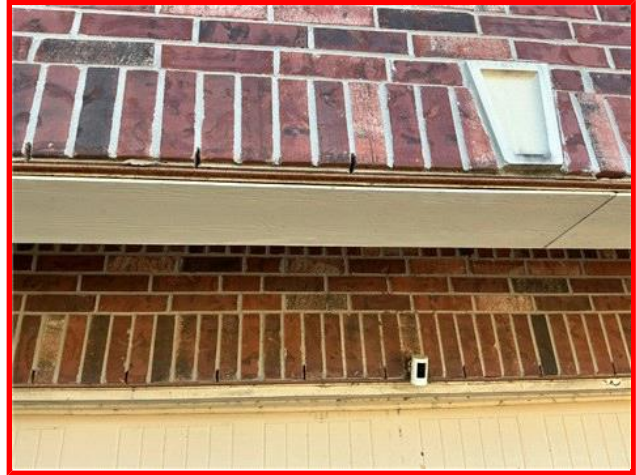
Rusted Lintel

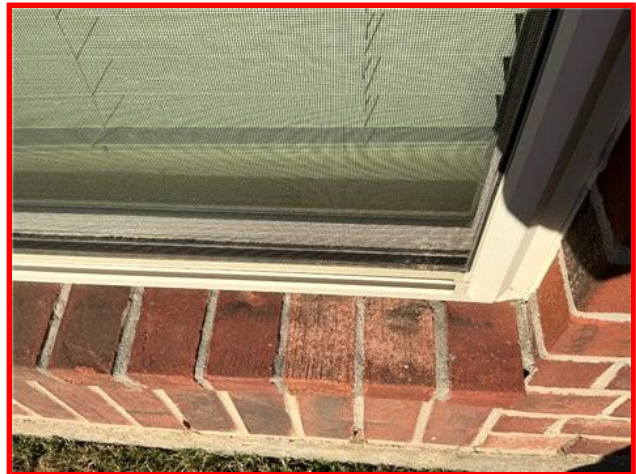
Voids in Mortar at Rear

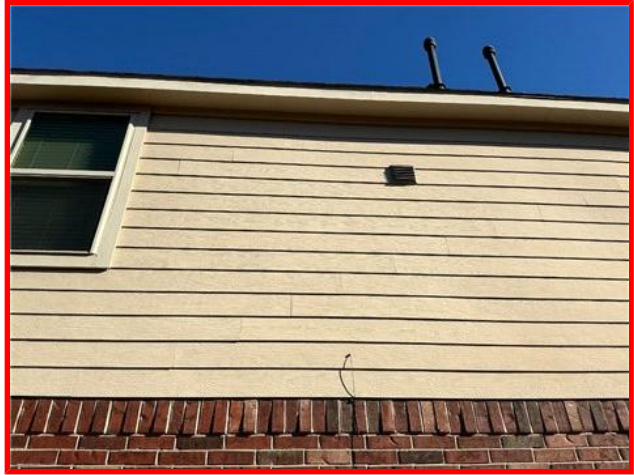
Siding Separation at Right

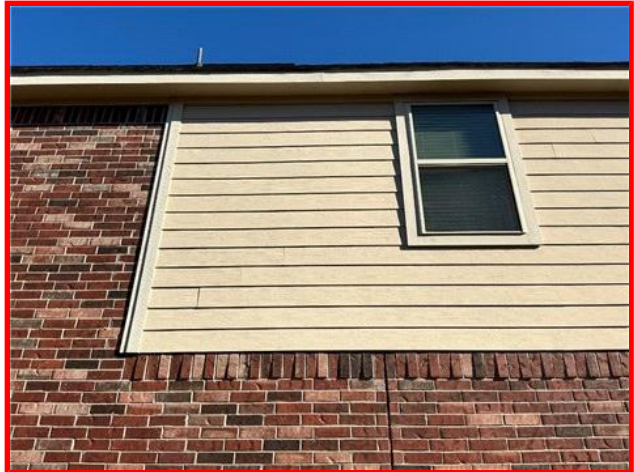
Siding Separation at Right

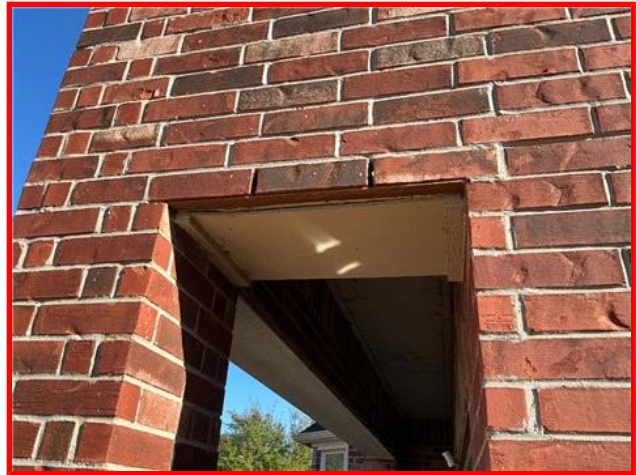
Separation at Garage Trim

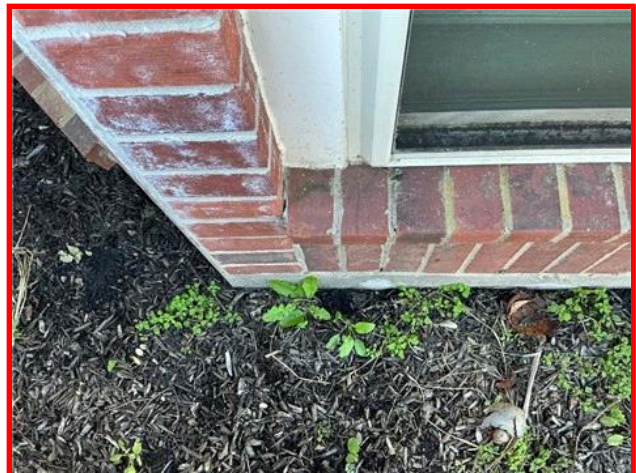
Missing / Separated Mortar at Front

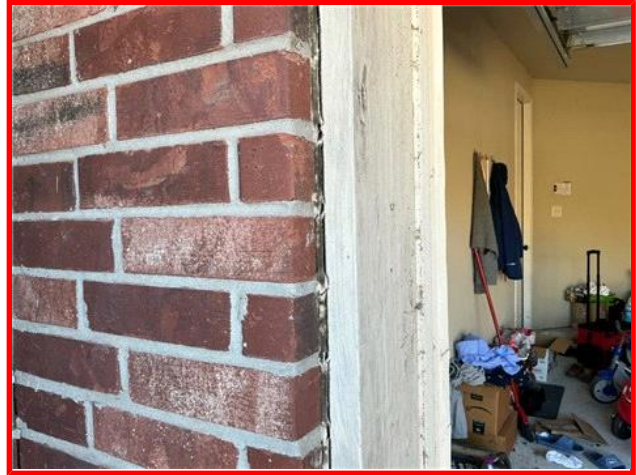
Deteriorated Caulk at Garage

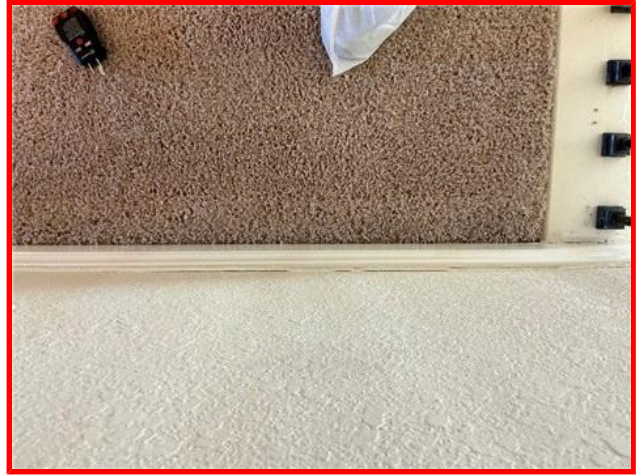
Separation in Baseboard Upstairs Hall

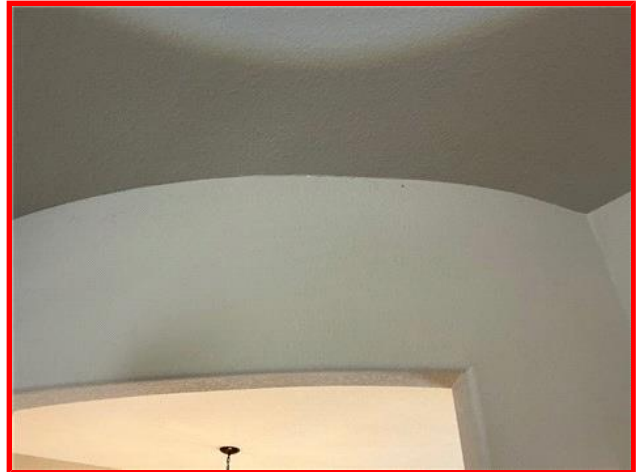
Crack in Upstairs Game Room

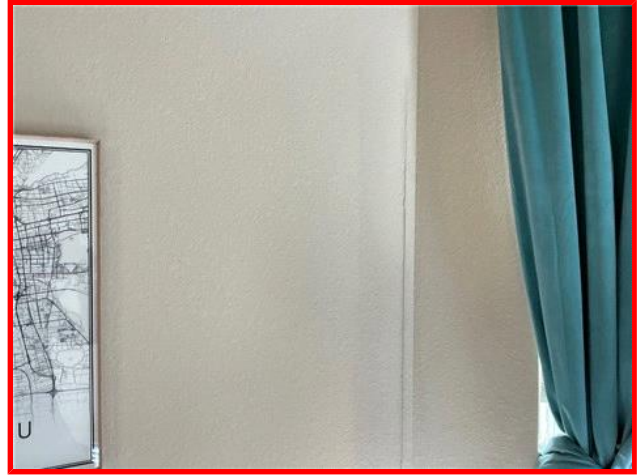
Seam Tape Failure in Primary

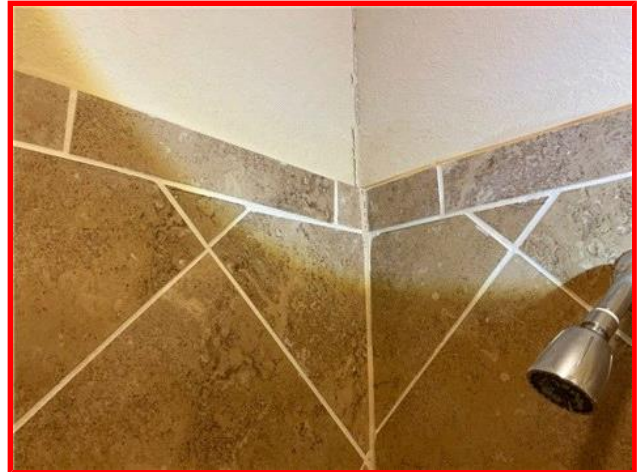
Separation / Corner Crack in Upstairs Bathroom

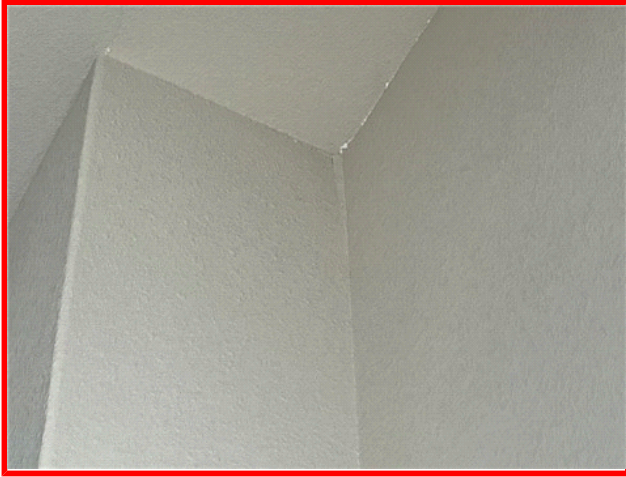
Seam Tape Failure in Downstairs Bedroom

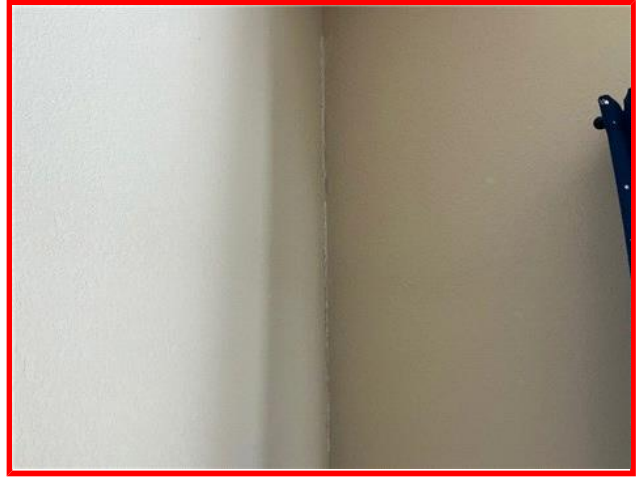
Separation in Downstairs Bedroom

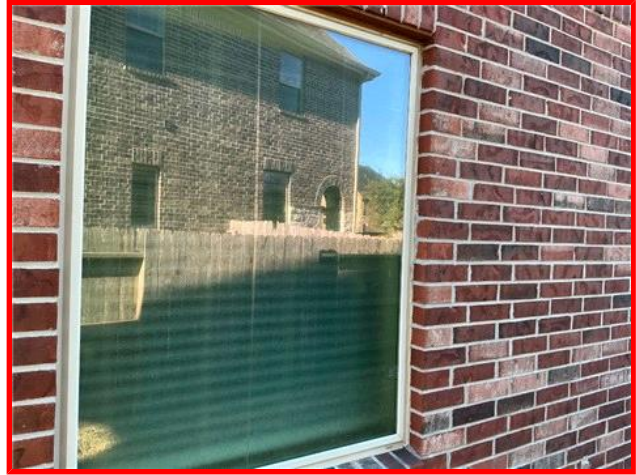
Failed Thermal Seal at Primary Bedroom

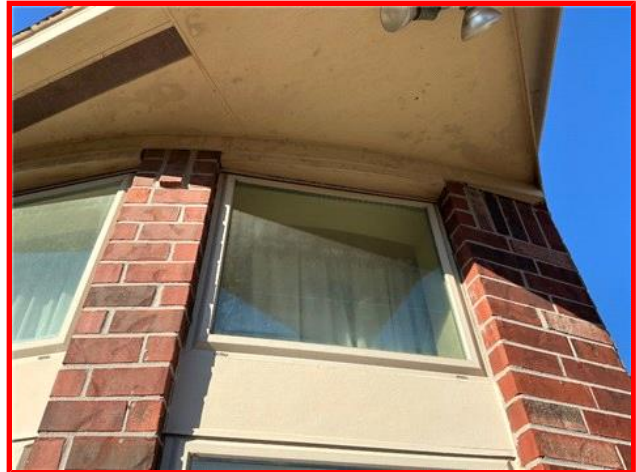
Failed Thermal Seal at Primary Bedroom

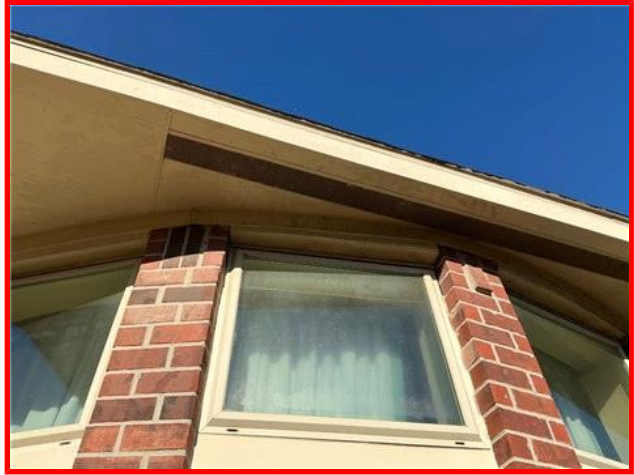
Failed Thermal Seal at Primary Bedroom

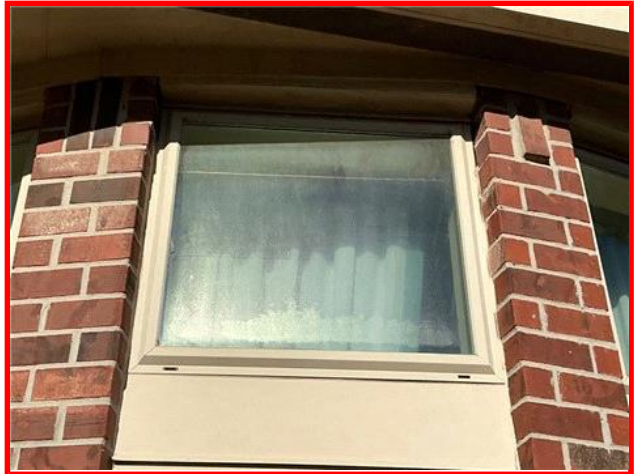
Failed Thermal Seal at Bedroom

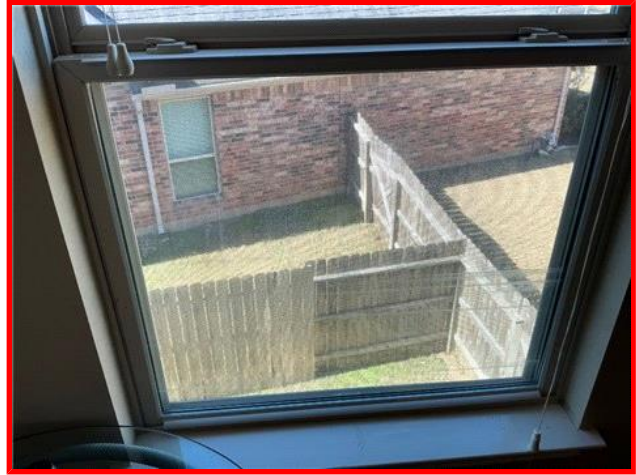
Failed Thermal Seal at Upstairs Rear Bedroom

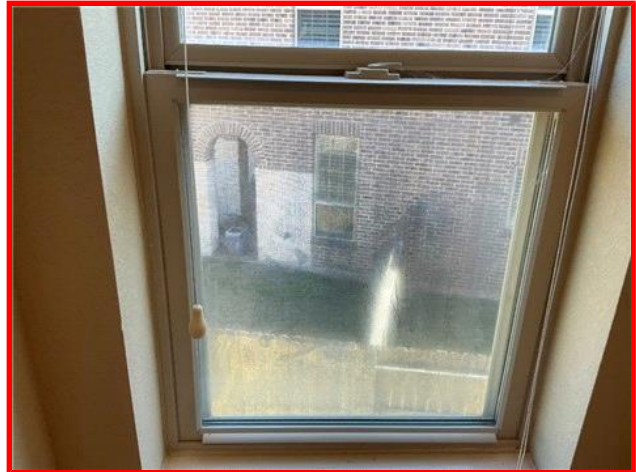
Failed Thermal Seal at Jack & Jill Bathroom

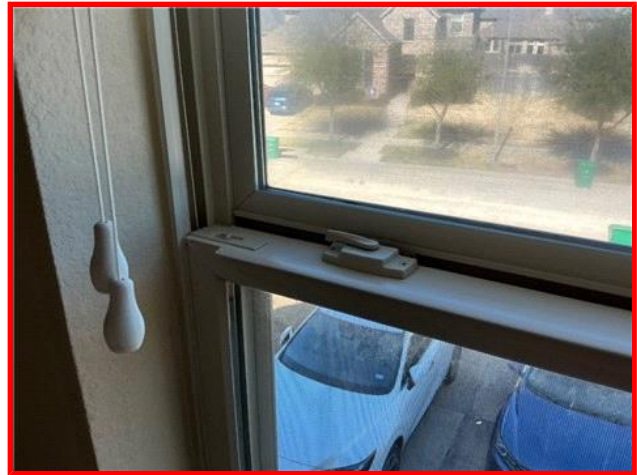
Failed Thermal Seal at Game Room - Window Difficult to Close

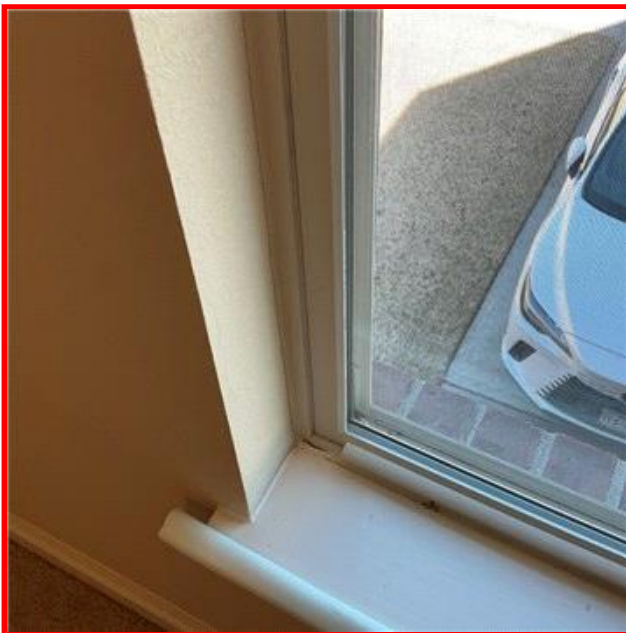
Crack in Window Framing at Upstairs Front

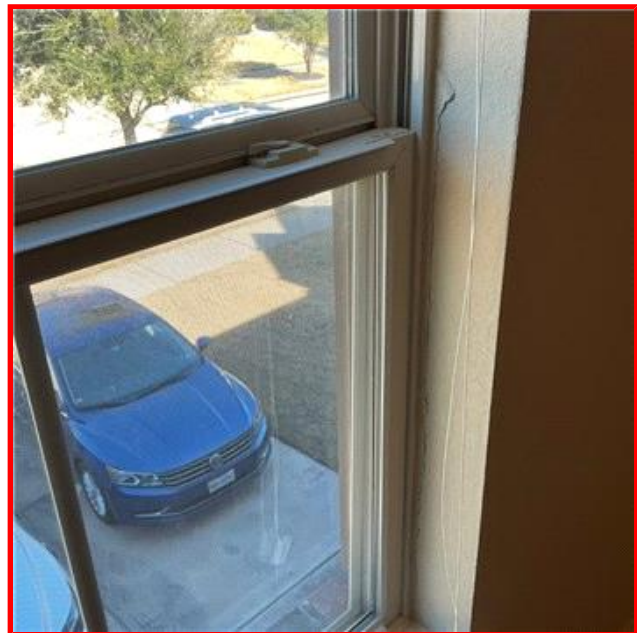
Window Framing Separation / Crack at Upstairs Front Bedroom

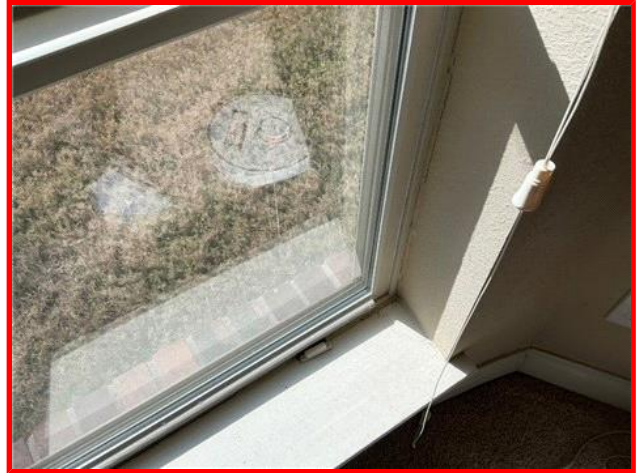
Separation around Window in Primary Bedroom

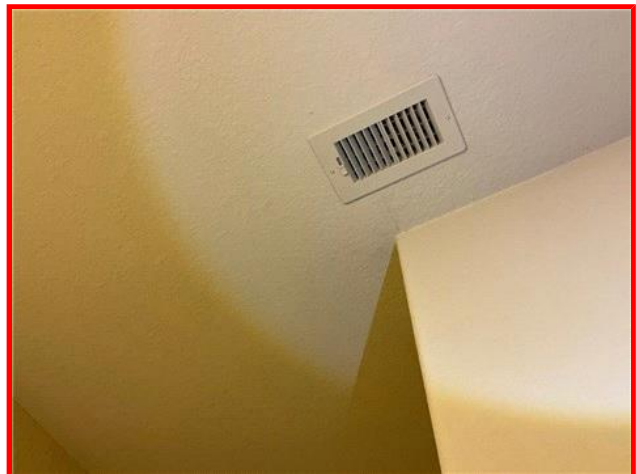
Crack in Ceiling in Upstairs Bathroom

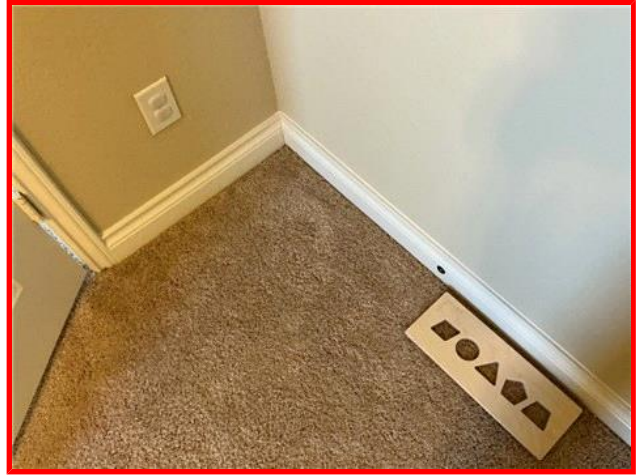
Missing Doorstop in Upstairs Front Room

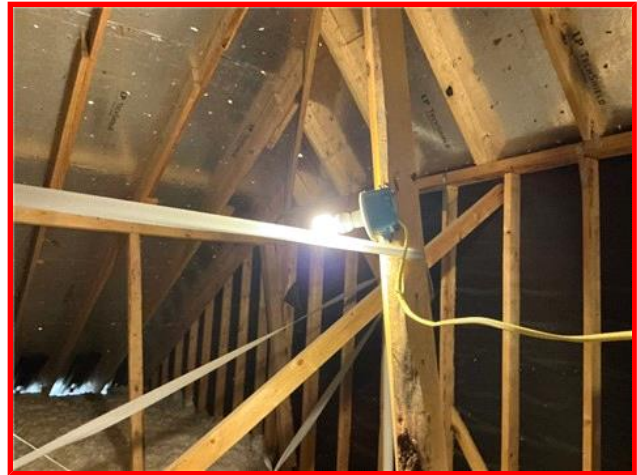
Attic Light Missing Cover

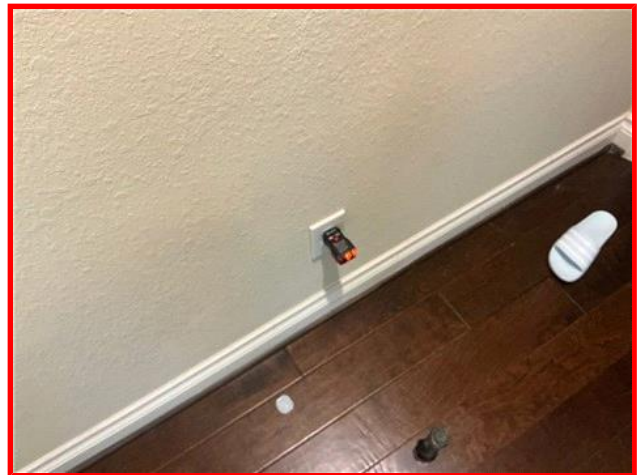
Loose Outlet in Primary Bedroom

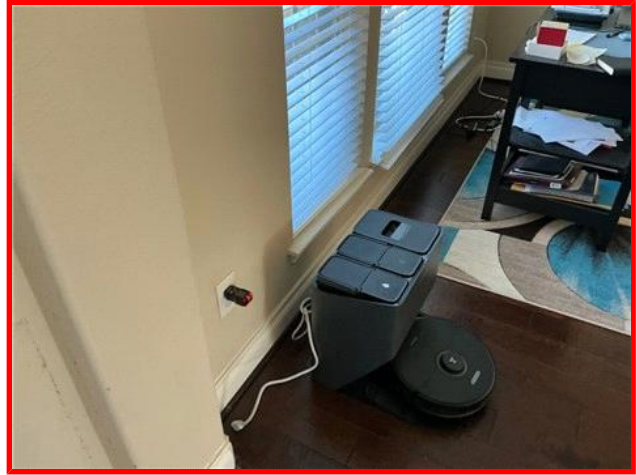
Loose Outlet in Office

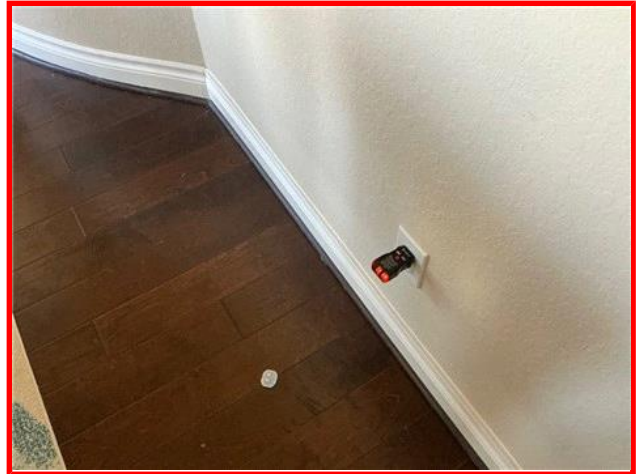
Loose Outlet in Dining Room

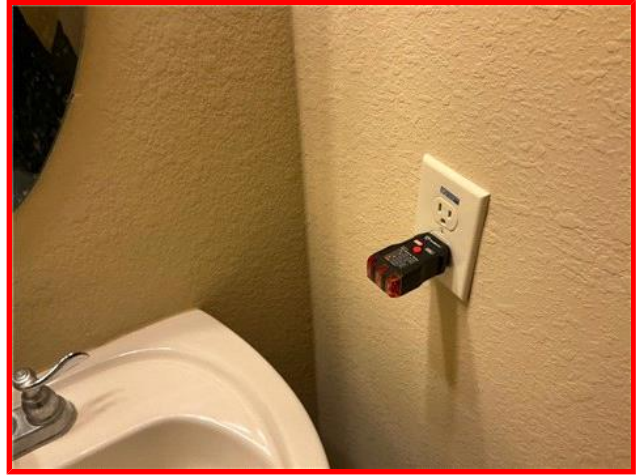
Loose Outlet in Half Bathroom

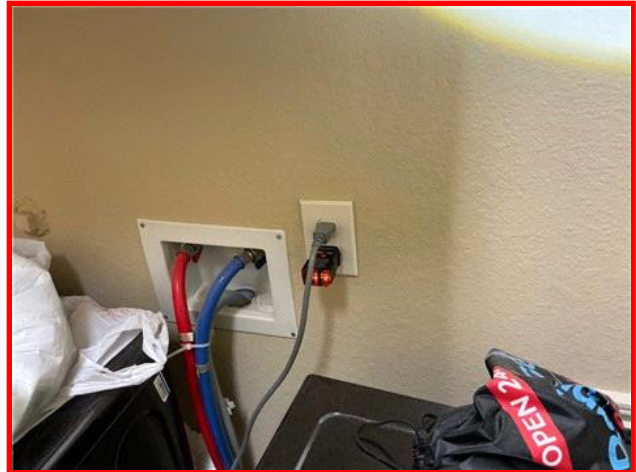
Missing GFCI Protection in Laundry Room

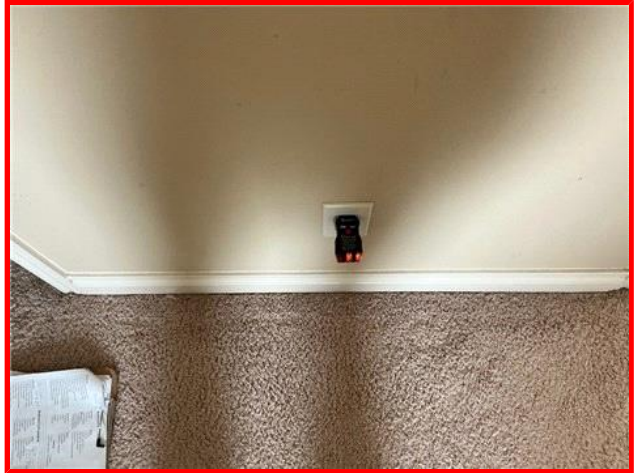
Loose Outlet in Downstairs Bedroom

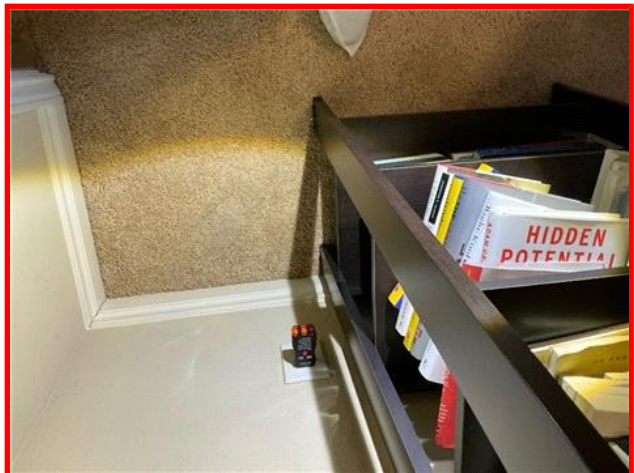
Loose Outlet at Upstairs Front Left

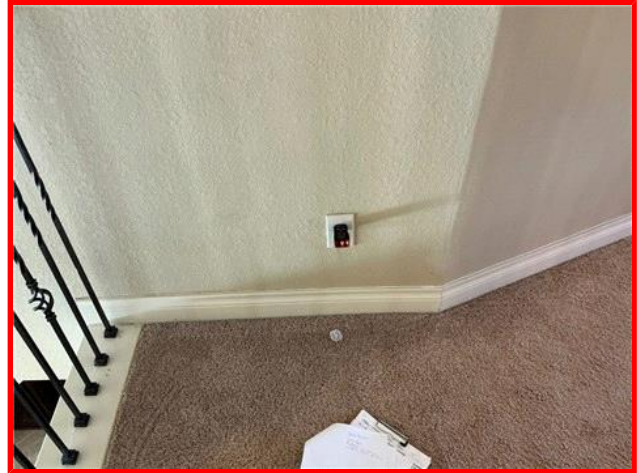
Loose Outlet in Upstairs Hall

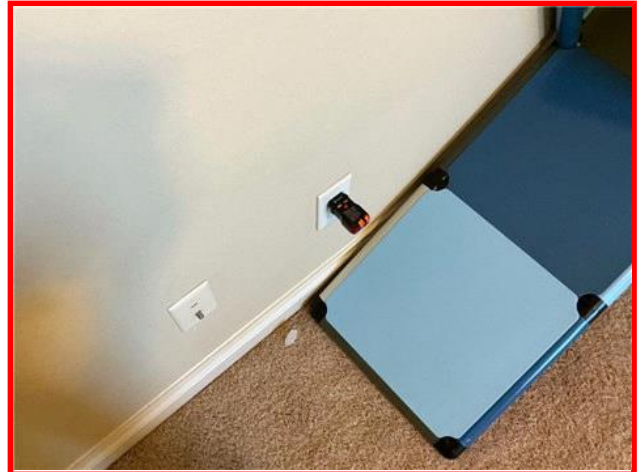
Loose Outlet in Upstairs Front Bedroom

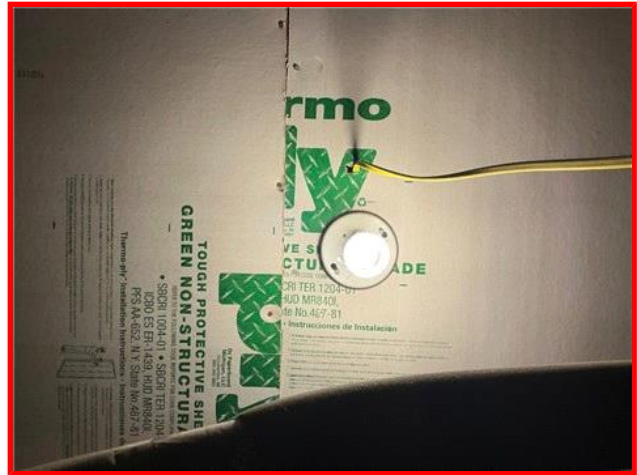
Missing Cover at Attic Light

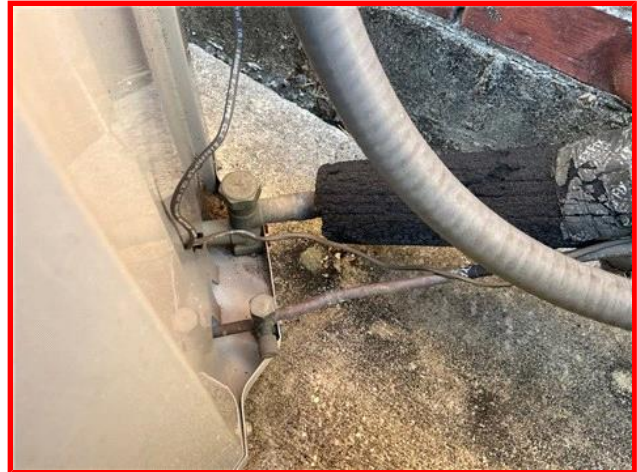
Deteriorated Refrigerant Line Insulation

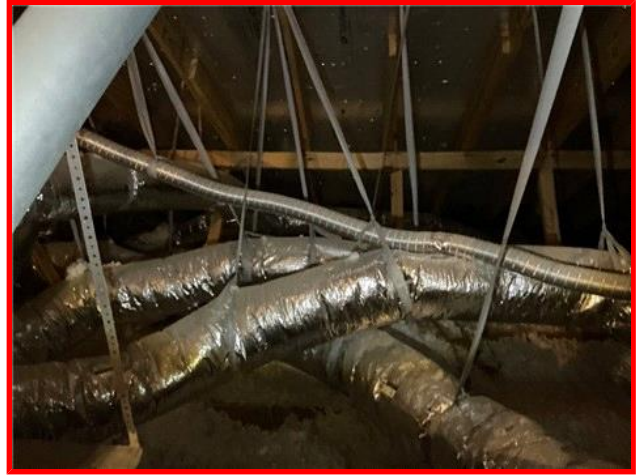
Exhaust Vent Pipes in Contact with Ducts

| Section | Remarks |
|---|--|
| HVAC Systems | Duct System, Chases, and Vents Problem: Ducts are improperly touching / in contact in the attic. An exhaust vent is improperly laying on the ducts. Corrective Action: Contractor to provide proper clearance between the ducts and exhaust vent. |

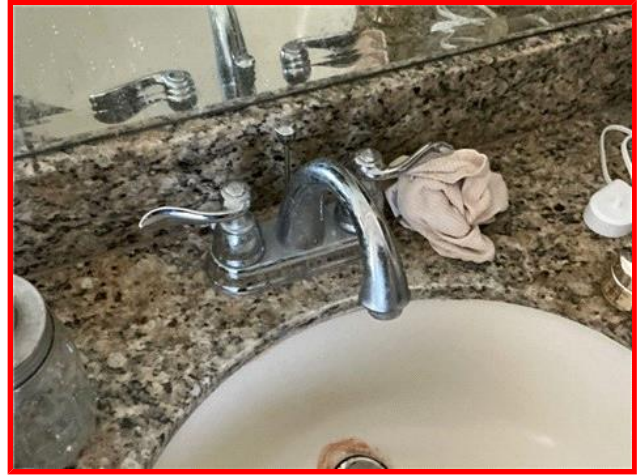
Loose Handle at Primary Bathroom Sink

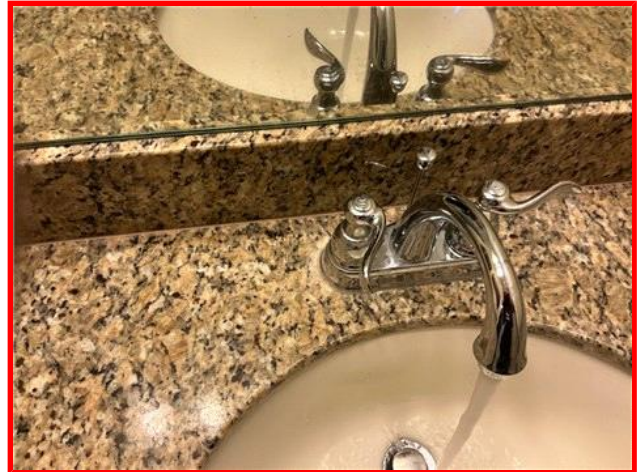
Loose Handle at Jack & Jill Bathroom Sink

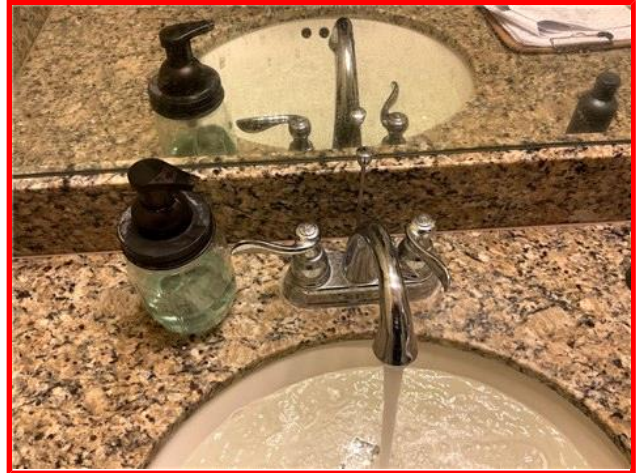
Loose Handle at Jack & Jill Bathroom Sink

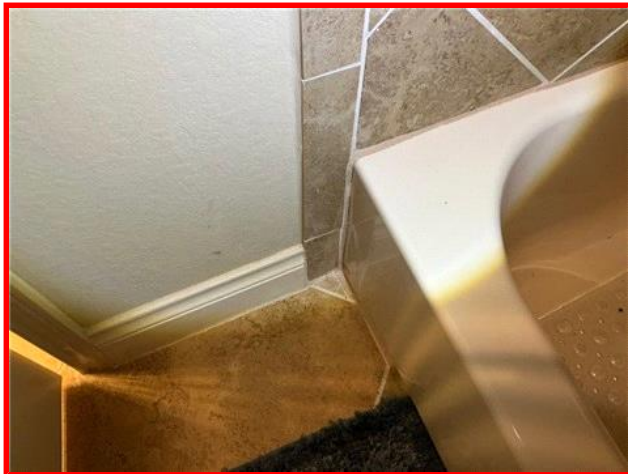
Deteriorated Caulk in Jack & Jill Bathroom

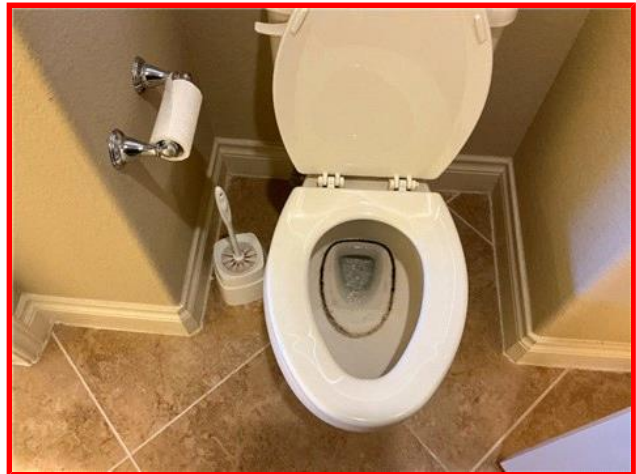
Toilet Seat Loose in Jack and Jill Bathroom

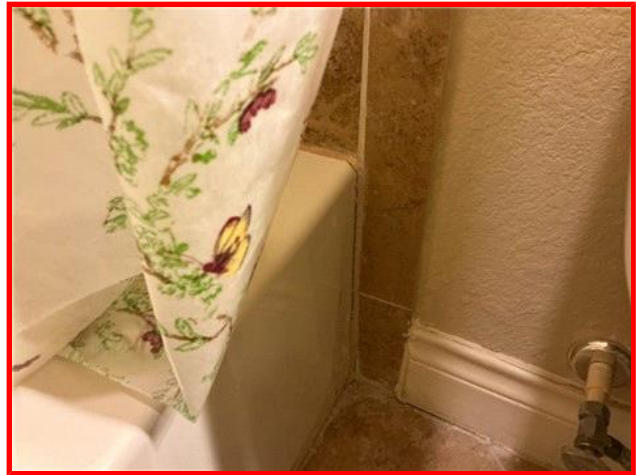
Deteriorated Caulk

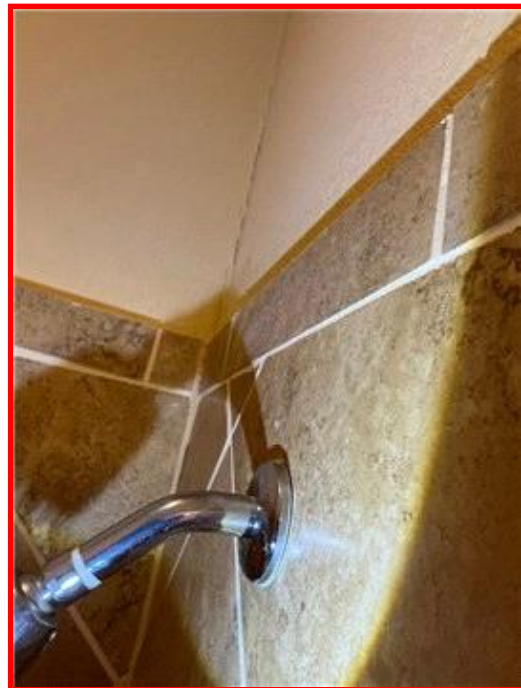
Caulk Missing around Shower Head in Upstairs Bathroom

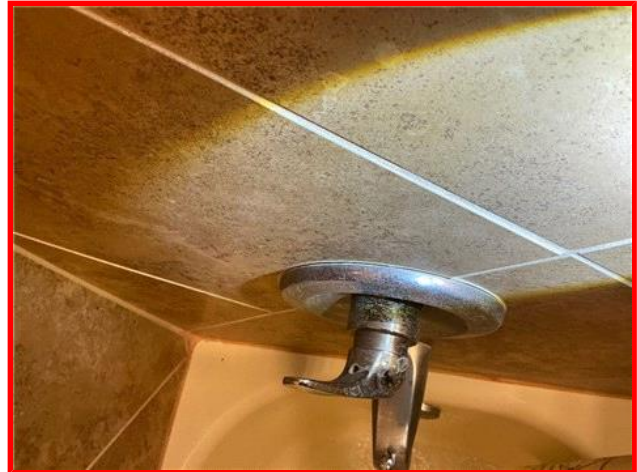
Missing Caulk at Tub Faucet

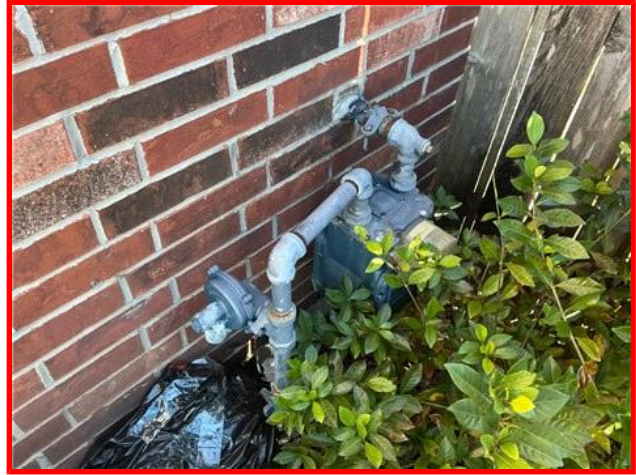
Missing Sleeve and Vegetation in Contact with Gas Meter

| Section | Remarks |
|---|--|
| | Gas Distribution Systems and Gas Appliances Problem: Inadequate clearance was observed around the gas meter (vegetation in contact). The gas meter line is missing a sleeve at the exterior. Corrective Action: Qualified contractor to eliminate the vegetation and install a sleeve. |

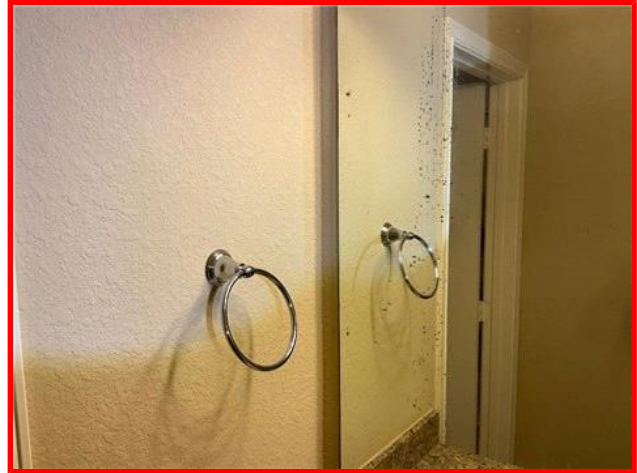
Mirror Damaged in Jack and Jill Bathroom

| Section | Remarks |
|---|--|
| | Other Problem: The mirror in the Jack and Jill bathroom is damaged. Corrective Action: Contractor to repair / replace the mirror as needed. |
