Date Inspected: 2/18/2026

3923 Birch Vale Ln

Inspection Type: Roof Inspection

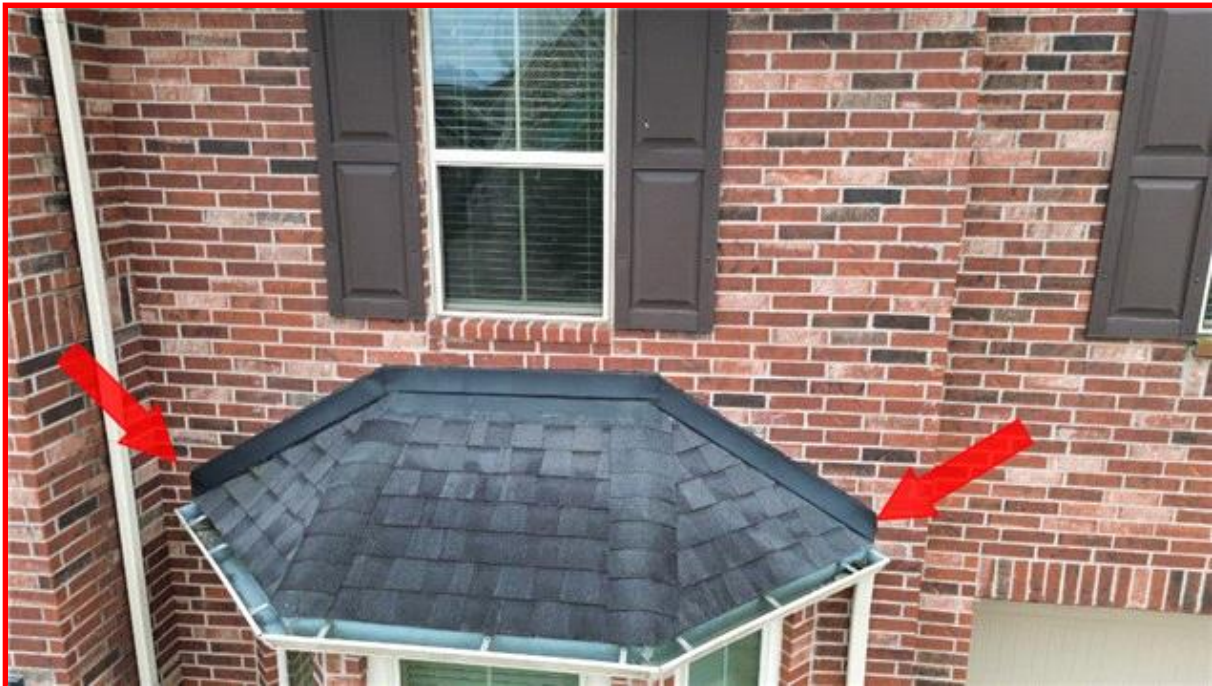
Kickout flashing is missing at the front bay window and raised flashing was observed at the chimney flue.

Kickout Flashing Missing at Front Bay Window

Qualified contractor to install kickout flashing at the front bay window and repair / secure the flashing at the chimney flue to prevent water intrusion.

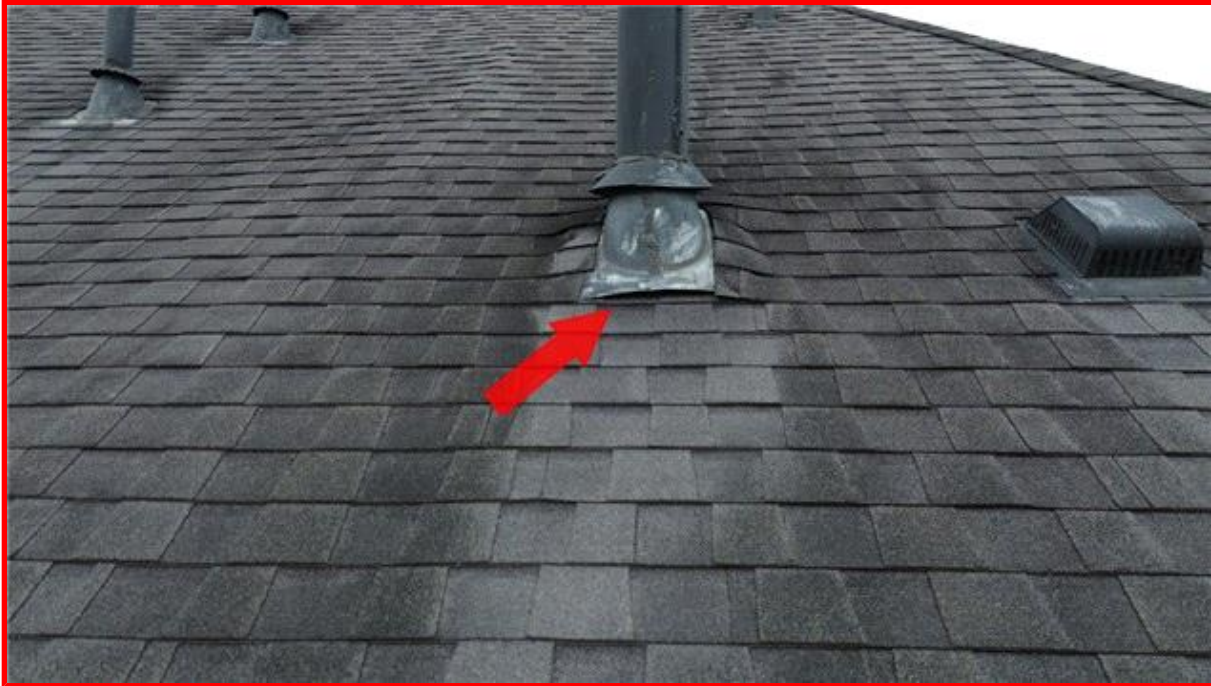
Raised Flashing at Chimney Flue

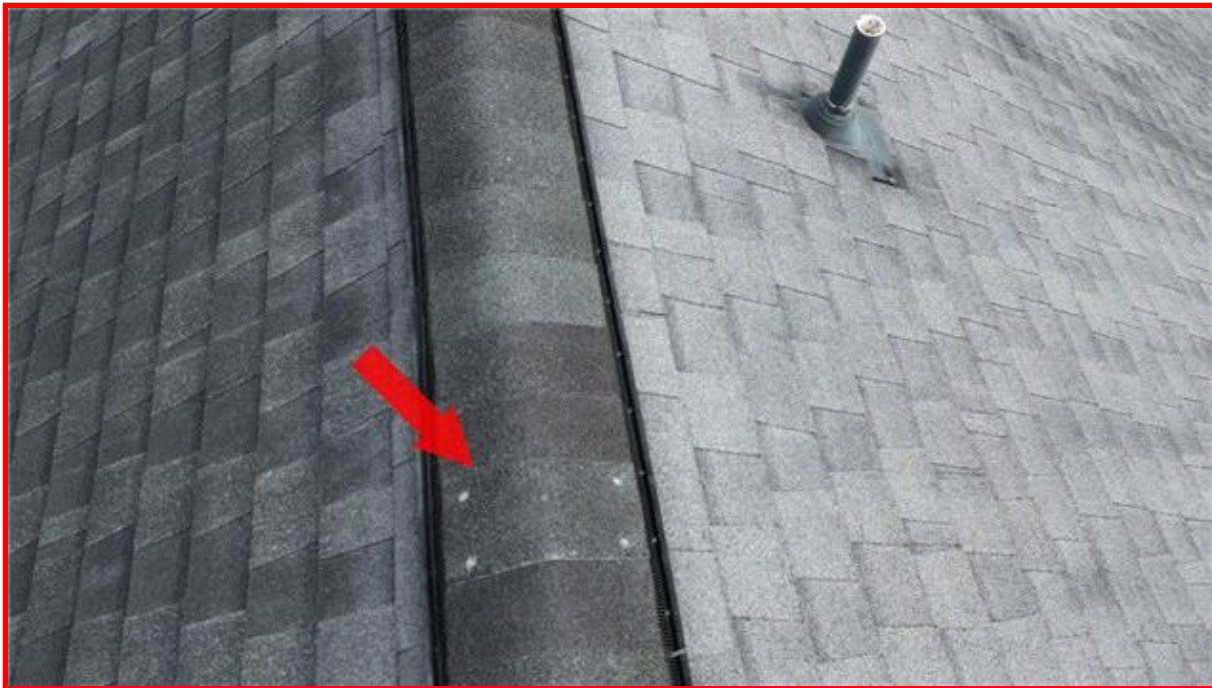
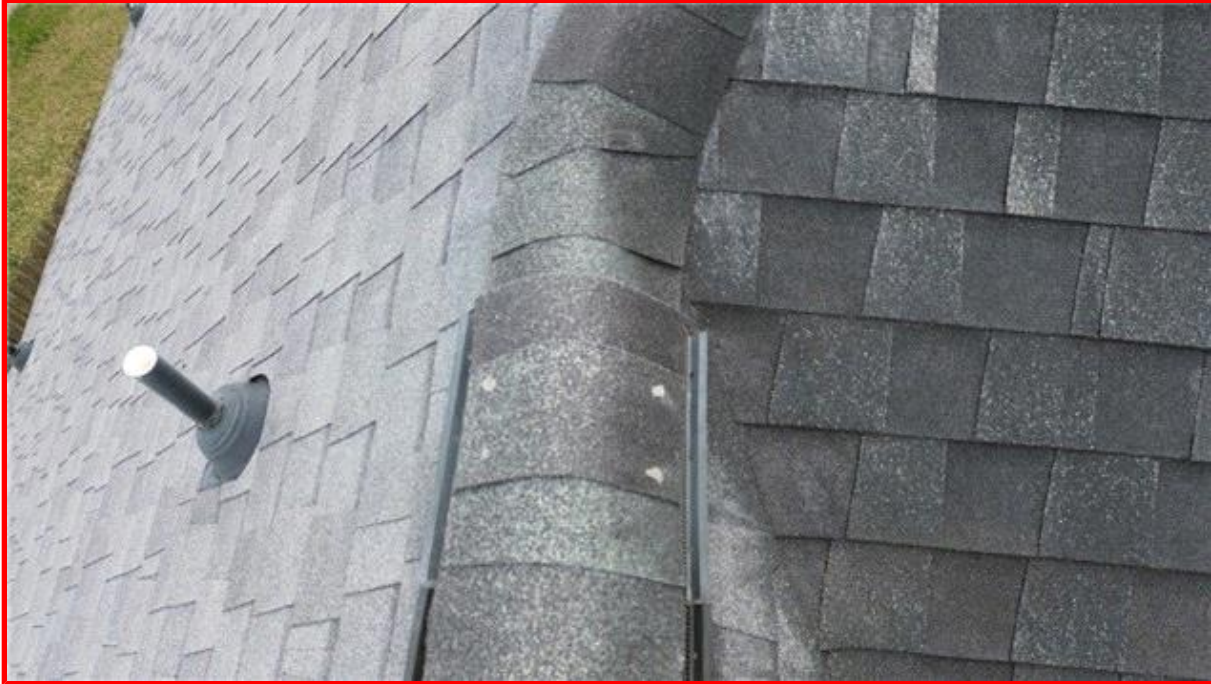
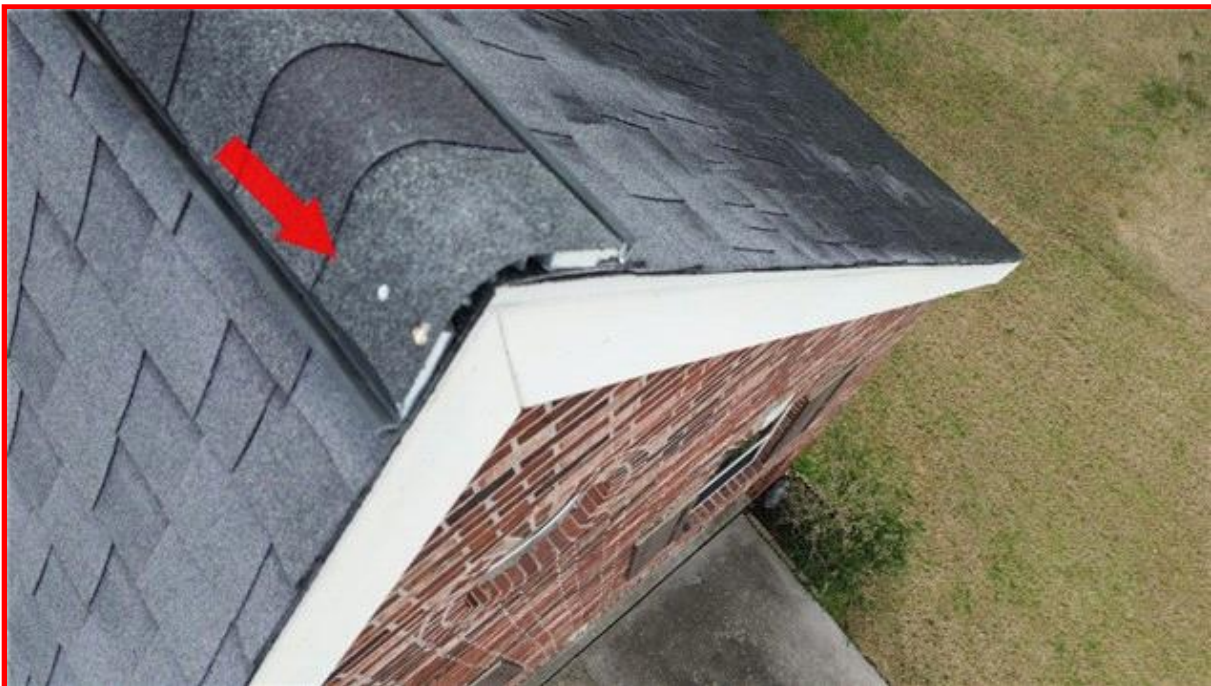
Exposed nail heads were observed on the roof ridge and vents/boots. Please note: Granule loss was observed at the roof surface; however, this is not affecting the function of the roof at this time. No warranty is expressed or implied as to the future condition or function of the roof system.

Exposed Nail Heads on Ridge

Corrective Action: Qualified contractor to repair / seal al exposed nail heads to prevent water intrusion.

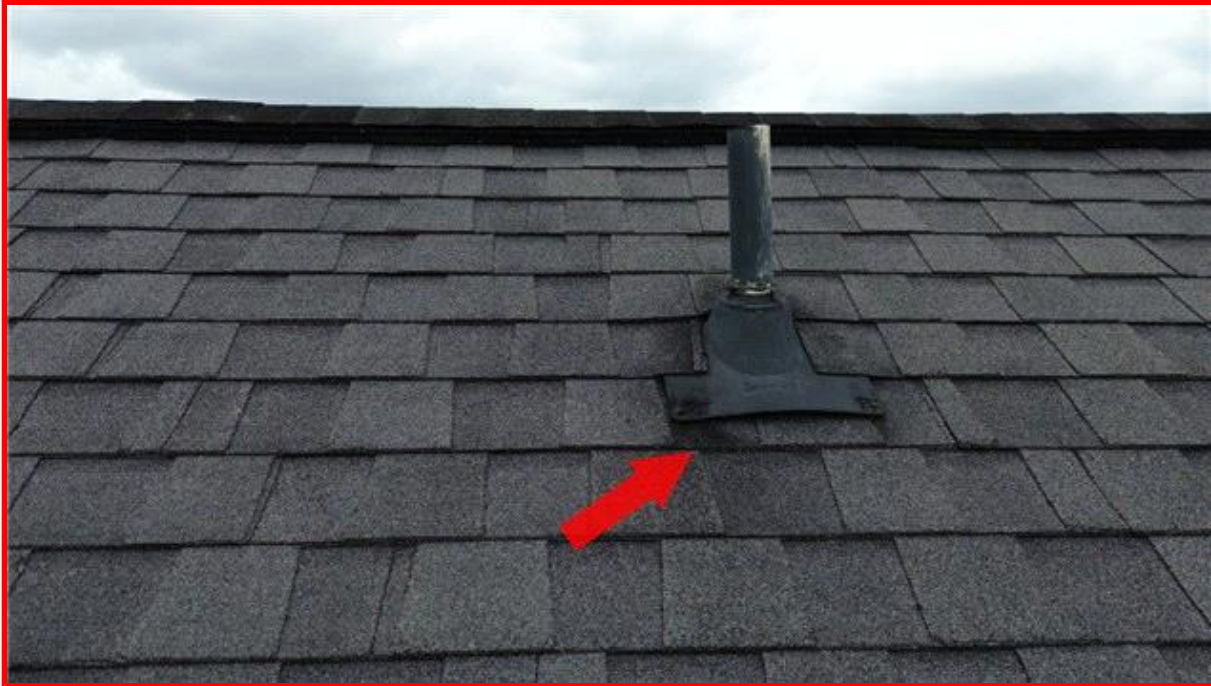
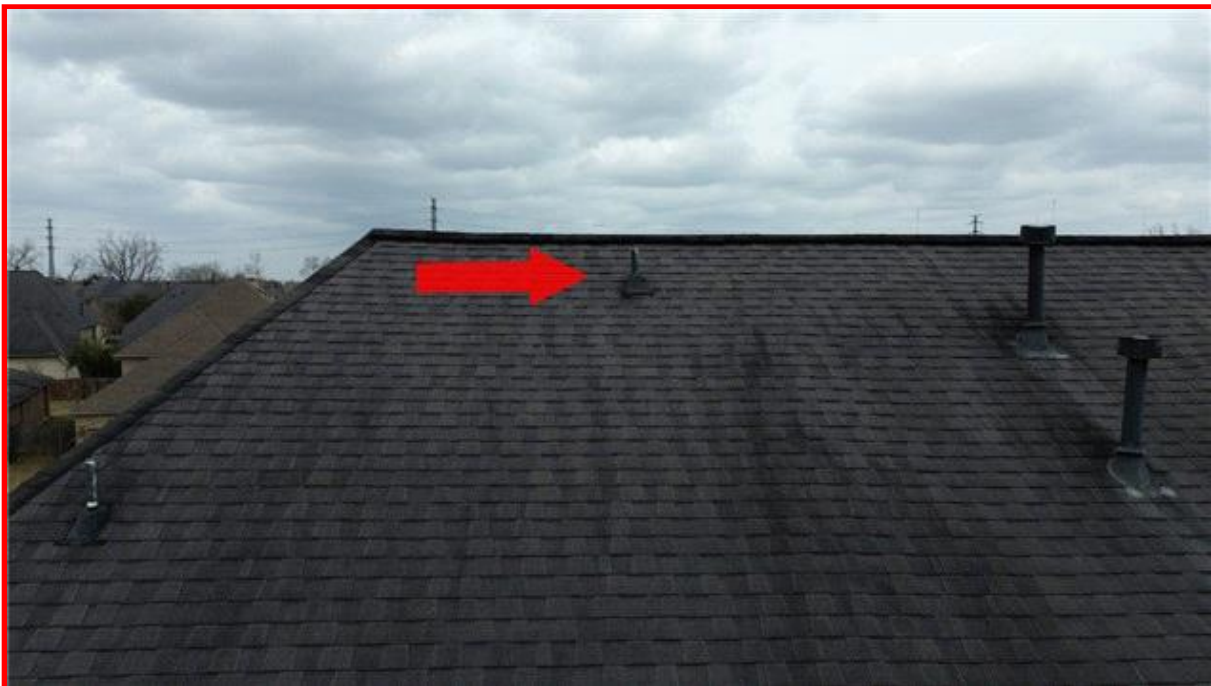
Remarks: The roof boot at the rear by the top ridge is loose. The plumbing vents are not sealed to the roof boots and the vents are not properly painted.
 Corrective Action: Qualified contractor to repair / secure the roof boot at the rear, re-seal all plumbing vents to the roof boots to prevent water intrusion, and re-paint the vents to prevent rust damage.

Loose Boot at the Rear By Top Ridge

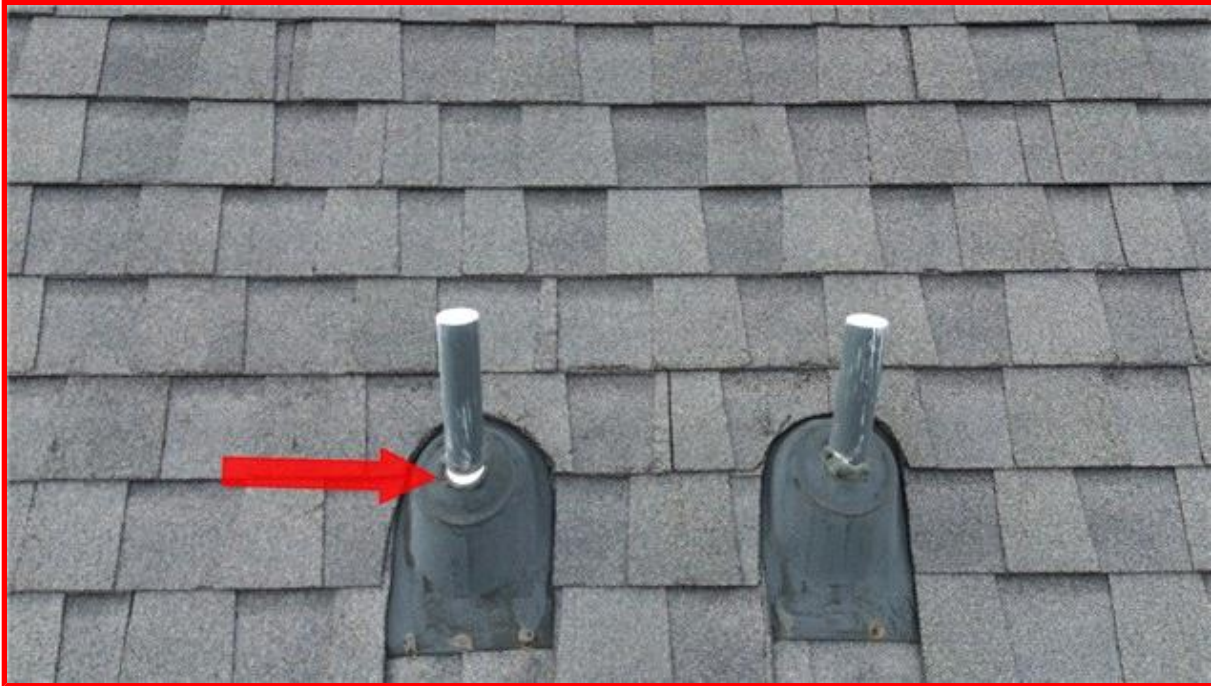
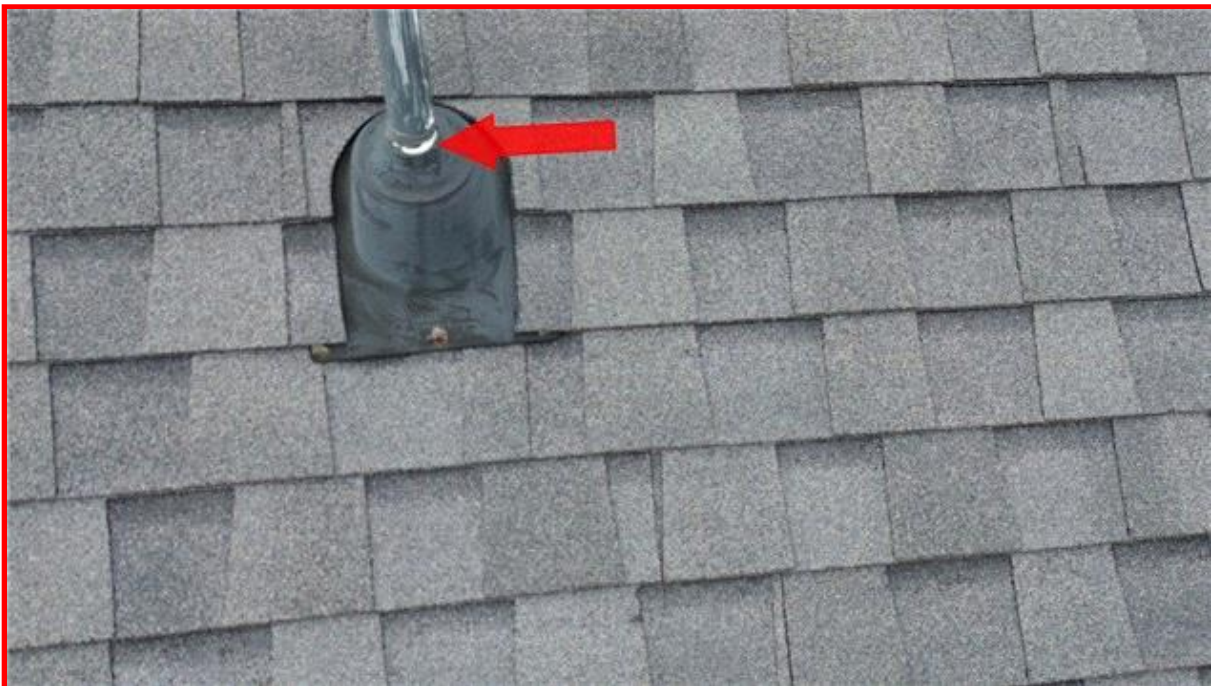
Plumbing Vent not Sealed to Roof Boot

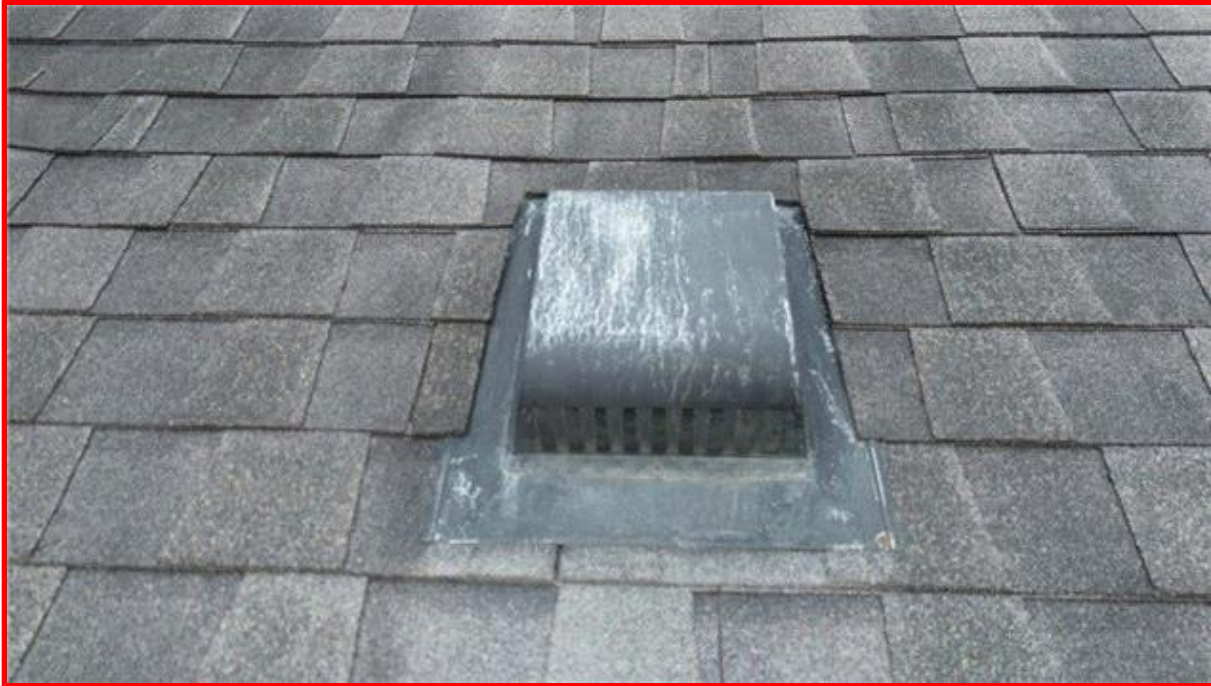
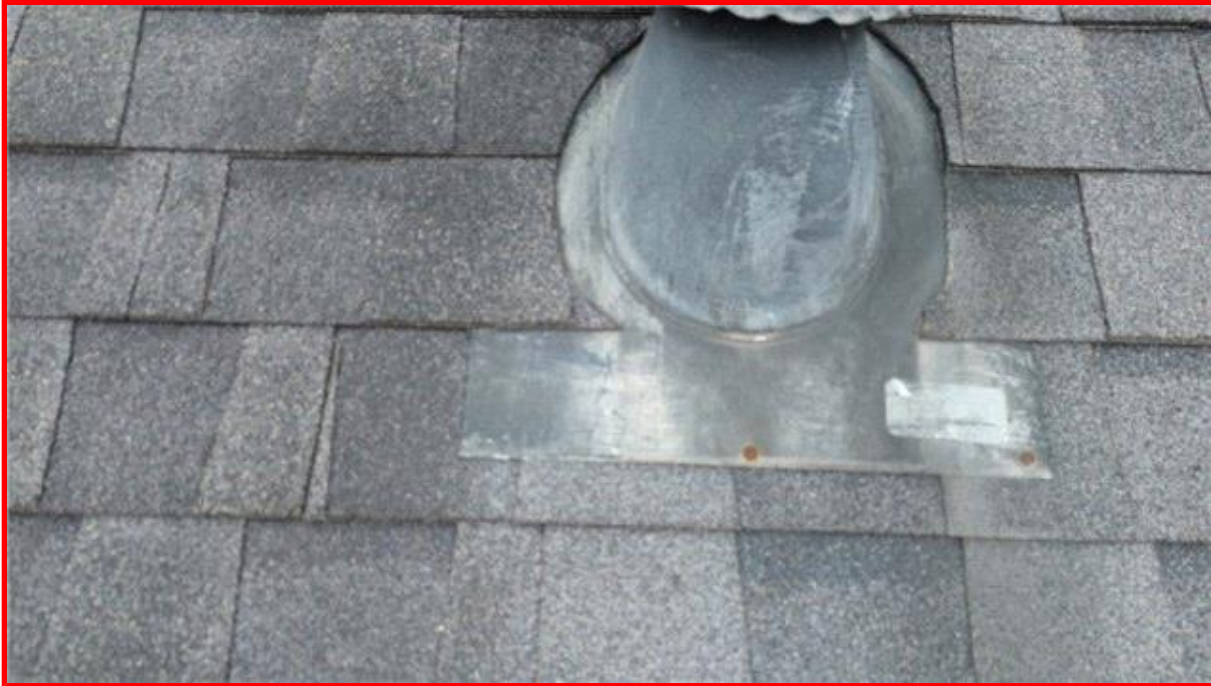
Vent not Properly Painted

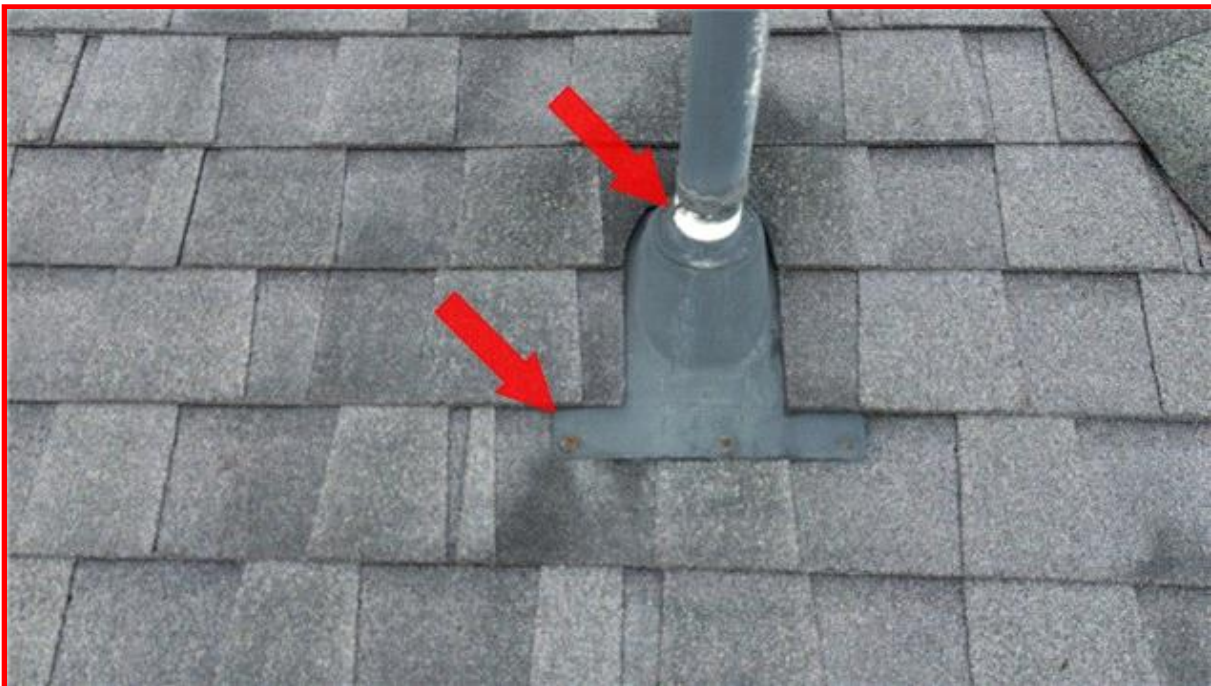
Plumbing Vent not Sealed to Roof Boot / Exposed Nail Heads

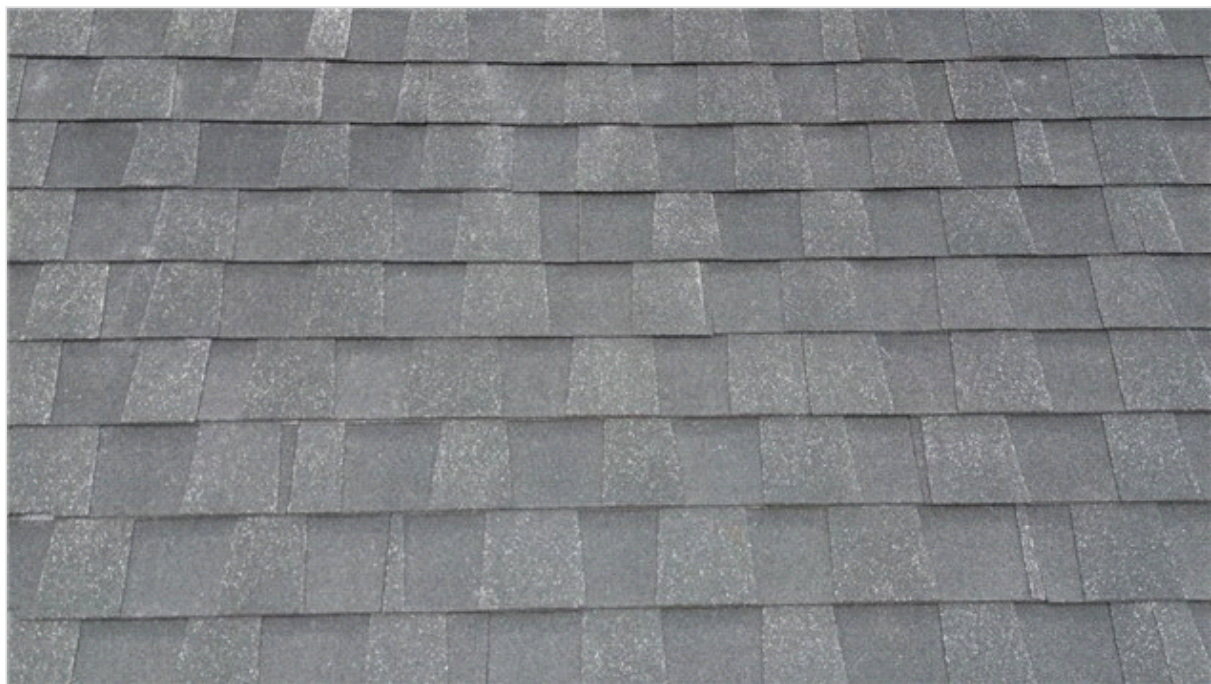
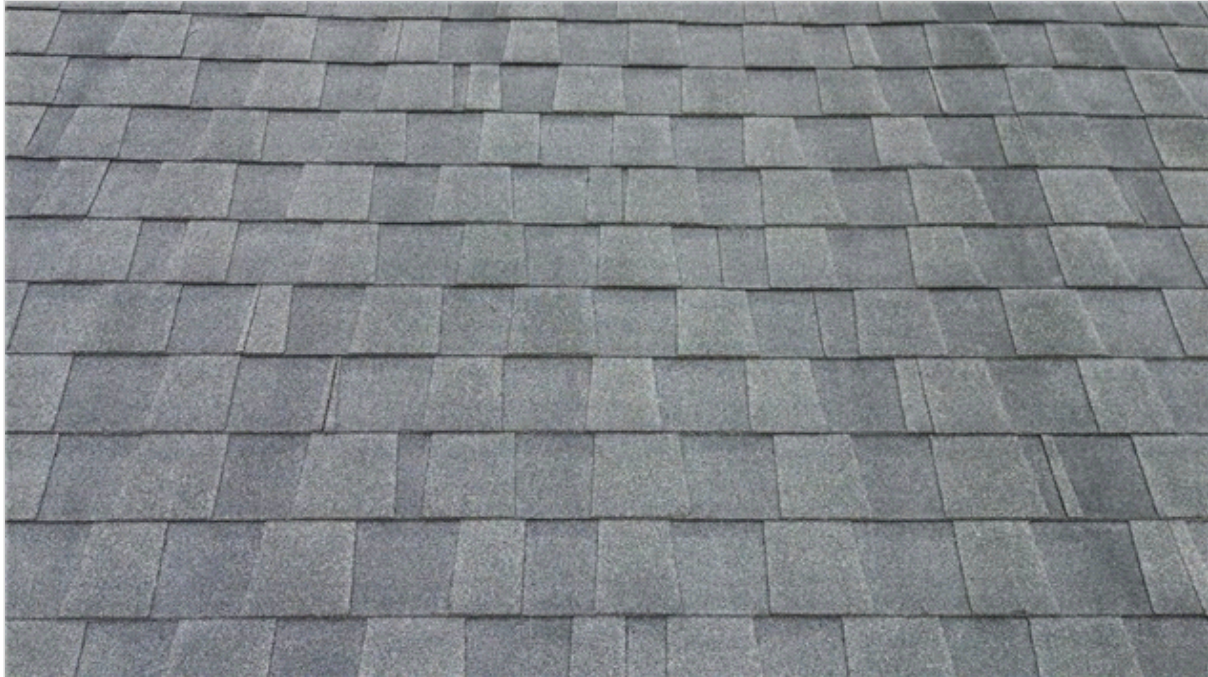
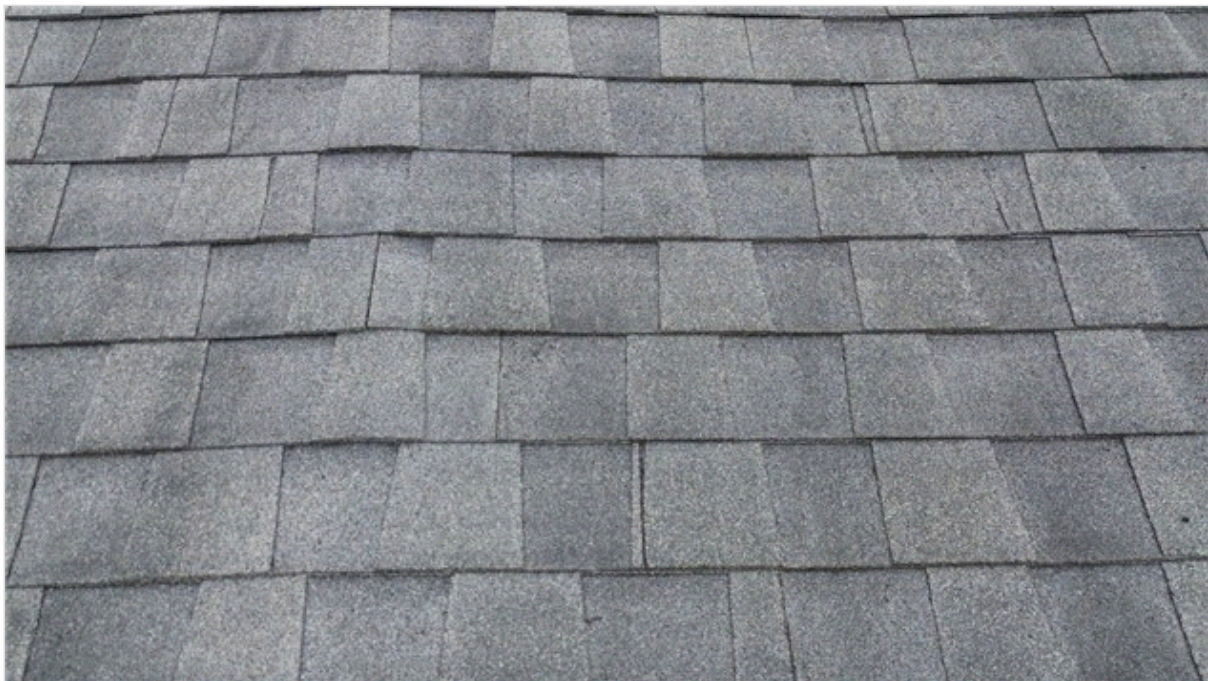
Granular Loss at Roof
