2713 Druid Street

Houston, Texas 77091

Client	--
Reference id	a4xPd000001zEwjIAE
Type	Home Inspection and Floor Plan Report - 2713 Druid Street
Inspected by	Rio Bravo - Inspectify Pro - Houston
State license	TREC 22388
InterNACHI	17031522
Scheduled	April 17, 2025, 5:00 PM
Completed	April 17, 2025, 5:39 PM

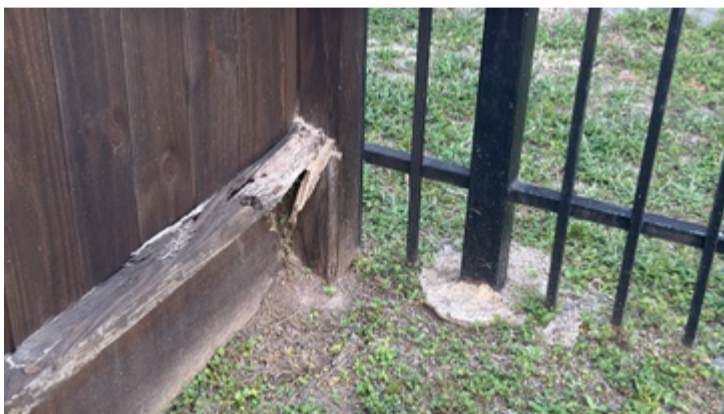
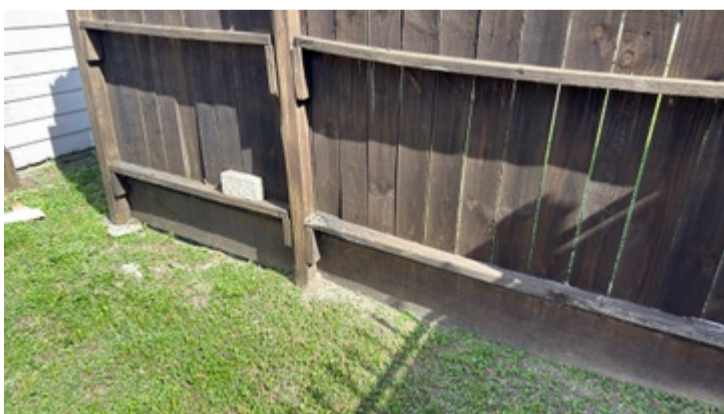
Damaged / Missing Fence Boards

One or more fence boards are missing or damaged.

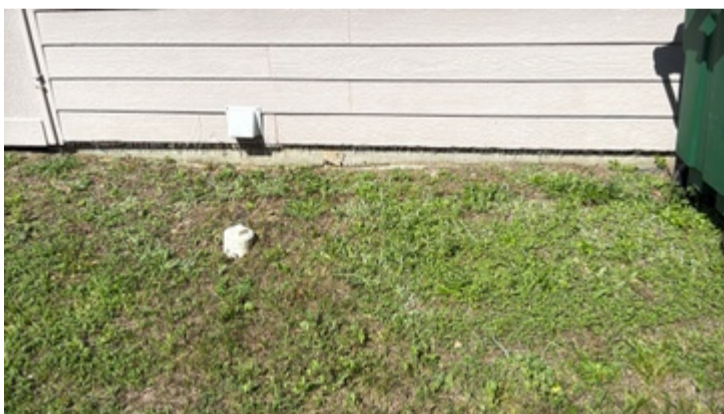
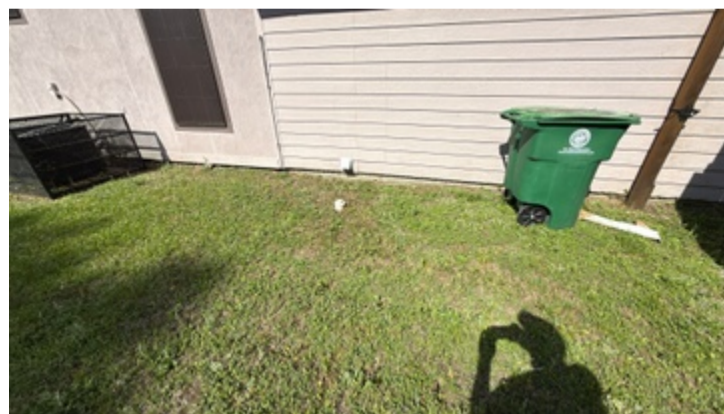
Eroding / Ponding Soil

Eroding / ponding soil is present on one or more areas of the property.

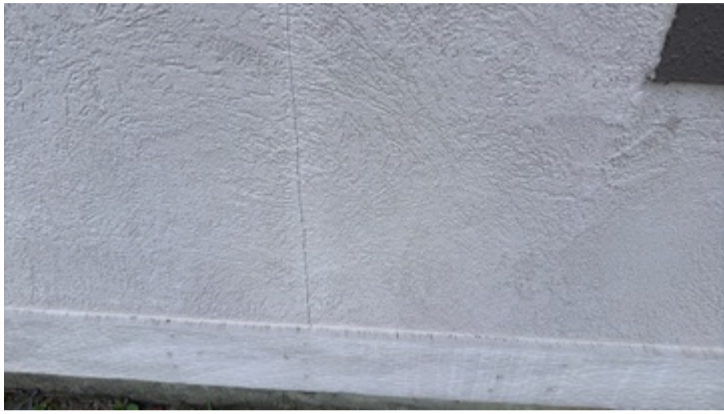
Cracked / Damaged Stucco

The exterior stucco is showing signs of cracking or damage.

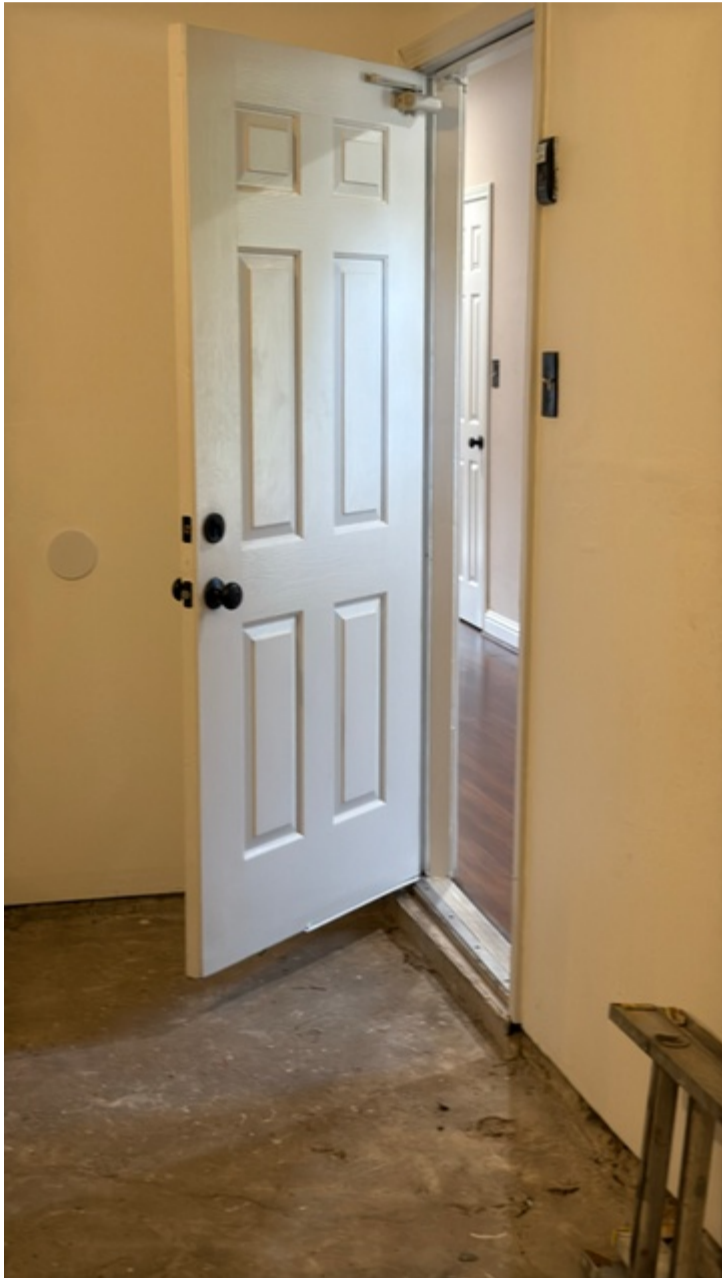
Missing / Inoperable Self-Closing Door Hinges

The self-closing door hinges are missing / inoperable.

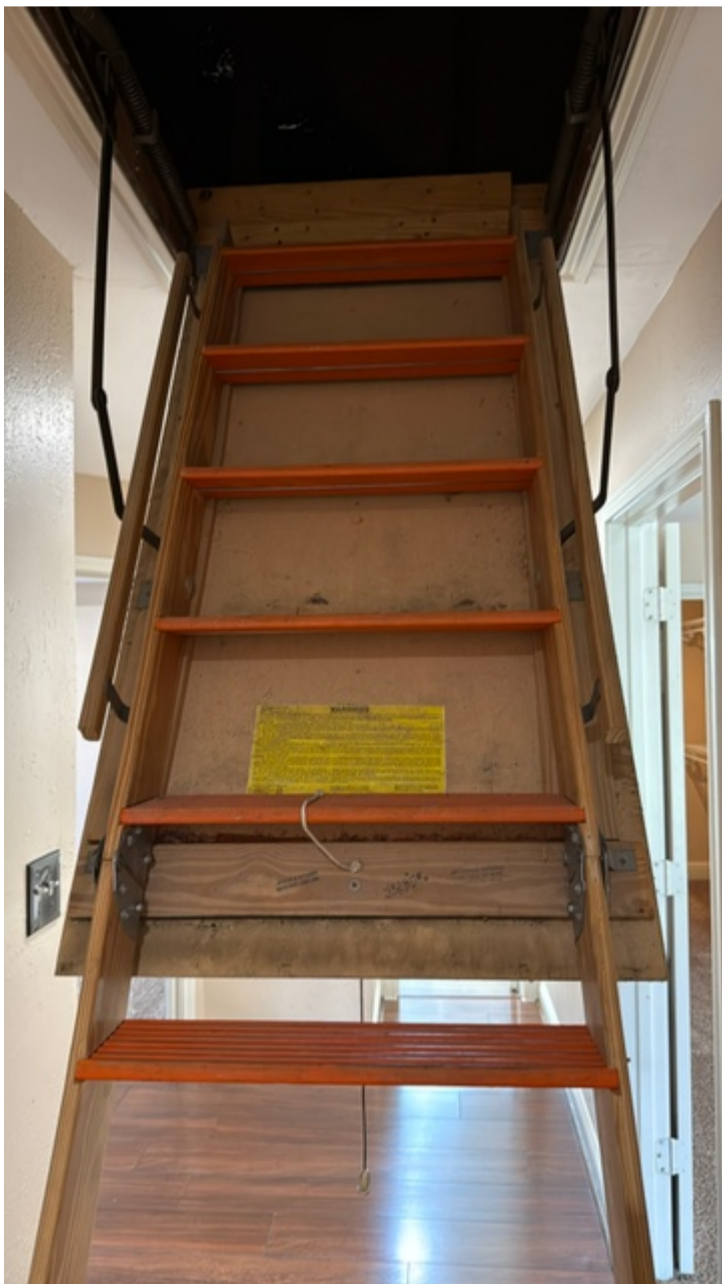
The attic pull-down stairs are not insulated.

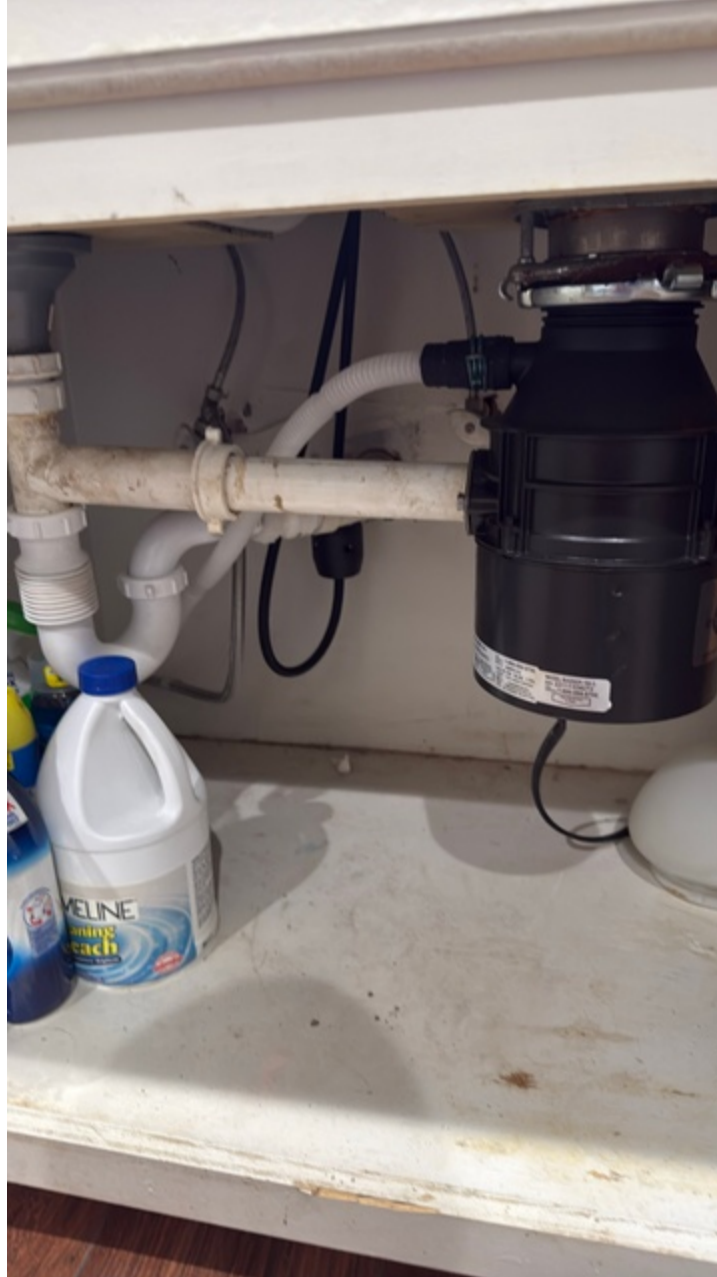
Missing Dishwasher High Loop

The dishwasher plumbing is missing a high loop.

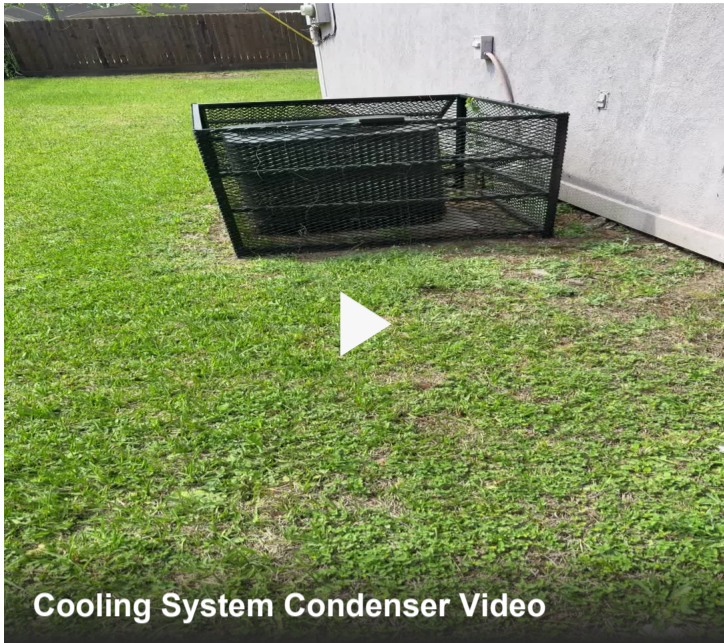
Rusting or Damaged HVAC Drip Pan

The drip pan below the air conditioning unit is rusting or damaged.

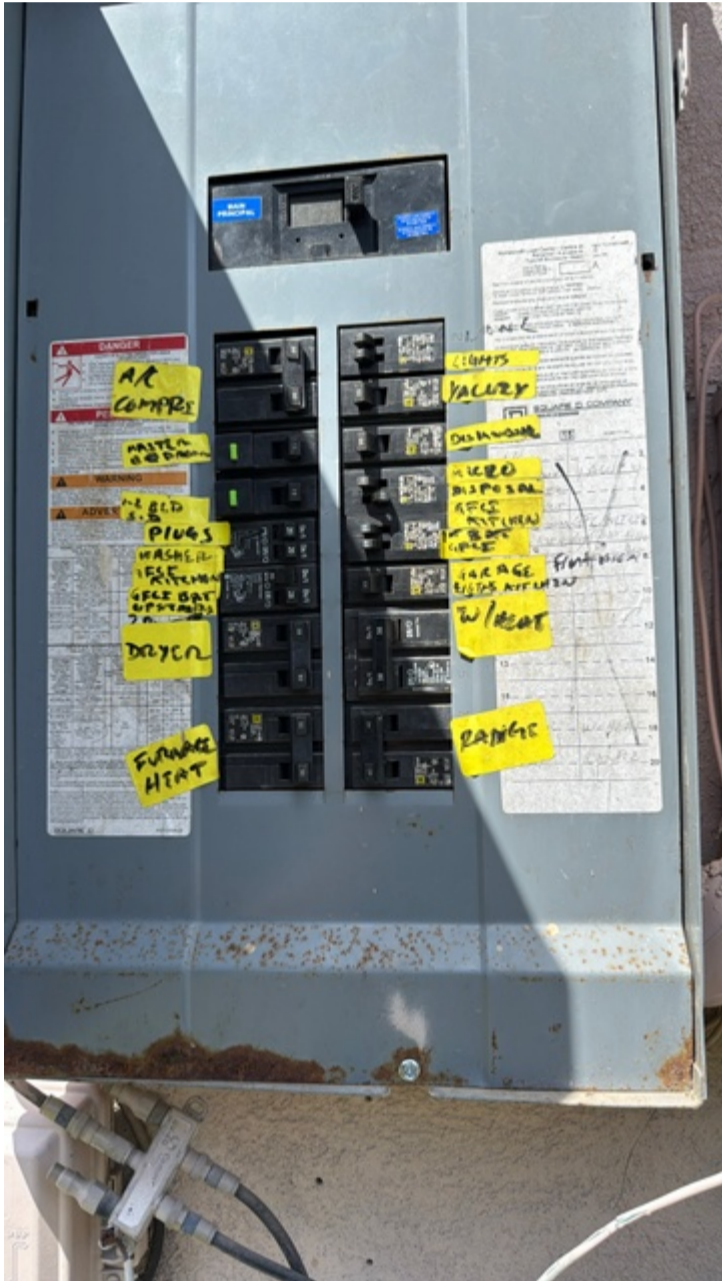
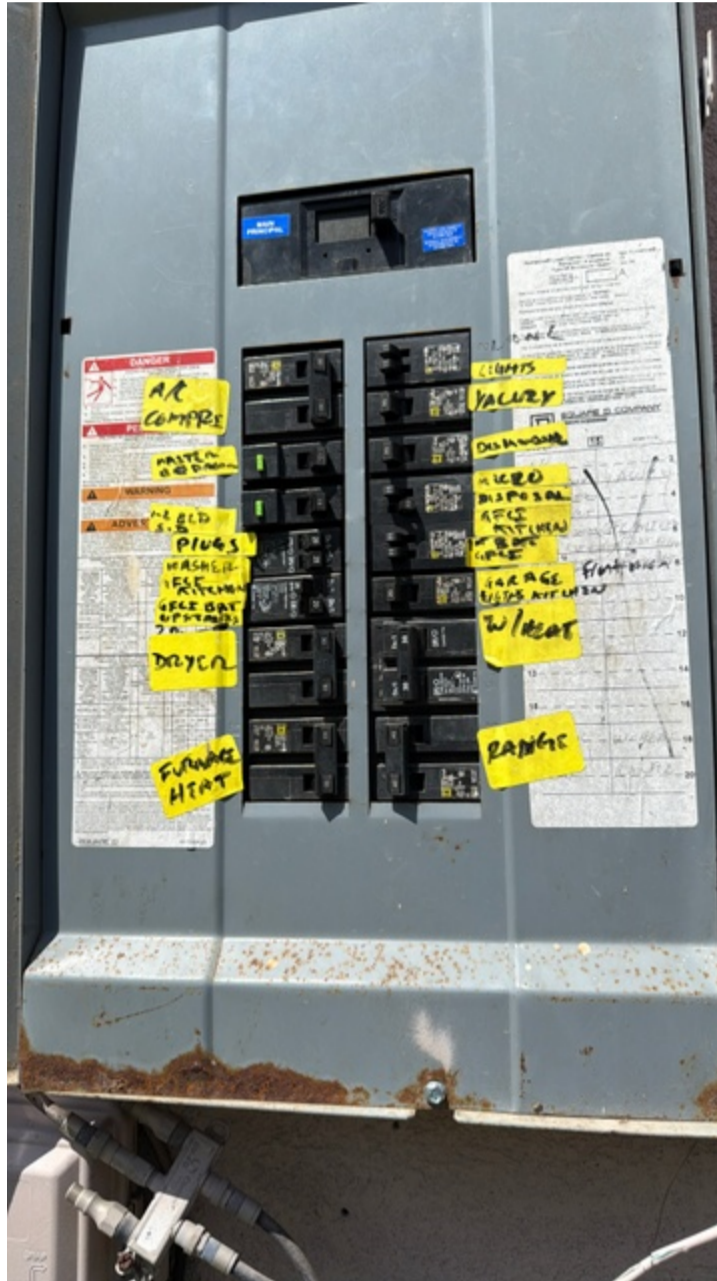
Missing Surge Protection

There is no whole-house surge protection installed.

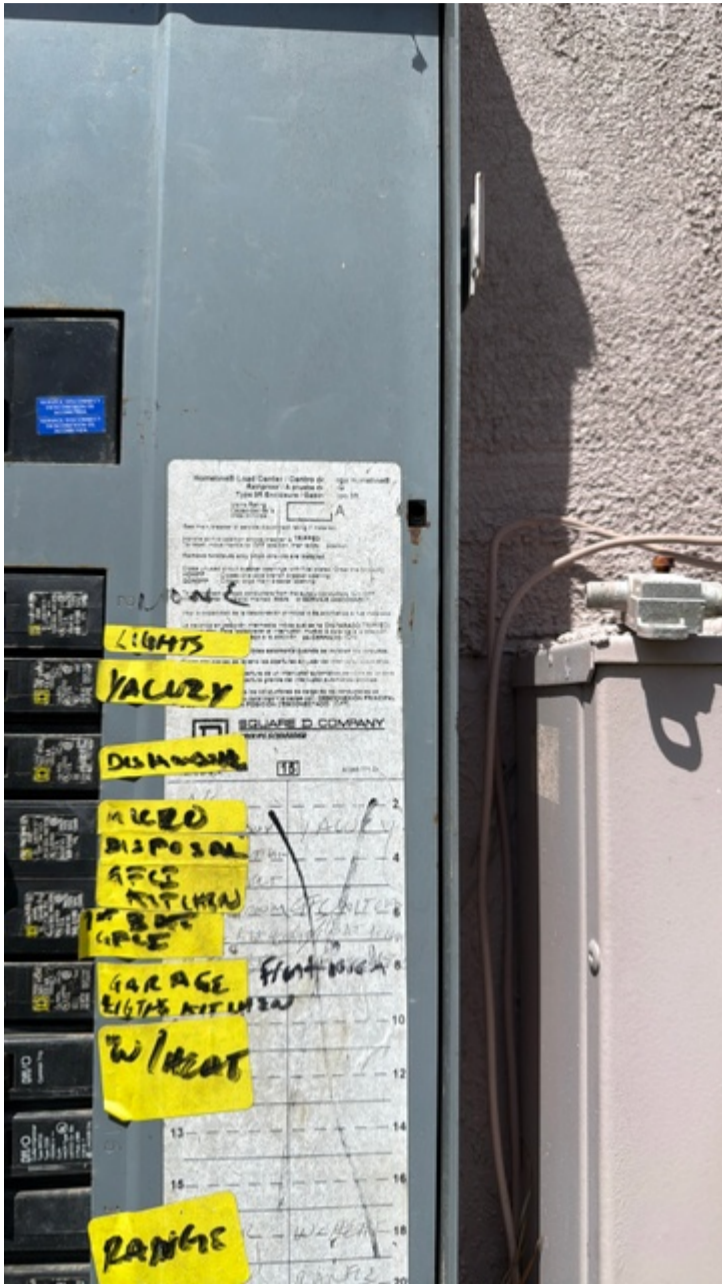
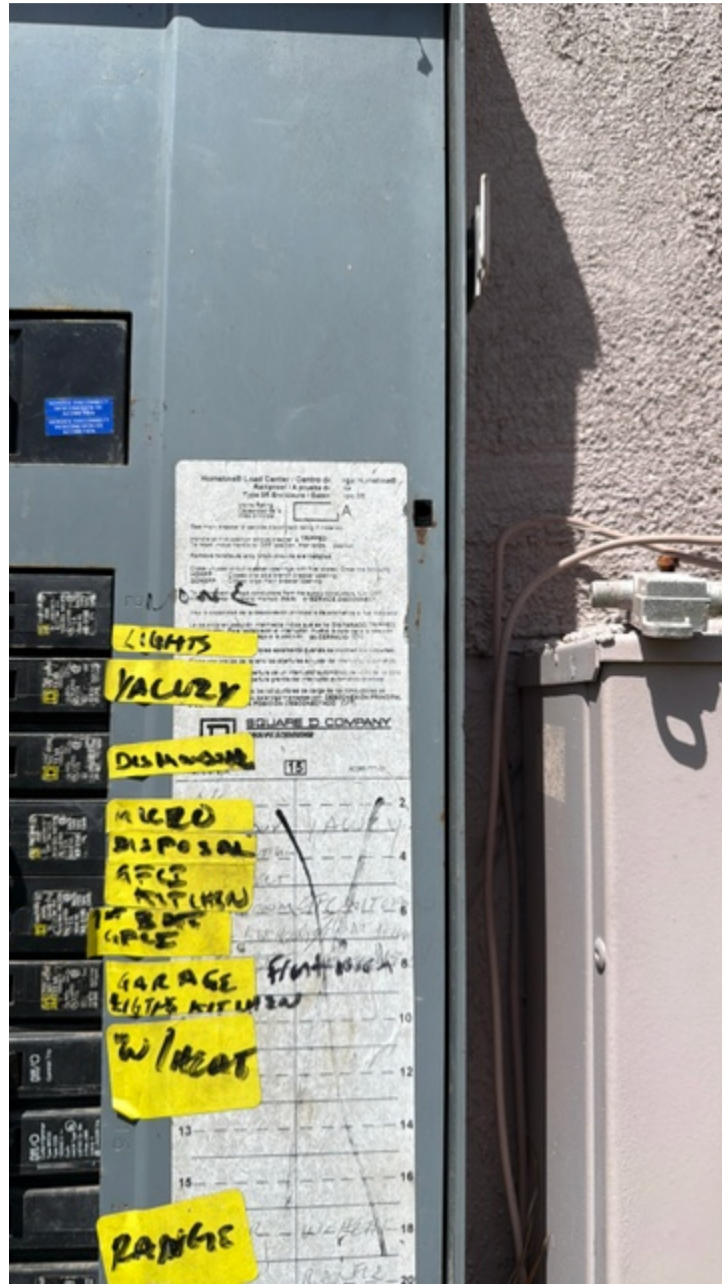
Missing / Incorrect Screws for Electrical Panel

There are missing / incorrect screws.
