## **INSPECTION REPORT**

**533A-M5SW  
Ebraheem Hamed  
5515 E Terrace Gable Cir  
Katy, TX 77494**

# PROPERTY INSPECTION REPORT FORM

5515 E Terrace Gable Cir, Katy, TX 77494

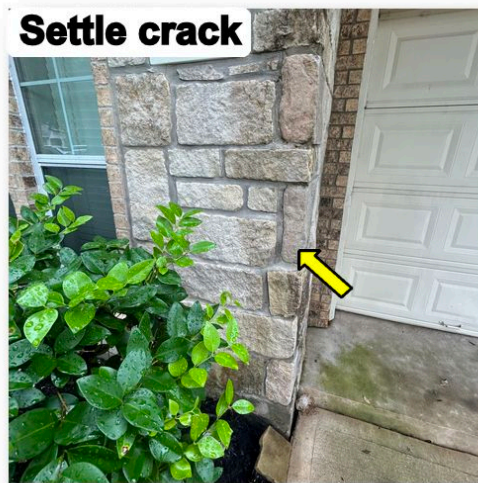
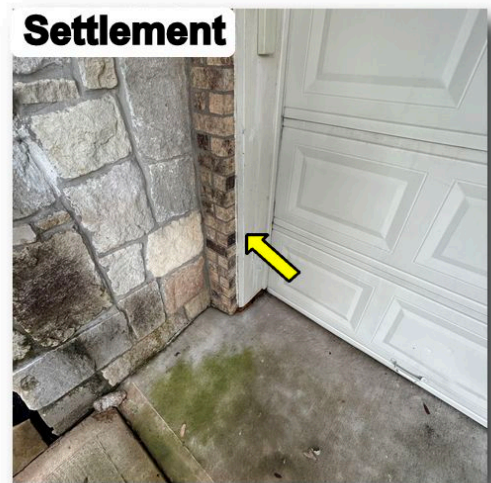
The dwelling appears to have experienced a common degree of settlement for its age and location. The cracking noted at interior and/or exterior areas is not in my opinion currently affecting the serviceability of the structure. If a more detailed evaluation is desired, I recommend further review by a structural engineer.

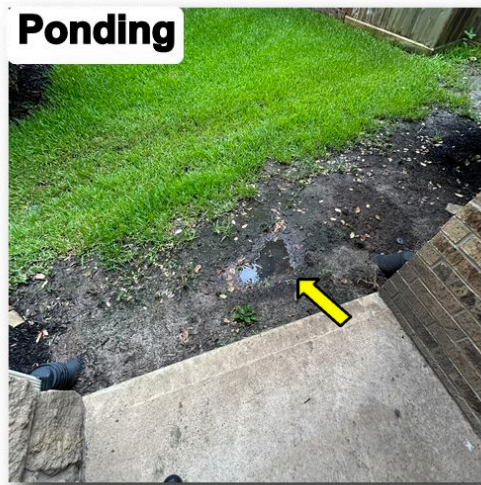
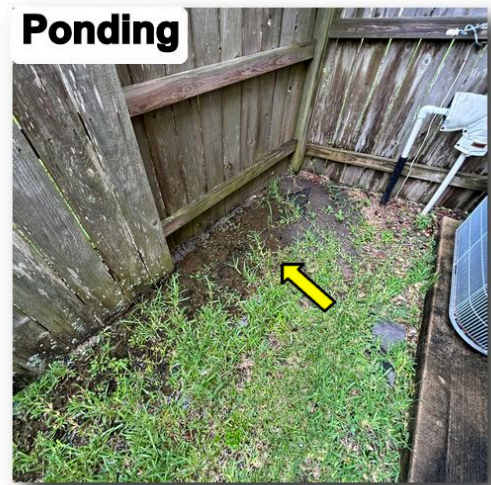
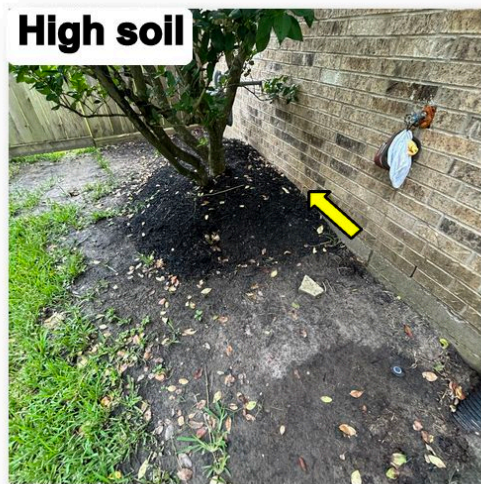
Areas of ponding were noted near the foundation on North, South side(s) of the house. We recommend repairs to these areas to allow water to drain away from the structure.

We recommend that at least two inches of concrete show between the brick or siding and the dirt line. A high soil line was noted at the North side(s). Inadequate clearance can allow water to penetrate into the structure causing moisture damage.

Surface drains were noted at the North side(s) of the house. Cleaning the drain covers and drain basins is recommended as a basic maintenance procedure. It is beyond the scope of our inspection to verify the operation or adequacy of drainage systems. If such a review is desired, we recommend consulting a specialist.

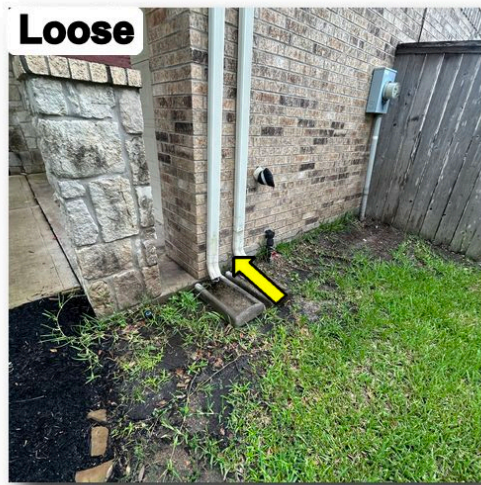
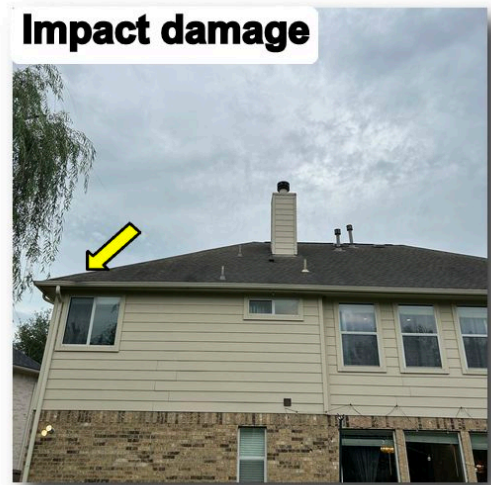
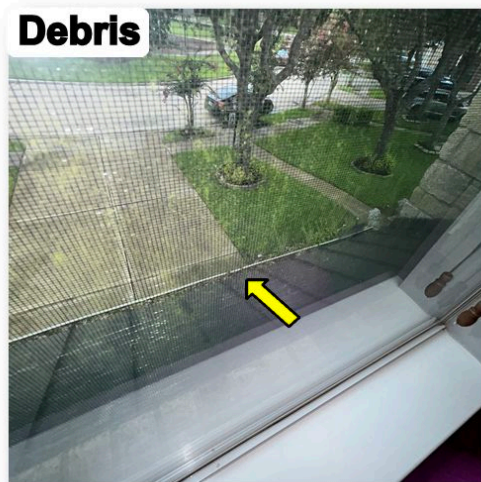
Deficiencies were noted in the installed gutter system including Loose/pulling away, debris/leaves. We recommend repairs as necessary to ensure serviceability.

Impact damage was present on the East side gutter.

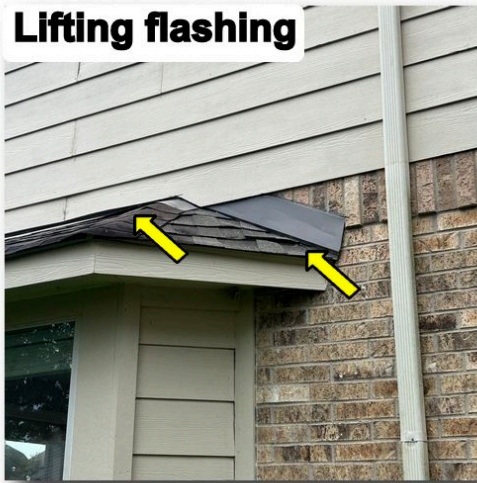
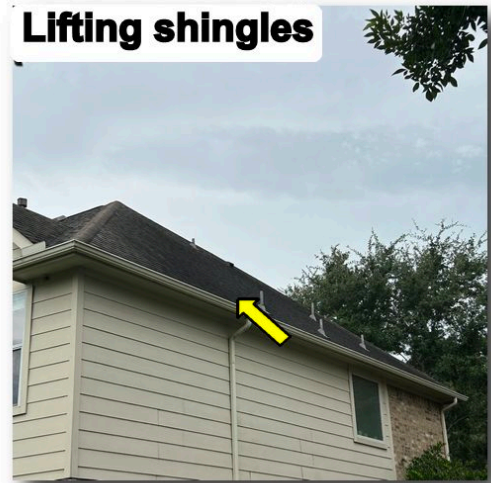
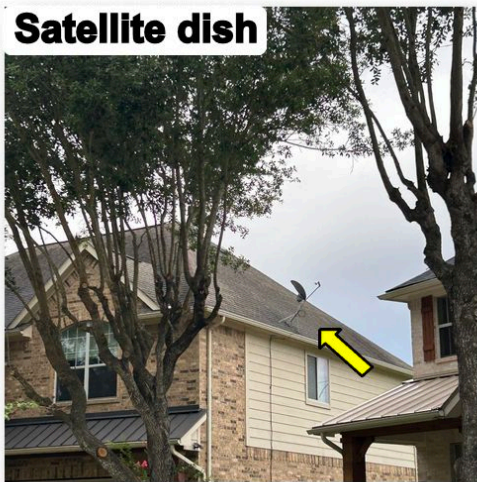
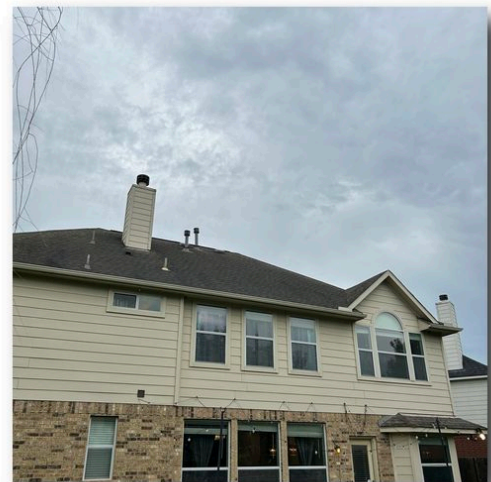
**Loose/lifted flashing was noted at the North, East side. Recommend evaluation and repair as necessary to help ensure serviceability.**

**Deficiencies were noted on the roof: Lifting shingles; recommend evaluation of the roof system and repair as necessary.**

The roof shows a common degree of wear for its age and type, but may be nearing the end of its useful life. We recommend that the insurability of the roof be verified prior to closing.

The T.V. satellite dish is surface mounted on the roof. Regular monitoring for leaks will be needed as the sealant used will deteriorate over time.

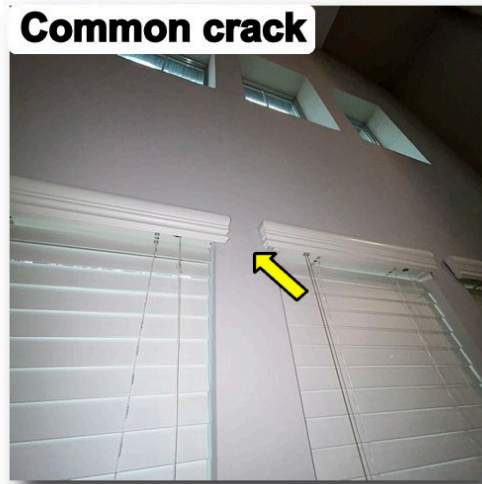
Common cracking was noted.

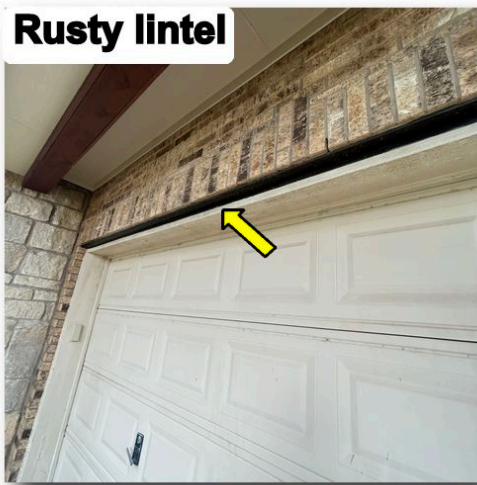
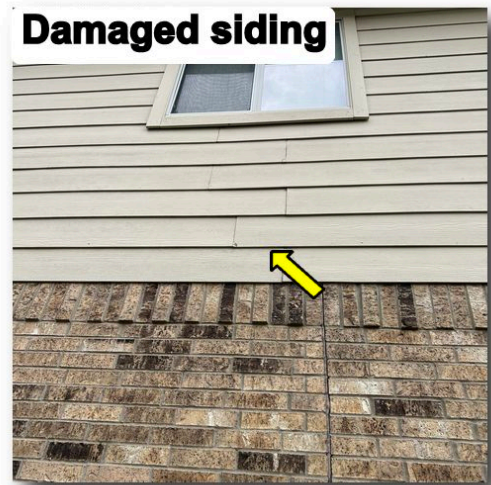
Cracked caulking noted around the structure; we recommend re-sealing to prevent moisture penetration where the caulk is pulling away/separating from adjacent surfaces.

Peeling paint was noted at various locations. We recommend scraping and painting as a matter of normal maintenance.

Rusty brick lintels were noted (metal supports over windows, doors, etc.); recommend repainting to prevent further damage to the metal surfaces.

Settlement cracks were noted at the West side(s). Recommend re-sealing the cracks to prevent moisture penetration into the wall structure.

Damaged siding was noted at the South side(s); recommend re-sealing, painting, and caulking as necessary to prevent further damage to the surface.

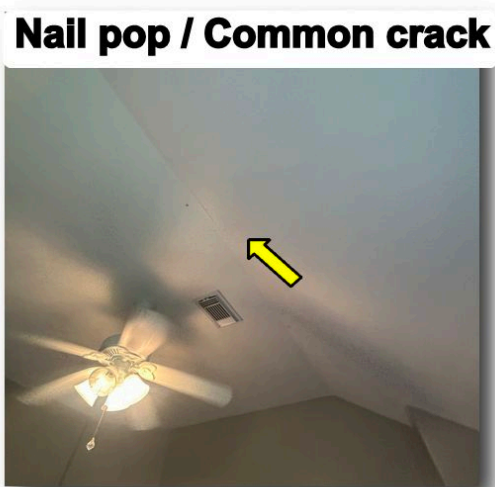
Common cracking was noted.

Nail pops were noted; these are cosmetic in nature typically resulting from normal settlement.

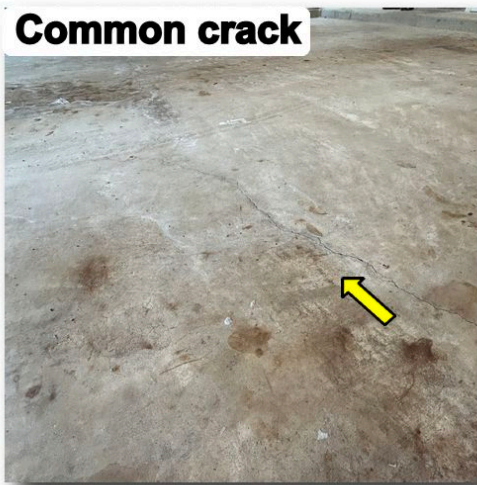
Normal stress fractures/surface cracks were present. (Garage floor)

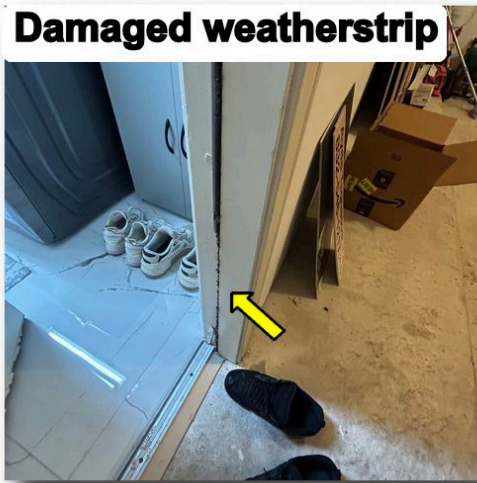
Some knobs/door hardware were loose at the time of inspection. Repairs may be necessary to restore serviceability.

The weather stripping on the Garage entry exterior door was damaged.

The garage entry door is not equipped with an auto-closing device. The Texas Real Estate Commission recommends auto-closing devices on garage entry doors to help ensure safety.

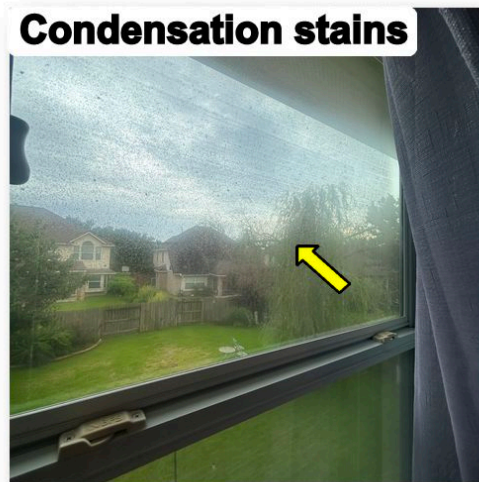
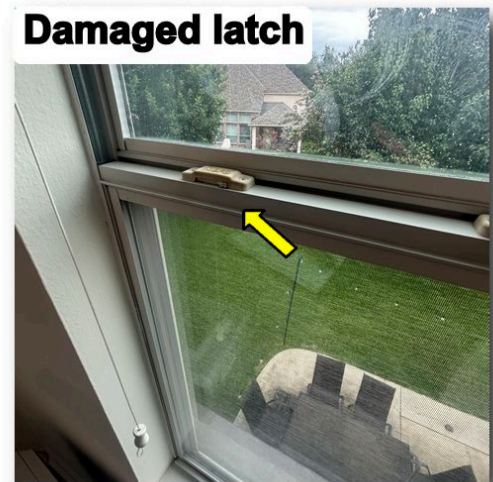
The windows were very dirty. The dirt and water spots on the windows can hide condensation stains between the panes.

The window latch(s) were damaged at some of window(s). Future repairs may be necessary to restore serviceability/security.

Damaged or loose tension springs were noted; future repairs/adjustments may be necessary.

Some windows would not open easily using normal force. We recommend ensuring that at least one window per room is operable.

Areas of window glazing stops (plastic trim around the window sashes) are cracked and/or missing.

Damaged screens were noted, these are not itemized by room.

**Condensation stains (failed seals) were noted in the thermal pane windows located in the following areas: South bedroom , master, game room. Repair or replacement will be required if the visibility of the windows is to be restored. Recommend further evaluation by licensed contractor to estimate costs and repair as necessary.**

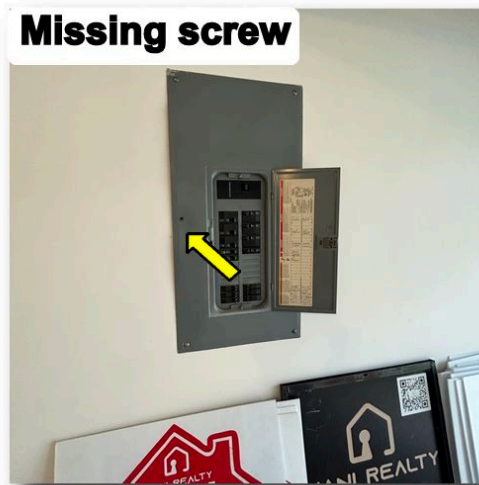
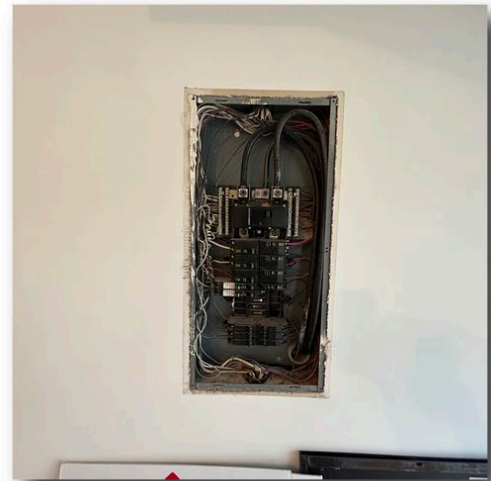
Missing panel screws were noted; proper fasteners should be installed to ensure safety.

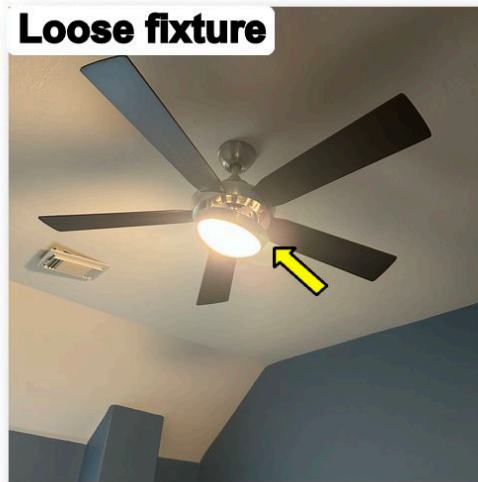
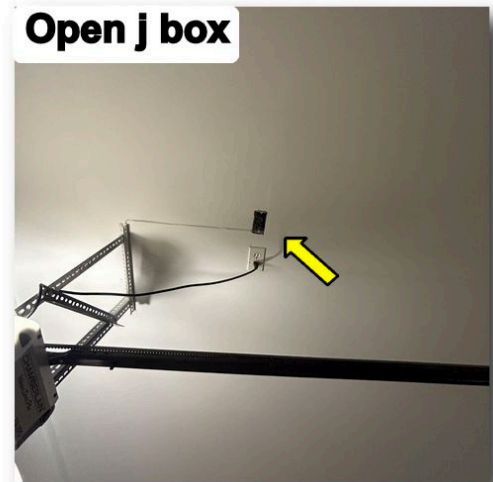
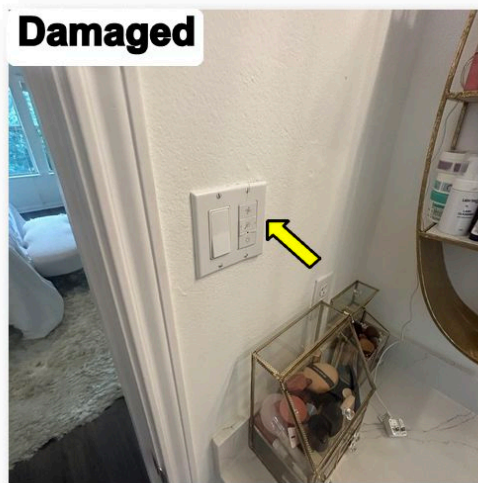
Open junction boxes were noted in the garage. Junction boxes are used whenever wires are spliced or branched. We recommend installing covers as necessary.

An extension cord was being used as a permanent power supply for the irrigation controller; it is recommended that an outlet be installed to eliminate the need for a cord.

Several loose outlets were noted throughout the home. Loose outlets need to be secured to help assure safety and serviceability.

Some damaged, loose outlet, switch covers were noted. We recommend replacement to help assure safety. Cost and repair is minimal.

The South bedroom loose light fixture needs to be secured to help assure safety and serviceability.

No remote controls could be located to operate the ceiling fan in the South bedroom .

Loose exterior outlet weather covers were noted; we recommend repair or replacement to help assure safety and serviceability.

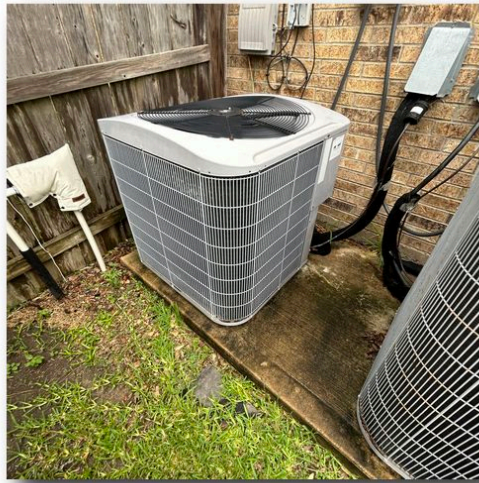
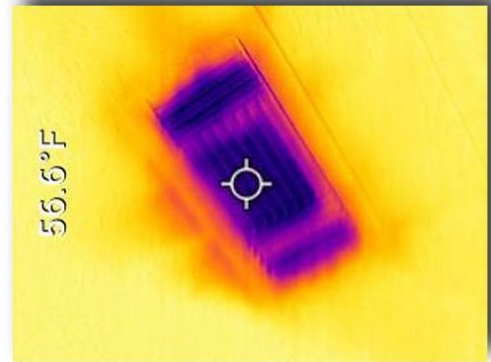
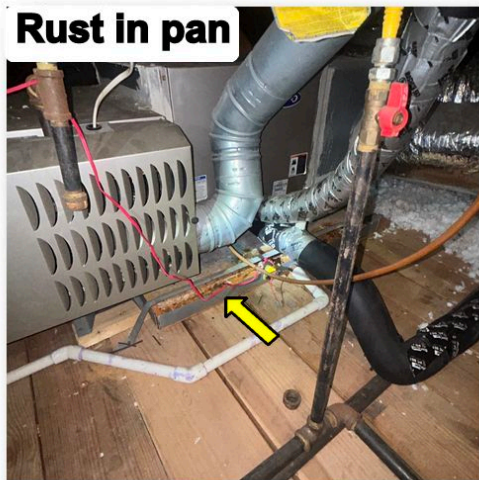
Rust was noted in the pan. At some time in the past, the primary condensate drain line was not properly removing water from the inside portion of the air conditioning system. No visible evidence of ongoing leaking water was noted at the time of our inspection. If review is desired, we recommend contacting a licensed heating and air conditioning contractor.

The return air temperature was 71°F and the supply air temperature was 55°F, giving a temperature differential of 16°F, which was within a serviceable range.

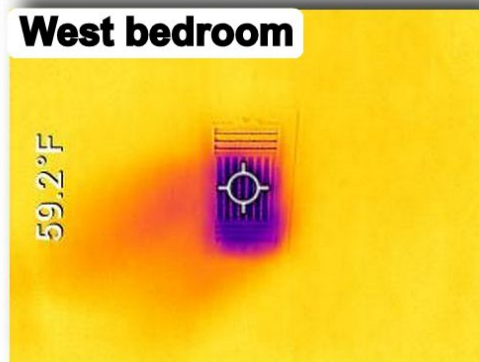
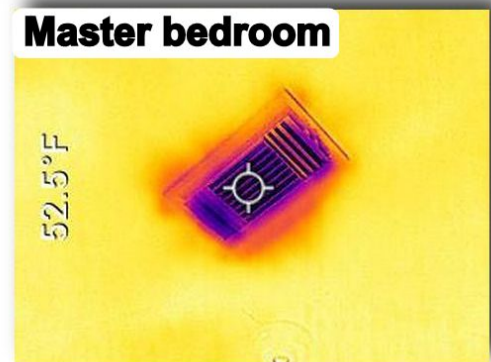
**The air flow was noted as low/reduced at the West bedroom, game room register. We recommend evaluation and repairs as needed to ensure serviceability.**

Loose registers were noted; recommend repairs to ensure proper air circulation.

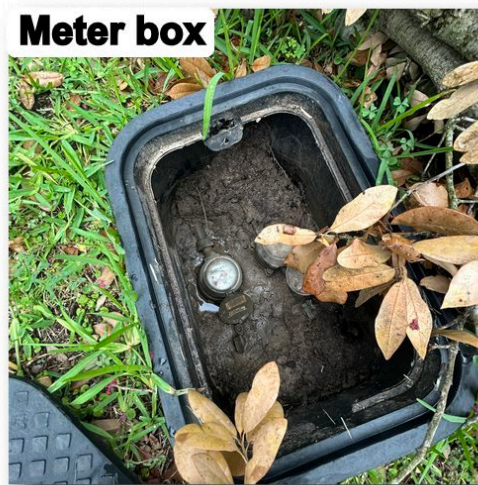
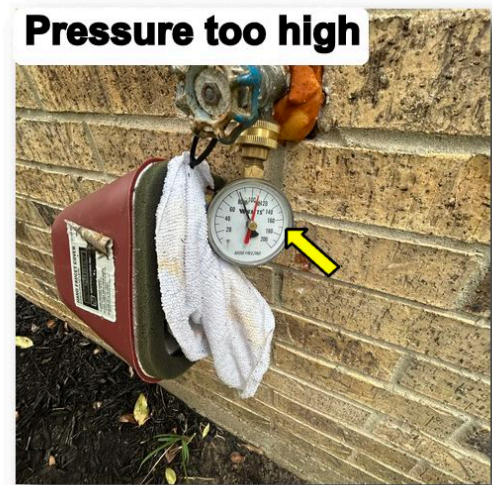
**The static water pressure reading was 83 psi. This reading was too high. The recommended pressure is recommend between 40 to 80 psi. Recommend evaluation and repairs as necessary to ensure serviceability.**

Some of the hose bibs leak while operating.

The hose bibs were winterized at the time of inspection; they were not operated (South, East side).

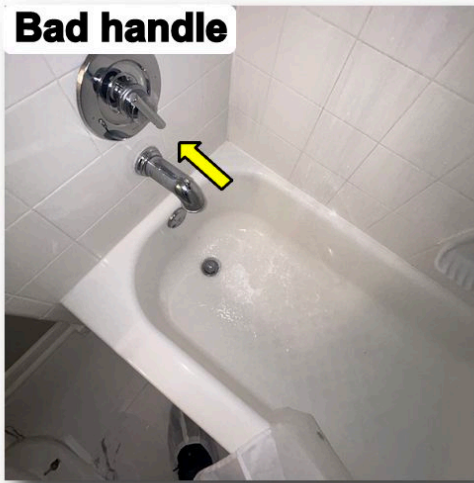
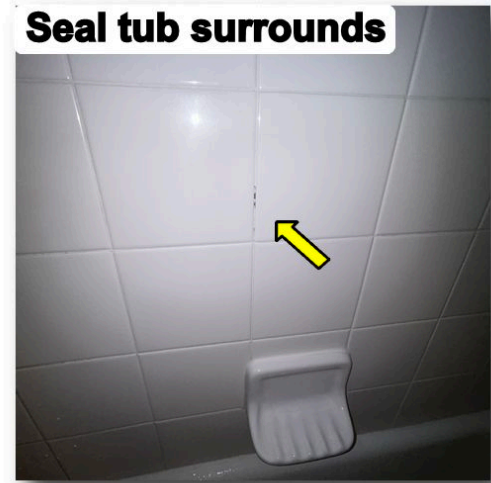
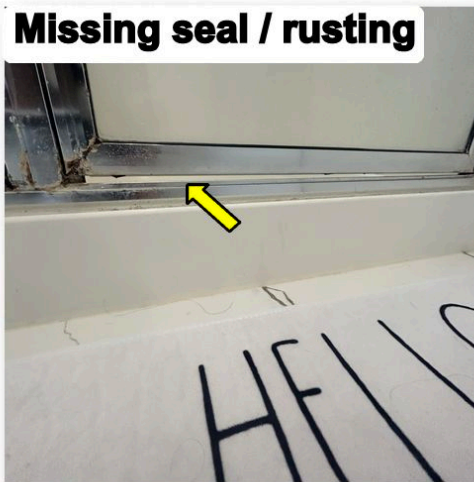
**The tub faucet handles in the upstairs common bath will not properly stop when off (the handles spin past the stops); recommend repair.**

Caulking and/or grout in the tub/shower surrounds is cracking or loose. The grout/caulking needs to be repaired to help prevent possible water penetration behind tile and damage to interior walls. Such damage may not be apparent from a visual inspection of the outer surface.

The master bath shower door seal was damaged/missing. We recommend repairing the enclosure.

The master shower door was rusting; Future repairs may be necessary.

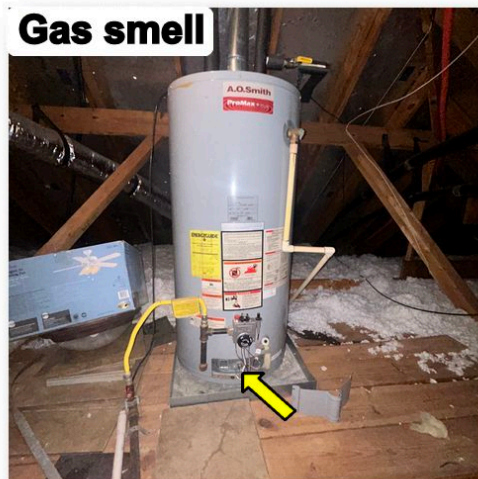
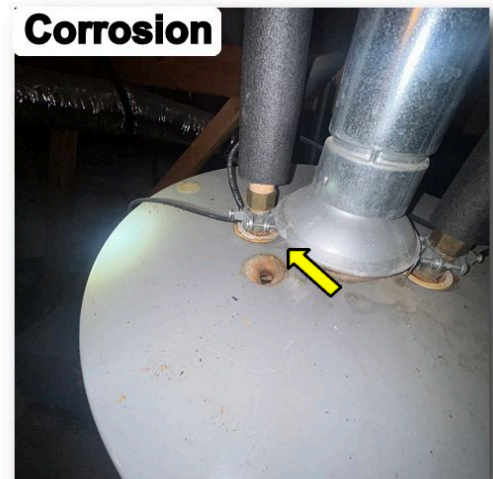
The 90 degree elbows on the condensate drain lines at the South exterior have been broken off; Recommend repairs as needed.

"Popping" sounds were noted at the water heater. This usually indicates sediment build-up inside the unit. Efficiency and remaining life may be reduced.

Corrosion was noted. Future repairs may be necessary to help prevent the connections from leaking.

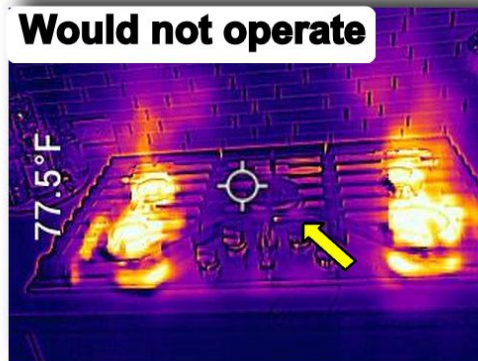
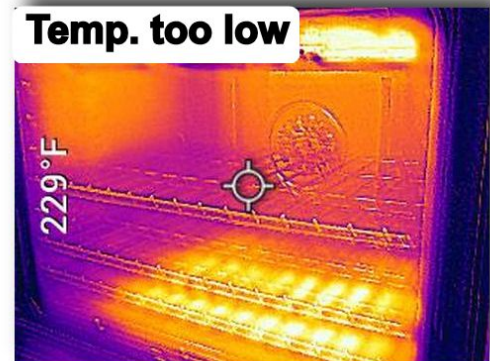
The center burner(s) would not operate.

An oven setting of 350°F gives an actual temperature of 230°F. We recommend adjusting or repairing the thermostat as necessary to allow a temperature within 25°F of the set point.

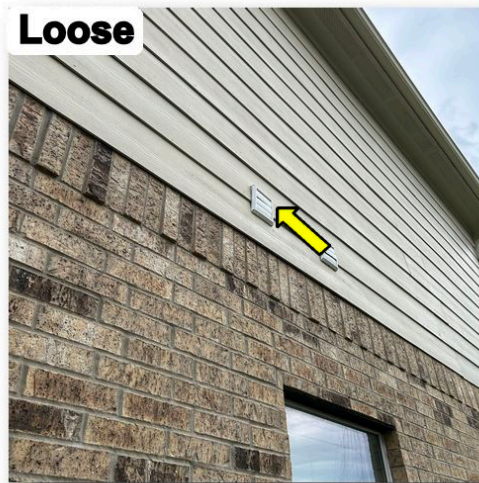
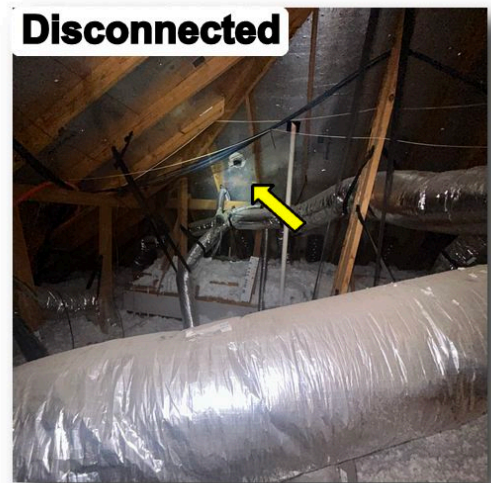
**The master exhaust fan will not operate.**

Some damaged/disconnected ducting for the vent fans were noted in the attic; recommend repairs.
