FOUNDATION CONSULTATION

2718 Lazy Spring Dr
Houston, TX 77080

Ariana White
08/31/2025

Project Information: GreenWorks	Project Information: Inspection	Project Information: Report Issue
Project Number	Date	Date
202103	08/31/2025	09/02/2025

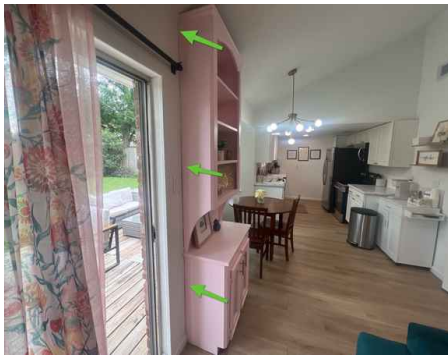
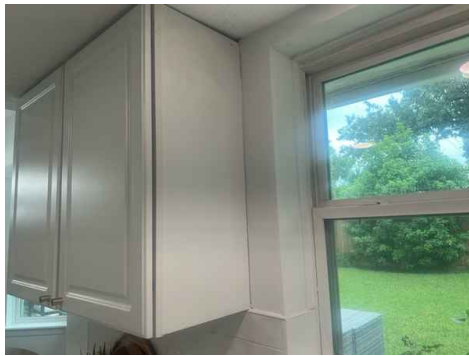
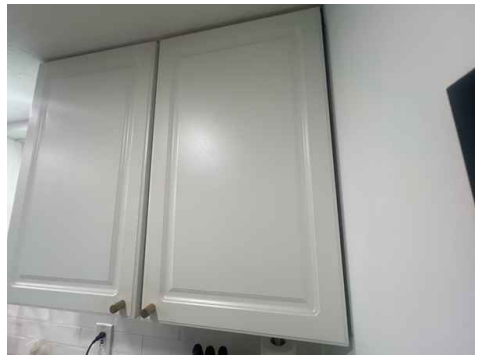
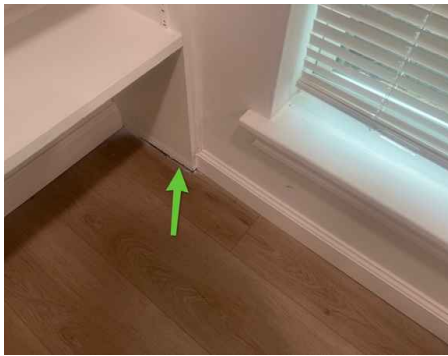
Cabinet Separation

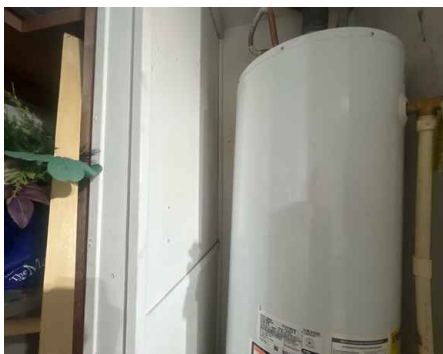
Trim Separation

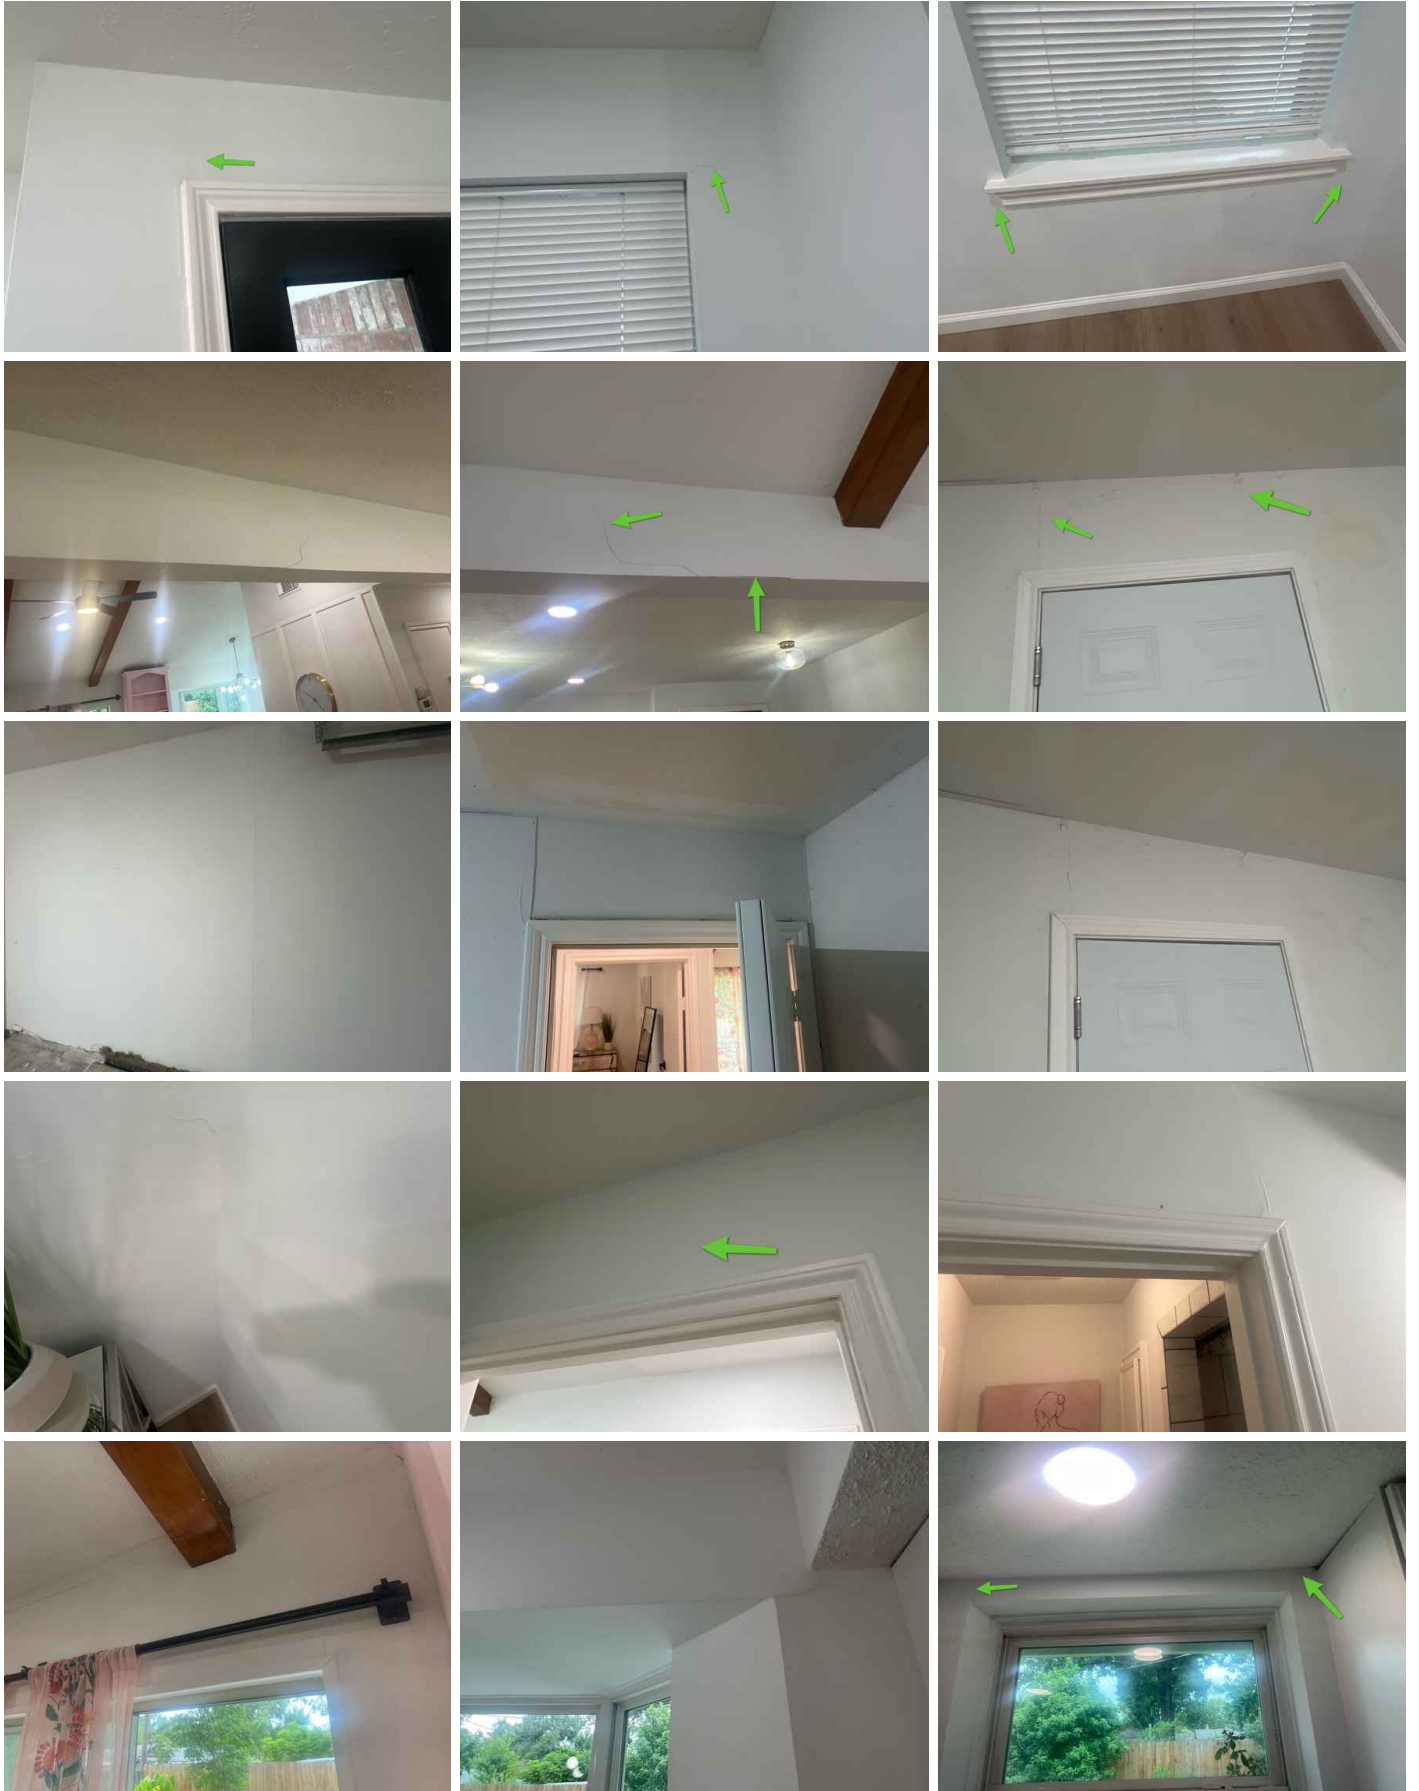
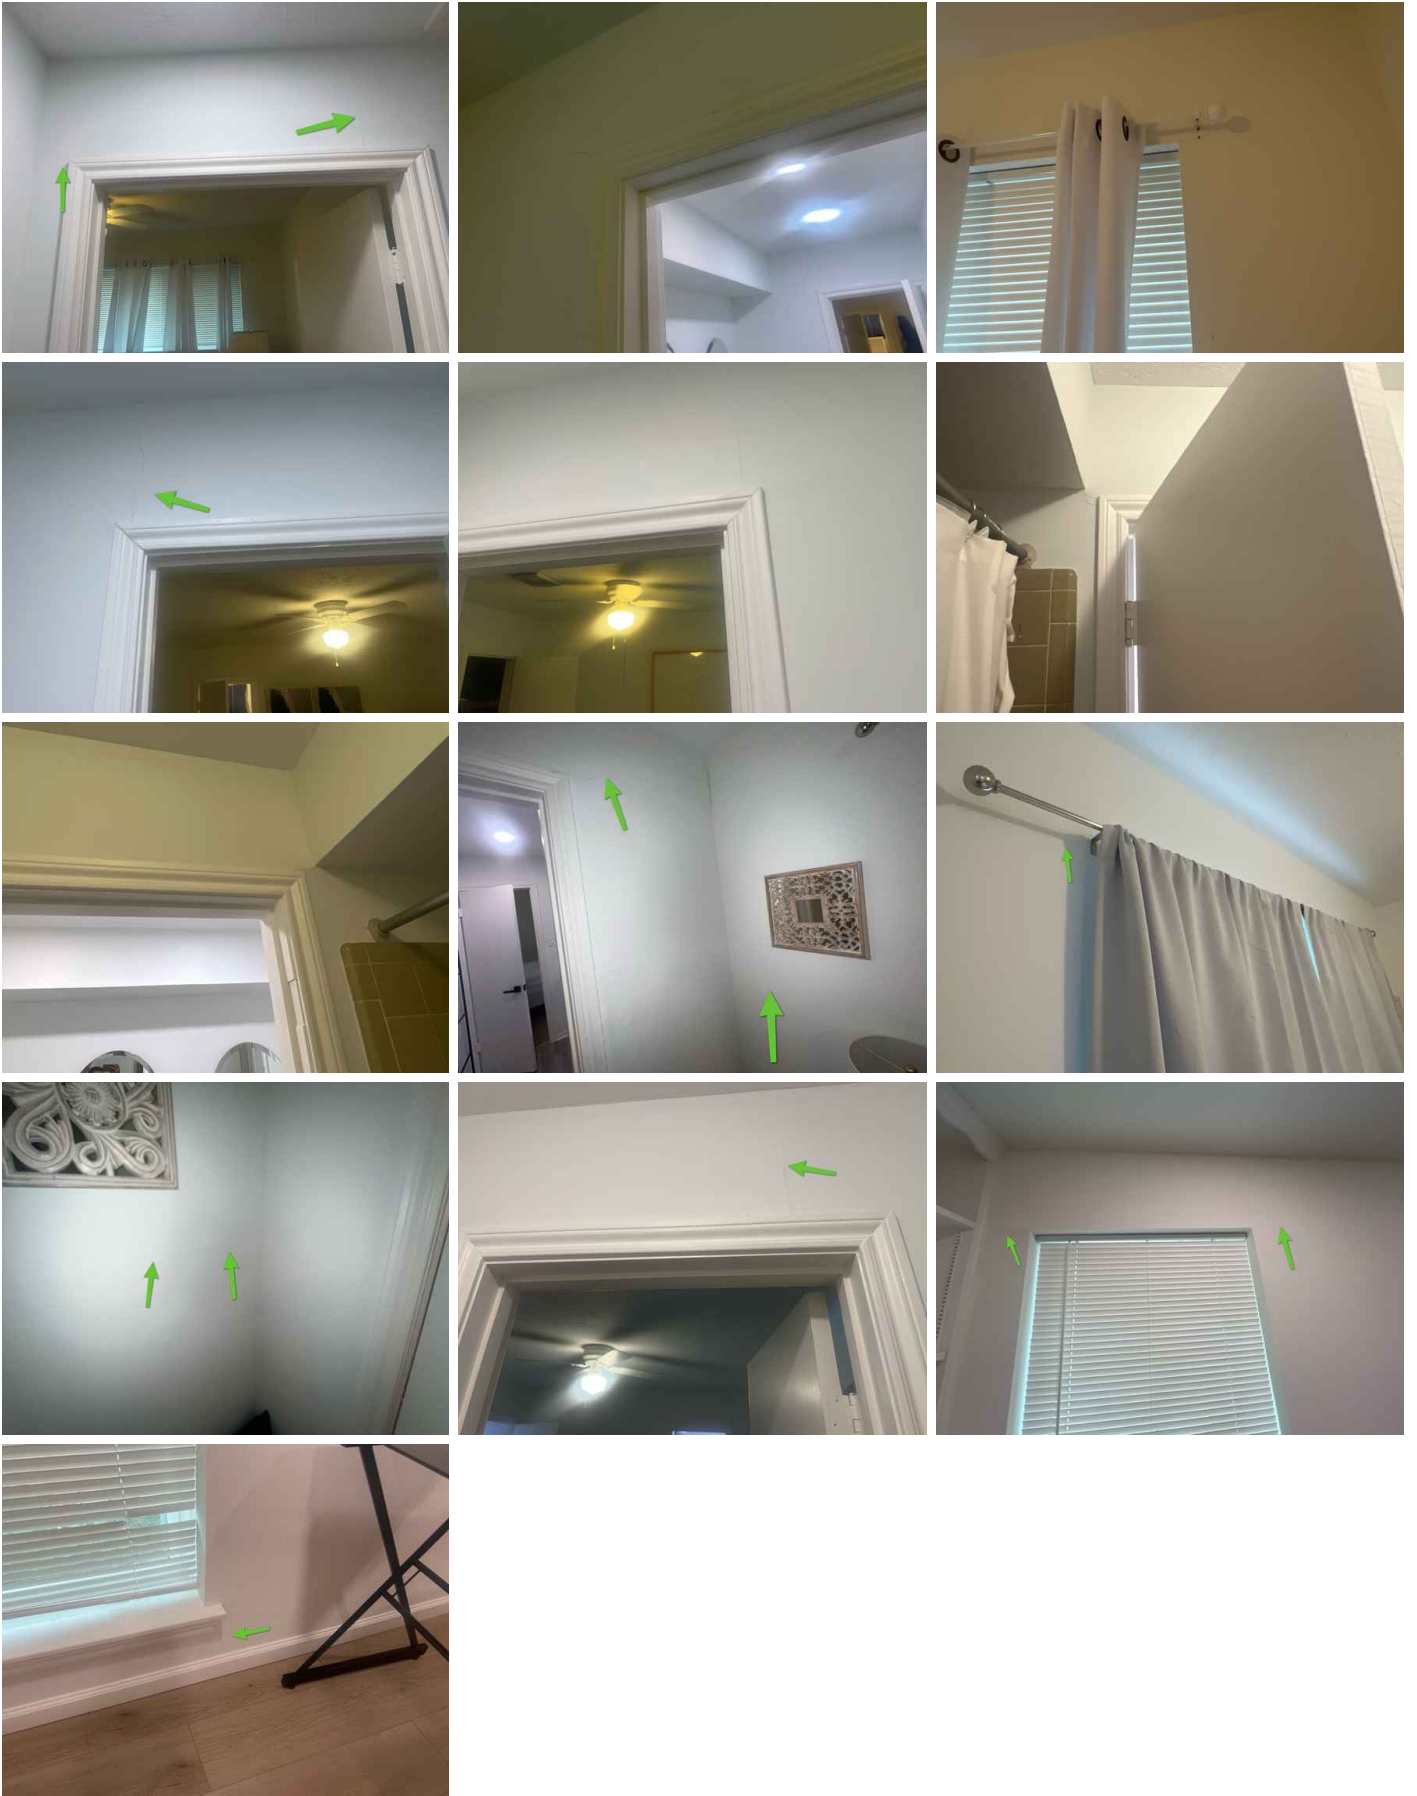
Wall Cracks Present

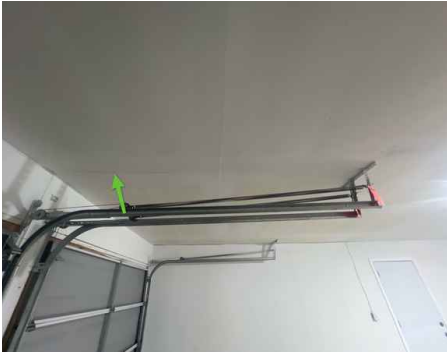
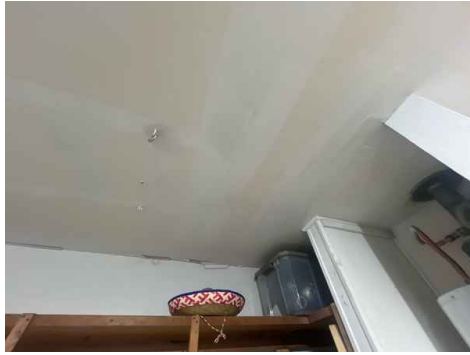
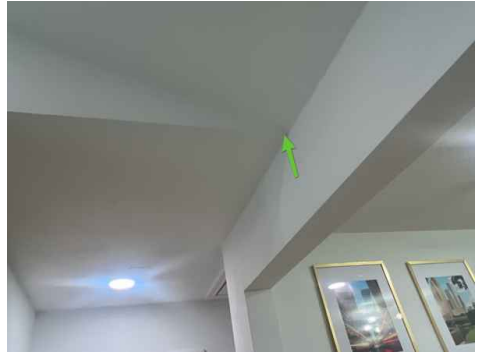
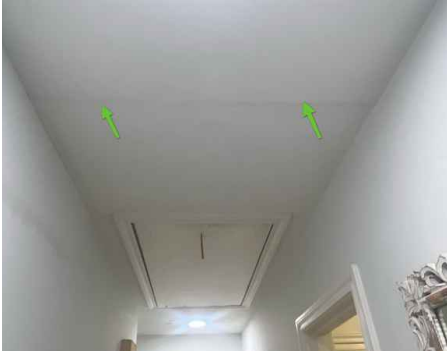
Ceiling Cracks Present

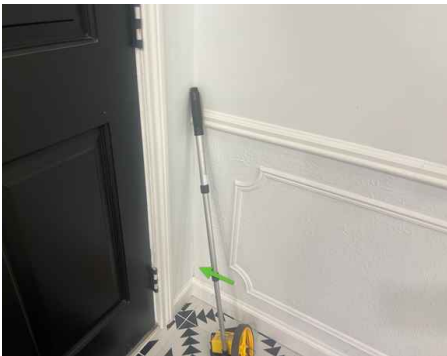
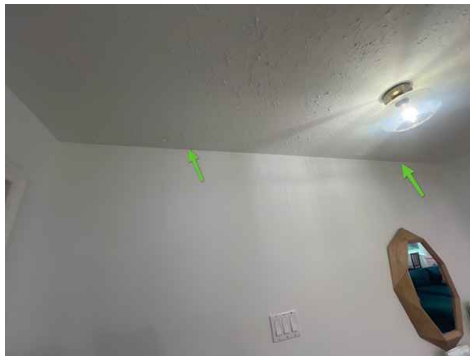
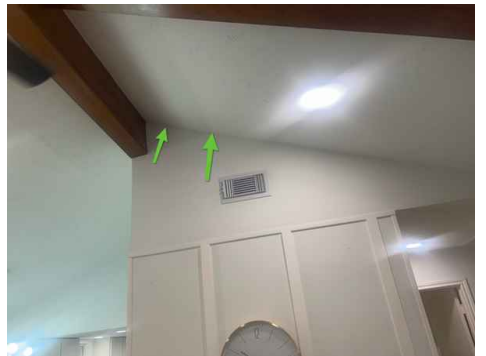
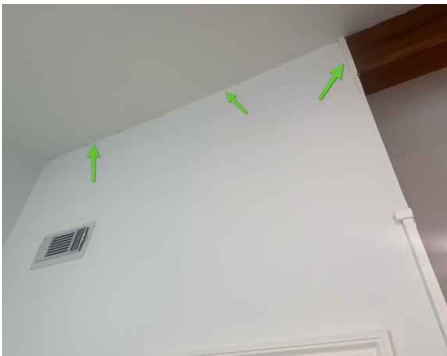
Intersection Separation

Separation of the drywall at the ceiling and wall intersection

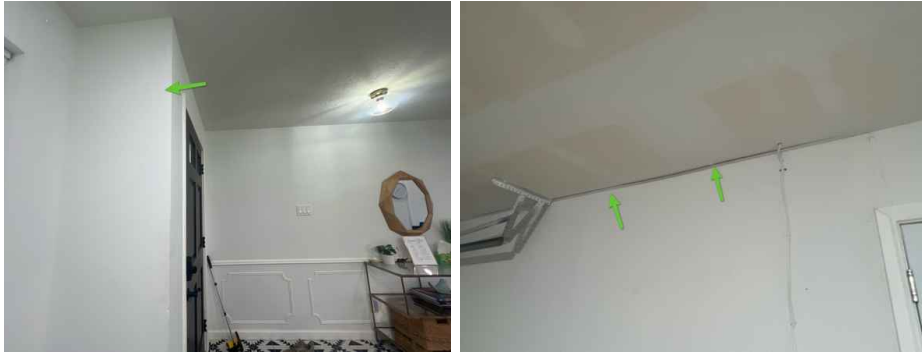
Tape Separation

Separation of the drywall tape from the drywall

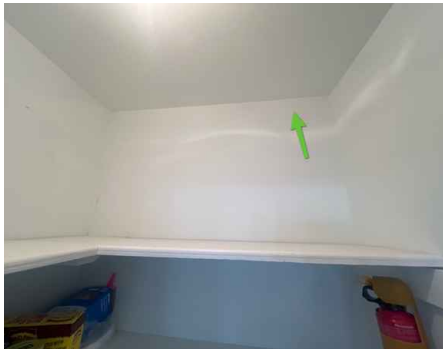
Nail pops

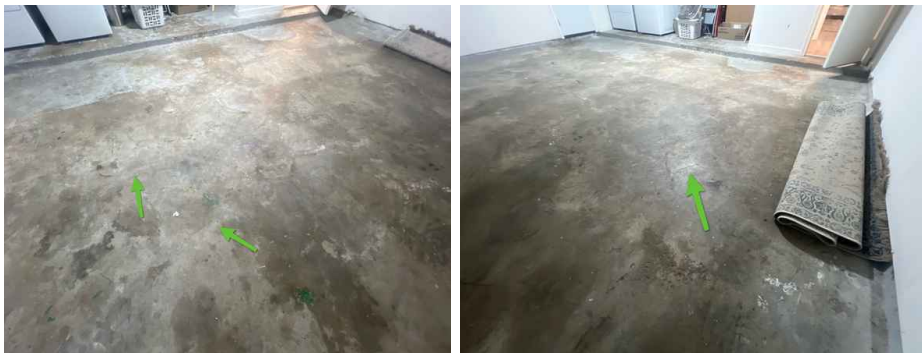
Floor Distress: Cracking at Top Surface of Slab

We recommending injecting slab cracks of about 1/16" and larger in width with epoxy repair cement to restore stiffness across the crack.

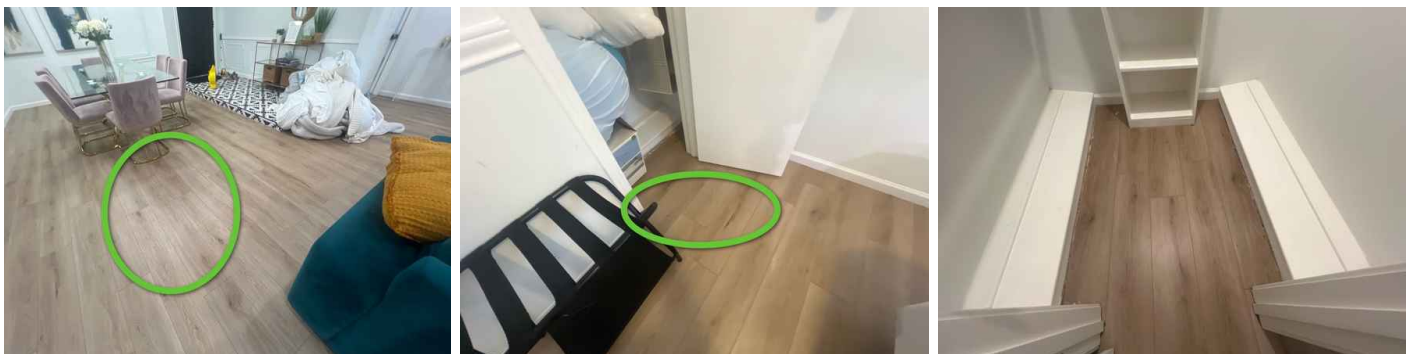
Floor Distress: Flooring Separation / Deformation / Buckling

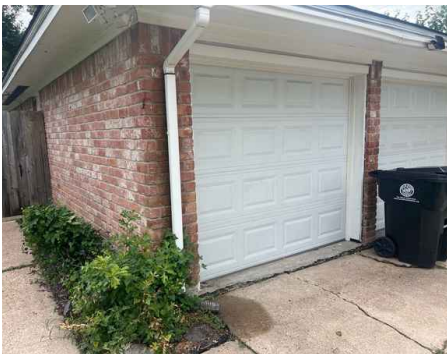
Front Left

Downspout Terminations

At foundation

A properly functioning gutter system will minimize ponding, soil loss and erosion, and can help control seasonal movement of the foundation. The gutter system should discharge the water a minimum of 5 feet from the foundation or into a below-grade drainage system.

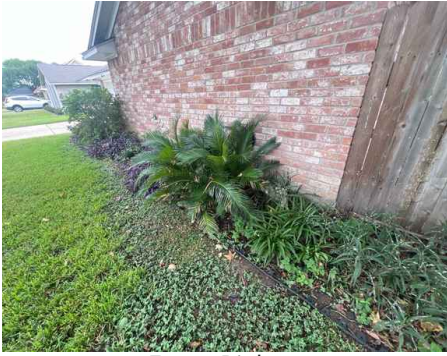
Front Right

Bushes/Foliage Within 5ft

Yes

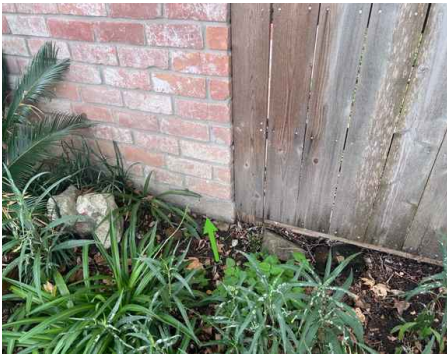
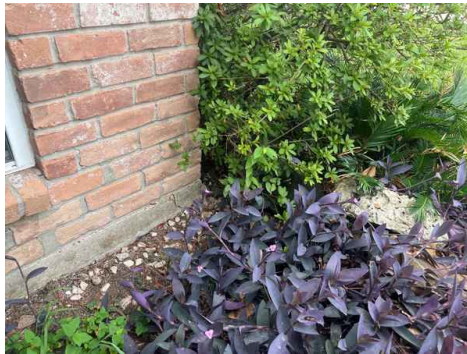
Foundation Corner Cracking

The foundation cracks at the corners of the house can be sealed and secured by injecting an epoxy into the cracks, such as Simpson Strong-Tie Crack-Pac or a similar product. Note, the broken foundation corners will not affect the overall performance of the foundation but could cause minor cracking in the veneer above that corner.

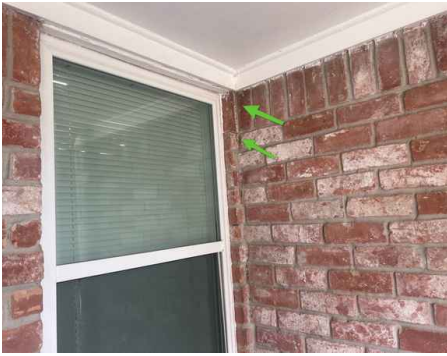
Front

Veneer Cracks

Brick/stone veneer cracks can be filled with mortar. Note, expansion joints in veneer should be filled with an elastic silicone caulk, not mortar.

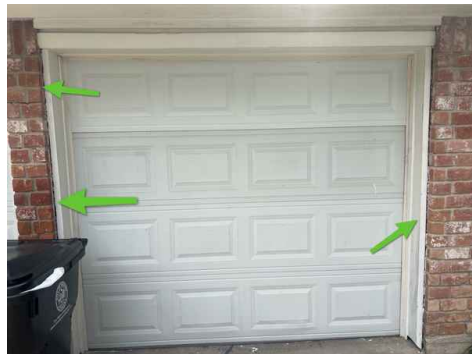
Front

Window/Door Frame Separation

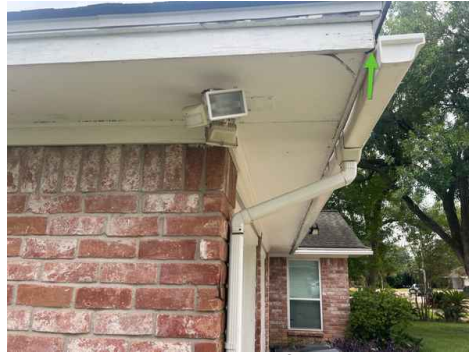
Front Left

Trim Separation

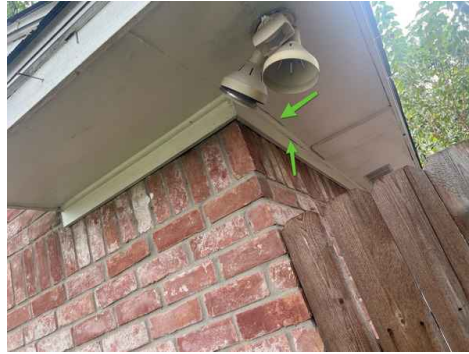
Front Right

Siding-Trim Separation

Separation of the lap siding from the trim boards

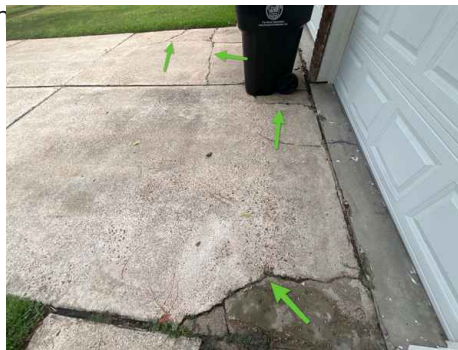
Front Left

Previous Repair

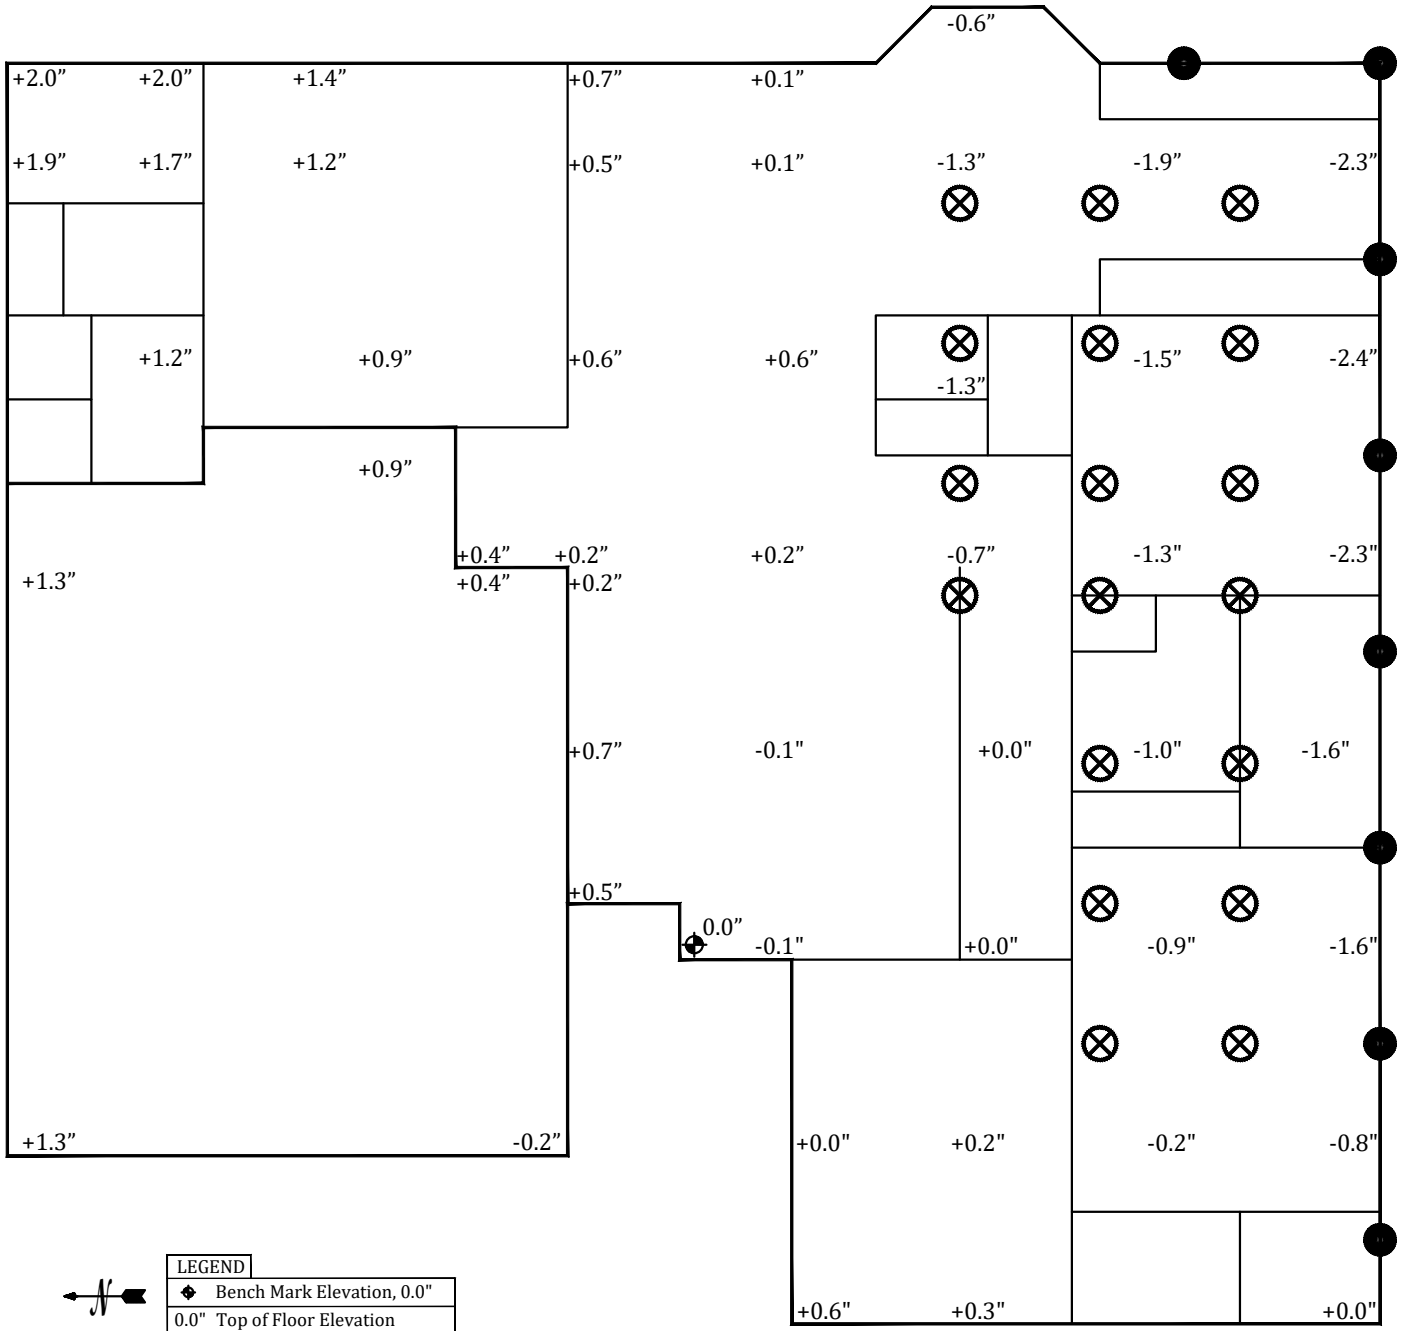
FIGURE 1

Based on our observations of the interior and exterior cosmetic distress, the floor elevations, and calculations, it is our opinion that the foundation has undergone an excessive amount of movement. The maximum differential deflection is 1.3 inches and occurred over an approximate distance of 21.0 feet. This amount of deflection exceeds the standard allowable deflection of 0.7 inches for this distance.

To stabilize and lift the foundation, install 8 perimeter and 18 interior piles/piers as shown on the attached elevation survey. The underpinning may be concrete cylinders, steel pipe, helical screws, or drilled concrete piers – refer to the included details. Use mudjacking or similar to fill voids caused by the lifting of the foundation.
