Sarah Watson
2718 Lazy Spring Dr.
Houston, TX 77080

May 25, 2022

PROPERTY INSPECTION REPORT FORM

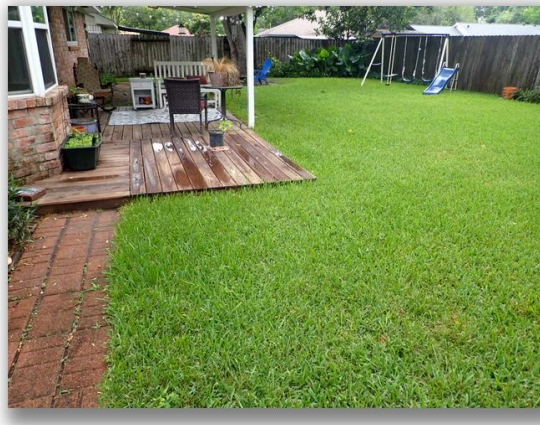
- Marginal site drainage was observed on the east side of the structure. Proper drainage is needed to help prevent water from standing and/or ponding next to the foundation beam. Corrective measures may be needed if the water stands within 10-feet of the foundation perimeter beam for more than 24-hours.

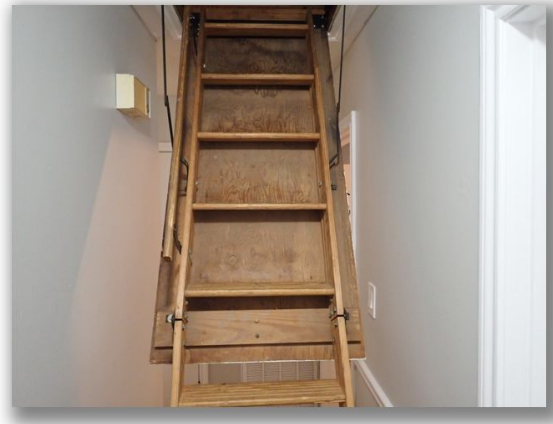
- One or more of the attic ladder components were observed to be damaged. This condition should be corrected for reasons of safety.
- The attic ladder appears to be in poor condition and improvements or replacement is recommended for reasons of safety.

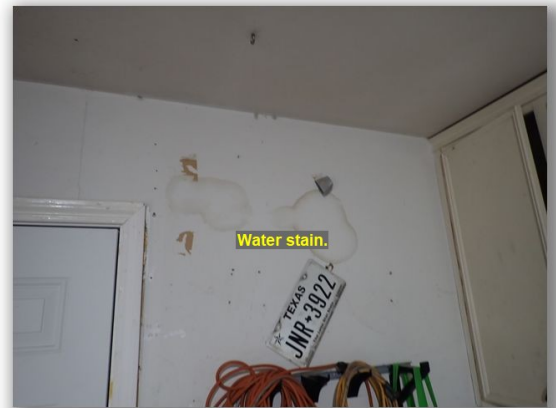
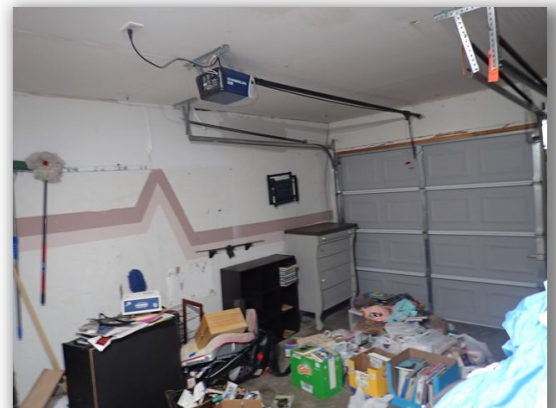
- Interior wall joint cracks were observed in the living room.
- The tape lines are pulling and/or twisting in the wall intersections in the front entrance area, front middle bedroom, garage. This condition is sometimes related to adverse foundation performance and should be further evaluated.
- Water stains were observed on the walls in the garage. The cause and remedy should be further evaluated and corrected as necessary.

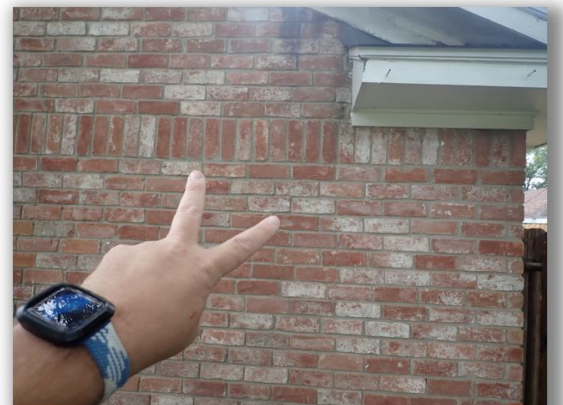
- All wood to ground contact at the base of the siding should be eliminated. Rotted or damaged siding that is uncovered should be repaired. The siding was observed to be in contact with the finish grade (ground) on the west side of the structure.
- All joints between two different types of siding should be properly sealed. It is recommended to use elastomeric sealant.
- The soldier bricks were observed to be loose on the north side of the structure. Some improvements are recommended.
- The area between the exterior cladding / veneer and all of the wall penetrations / openings need to be properly sealed. Areas such as utility connections, downspouts, hose bibbs, lighting fixtures, receptacles etc. It is recommended to use an elastomeric caulking / sealant.
- All of the exterior wood type surfaces need a fresh coat of paint.

Note: Minor mortar and/or brick cracks were observed in the exterior veneer on the north, east, west and south sides of the structure.

Note: Previous repairs to the exterior masonry mortar / grout was observed on the north side, north, east, west and south sides of the structure.

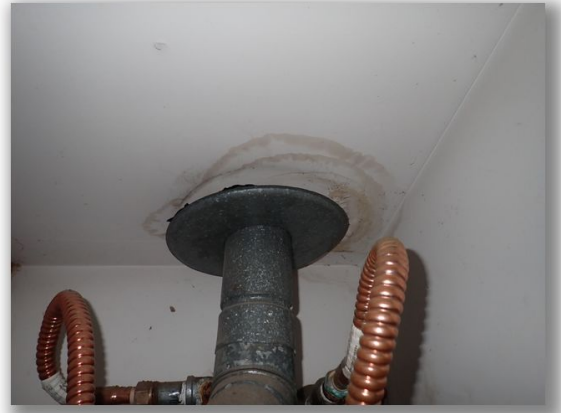
- Ceiling joint cracks were observed in the living room, garage.
- Water stains observed on the ceiling at and/or around the water heater flue area. The sealant at the flue roof level storm collar needs to be further investigated and corrected as necessary.

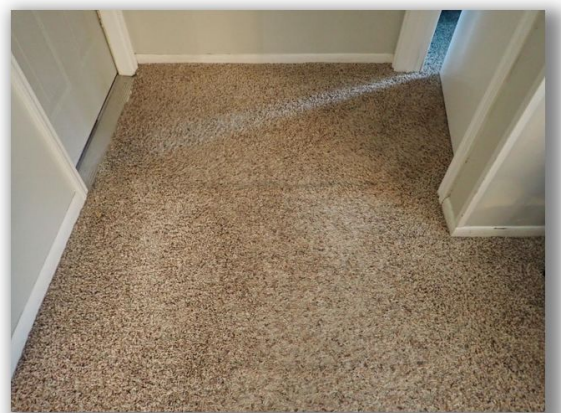
- The floor covering is worn and/or damaged in one or more locations of the home.

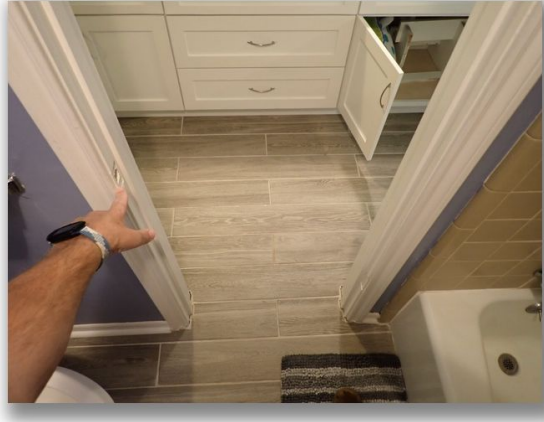
- The door is missing to the Jack and Jill bathroom.

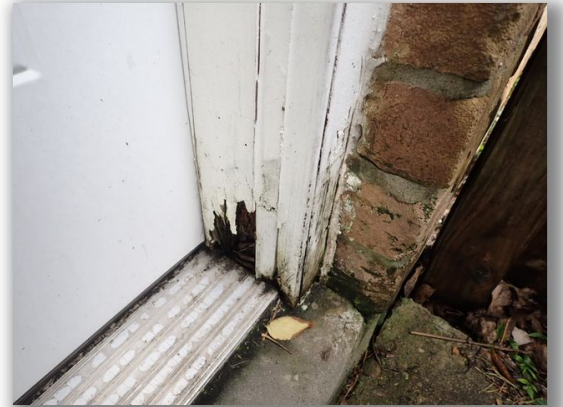
- The garage entry door is not equipped with a self-closing device.
- The exterior door frame has some deterioration and/or damage to the garage entry door(s).

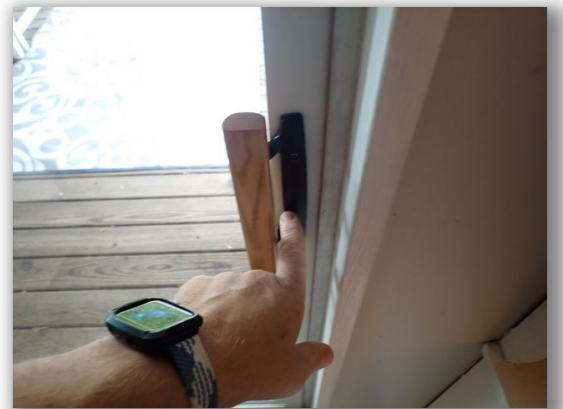
- The backyard entry sliding glass door lock is damaged and does not function properly.

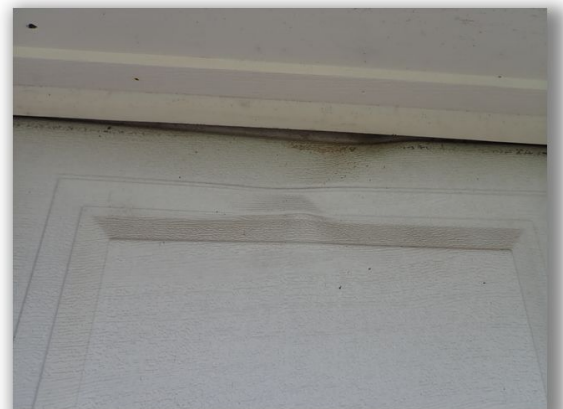
- Some damage to the overhead garage door was observed.

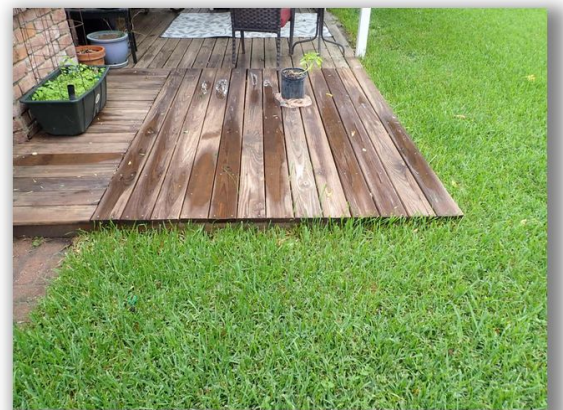
Note: The deck has been built at grade level (Wood/Ground contact should be avoided). This configuration is prone to rot and insect activity.

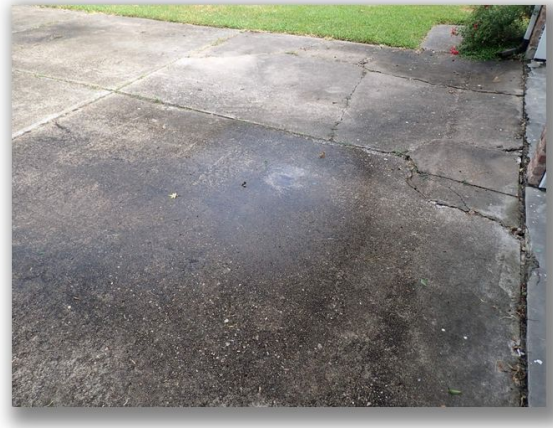
- Larger than typical cracks and/or deficiencies were observed in the driveway.

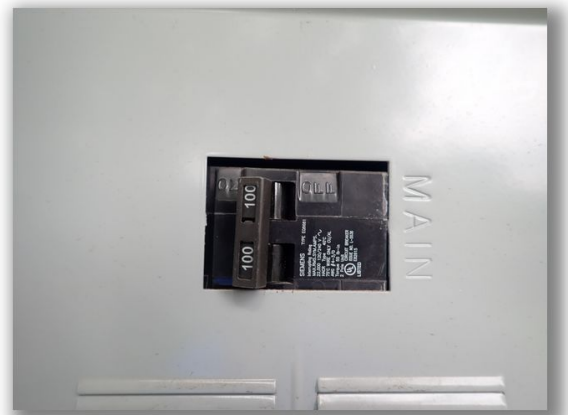
- There was no anti-oxidant gel observed on the exposed aluminum conductor terminations.
- Improper copper/aluminum connections were observed in the electrical distribution system. Copper/aluminum connections should be enclosed in either a purple wire nut or a purple splice connector. Repairs are recommended by a licensed electrician.

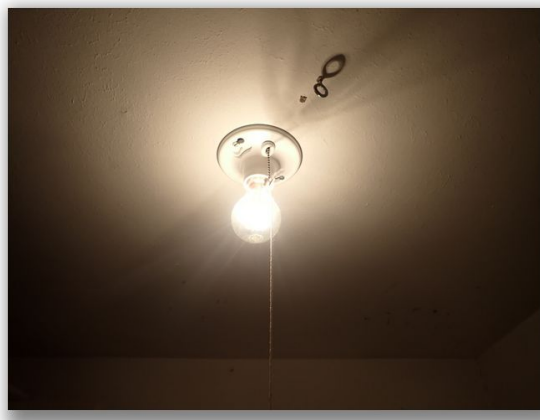
- One or more of the closet light fixtures appear to be installed without globes and/or covers. Safety precautions should be taken around these light fixtures.

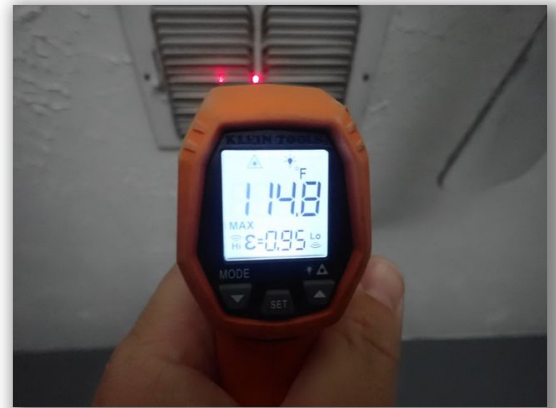
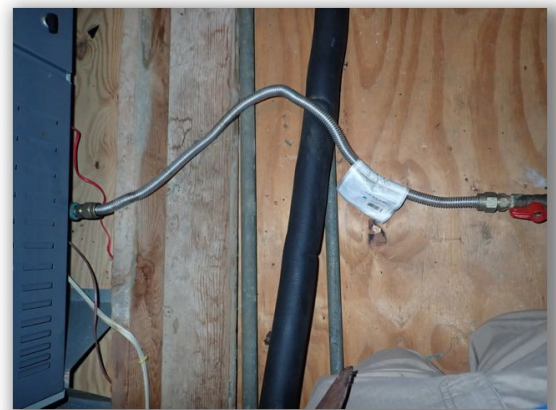
- The air return system currently has two filters in place (Double Filtered). The configuration will adversely affect the return air flow and performance of the HVAC system. This condition should be further evaluated and corrected as necessary.
- The heater gas supply line is not equipped with a sediment trap just before the gas appliance connector. This condition does not meet current installation requirements and should be corrected.

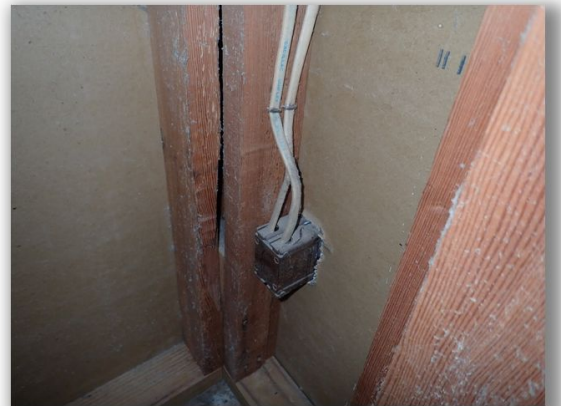
- The duct system was observed to be dirty and needs to be cleaned for air quality purposes.
- There is visible dust and/or mildew on the air registers in the front middle bedroom. The cause and remedy should be further evaluated. It is recommended to have the air registers and duct system cleaned for air quality purposes.
- There are electrical romex wires observed in the air return chase. Under current building standards, this is no longer an accepted practice.

Additional Notice from the Inspector: The ductwork was observed to be older and in poor condition. It is recommended to replace the ductwork for improved air quality and efficiency.

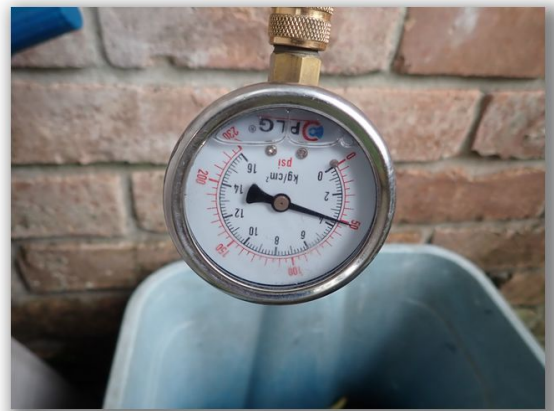
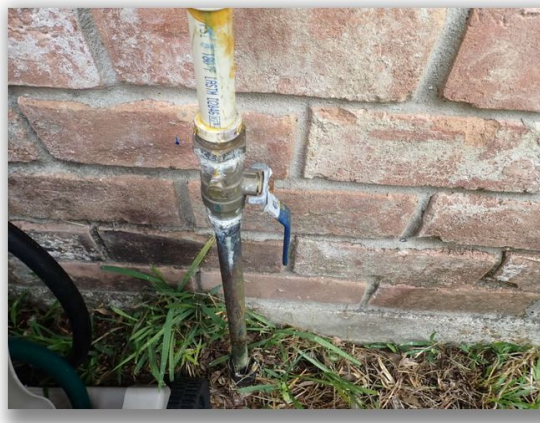
- There are galvanized water lines in use at the time of this inspection. This is an older obsolete water supply system that is prone to water leaks. Full evaluation of all of the galvanized water line components and the integrity of those components are beyond the scope of this inspection. You are strongly encouraged to have the integrity of all of the galvanized water line components further evaluated by a qualified plumber prior to the expiration of any time limitations such as option or warranty periods. All plumber recommended repairs should be made. It would be wise to budget for replacement of all the older galvanized water supply system and to make a conversion over to a newer type of water supply system as soon as it is financially feasible.

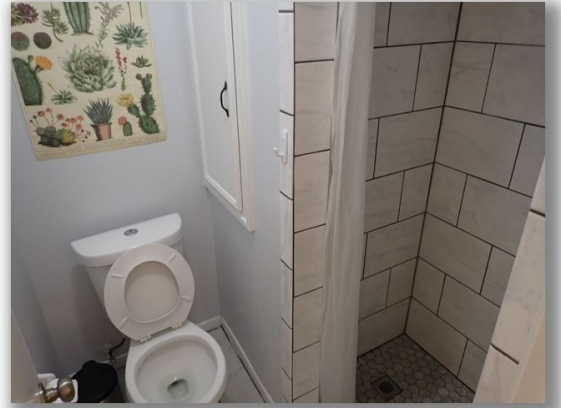
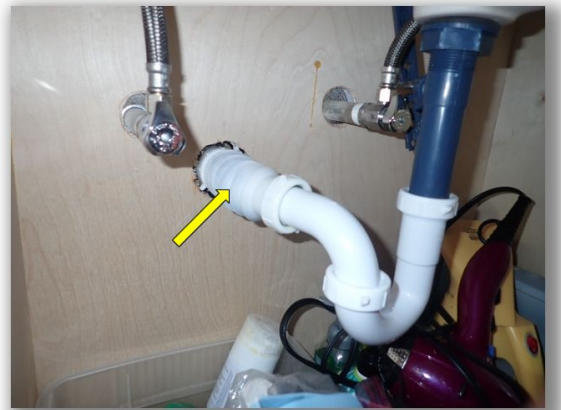
- The drain line is made of corrugated material. It is recommended to use smooth wall/PVC type material to prevent blockage.

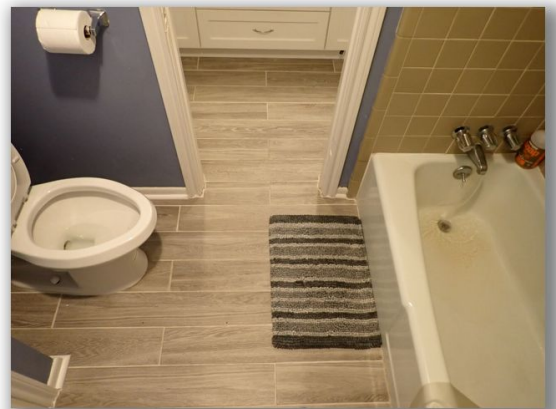
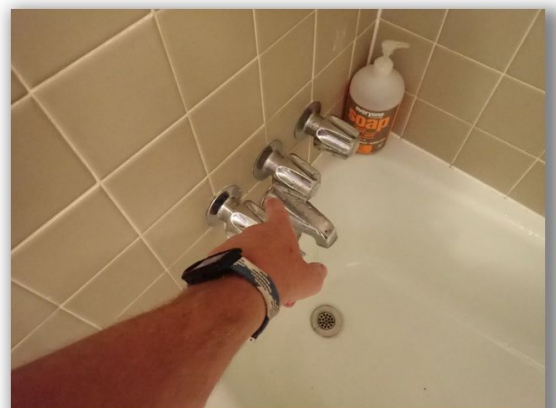
- Cracked, deteriorated and/or missing bathtub enclosure grout and/or caulking should be repaired or replaced as necessary.
- The tub spout is not sealed at the wall. This condition has the potential to allow water to leak back into the wall cavity.
- The faucet assembly is not sealed at the wall. This condition has the potential to allow water to leak back into the wall cavity.

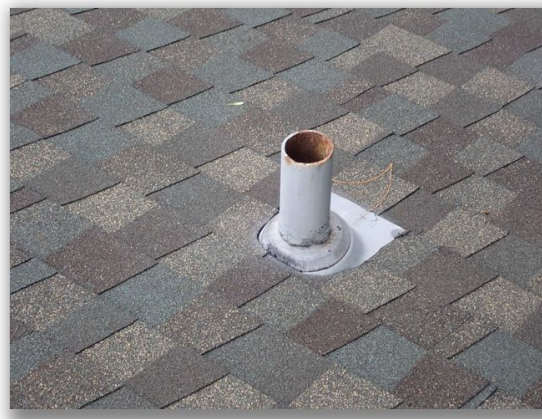
- Cast iron material was observed to be present in the drains, wastes and vents system. Full evaluation of the integrity of this type of material is beyond the scope of this inspection. Due to the known latent defects that are associated with this type of older material, it is recommended to have the integrity of the drain system further evaluated by a qualified plumber. It is recommended to have a hydrostatic test and to have the inaccessible and buried pipes scoped with a camera as part of this evaluation. This evaluation should occur prior to the expiration of any time limitations such as option or warranty periods.

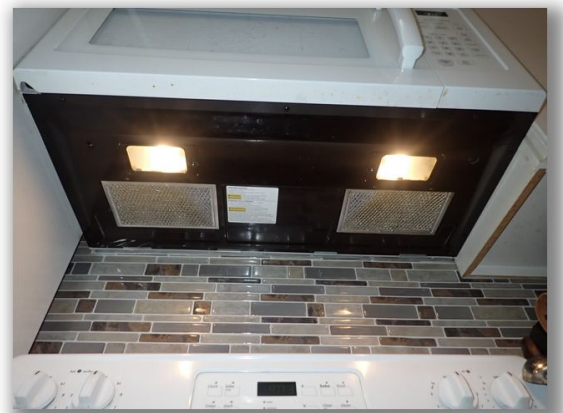
- The range hood in place is ductless. The range hood does not terminate outside and is dependent on the charcoal filter installed. It is recommended to regularly clean your filter system to prevent damage to the structure.

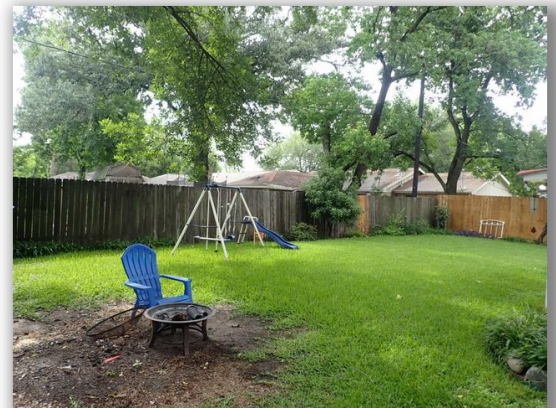
- The overall condition of the fence material, railing and posts are in poor condition and repair or replacement is necessary.
- One or more of the posts are damaged and the fence panels are leaning.
