Re: 12911 Cricket Hollow, Cypress, Texas

FOUNDATION INSPECTION REPORT

Ms. Victoria Kelley & Mr. Quinten Vardman
12911 Cricket Hollow
Cypress, Texas
March 16, 2023

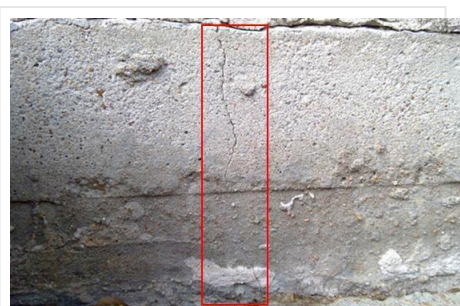
A. Item 1 (Picture)
Right (front facing) side of home

Recommend having these issues looked at further by a licensed foundation company and all required repairs be made.

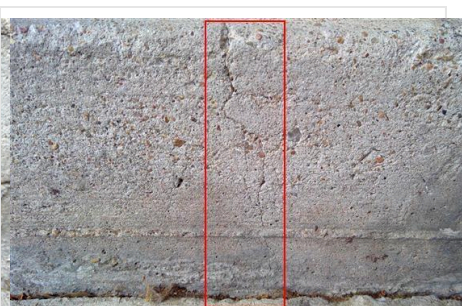
A. Item 2 (Picture)
Right (front facing) side of home

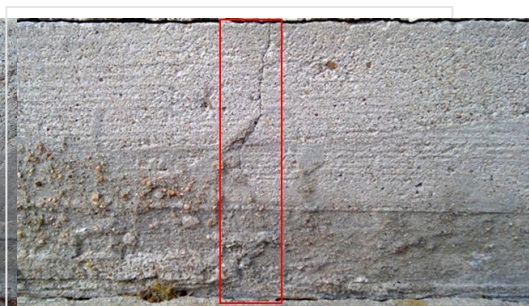
A. Item 3 (Picture)
Right (front facing) side of home

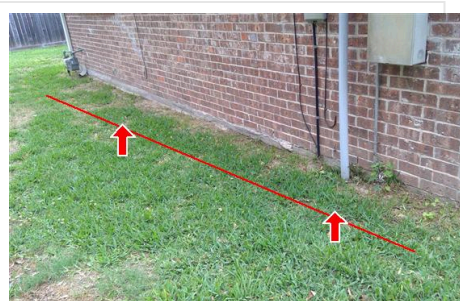
B. Item 1 (Picture)
Back of home

Recommend having these issues looked at further by a licensed grading and drainage/landscaping company and all required repairs be made.

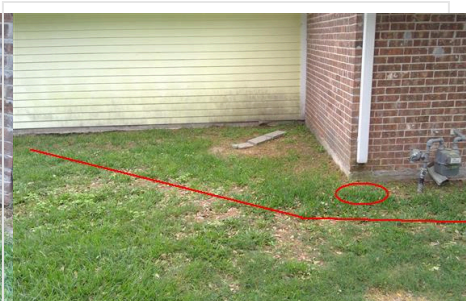
B. Item 2 (Picture)
Back of home/missing splash block

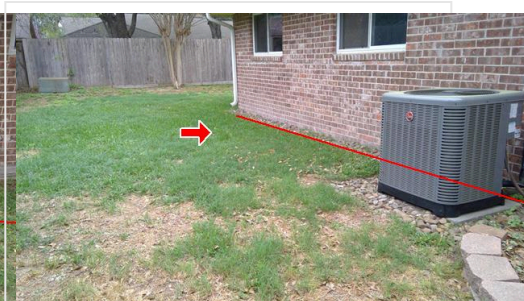
B. Item 3 (Picture)
Left (front facing) side of home

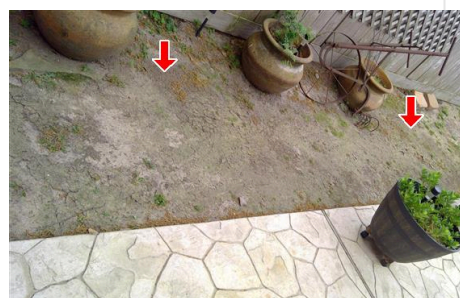
B. Item 4 (Picture)
Left (front facing) side of home

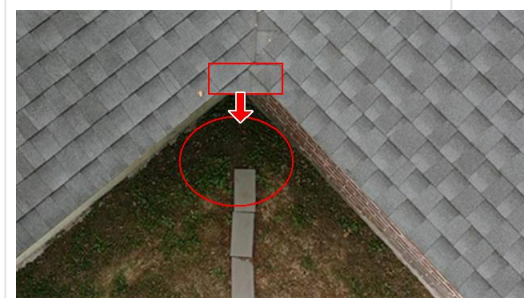
3) A missing kick-out flashing was noted at the bottom of the roof valley at the back of the home at the time of inspection. This is considered deficient since this missing kick-out flashing allows water to wash away the grade (dirt) below this area, creating a low point for water to collect near the foundation of the home.

B. Item 6 (Picture)
Missing kick out flashing: Back of the home

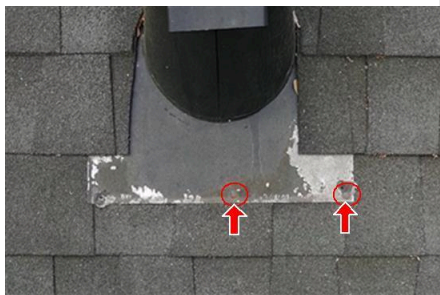
C. Item 1 (Picture)
Exposed/degraded fastener (nail) heads

Recommend having these issues looked at further by a licensed roofing company and all required repairs be made.

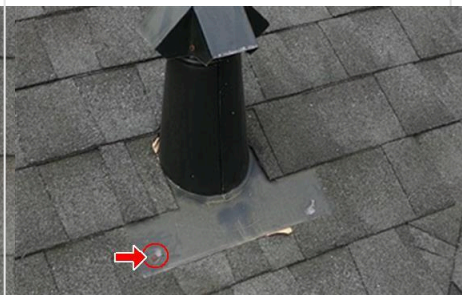
C. Item 2 (Picture)
Exposed/degraded fastener (nail) head

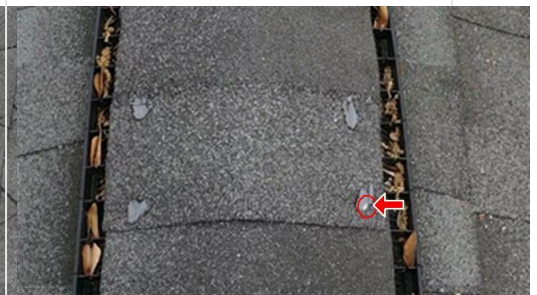
C. Item 3 (Picture)
Exposed fastener (nail) head

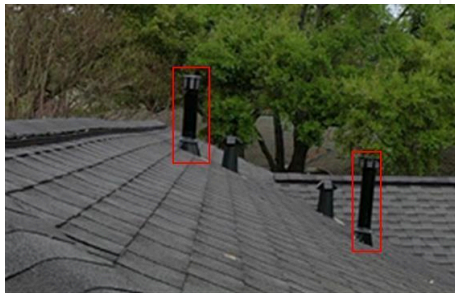
C. Item 4 (Picture)
Combustion air vents for water heater and furnace

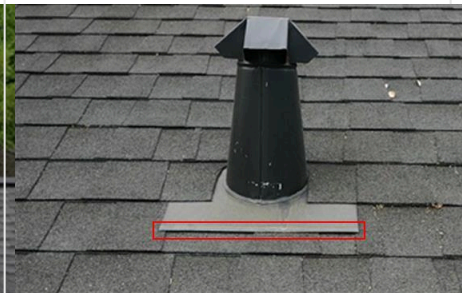
C. Item 5 (Picture)
Raised flashing for roof vent

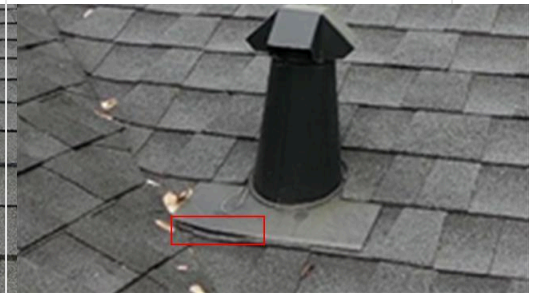
C. Item 6 (Picture)
Raised flashing for roof vent

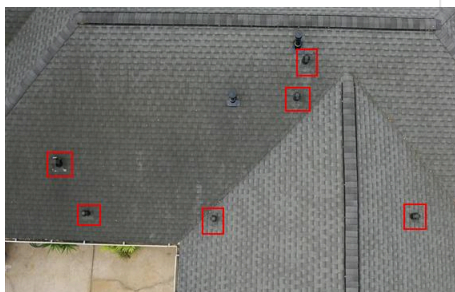
C. Item 7 (Picture)
No plumbing vents on roof

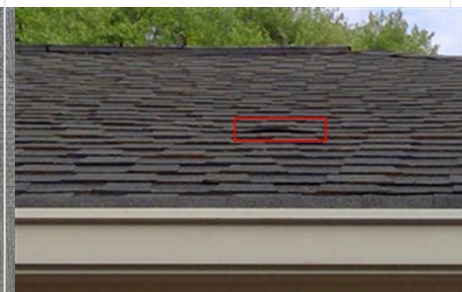
C. Item 8 (Picture)
Raised shingle

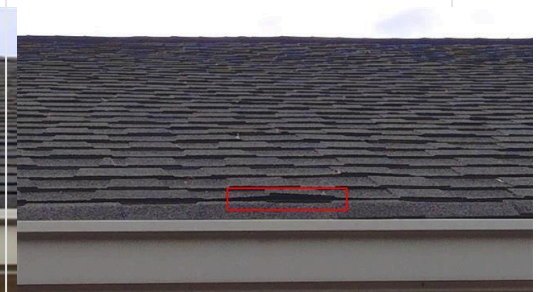
C. Item 9 (Picture)
Raised shingle

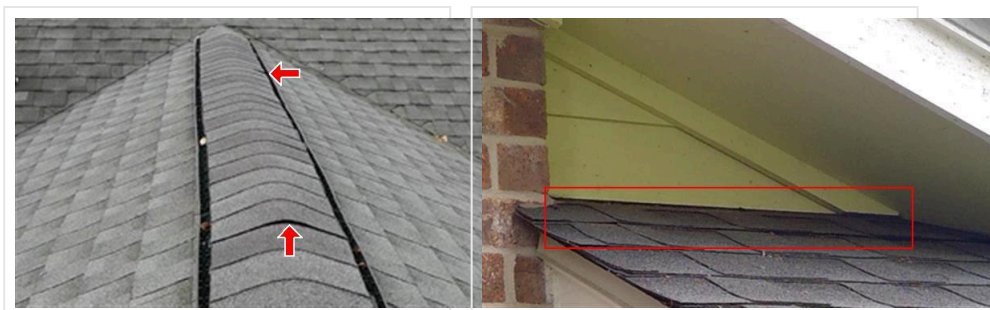
C. Item 10 (Picture)
Raised shingles

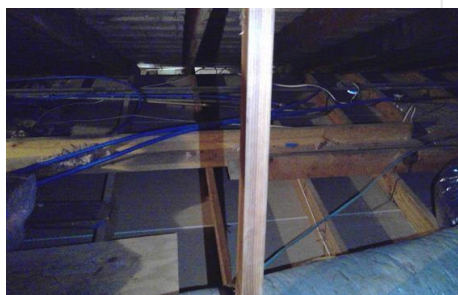
D. Item 1 (Picture)
Insufficient insulation

Recommend having these issues looked at further by a licensed roofing company and all required repairs be made.

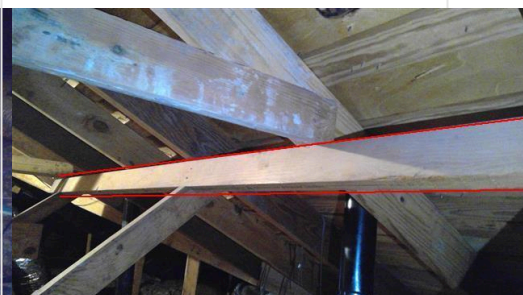
D. Item 3 (Picture)
Undersized purlin bracing members

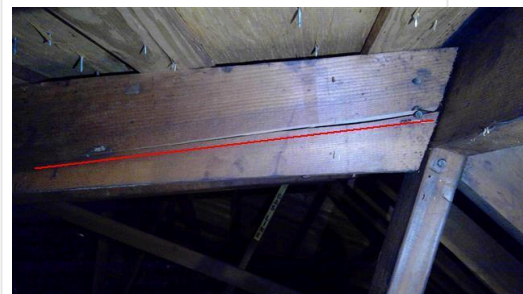
D. Item 6 (Picture)
Cracked rafter

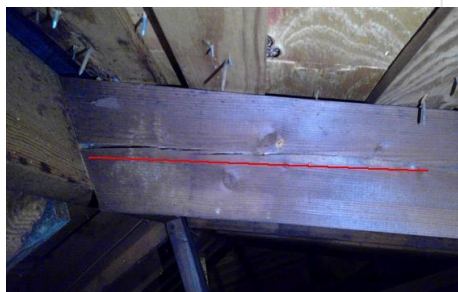
D. Item 7 (Picture)
Cracked rafter

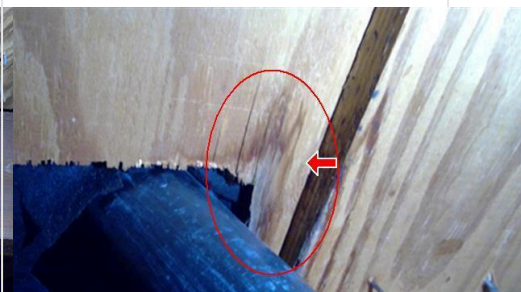
4) A moisture damaged area of roof decking material was observed in the attic space above the garage. This is considered deficient and can lead to the roof decking not performing as intended over time, while resulting in other roof supporting members being damaged by moisture.

D. Item 8 (Picture)
Moisture damaged roof decking

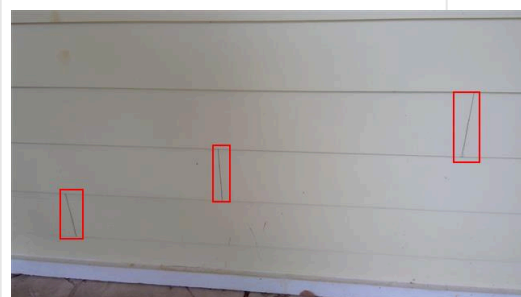
E. Item 6 (Picture)
Exterior siding board material

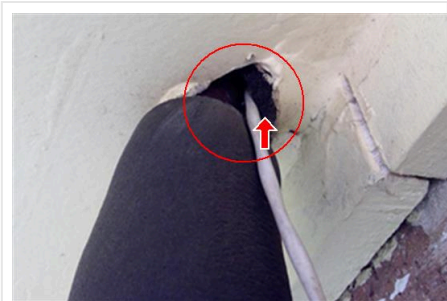
E. Item 7 (Picture)
AC lines passing into home

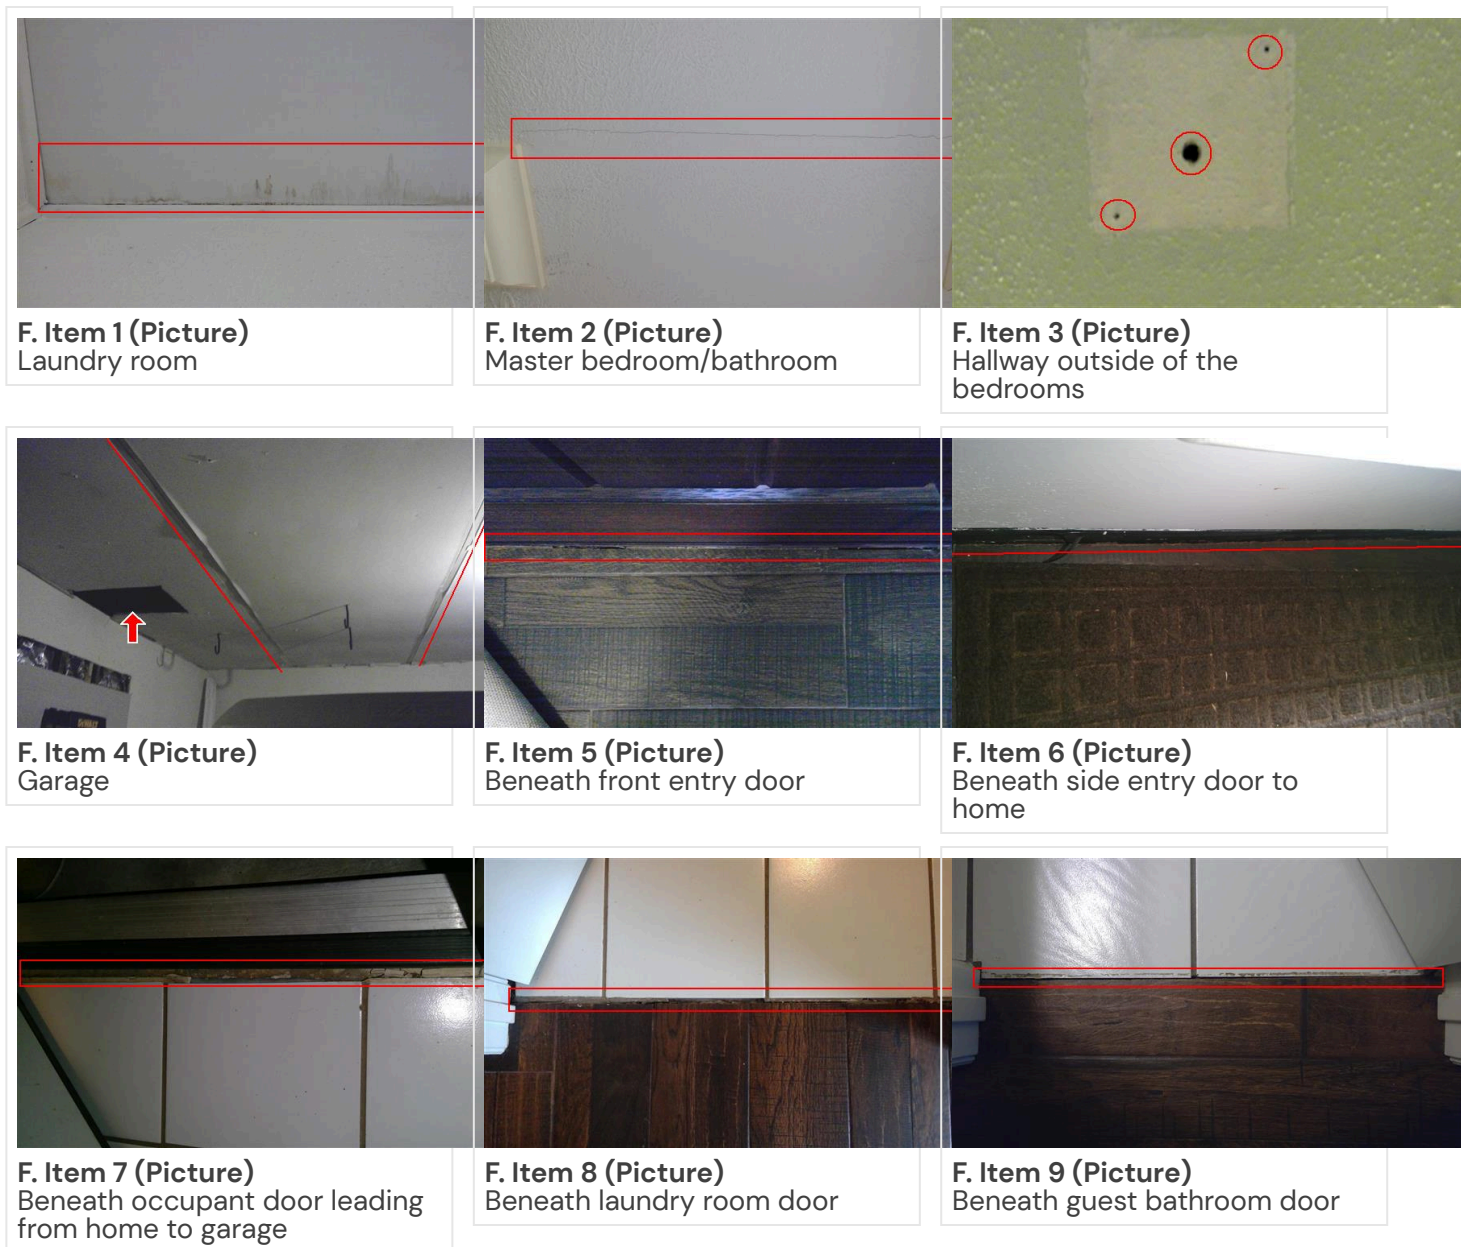
4) Openings in the interior flooring/insufficient grout was observed beneath front entry door, side entry door, occupant door leading from the home to the garage, laundry room door, and guest bathroom door. This is considered deficient as these are openings for moisture intrusion which will degrade the interior flooring material in these areas.

Recommend having these issues looked at further by a licensed general contractor and all required repairs be made.

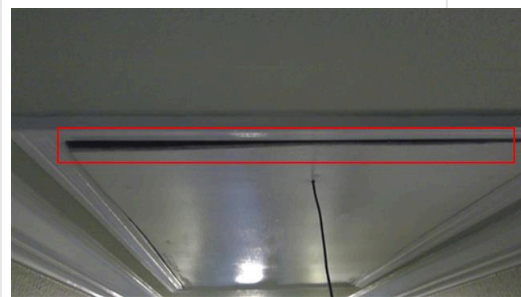
G. Item 3 (Picture)
Attic access door

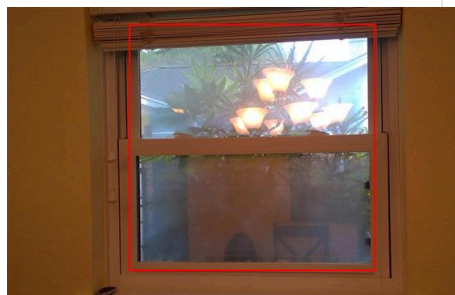
H. Item 1 (Picture)
Dining area

The seal on the window in the dining area, middle guest bedroom, and the window in the main living area to the left of the front entry door appear to be damaged. This diminishes the energy efficiency of these windows, and prevents the windows from performing as intended. This is considered deficient and does not meet the minimum standard of practice.

Recommend having these issues looked at further by a licensed general contractor and all required repairs be made.

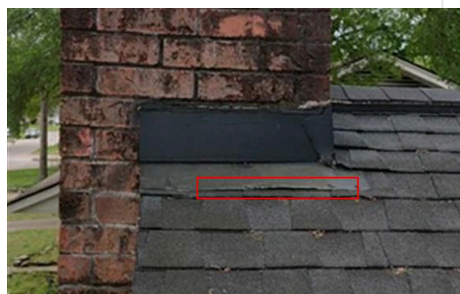
J. Item 1 (Picture)
Raised chimney flashing

Recommend having these issues looked at further by a licensed roofing company/general contractor and all required repairs be made.

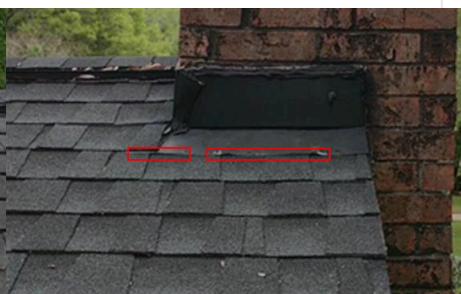
J. Item 2 (Picture)
Raised chimney flashing

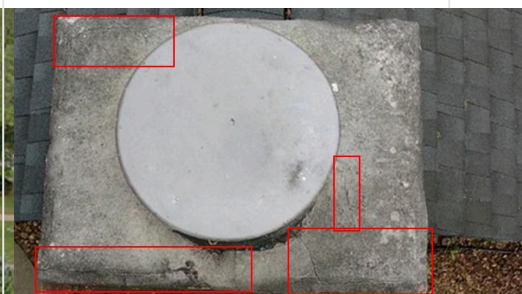
J. Item 3 (Picture)
Cracks on chimney mortar cap

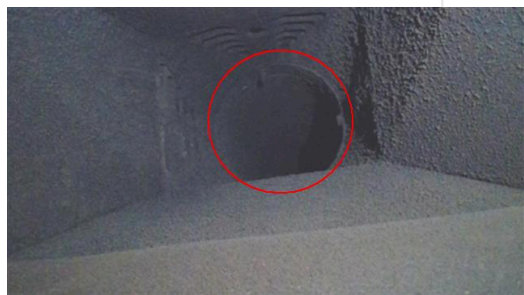
3) A damper was not visible and did not appear to be present for the fireplace at the time of inspection. This is considered deficient and does not meet the minimum standard of practice, since this missing damper prevents the chimney flue from being closed.

J. Item 4 (Picture)
Missing fireplace damper

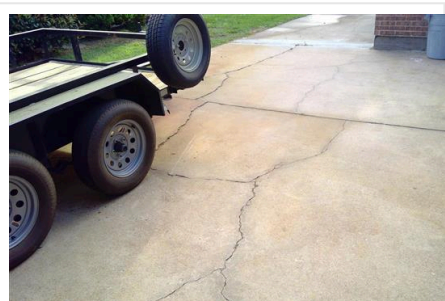
K. Item 1 (Picture)
Driveway

Multiple cracks were noted in the driveway and walkway at the front of the home. This can lead to water getting under the damaged areas, resulting in the slabs not being even, and becoming a trip and fall hazard. This is considered deficient and does not meet the minimum standard of practice.

Recommend having this looked at further by a licensed general contractor and all required repairs be made.

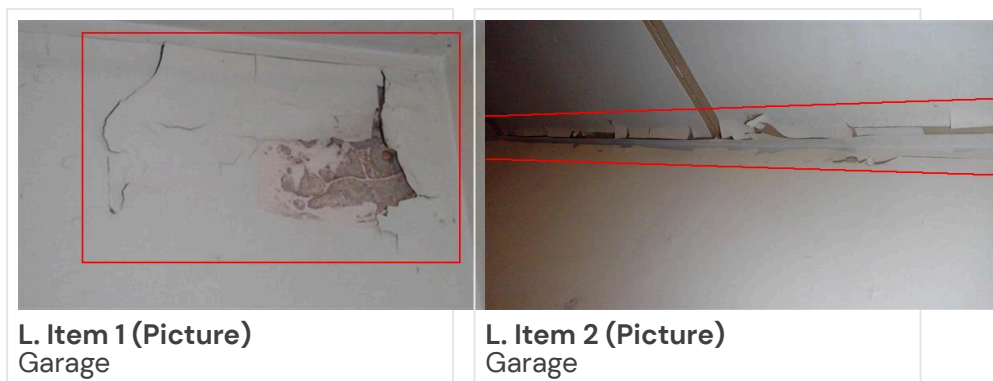
Discolored areas of wall material were noted at the back wall in the garage, and cracked/peeling areas of wall and ceiling material were also observed in the garage at the time of inspection. This is considered deficient as these can be indications of moisture damage to the wall and ceiling material in this area.

Recommend having this looked at further by a licensed general contractor and all required repairs be made.

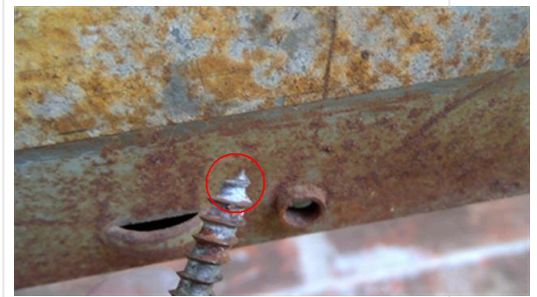
A. Item 3 (Picture)
Sharp piercing screw

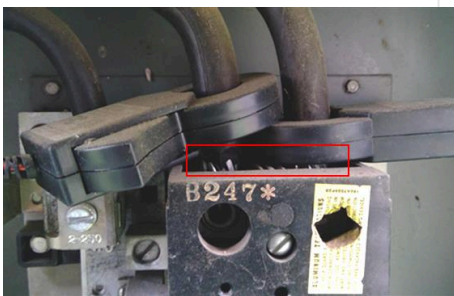
A. Item 4 (Picture)
Aluminum main service entrance conductors

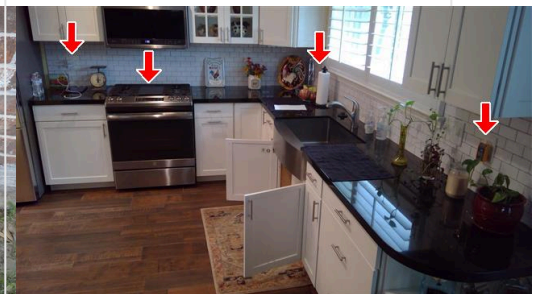
B. Item 3 (Picture)
Kitchen GFCI/Oven

Recommend having these issues looked at further by a licensed electrician and all required repairs be made.

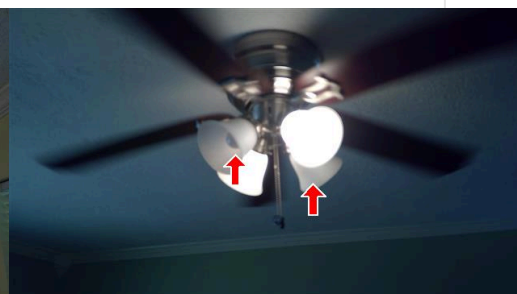
B. Item 5 (Picture)
Master bedroom

6) Multiple light fixtures in the master bedroom did not work at the time of inspection. This is considered deficient since these light fixtures did not perform their intended function, diminishing the lighting in this area.

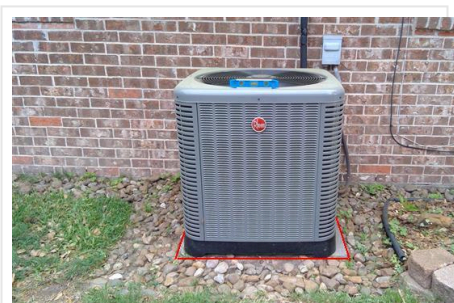
B. Item 1 (Picture)
Tilted exterior air handler unit

Recommend having these issues looked at further by a licensed HVAC tech and all required repairs be made.

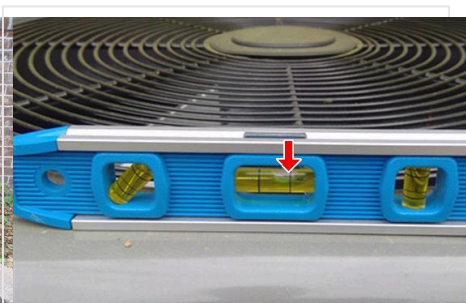
B. Item 2 (Picture)
Tilted exterior air handler unit

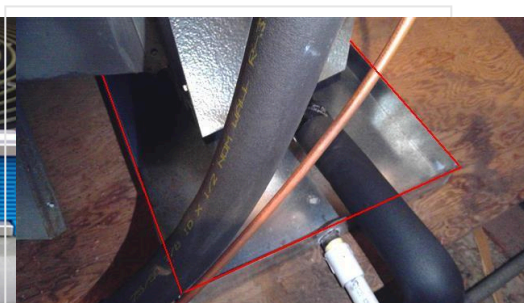
2) The drain pan beneath the coil for the interior air handler unit is missing a float switch. This is considered deficient since a float switch is required to shut down the AC system in a home if this drain pan were to clog and be filled with water. This is to prevent moisture damage to the wood structural members in the attic in this area.

B. Item 3 (Picture)
Missing float switch in drain pan

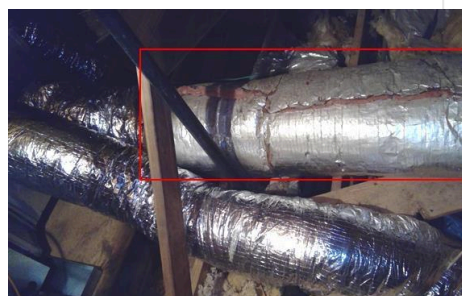
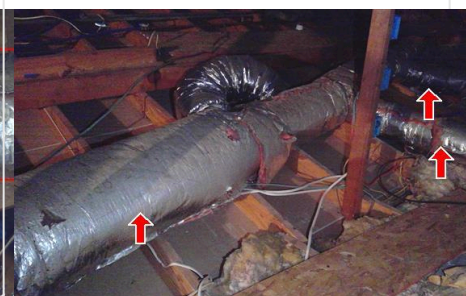
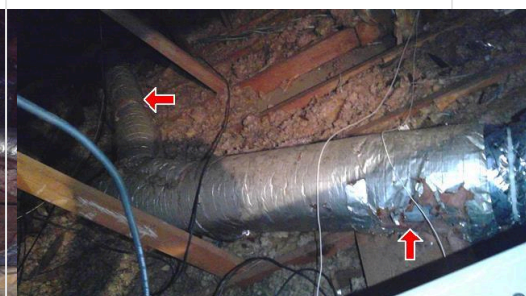
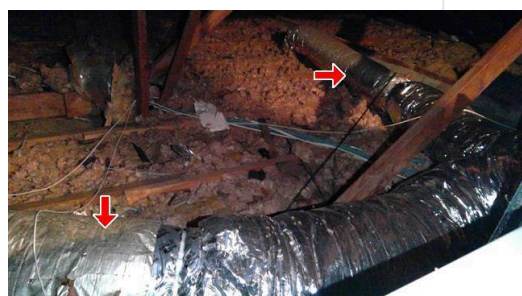
2) AC ducts in the attic space of the home are sitting on insulation and ceiling joists. This is considered deficient since this is an incorrect installation. These ducts should be hung from rafters/attic framing members in order to prevent them from prematurely deteriorating.

Recommend having these issues looked at further by a licensed HVAC tech and all required repairs be made.

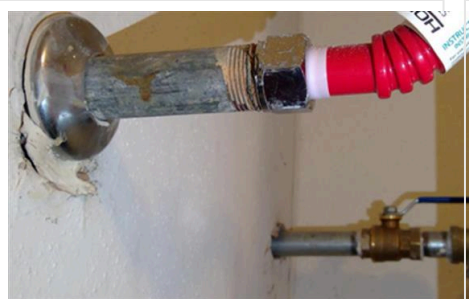
A. Item 1 (Picture)
Galvanized plumbing

Recommend having these issues looked at further by a licensed plumber and all required repairs be made.

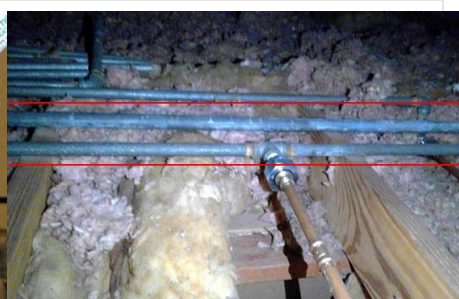
A. Item 2 (Picture)
Galvanized plumbing

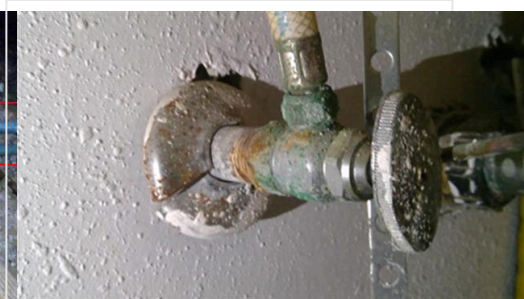
A. Item 3 (Picture)
Galvanized plumbing

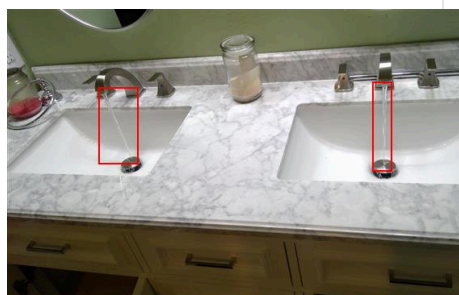
A. Item 5 (Picture)
Master bathroom

3) A drop in water pressure was noted for the sink/vanity fixtures in the bathrooms when the bathtub fixtures were being tested simultaneously. This is considered deficient as this can be an indication of an issue with these fixtures and/or the plumbing lines for these fixtures.

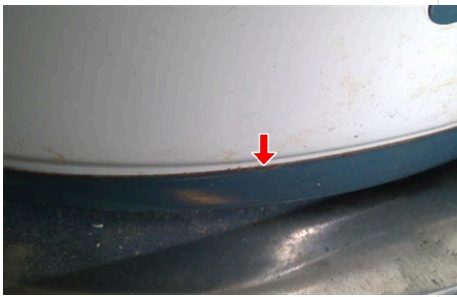
C. Item 1 (Picture)
Rust at the bottom of water heater

Recommend having these issues looked at further by a licensed plumber and all required repairs be made.

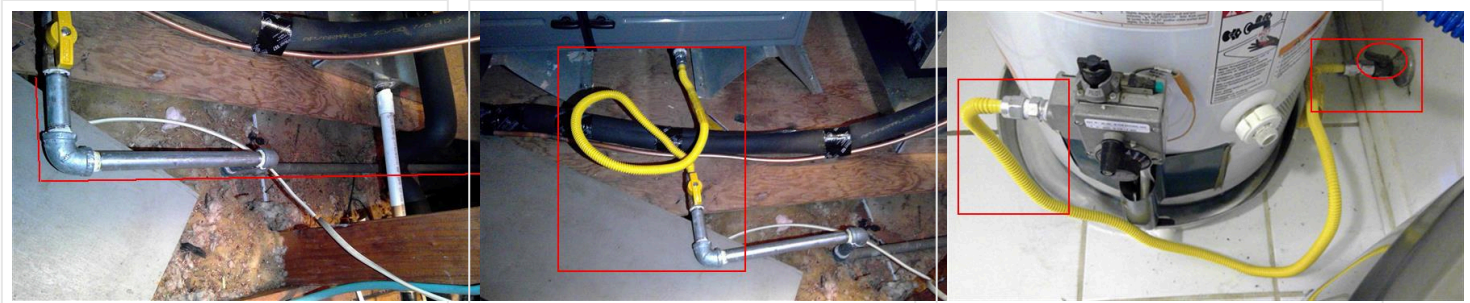
2) A sediment trap/drip leg was not present and/or visible near the gas valves for the furnace or water heater at the time of inspection. This is considered deficient and does not meet the minimum standard of practice since sediment trap/drip leg is required for the gas line.

E. Item 1 (Picture)
Improperly supported/secured gas line

Recommend having these issues looked at further by a licensed plumber and all required repairs be made.

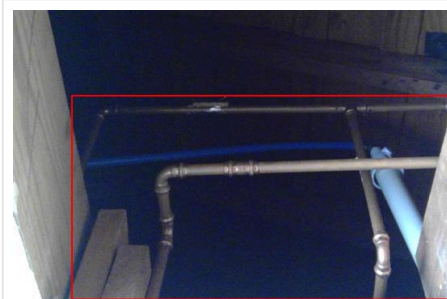
F. Item 2 (Picture)
Exposed plumbing lines in attic space above garage
